Re: WBI Energy Transmission, Inc. Docket Nos. CP20-52-000 and CP20-52-001 North Bakken Expansion Project Weekly Status Report No. 23

WBI Energy Transmission, Inc. North Bakken Expansion Project Status Report No. 23 FERC Docket Nos. CP20-52-000 CP20-52-001

Reporting Period: November 1, 2021 through November 7, 2021

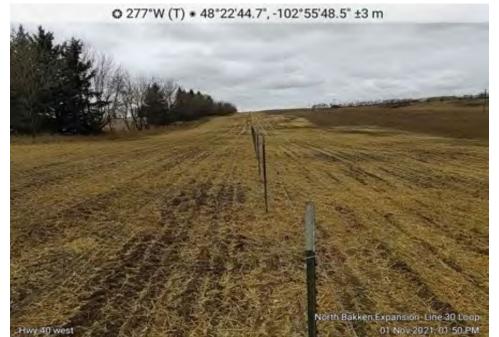
Date	Name	Milepost / Alignment Sheet #	Problem/Concern	Corrective Action
11/5/2021	Mark Schmidt	3.5/ 2	A natural drainage swale had its outlet covered up during restoration.	The covered drainage area was uncovered and restored. The Environmental Inspector found the restoration acceptable.
	© 23°N (T) + 4	8°21'48.9", -10	2°58'10.6" ±3 m	Date: 11/05/2021

Notes: Restored drainage path.

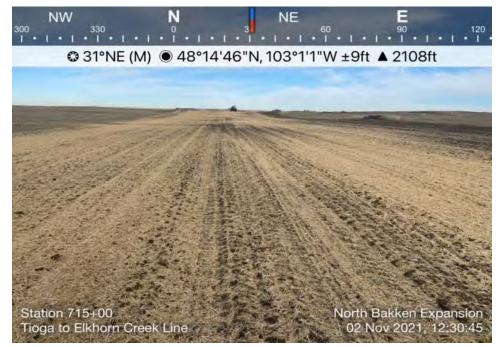
Location: Sta. No. 641+20

Notes: Erosion control blankets in place and properly functioning in bar ditch north of 60th Street NW on the Tioga-Elkhorn Creek Pipeline.

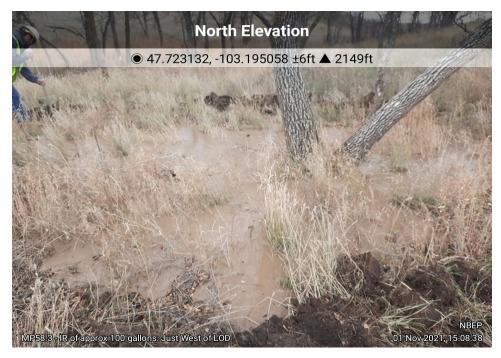
Location: Sta. No. 3046+36

On November 1, 2021, multiple small inadvertent releases (IRs) occurred in an upland area at milepost 58.3 during boring activities. WBI Energy quickly implemented measures identified in the Horizontal Directional Drill/Guided Bore Drilling Fluid Monitoring and Operations Plan (HDD Plan) for the containment and cleanup of drilling fluids. Hand tools, sediment control devices, and a vac-truck were utilized to contain and remove released fluids. The IRs originated within the Project right-of-way, though some drilling fluid migrated slightly west of the approved limits of disturbance. The FERC Compliance Monitor was informed of the IR location and response efforts. No further cleanup was required. No wetland or waterbody resources were impacted.

Notes: A discovered inadvertent release on the Tioga-Elkhorn Creek Pipeline before containment and removal.

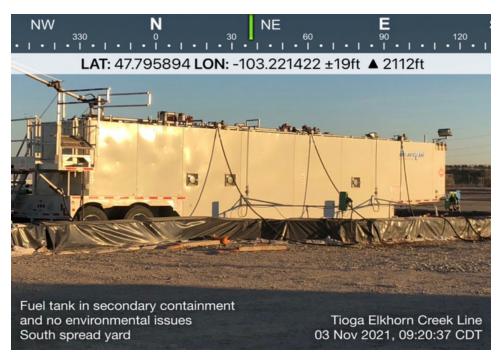
Location: South Spread HDD bore site.

Notes: Fuel tank within adequate secondary containment at the South Spread HDD bore site.

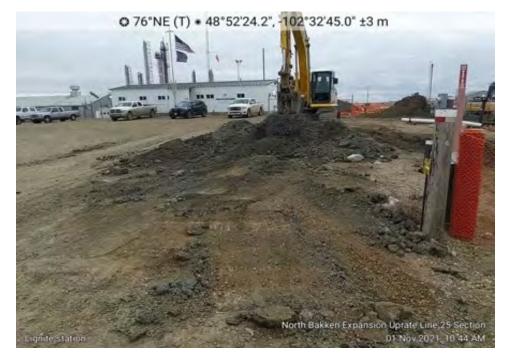
Location: Lignite Plant Receipt Station

Notes: Removal of contaminated soil discovered last week during excavation for tie-in activity.

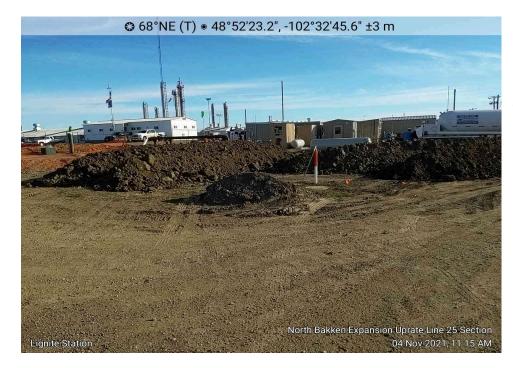
Location: Lignite Plant Receipt Station

Notes: Stockpile of fill dirt to replace removed contaminated soil.
