Re: WBI Energy Transmission, Inc.
Docket Nos. CP20-52-000 and CP20-52-001
North Bakken Expansion Project
Weekly Status Report No. 24

WBI Energy Transmission, Inc.
North Bakken Expansion Project Status Report No. 24
FERC Docket Nos. CP20-52-000
CP20-52-001

Reporting Period: November 8, 2021 through November 14, 2021

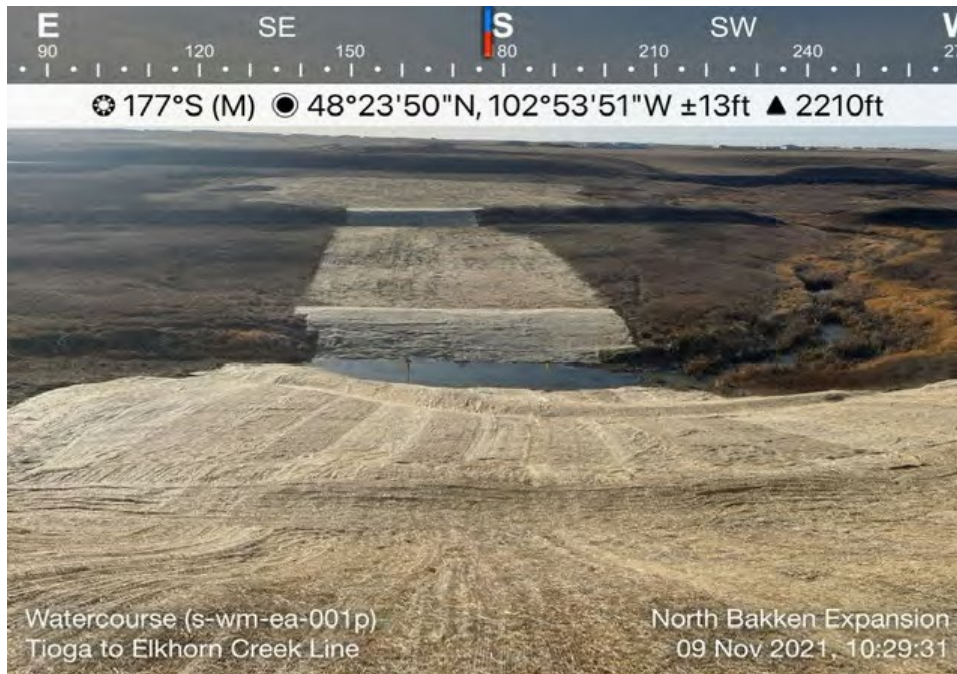
Location:
Sta. No. 42+26

Notes: Erosion control devices in place and properly functioning at watercourse s-wm-ea-001p on the Tioga-Elkhorn Creek Pipeline.

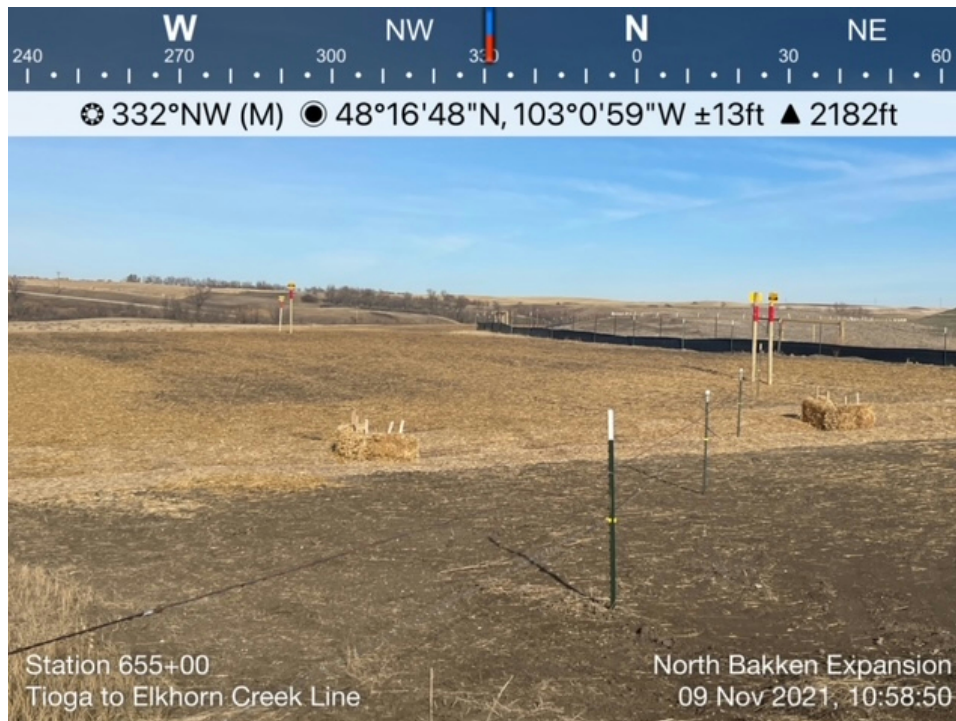
Location:
Sta. No. 655+00

Notes: Erosion control devices in place and properly functioning on the Tioga-Elkhorn Creek Pipeline.

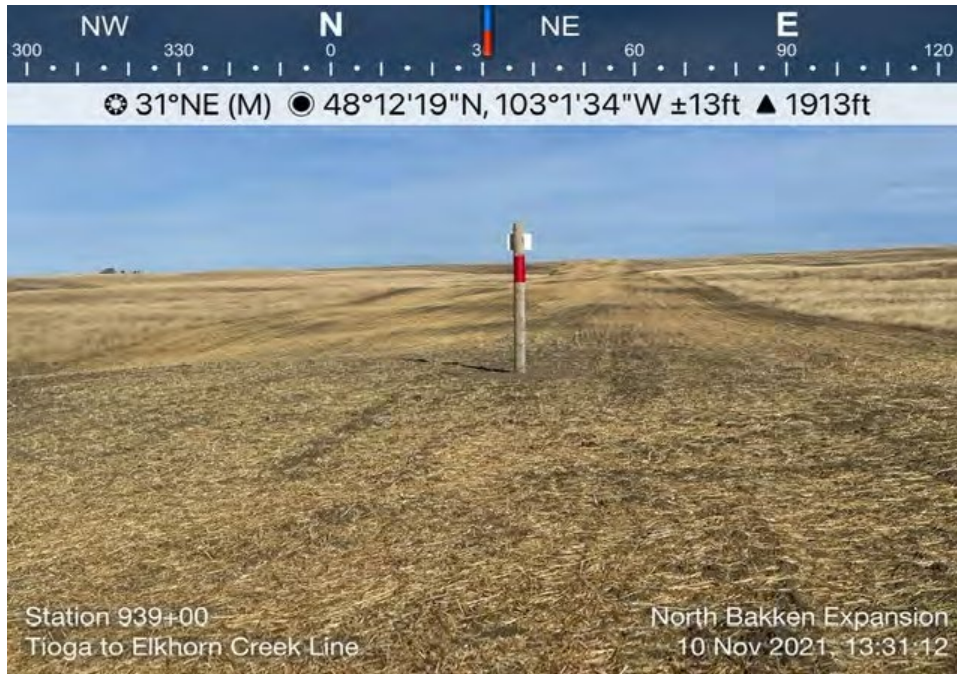
Location:
Sta. No. 939+00

Notes: Seeded,
mulched, and crimped
right-of-way on the
Tioga-Elkhorn Creek
Pipeline.

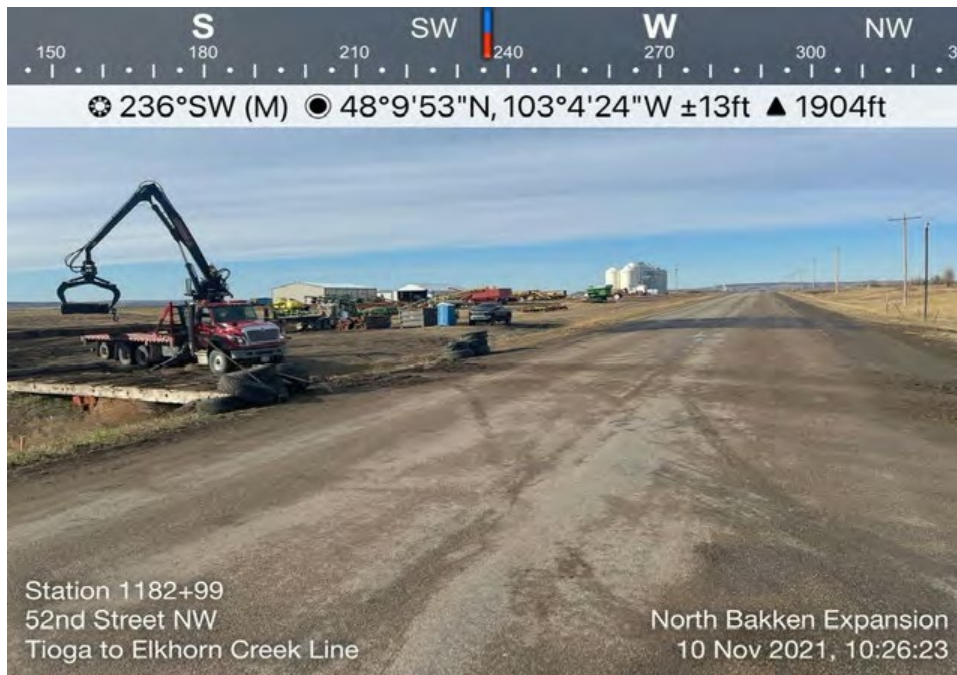
Location:
Sta. No. 1182+99

Notes: Removal of
timber mats from bar
ditch on the Tioga-
Elkhorn Creek
Pipeline.

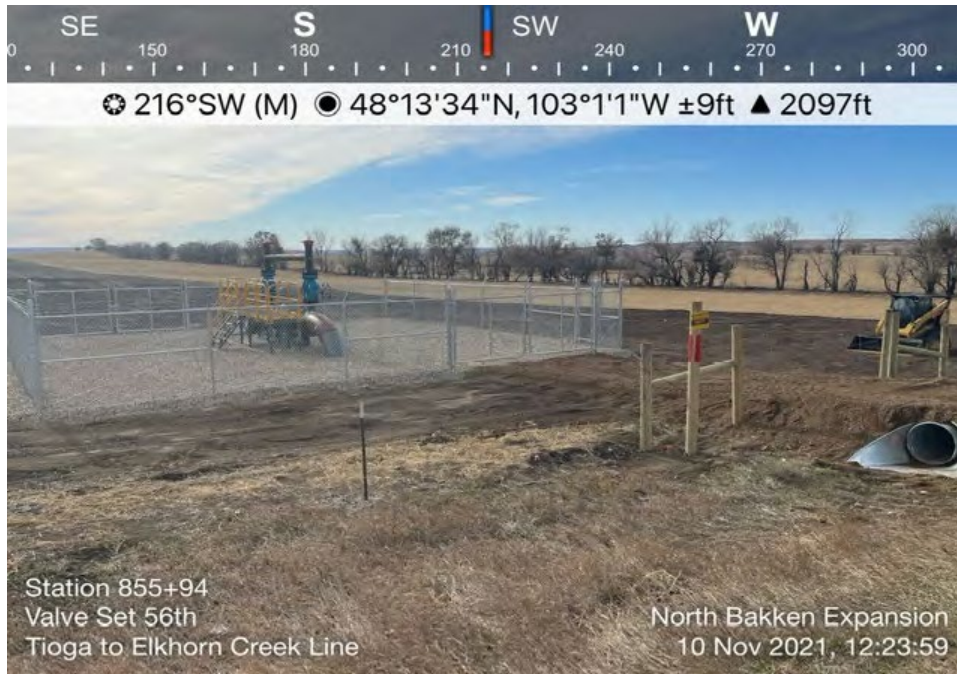
Location:
Sta. No. 855+94

Notes: Spread gravel
within the security
fence around a block
valve at 56th Avenue
NW on the Tioga-
Elkhorn Creek
Pipeline.

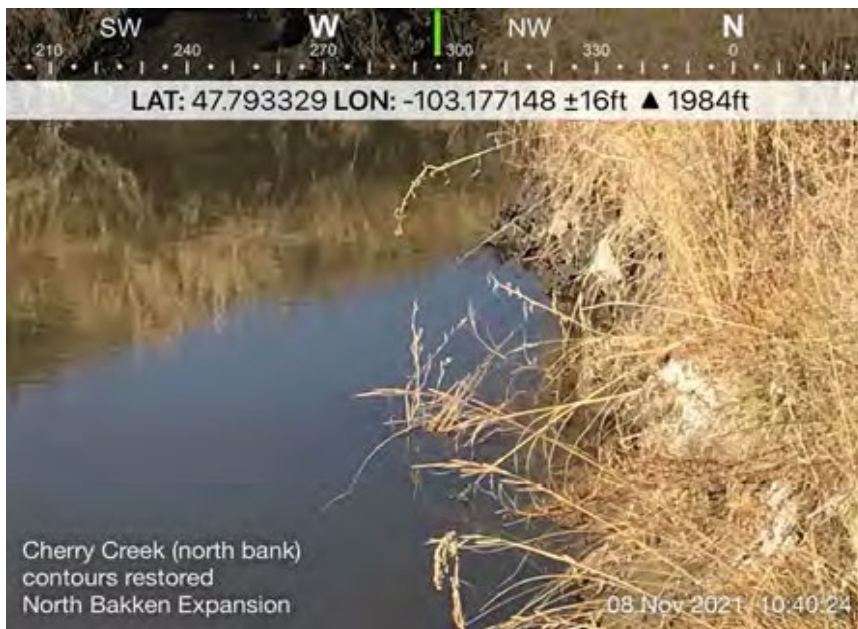
Location: Cherry Creek

Notes: Restored contour of the north bank.

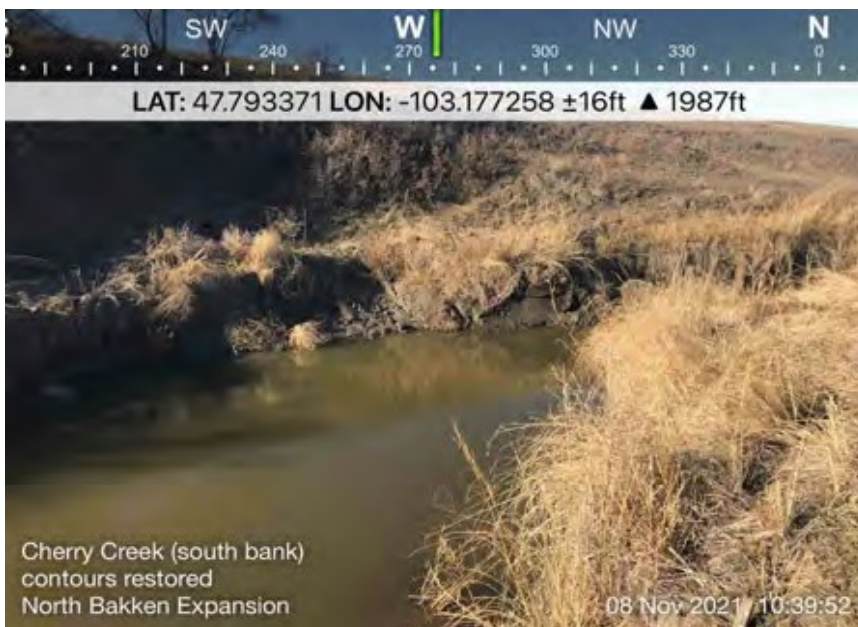
Location: Cherry Creek

Notes: Restored contour of the south bank.

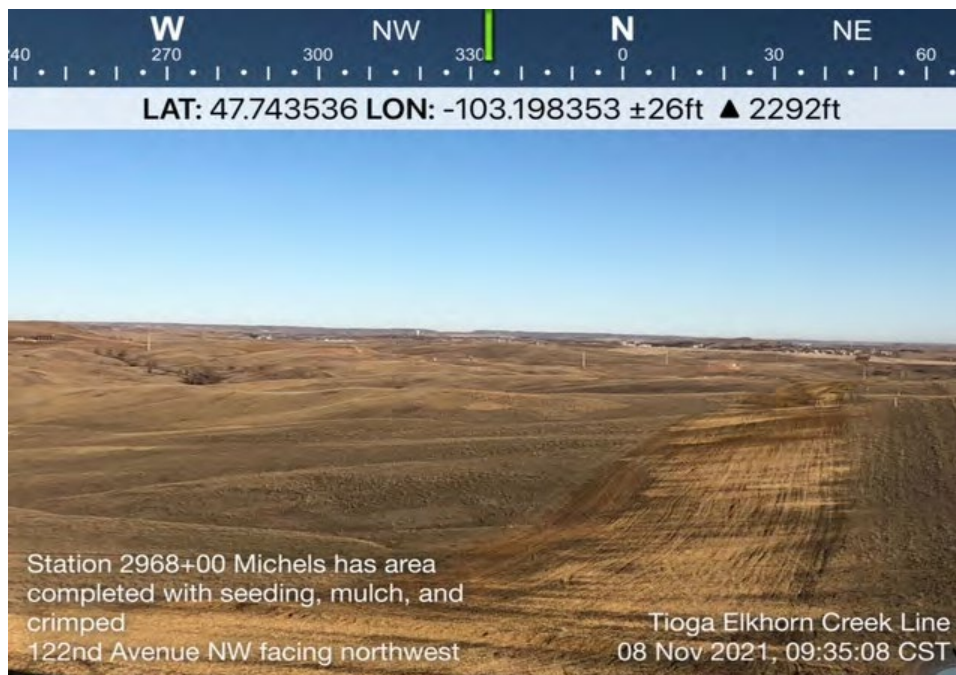
Location:
Sta. No. 2968+00

Notes: Seeded,
mulched, and
crimped right-of-way
on the Tioga-Elkhorn
Creek Pipeline.

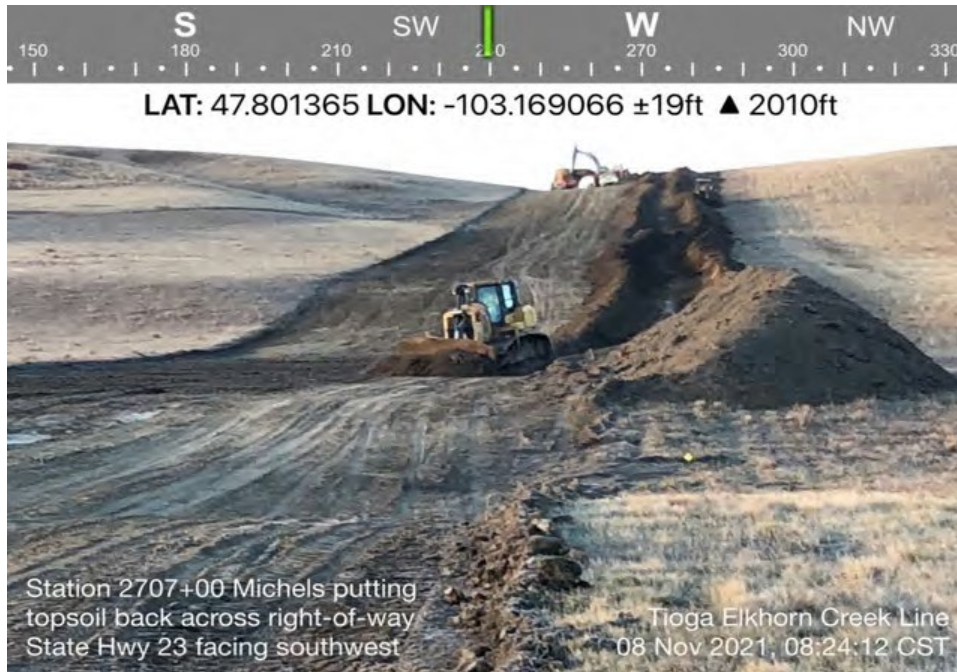
Location:
Sta. No. 2707+00

Notes: Spreading of topsoil across the right-of-way on the Tioga-Elkhorn Creek Pipeline

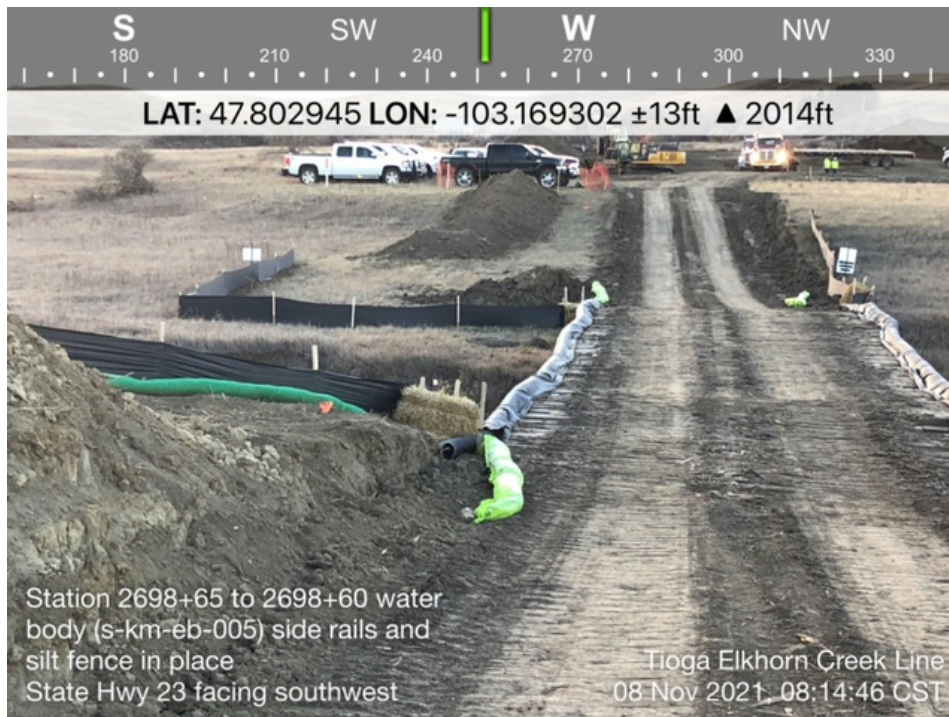
Location: Sta. Nos.
2698+65 to 2698+60

Notes: Erosion control devices in place and properly functioning at waterbody s-km-eb-005 on the Tioga-Elkhorn Creek Pipeline.

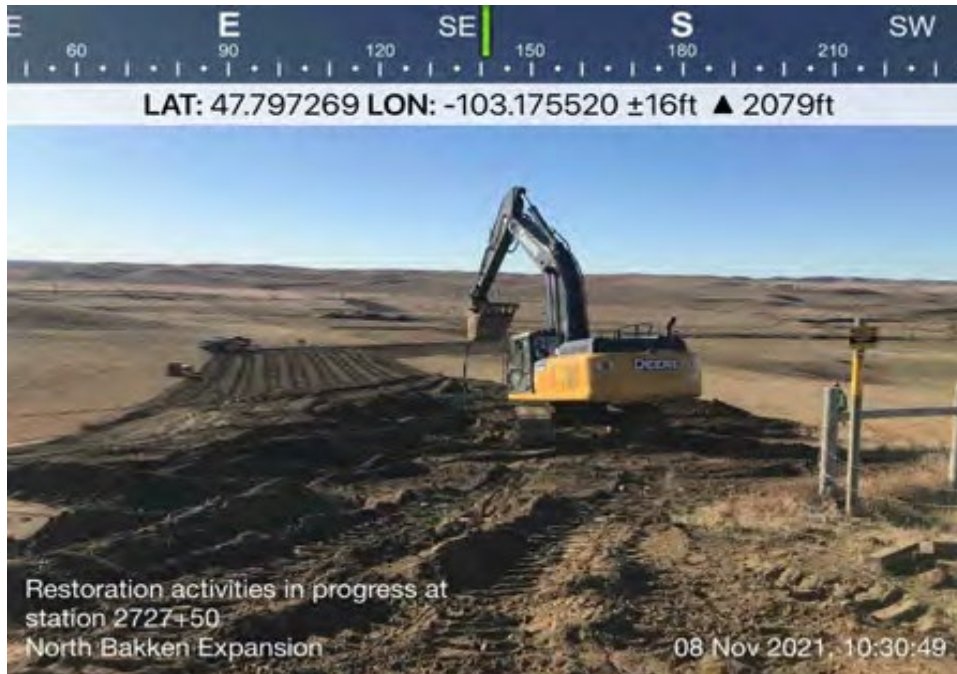
Location:
Sta. No. 2727+50

Notes: Restoration of right-of-way on the Tioga-Elkhorn Creek Pipeline.

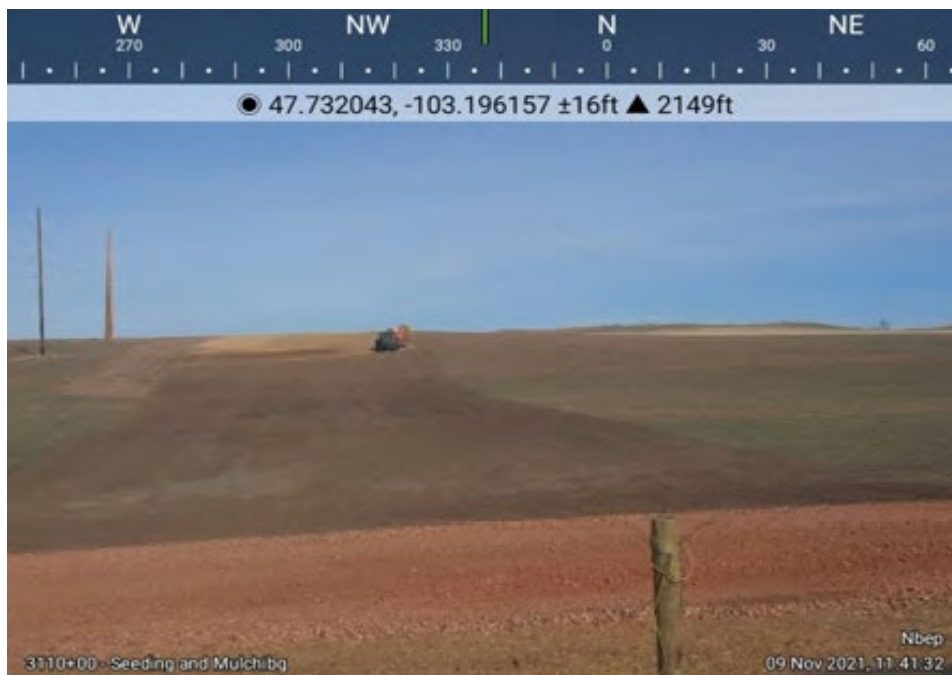
Location:
Sta. No. 3110+00

Notes: Seeded and mulched right-of-way on the Tioga-Elkhorn Creek Pipeline.

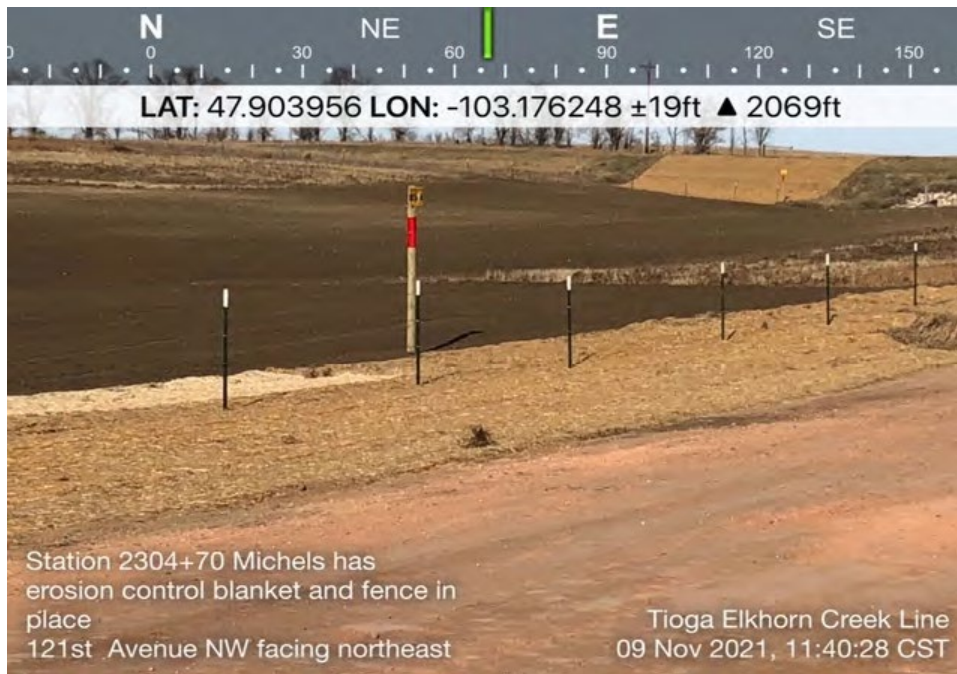
Location:
Sta. No. 2304+70

Notes: Installed permanent fencing and an erosion control blanket in the bar ditch on the Tioga-Elkhorn Creek Pipeline.

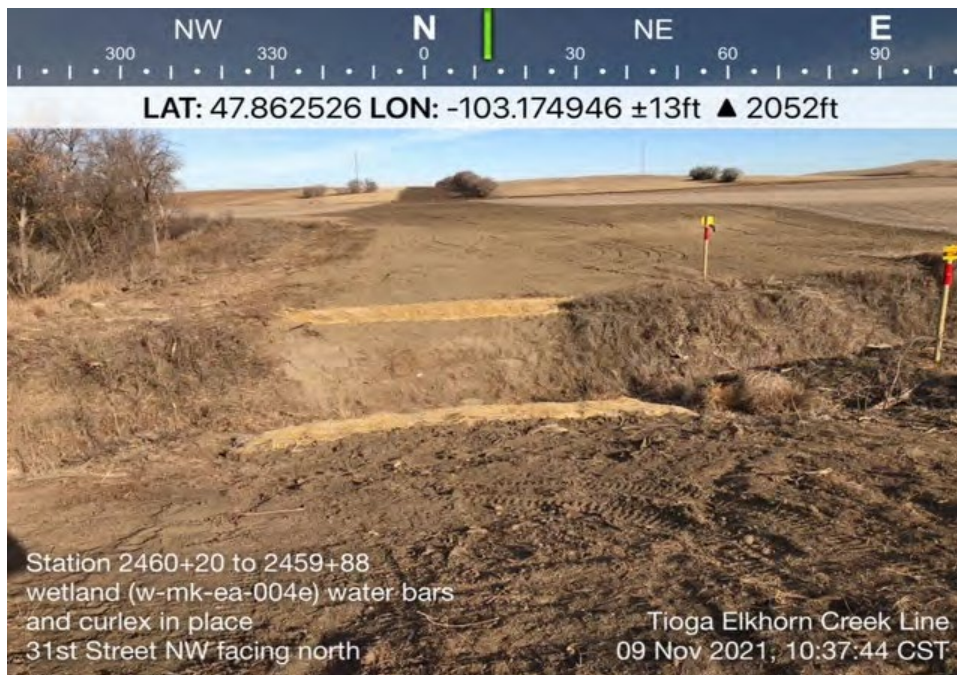
Location: Sta. Nos.
2460+20 to 2459+88

Notes: Installed erosion control blankets and water bars at wetland w-mk-ea-004e on the Tioga-Elkhorn Creek Pipeline.

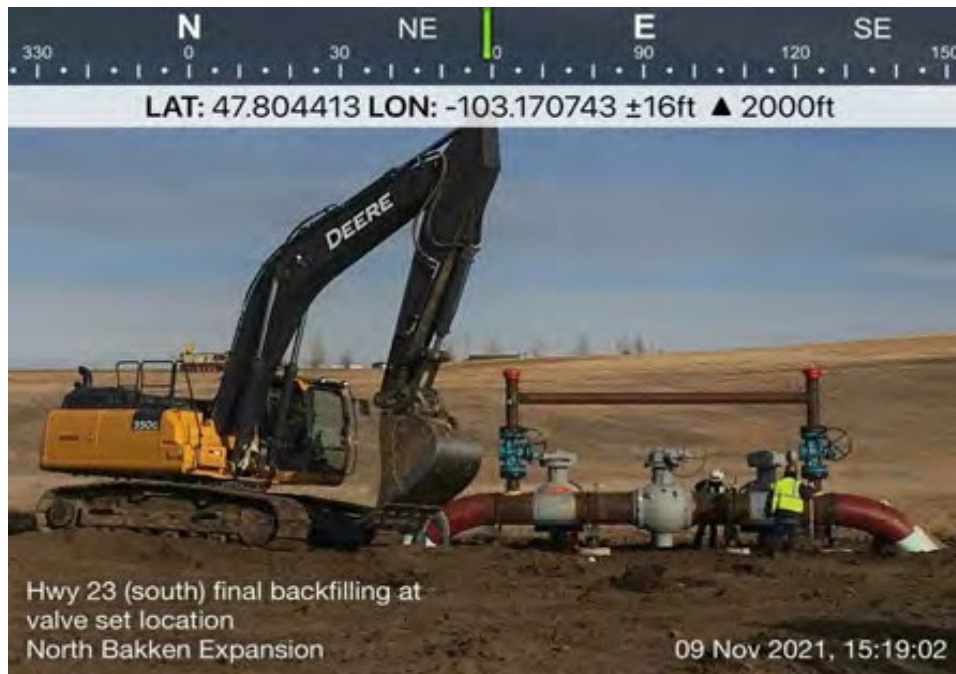
Location:
Sta. No. 2693+69

Notes: Backfilling activities around the Cherry Creek block valve on the Tioga-Elkhorn Creek Pipeline.

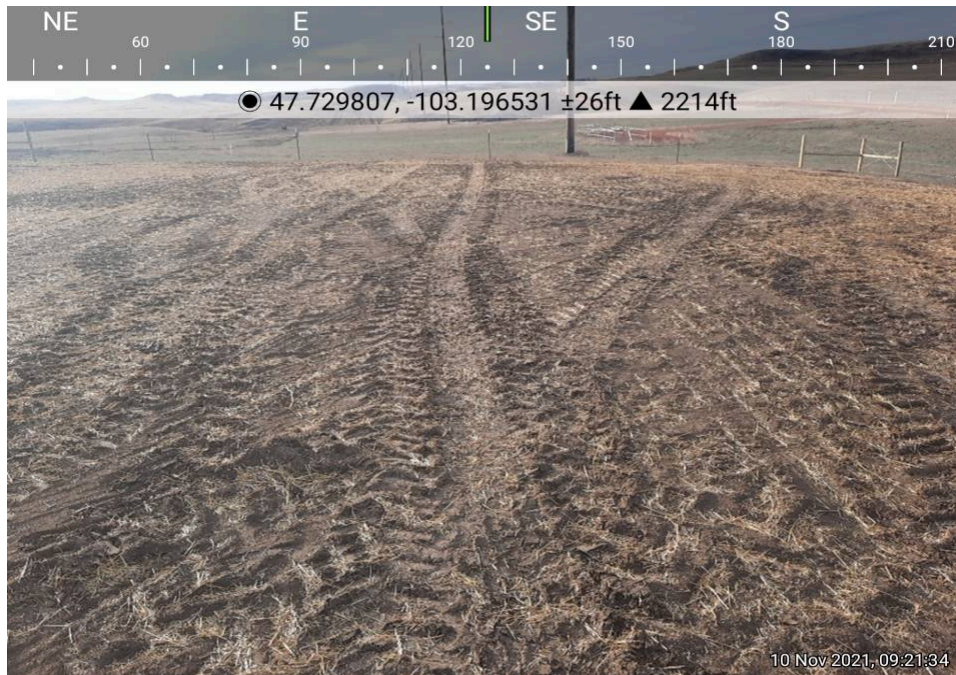
Location:
Sta. No. 3021+88

- Completed hydrostatic testing activities.
- On November 9, 2021, an approximate 20-gallon hydraulic fluid spill occurred from a ruptured hydraulic hose on a tractor used for mulching at Sta. No. 3021+88. WBI Energy quickly implemented measures identified in the Spill Prevention, Control and Countermeasure (SPCC) Plan to contain, clean up, and dispose of approximately 15 cubic feet of contaminated soil and cleanup materials. No cultural or sensitive resources were impacted. Requisite agency and internal spill reports were filed.

Notes: Clean-up of right-of-way after previous day's hydraulic fluid spill on the Elkhorn Creek Pipeline.

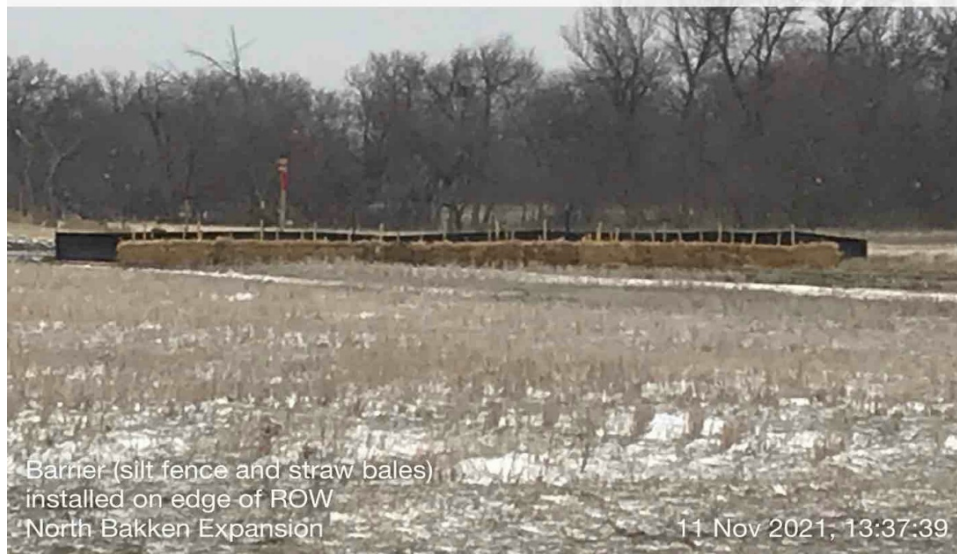
Location:
Sta. No. 2335+00

- On November 11, 2021, hydrostatic test water was seen flowing slowly across a road at approximately Sta. No. 2340+00. Hydrostatic test water had been discharged through an approved dewatering structure at Sta. No. 2335+00 into a well-vegetated field across from 121st Avenue NW. Upon the discovery, a large diversion structure was constructed along the edge of the right-of-way with a smaller diversion structure constructed along the edge of 121st Avenue NW to redirect the discharge water to a southeast direction through a field and away from the road. No rutting, riling, or undercutting of the gravel-packed road occurred. Minor riling occurred within the field and will be restored. Discharged water did not reach nearby wetlands s-lbt-003a, s-lbt-003b, and s-lbt-003c.

Barrier (silt fence and straw bales)
installed on edge of ROW
North Bakken Expansion

Notes: Dewatering
structure used for
discharging
hydrostatic test water
from the Tioga-
Elkhorn Creek
Pipeline.

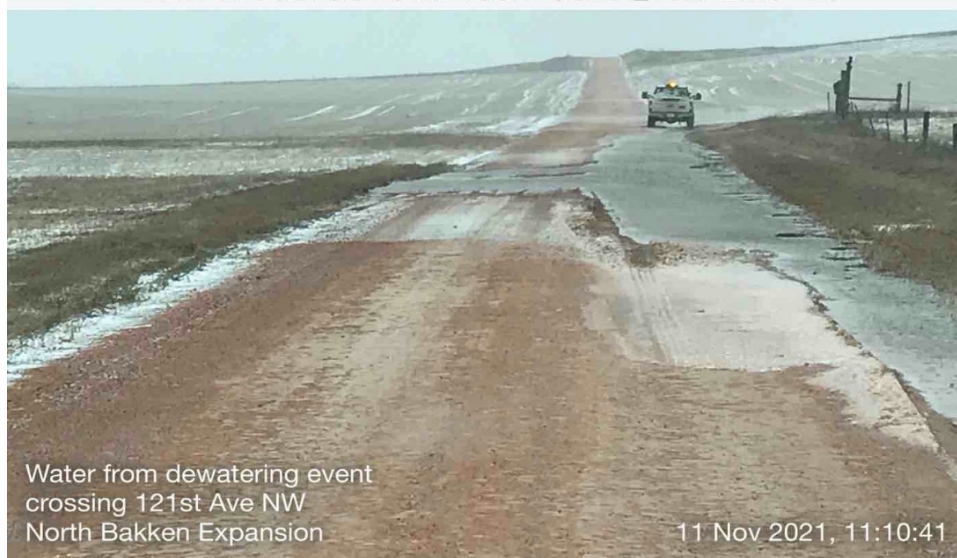
Location:
Sta. No. 2344+50

Water from dewatering event
crossing 121st Ave NW
North Bakken Expansion

Notes: Discharged
hydrostatic test water
flowing across 121st
Avenue NW and west
of the right-of-way on
the Tioga-Elkhorn
Creek Pipeline.

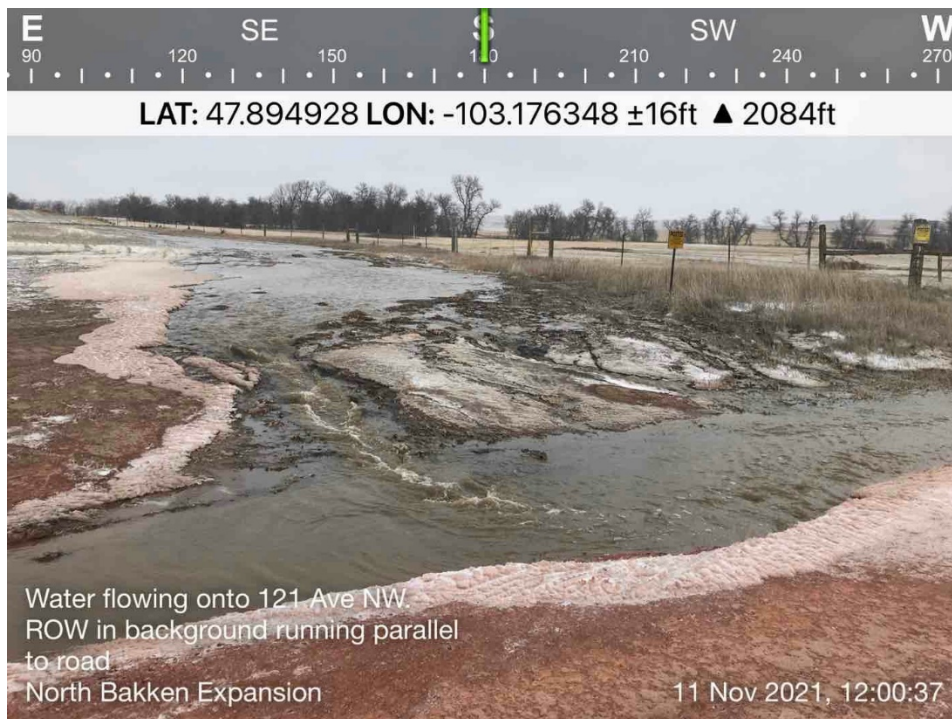
Location:
Sta. No. 2343+00

Notes: Flowing
discharged hydrostatic
test water onto 121st
Avenue NW.
Minimal rutting
occurred within the
field west of the right-
of-way on the Tioga-
Elkhorn Creek
Pipeline.

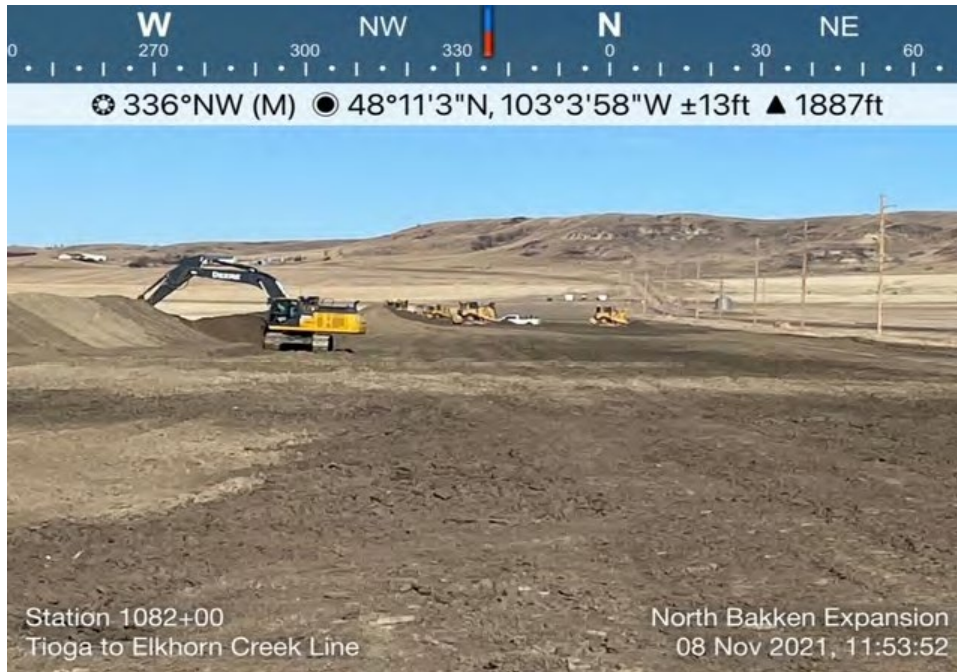
Location: Sta. Nos.
1045+39 to 1099+16

Notes: Spreading
topsoil along the
pullback string right-
of-way north of the
North Spread HDD
bore site.

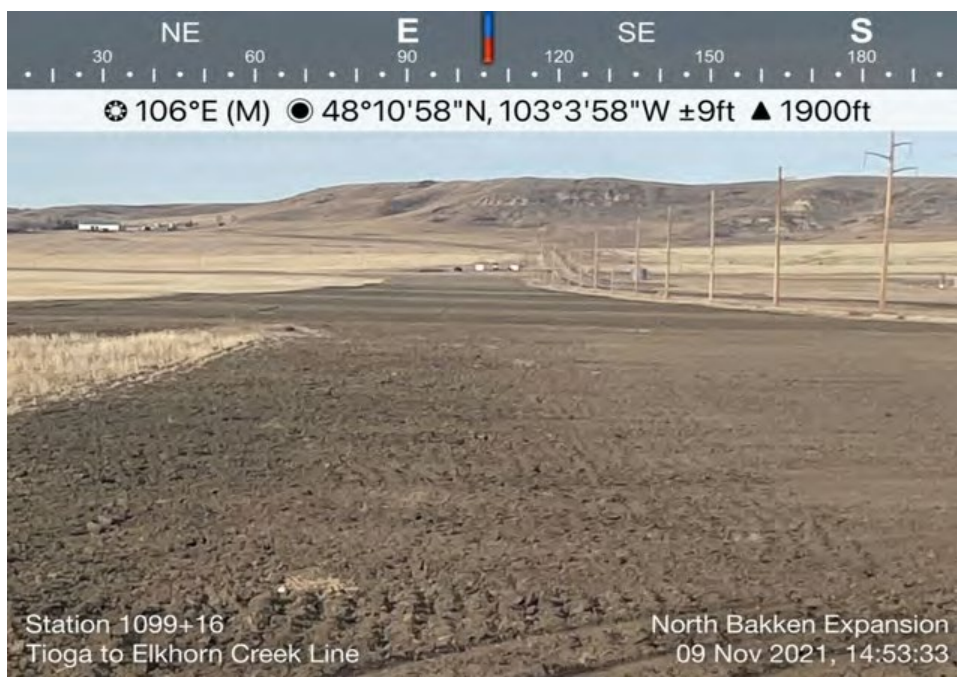
Location: Sta. Nos.
1045+39 to 1099+16

Notes: Restoration of
the pullback string
right-of-way north of
the North Spread
HDD bore site.

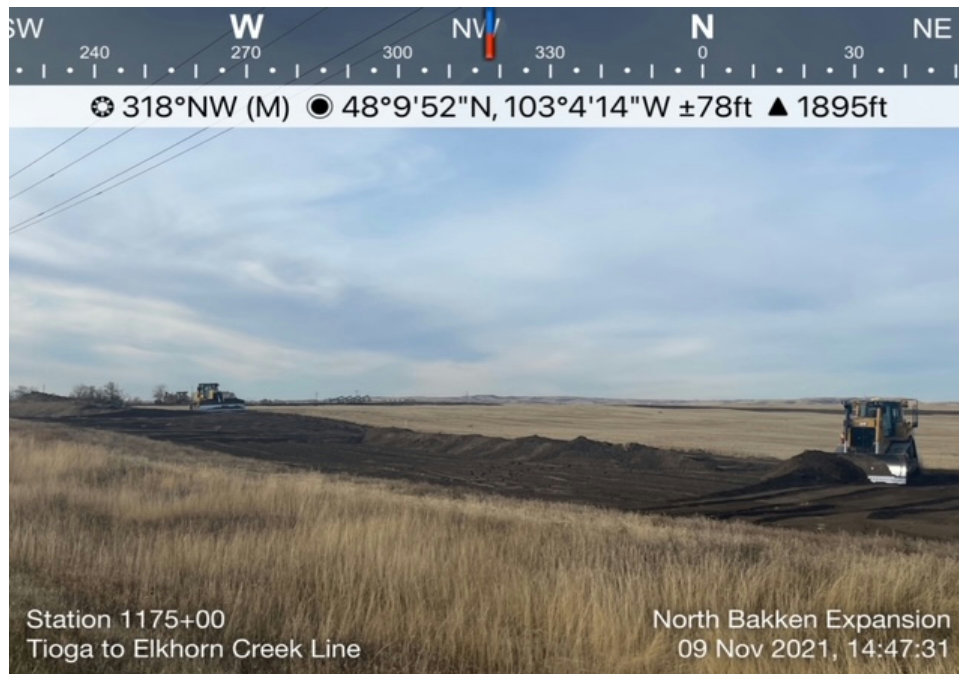
Location:
Sta. No. 1175+00

Notes: Spreading
topsoil along the
pullback string right-
of-way north of the
North Spread HDD
bore site.

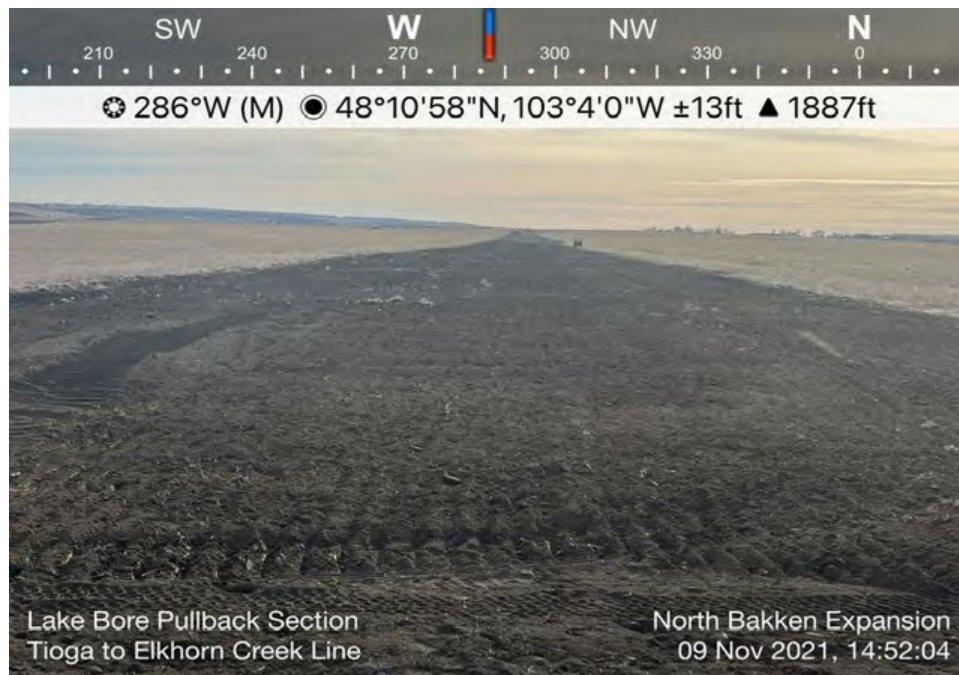
Location: Sta. Nos.
1100+00 to 1120+00

Notes: Restoration of
the pullback string
right-of-way north of
the North Spread
HDD bore site.

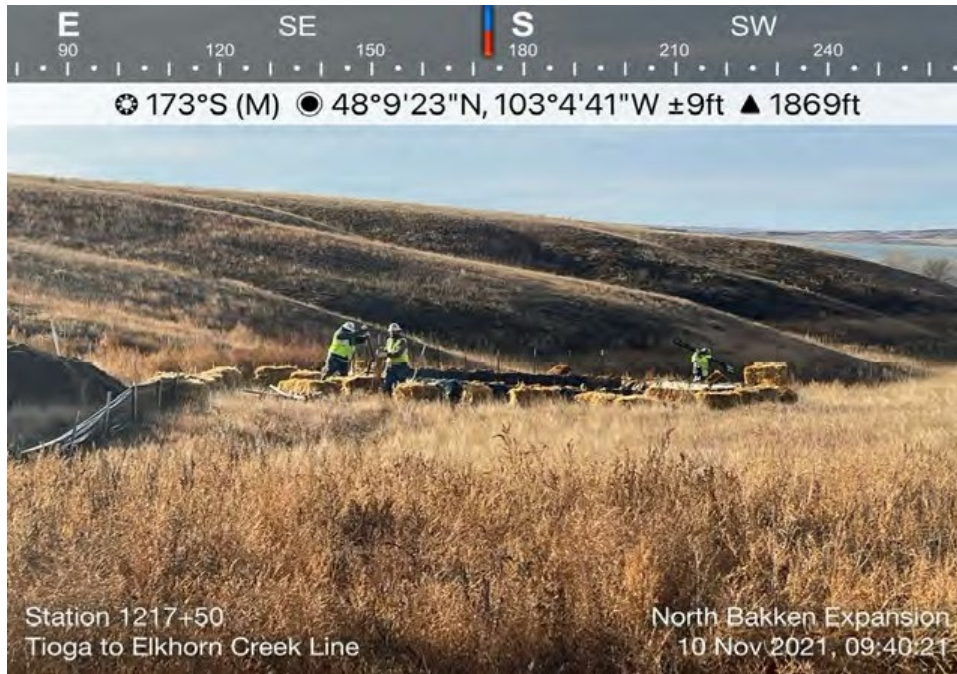
Location:
Sta. No. 1217+50

Notes: Removal of the dewatering structure used for dewatering of bore pipe.

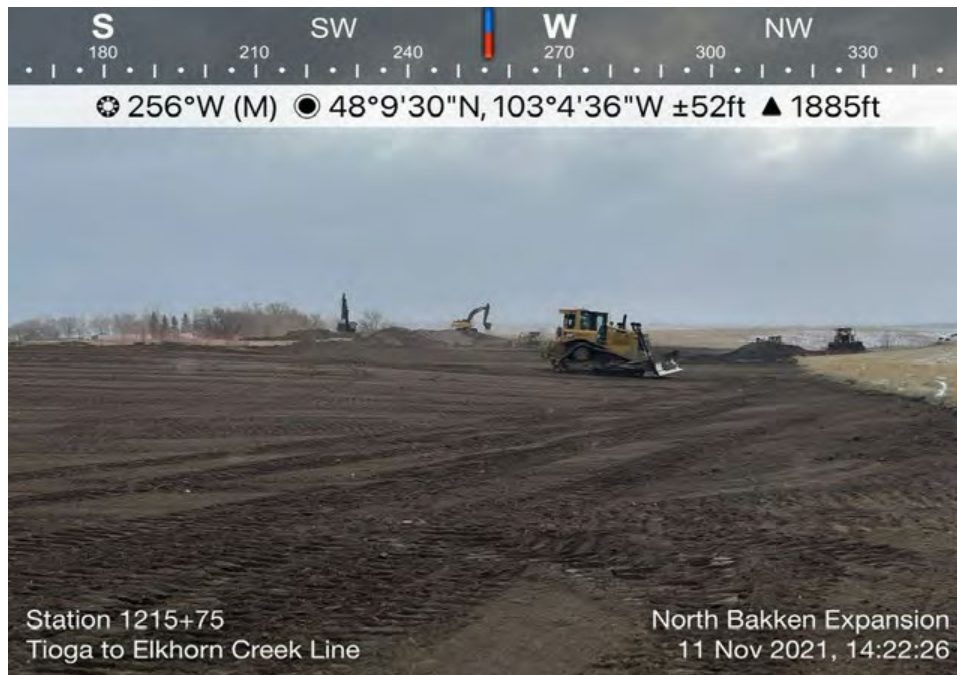
Location:
Sta. No. 1215+75

Notes: Restoration of the pullback string right-of-way north of the North Spread HDD bore site.

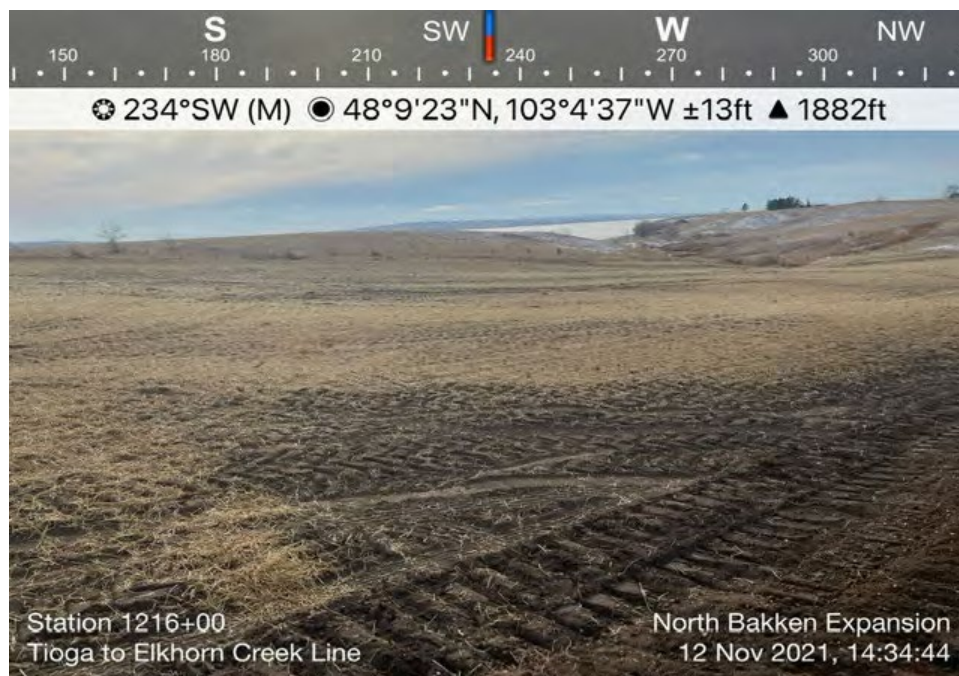
Location:
Sta. No. 1216+00

Notes: Seeded,
mulched, and
crimped right-of-way
north of the North
Spread HDD bore
site

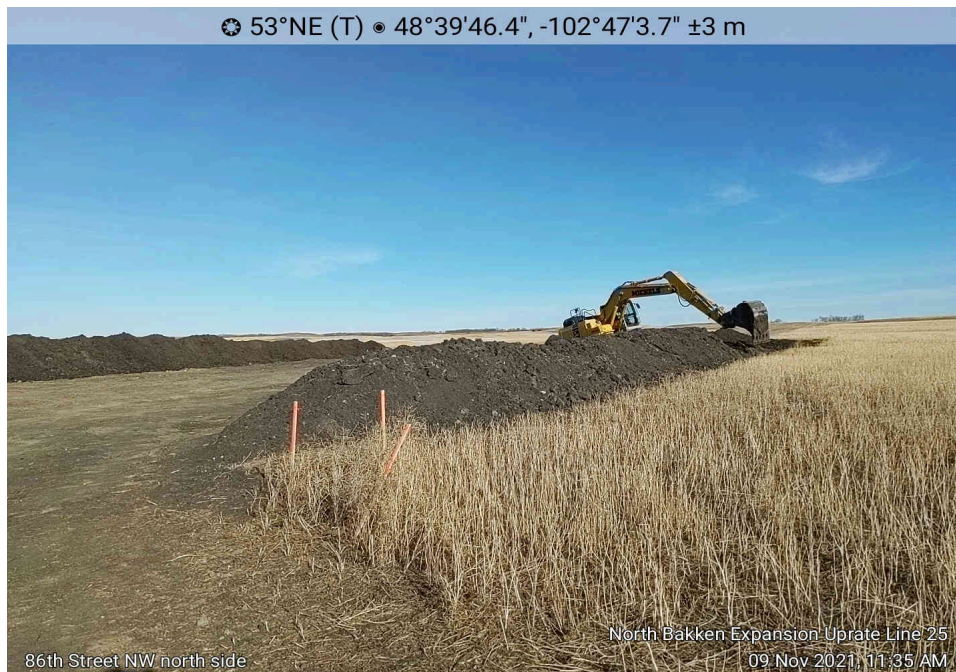
Location: 86th Street
NW bore crossing
(north side tie-in).

Notes: Restoration of
the 8-inch bore
replacement pipeline.

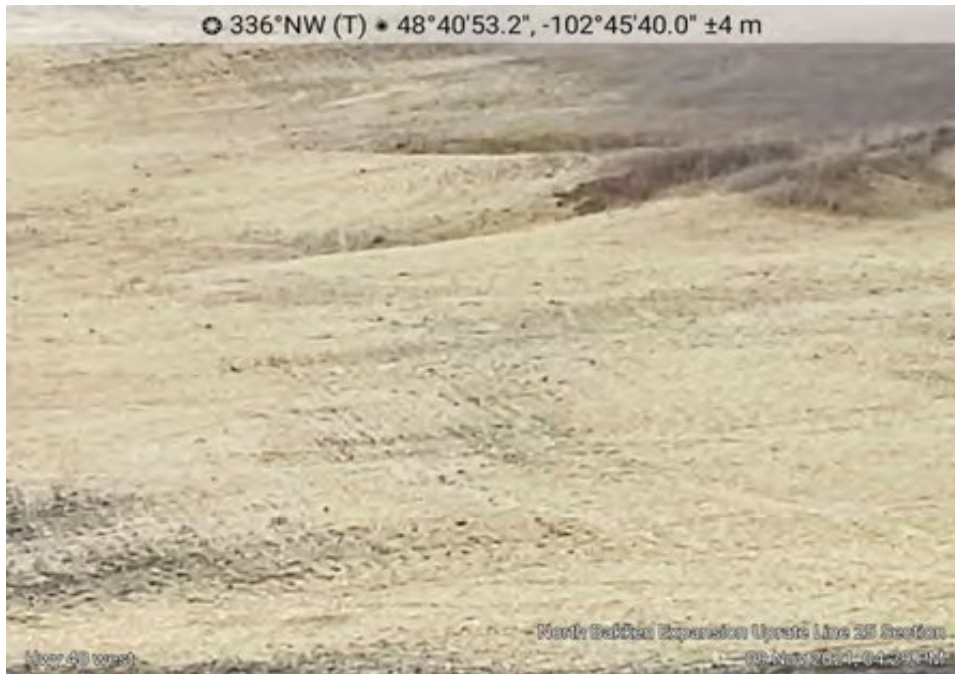
Location: Highway 40
guided bore crossing
(west side tie-in).

Notes: Seeded,
mulched, and crimped
right-of-way at the
tie-in of the 8-inch
bore replacement
pipeline.

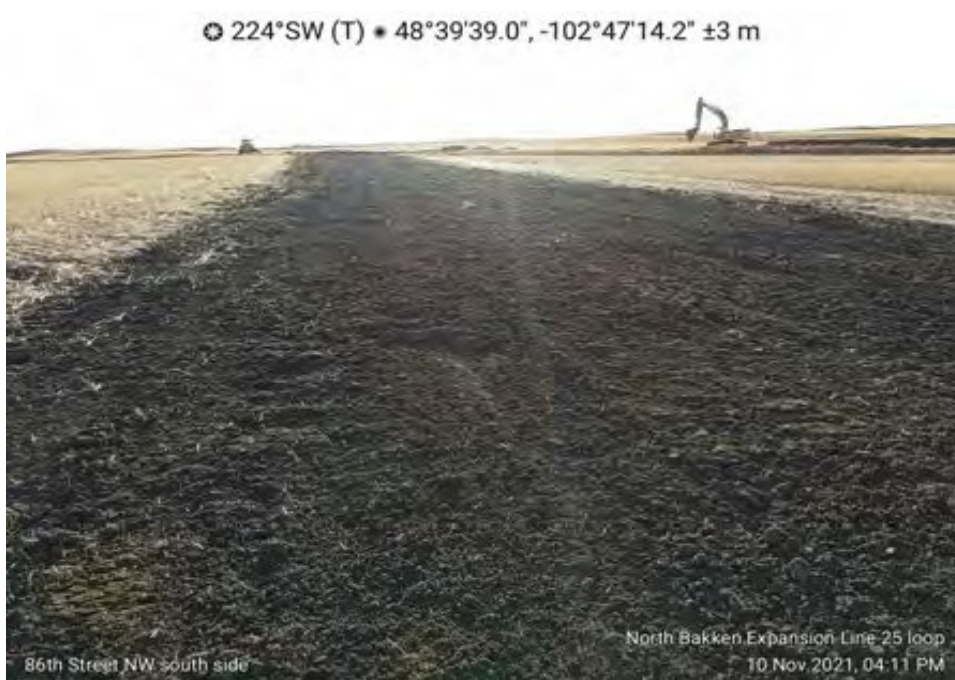
Location: South of
Norse Transfer
Station.

Notes: Restoration of
right-of-way in a
cultivated field after
the removal of the 8-
inch Line Section 25
pipeline that was
replaced with new 8-
inch pipeline.

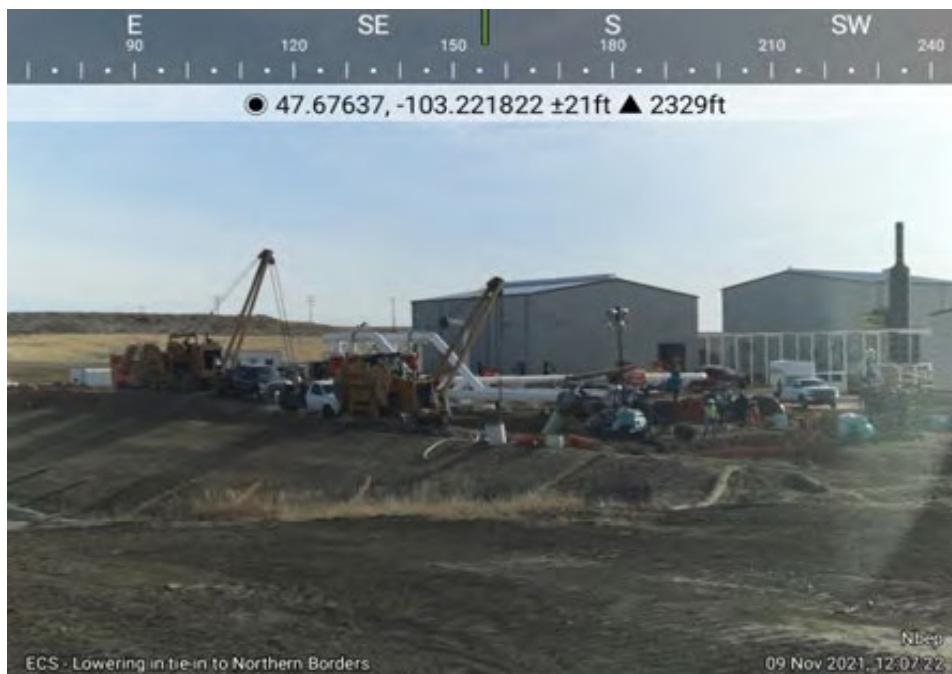
Location: Elkhorn
Creek Compressor
Station

Notes: Tie-in
activities of a pig
launcher/receiver.

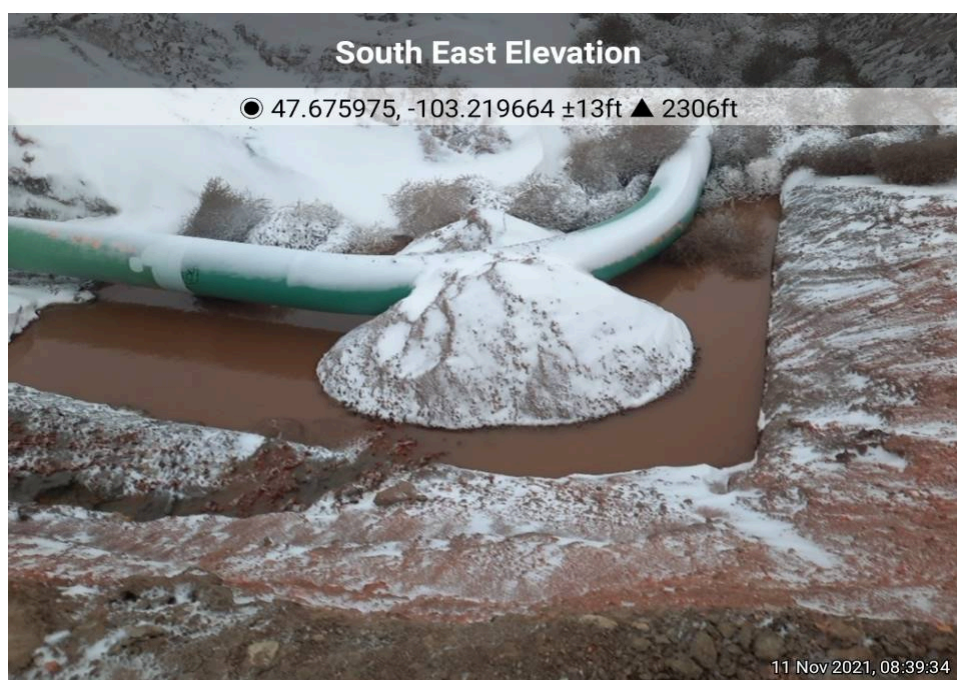
Location: Elkhorn
Creek Compressor
Station

- Completed foundation and concrete activities.
- Continued installing piping, structural supports and equipment.
- On November 11, 2021, approximately 1,260 gallons of water containing 24-gallons of methanol was spilled while stabilizing water levels between two storage frac tanks. Water was being held on site for hydrostatic testing purposes. WBI Energy quickly implemented measures identified in the Spill Prevention, Control and Countermeasure (SPCC) Plan to contain the fluid and stockpile affected soil from an area covering approximately 60 feet by 60 feet at a depth of 2-4 inches; the soil was stockpiled on plastic sheeting within the station for later disposal at an approved facility. Given the low concentration of methanol, the soil was not considered hazardous. No cultural or sensitive resources were impacted. Requisite agency and internal spill reports were filed.

Notes: Bell hole
containing spilled
methanol-water
solution.

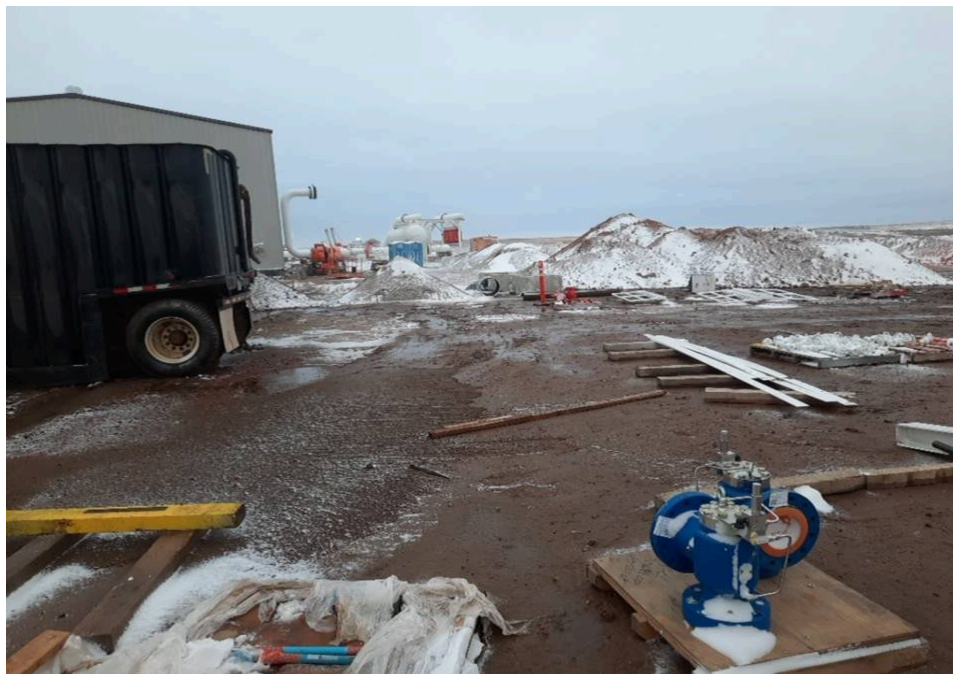
Location: Elkhorn
Creek Compressor
Station

Notes: Area of
dispersed spilled
methanol-water
solution.

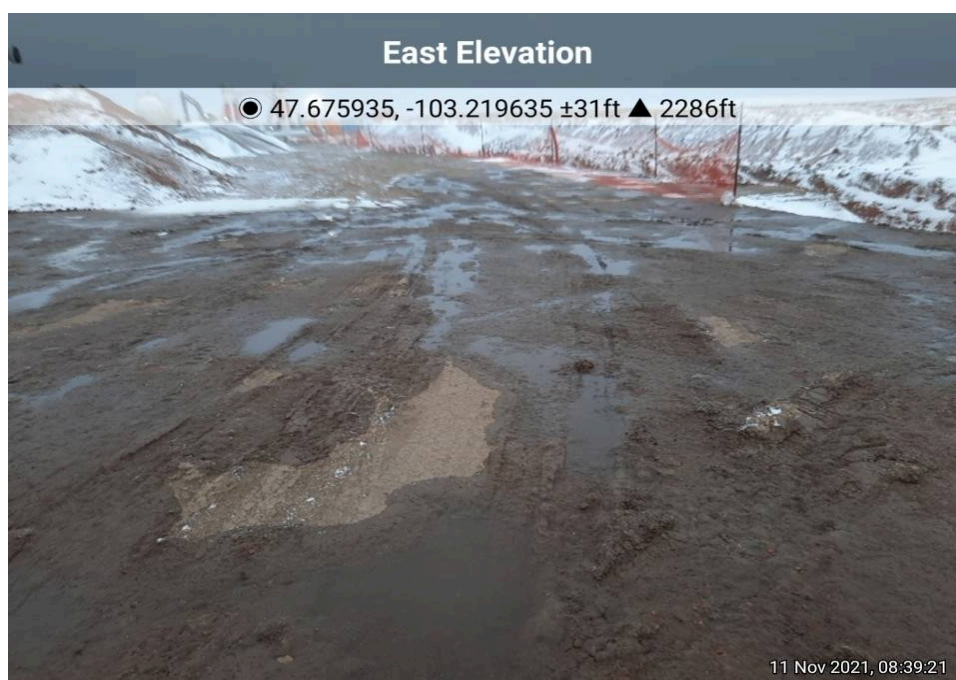
Location: Elkhorn
Creek Compressor
Station

Notes: Area of
dispersed spilled
methanol-water
solution.
