Re: WBI Energy Transmission, Inc.
Docket Nos. CP20-52-000 and CP20-52-001
North Bakken Expansion Project
Weekly Status Report No. 15

WBI Energy Transmission, Inc.
North Bakken Expansion Project Status Report No. 15
FERC Docket Nos. CP20-52-000
CP20-52-001

Reporting Period: September 6, 2021 through September 12, 2021

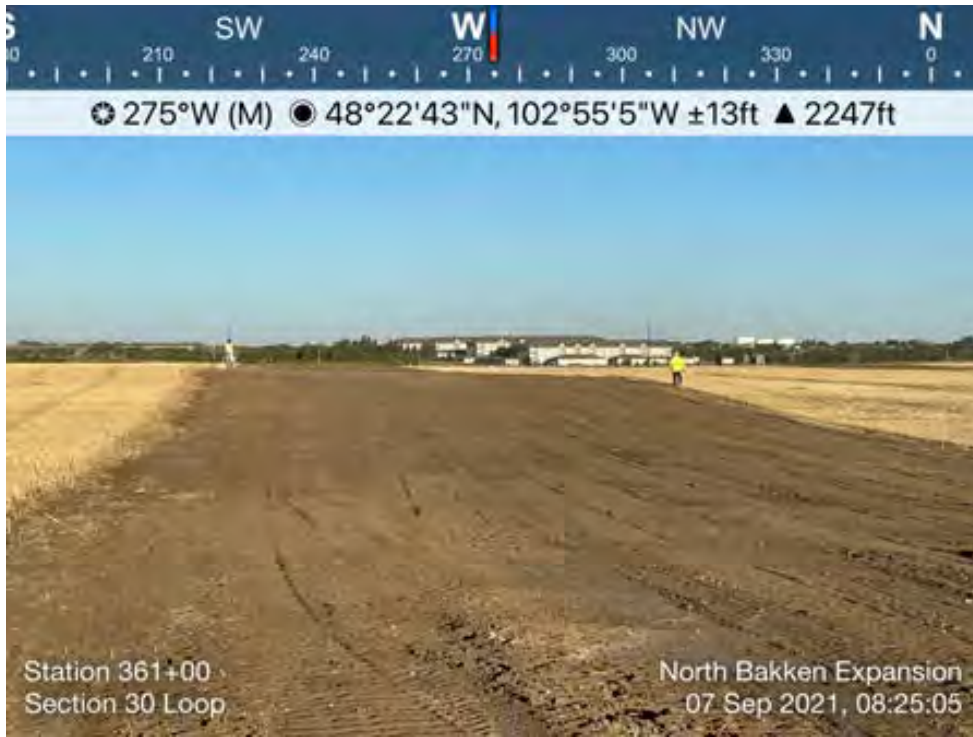
Location:
Sta. No. 361+00

Notes: Final graded
right-of way on Line
Section 30 Loop.

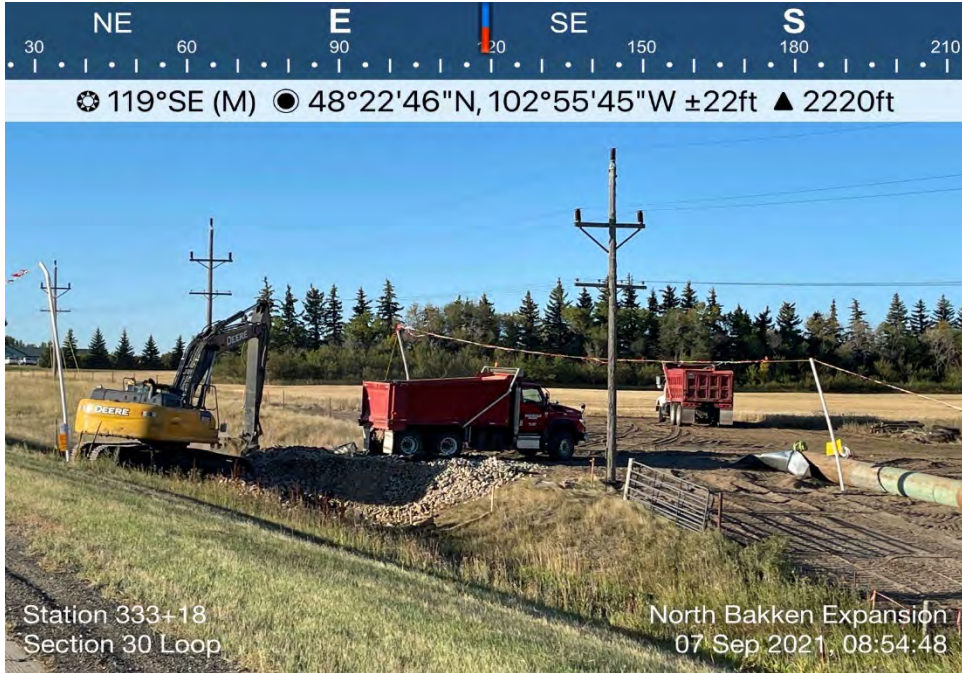
Location:
Sta. No. 333+18

Notes: Removal of
culvert and riprap
from an access road
approach on Line
Section 30 Loop.

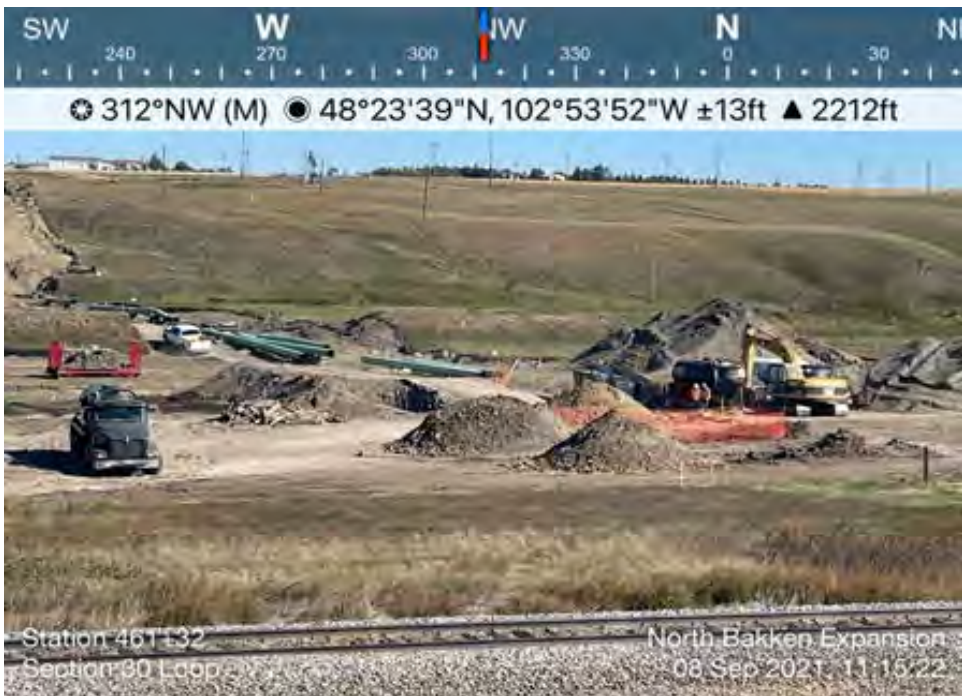
Location:
Sta. No. 461+32

Notes: Boring
activities of the last
bore on the Line
Section 30 Loop.

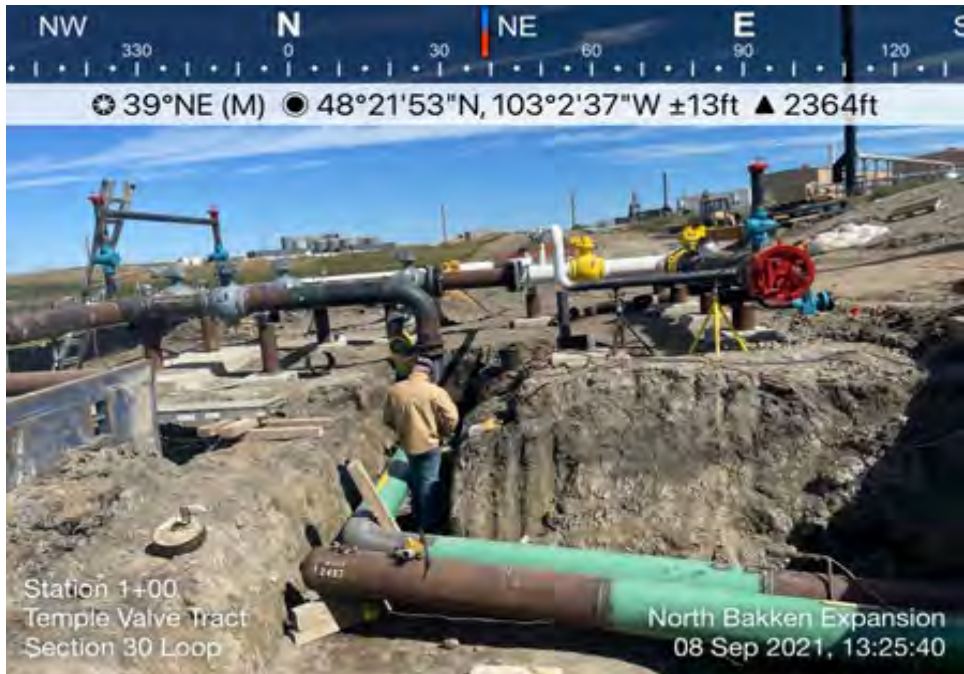
Location:
Sta. No. 01+00

Notes: Welding activities at the Temple valve setting on Line Section 30 Loop.

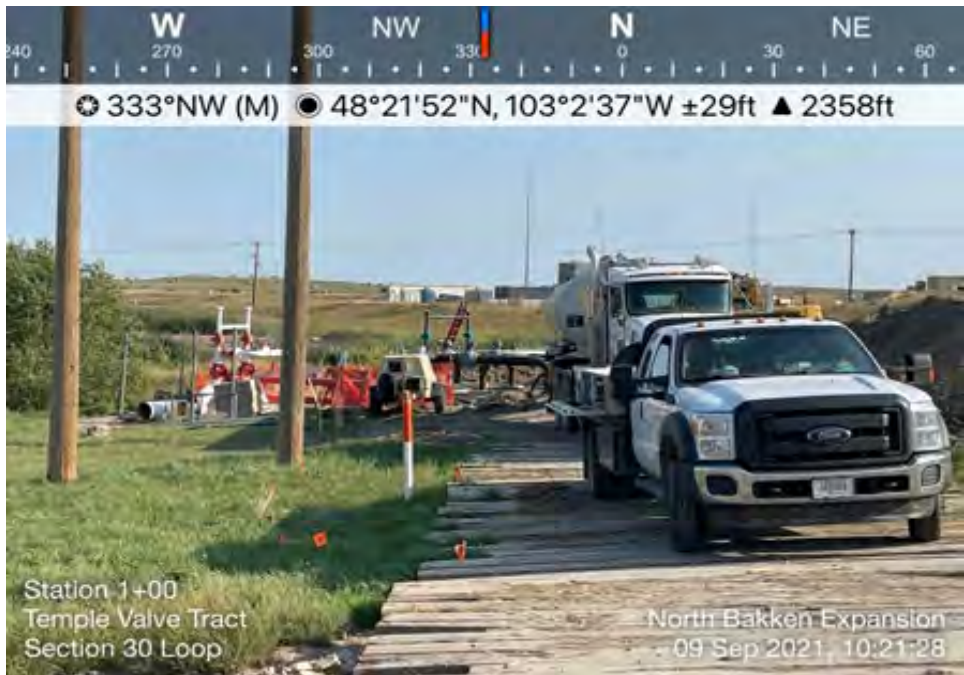
Location:
Sta. No. 1+00

Notes: Performing a hydrostatic test of the 12-inch pipe for the Temple valve setting on the Line Section 30 Loop.

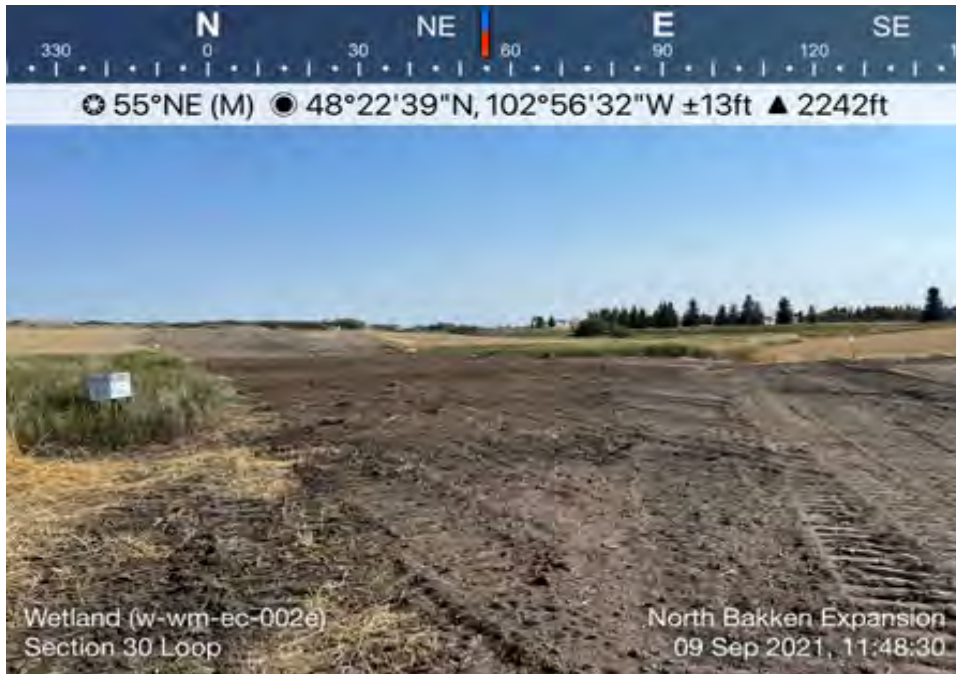
Location:
Sta. No. 300+00

Notes: Final grading
of wetland w-wm-ec-
002 on Line Section
30 Loop.

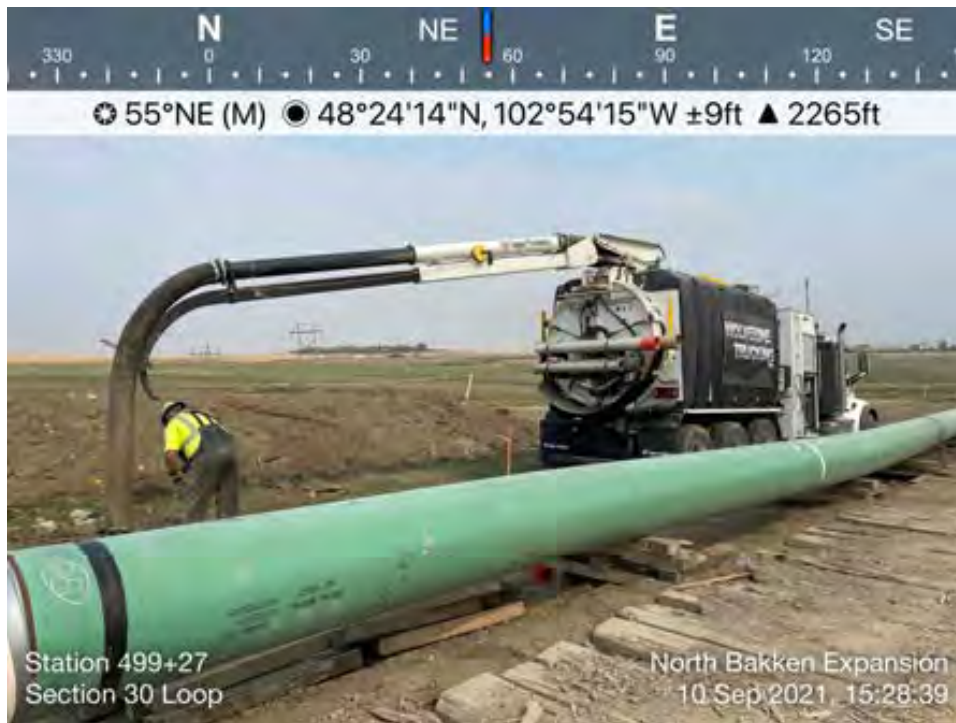
Location:
Sta. No. 499+27

Notes: During pot-
holing activities,
encountered
contaminated soil on
the Line Section 30
Loop.

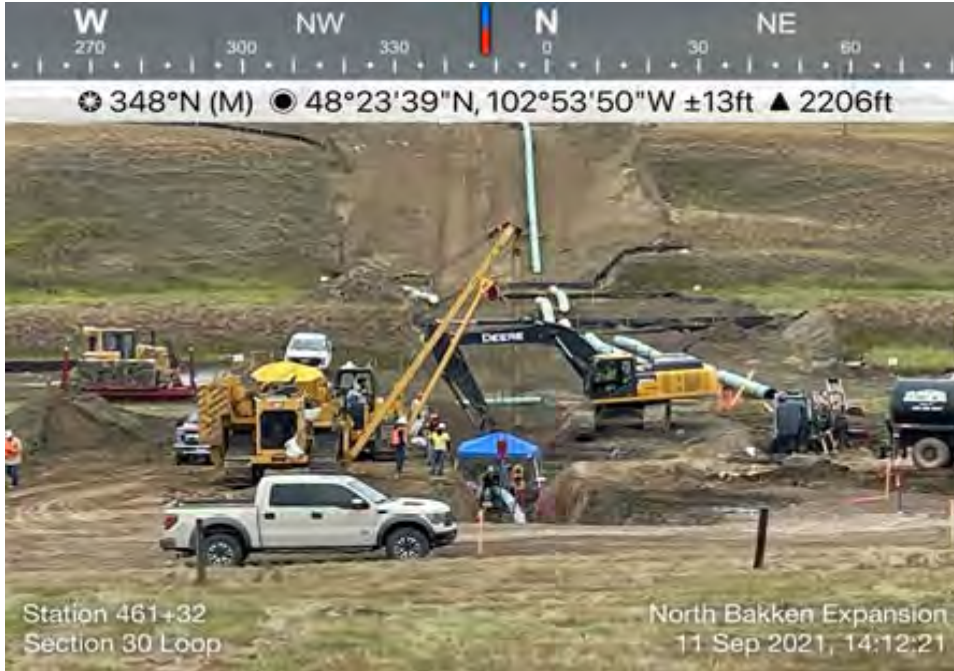
Location:
Sta. No. 461+32

Notes: Lowering of
bore pipe on the Line
Section 30 Loop.

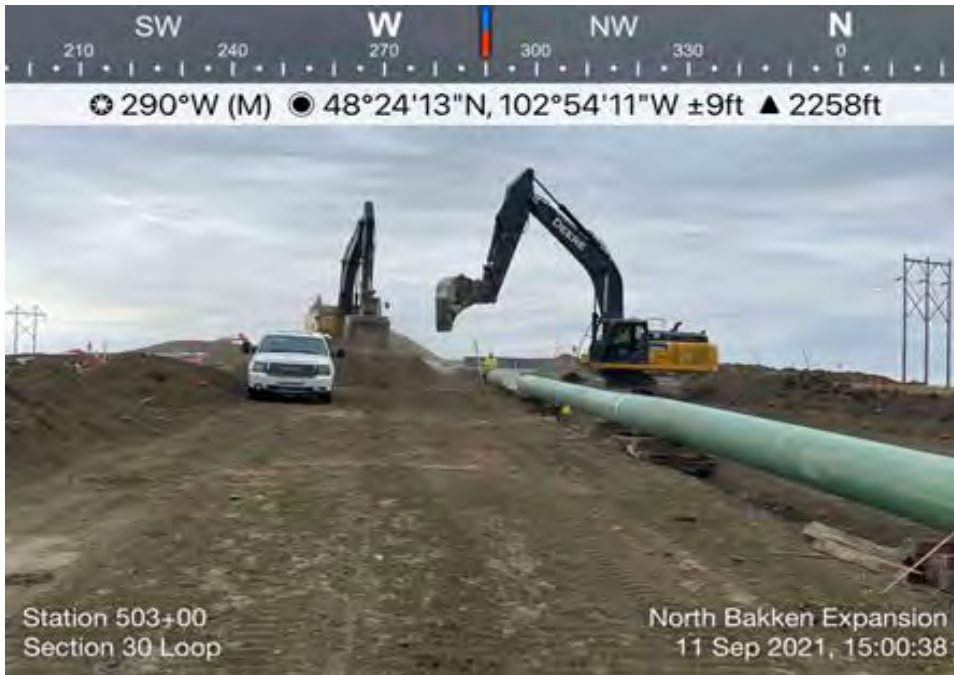
Location:
Sta. No. 503+00

Notes: Padding and
backfilling activities
on the Line Section
30 Loop.

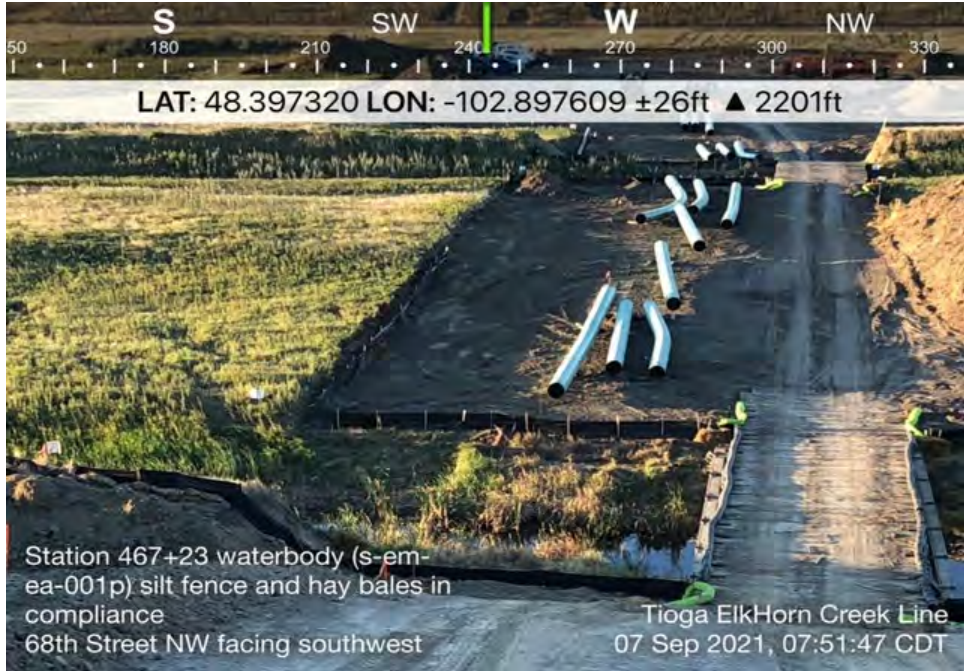
Location:
Sta. No. 467+23

Notes: Erosion control devices in compliance at waterbody s-wm-ea-001p on the Tioga-Elkhorn Creek Pipeline.

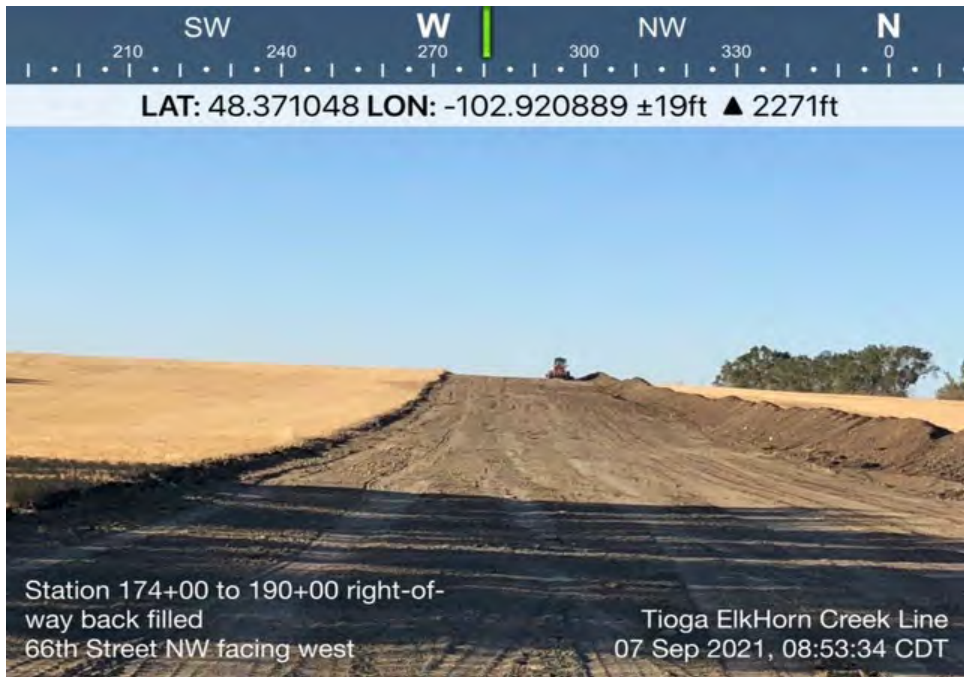
Location:
Sta. No. 174+00 to 190+00

Notes: Backfilling activities along the Tioga-Elkhorn Creek Pipeline.

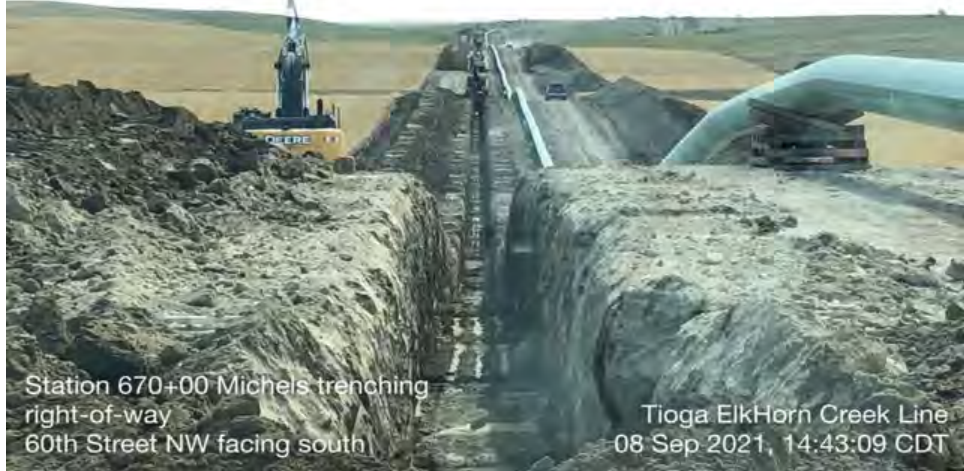
Location:
Sta. No. 670+00

Station 670+00 Michels trenching right-of-way 60th Street NW facing south

Notes: Trenching activities along the Tioga-Elkhorn Creek Pipeline.

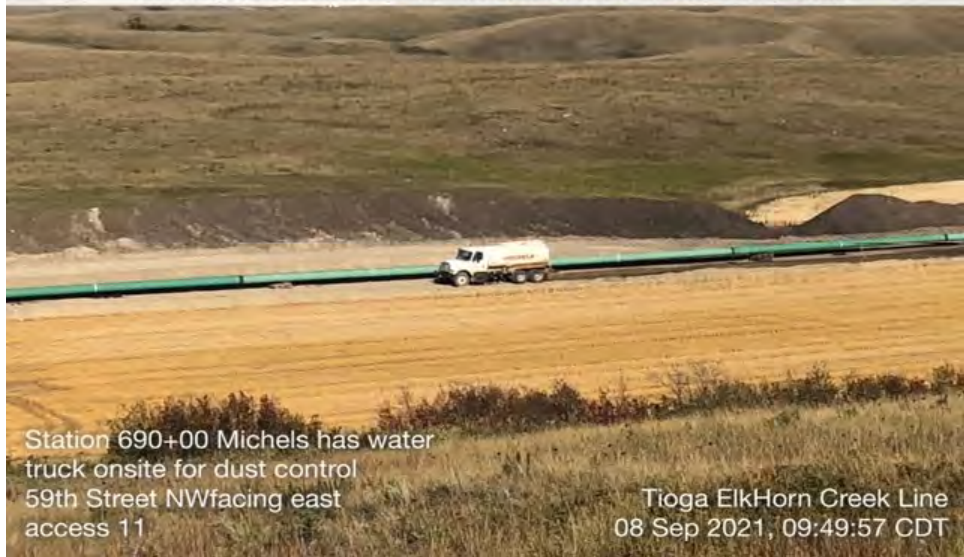
Location:
Sta. No. 690+00

Station 690+00 Michels has water truck onsite for dust control 59th Street NW facing east access 11

Notes: Dust mitigation measures along the right-of-way of the Tioga-Elkhorn Creek Pipeline.

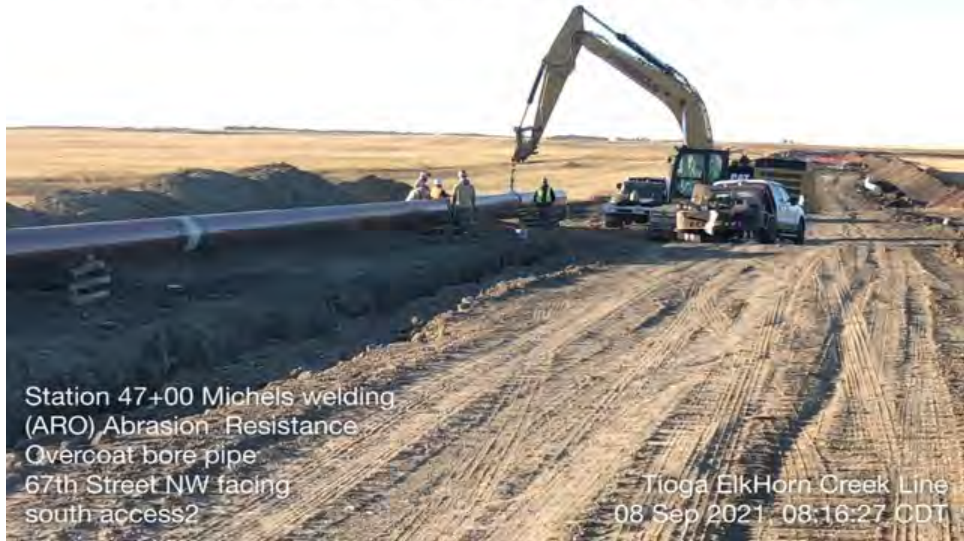
Location:
Sta. No. 47+00

Station 47+00 Michels welding (ARO) Abrasion Resistance Overcoat bore pipe 67th Street NW facing south access2

Notes: Welding activities on the Tioga-Elkhorn Creek Pipeline.

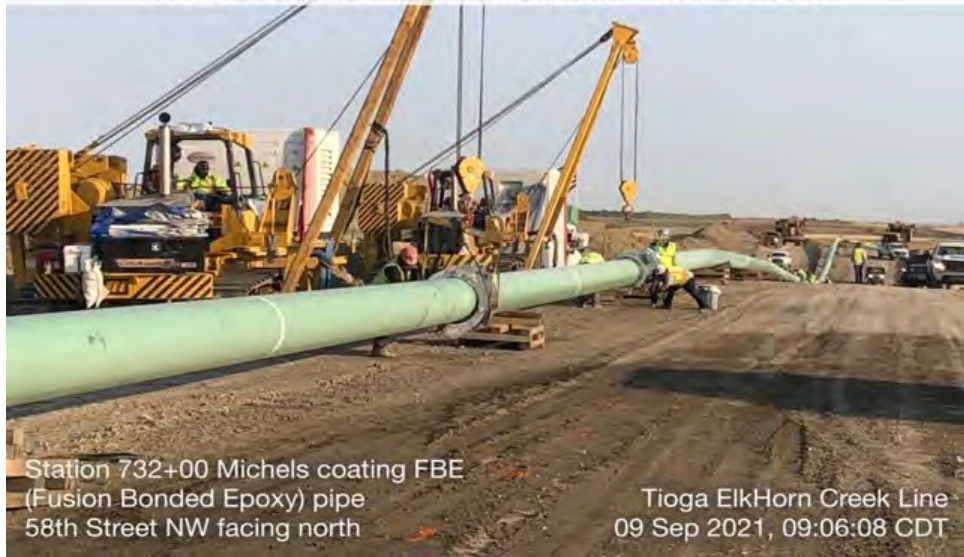
Location:
Sta. No. 732+00

Station 732+00 Michels coating FBE (Fusion Bonded Epoxy) pipe 58th Street NW facing north

Notes: Joint coating activities along the Tioga-Elkhorn Creek Pipeline.

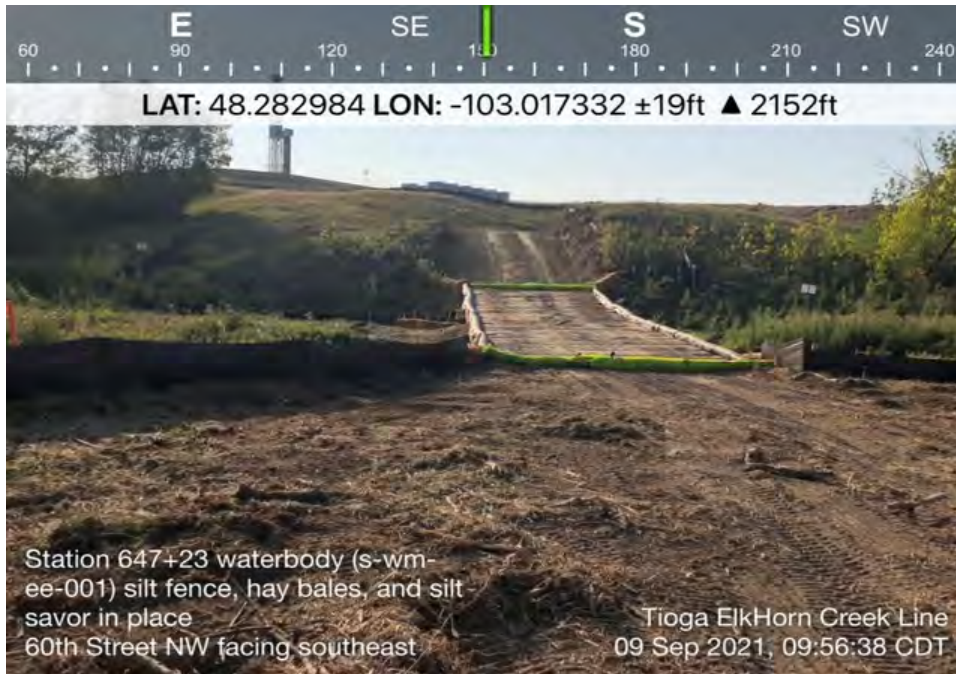
Location:
Sta. No. 647+23

Notes: Erosion controls at waterbody s-wm-ee-001 on the Tioga-Elkhorn Creek Pipeline.

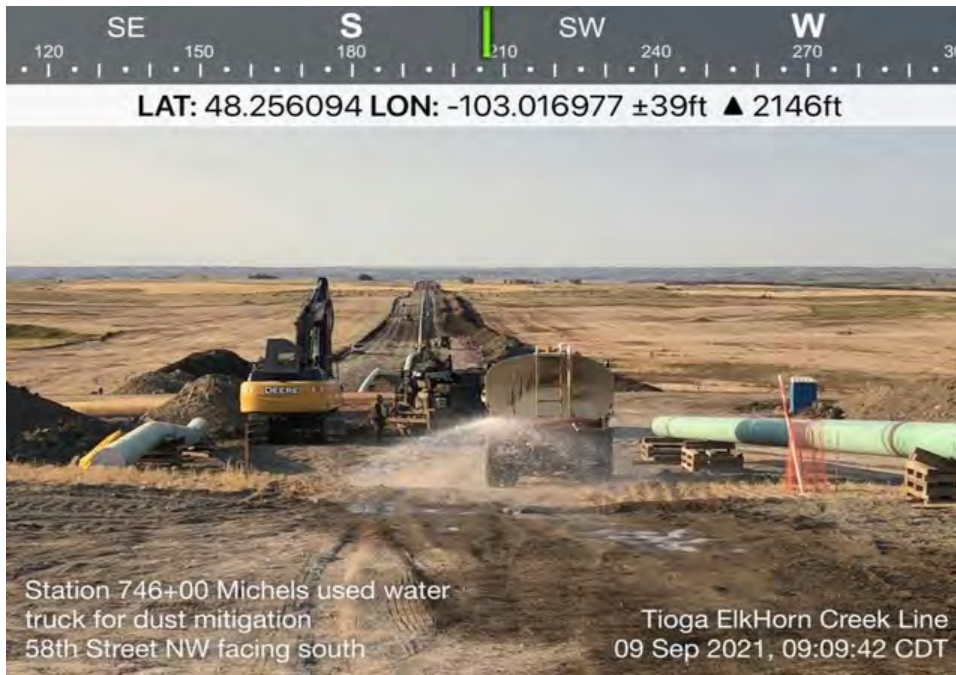
Location:
Sta. No. 746+00

Notes: Dust mitigation measures along the Tioga-Elkhorn Creek Pipeline.

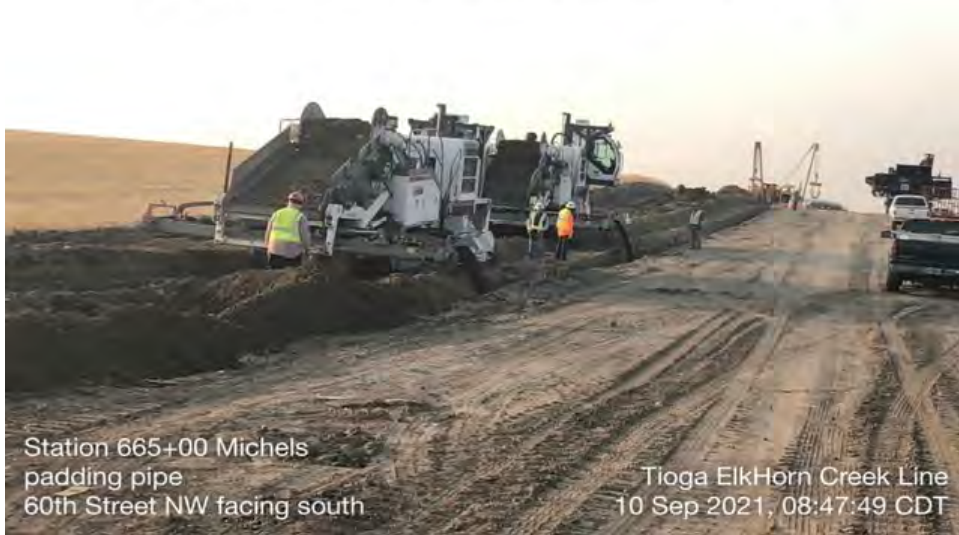
Location:
Sta. No. 665+00

Notes: Padding the trench on the Tioga-Elkhorn Creek Pipeline.

Station 665+00 Michels padding pipe 60th Street NW facing south

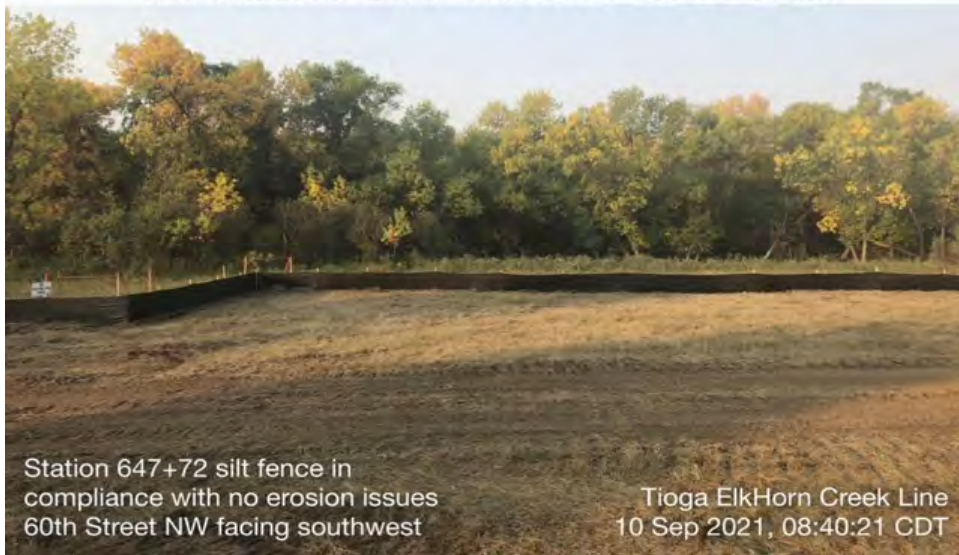
Location:
Sta. No. 647+72

Notes: Erosion control devices in compliance on the Tioga-Elkhorn Creek Pipeline.

Station 647+72 silt fence in compliance with no erosion issues 60th Street NW facing southwest

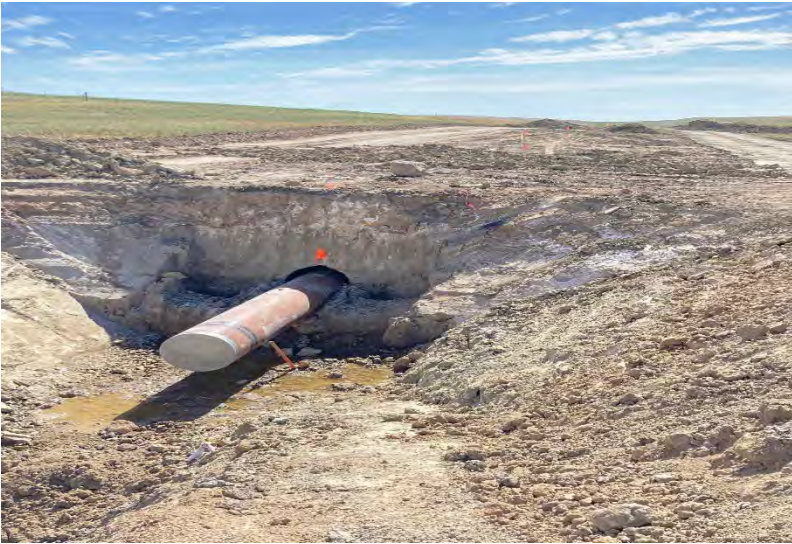
Location: MP: 32.8-33.0

Non-Compliance Issues, Corrective Actions and Effectiveness:				
Date	Location	Description	Correction	Effectiveness of Corrective Action
9/8/2021	MP 32.8 to 33.0	The contractor completed a cradle bore prior to receiving FERC approval via a proposed variance request V53 to change the construction method from open cut to a cradle bore.	The lead environmental inspector stressed the importance of not proceeding with a crossing method change until WBI Energy had approval from FERC via a variance request.	The contractor was reminded of the variance request process and that changes cannot be implemented without an approved variance from the FERC.

Notes: Noncompliance for conducting a construction method change prior to variance approval from FERC. Entry point of the cradle bore associated with proposed variance request V53.

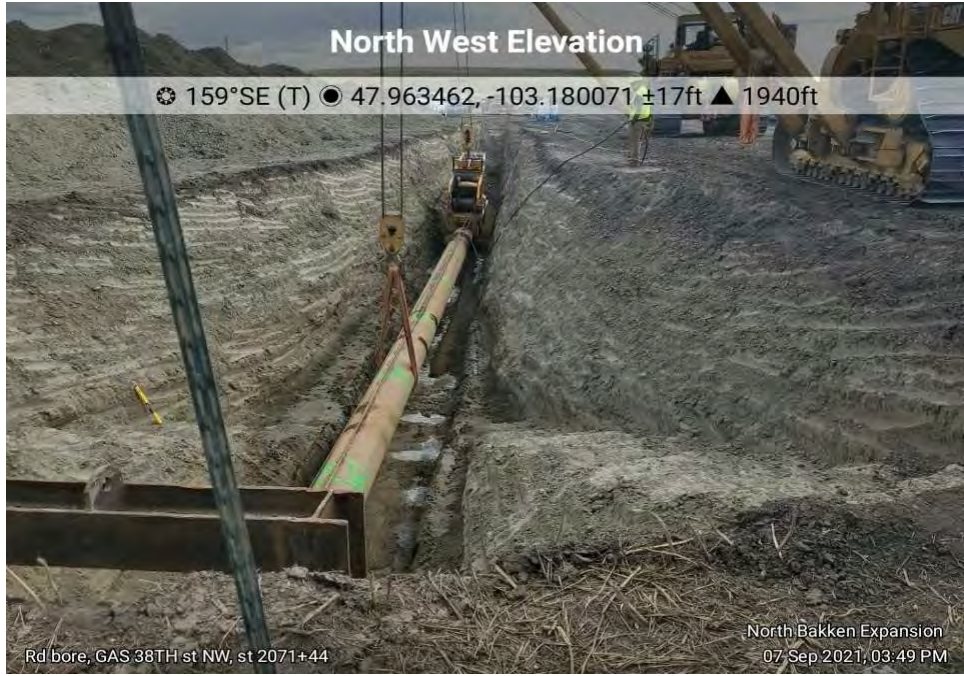
Date: 9/07/2021
 Location: 2071+44
 Notes: Cradle road bore activity on the Tioga-Elkhorn Creek Pipeline.

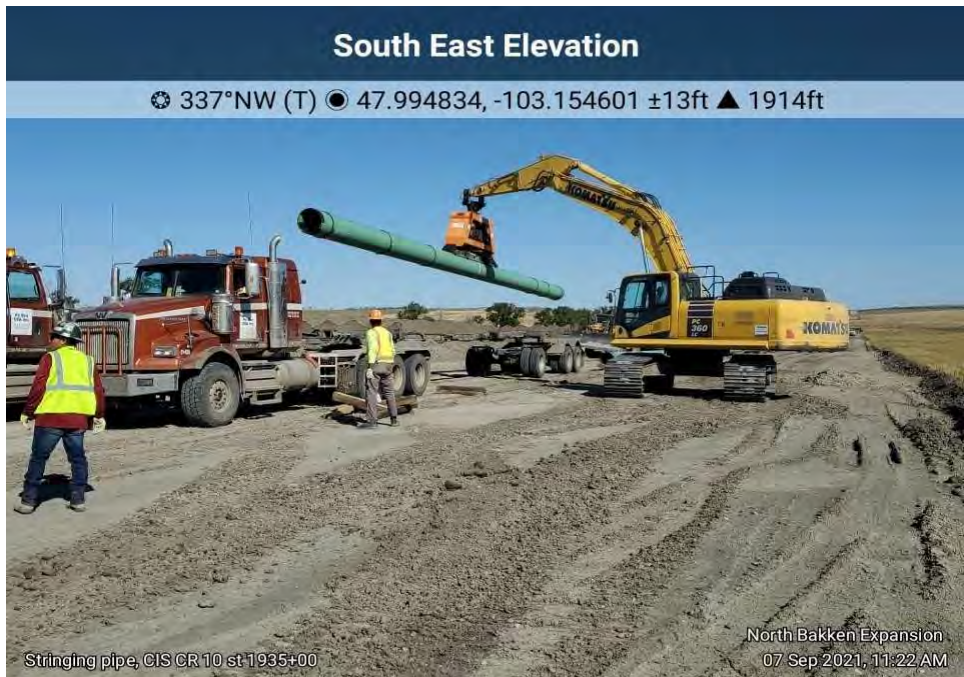
Date: 9/07/2021
 Location:
 Sta. No. 1935+00
 Notes: Stringing activities on the Tioga-Elkhorn Creek Pipeline.

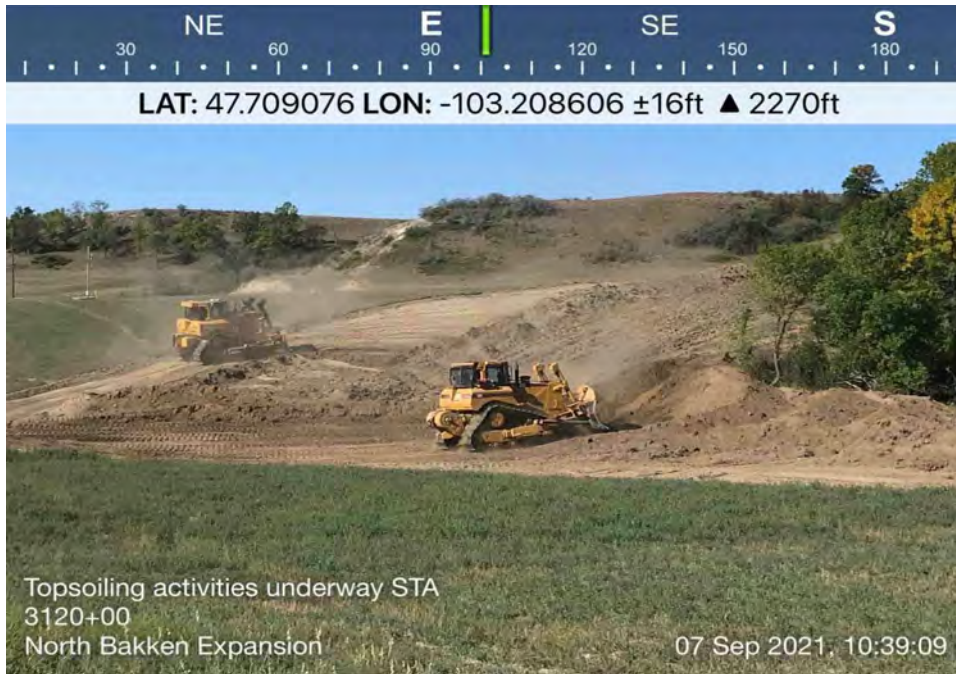
Location:
Sta. No. 3120+00

Notes:
Clearing/grading activities on the Tioga-Elkhorn Creek Pipeline.

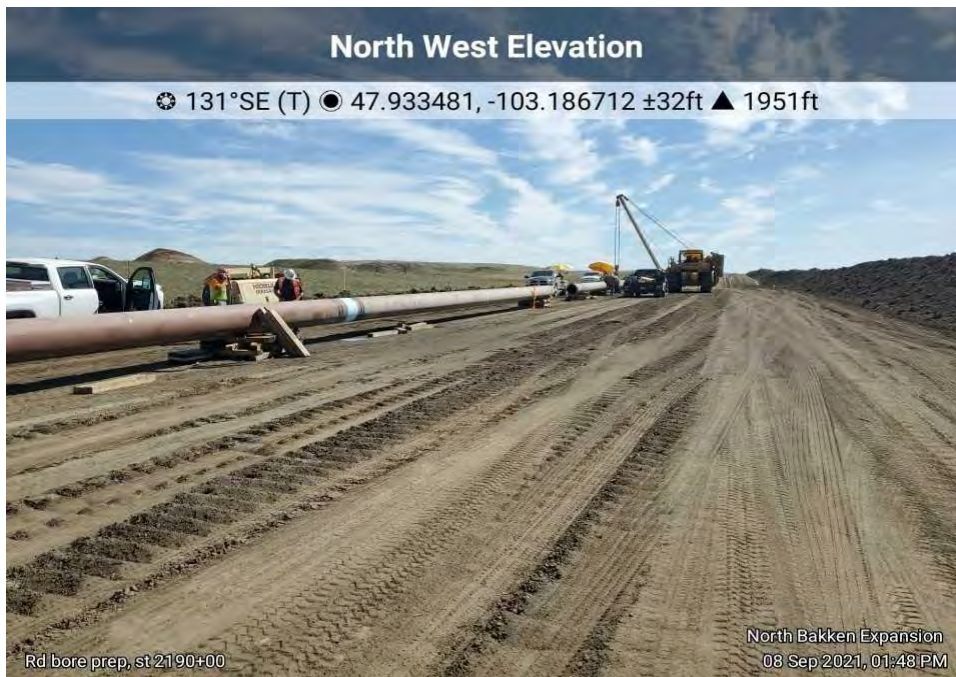
Location:
Sta. No. 2190+00

Notes: Welding activities at the Tioga-Elkhorn Creek Pipeline.

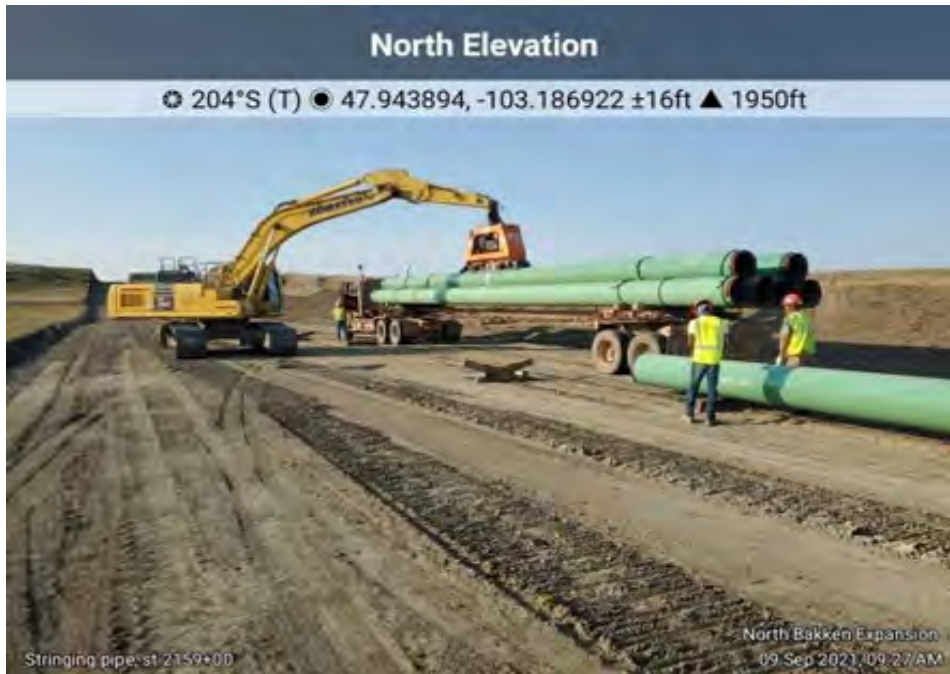
Location:
Sta. No. 2159+00

Notes: Stringing activities on the Tioga-Elkhorn Creek Pipeline.

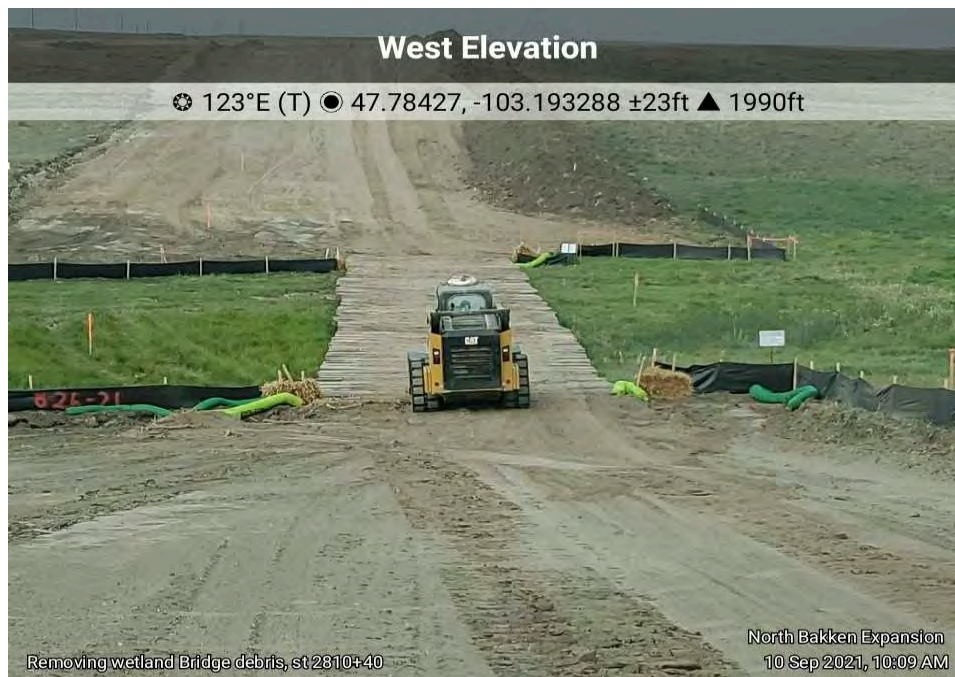
Location:
Sta. No. 2810+00

Notes: Removal of construction material at wetland 2-mk-wa-002 on the Tioga-Elkhorn Creek Pipeline.

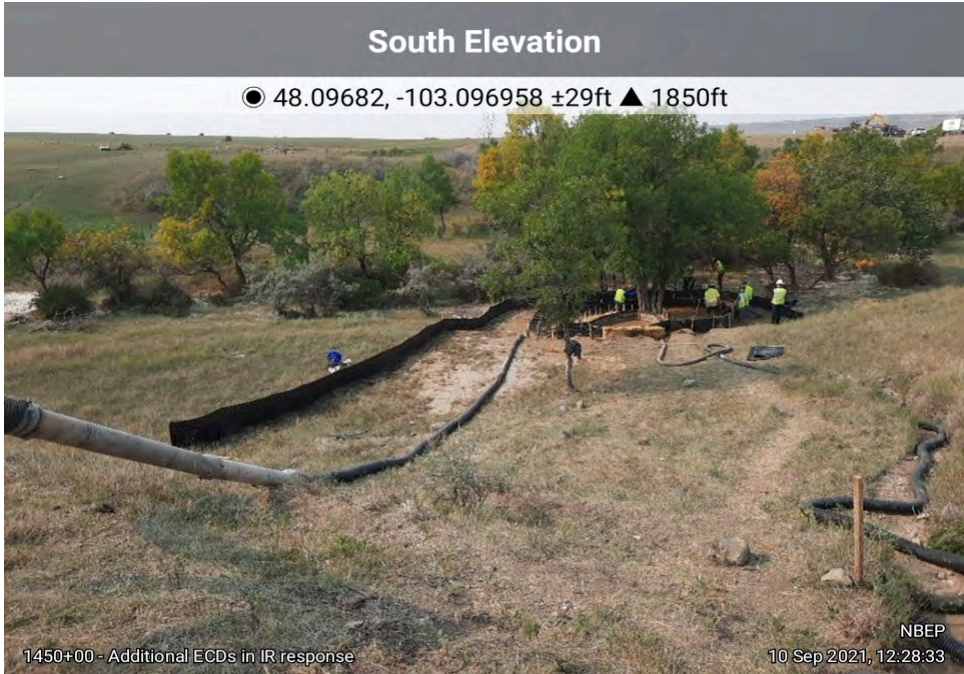
Location:
Sta. No. 1450+00

Notes: Multiple containment layers for an inadvertent return near and within dry stream s-mk-ea-001 on the Tioga-Elkhorn Creek Pipeline.

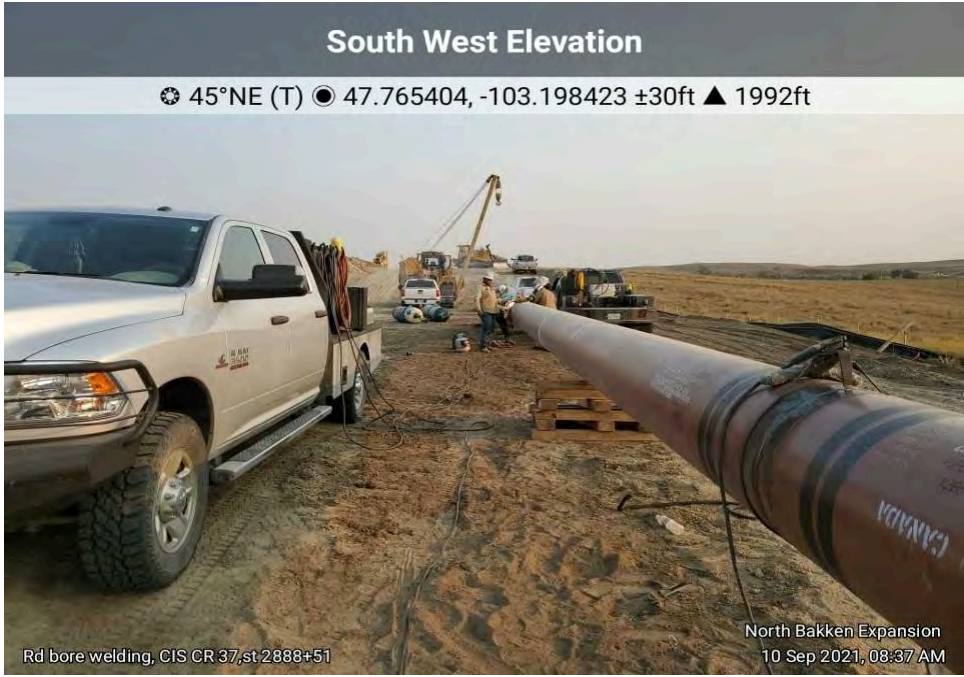
Location:
Sta. No. 2888+51

Notes: Welding activities on the Tioga-Elkhorn Creek Pipeline.

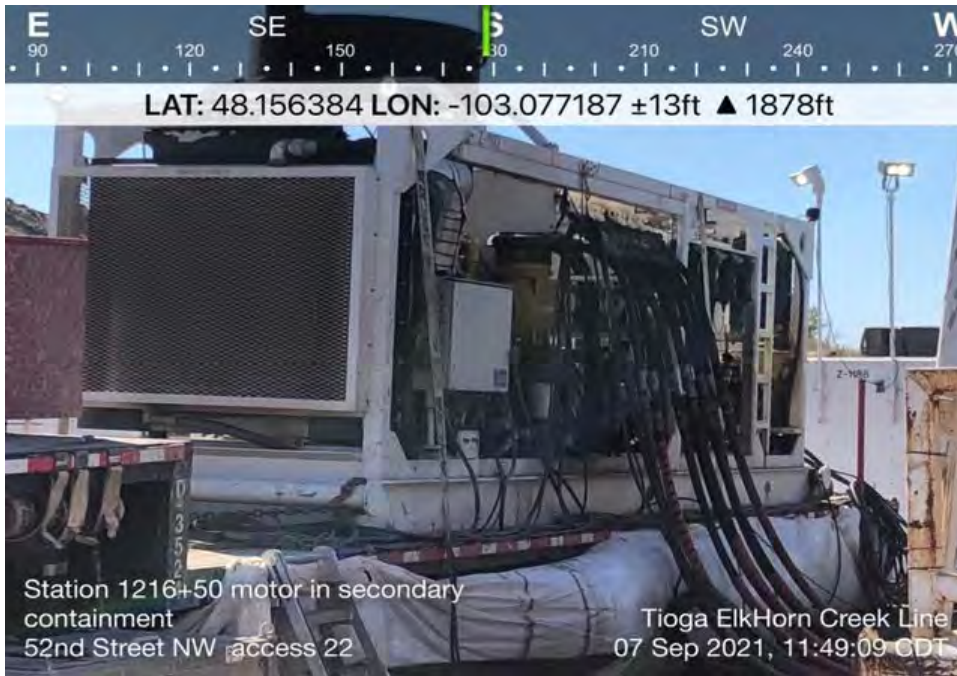
Location: North Spread HDD bore site.

Notes: HDD equipment within adequate secondary containment at the North Spread HDD bore site.

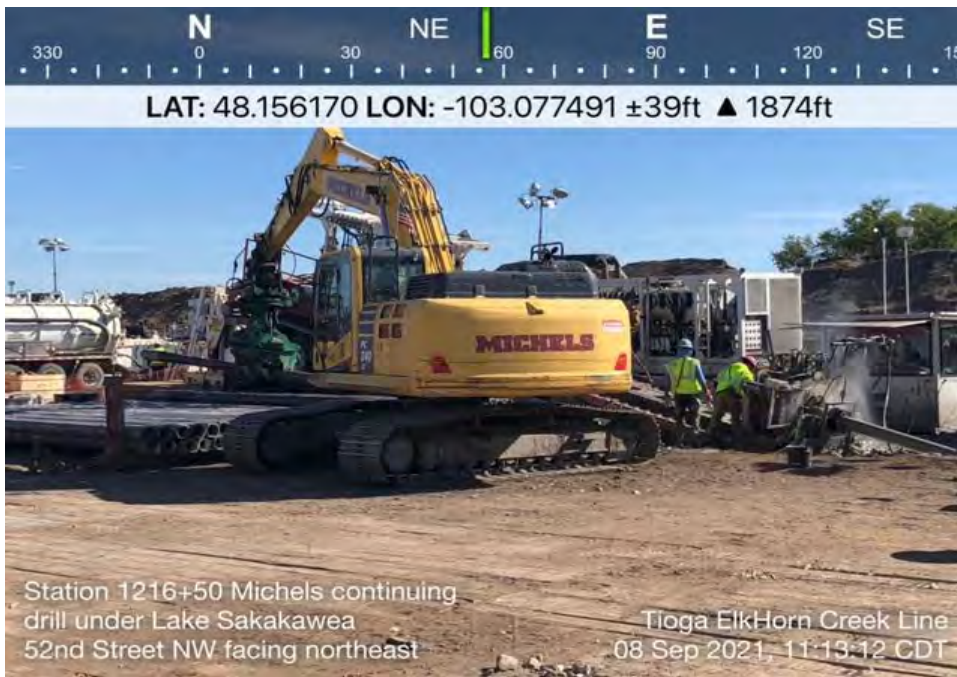
Location: North Spread HDD bore site.

Notes: Continued HDD drilling activities at the North Spread HDD bore.

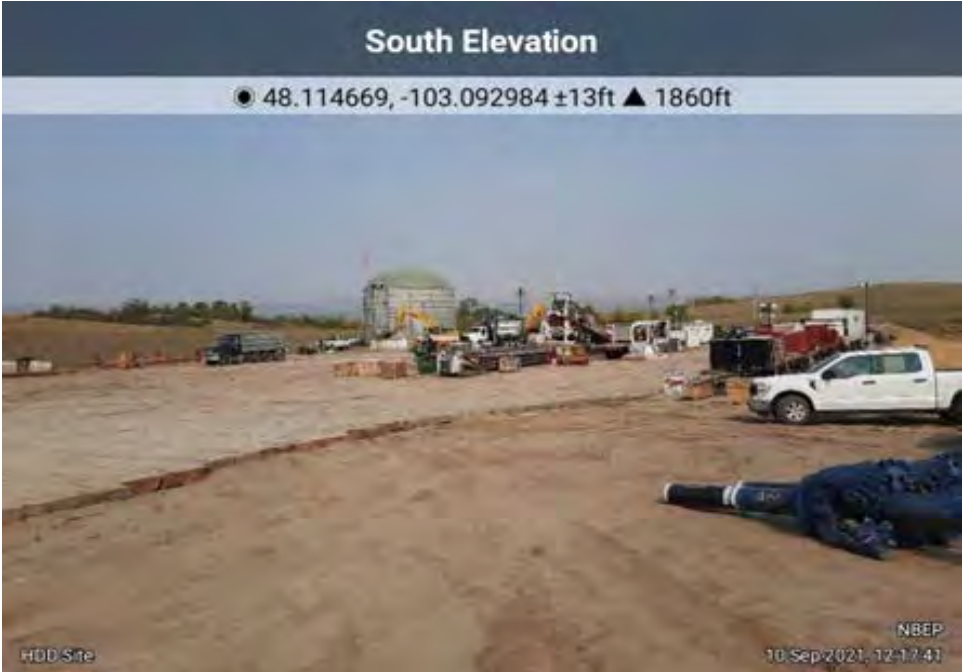
Location: South Spread HDD bore site.

Notes: Continued HDD drilling activities at the South Spread HDD bore.

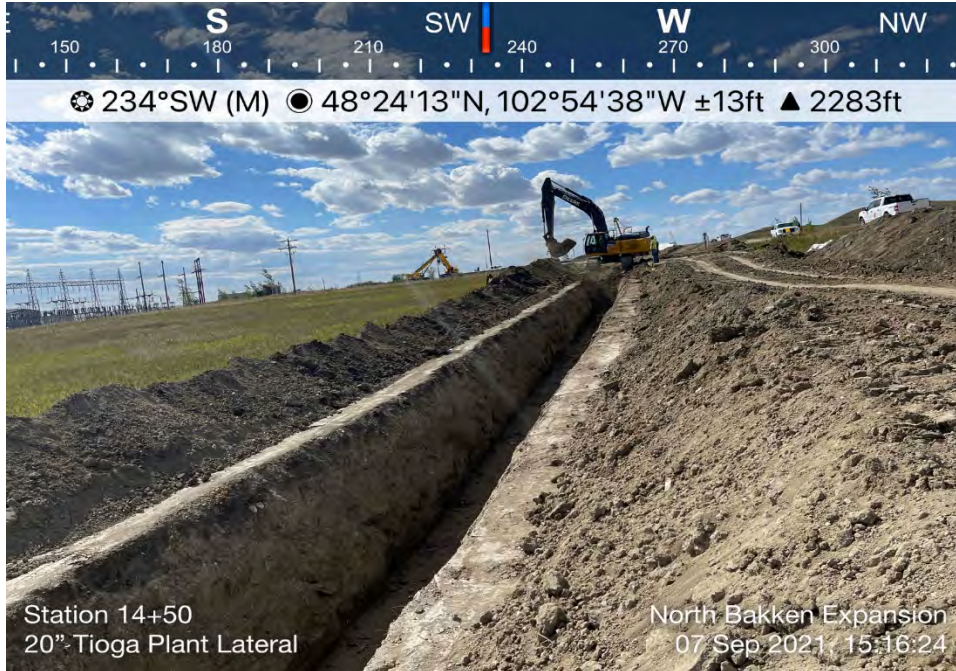
Location:
Sta. No. 14+50

Notes: Trenching activities on the Tioga Compressor Lateral.

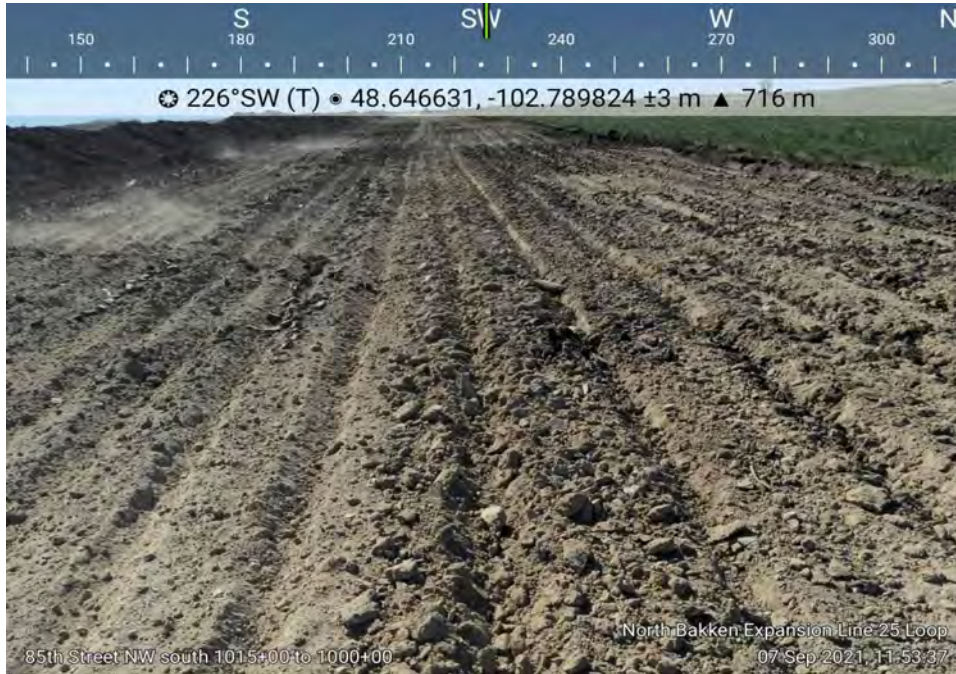
Location:
Sta. No. 1000+00 to
1015+00

Notes: De-compacted
subsoil prior to
spreading topsoil
along the right-of-way
on the Line Section
25 Loop.

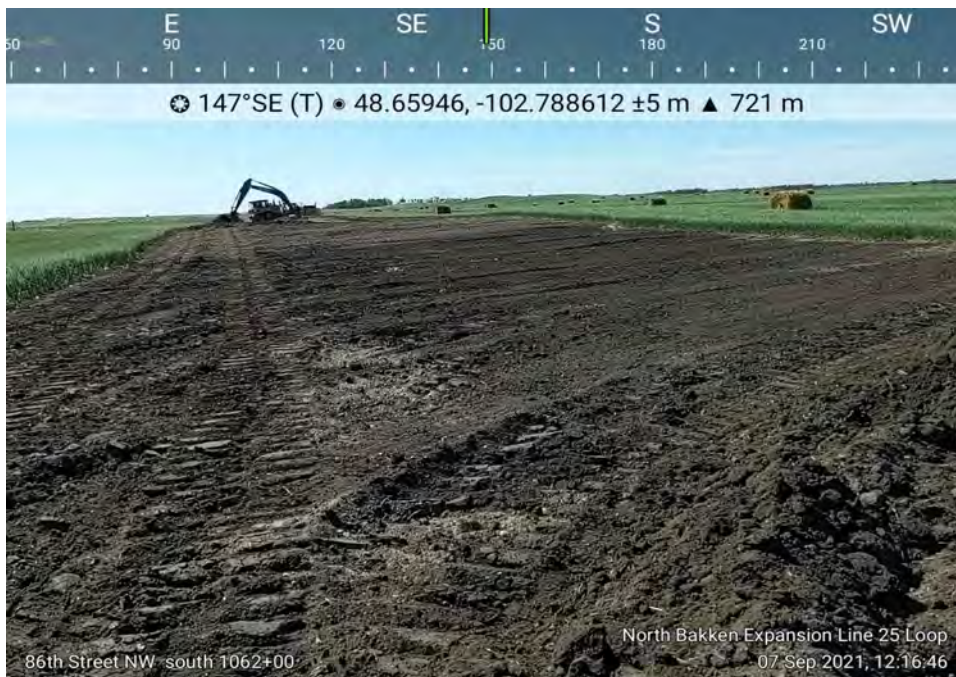
Location:
Sta. No. 1062+00

Notes: Final grading
activities on the Line
Section 25 Loop.

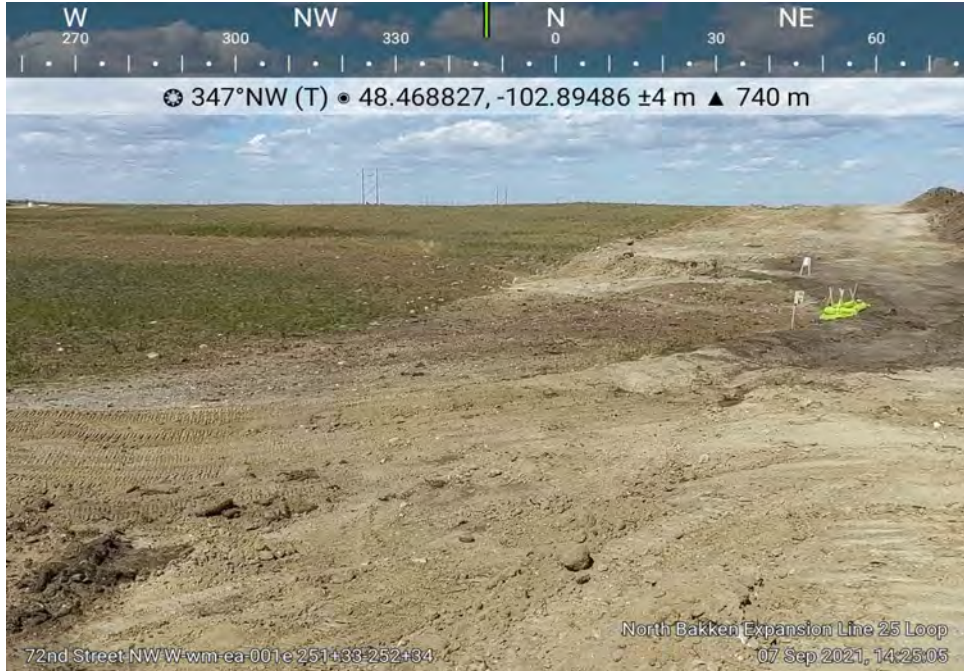
Location:
Sta. No. 251+33 to
252+34

Notes: Removed silt fence and installed a water bar at wetland w-wm-ea-002 due to cattle damaging the silt fence on the Line Section 25 Loop.
