Re: WBI Energy Transmission, Inc.
Docket Nos. CP20-52-000 and CP20-52-001
North Bakken Expansion Project
Weekly Status Report No. 15

WBI Energy Transmission, Inc.
North Bakken Expansion Project Status Report No. 15
FERC Docket Nos. CP20-52-000
CP20-52-001

Reporting Period: September 6, 2021 through September 12, 2021

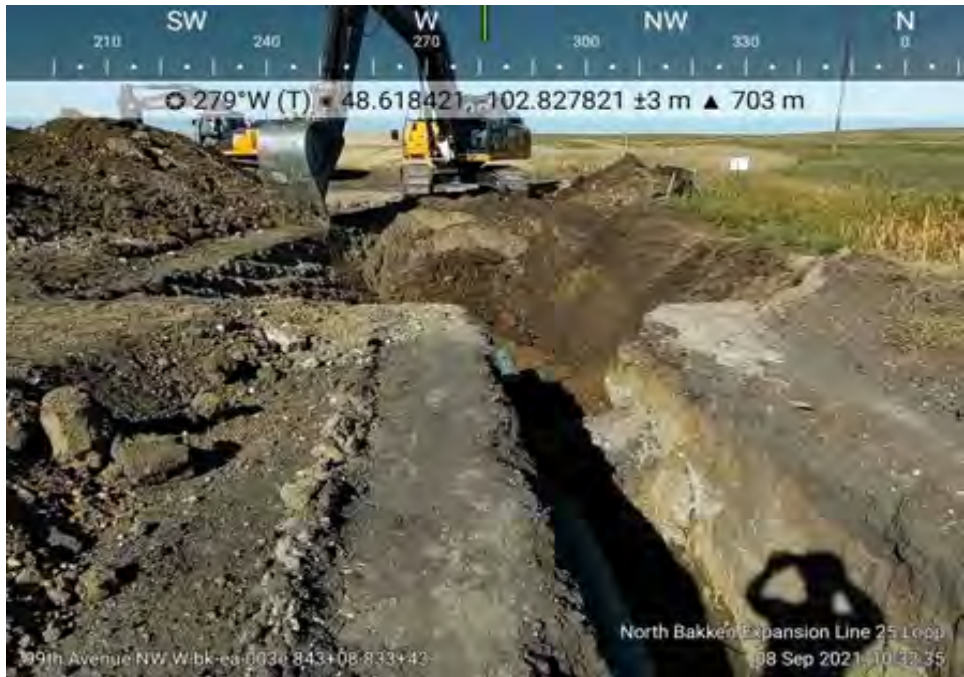
Location:
Sta. No. 840+00 to
845+00

Notes: Tie-in activities at wetland w-bk-ea-003e on the Line Section 25 Loop.

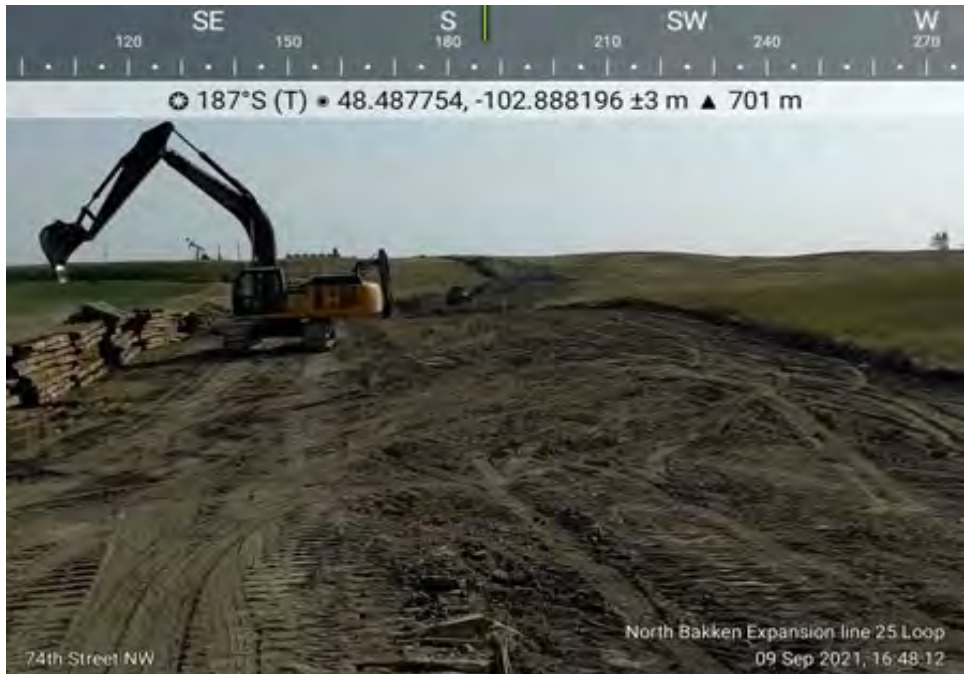
Location:
Sta. No. 315+00

Notes: Grading activities and removal of timber mats on the Line Section 25 Loop.

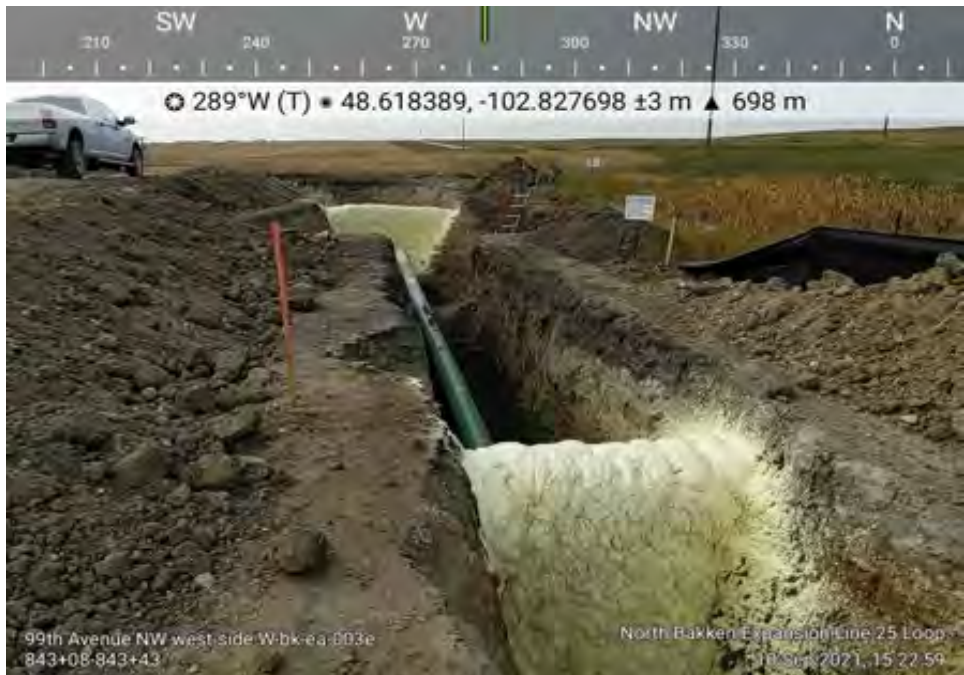
Location: Sta. No.
843+08 to 843+43

Notes: Installed trench breakers on the east and west sides of wetland w-bk-ea-003e on the Line Section 25 Loop.

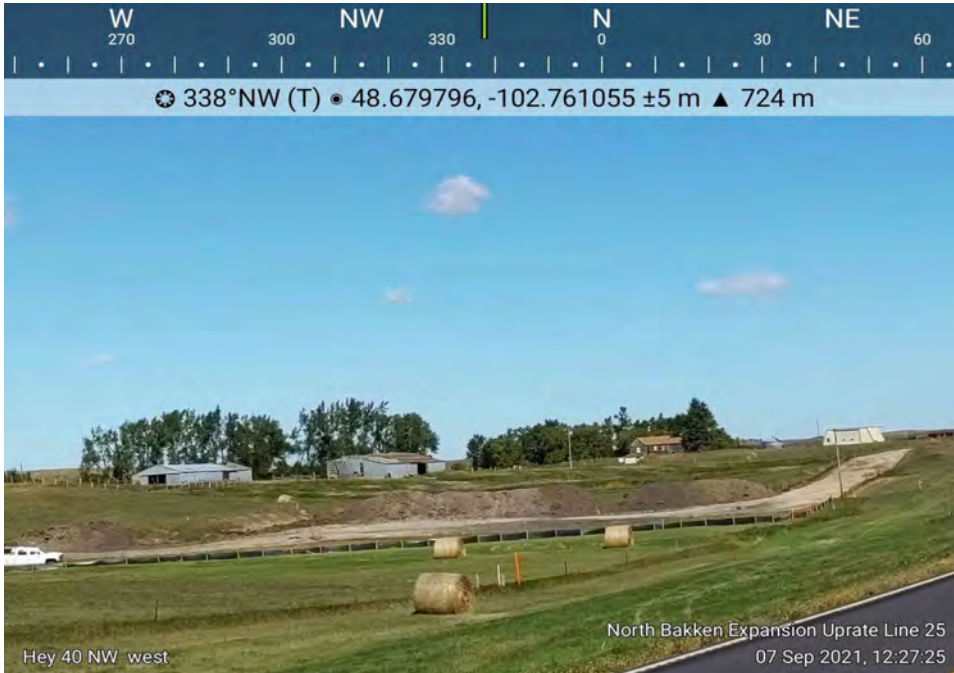
Location: Sta. No. 6+76 to 12+31

Notes: Clearing / grading activities for the bore string on the Highway 40 bore site.

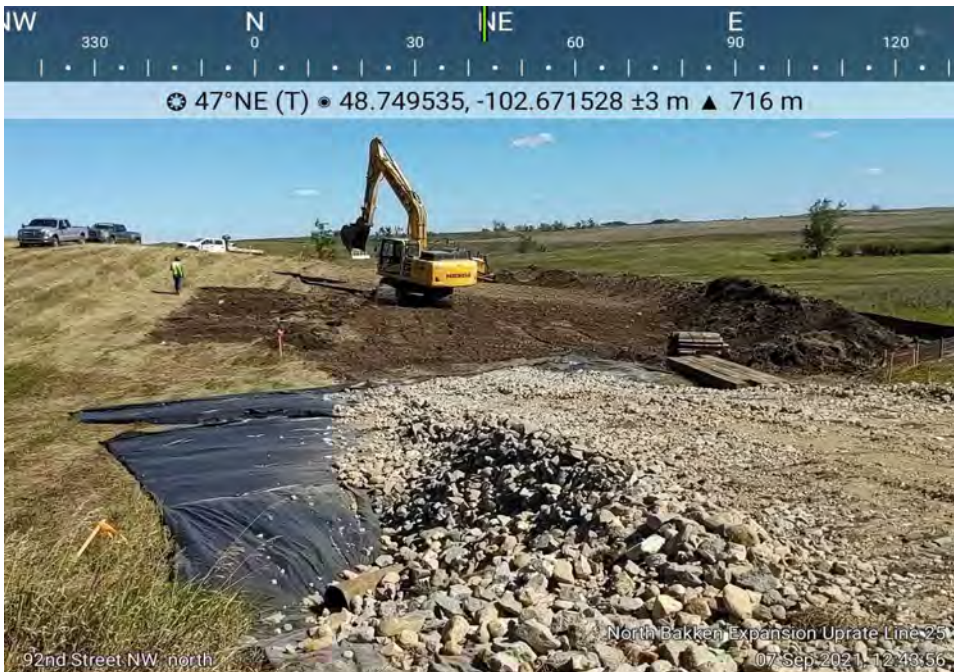
Location: Sta. No. 568+00 to 578+00

Notes: Clearing / grading activities for the bore string on the 92nd Street bore site.

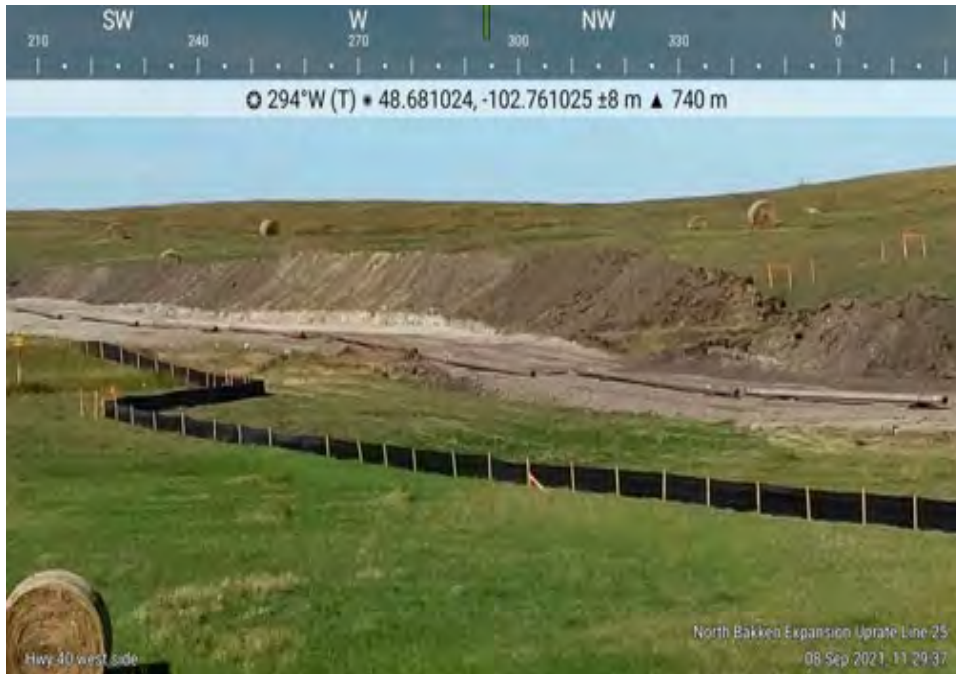
Location: Sta. No. 6+76 to 12+31

Notes: Bore pipe strung for the Highway 40 bore site.

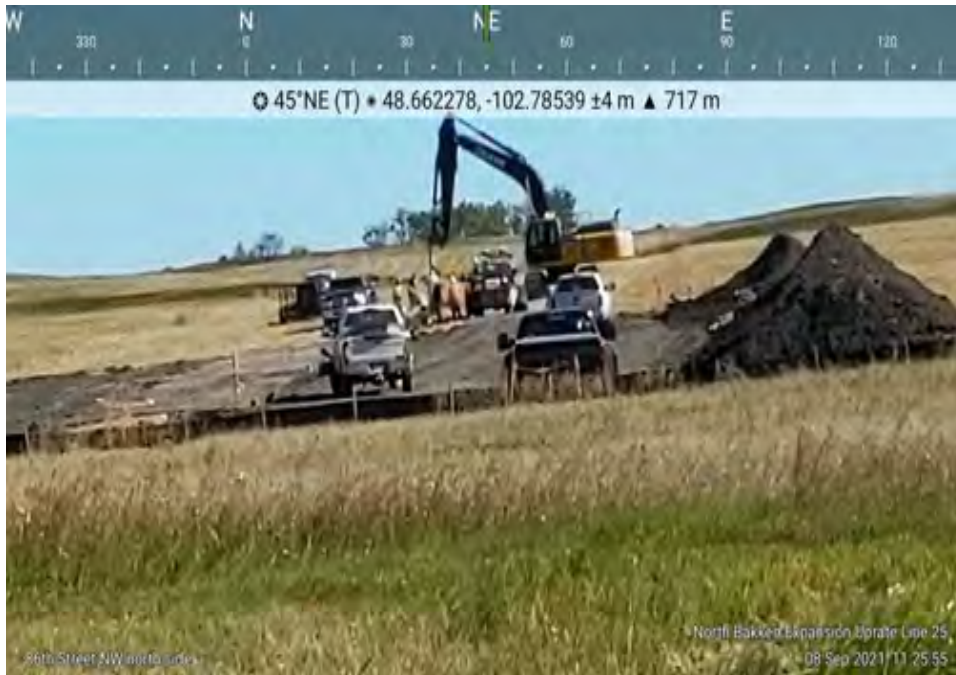
Location: Sta. No. 12+30

Notes: Welding of bore pipe on the 86th Street NW bore site.

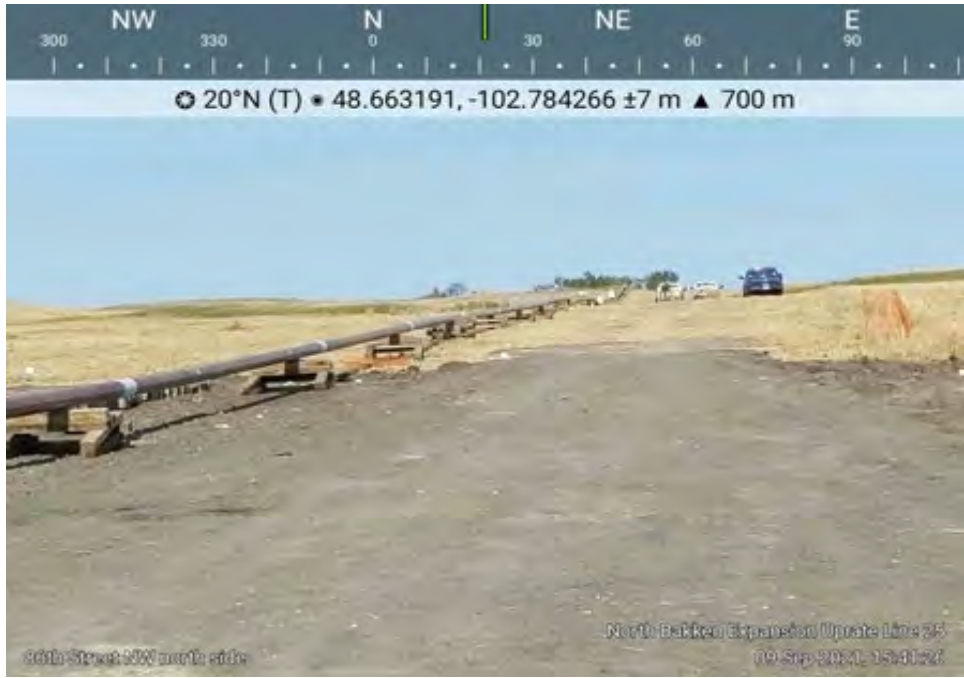
Location:
Sta. No. 12+30

Notes: Joint coating
of bore pipe on the
86th Street NW bore
site.

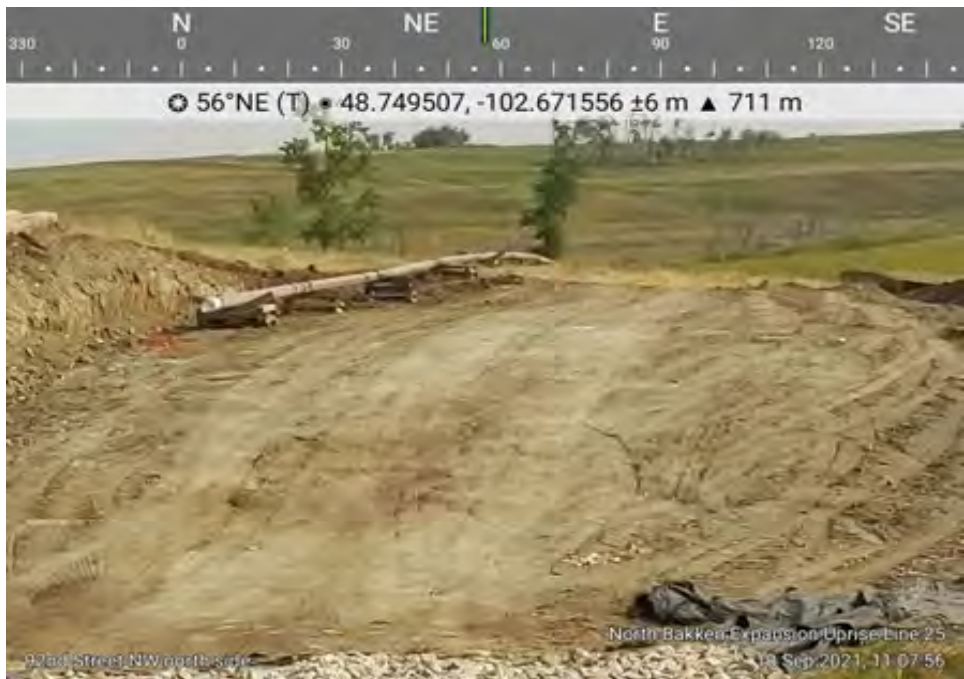
Location: Sta. No.
568+00 to 578+00

Notes: Welded bore
pipe on the 92nd Street
bore site.

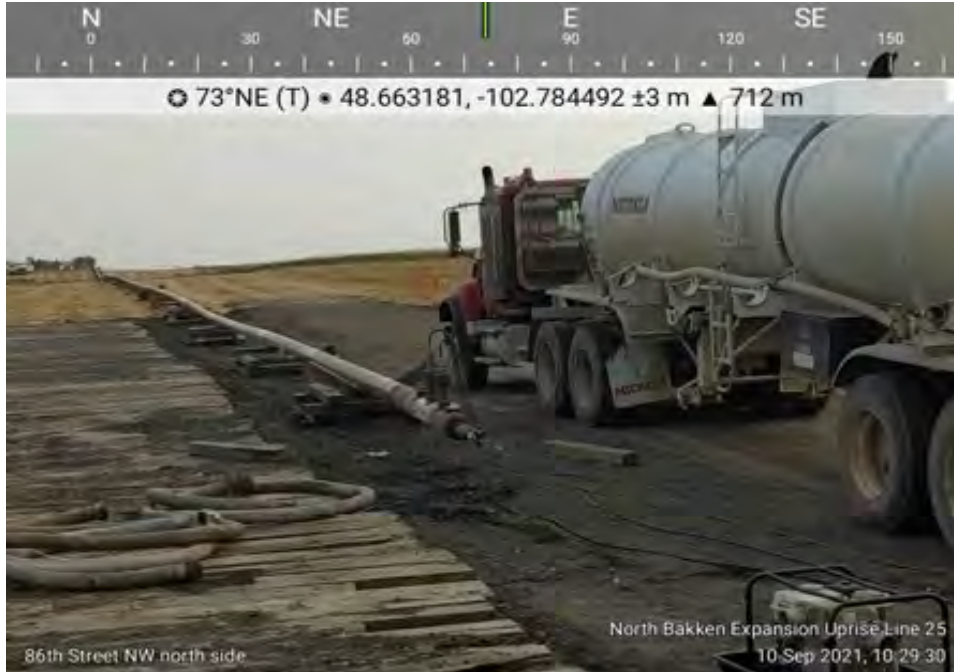
Location:
Sta. No. 12+30

Notes: Hydrostatic testing of bore pipe on the 86th Street NW bore site.

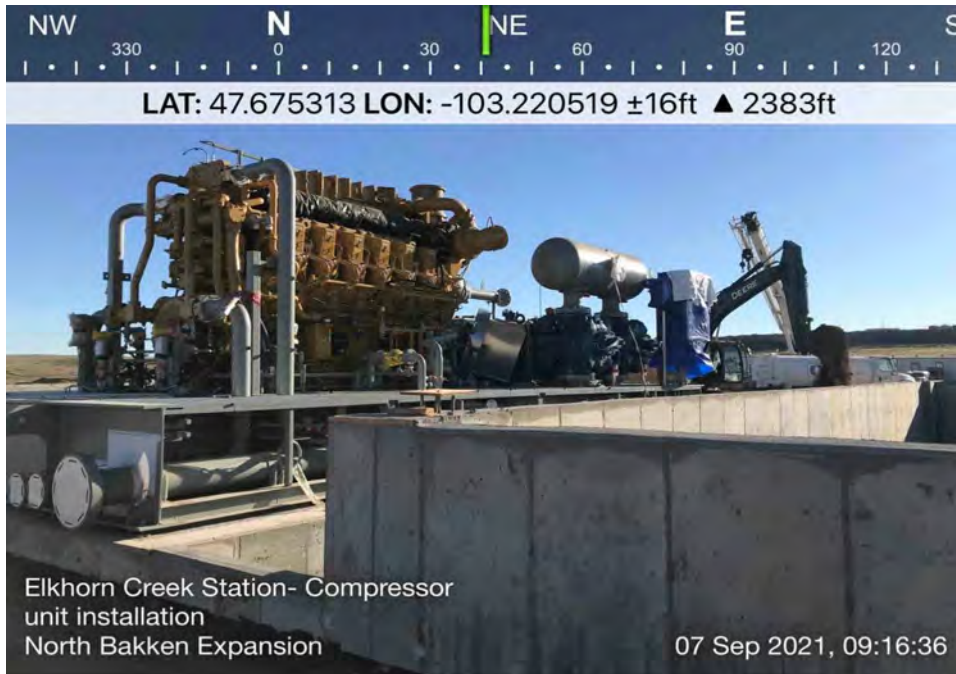
Location: Elkhorn Creek Compressor Station

Notes: Completed setting compressor unit and cooler.

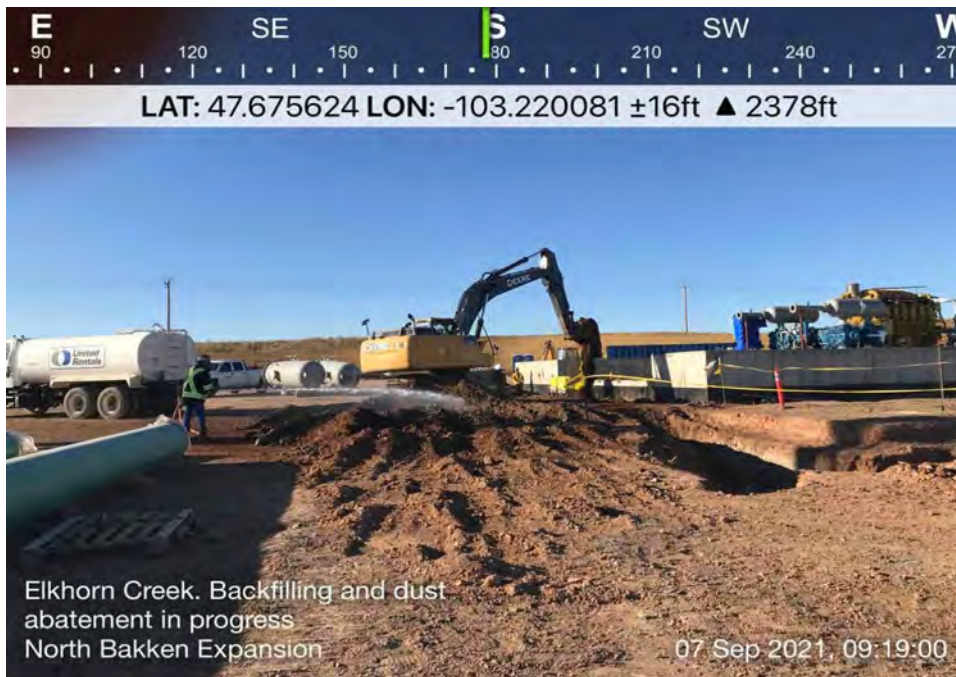
Location: Elkhorn Creek Compressor Station

Notes: Backfilling around foundation of Compressor building.

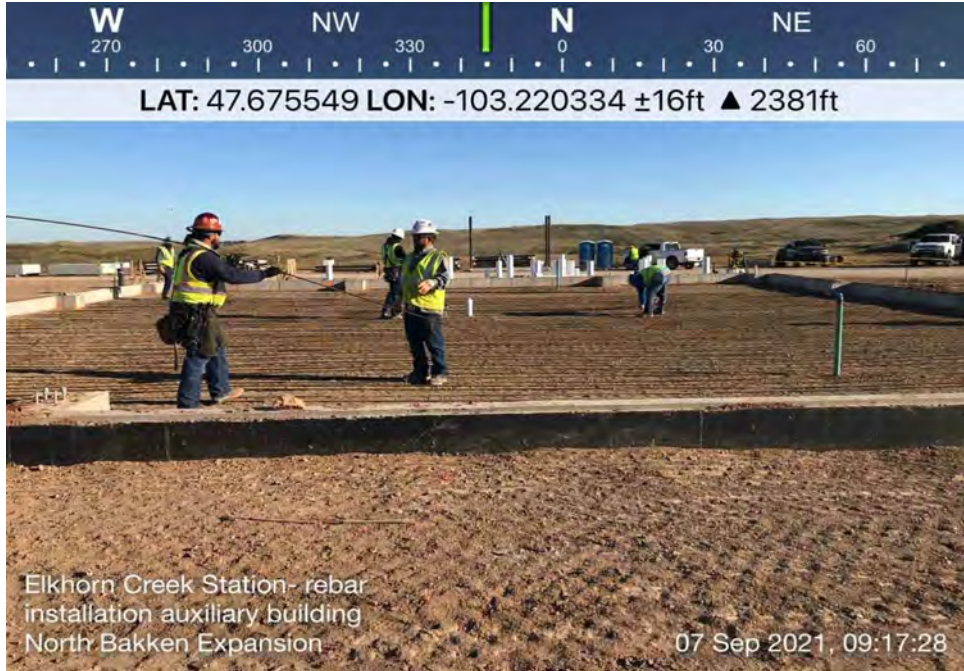
Location: Elkhorn Creek Compressor Station

Notes: Installation of rebar at the Auxiliary building.

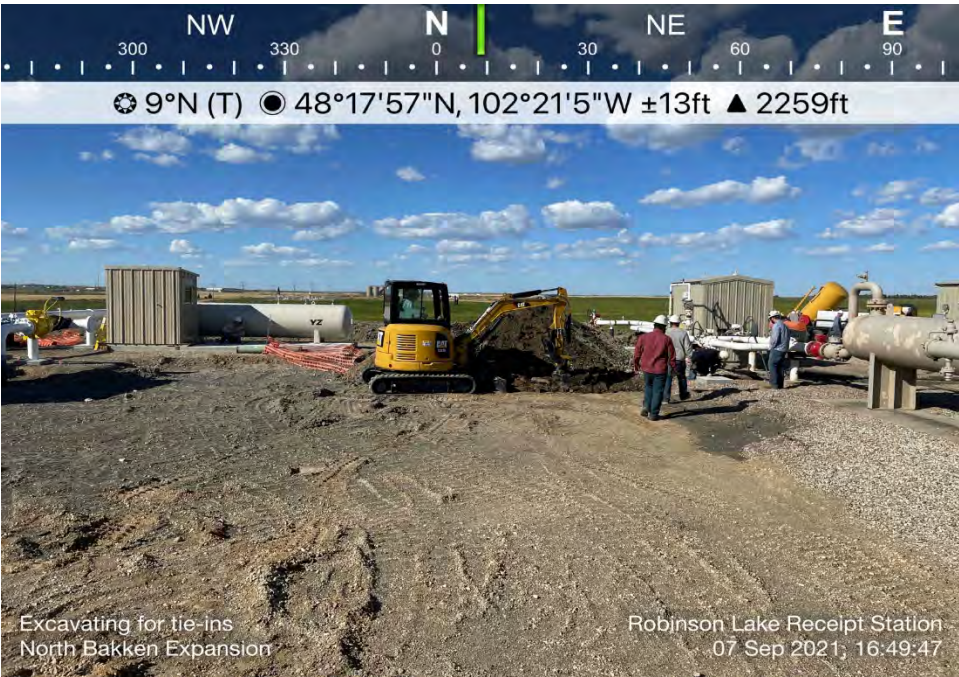
Location: Robinson Lake Receipt Station

Notes: Excavation for tie-in activities.
