Re: WBI Energy Transmission, Inc.  
Docket Nos. CP20-52-000 and CP20-52-001  
North Bakken Expansion Project  
Weekly Status Report No. 16

**WBI Energy Transmission, Inc.**  
**North Bakken Expansion Project Status Report No. 16**  
**FERC Docket Nos. CP20-52-000**  
**CP20-52-001**

**Reporting Period:** September 13, 2021 through September 19, 2021

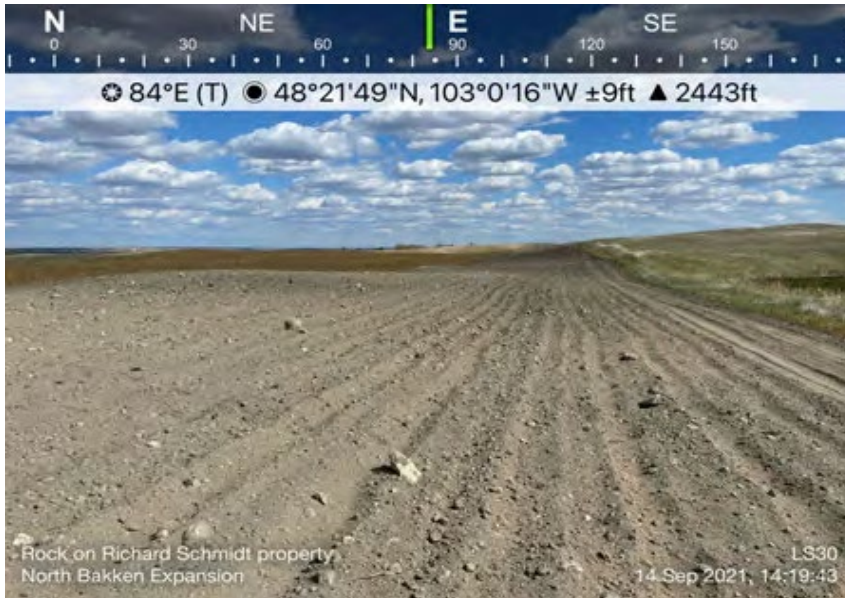
Location:  
Sta. No. 93+00

Date	Name	Milepost / Alignment Sheet #	Problem/Concern	Corrective Action
9/14/2021	Richard Schmidt	Mileposts 1.6 – 2.5 Sheet 1	The landowner had concerns of rocks located immediately below the surface in his cultivated fields. The landowner had tilled the restored right-of-way and a significant amount of medium to large rock had been brought to the surface.	It was recommended performing additional rock picking in this area to comply with FERC's Plan and Procedures. The contractor has been directed to complete additional rock picking in order to close out the concern.

Notes: Rocks brought to the surface following restoration of the right-of-way.

Rock on Richard Schmidt property  
North Bakken Expansion  
LS30  
14 Sep 2021, 14:19:43

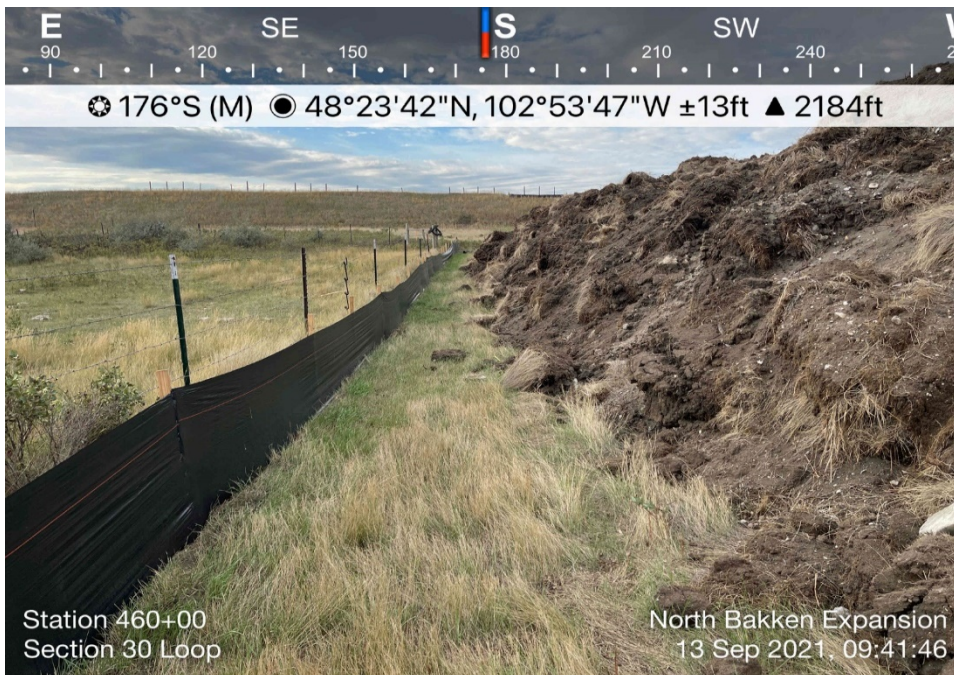
Location:  
Sta. No. 460+00

Notes: Erosion control devices intact and topsoil segregated on the Line Section 30 Loop.

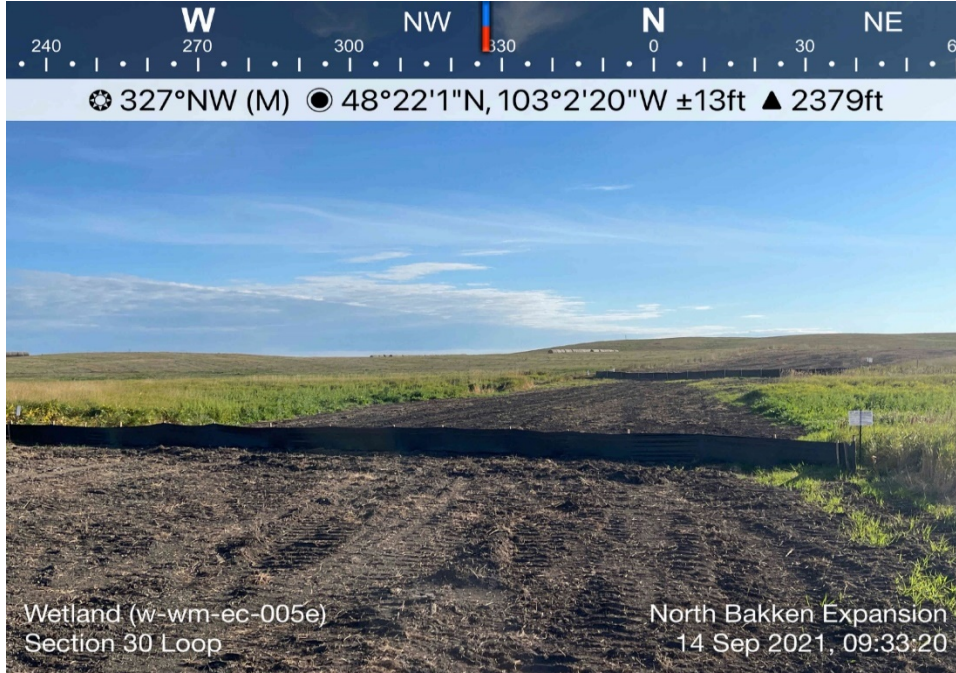
Location: Sta. Nos. 14+70 to 16+65

Notes: Erosion control devices intact at boundaries of wetland w-wm-ec-005e on the Line Section 30 Loop.

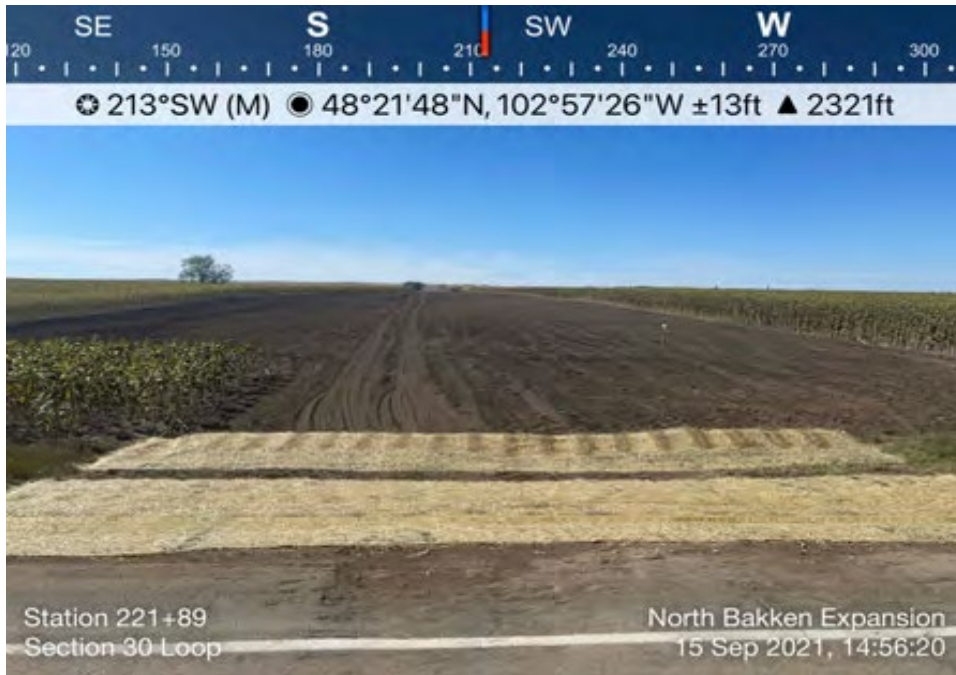
Location: Sta. No. 221+89

Notes: Reseeded and installed erosion control blankets at the bar ditch off of 105<sup>th</sup> Avenue NW along Line Section 30 Loop.

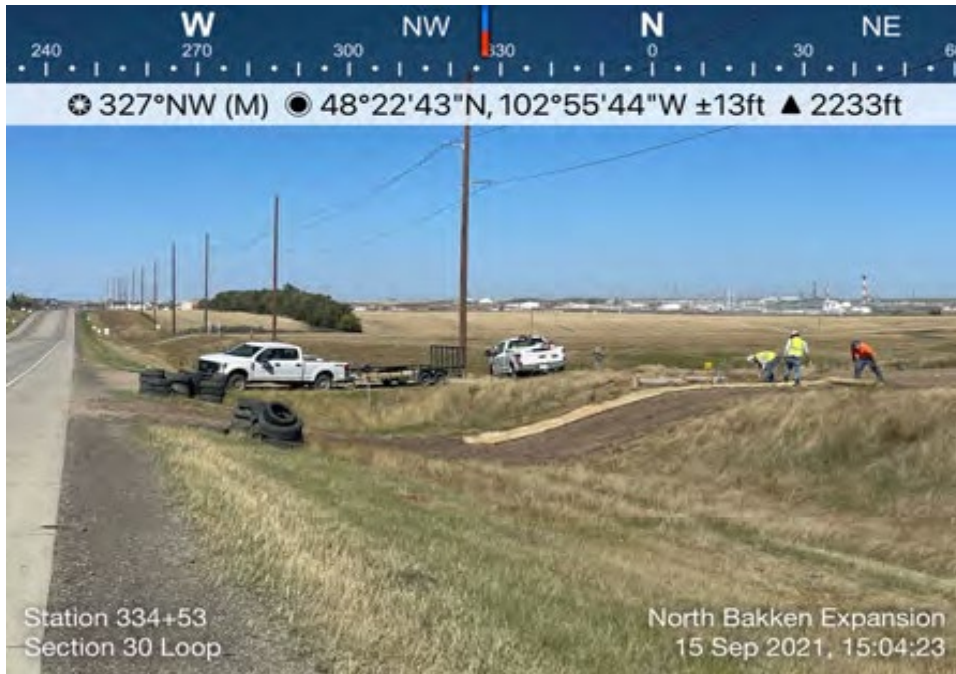
Location:  
Sta. No. 334+53

Notes: Installation of erosion control blankets at the bar ditch at Highway 40 along Line Section 30 Loop.

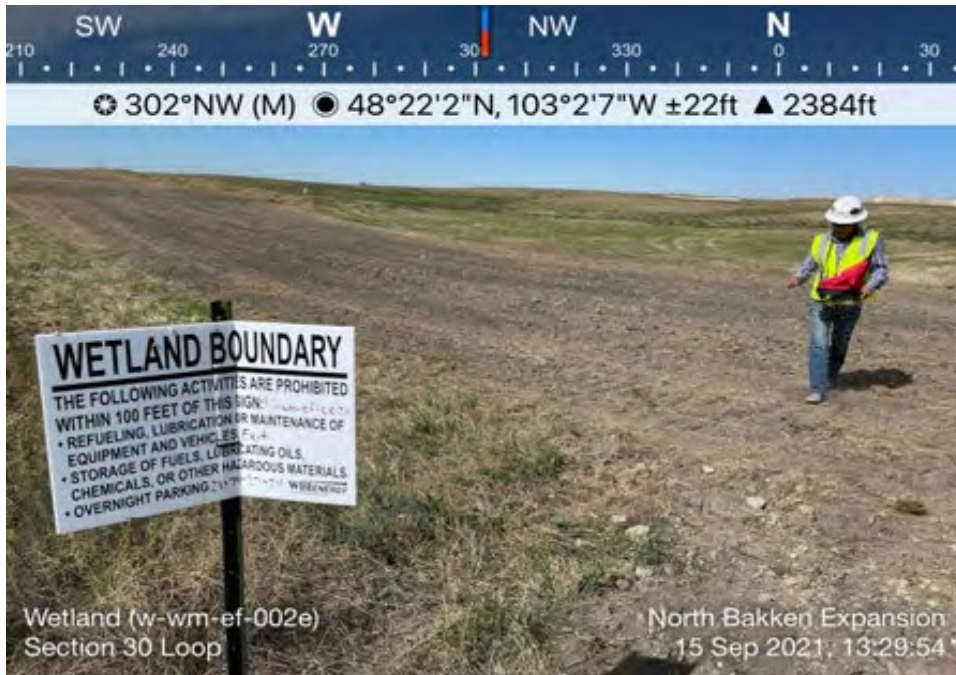
Location: Sta. Nos.  
21+78 to 23+24

Notes: Reseeding wetland w-wm-ef-002e with annual ryegrass on the Line Section 30 Loop.

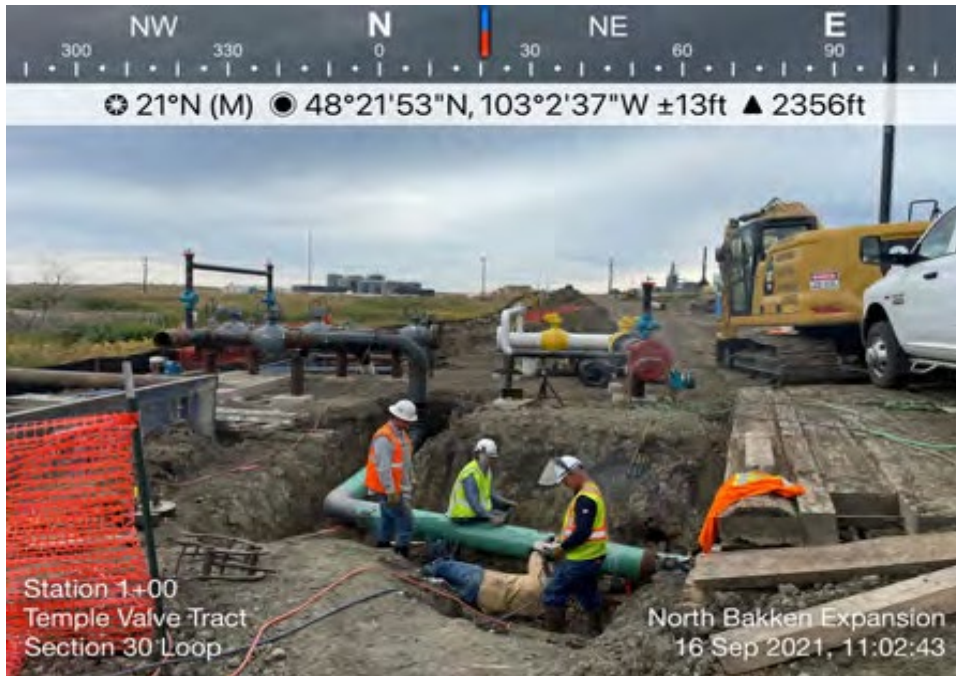
Location:  
Sta. No. 1+00

Notes: Began the tie-in of the Temple valve setting to the existing Line Section 30 and the Line Section 30 Loop.

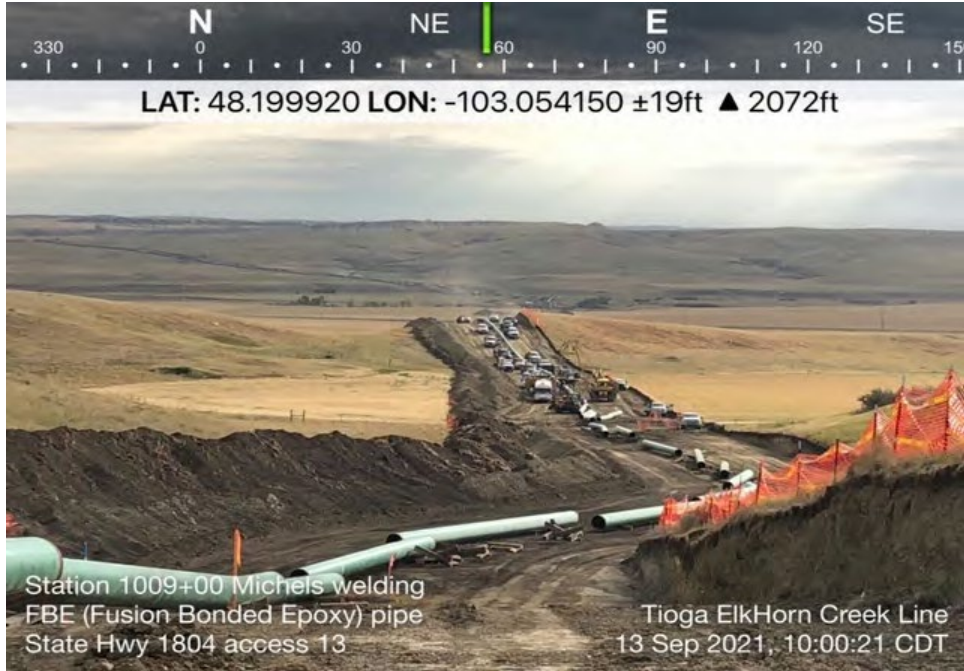
Location:  
Sta. No. 1009+00

Notes: Welding activities on the Tioga-Elkhorn Creek Pipeline.

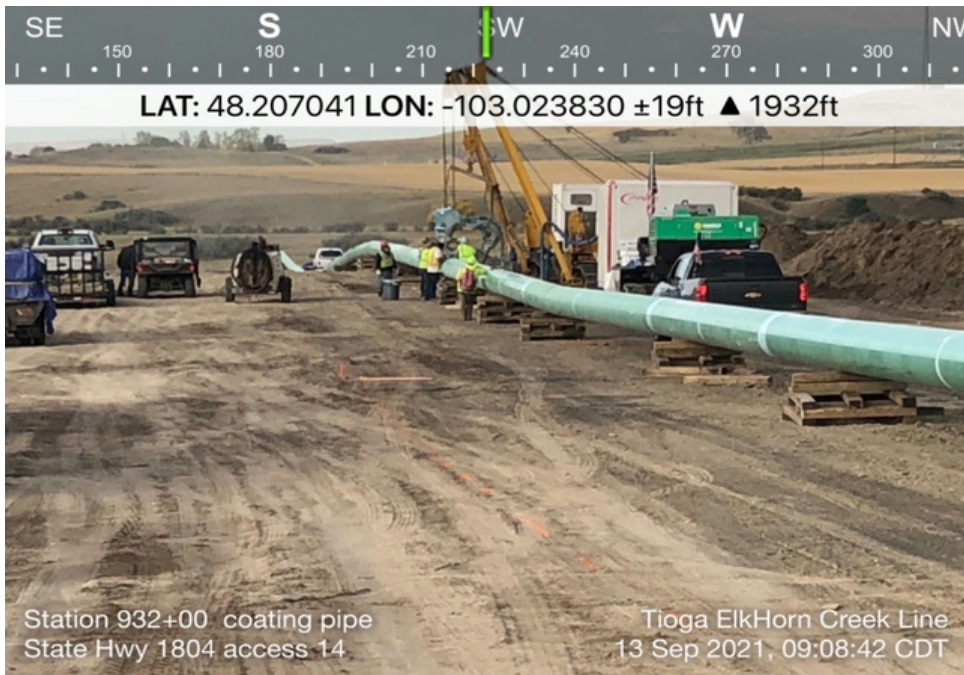
Location:  
Sta. No. 932+00

Notes: Pipe coating activities along the Tioga-Elkhorn Creek Pipeline.

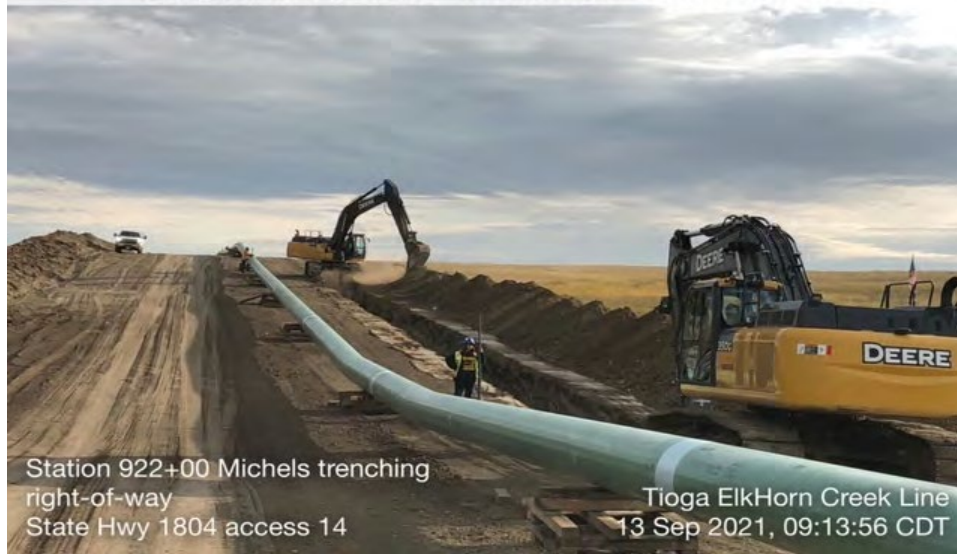
Location:  
Sta. No. 902+00

Notes: Trenching activities along the Tioga-Elkhorn Creek Pipeline.

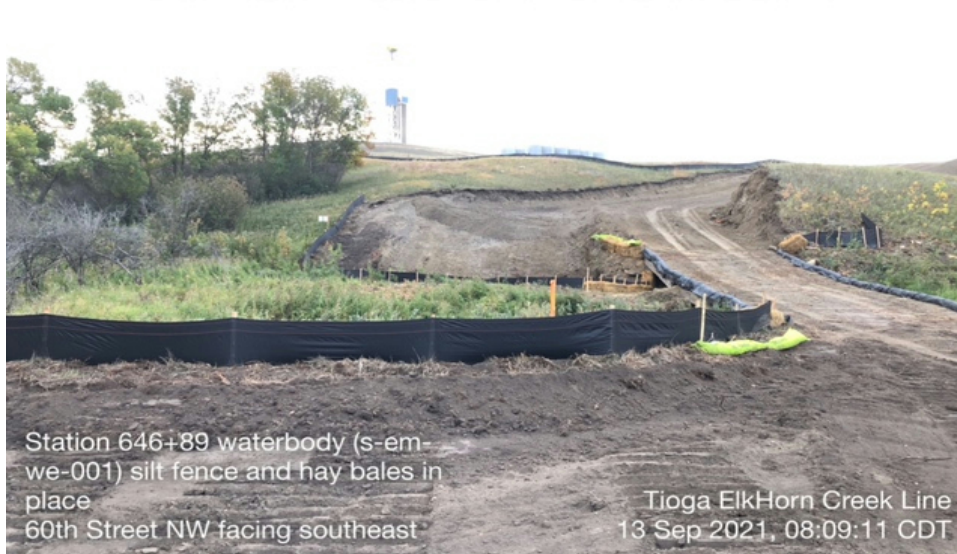
Location:  
Sta. No. 646+89

Notes: Erosion control devices intact at waterbody s-wm-ee-001 on the Tioga-Elkhorn Creek Pipeline.

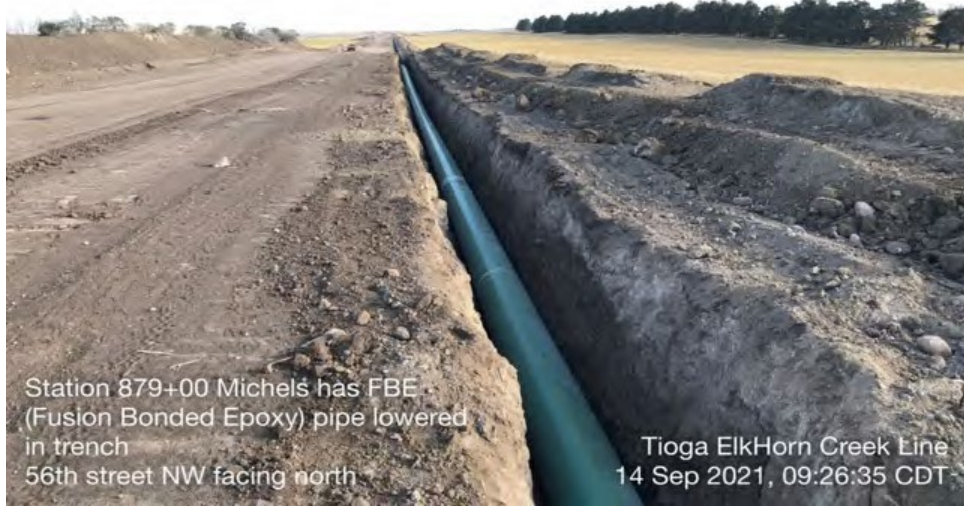
Location: Sta. No. 879+00

Notes: Pipe lowered in trench along the right-of-way of the Tioga-Elkhorn Creek Pipeline.

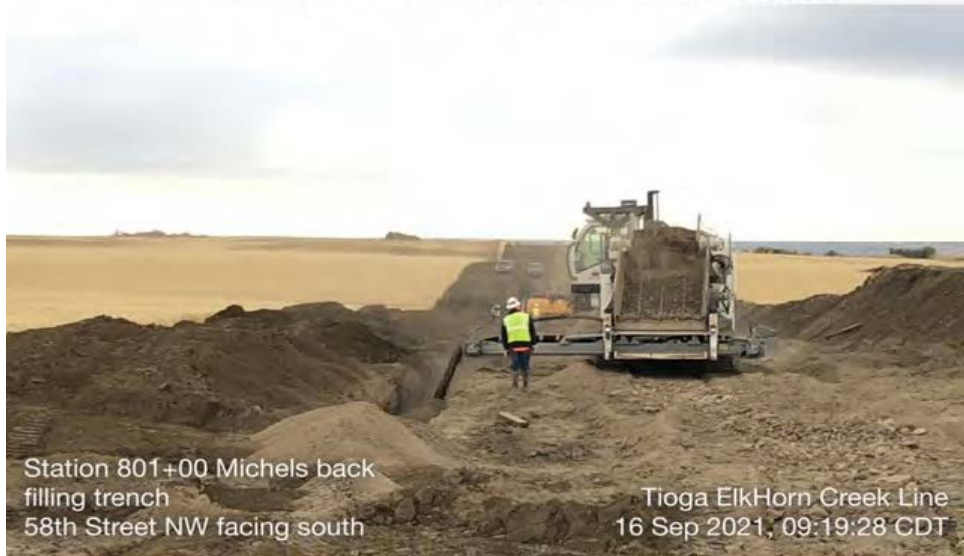
Location: Sta. No. 801+00

Notes: Backfilling activities on the Tioga-Elkhorn Creek Pipeline.

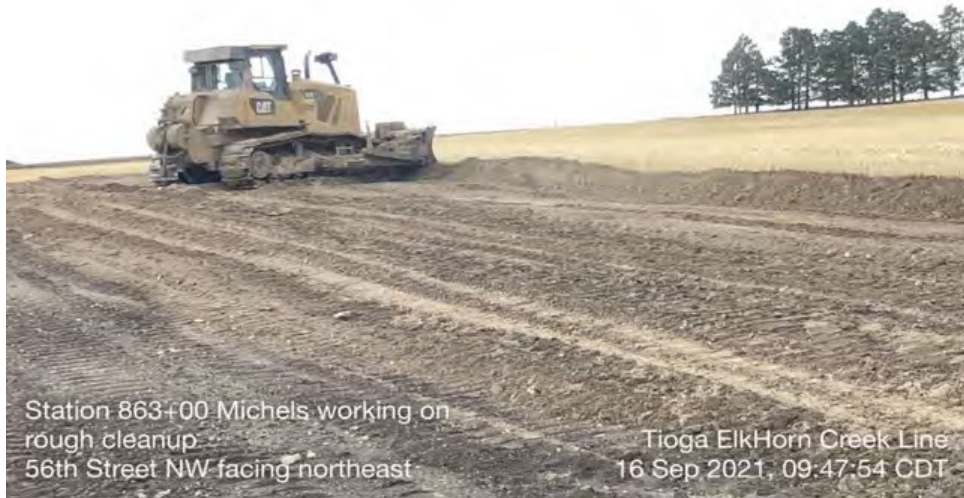
Location: Sta. No. 863+00

Notes: Rough cleanup of right-of-way along the Tioga-Elkhorn Creek Pipeline.

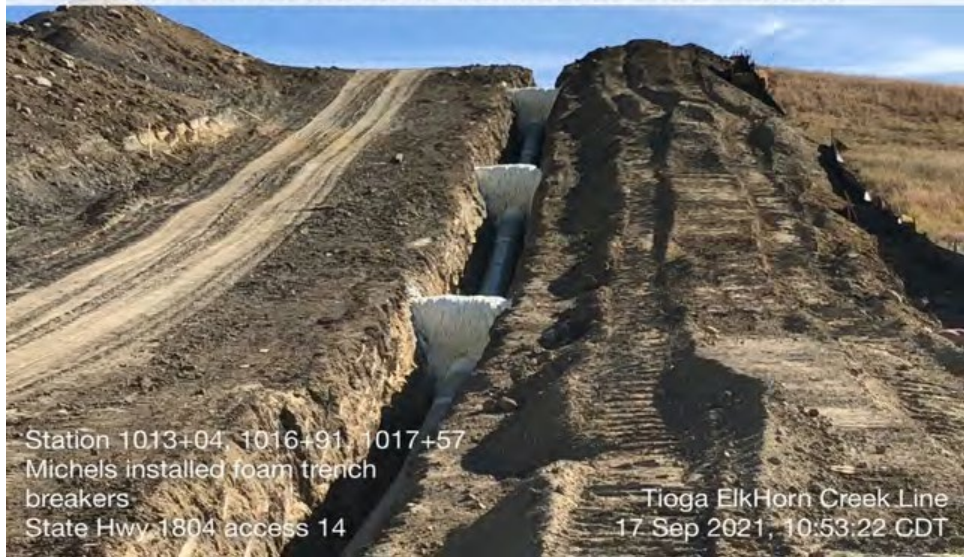
Location: Sta. No. 1013+04 to 1017+57

Notes: Installed trench breakers along the Tioga-Elkhorn Creek Pipeline.

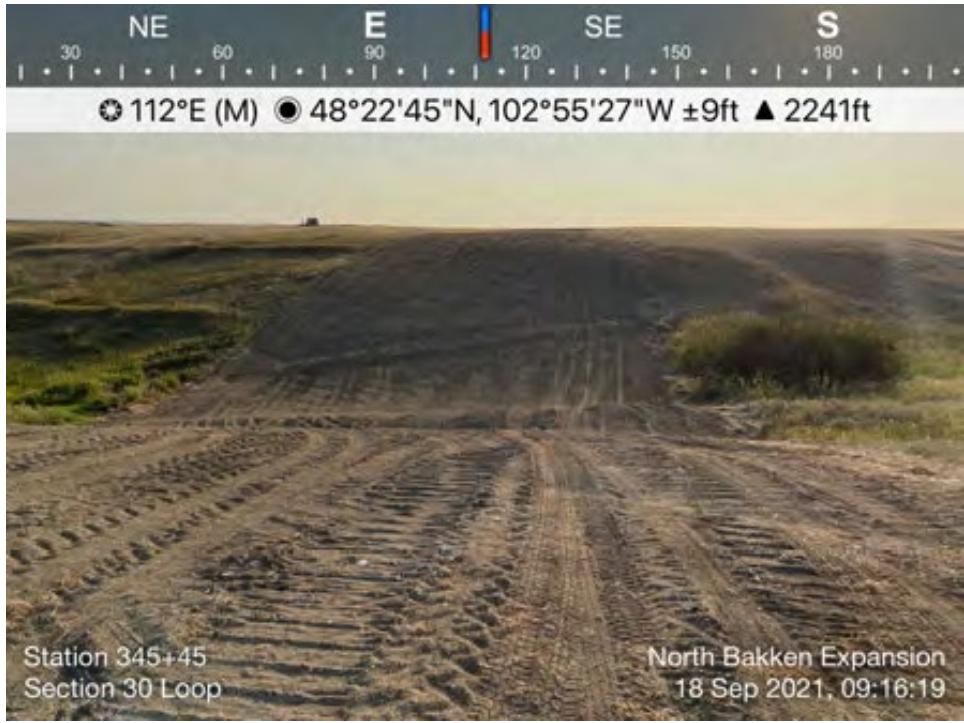
Location:  
Sta. No. 345+45

Notes: Slope breakers  
in place and properly  
functioning on the  
Tioga-Elkhorn Creek  
Pipeline.

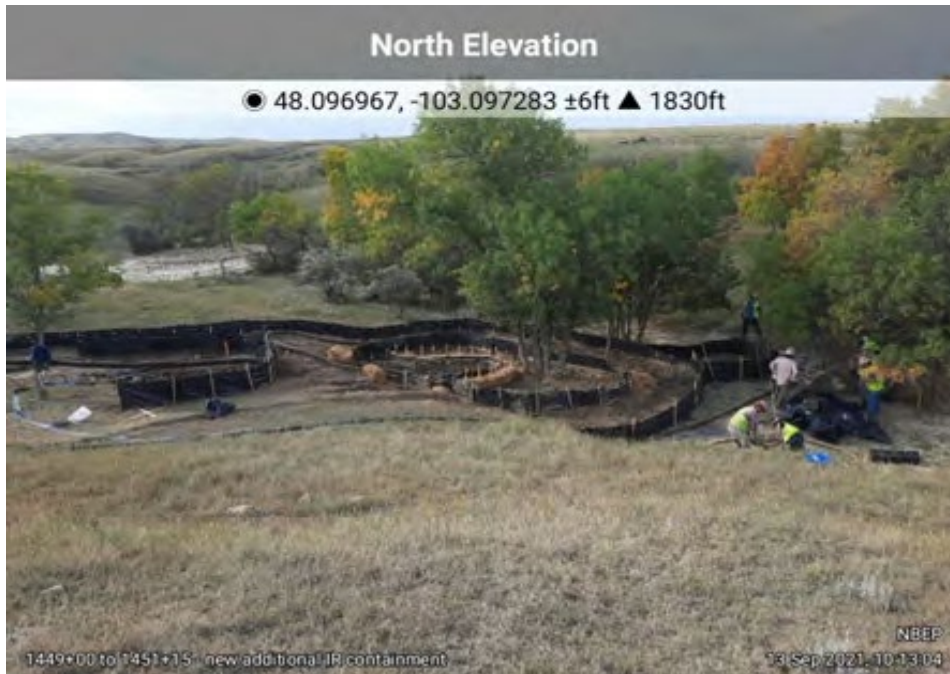
Location:  
Sta. Nos. 1449+00 to  
1451.15

Notes: Inadvertent  
release containment  
using temporary  
erosion control  
devices installed  
within the limit of  
disturbance on the  
Tioga-Elkhorn Creek  
Pipeline.

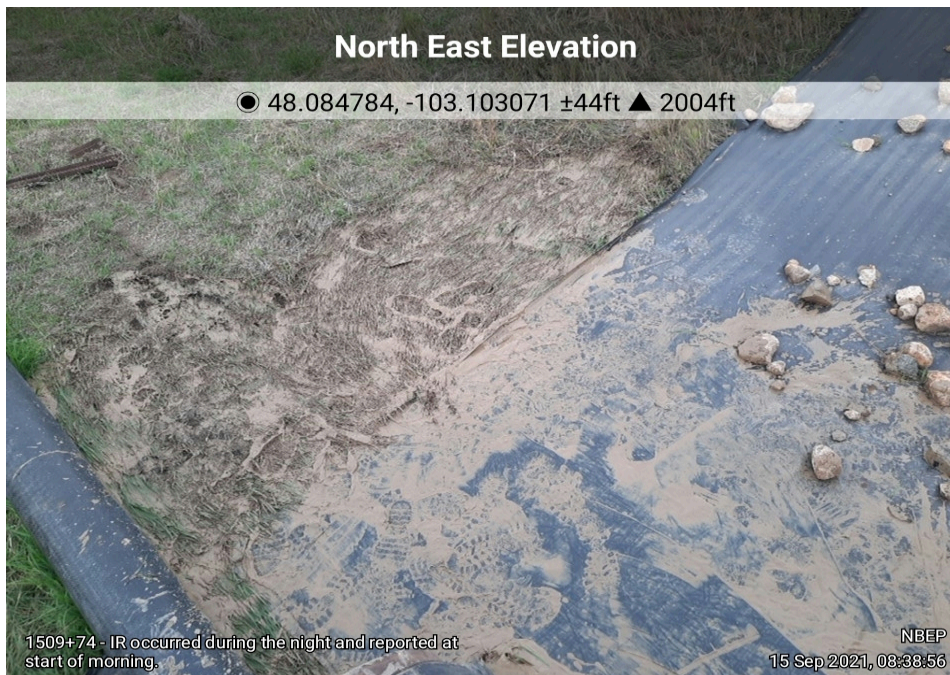
Location:  
Sta. No. 1509+74

Notes: An inadvertent  
release on the Tioga-  
Elkhorn Creek  
Pipeline.

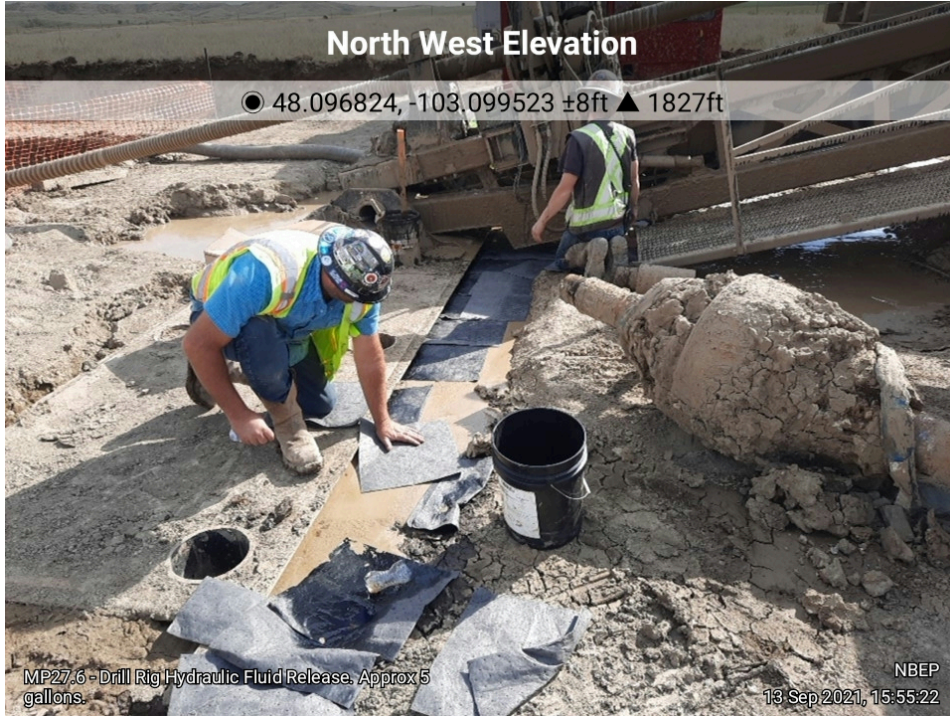
Location:  
Sta. No. 1455+80

Notes: Cleanup of a hydraulic fluid release on the Tioga-Elkhorn Creek Pipeline.

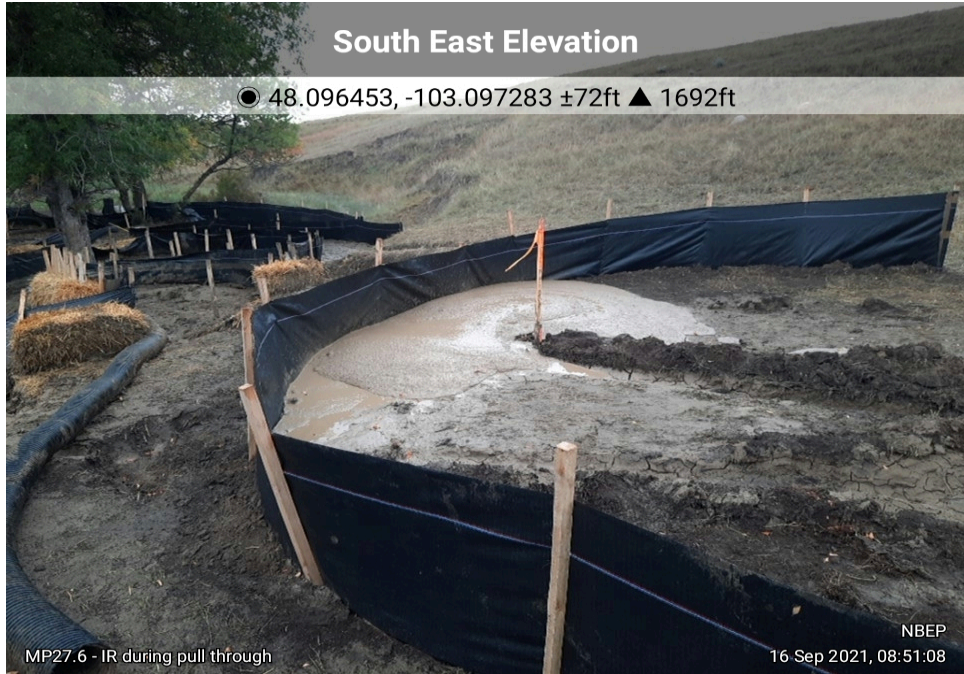
Location:  
Sta. No. 1450+50

Notes: Inadvertent release containment using temporary erosion control devices installed within the limit of disturbance on the Tioga-Elkhorn Creek Pipeline.

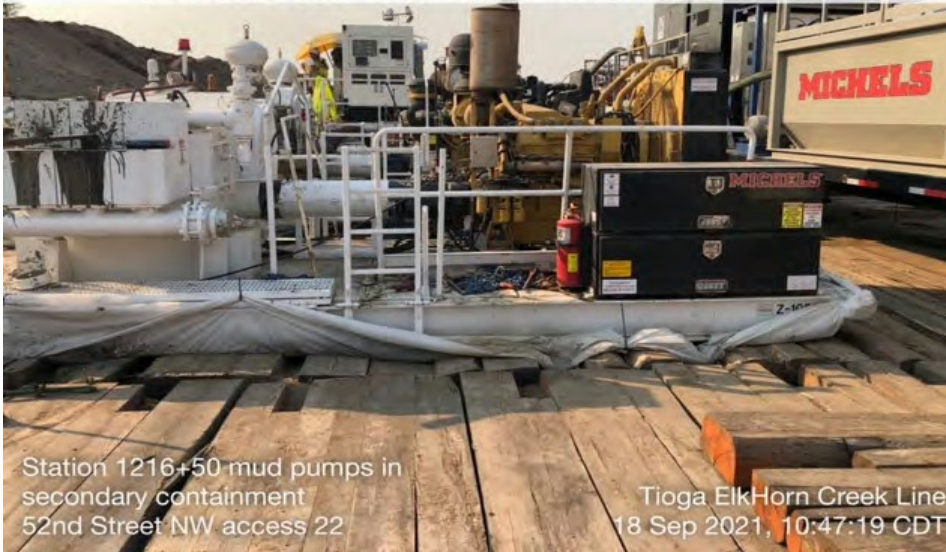
Location: North Spread HDD bore site.

Notes: HDD equipment within adequate secondary containment at the North Spread HDD bore site.

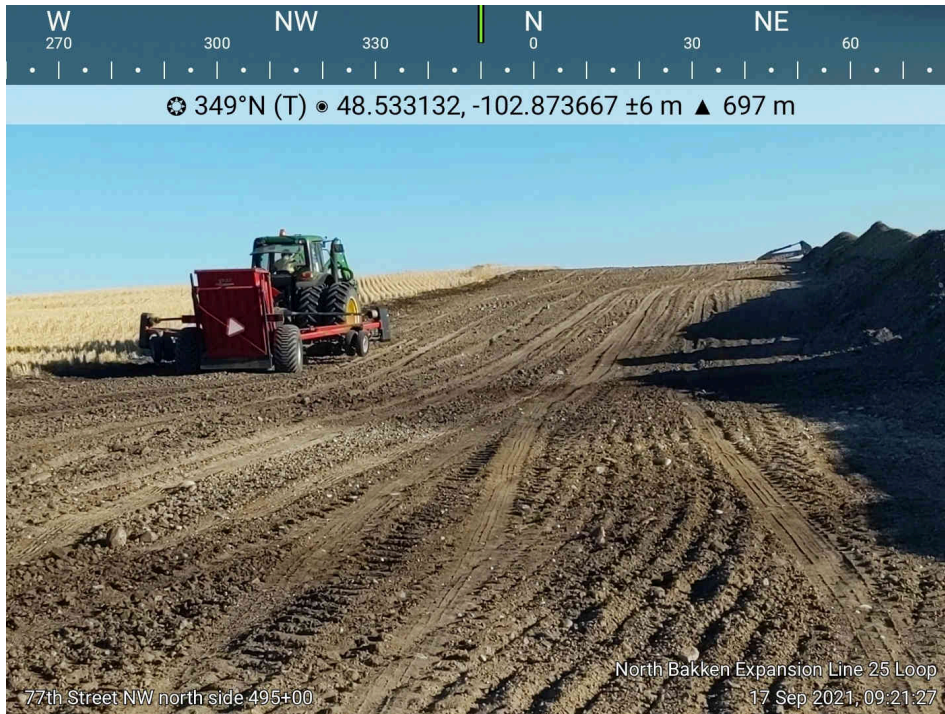
Location:  
Sta. No. 495+00

Notes: Picked rocks from subsoil prior to replacement of topsoil on the Line Section 25 Loop.

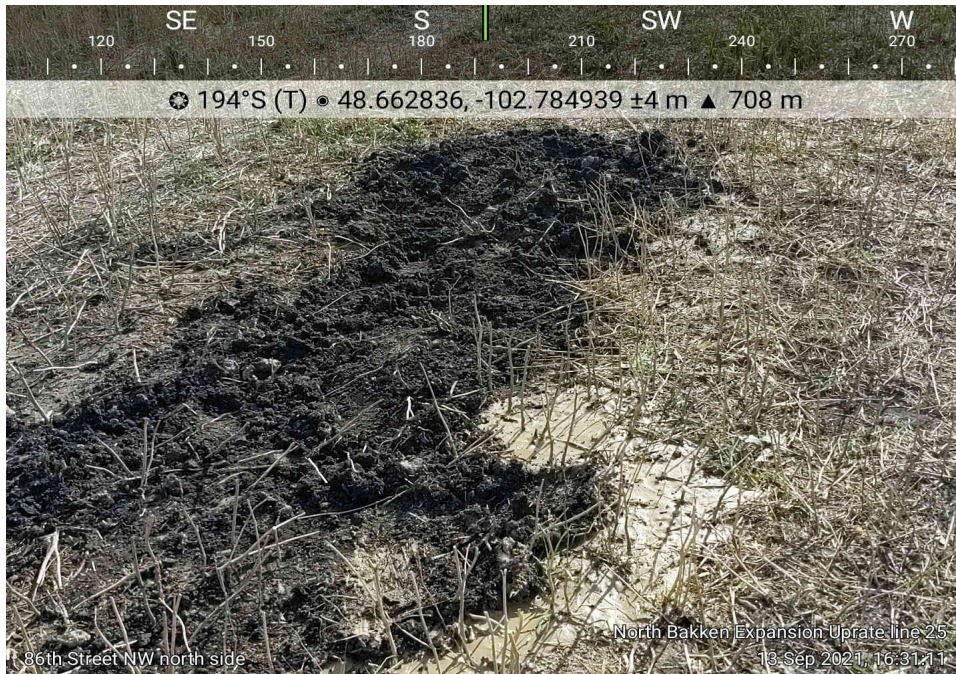
Location:  
Sta. No. 17+75

Notes: A partial cleanup of an inadvertent release at the 86<sup>th</sup> Street NW bore site.

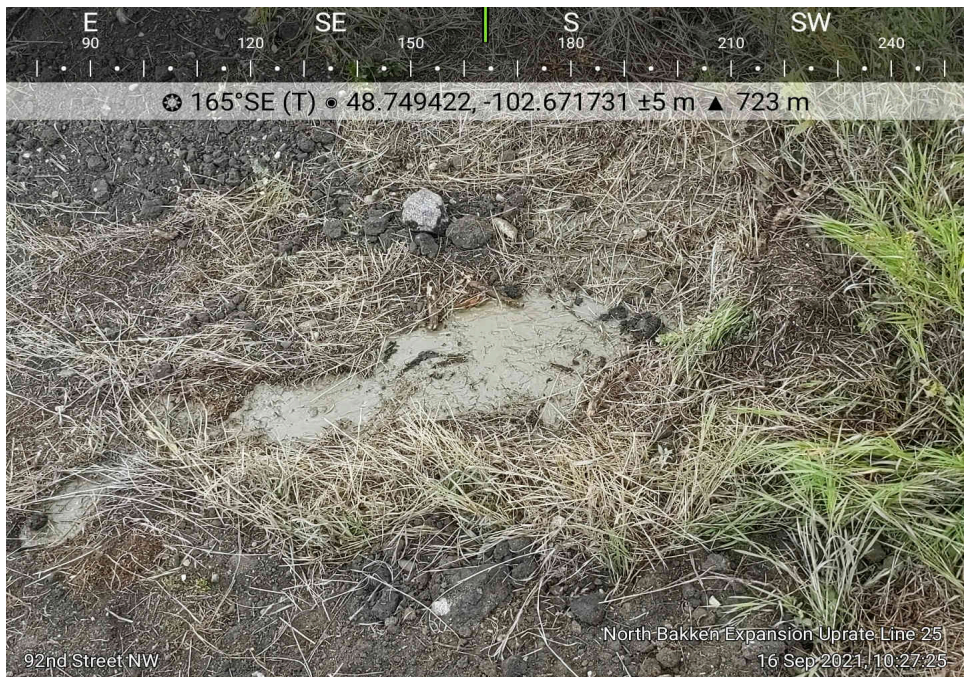
Location:  
Sta. No. 575+00

Notes: An  
inadvertent release  
south of the 92<sup>nd</sup>  
Street NW bore site.
