**WBI Energy Transmission, Inc.**  
**North Bakken Expansion Project Status Report No. 17**  
**FERC Docket Nos. CP20-52-000**  
**CP20-52-001**

**Reporting Period:** September 20, 2021 through September 26, 2021

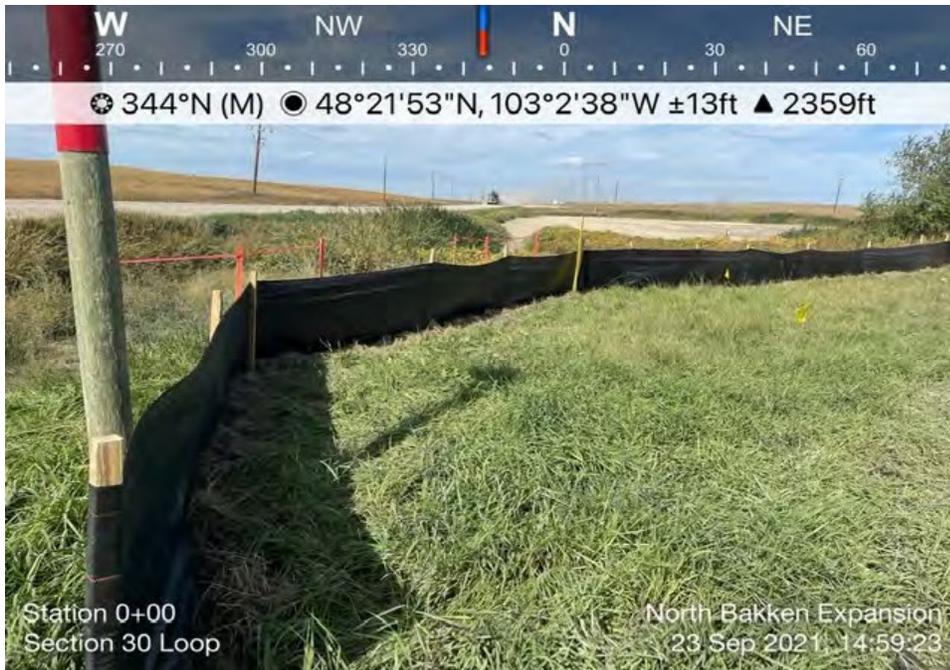
Location:  
Sta. No. 0+00

Notes: Erosion control devices intact on the Line Section 30 Loop.

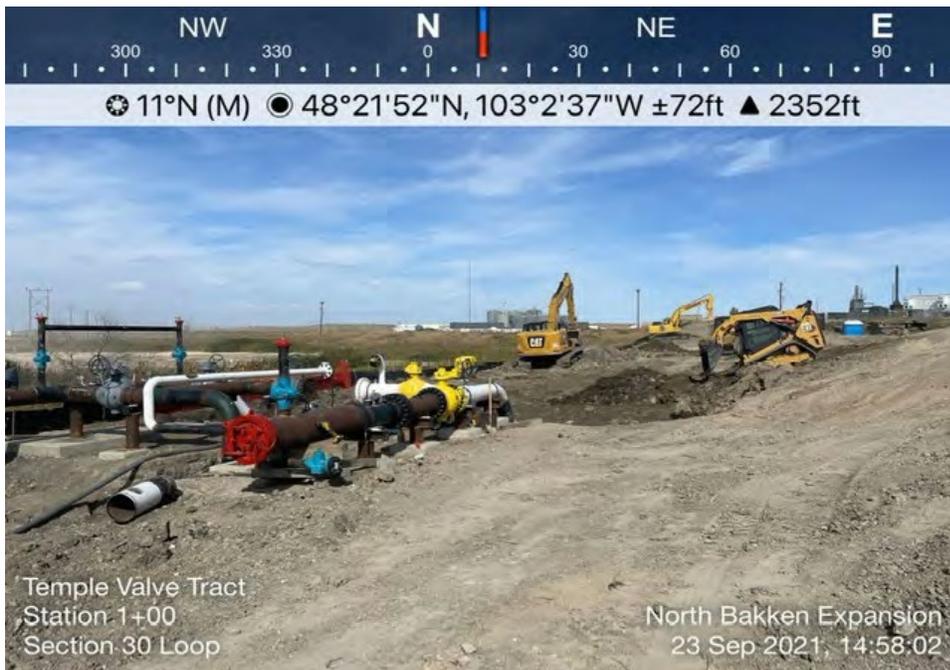
Location:  
Sta. No. 1+00

Notes: Backfilling and clean-up activities at the Temple valve setting.

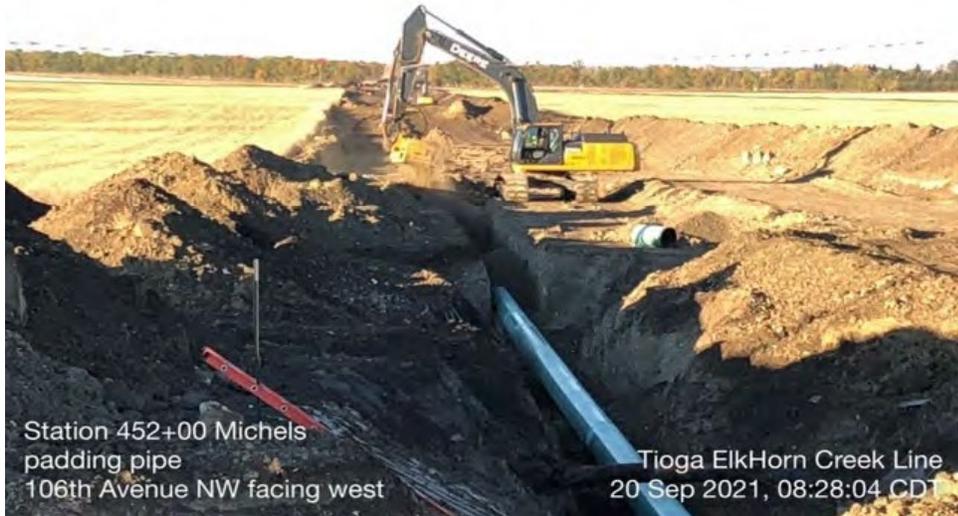
Location: Sta. No. 452+00

Notes: Padding activities on the Tioga-Elkhorn Creek Pipeline.

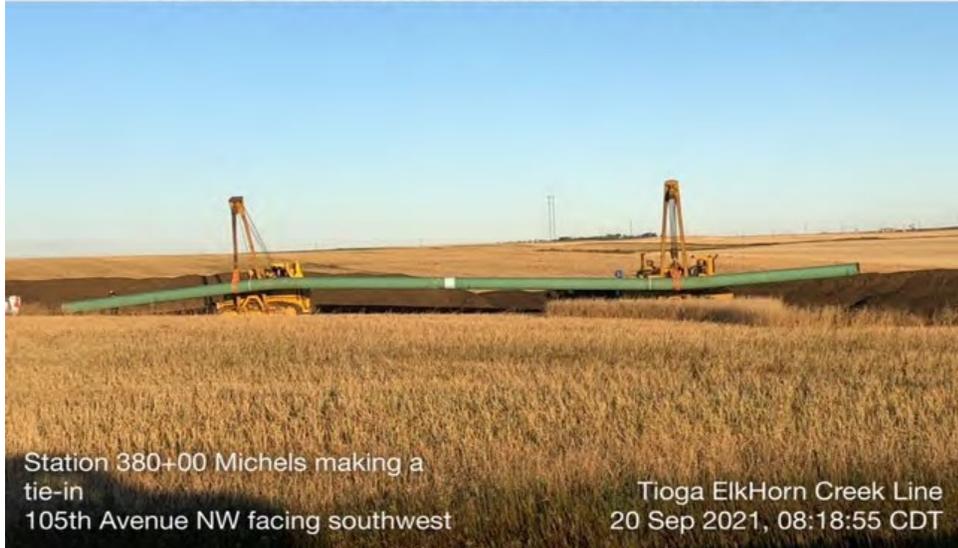
Location: Sta. No. 380+00

Notes: Tie-in activities along the Tioga-Elkhorn Creek Pipeline.

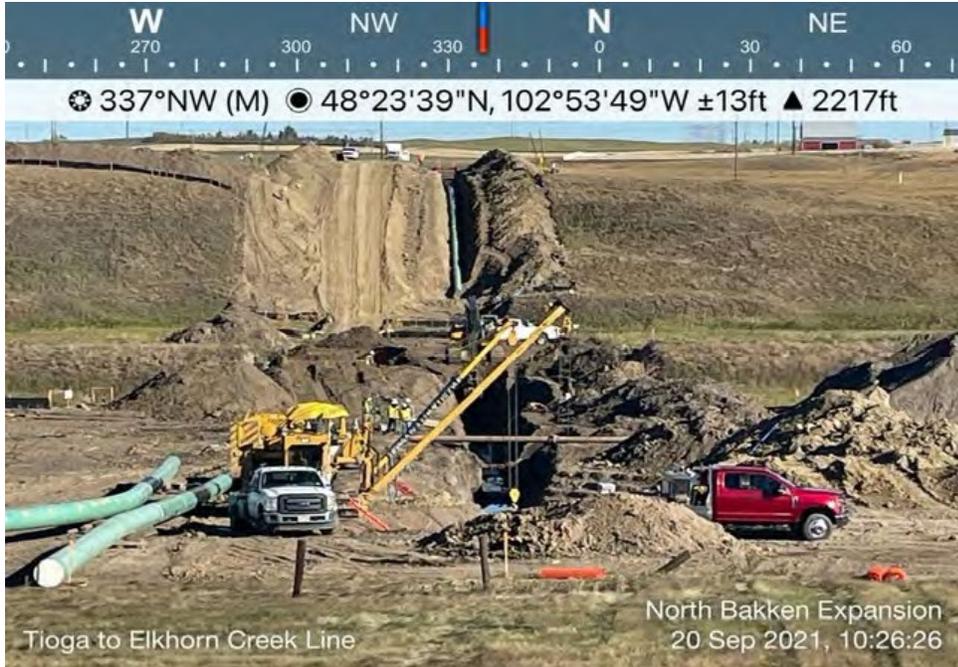
Location: Sta. Nos. 464+65 to 464+61

Notes: Lowering and tie-in of a prefabricated section of pipe at wetland w-wm-ea-006 on the Tioga-Elkhorn Creek Pipeline.

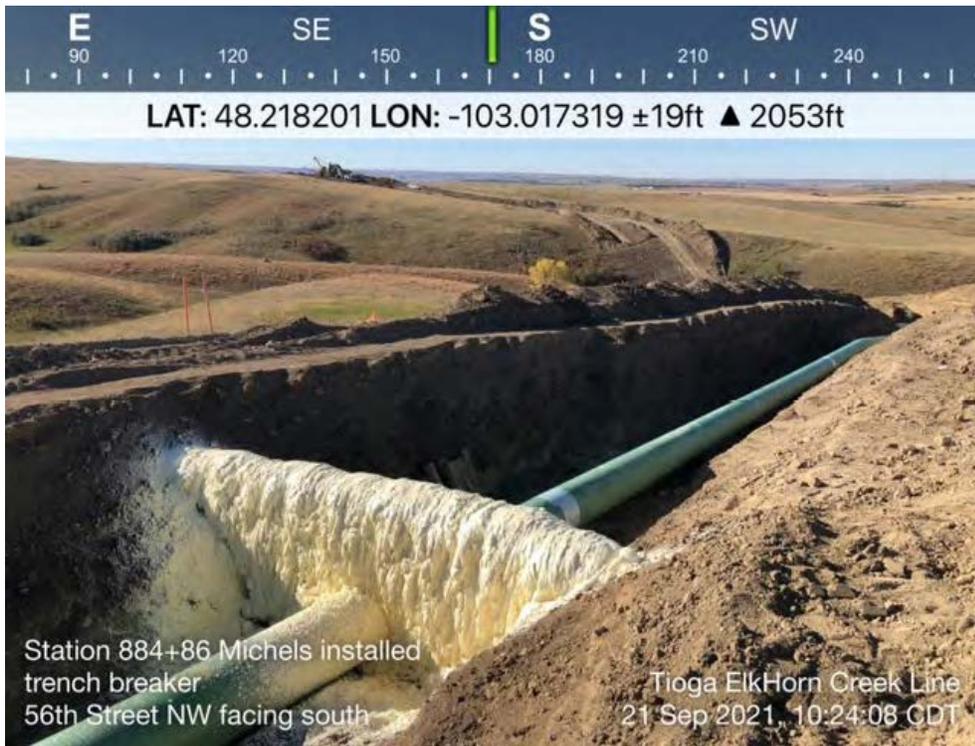
Location: Sta. No.884+86

Notes: Installed trench breaker on the Tioga-Elkhorn Creek Pipeline.

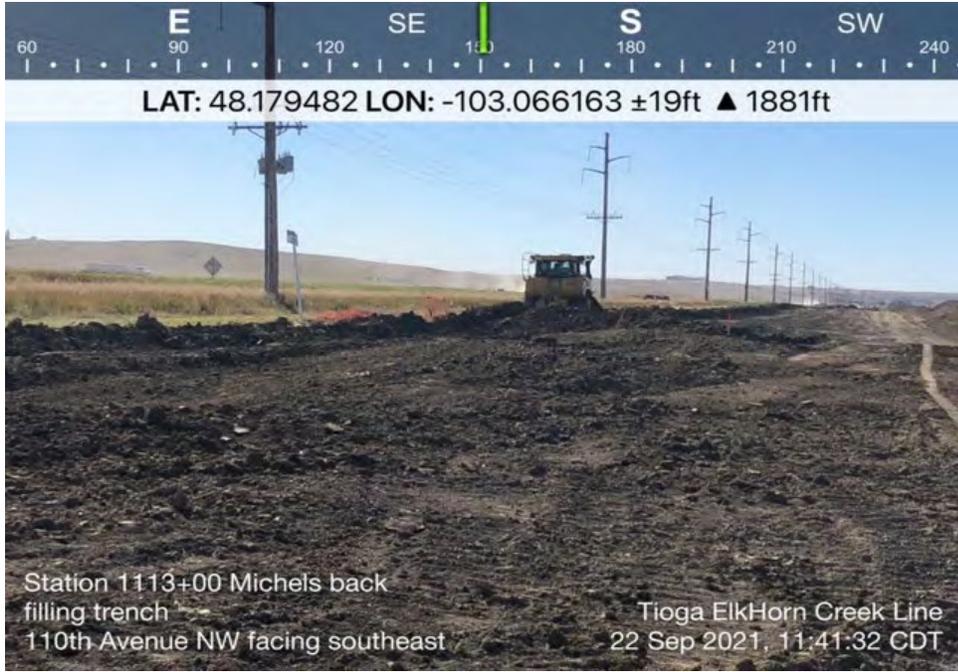
Location:  
Sta. No. 1113+00

Notes: Backfilling  
activities on the  
Tioga-Elkhorn Creek  
Pipeline.

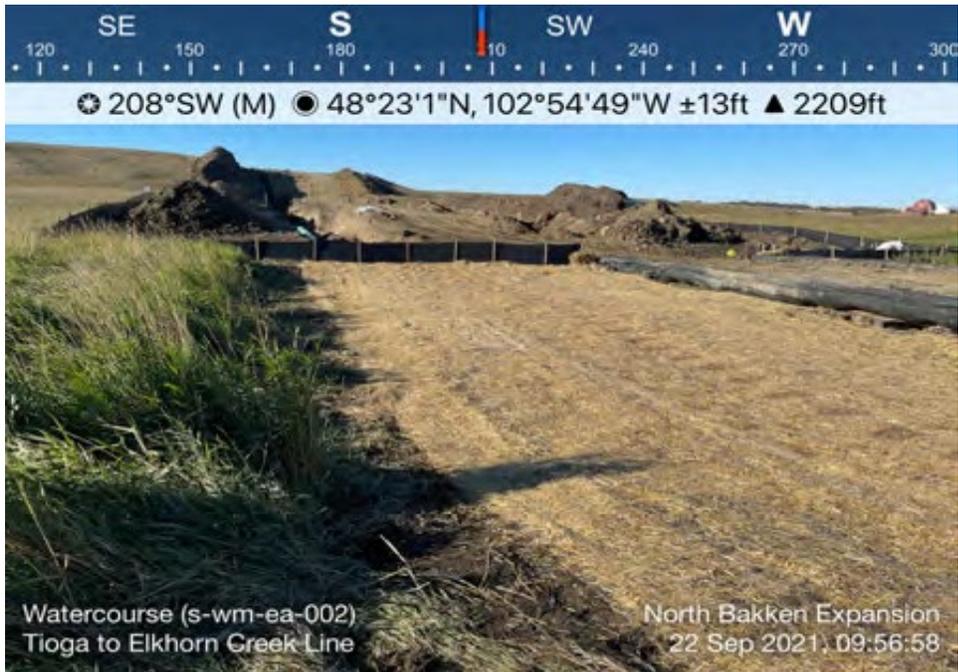
Location: Sta. Nos.  
384+90 to 385+14

Notes: Seeded and  
installed erosion  
control blankets at  
watercourse s-wm-ea-  
002 along the Tioga-  
Elkhorn Creek  
Pipeline.

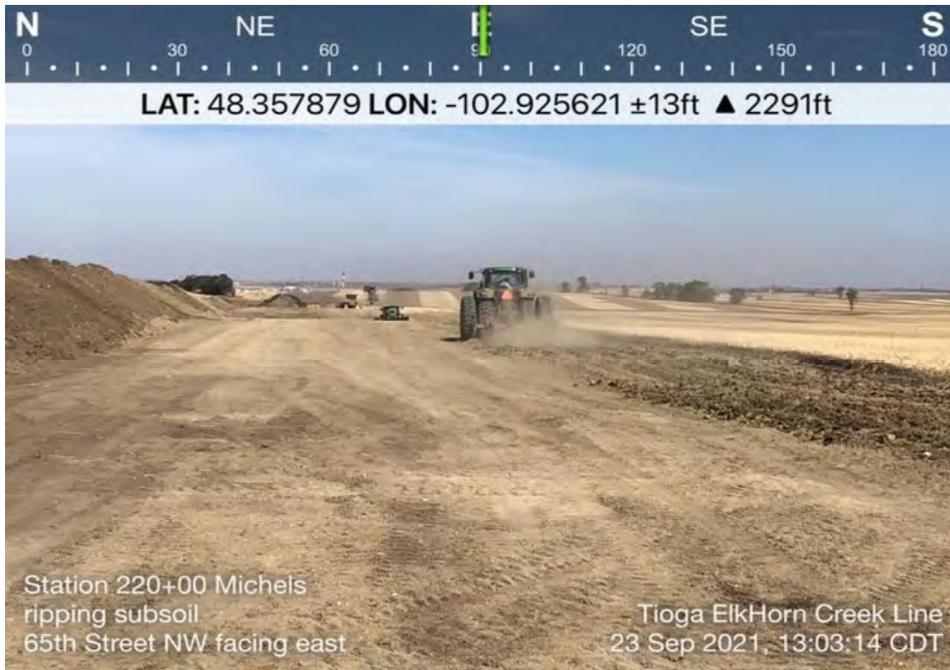
Location:  
Sta. No. 220+00

Notes: Ripping of subsoil along the right-of-way on the Tioga-Elkhorn Creek Pipeline.

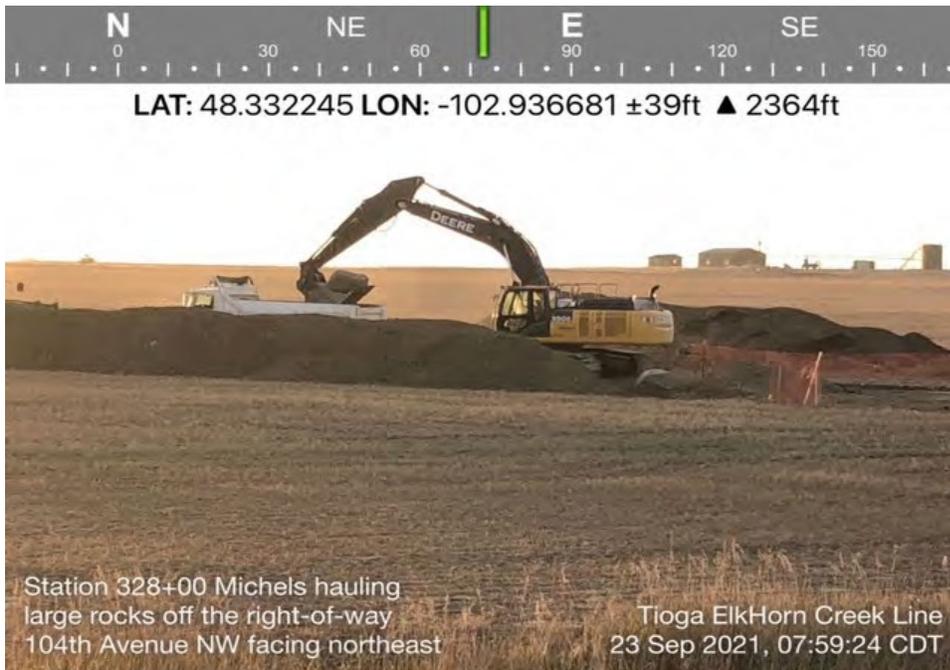
Location:  
Sta. No. 328+00

Notes: Removal of large rocks along the right-of-way on the Tioga-Elkhorn Creek Pipeline.

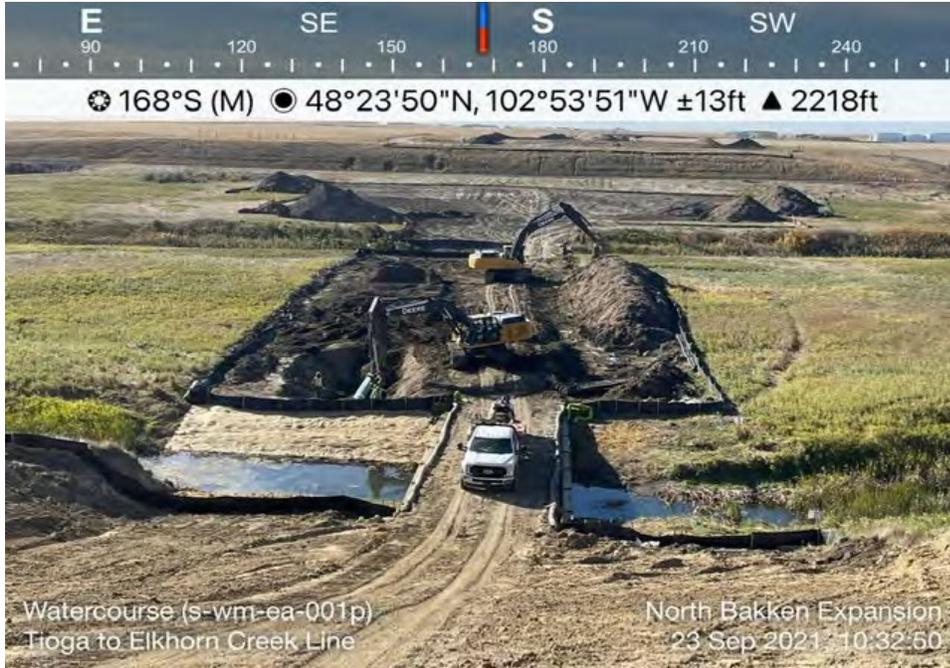
Location: Sta. Nos. 464+90 to 467+72

Notes: Seeded and installed erosion control blankets on waterbody banks of s-wm-ea-001p along the Tioga-Elkhorn Creek Pipeline.

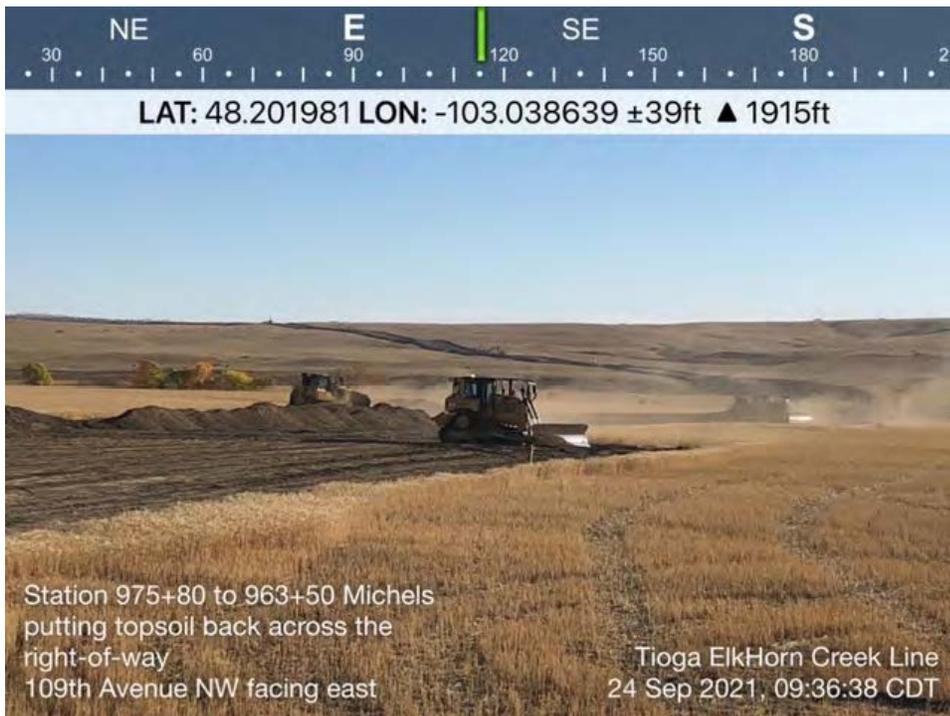
Location: Sta. Nos. 975+80 to 963+50

Notes: Restoring topsoil along the right-of-way on the Tioga-Elkhorn Creek Pipeline.

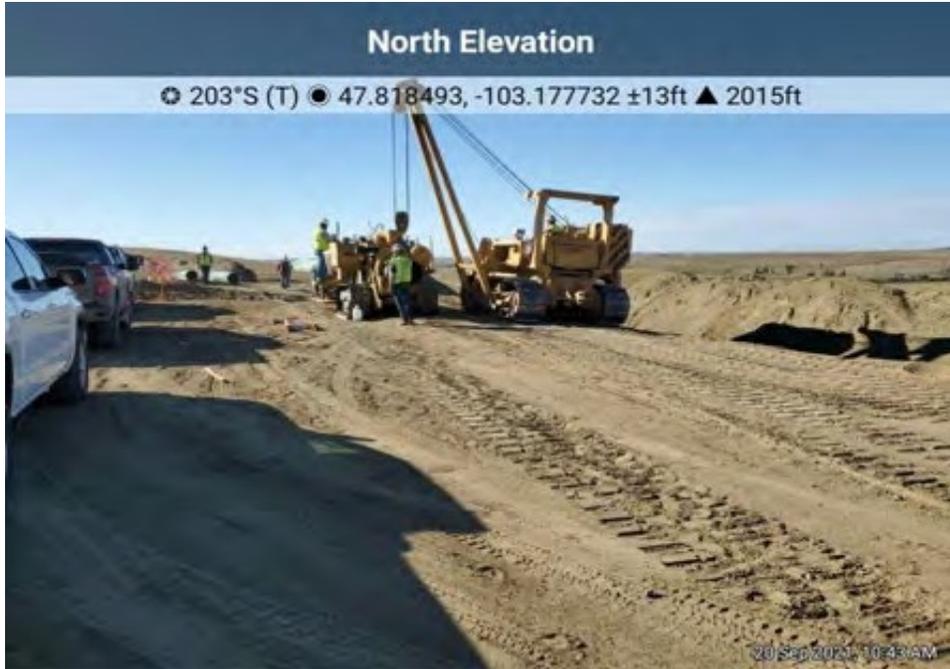
Date: 9/20/2021  
Location:  
Sta. No. 2625+87

Notes: Bending activities on the Tioga-Elkhorn Creek Pipeline.

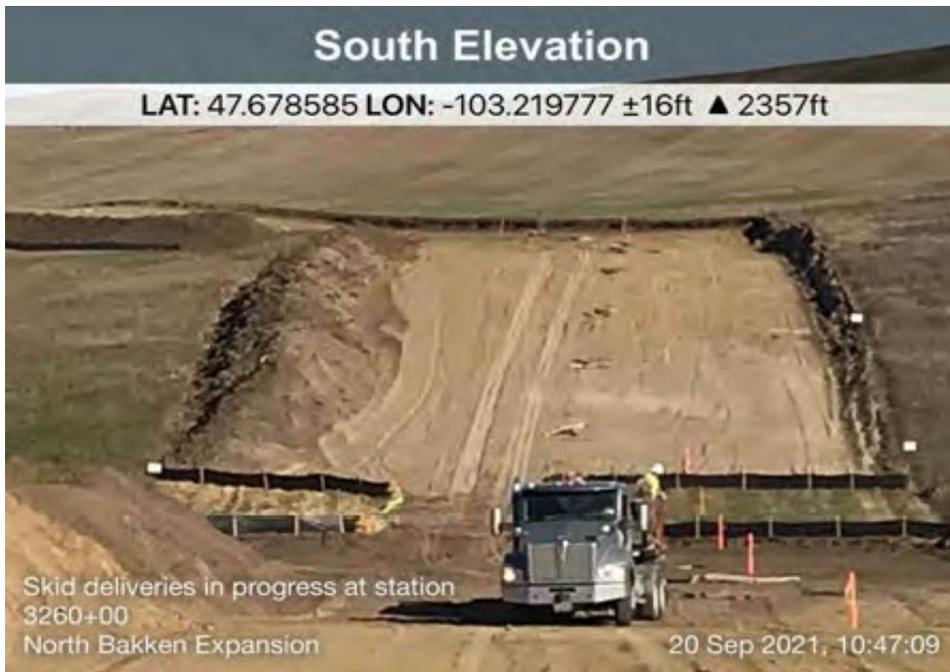
Date: 9/20/2021  
Location:  
Sta. No. 3260+00

Notes: Unloading of skids prior to stringing activities on the Tioga-Elkhorn Creek Pipeline.

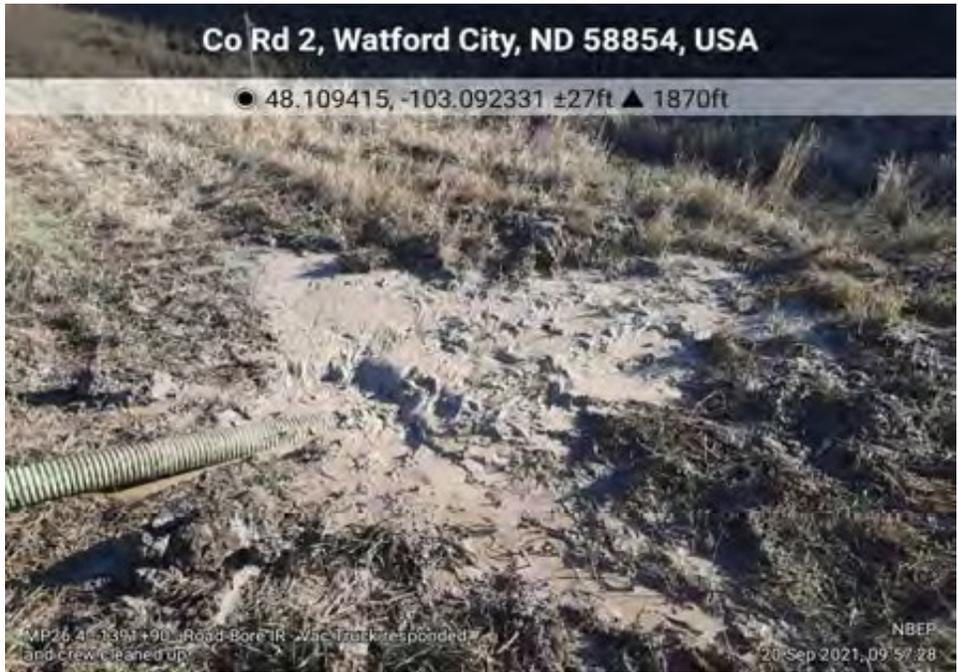
Location: Sta. Nos.  
1391+90 to 1400+00

Notes: A small  
inadvertent release on  
the Tioga-Elkhorn  
Creek Pipeline.

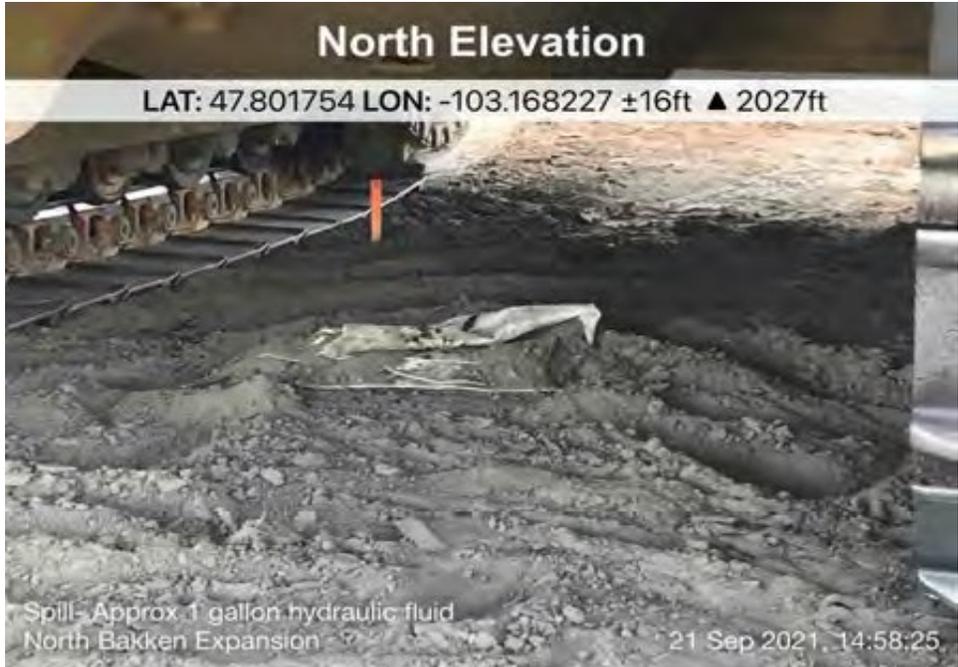
Location:  
Sta. No. 2709+00

Notes: Cleanup of an approximate one-gallon hydraulic fluid release on the Tioga-Elkhorn Creek Pipeline.

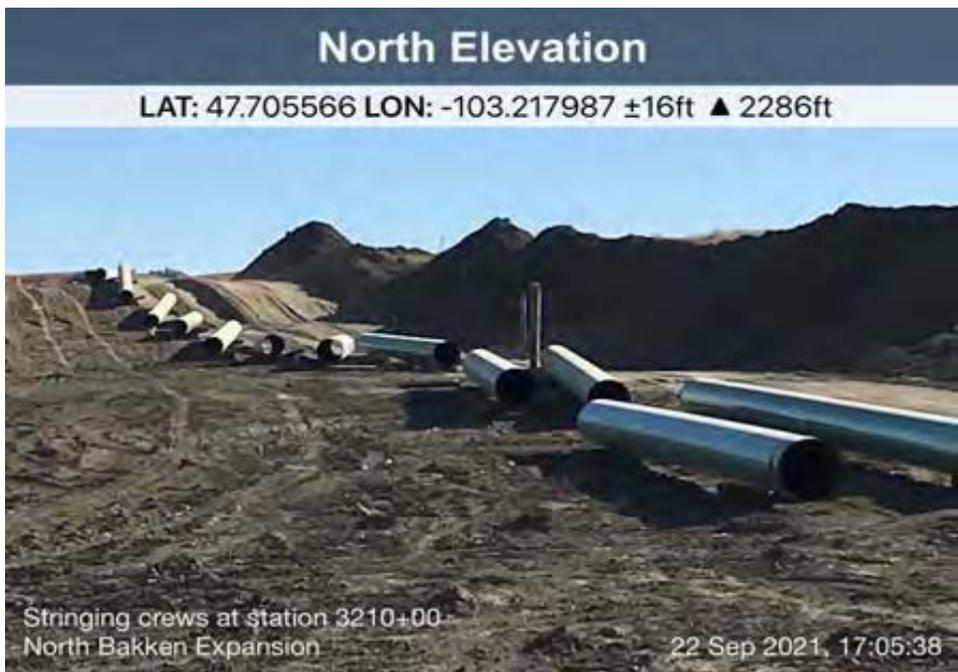
Location:  
Sta. No. 3210+00

Notes: Stringing activities on the Tioga-Elkhorn Creek Pipeline.

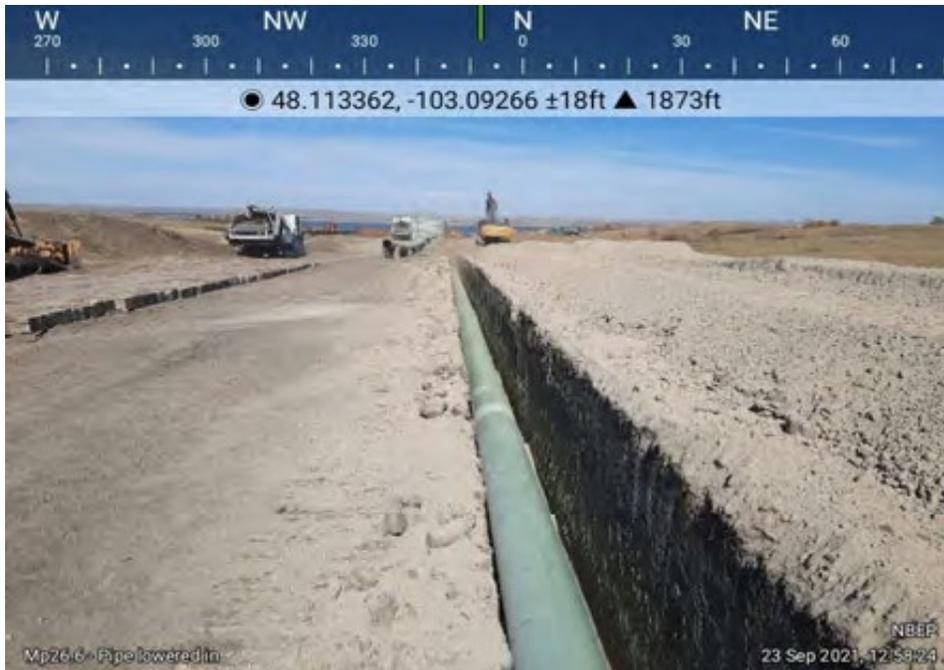
Location:  
Sta. No. 1405+00

Notes: Lowering activities on the Tioga-Elkhorn Creek Pipeline.

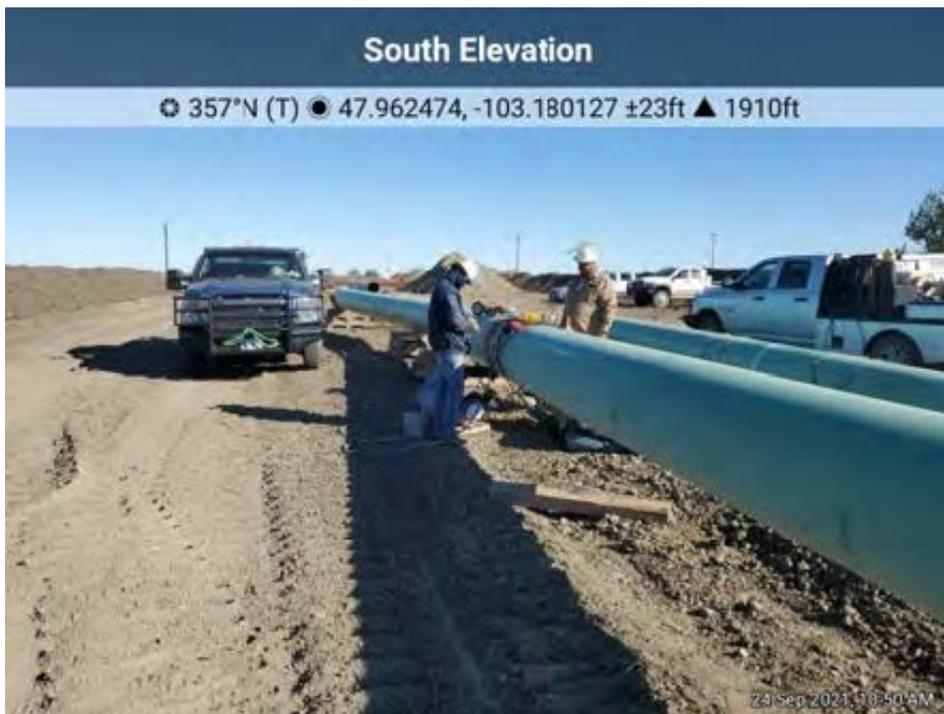
Location:  
Sta. No. 2075+00

Notes: Welding activities on the Tioga-Elkhorn Creek Pipeline.

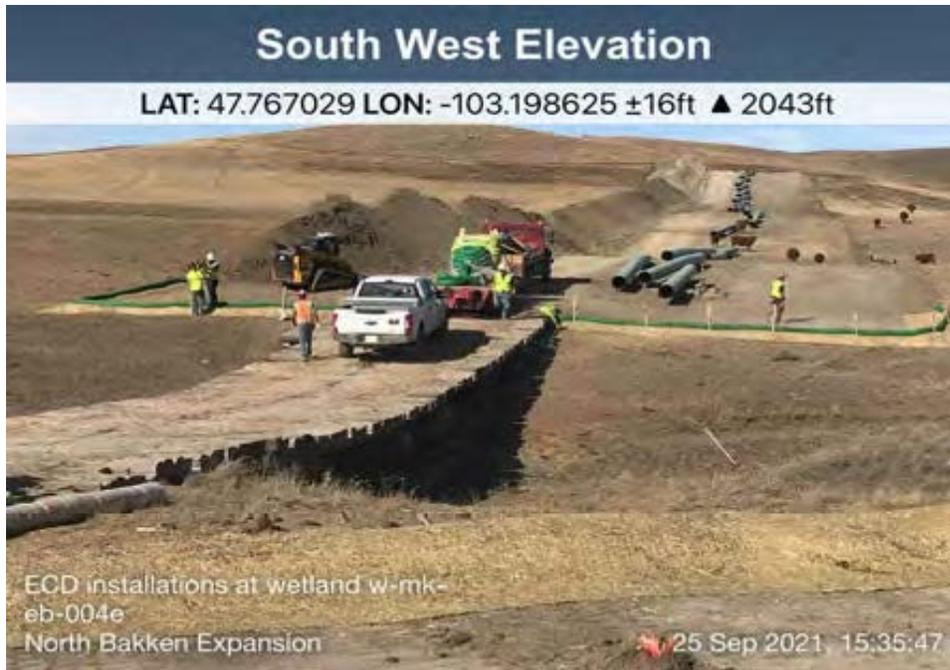
Location:  
Sta. No. 2692+80

Notes: Installed erosion control devices at wetland w-mk-eb-004e on the Tioga-Elkhorn Creek Pipeline.

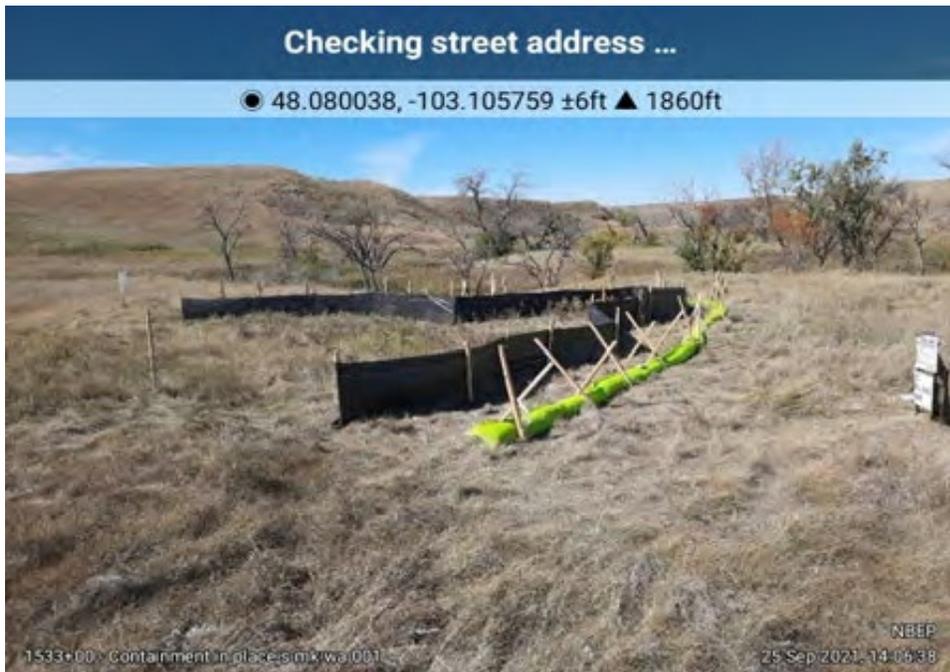
Location:  
Sta. No. 1533+00

Notes: Inadvertent release containment using temporary erosion control devices installed within the limit of disturbance on the Tioga-Elkhorn Creek Pipeline.

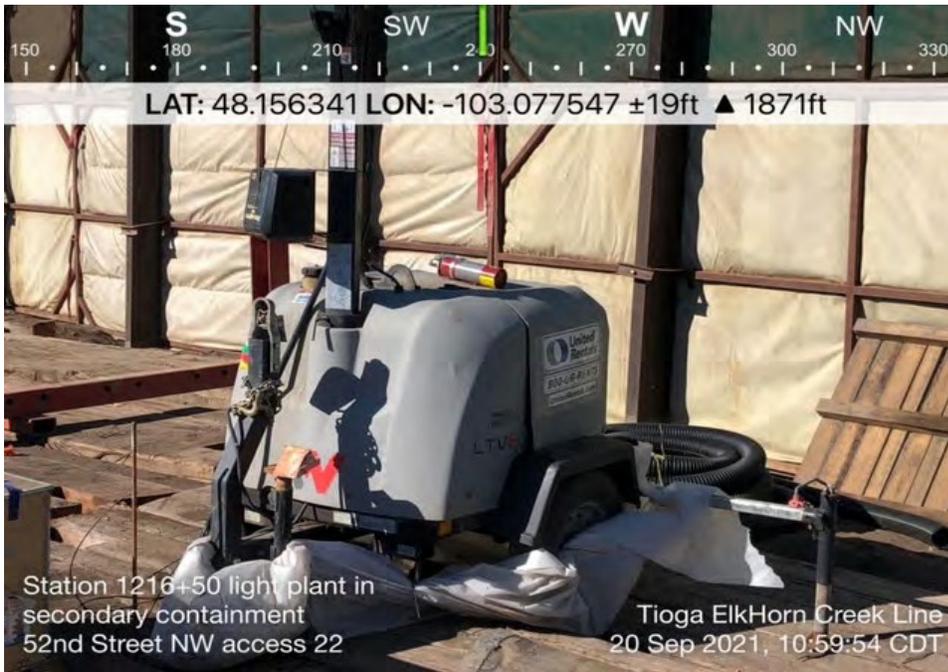
Location: North Spread HDD bore site.

Notes: Equipment within adequate secondary containment at the North Spread HDD bore site.

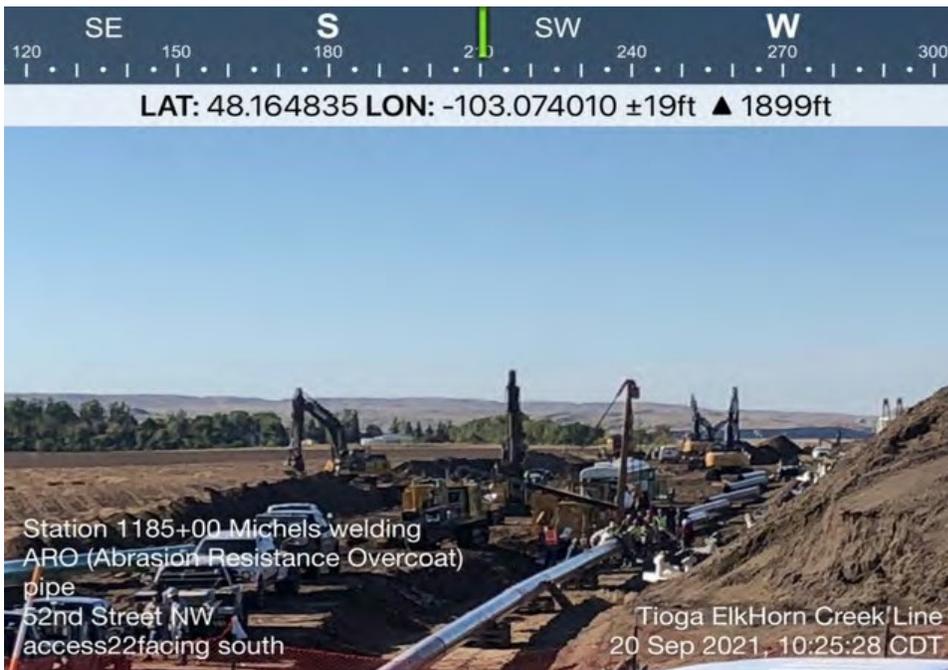
Location: Sta. No. 1185+00

Notes: Welding of bore pipe at the North Spread HDD bore site.

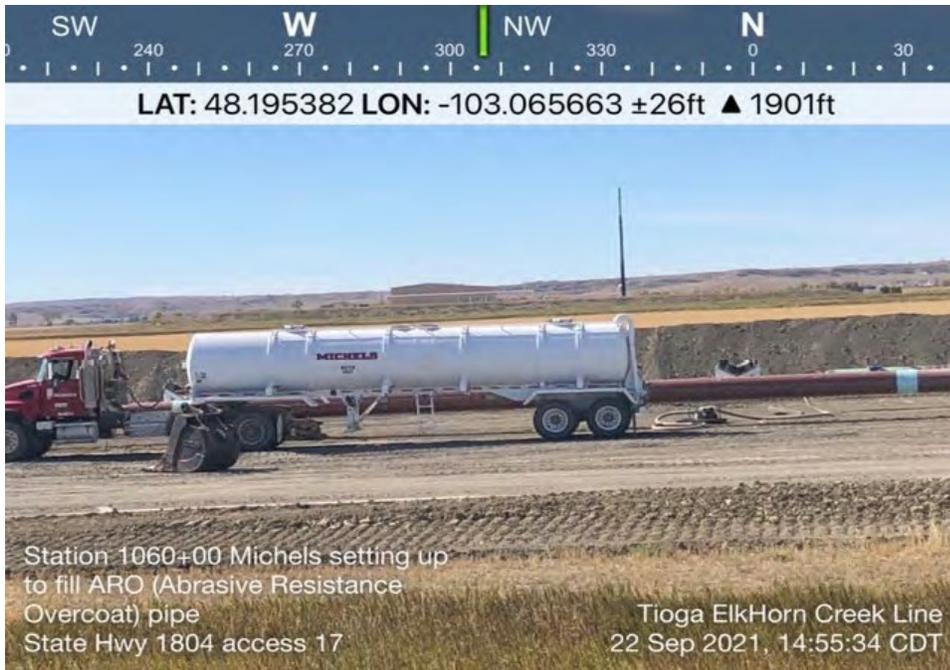
Location: North Spread HDD bore site.

Notes: Preparations prior to hydrostatic testing a section of bore pipe for the HDD bore.

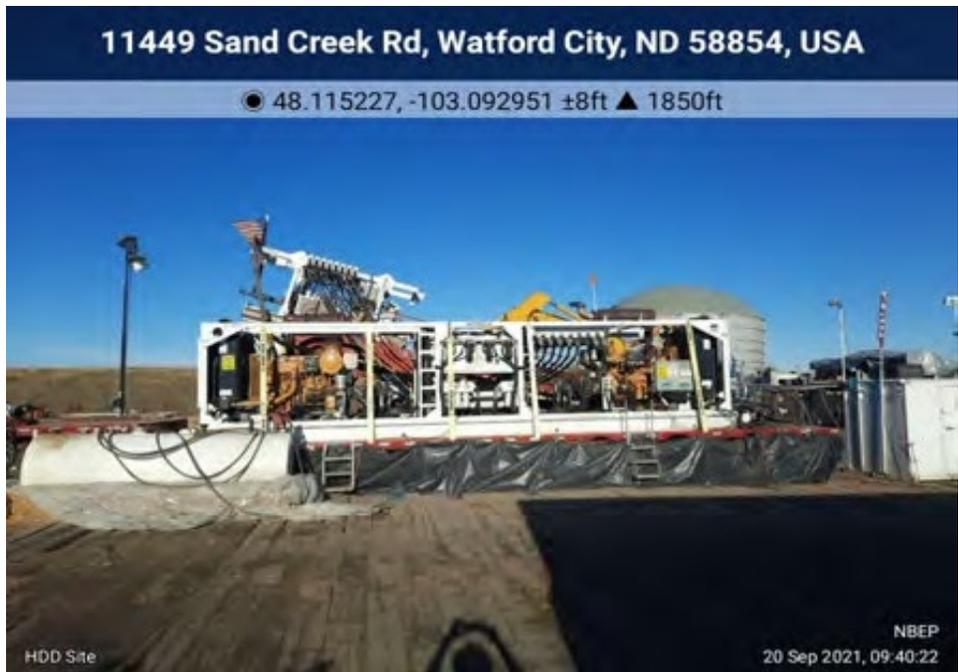
Location: South Spread HDD bore site.

Notes: Continued HDD drilling activities at the South Spread HDD bore site.

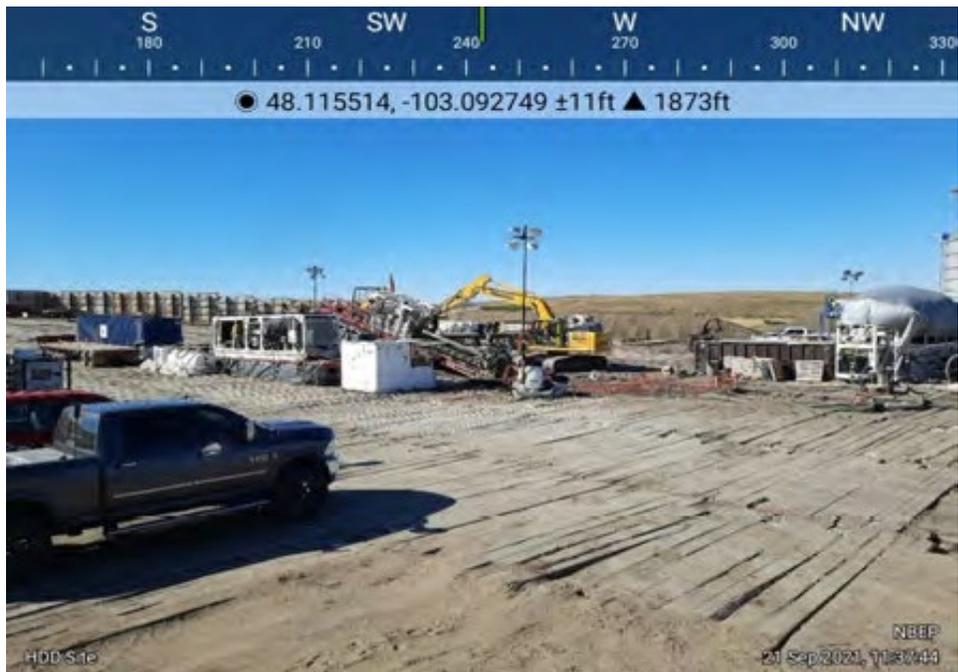
Location: South Spread HDD bore site.

Notes: Continued HDD drilling activities at the South Spread HDD bore site.

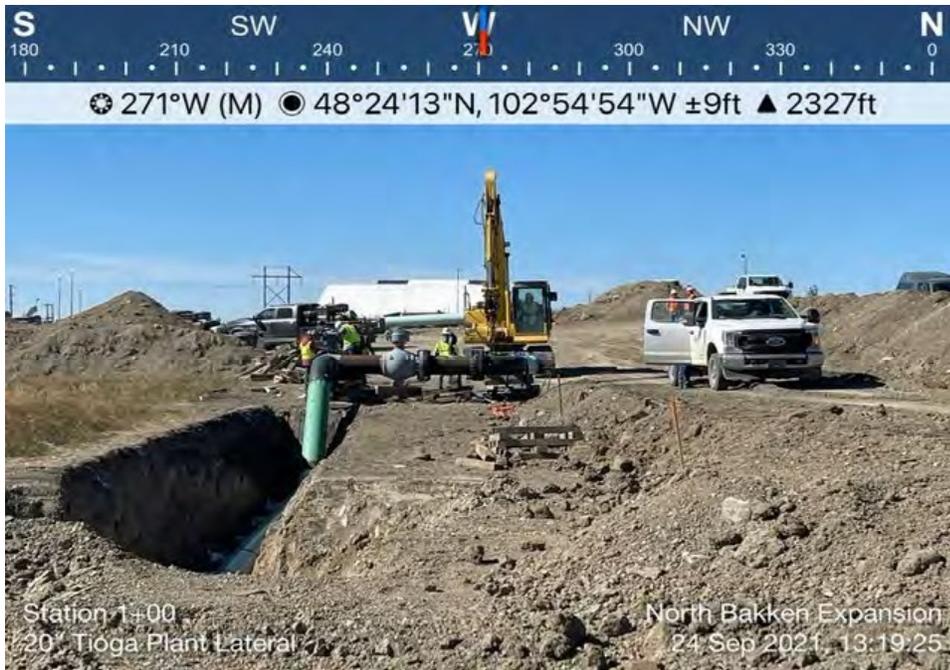
Location:  
Sta. No. 1+00

Notes: Construction activities at the pig launcher/receiver for the Tioga Compressor Lateral.

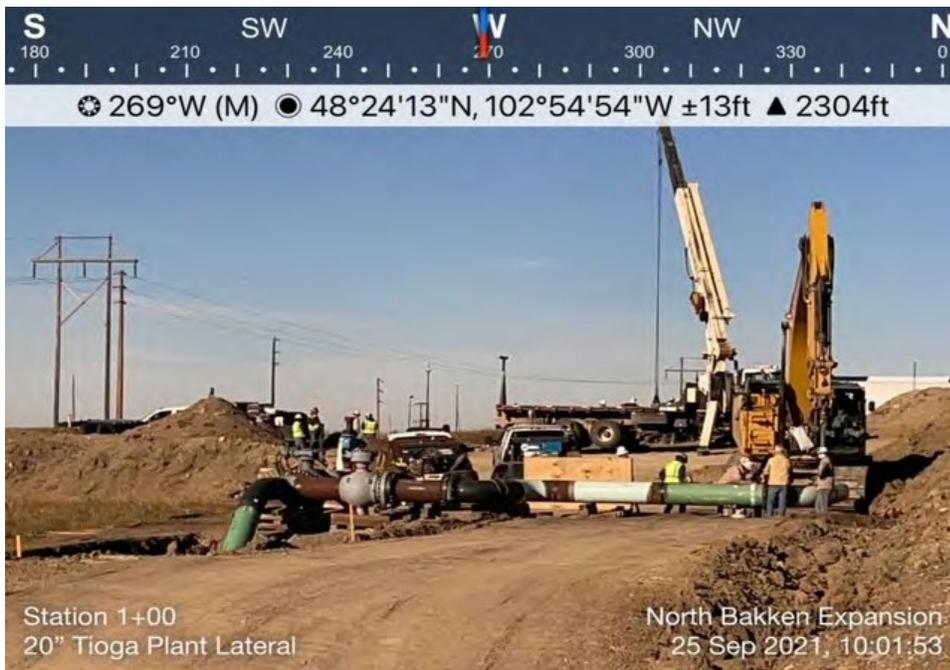
Location:  
Sta. No. 1+00

Notes: Construction activities at the pig launcher/receiver for the Tioga Compressor Lateral.

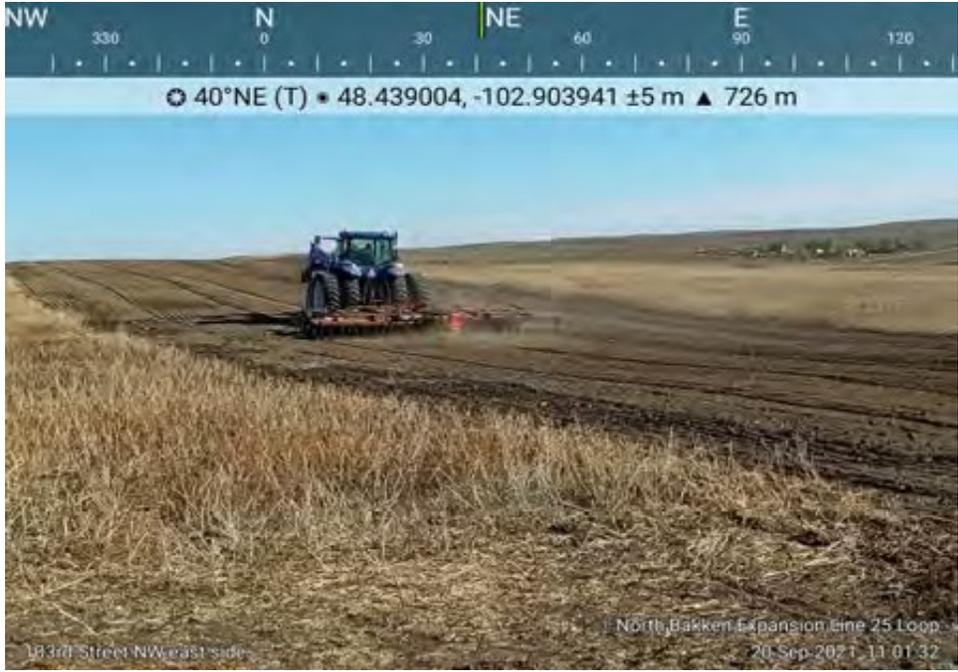
Location:  
Sta. No. 145+00

Notes: Restoration of  
right-of-way on the  
Line Section 25 Loop.

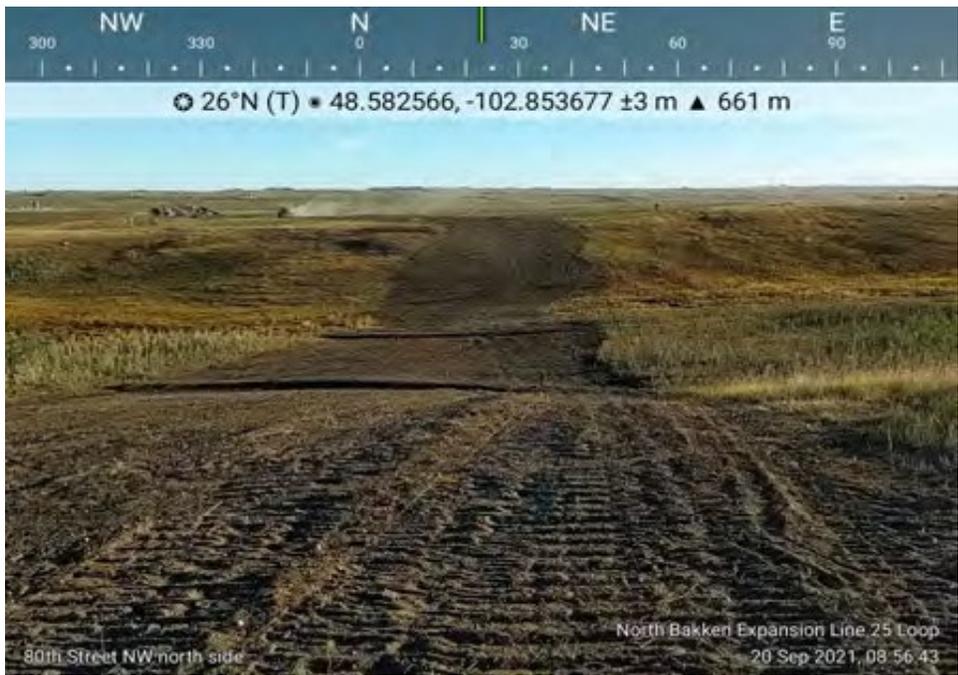
Location: Sta. Nos.  
703+00 to 685+00

Notes: Restoration of  
right-of-way and  
wetland w-bk-ea-002e  
on the Line Section  
25 Loop.

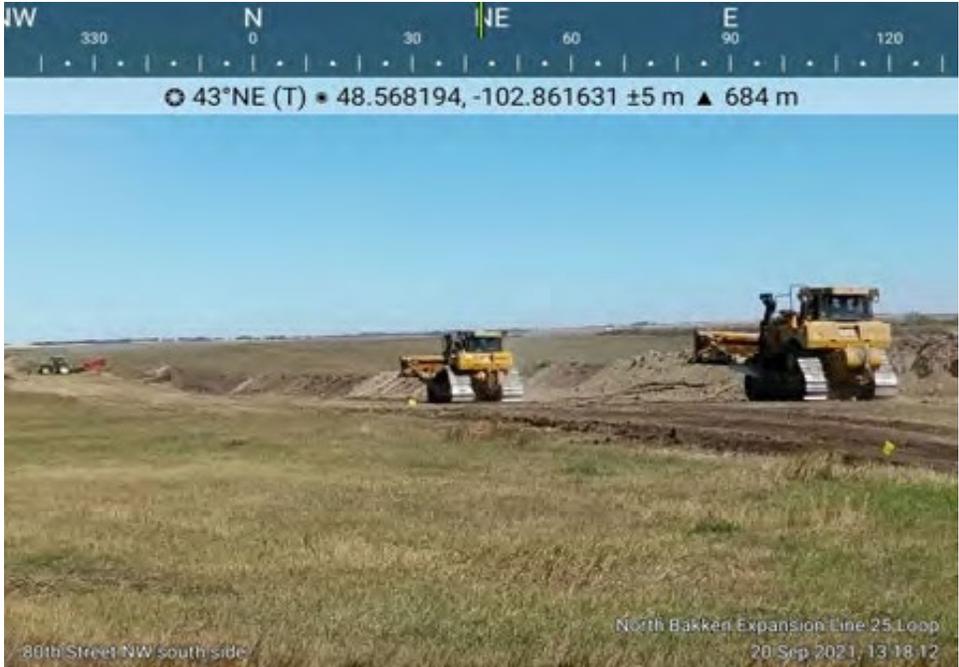
Location:  
Sta. No. 640+00

Notes: Ripping of compacted subsoil on the Line Section 25 Loop.

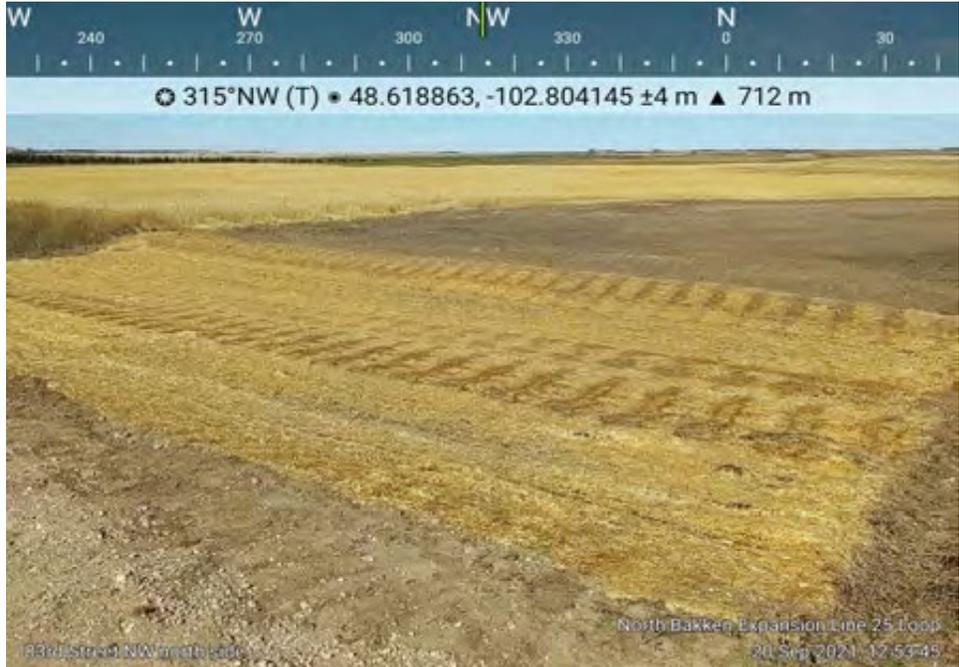
Location:  
Sta. No. 335+00

Notes: Seeded and installed erosion control blankets at the bar ditch north of 83<sup>rd</sup> Street NW on the Line Section 25 Loop.

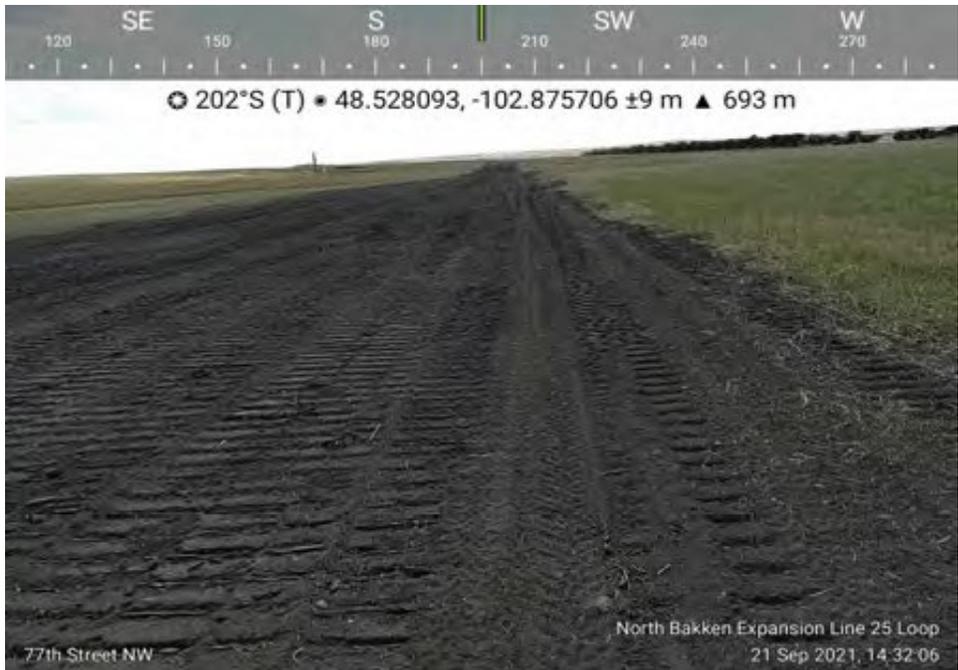
Location:  
Sta. No. 475+00

Notes: Restoration of  
right-of-way on the  
Line Section 25 Loop.

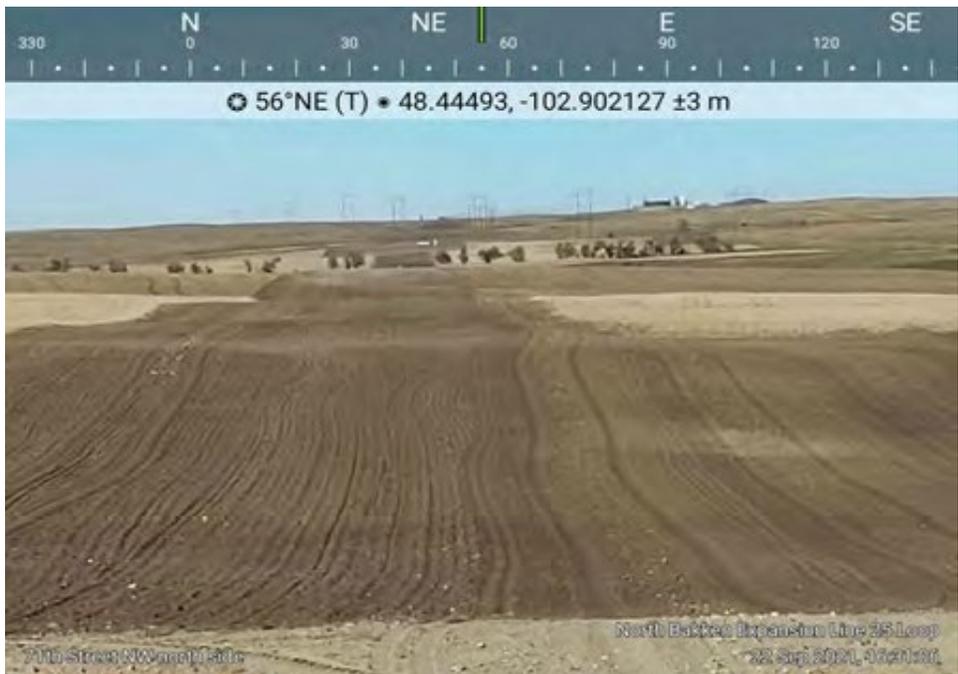
Location: Sta. Nos.  
216+00 to 263+00

Notes: Restoration of  
right-of-way on the  
Line Section 25 Loop.
