**WBI Energy Transmission, Inc.**  
**North Bakken Expansion Project Status Report No. 17**  
**FERC Docket Nos. CP20-52-000**  
**CP20-52-001**

**Reporting Period:** September 20, 2021 through September 26, 2021

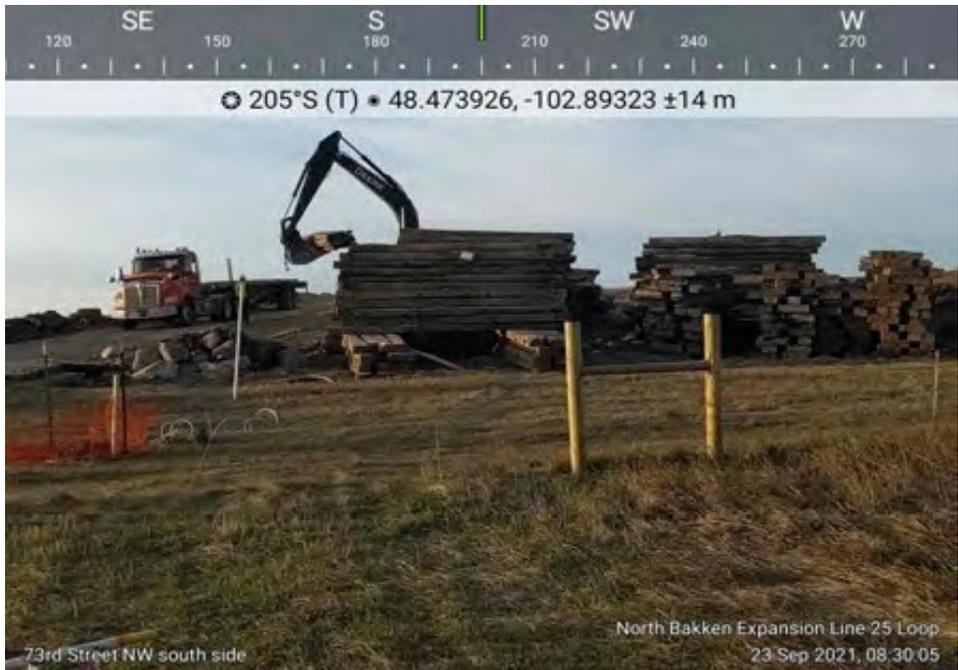
Location:  
Sta. No. 240+00

Notes: Removal of  
timber mats from the  
right-of-way on the  
Line Section 25 Loop.

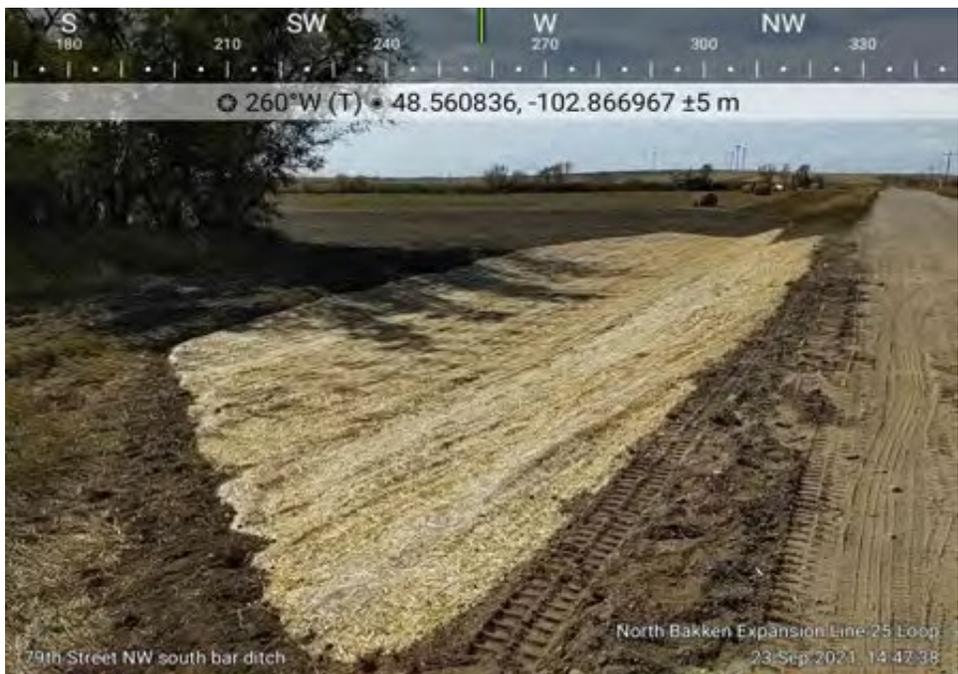
Location:  
Sta. No. 580+00

Notes: Seeded and  
installed erosion  
control blankets at the  
bar ditch south of 79<sup>th</sup>  
Street NW on the  
Line Section 25 Loop.

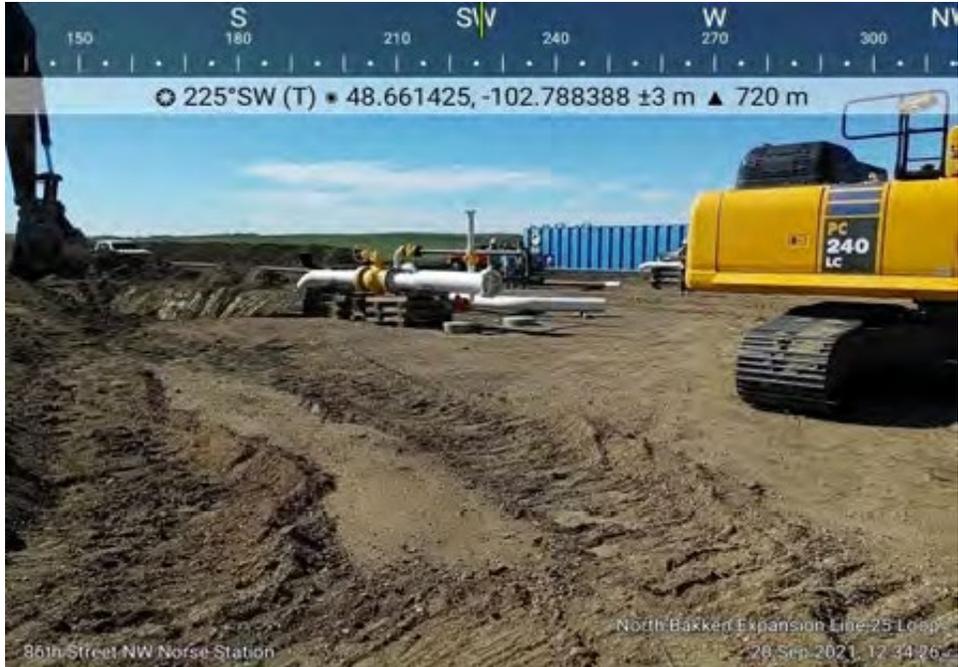
Location: Norse Transfer Station

Notes: Installation of the Line Section 30 (12-inch) and the Stoneview-Conoco Lateral (8-inch) pig-launcher/receivers at the Norse Transfer Station.

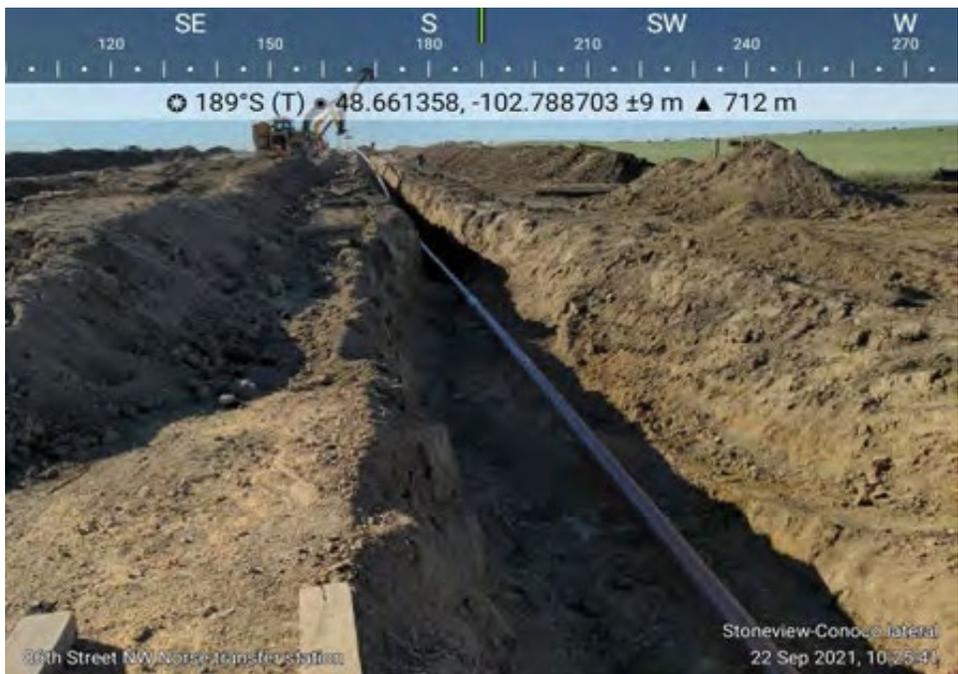
Location: Stoneview-Conoco Lateral

Notes: Lowering activities of the Stoneview-Conoco Lateral.

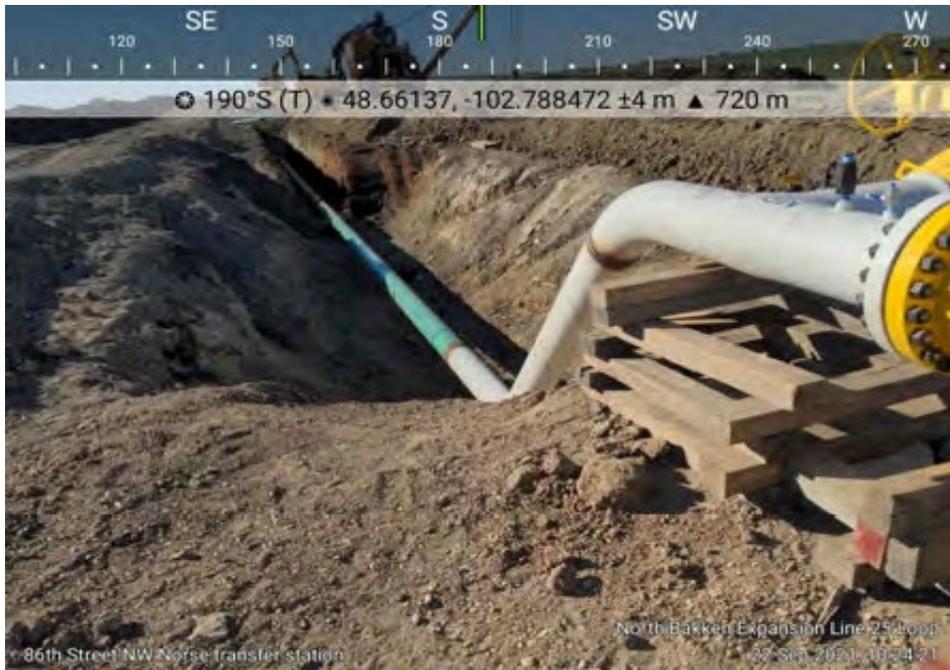
Location: Norse Transfer Station

Notes: Tie-in of the 12-inch pig launcher/receiver.

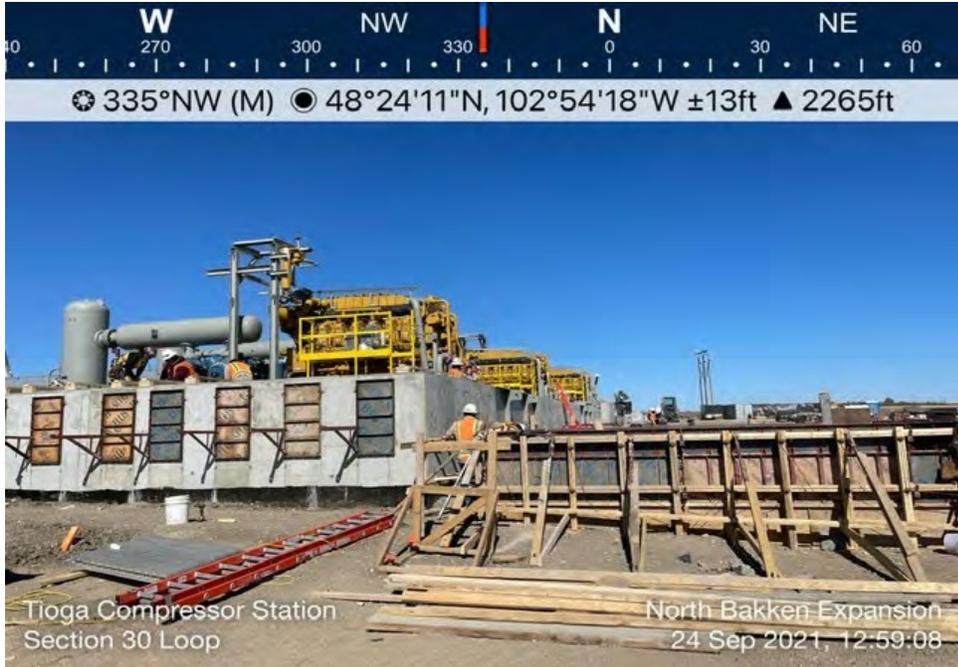
Location: Tioga Compressor Station

Notes: Installing form boards.

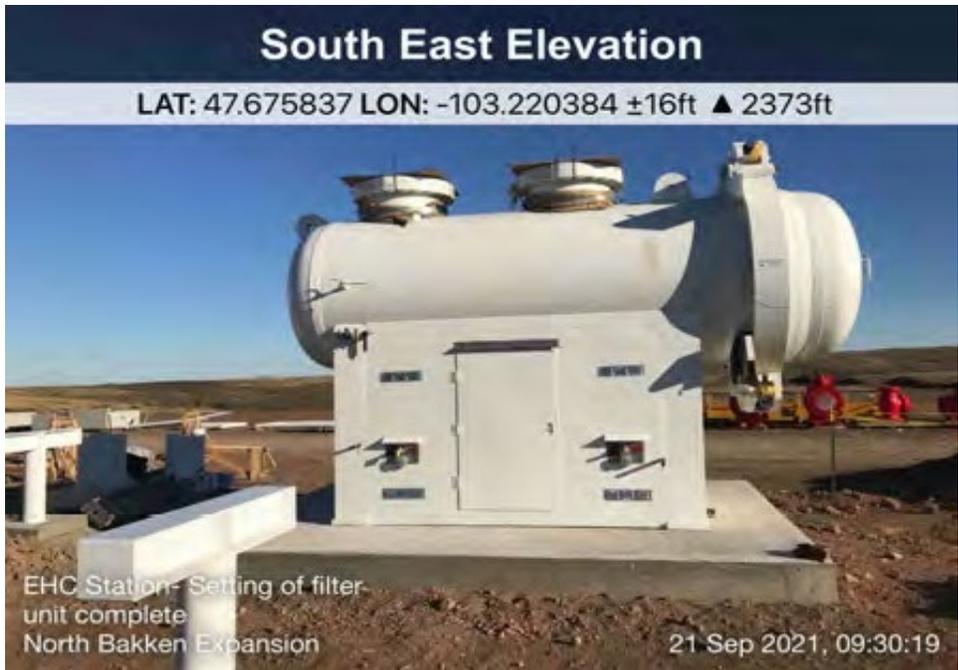
Location: Elkhorn Creek Compressor Station

Notes: Setting of air intake filter on pad.

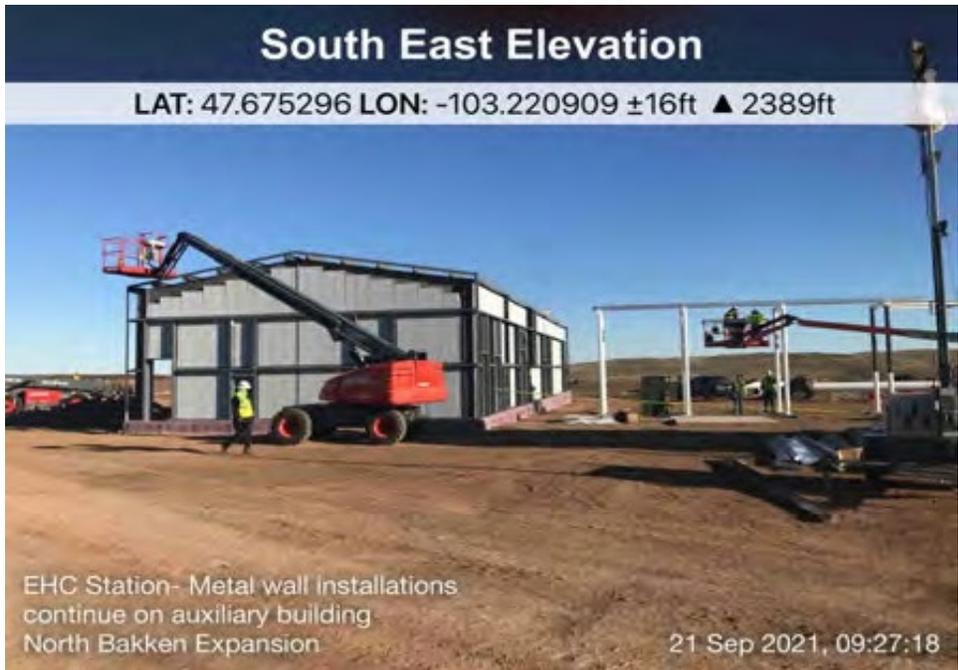
Location: Elkhorn Creek Compressor Station

Notes: Installation of pipe support structures and metal walls for the Auxiliary building.

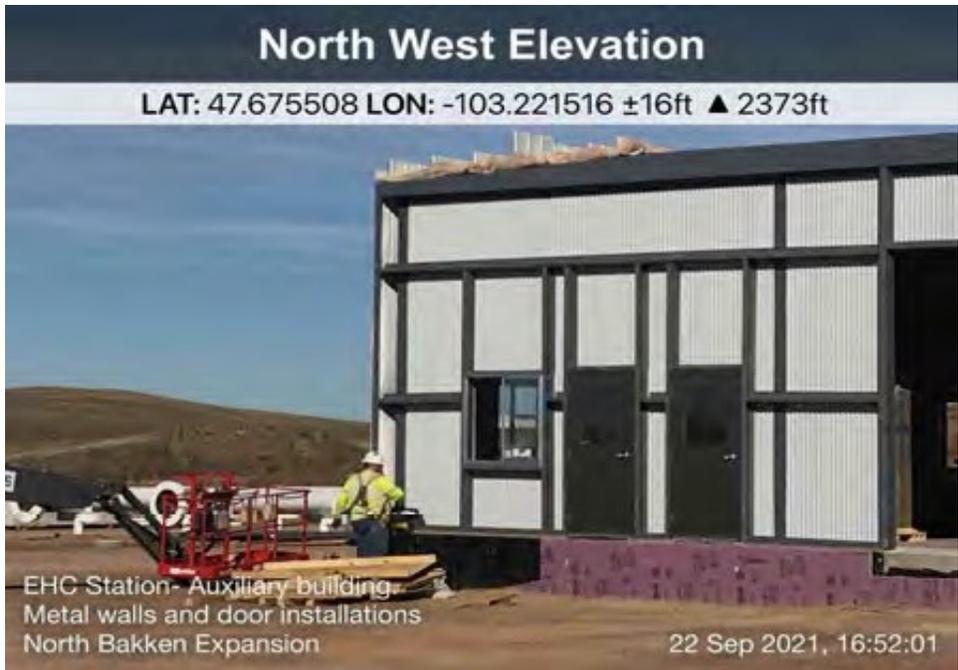
Location: Elkhorn Creek Compressor Station

Notes: Installation of doors and windows on the Auxiliary building.

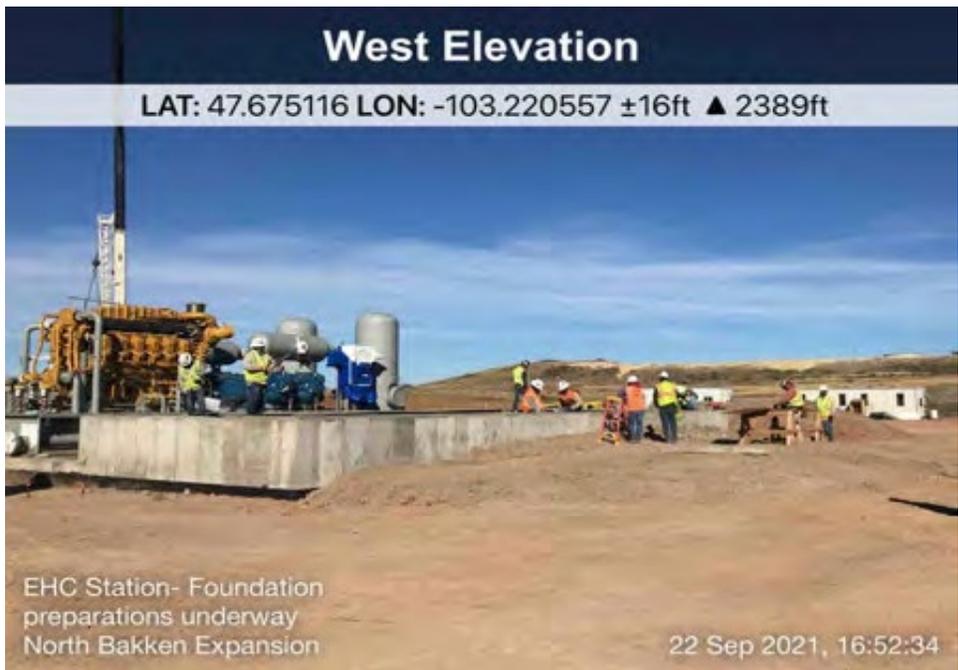
Location: Elkhorn Creek Compressor Station

Notes: Foundation preparation for the exhaust pad for the Compressor building.

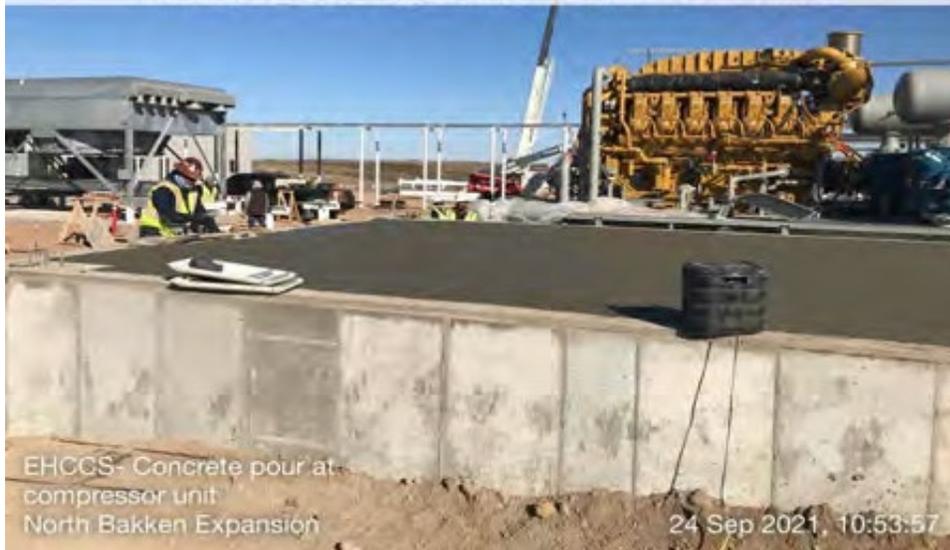
Location: Elkhorn Creek Compressor Station

Notes: Poured concrete for the exhaust pad for the Compressor building.

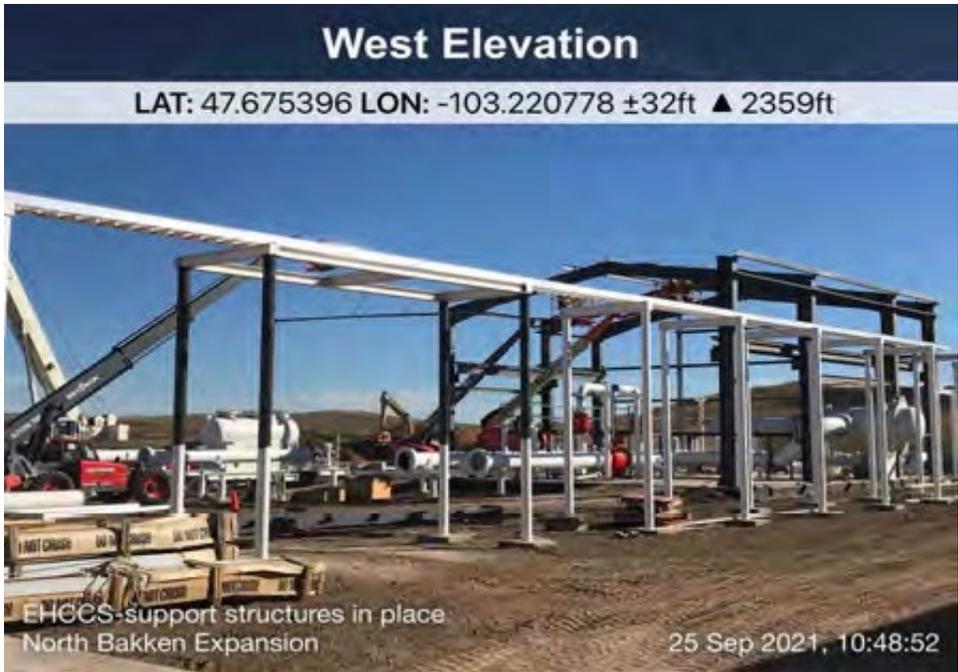
Location: Elkhorn  
Creek Compressor  
Station

Notes: Pipe support  
structures installation.

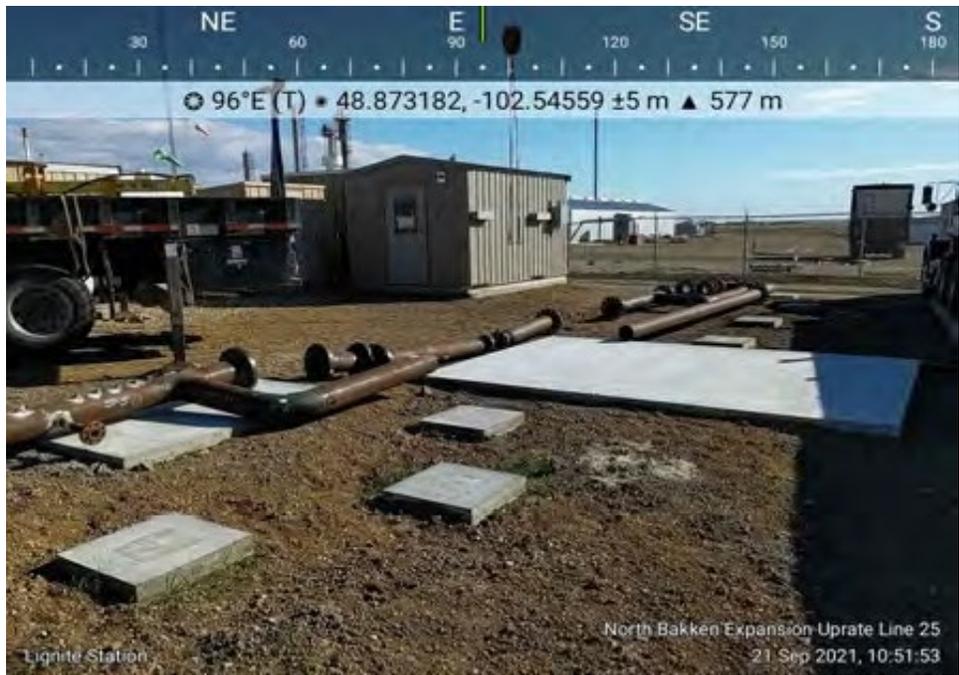
Location: Lignite Plant Receipt Station

Notes: Staging pipe to be assembled.

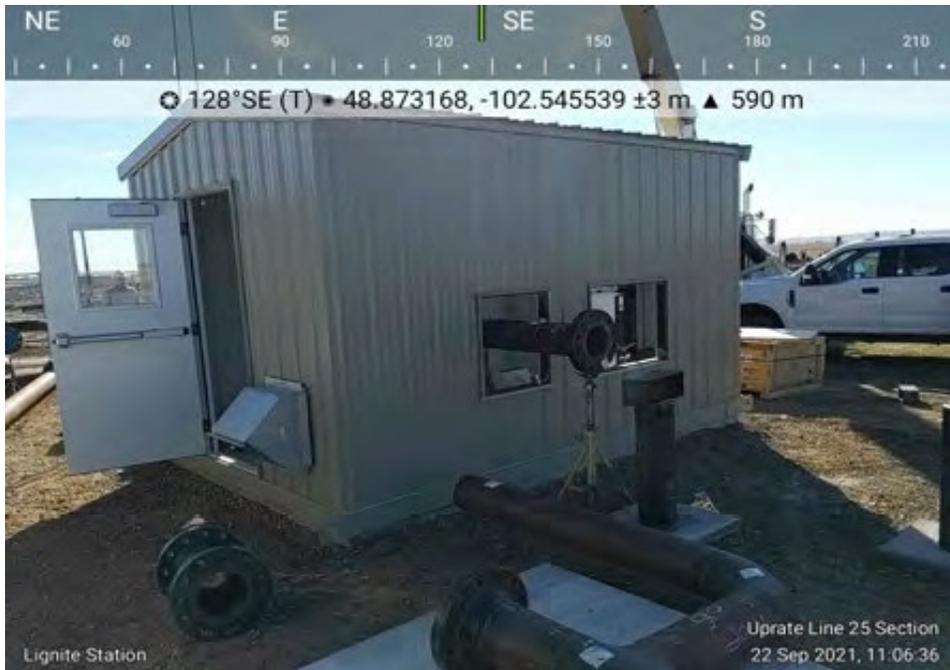
Location: Lignite  
Plant Receipt Station

Notes: Setting new  
meter building.

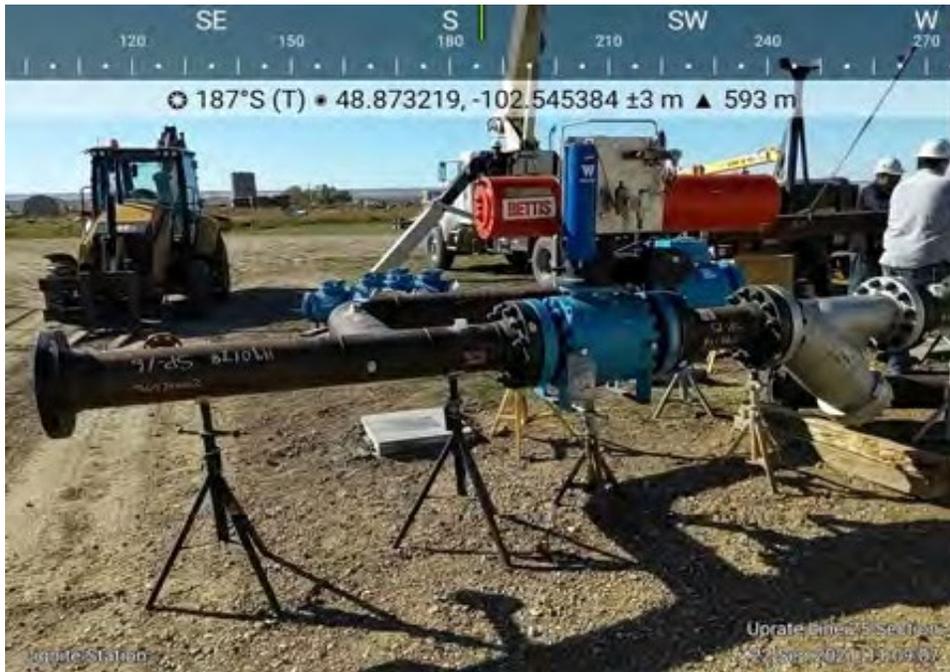
Location: Lignite  
Plant Receipt Station

Notes: Pipe valve  
assembly.
