Re: WBI Energy Transmission, Inc.  
Docket Nos. CP20-52-000 and CP20-52-001  
North Bakken Expansion Project  
Weekly Status Report No. 18

**WBI Energy Transmission, Inc.**  
**North Bakken Expansion Project Status Report No. 18**  
**FERC Docket Nos. CP20-52-000**  
**CP20-52-001**

**Reporting Period:** September 27, 2021 through October 3, 2021

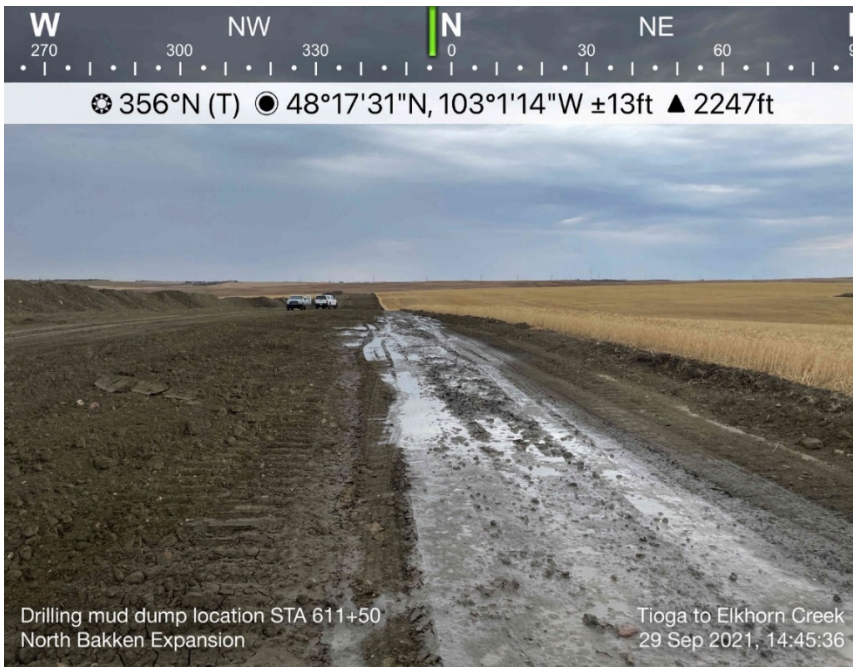
**Location: Sta. No. 611+50**

Date	Location	Description	Correction	Effectiveness of Corrective Action
9/29/2021	Sta. Nos. 608+00 to 611+50	A vac-truck had dumped used drilling fluid on a slope off the right-of-way (ROW). The drilling fluid eventually migrated downslope and was diverted by a small berm to an off-ROW location. The drilling fluid traveled off-ROW approximately 50-feet into an agricultural field and spread to a width of approximately 60-feet and approximately ¼-inch to 1-inch deep.	A subcontractor cleaned up as much material as possible using squeegees and an on-site vac-truck. Once the material dries atop the soil, it is expected to be easier to remove from the off-ROW area using shovels and other hand tools. The area will continue to be monitored until the drilling fluid has been sufficiently cleaned up from the area.	Utilizing the vac-truck and squeegees proved to be effective for removing a majority of the drilling fluid. Additional cleanup using hand tools is scheduled to occur when the soil is dry to effectively remove all attainable traces of the drilling fluid.

**Notes: Drilling fluid on downslope of ROW.**

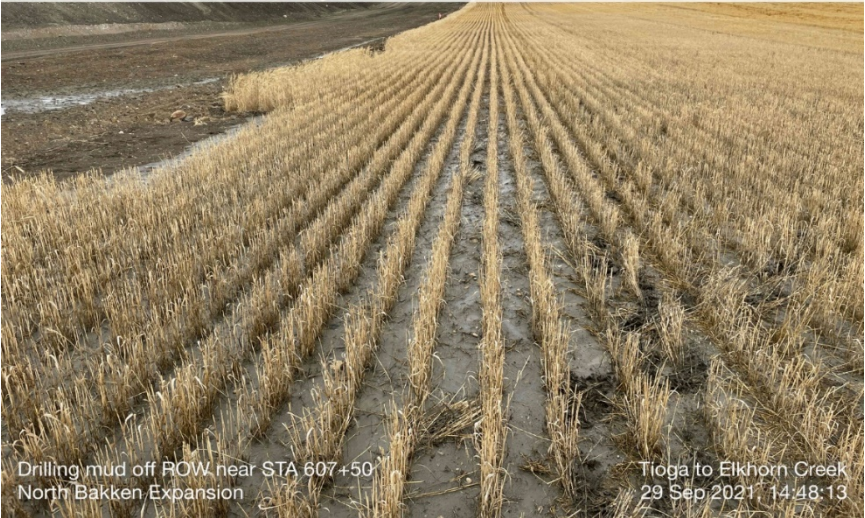
**Location:** Sta. No. 607+50

Drilling mud off ROW near STA 607+50 North Bakken Expansion Tioga to Elkhorn Creek 29 Sep 2021 14:48:13

**Notes:** Drilling fluid that had migrated off ROW into a harvested agricultural field.

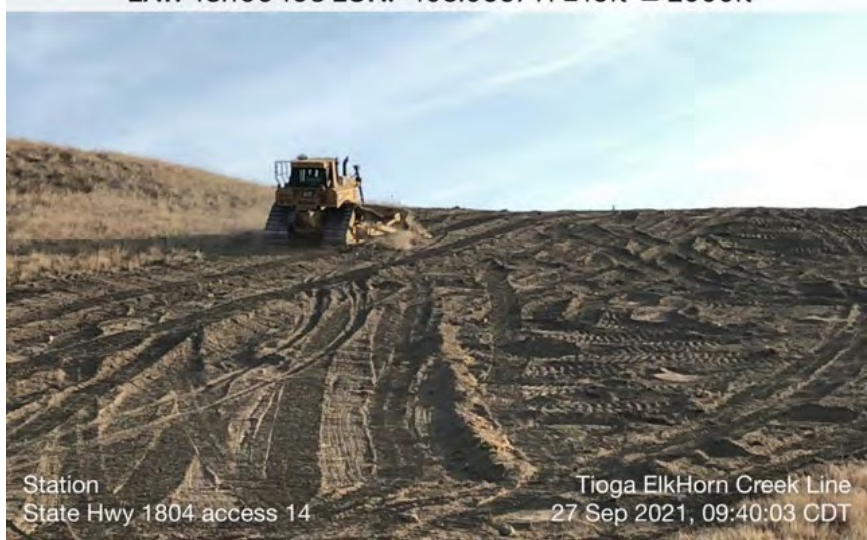
**Location:** Sta. No. 1018+00

**Notes:** Grading activities on the Tioga-Elkhorn Creek Pipeline.

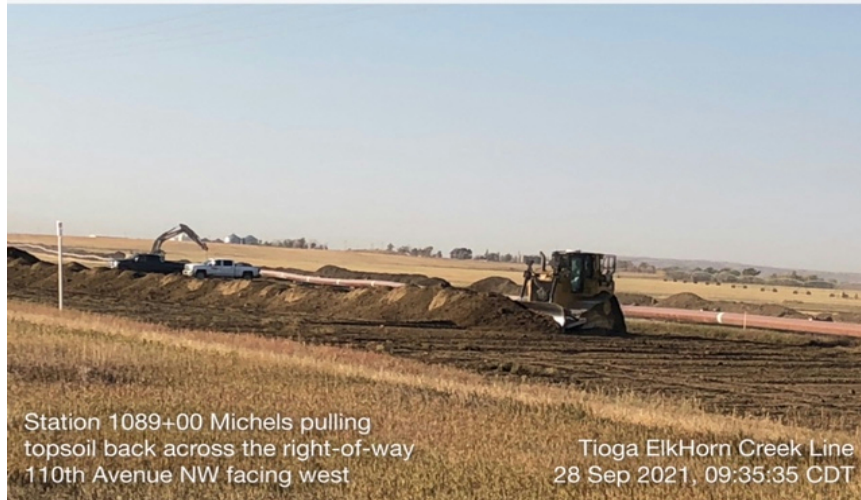
Location: Sta. No. 1089-00

Notes: Backfilling activities on the Tioga Elkhorn Creek Pipeline.

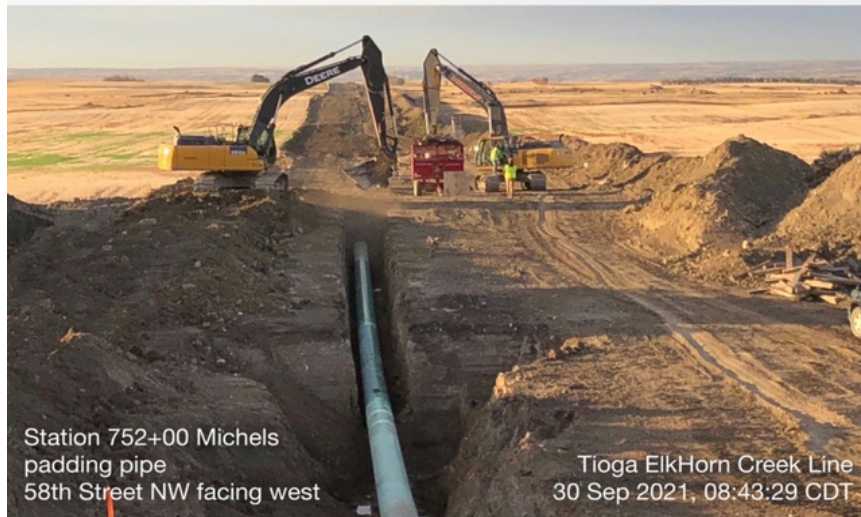
Location: Sta. No. 752+00

Notes: Padding activities on the Tioga-Elkhorn Creek Pipeline.

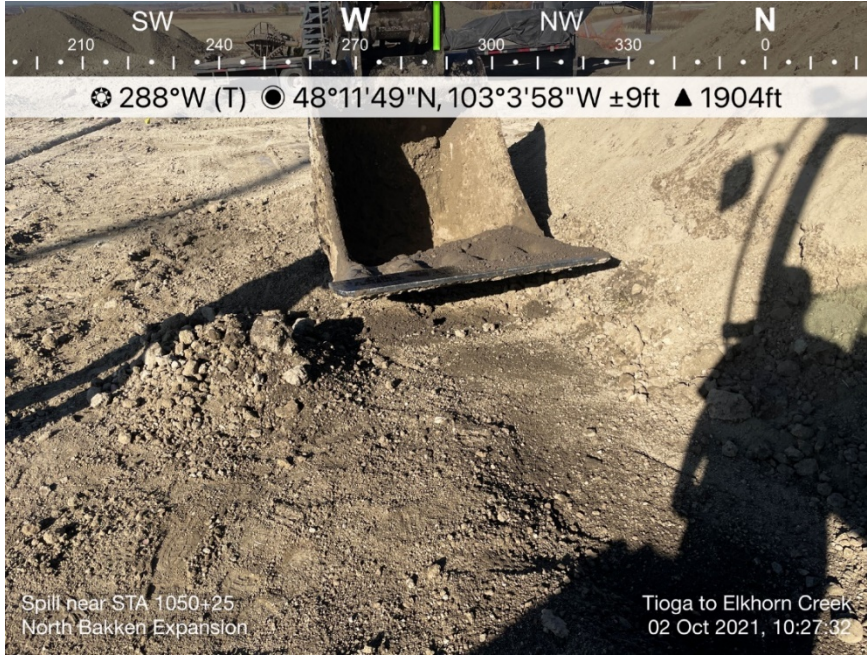
Location: Sta. No. 1050+25

- Continued clean-up activities.
- On October 2, 2021, an approximate 2-gallon hydraulic leak occurred from an excavator at Sta. No 1048+00. WBI Energy quickly implemented measures identified in the Spill Prevention, Control and Countermeasure (SPCC) Plan to contain, clean up, and dispose of approximately 20 gallons of contaminated soil and cleanup materials. No cultural or sensitive resources were impacted. Requisite agency and internal spill reports were filed.

Notes: An approximate two-gallon hydraulic leak on the Tioga-Elkhorn Creek Pipeline.

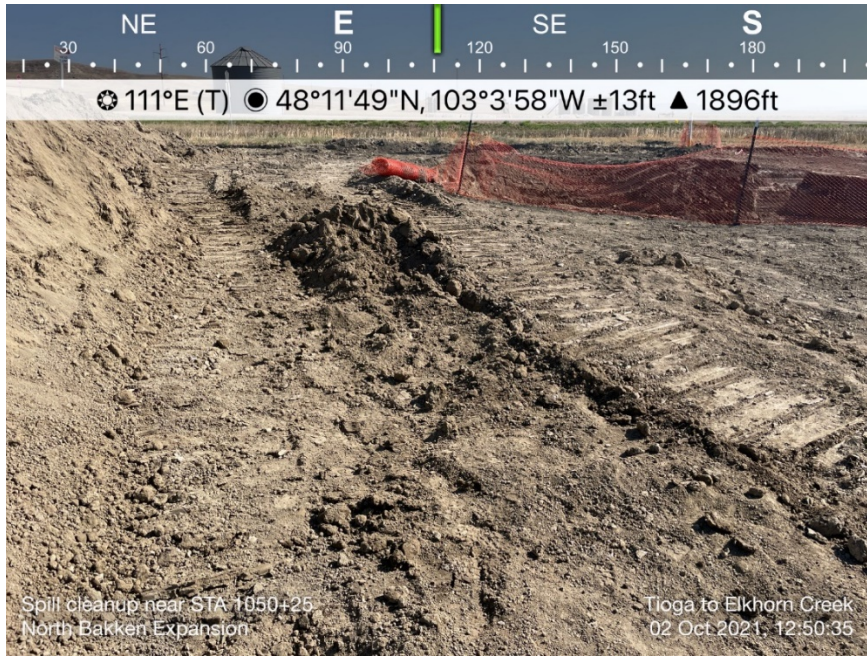
Location: Sta. No. 1050+25

Notes: Cleanup of an approximate two-gallon hydraulic leak on the Tioga-Elkhorn Creek Pipeline.

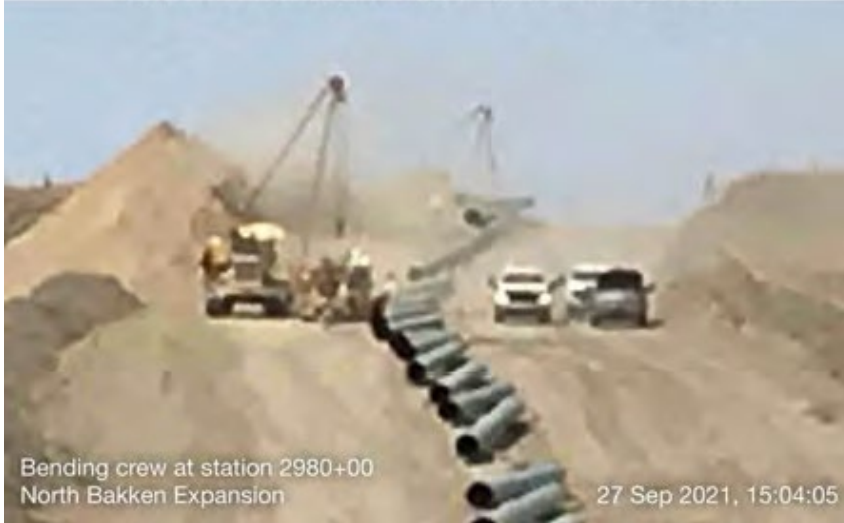
Location; Sta. No. 2980+00

Notes: Bending activities on  
the Tioga-Elkhorn Creek  
Pipeline.

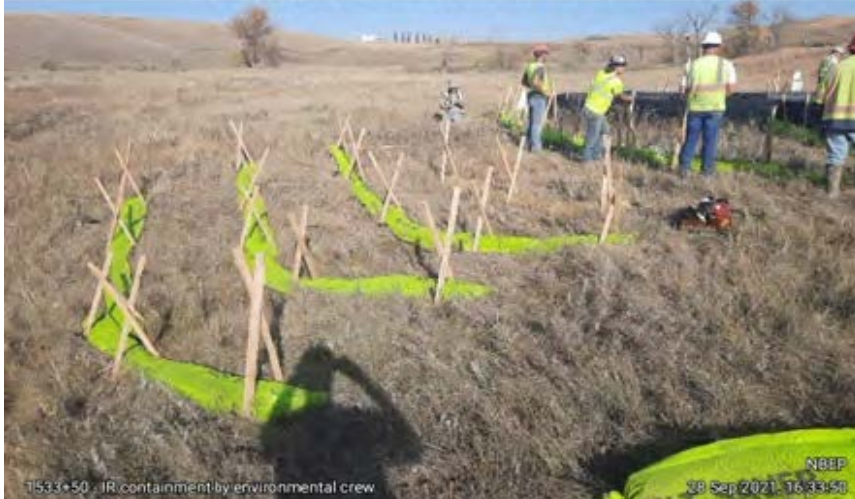
Location: Sta. No. 1533+50

1533+50 - IR containment by environmental crew

Notes: Additional erosion  
control devices installed for  
containment of potential  
inadvertent returns on the  
Tioga-Elkhorn Creek Pipeline.

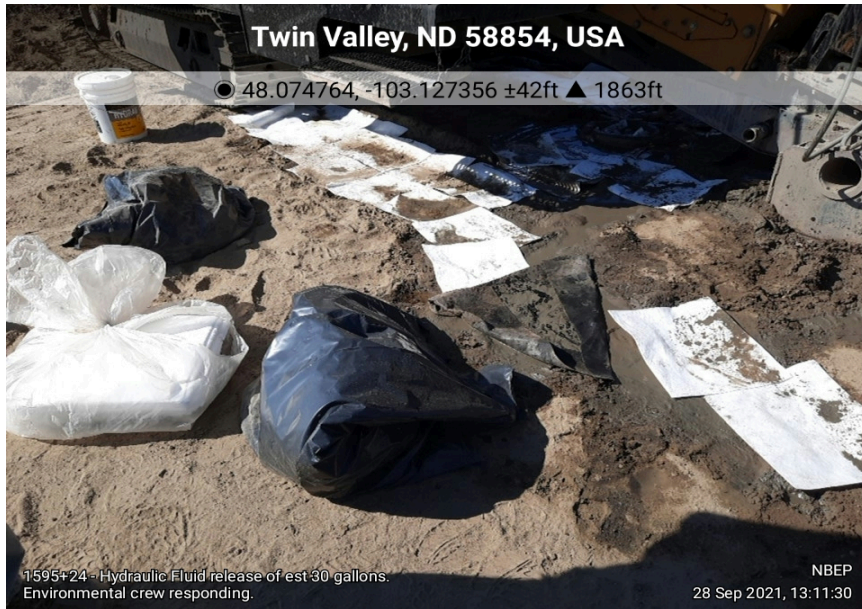
Location: Sta. No. 1595+24

- On September 28, 2021, an approximate 30-gallon hydraulic leak occurred from a bore drill rig at Sta. No. 1595+00. WBI Energy quickly implemented measures identified in the SPCC Plan to contain, clean up, and dispose of approximately 1,212 gallons (six cubic yards) of contaminated soil and cleanup materials. No cultural or sensitive resources were impacted. Requisite agency and internal spill reports were filed.

Notes: Hydraulic fluid release area beneath bore rig – absorbent diapers and bagged cleanup materials.

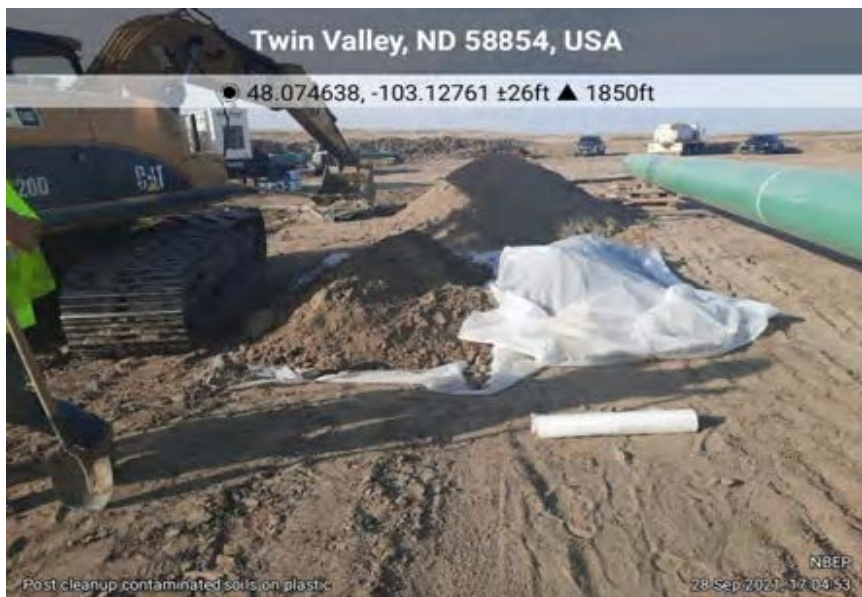
Location: Sta. No. 1595+24

Notes: Hydraulic fluid release site – excavated soil atop plastic sheeting.

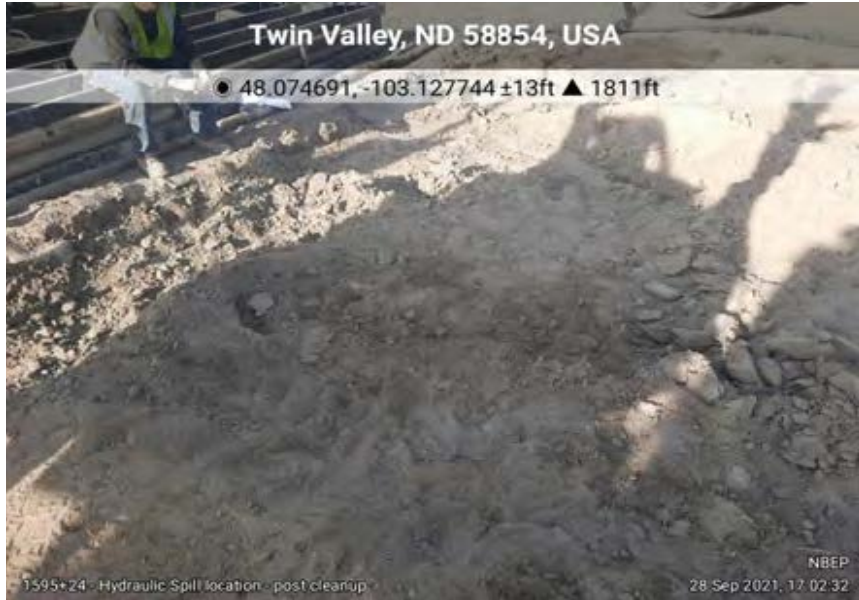
Date: 9/28/2021  
Location: Sta. No. 1595+24  
Notes: Hydraulic fluid release location following cleanup.

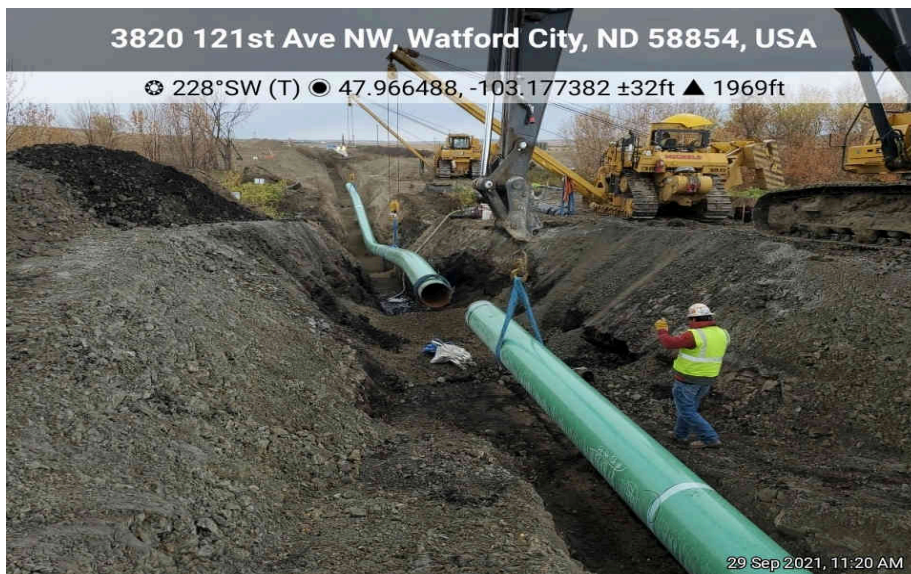
Date: 9/29/2021  
Location:  
Sta. No. 2059+76  
Notes: Lowering activities on the Tioga-Elkhorn Creek Pipeline.

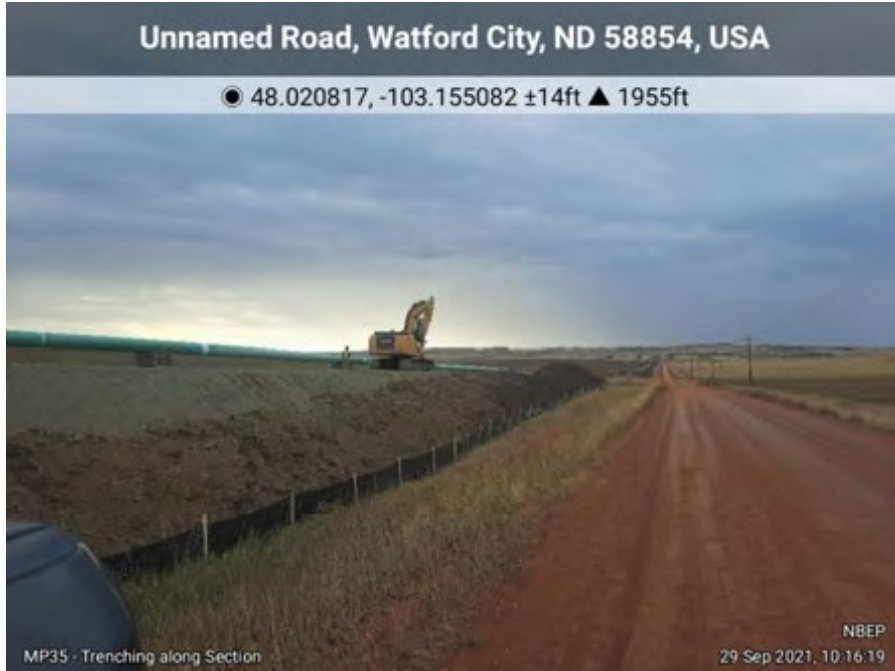
Location:  
Sta. No. 1848+00

Notes: Trenching activities on the Tioga-Elkhorn Creek Pipeline.

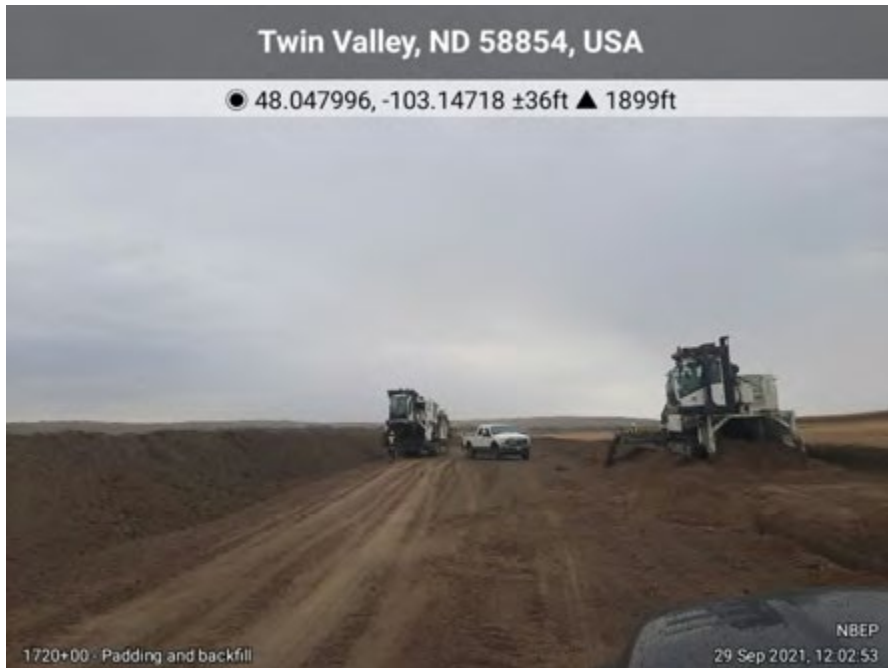
Location:  
Sta. No. 1720+00

Notes: Backfilling activities on the Tioga-Elkhorn Creek Pipeline.

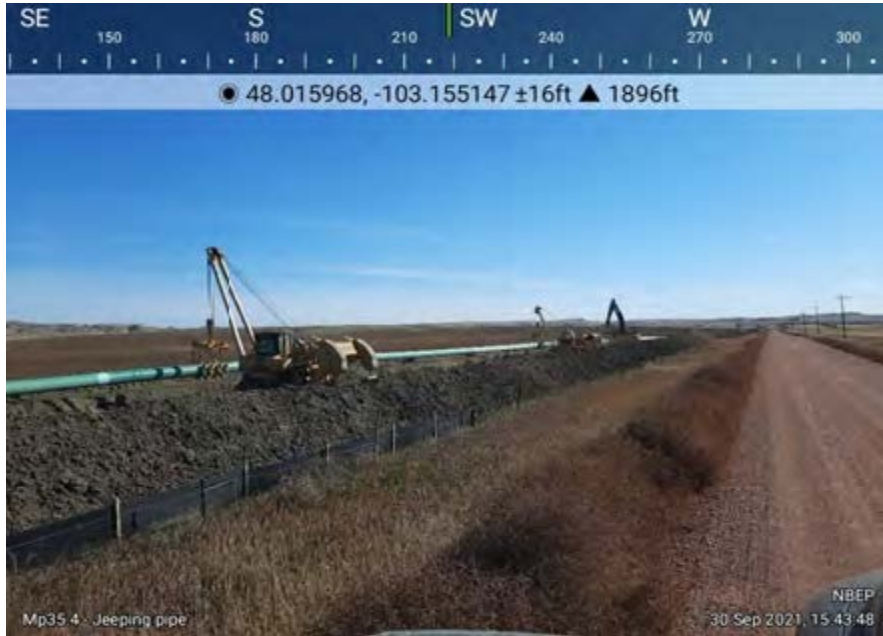
Location:  
Sta. No. 1869+00

Notes: Jeeping activities on  
the Tioga-Elkhorn Creek  
Pipeline.

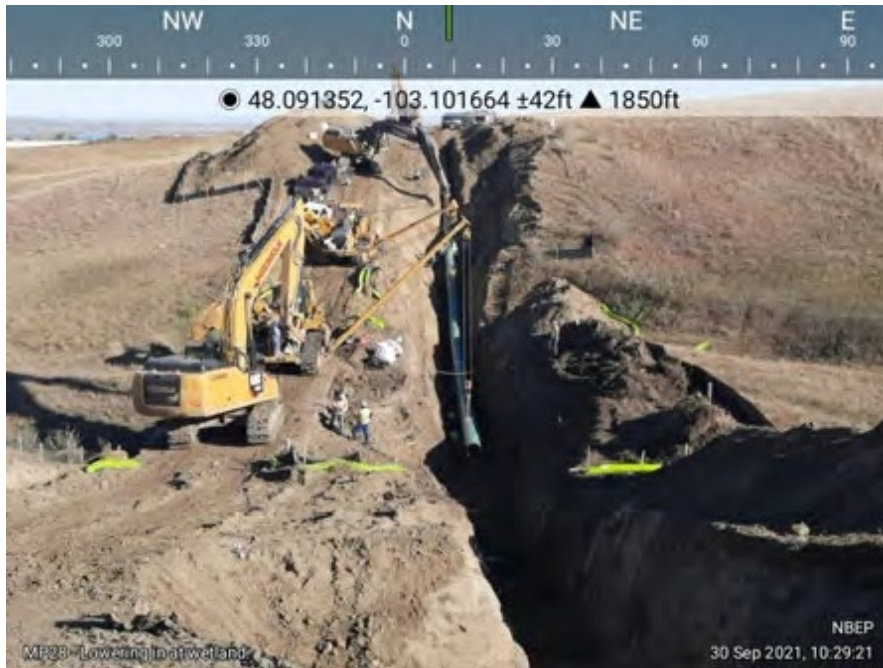
Location:  
Sta. No. 1478+40

Notes: Lowering activities  
on the Tioga-Elkhorn Creek  
Pipeline.

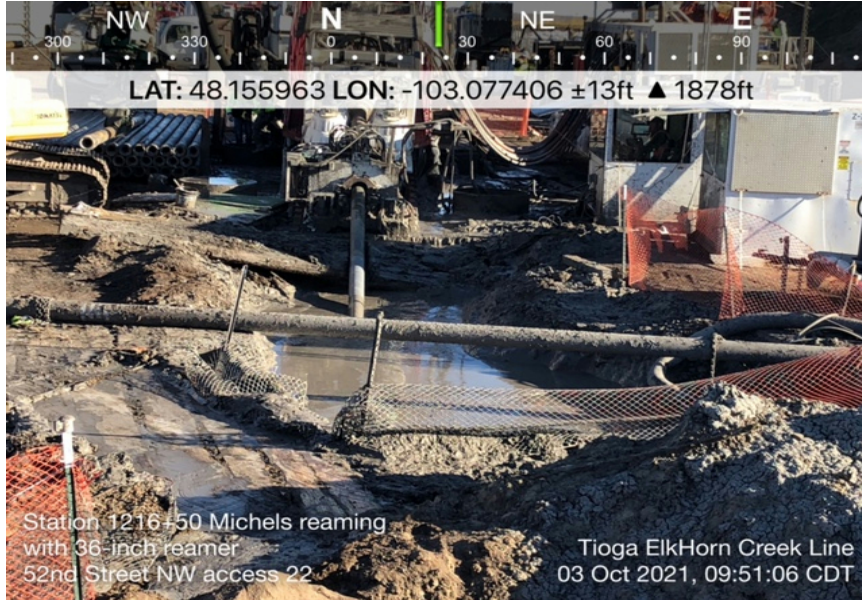
Location: North Spread HDD bore site.

Notes: Drilling activities with a 36-inch reamer at the North Spread HDD bore site.

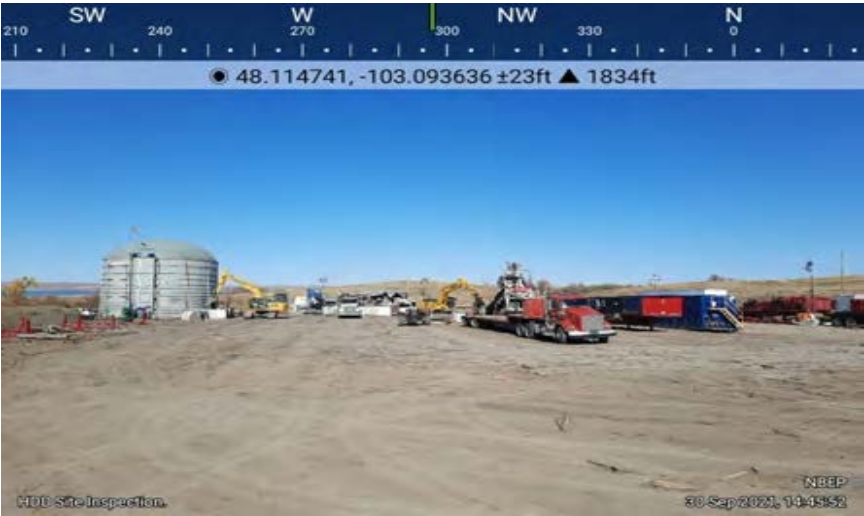
Location: South Spread HDD bore site.

Notes: Continued HDD drilling activities at the South Spread HDD bore site.

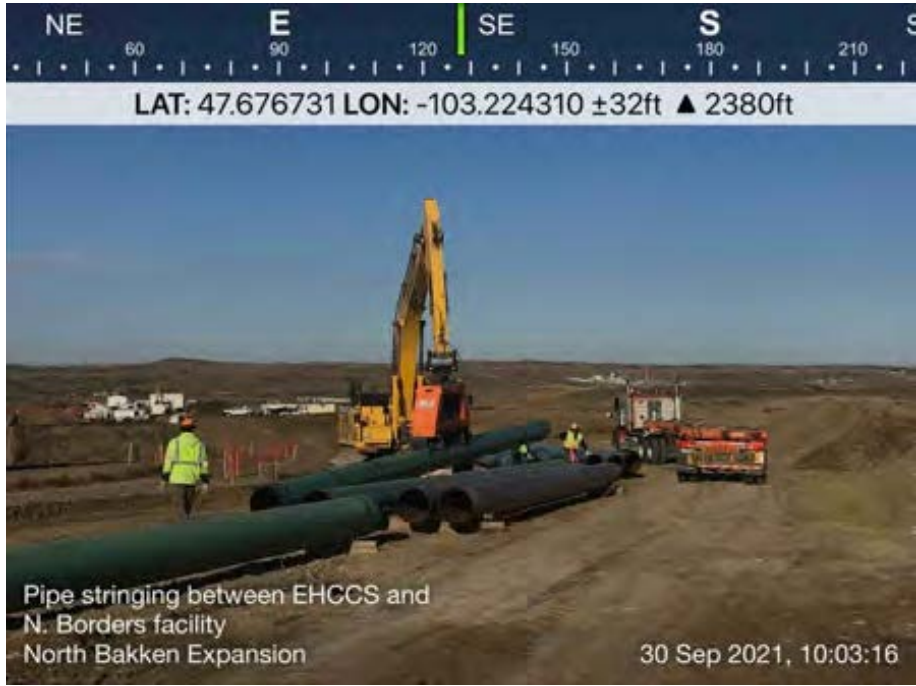
Location: Elkhorn Creek to Northern Border Interconnect Pipeline

Notes: Stringing activities on the Elkhorn Creek to Northern Border Interconnect Pipeline.

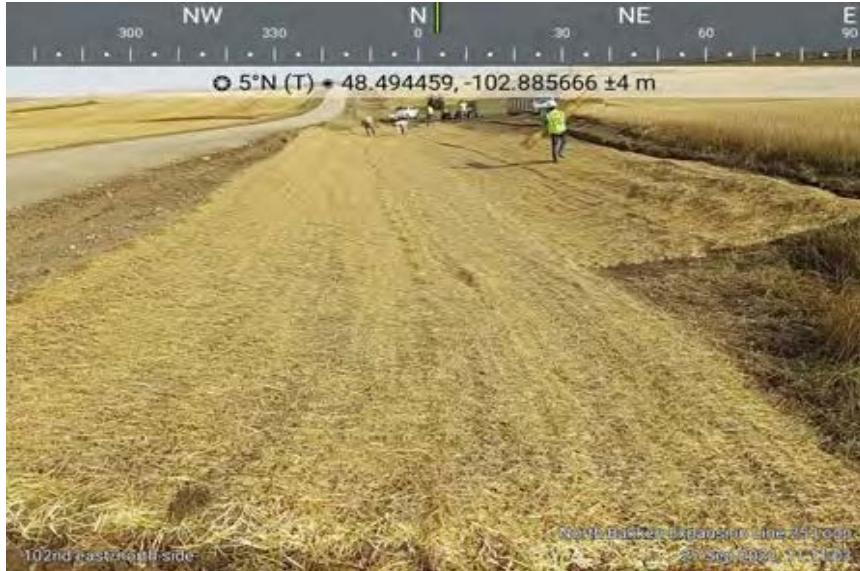
Location: Off of 102<sup>nd</sup> Ave. NW

Notes: h.  
Seeded and installed erosion control blankets at the bar ditch at 102<sup>nd</sup> Avenue NW on the Line Section 25 Loop.

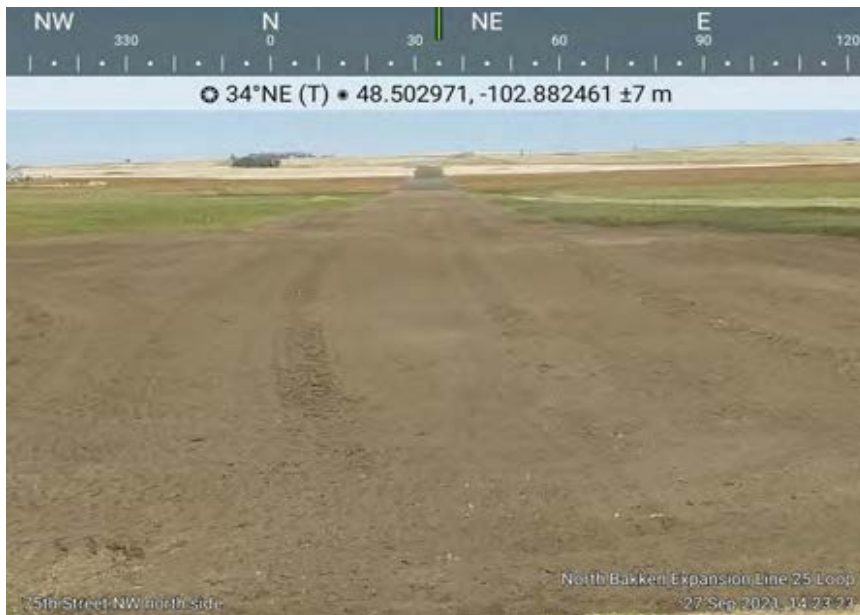
Location: Off of 75<sup>th</sup> St. NW

Notes: Restoration of right-of-way on the Line Section 25 Loop.

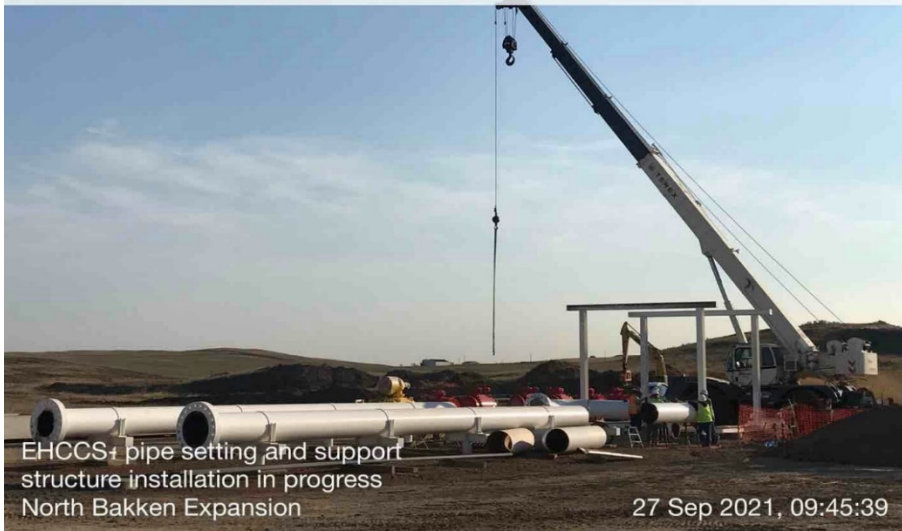
Location: Elkhorn Creek  
Compressor Station

EHCCS+ pipe setting and support  
structure installation in progress  
North Bakken Expansion

Notes: Installation of  
support structures and  
piping.

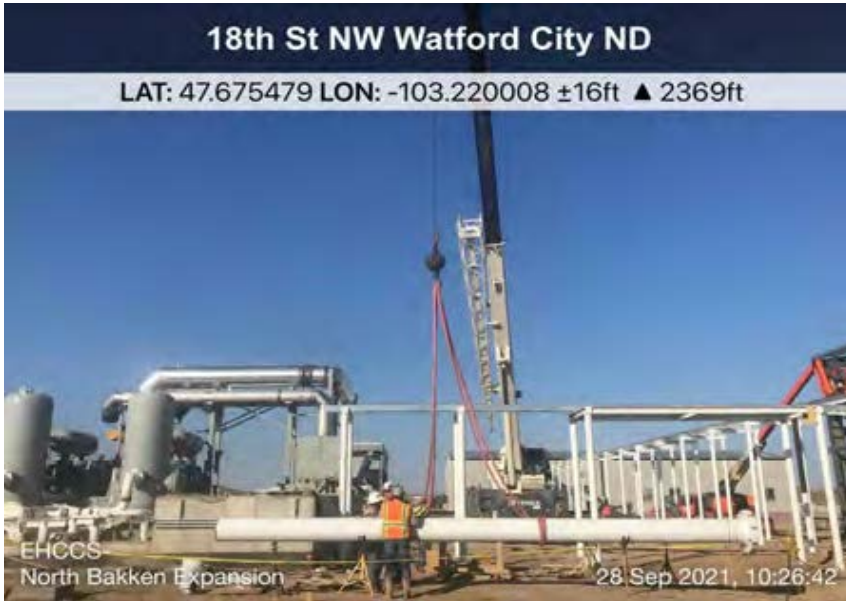
Location: Elkhorn Creek Compressor Station

Notes: Installation of overhead pipe.

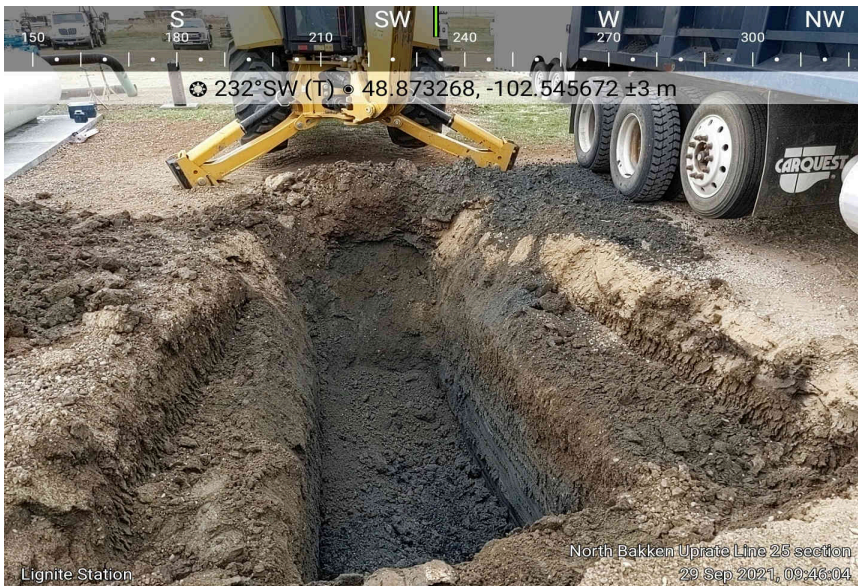
Location: Lignite Plant Receipt Station

Notes: Discolored soil during excavation.

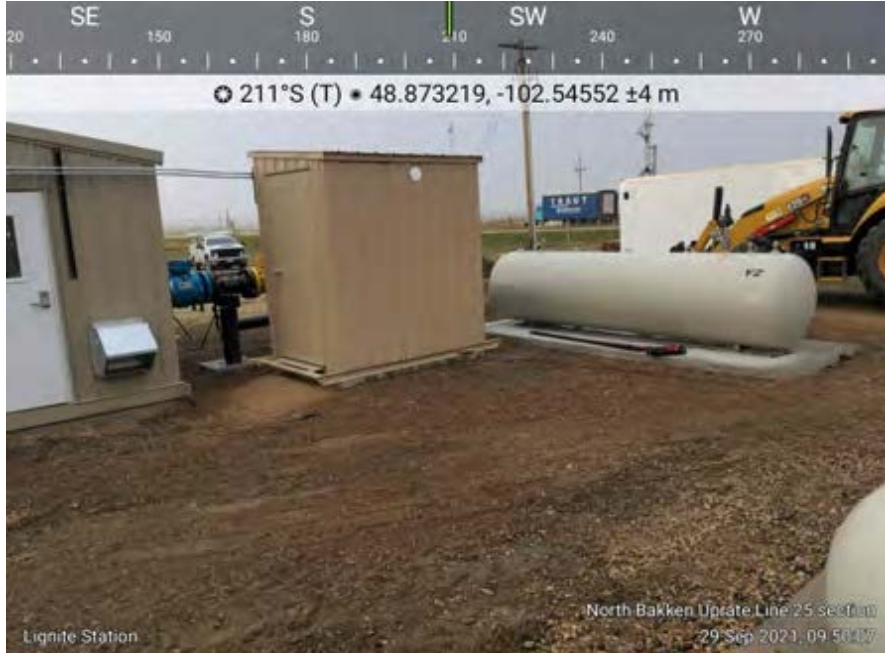
Location: Lignite Plant  
Receipt Station

Notes: Installed odorizer  
building and tank.

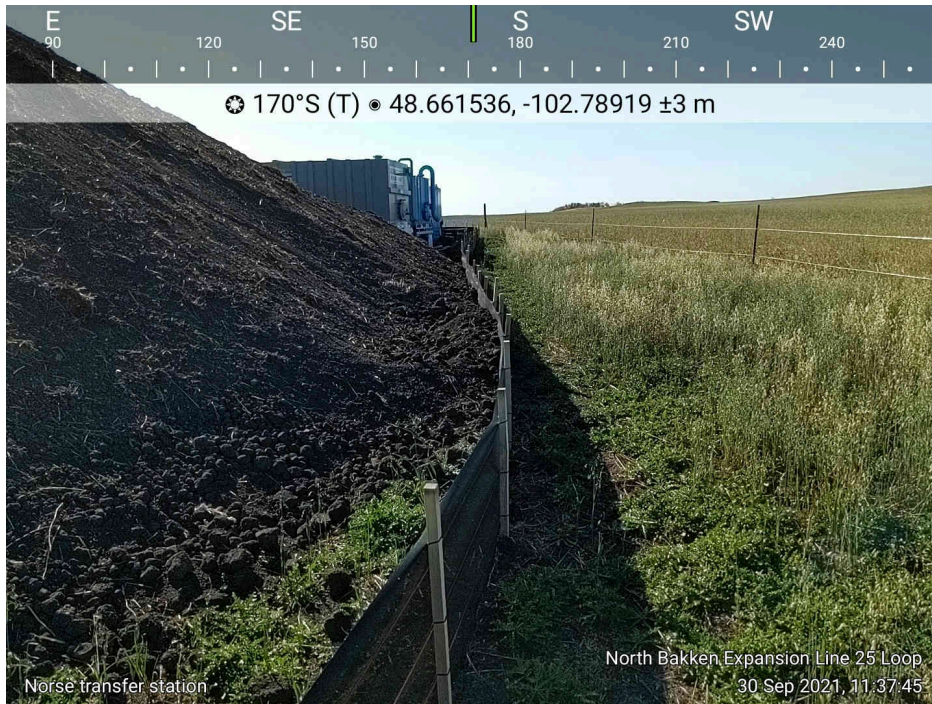
Location: Norse Transfer Station

Notes: Erosion control devices in compliance.

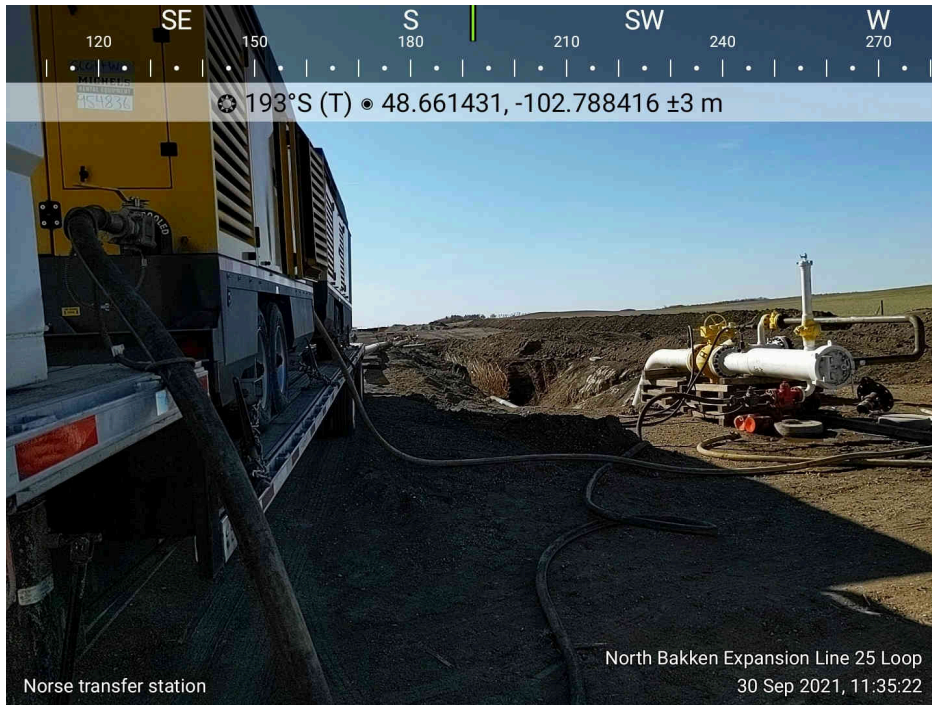
Location: Norse Transfer Station

Notes: Dewatering the Line Section 25 Loop from the Norse Transfer Station to the Tioga Compressor Station after a hydrostatic test.
