Re: WBI Energy Transmission, Inc.
Docket Nos. CP20-52-000 and CP20-52-001
North Bakken Expansion Project
Weekly Status Report No. 19

WBI Energy Transmission, Inc.
North Bakken Expansion Project Status Report No. 19
FERC Docket Nos. CP20-52-000
CP20-52-001

Reporting Period: October 4, 2021 through October 10, 2021

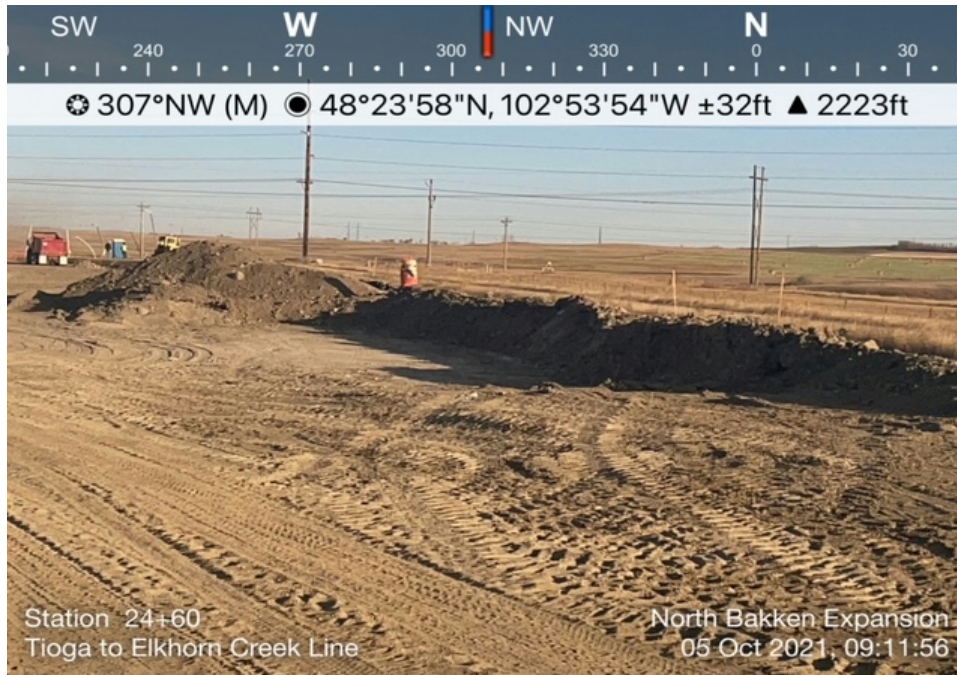
Location:
Sta. No. 24+60

- Completed welding, joint coating and ditching activities.
- Continued clean-up activities.
- On October 5, 2021, contaminated soils discovered during trenching activities on August 4, 2021 from Sta. No. 8+43 and August 31, 2021 from Sta. No.479+80 were removed and disposed of at an approved disposal site.

Notes: Removal of contaminated soil stored at Sta. 24+60 from an unanticipated discovery during trenching activities at Sta. No. 479+80 on August 31, 2021. Removed media was disposed at an approved disposal site.

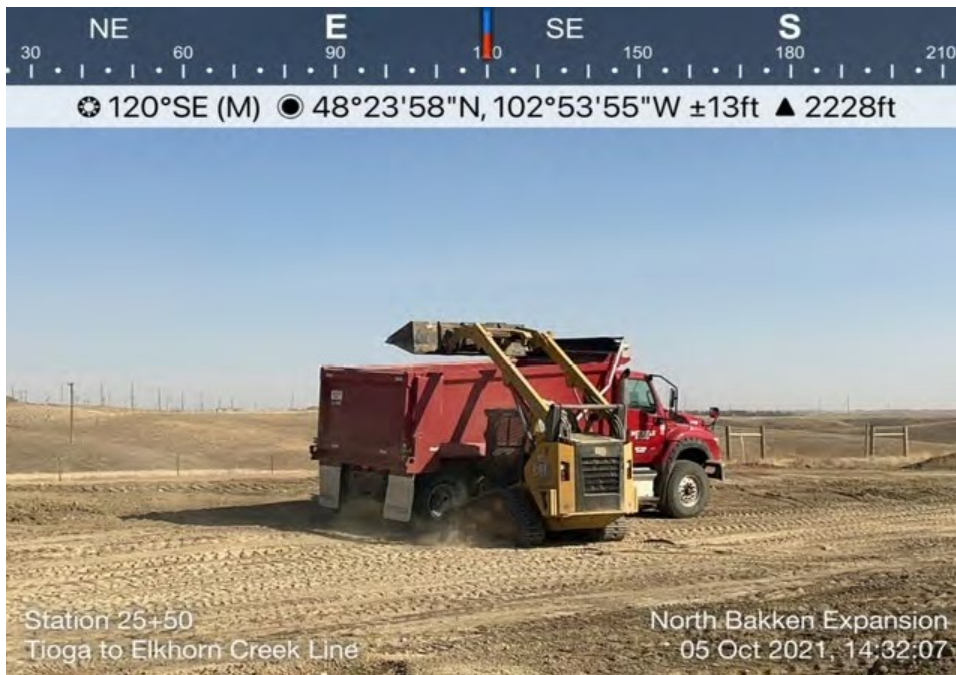
Location:
 Sta. No. 25+50

Notes: Removal of
 oversized rocks on the
 right-of-way on the
 Tioga-Elkhorn Creek
 Pipeline.

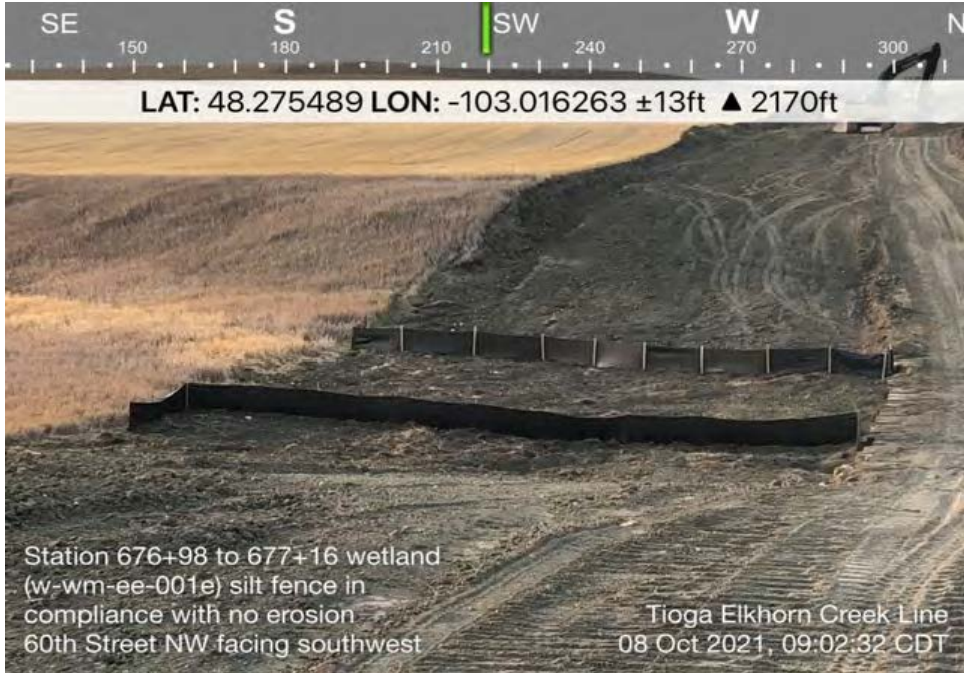
Location: Sta. Nos. 676+98 to 677+16

Notes: Erosion control devices in compliance at wetland w-wm-ee-001e on the Tioga-Elkhorn Creek Pipeline.

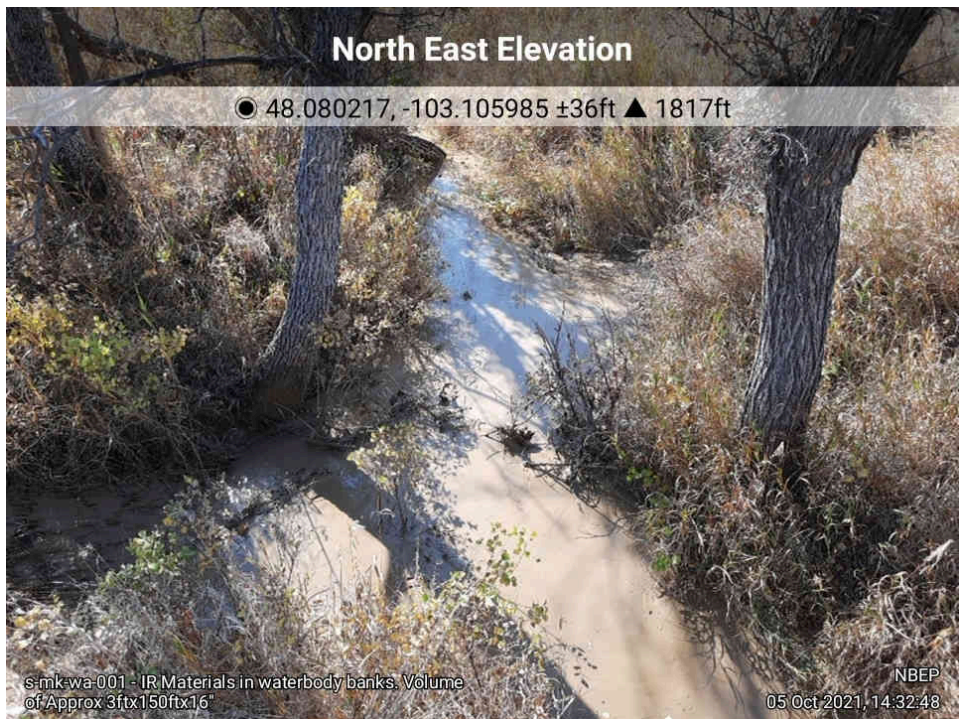
Location:
Sta. No. 1535+59

- Began cleanup activities.
- Began construction activities at a block valve location.
- Between October 4 to October 8, 2021, multiple inadvertent releases (IRs) occurred between Sta. Nos. 1535+25 to 2032+80 during boring activities. WBI Energy quickly implemented measures identified in the Horizontal Directional Drill/Guided Bore Drilling Fluid Monitoring and Operations Plan (HDD Plan) for the containment and cleanup of drilling fluids. Hand tools, sediment control devices, and vac-trucks were utilized to contain and remove released fluids. Two IRs occurred outside the approved limits of disturbance at Sta. No. 1535+25 and 2032+80. IRs occurred in upland areas and three resources (dry stream waterbody s-mk-wa-001, flowing waterbody s-mk-ea-003, and wetland w-mk-ea-003e). The FERC Monitor was informed of all IRs. The U.S. Army Corps of Engineers, the U.S. Fish and Wildlife Service, and the ND Department of Environmental Quality, Division of Water Quality personnel were also notified of the IR into waterbody s-mk-ea-003 (Tobacco Garden Creek).

Notes: An inadvertent release within dry stream waterbody s-mk-wa-001 on the Tioga-Elkhorn Creek Pipeline.

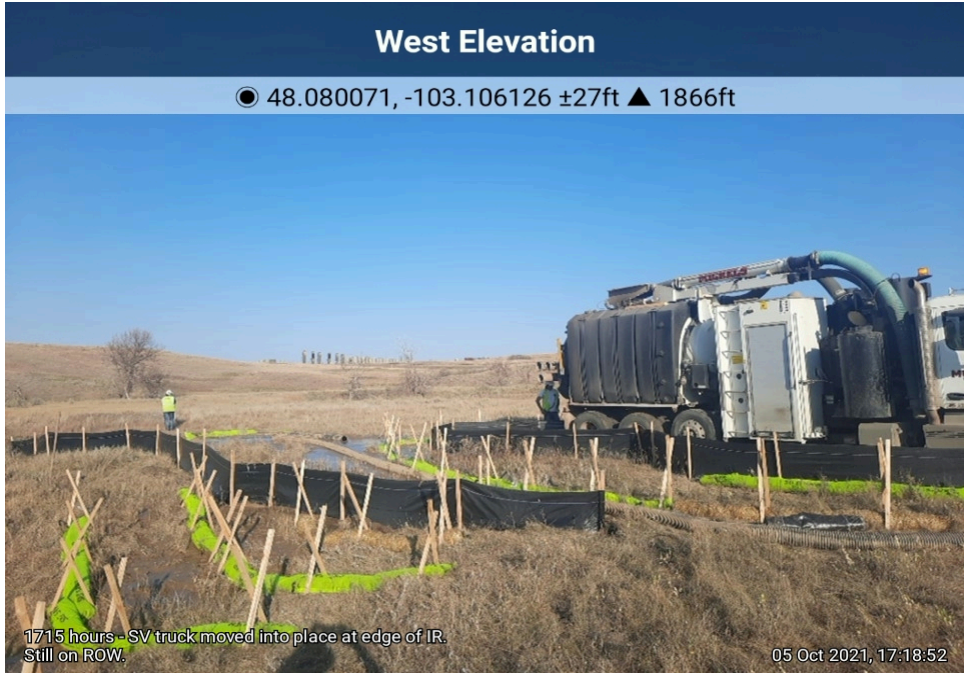
Location:
 Sta. No. 1535+59

Notes: A vac truck was utilized to remove IR fluids from dry stream waterbody s-mk-wa-001 on the Tioga-Elkhorn Creek Pipeline.

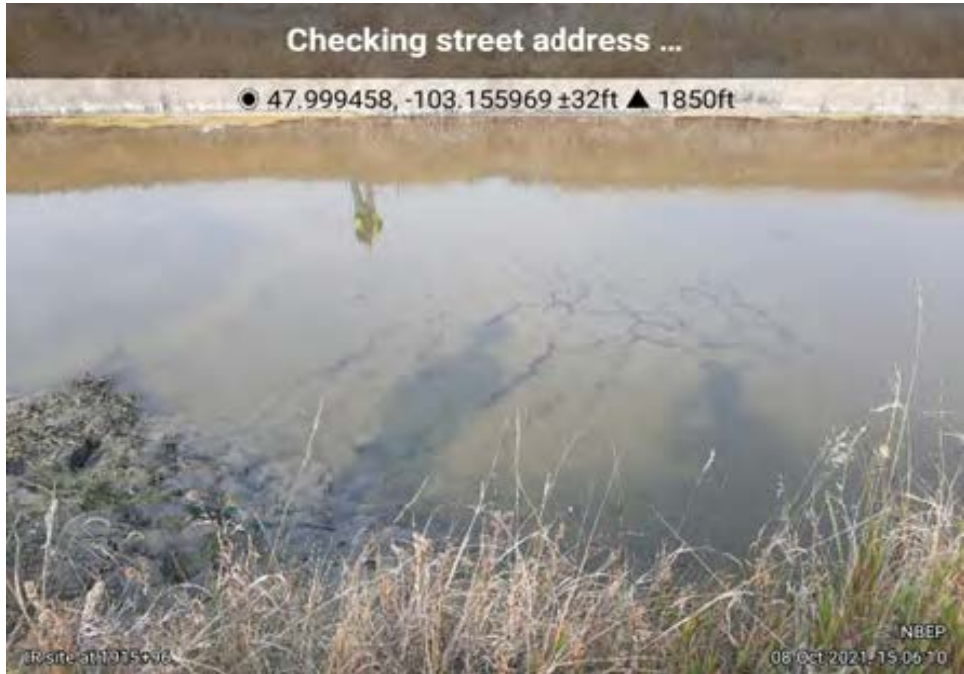
Location:
Sta. No. 1916+07

Notes: An inadvertent release within waterbody s-mk-ea-003 on the Tioga-Elkhorn Creek Pipeline.

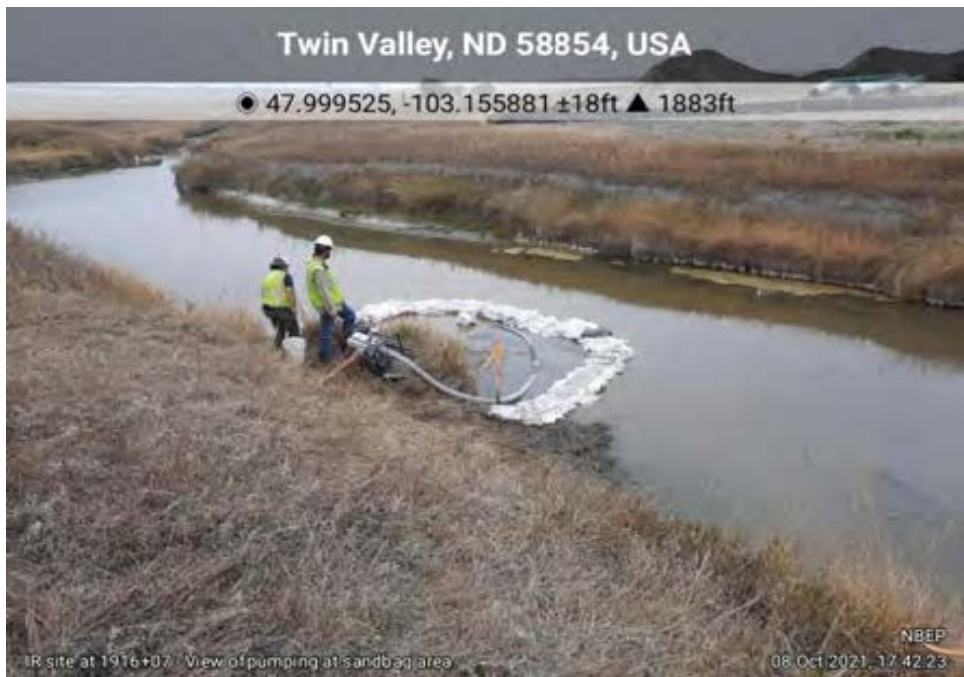
Location:
Sta. No. 1916+07

Notes: A sandbag dam was installed within waterbody s-mk-ea-003 and a pump set was utilized to remove IR fluids from the Tobacco Garden Creek on the Tioga-Elkhorn Creek Pipeline.

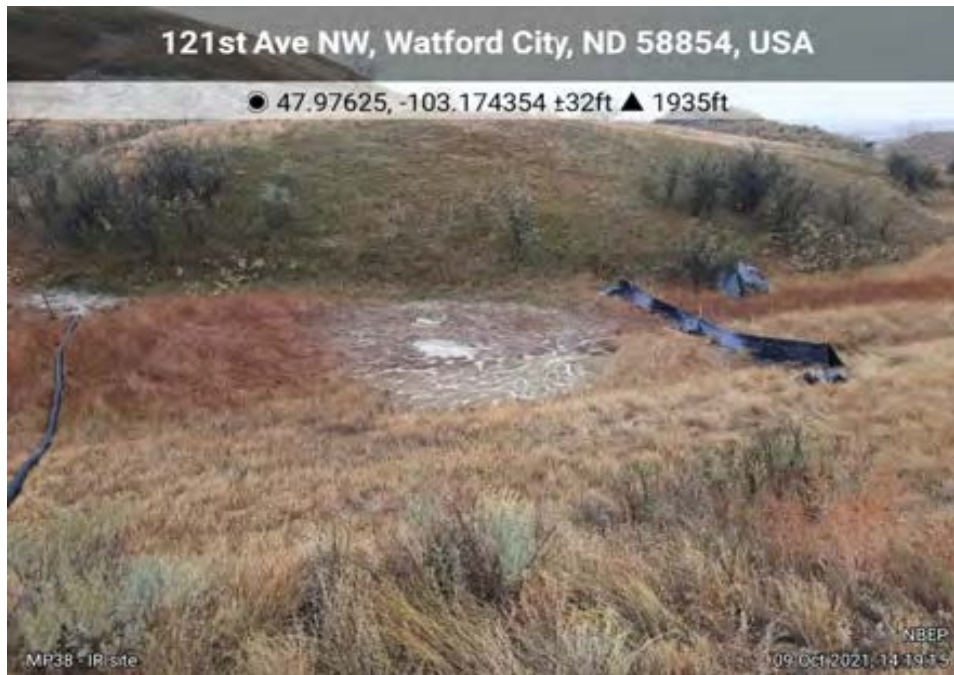
Location:
Sta. No. 2032+80

Notes: An inadvertent release within wetland w-mk-ea-003e on the Tioga-Elkhorn Creek Pipeline.

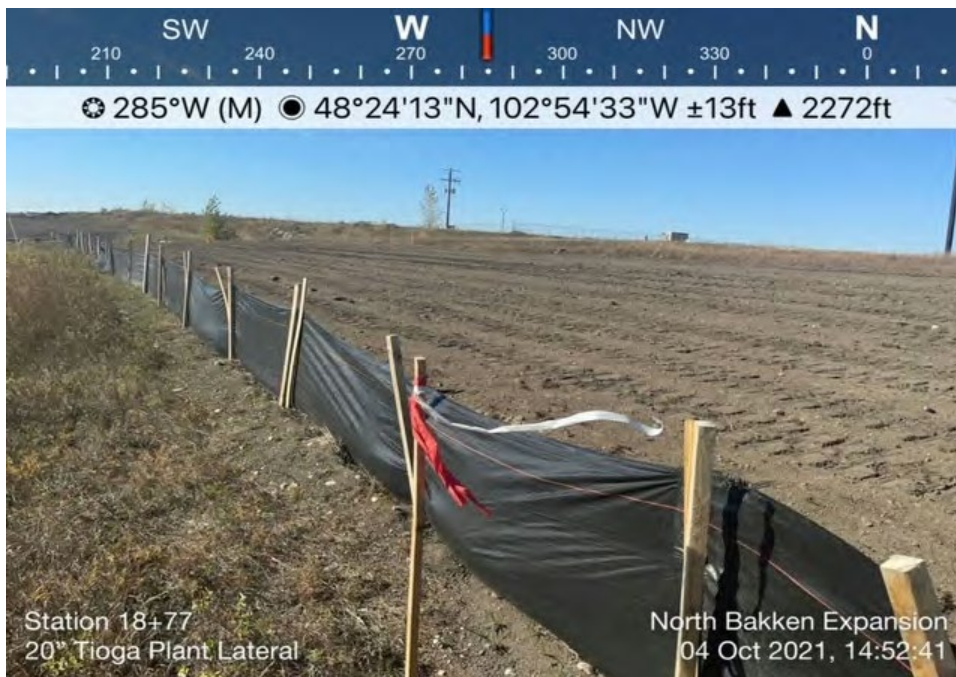
Location:
Sta. No. 18+77

Notes: Erosion
control devices in
compliance on the
Tioga Compressor
Lateral.

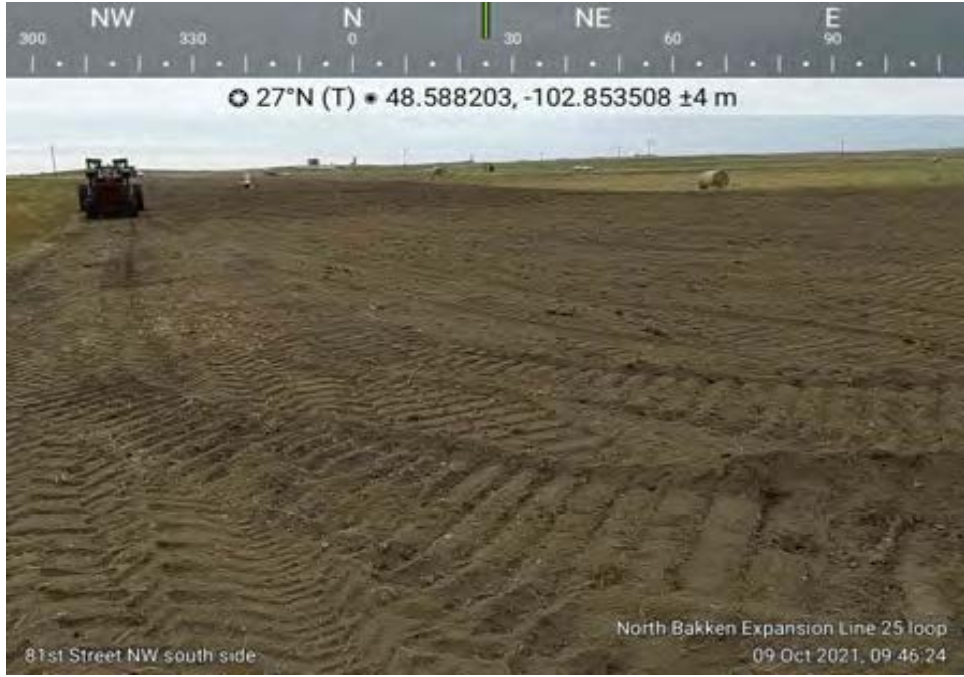
Location:
Sta. No. 717+00

Notes: Removal of
rocks along the right-
of-way on the Line
Section 25 Loop.
