Re: WBI Energy Transmission, Inc.
Docket Nos. CP20-52-000 and CP20-52-001
North Bakken Expansion Project
Weekly Status Report No. 20

WBI Energy Transmission, Inc.
North Bakken Expansion Project Status Report No. 20
FERC Docket Nos. CP20-52-000
CP20-52-001

Reporting Period: October 11, 2021 through October 17, 2021

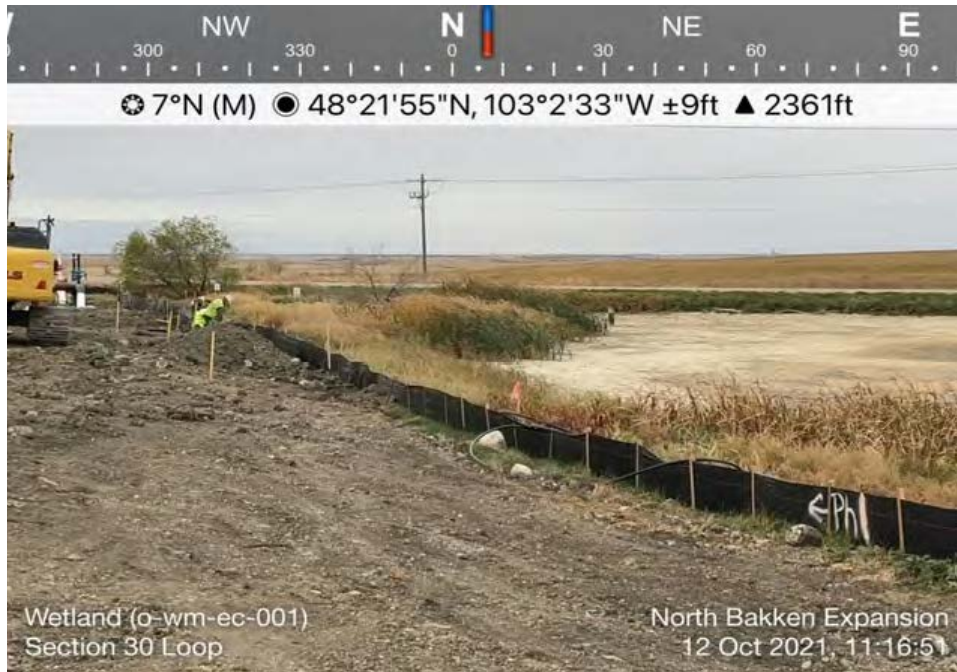
Location:
Sta. No. 0+00

Notes: Repair of the
silt fence at wetland
o-wm-ec-001 on the
Line Section 30 Loop.

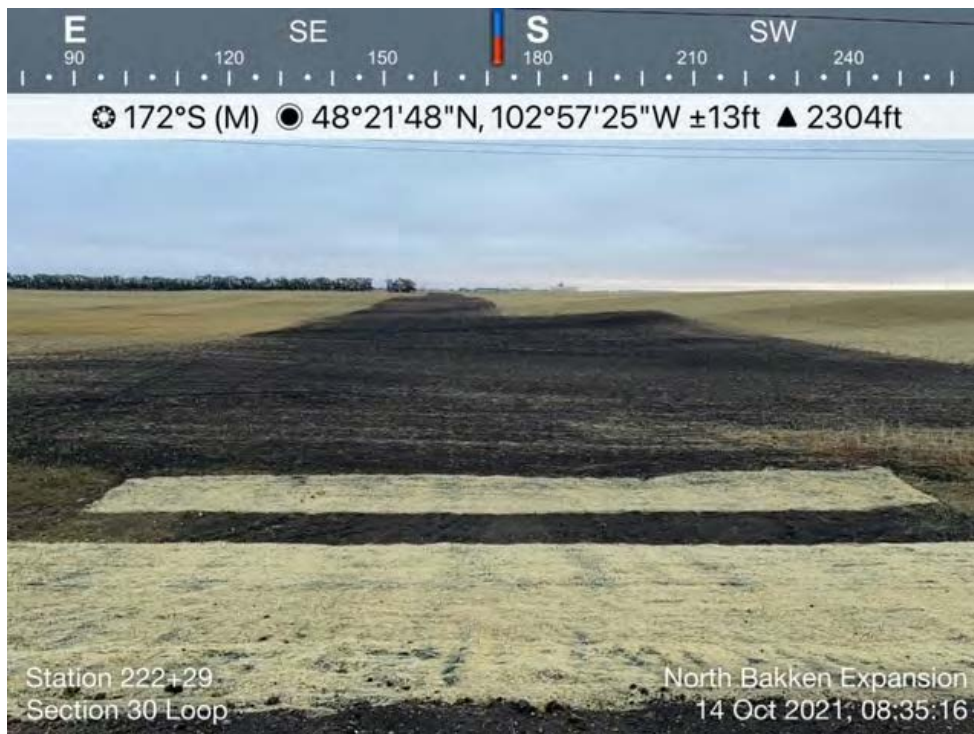
Location:
Sta. No. 222+29

Notes: Erosion
control blankets in
place and properly
functioning at bar
ditch on the Line
Section 30 Loop.

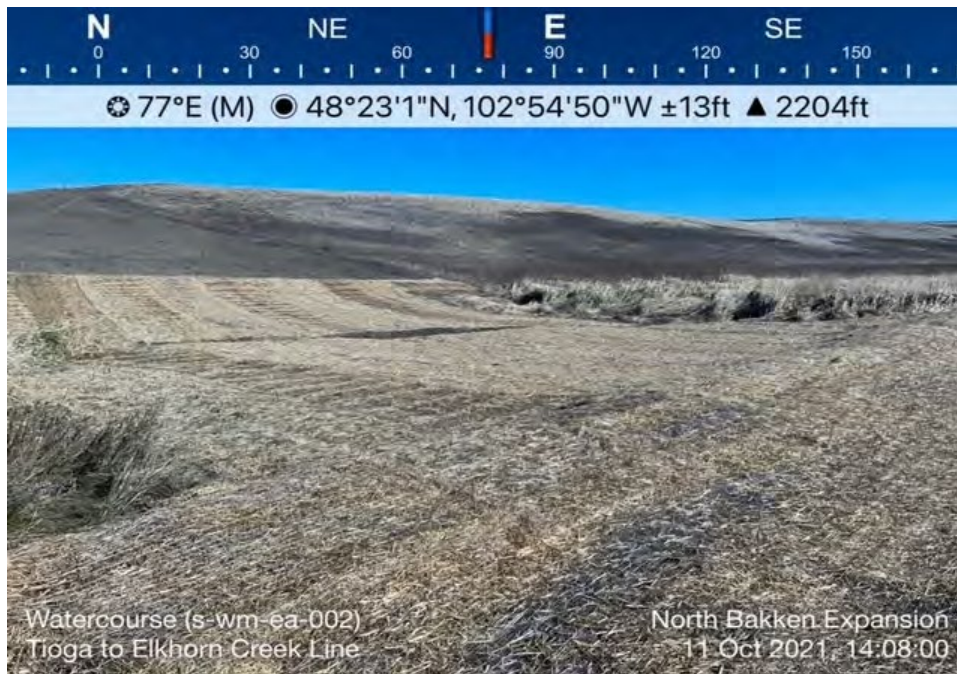
Location:
Sta. No. 124+64

Notes: Erosion control blankets in place and properly functioning on the banks of waterbody s-wm-ea-002 on the Tioga-Elkhorn Creek Pipeline.

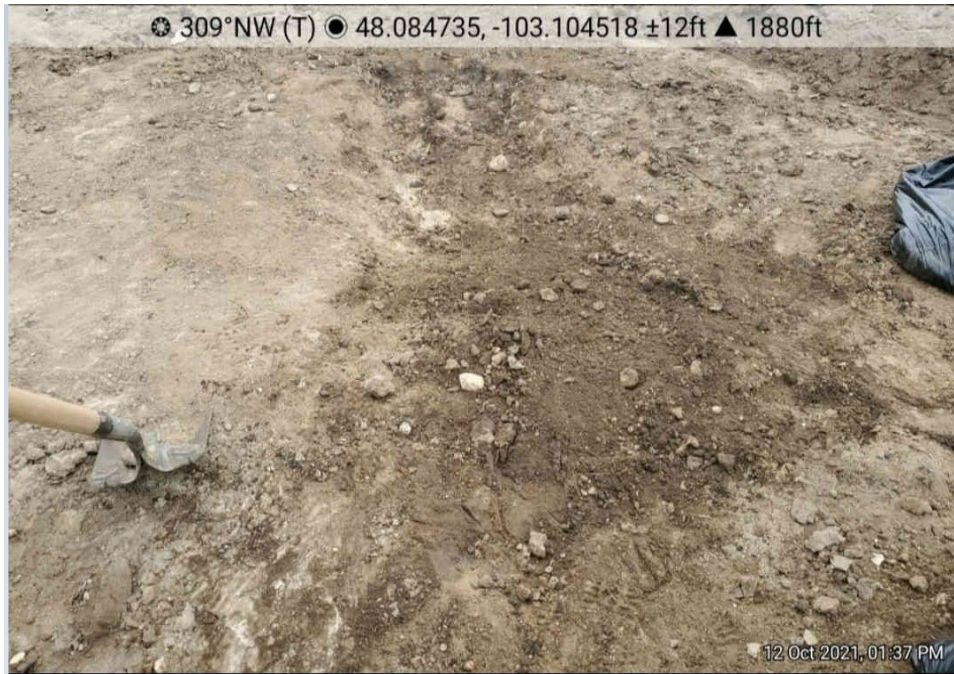
Location:
Sta. No. 1512+00

- On October 12, 2021, an approximate one-gallon hydraulic fluid leak occurred from a grader at Sta. No. 1512+00. WBI Energy quickly implemented measures identified in the Spill Prevention, Control and Countermeasure (SPCC) Plan to contain, clean up, and dispose of approximately 10 cubic feet of contaminated soil and cleanup materials. No cultural or sensitive resources were impacted. Requisite agency and internal spill reports were filed.

Notes: Cleanup of an approximate one-gallon hydraulic leak on the Tioga-Elkhorn Creek Pipeline.

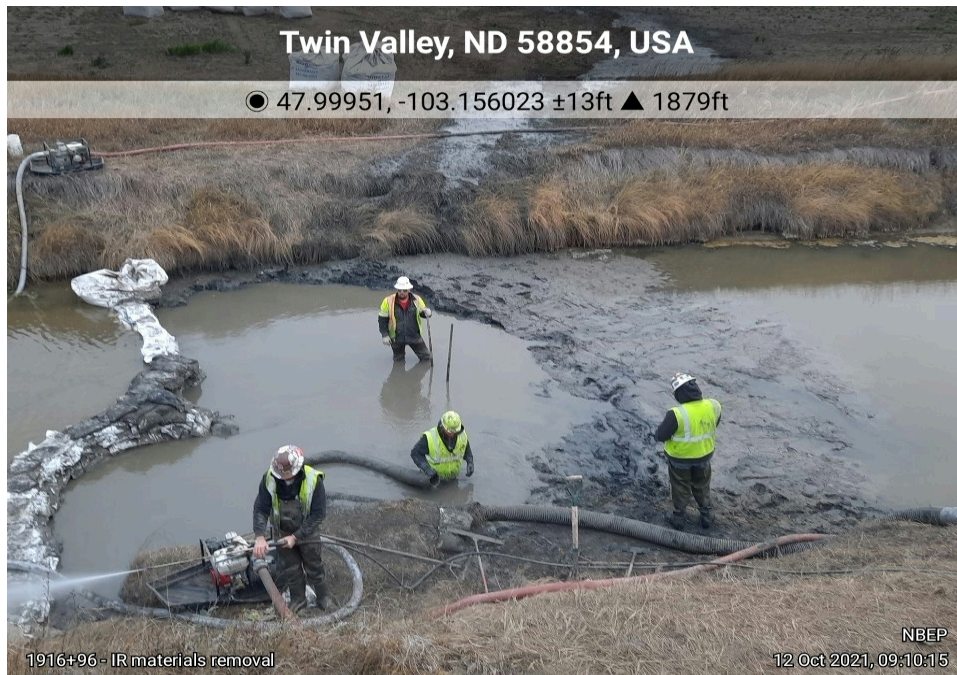
Location:
Sta. No. 1916+96

Notes: Continued removal of IR fluids from the previous week's release. A pump was utilized to remove IR fluids from waterbody s-mk-ea-003 (Tobacco Garden Creek) on the Tioga-Elkhorn Creek Pipeline.

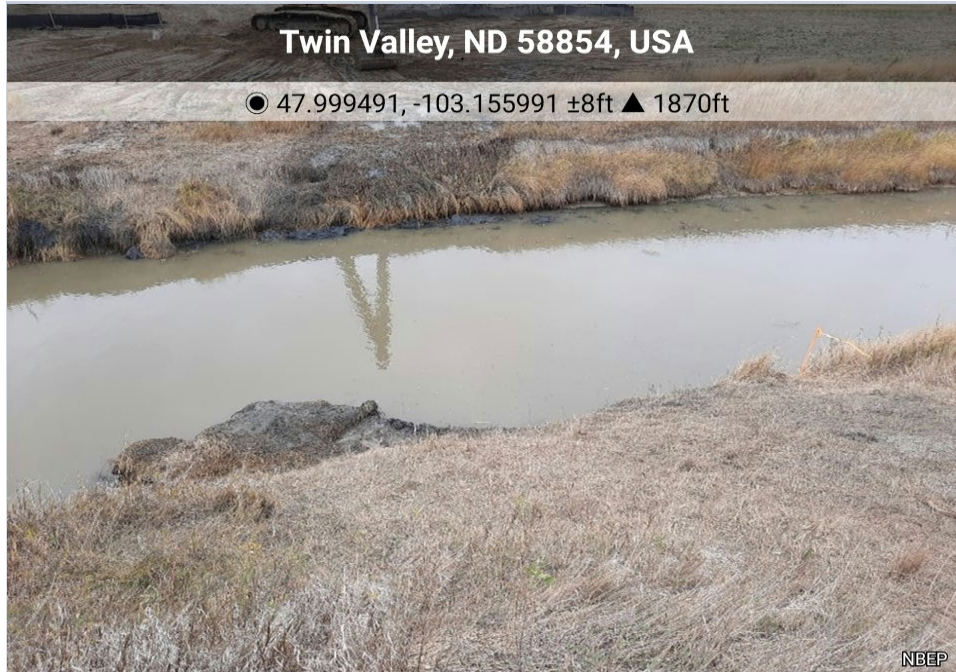
Location:
Sta. No. 1916+96

Notes: Completed cleanup of IR fluids from waterbody s-mk-ea-003 (Tobacco Garden Creek) on the Tioga-Elkhorn Creek Pipeline.

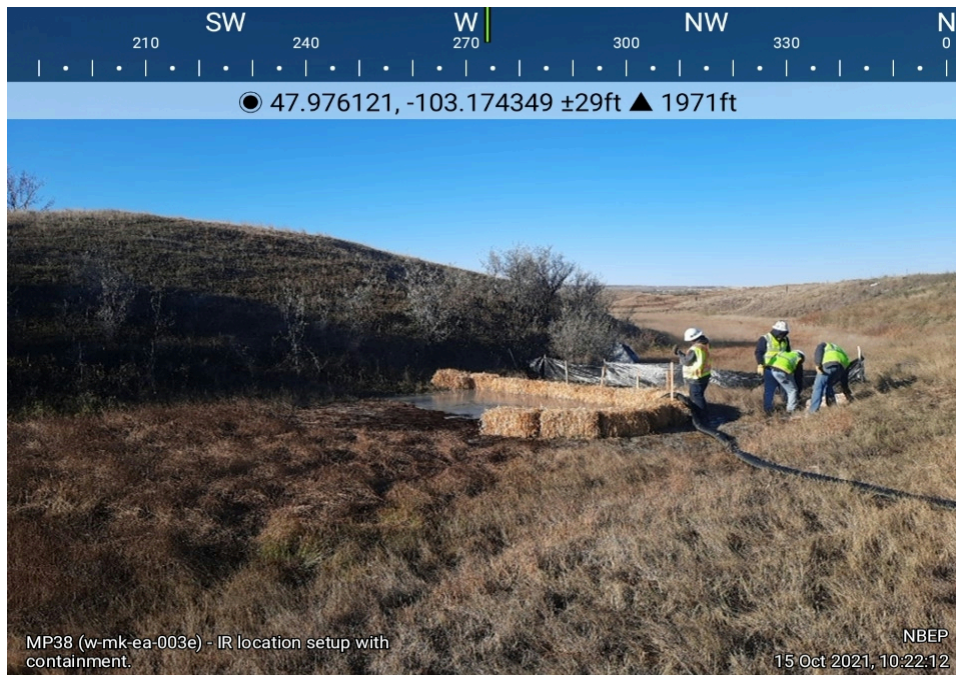
Location:
Sta. No. 2032+80

- Continued construction activities at a block valve location.
- Between October 12 to October 16, 2021, multiple inadvertent releases (IRs) occurred between Sta. Nos. 2032+80 to 2481+60 during boring activities. WBI Energy quickly implemented measures identified in the Horizontal Directional Drill/Guided Bore Drilling Fluid Monitoring and Operations Plan (HDD Plan) for the containment and cleanup of drilling fluids. Hand tools, sediment control devices, and vac-trucks were utilized to contain and remove released fluids. The IRs occurred in upland areas and in one resource (wetland w-mk-ea-003e). The FERC Monitor was informed of all IRs.

Notes: Inadvertent release containment structure within wetland w-mk-ea-003e on the Tioga-Elkhorn Creek Pipeline.

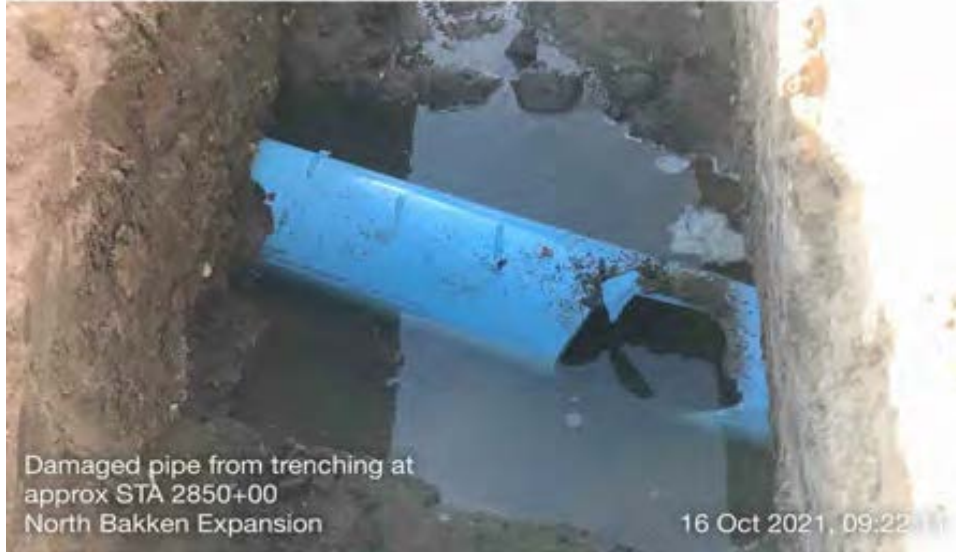
Location:
Sta. No. 2850+00

- On October 16, 2021, a trenching crew punctured a foreign non-metal pipe (approximately 16-inch diameter) while excavating at Sta. No. 2850+00. Approximately 300 gallons of water from the punctured foreign pipe drained into the trench. The foreign pipe had not been identified during pre-construction line location, resulting in the trenching crew being unaware of the foreign pipe's location. It was determined that the punctured foreign pipe was a water line belonging to a water company. The water company representative indicated that flow through the water line would not be necessary for several weeks. WBI Energy is working with contractors to have the pipe repaired on October 22, 2021. Water from the punctured water line remained in the trench and did not exit the right-of-way.

Damaged pipe from trenching at
approx STA 2850+00
North Bakken Expansion

Notes: Punctured
water pipe during
trenching activities on
the Tioga-Elkhorn
Creek Pipeline.
