Re: WBI Energy Transmission, Inc. Docket Nos. CP20-52-000 and CP20-52-001 North Bakken Expansion Project Weekly Status Report No. 22

WBI Energy Transmission, Inc. North Bakken Expansion Project Status Report No. 22 FERC Docket Nos. CP20-52-000 CP20-52-001

Reporting Period: October 25, 2021 through October 31, 2021

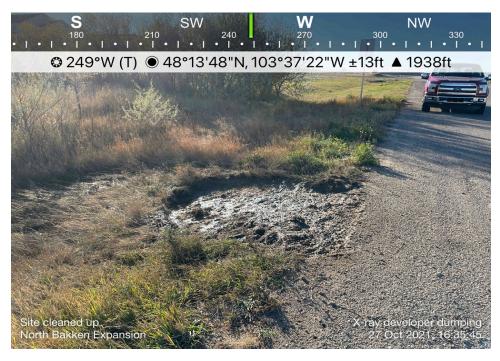
Location: Off rightof-way, Williston, ND

Notes: The NDDEQ informed WBI Energy of contaminated soil discovered approximately 25 miles from the Project right-of-way. The site contained x-ray film developing chemicals dumped in a road ditch by a subcontractor.

Notes: Contaminated soil was removed and replaced with clean topsoil at the direction of the NDDEQ representative on site. Contaminated soil will be disposed of at an approved facility.

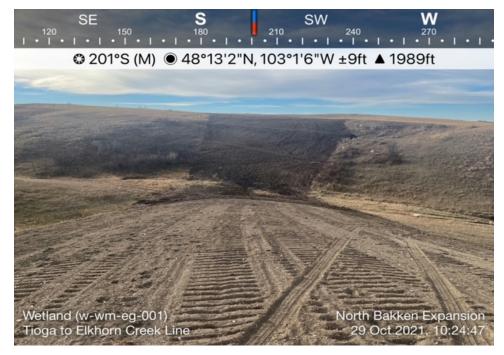
Location: Sta. No. 889+00

Notes: Slope breakers in place and properly functioning above wetland w-wm-eg-001 on the Tioga-Elkhorn Creek Pipeline.

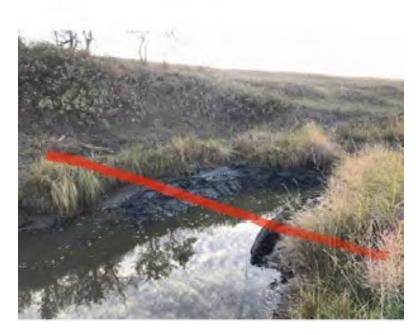
Notes: Approximately 1-foot uplift of the waterbody's banks as a result of pipe pulling activities below the waterbody. The red line indicates the approximate location of the underground pipe.

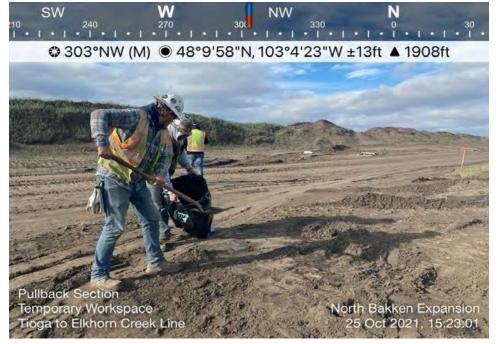
Location: North Spread HDD bore site.

Notes: Removal of contaminated soil discovered from an unknown hydraulic fluid spill that had occurred within the right-of-way at the pullback section of bore pipe.
 S
 SW
 NW
 NW

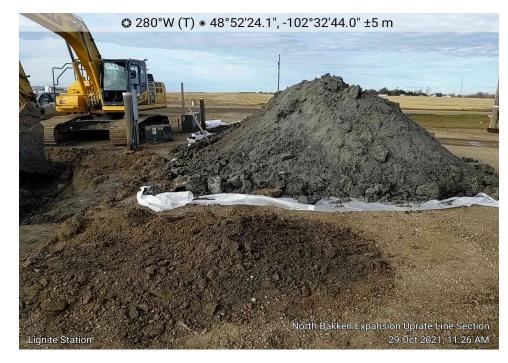
Location: Lignite Plant Receipt Station.

Notes: Contaminated soil discovered during excavation for tie-in activity placed on plastic sheeting before disposal.
