**FEDERAL ENERGY REGULATORY COMMISSION**  
**ENVIRONMENTAL COMPLIANCE MONITORING PROGRAM**  
WEEKLY SUMMARY REPORT NO. 17  
**NORTH BAKKEN EXPANSION PROJECT**  
**DOCKET NOS.: CP 20-52-000 AND CP 20-52-001**  
FOR THE PERIOD: NOVEMBER 21 THROUGH 27, 2021

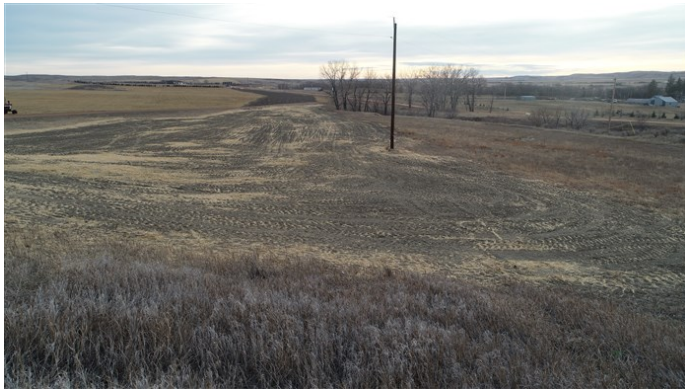
Tioga Elkhorn Creek PL Spread 2 – Final clean-up was conducted on tract 152-98-24-105. The landowner will seed the areas of the tract that were not seeded/mulched. Line markers and permanent fencing were installed. (November 22, 2021) – Acceptable – MP 38.4

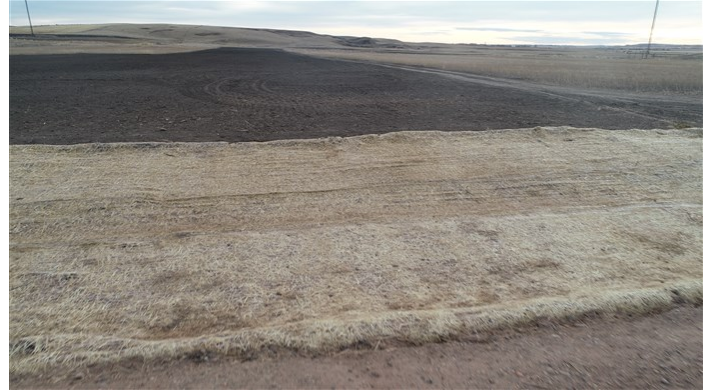
Tioga Elkhorn Creek PL Spread 2 – Curlex installed on both sides of 38<sup>th</sup> Street NW (November 22, 2021) – Acceptable – MP 39.2

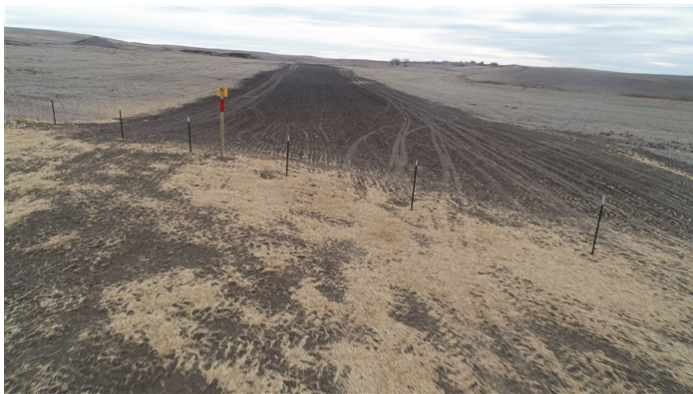
Tioga Elkhorn Creek PL Spread 2 – Final clean-up completed on this area of the right-of-way. Wetland w-mk-eb-003e and contours restored (November 23, 2021) – Acceptable – MP 41.1

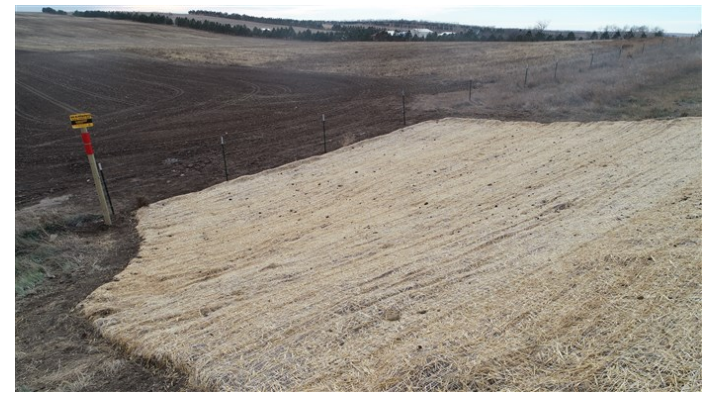
Tioga Elkhorn Creek PL Spread 2 – Curlex installed on the south side of Highway 12 at the downslope area of the road shoulder (November 23, 2021) – Acceptable – MP 43.5

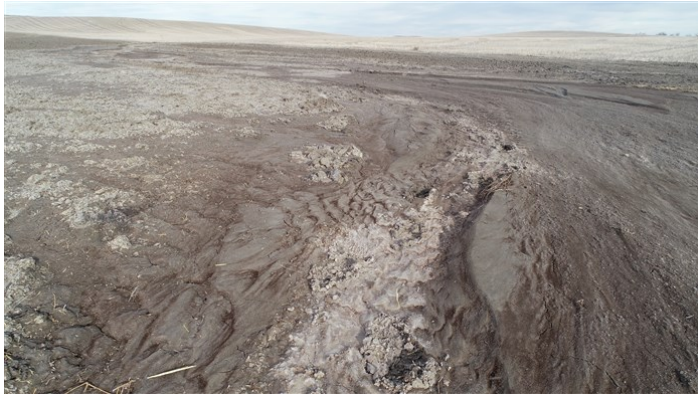
- *Tioga to Elkhorn Creek Pipeline Spread 2 – South Spread (MP 23.0 – 62.8) – all construction activities including final clean-up were completed; right-of-way topsoil erosion with off right-of-way sediment migration was observed, WBI used excavation equipment positioned within the right-of-way to pull the sediment back to within the limits of disturbance and to fix eroded areas of the right-of-way;*

Tioga Elkhorn Creek PL Spread 2 – Flow of the sediment from the right-of-way (November 24, 2021) – Communication – MP 44.4

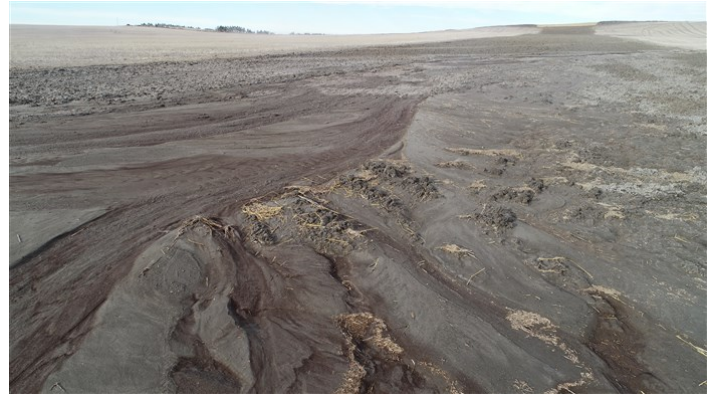
Tioga Elkhorn Creek PL Spread 2 – Right-of-way topsoil erosion and sediment migration occurring. Top of the sloped area of the right-of-way (November 24, 2021) – Communication – MP 44.4

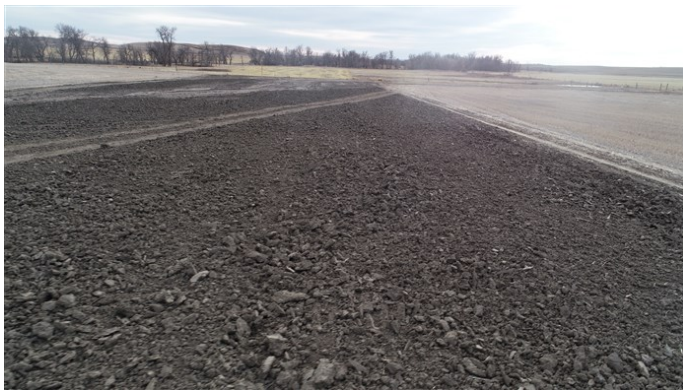
Tioga Elkhorn Creek PL Spread 2 – Final clean-up had been conducted at the area of right-of-way where the erosion and sediment migration occurred (November 24, 2021) – Communication – MP 44.4

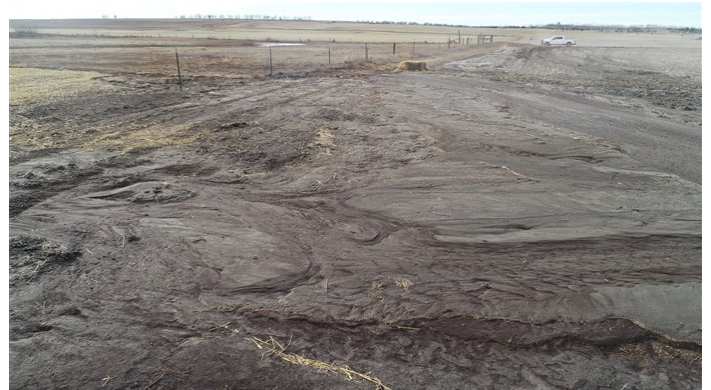
Tioga Elkhorn Creek PL Spread 2 – Topsoil erosion occurring (November 24, 2021) – Communication – MP 44.4

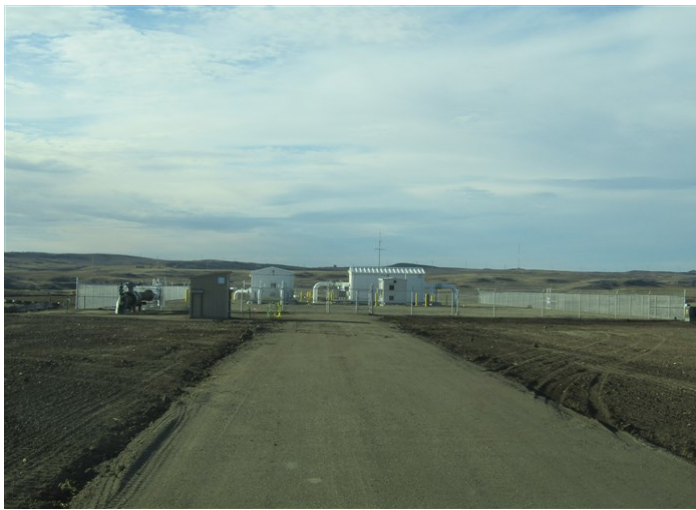
Elkhorn Creek Compressor Station – Northern Border Interconnect site with permanent fencing installation completed (November 26, 2021) – Acceptable – MP 61.7

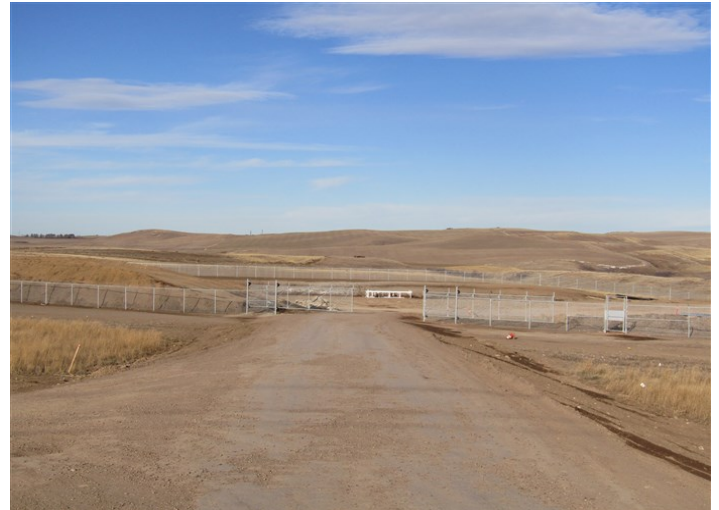
Elkhorn Creek Compressor Station – Entrance to the Elkhorn Creek Compressor Station site. Permanent fencing installation has been completed around the site (November 26, 2021) – Acceptable – MP 61.7
