Re: WBI Energy Transmission, Inc.  
Docket Nos. CP20-52-000 and CP20-52-001  
North Bakken Expansion Project  
Weekly Status Report No. 26

**WBI Energy Transmission, Inc.**  
**North Bakken Expansion Project Status Report No. 26**  
**FERC Docket Nos. CP20-52-000**  
**CP20-52-001**

**Reporting Period:** November 22, 2021 through November 28, 2021

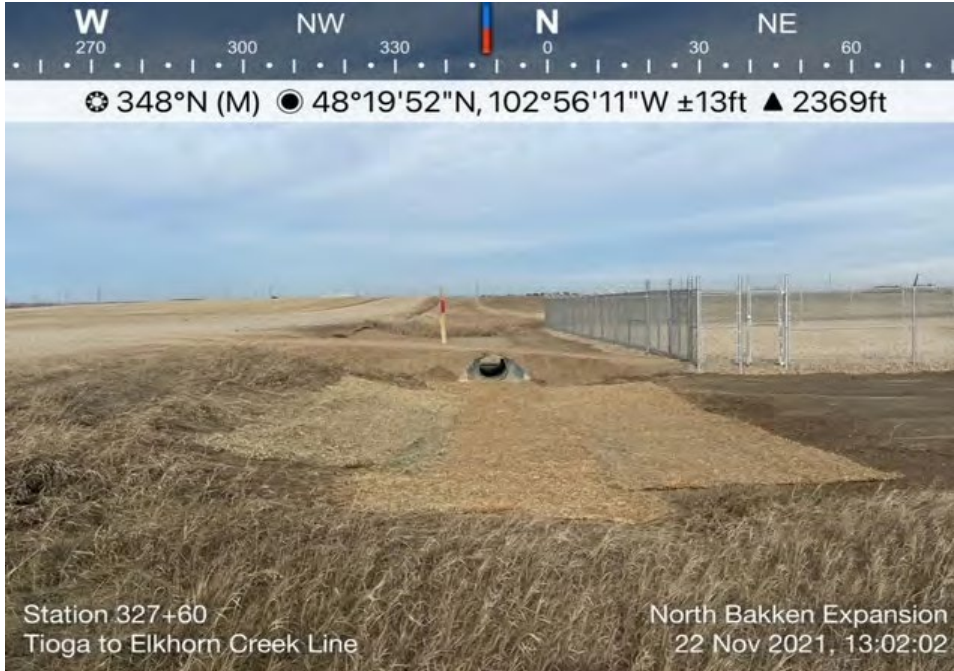
Location:  
Sta. No. 327+60

Notes: Erosion control devices in place and properly functioning at wetland w-wm-eb-008e on the Tioga-Elkhorn Creek Pipeline.

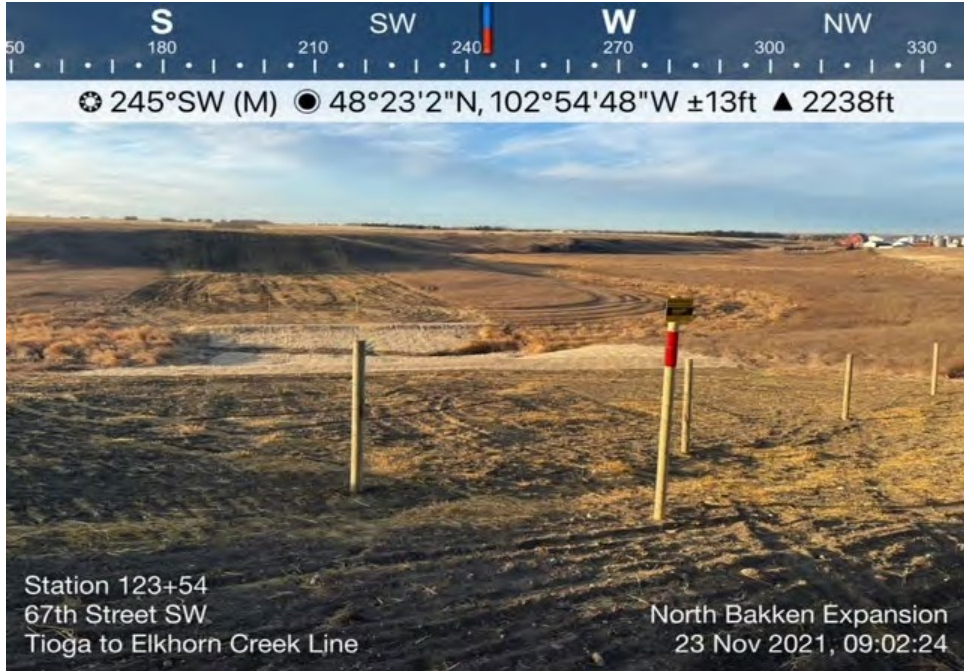
Location:  
Sta. No. 123+54

Notes: Erosion control devices in place and properly functioning at waterbody s-wm-ea-002 on the Tioga-Elkhorn Creek Pipeline.

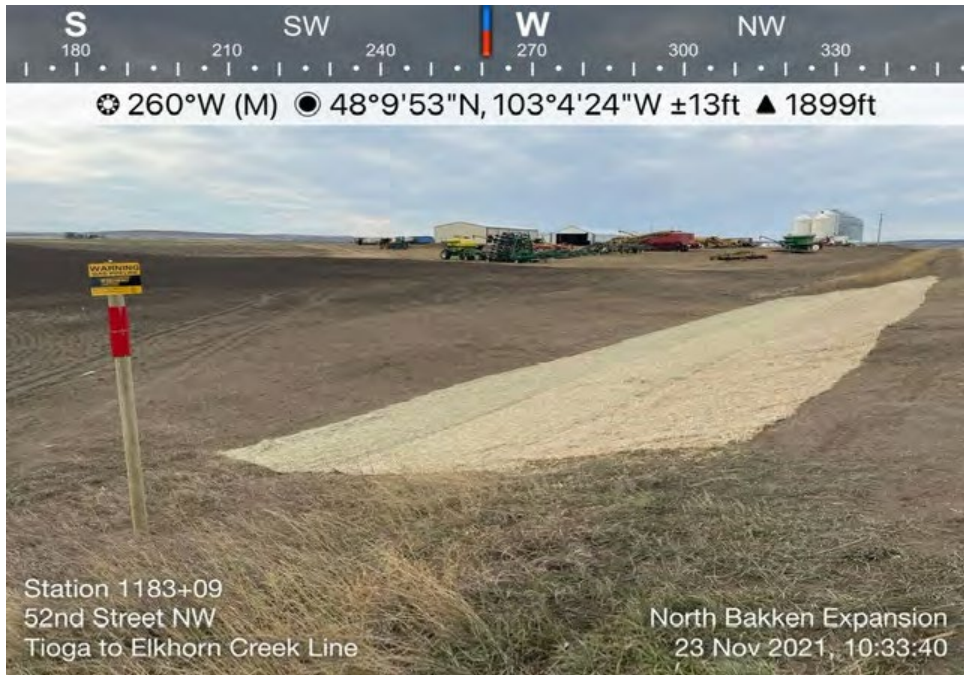
Location:  
Sta. No. 1183+09

Notes: Erosion control devices in place and properly functioning in bar ditch south of 52<sup>nd</sup> Street NW on the Tioga-Elkhorn Creek Pipeline.

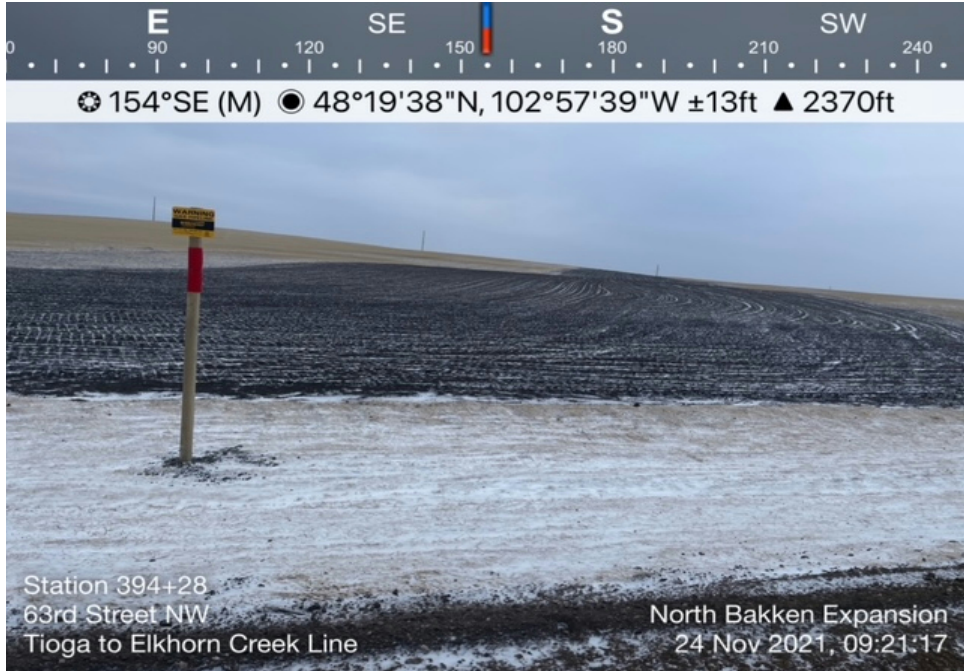
Location:  
Sta. No. 394+28

Notes: Erosion control devices in place and properly functioning in bar ditch and completed restoration of right-of-way in cultivated field on the Tioga-Elkhorn Creek Pipeline.

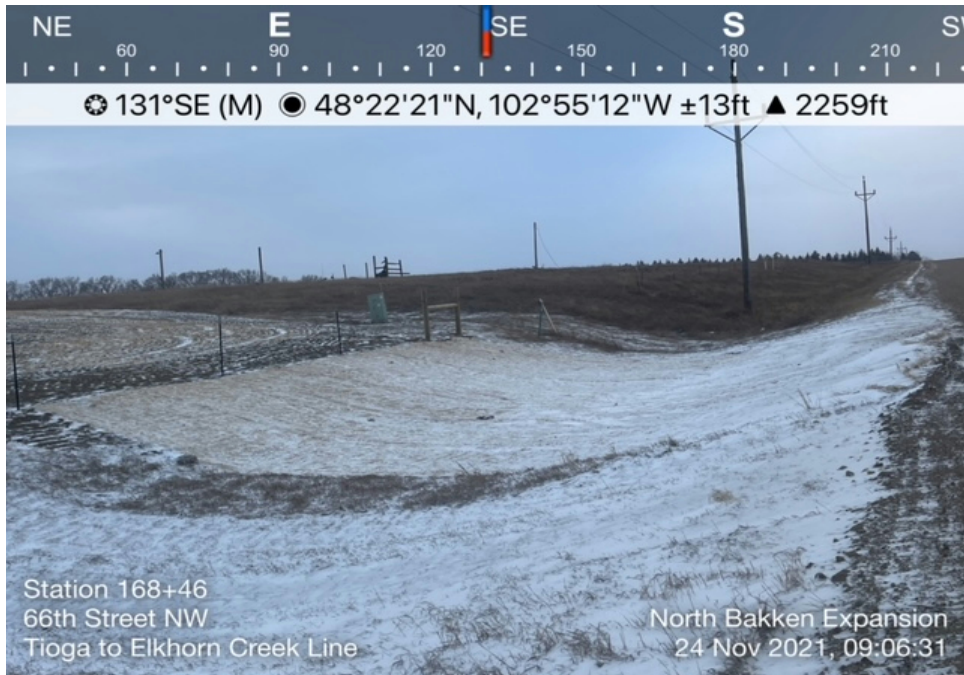
Location:  
Sta. No. 168+46

Notes: Erosion control devices in place and properly functioning in bar ditch on the Tioga-Elkhorn Creek Pipeline.

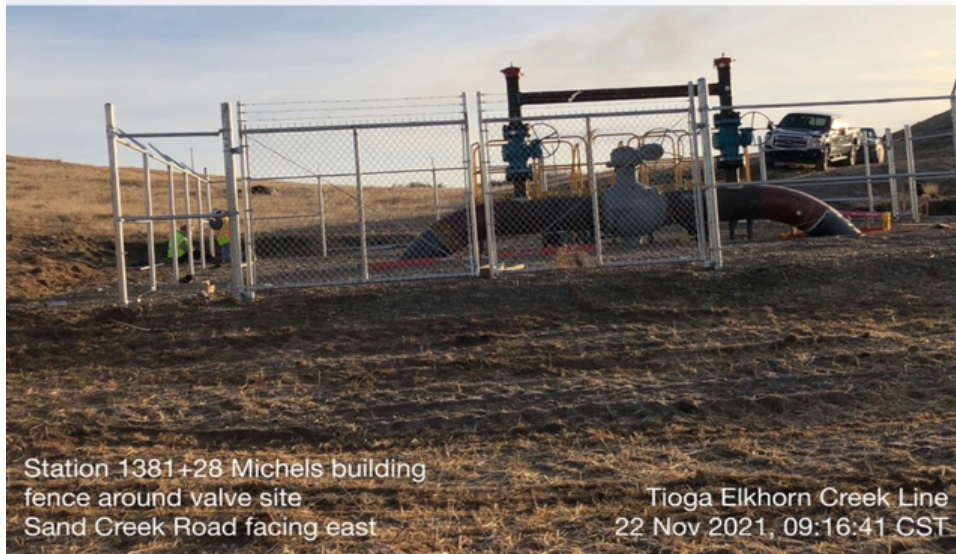
Location:  
Sta. No. 1381+28

Station 1381+28 Michels building  
fence around valve site  
Sand Creek Road facing east

Notes: Installed  
security fence around  
the South Lake block  
valve on the Tioga-  
Elkhorn Creek  
Pipeline.

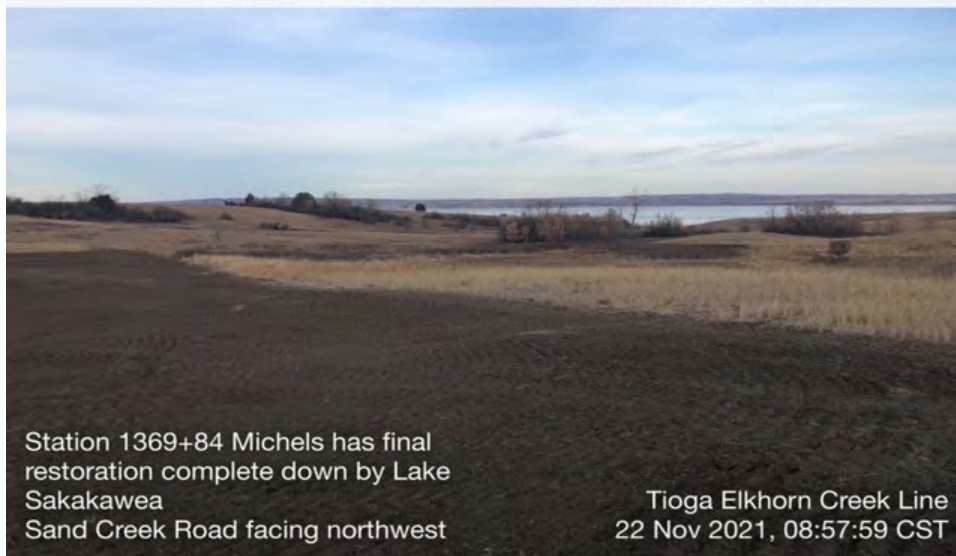
Location:  
Sta. No. 1369+84.

Station 1369+84 Michels has final  
restoration complete down by Lake  
Sakakawea  
Sand Creek Road facing northwest

Notes: Restoration of  
right-of-way on the  
Tioga-Elkhorn Creek  
Pipeline.

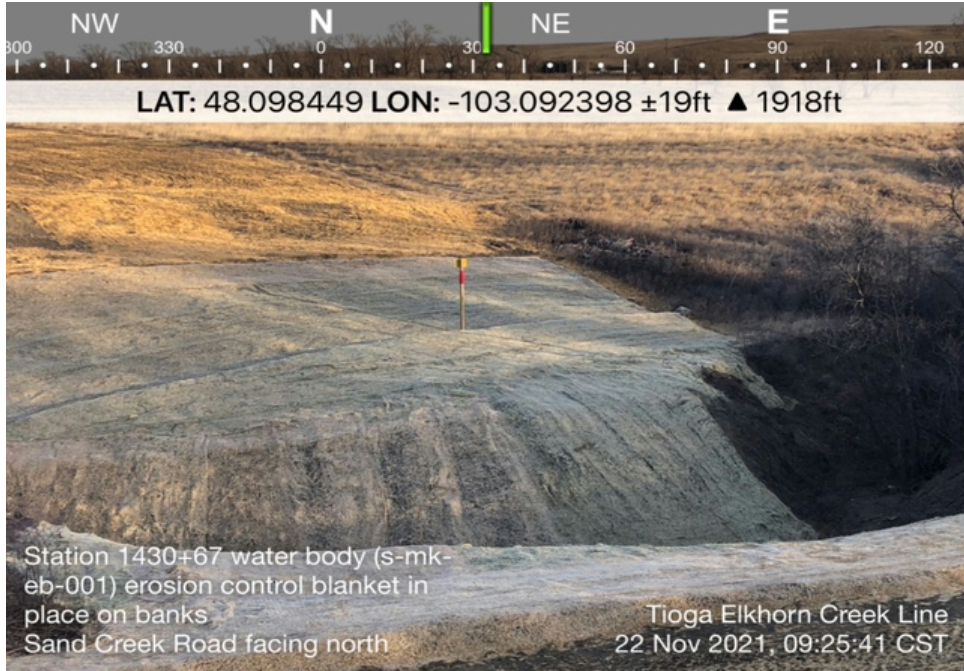
Location:  
Sta. No. 1430+70

Notes: Erosion control devices in place and properly functioning along the banks of waterbody s-mk-eb-00a on the Tioga-Elkhorn Creek Pipeline.

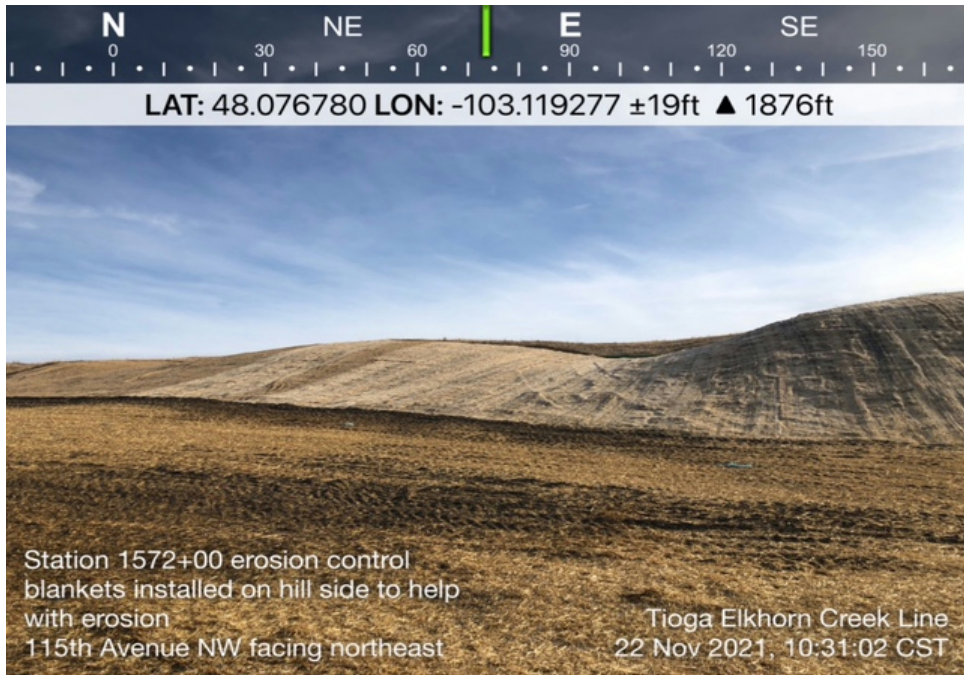
Location:  
Sta. No. 1572+00

Notes: Erosion control devices in place and properly functioning on a hillside on the Tioga-Elkhorn Creek Pipeline.

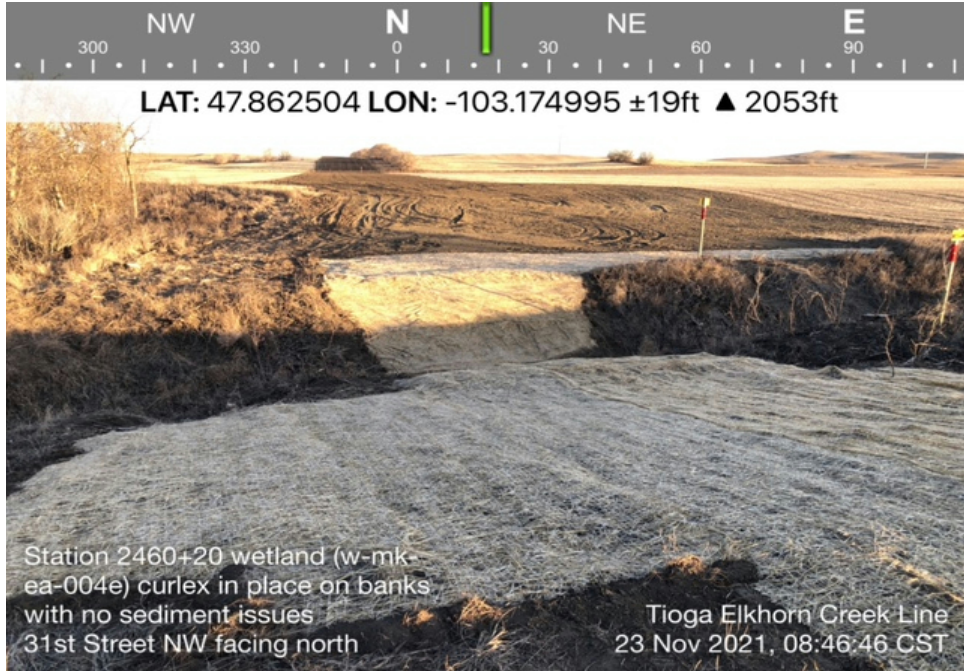
Location:  
Sta. No. 2460+20

Notes: Erosion control devices in place and properly functioning on banks of wetland w-mk-ea-004e on the Tioga-Elkhorn Creek Pipeline.

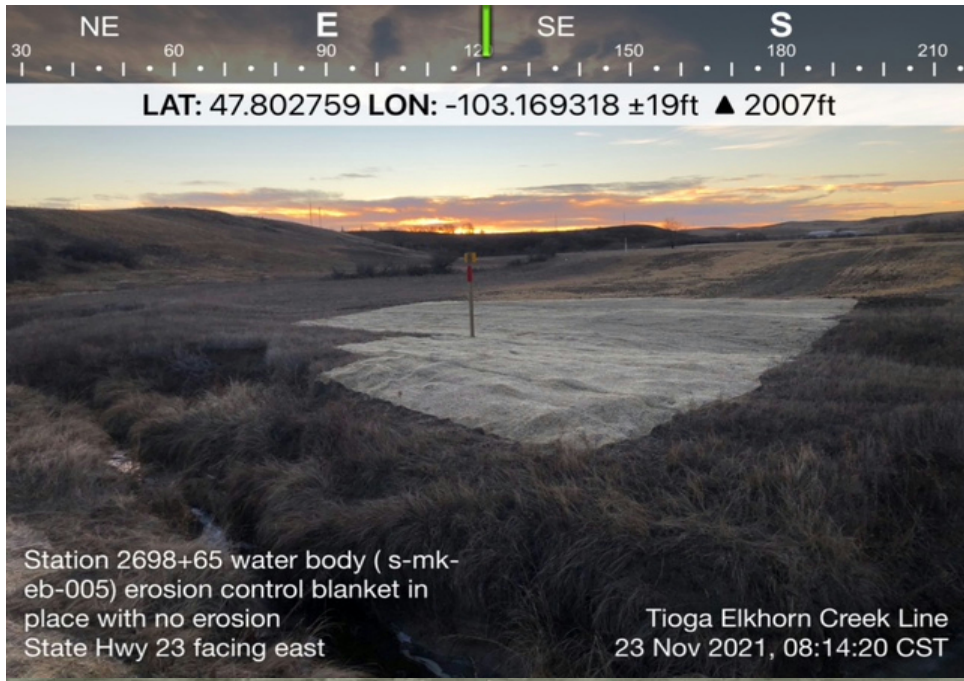
Location:  
Sta. No. 2698+65

Notes: Erosion control devices in place and properly functioning on banks of waterbody s-mk-eb-005 on the Tioga-Elkhorn Creek Pipeline.

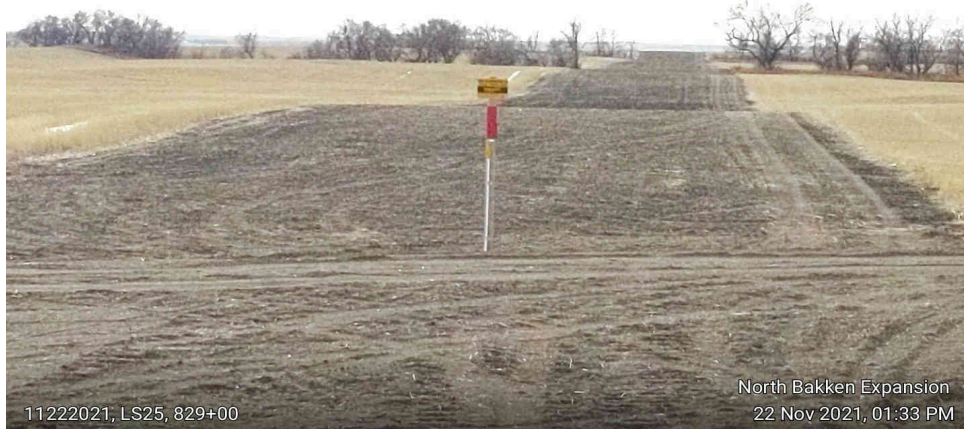
Location:  
Sta. No. 829+00

Notes: Restored  
right-of-way in  
cultivated field on  
the Line Section 25  
Loop.

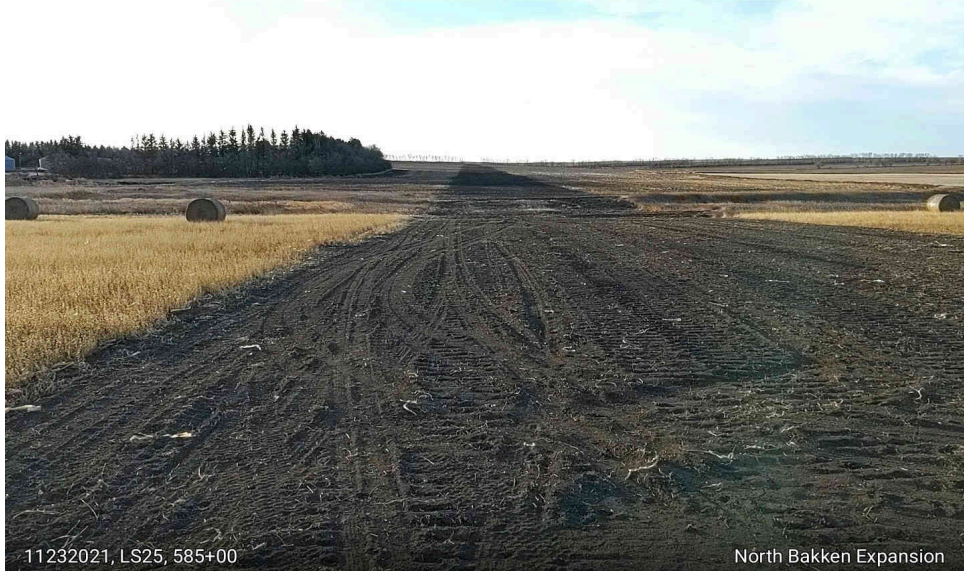
Location:  
Sta. No. 585+00

Notes: Restored  
right-of-way in  
cultivated field on the  
Line Section 25  
Loop.

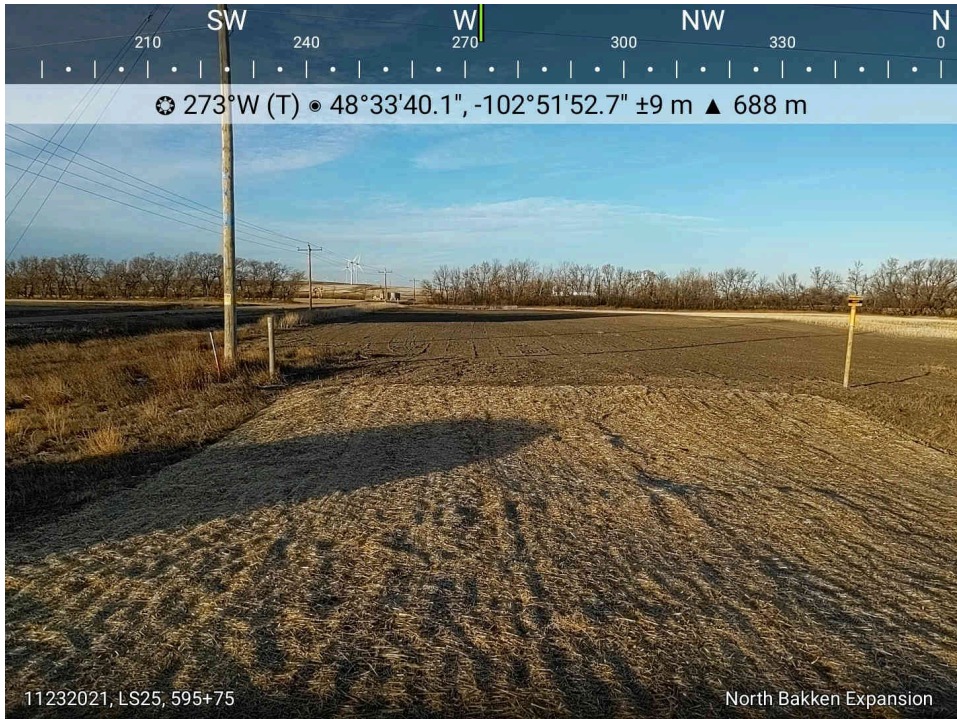
Location:  
Sta. No. 595+75

Notes: Erosion control  
devices in place and  
properly functioning on  
bar ditch west of 101<sup>st</sup>  
Avenue NW on the  
Line Section 25 Loop.

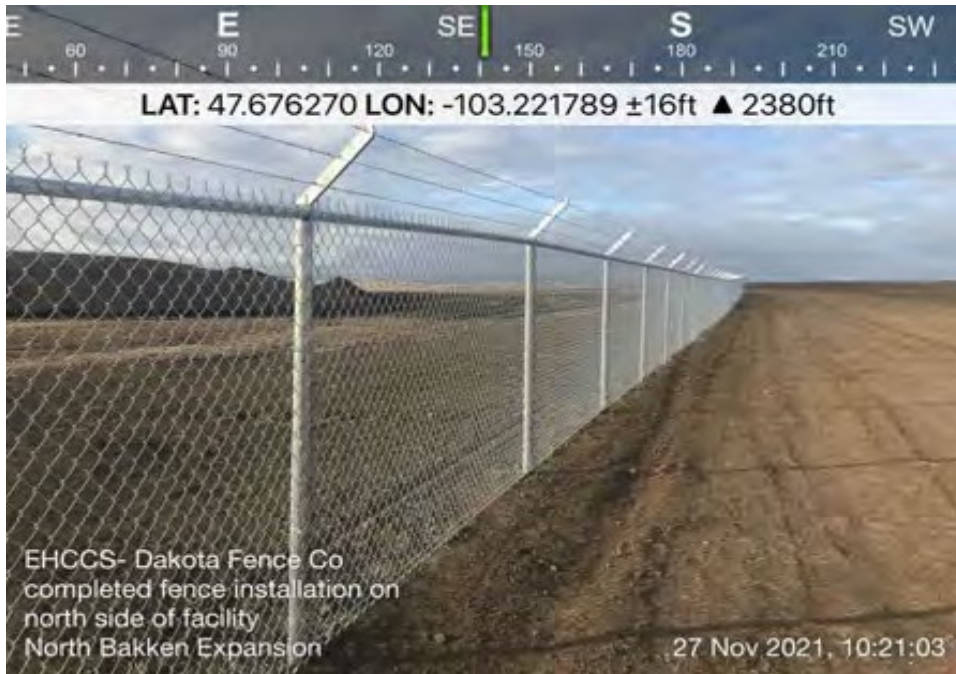
Location: Elkhorn Creek Compressor Station

Notes: Completed installation of security fence on the north side of station yard.

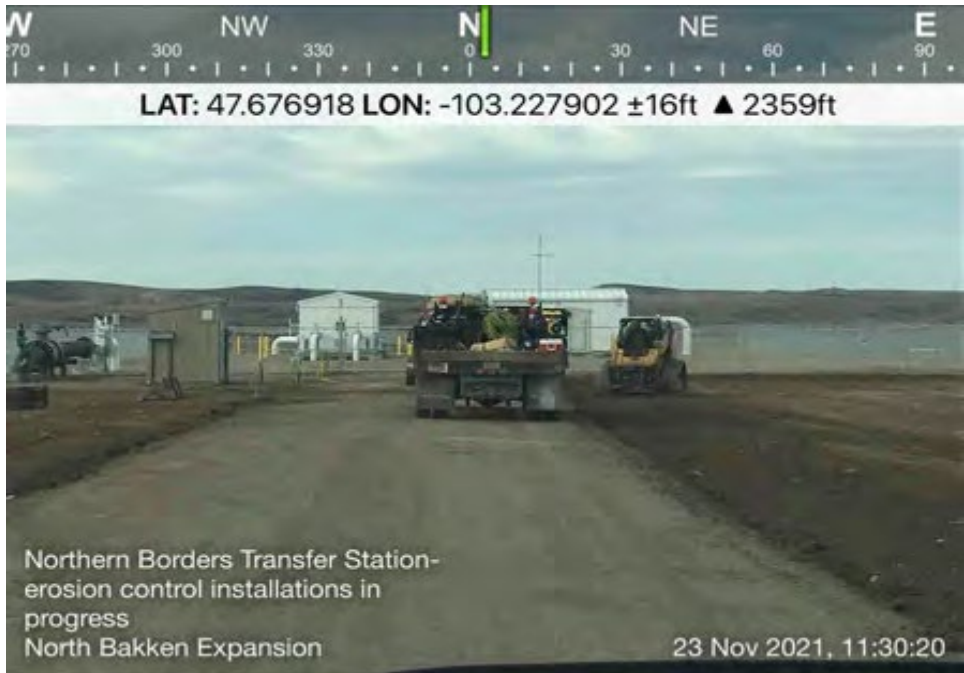
Location: Northern Border Interconnect

Notes: Installation of erosion control devices.
