Re: WBI Energy Transmission, Inc.
Docket Nos. CP20-52-000 and CP20-52-001
North Bakken Expansion Project
Weekly Status Report No. 27

WBI Energy Transmission, Inc.
North Bakken Expansion Project Status Report No. 27
FERC Docket Nos. CP20-52-000
CP20-52-001

Reporting Period: November 29, 2021 through December 5, 2021

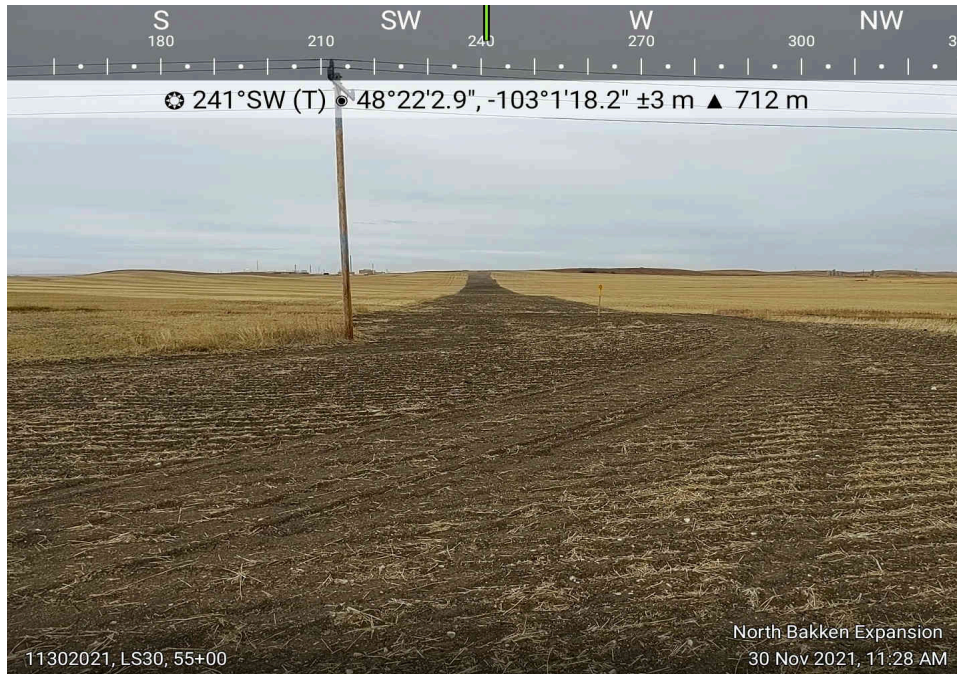
Location:
Sta. No. 55+00

Notes: Restored right-of-way in a cultivated field on the Line Section 30 Loop.

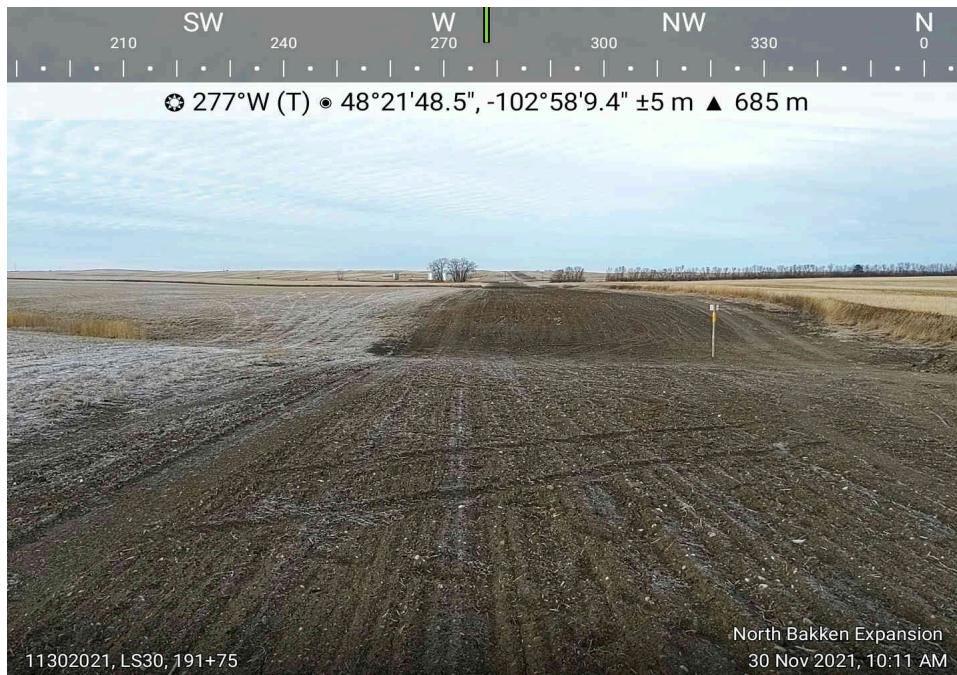
Location:
Sta. No. 191+75

Notes: Restored right-of-way in a cultivated field on the Line Section 30 Loop.

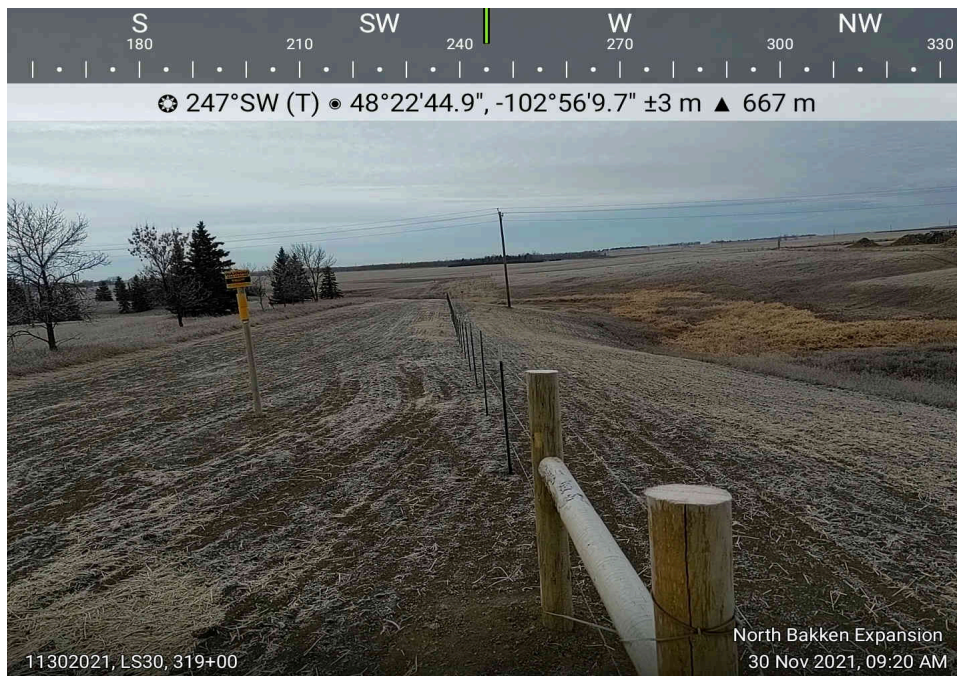
Location:
Sta. No. 319+00

Notes: Restored right-of-way on the Line Section 30 Loop.

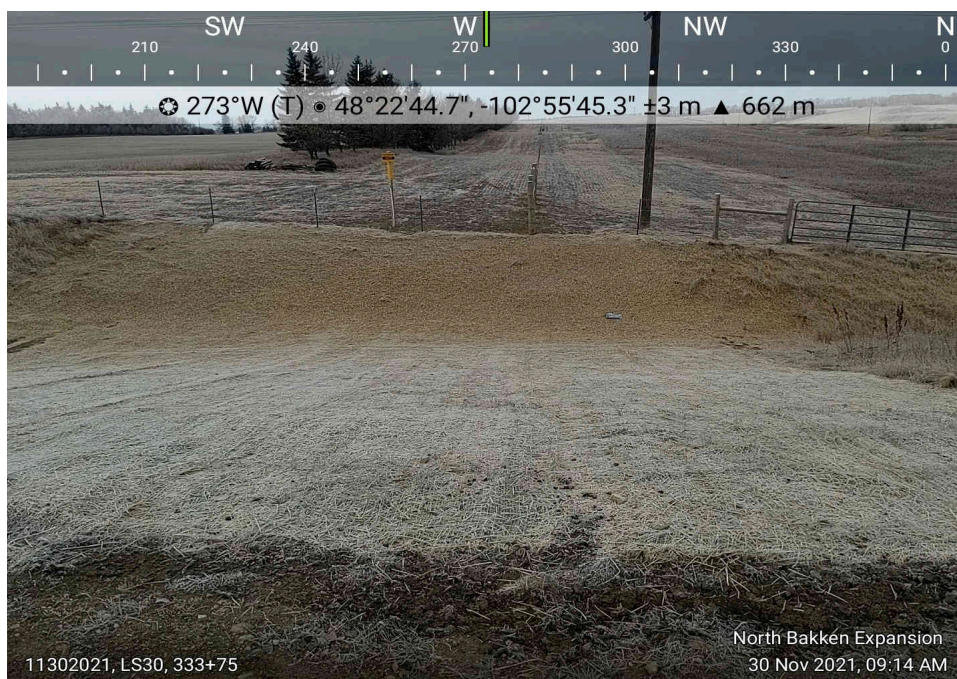
Location:
Sta. No. 333+75

Notes: Erosion control devices in place and properly functioning in bar ditch on the Line Section 30 Loop.

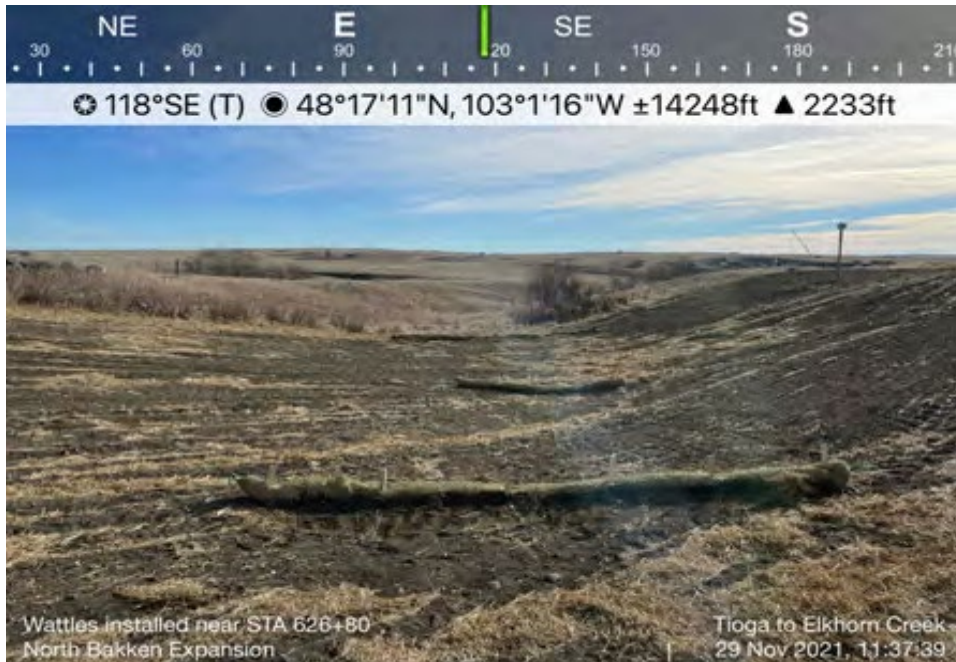
Location:
Sta. No. 626+80

Notes: Installed
straw wattles.

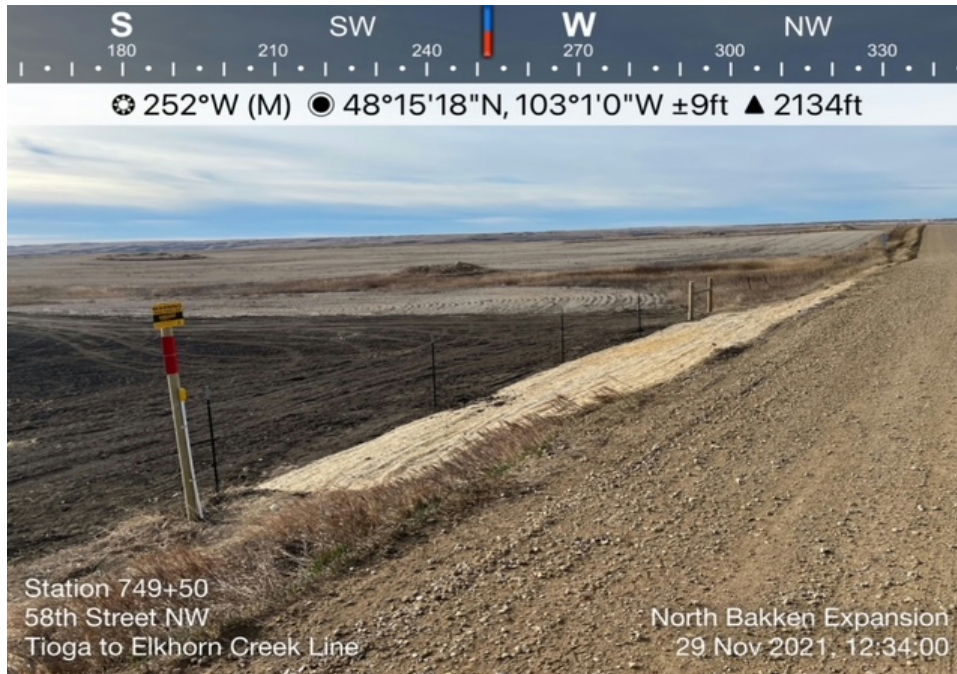
Location:
Sta. No. 749+50

Notes: Erosion control devices in place and properly functioning in bar ditch on the Tioga-Elkhorn Creek Pipeline.

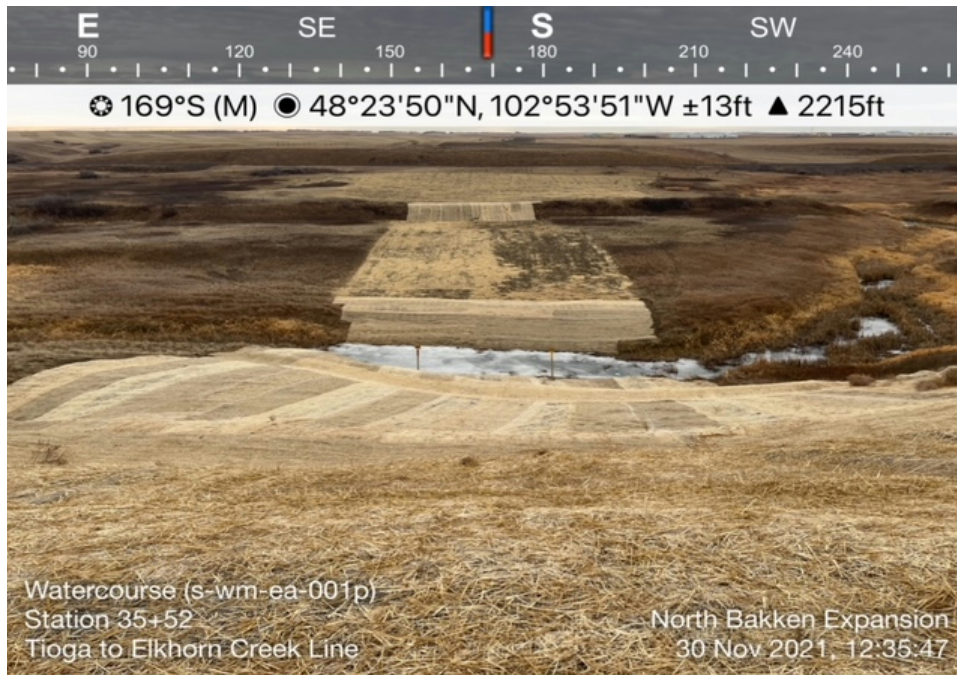
Location:
Sta. No. 35+52

Notes: Erosion control devices in place and properly functioning at waterbody s-wm-ea-001p on the Tioga-Elkhorn Creek Pipeline.

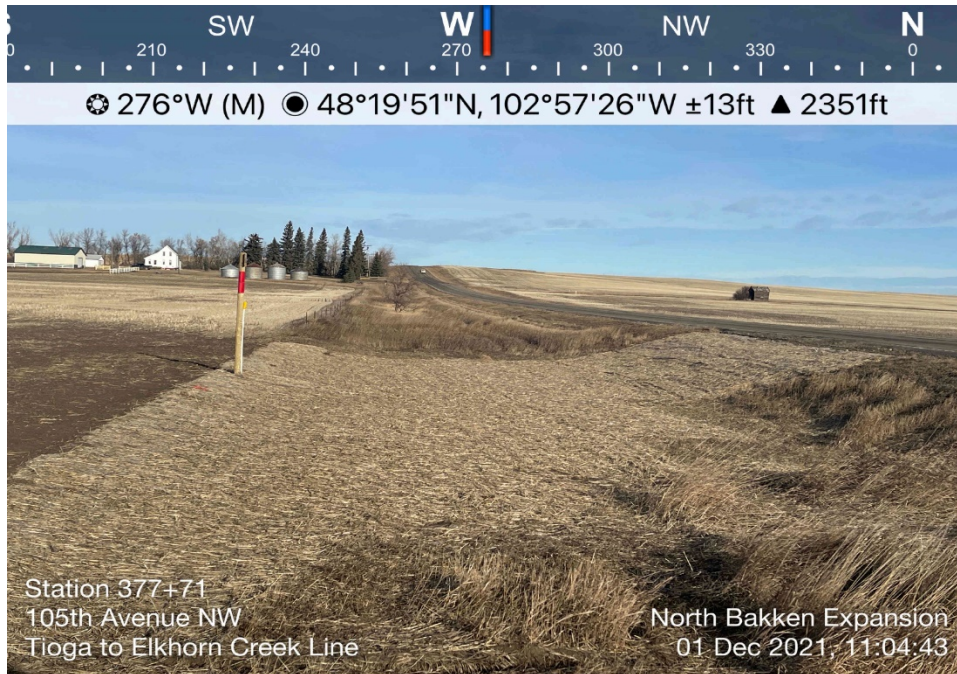
Location:
Sta. No. 377+71

Notes: Erosion control devices in place and properly functioning in bar ditch on the Tioga-Elkhorn Creek Pipeline.

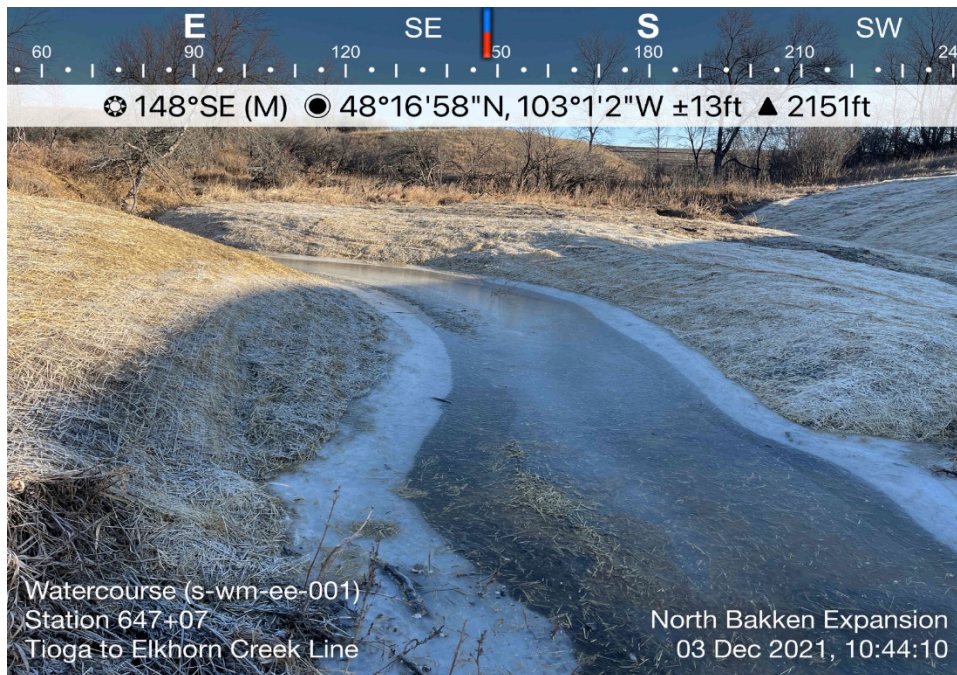
Location: Sta. Nos.
646+89 to 647+34

Notes: Erosion control devices in place and properly functioning at watercourse s-wm-ee-001 on the Tioga-Elkhorn Creek Pipeline.

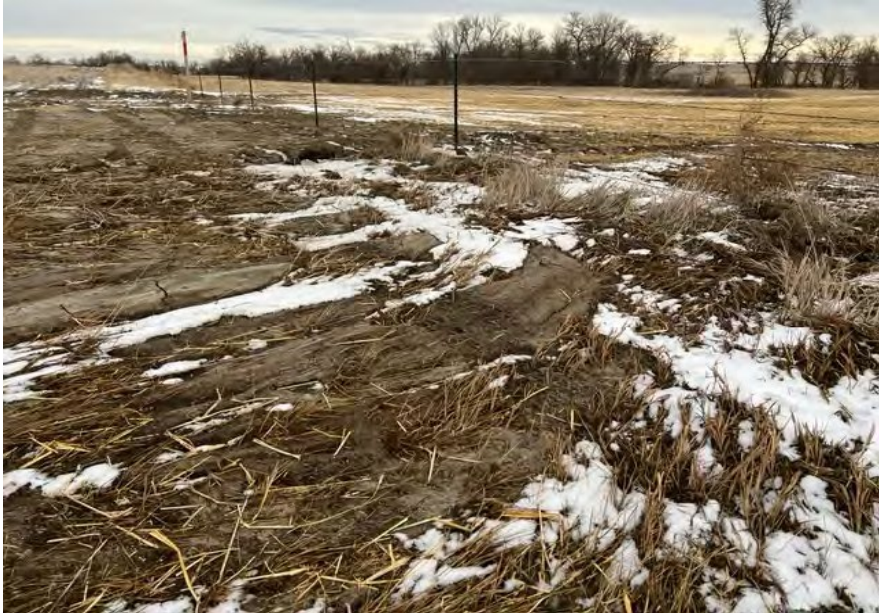
Problem Areas, Corrective Actions and Effectiveness:				
Date	Location	Description	Correction	Effectiveness of Corrective Action
12/01/2021	MP 44.7 – 44.9 East of 121 st Avenue NW and on the west side of the right-of-way	As reported in Weekly Status Report 24 for work completed for November 8 to November 14, 2021, hydrostatic test water had been discharged through an approved dewatering structure at Sta. No. 2335+00 into a well-vegetated field across from 121st Avenue NW. A large amount of water had flowed from the right-of-way southwest towards 121 st Avenue NW, an unpaved farm trail. Straw bales and other energy-dissipating structures were installed at approved locations to slow water flow and limit potential sediment migration. On, November 24, 2021 WBI Energy was notified that some sediment had exited the western edge of the ROW and some soil had deposited on the eastern side of 121 st Avenue NW.	With landowner and FERC compliance monitor approval, WBI Energy accessed the locations between the right-of-way and 121 st Avenue NW with a skid steer and by foot to retrieve the soil.	The migrated soil was gathered and returned. No damage was done to the restored right-of-way or locations of deposited soil.

Date: 12/01/2021 Location: Sta. No. 2345+00 Notes: Observed sediment off the right-of-way.

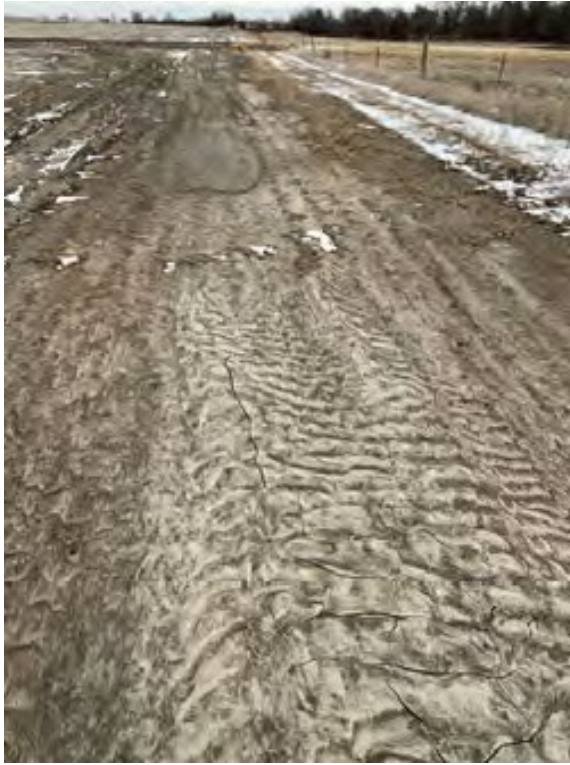
Location:
Sta. No. 2345+00

Notes: Observed sediment off the right-of-way.

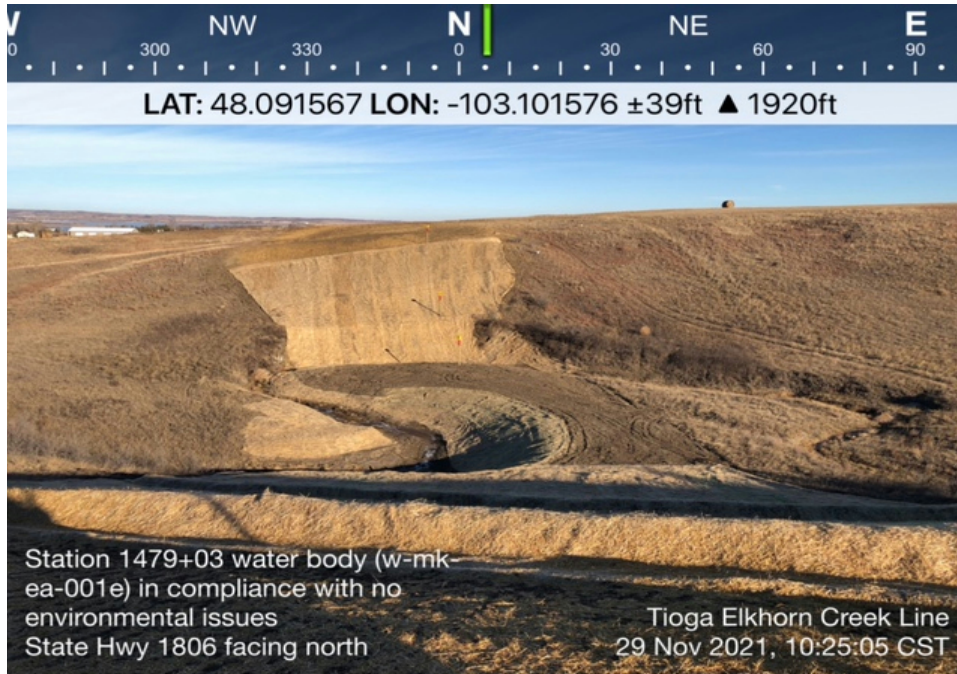
Location:
Sta. No. 1479+03

Notes: Erosion control devices in place and properly functioning at waterbody s-km-ea-001e on the Tioga-Elkhorn Creek Pipeline.

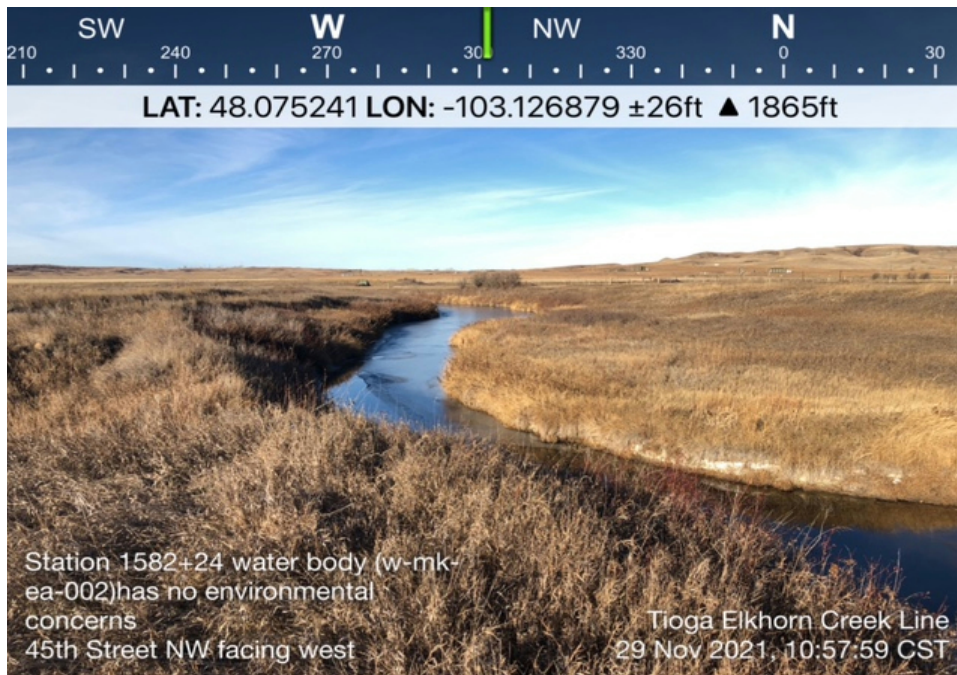
Location:
Sta. No. 1582+24

Notes: Waterbody w-mk-ea-002 on the Tioga-Elkhorn Creek Pipeline.

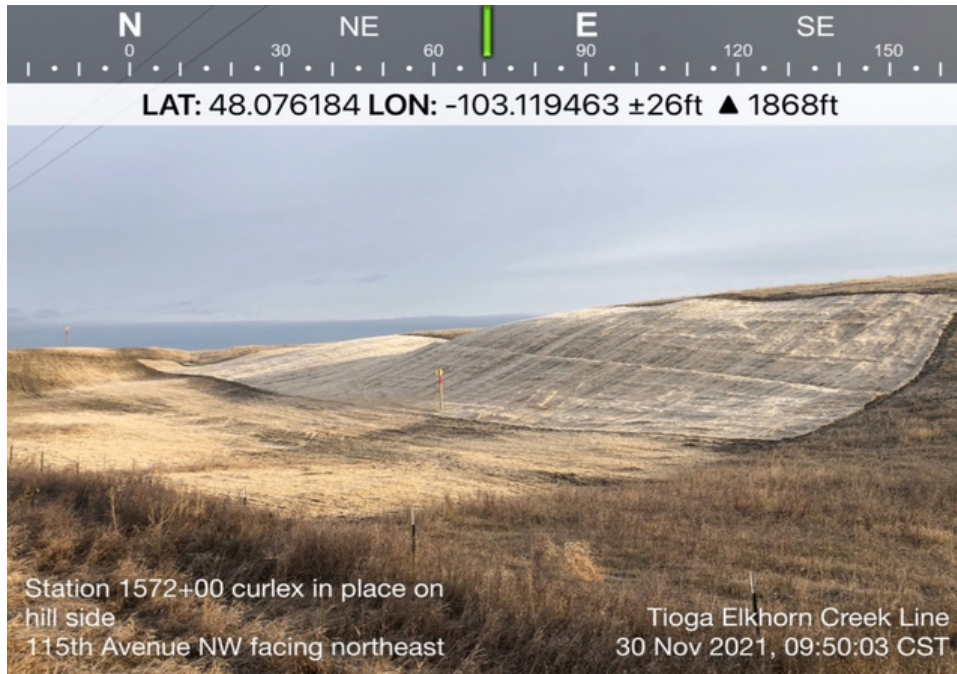
Location:
Sta. No. 1572+00

Notes: Erosion control devices in place and properly functioning on hillside on the Tioga-Elkhorn Creek Pipeline.

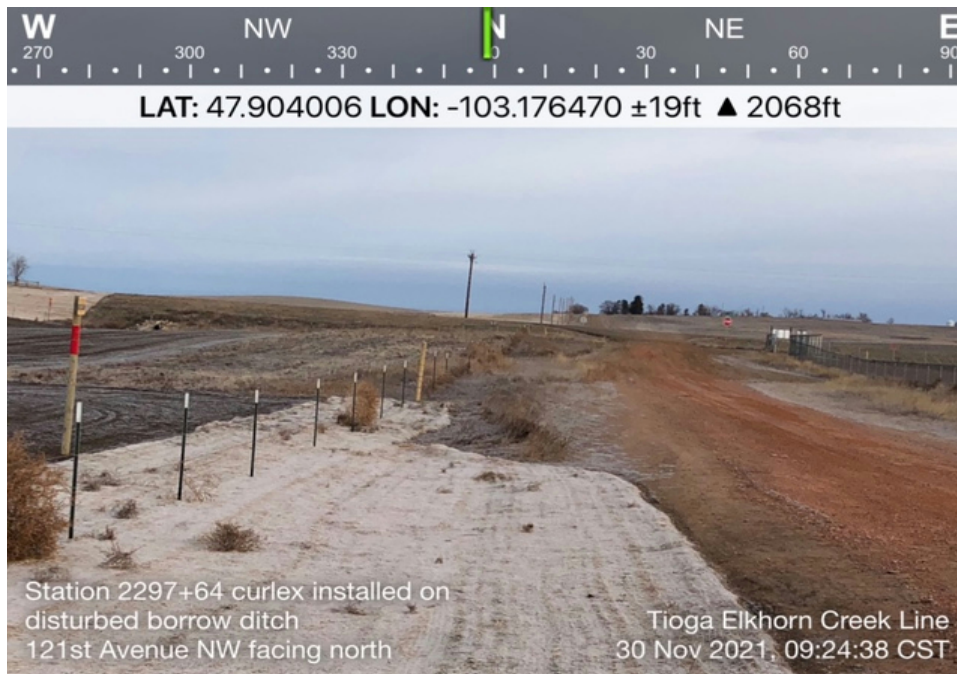
Location:
Sta. No. 2297+64

Notes: Erosion control devices in place and properly functioning in bar ditch on the Tioga-Elkhorn Creek Pipeline.

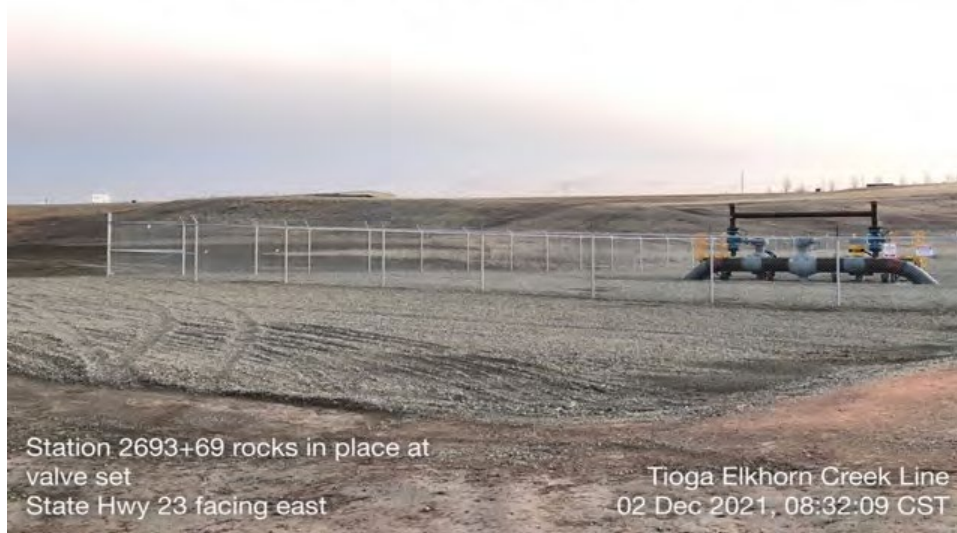
Location:
Sta. No. 2693+69

Notes: Installed
security fence around
the Cherry Creek
block valve on the
Tioga-Elkhorn Creek
Pipeline.

Station 2693+69 rocks in place at
valve set
State Hwy 23 facing east

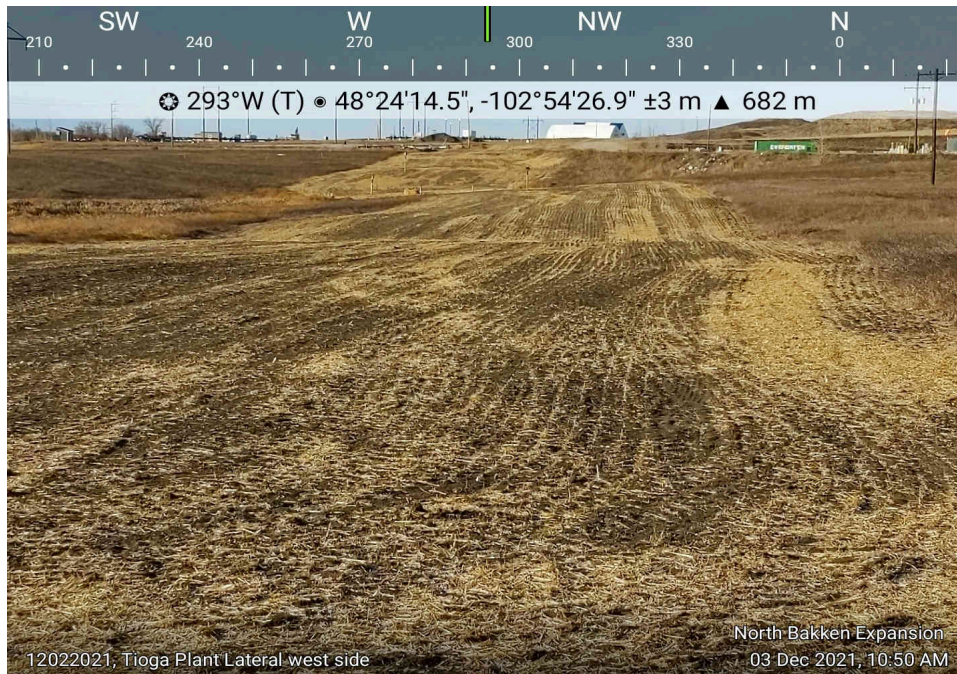
Location:
Sta. No. 22+97

Notes: Restored right-
of-way on the Tioga
Compressor Lateral.

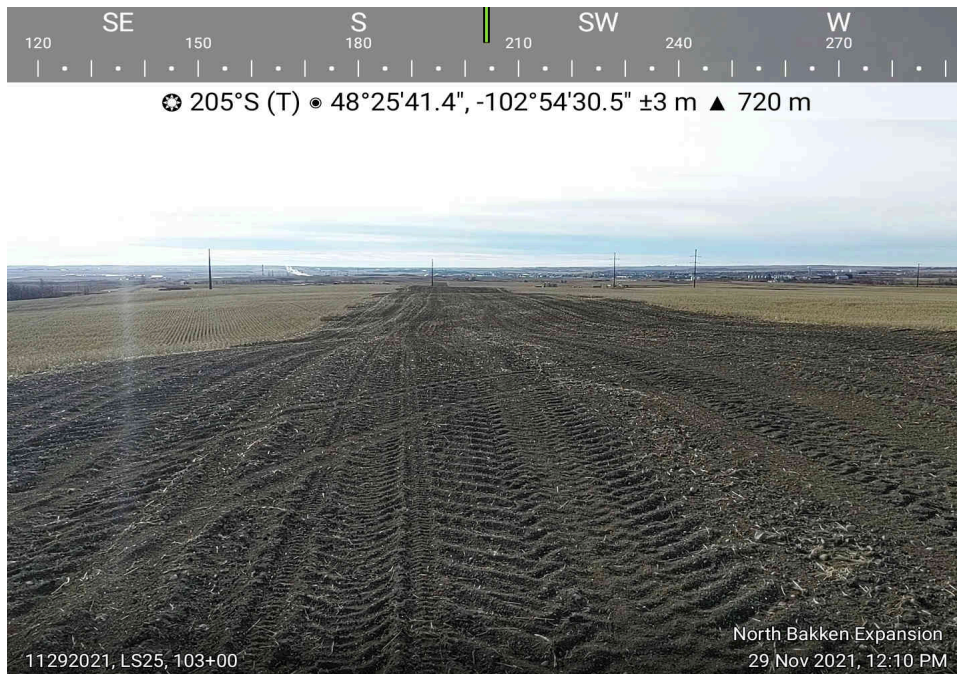
Location:
Sta. No. 103+00

Notes: Restored right-
of-way in cultivated
field on the Line
Section 25 Loop.

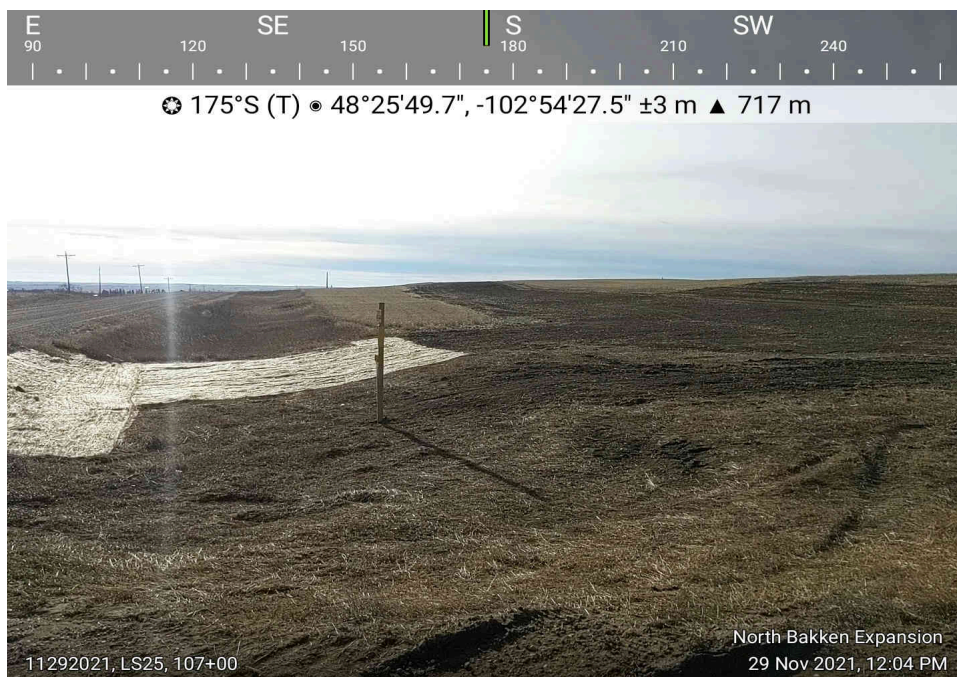
Location:
Sta. No. 107+00

Notes: Erosion
control devices in
place and properly
functioning on bar
ditch on the Line
Section 25 Loop.

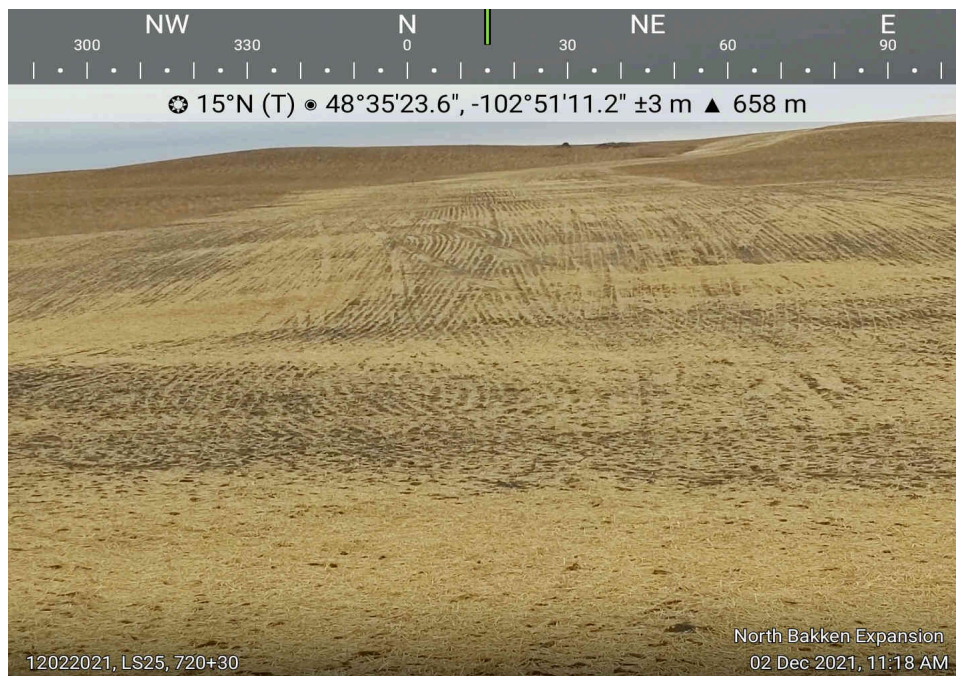
Location:
Sta. No. 720+30

Notes: Restored right-
of-way on the Line
Section 25 Loop.

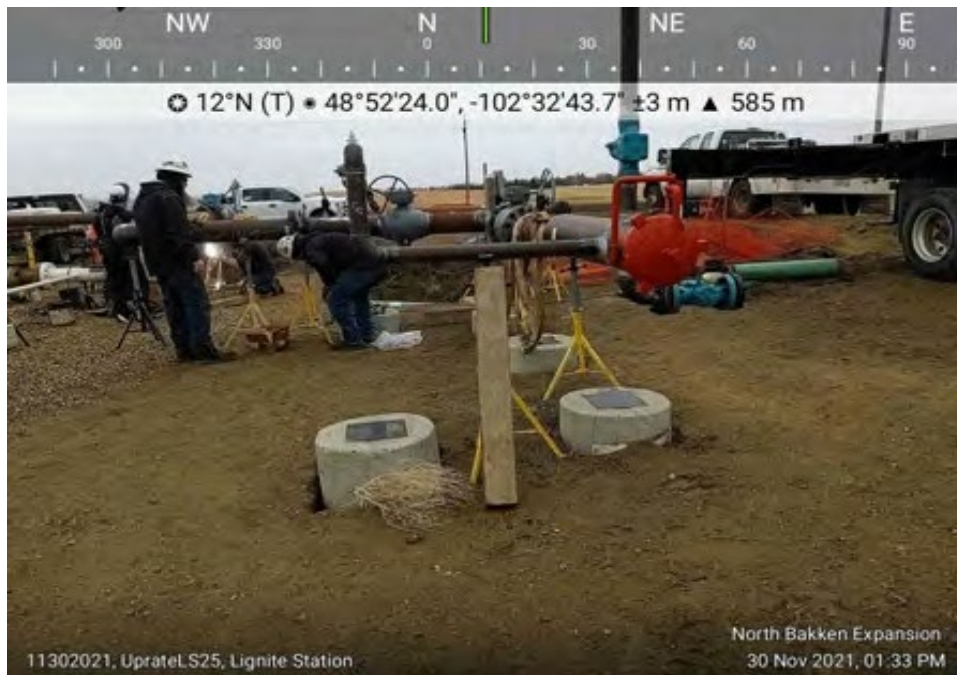
Location: Lignite Plant Receipt Station

Notes: Installation of a pig launcher/receiver.

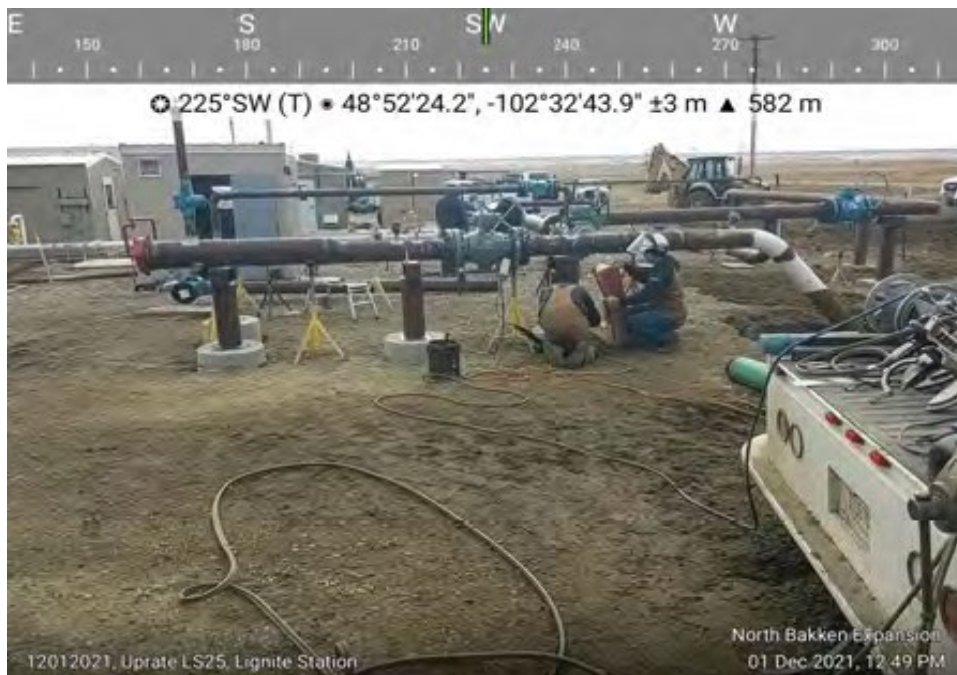
Location: Lignite Plant Receipt Station

Notes: Welding pipe supports for the pig launcher/receiver.

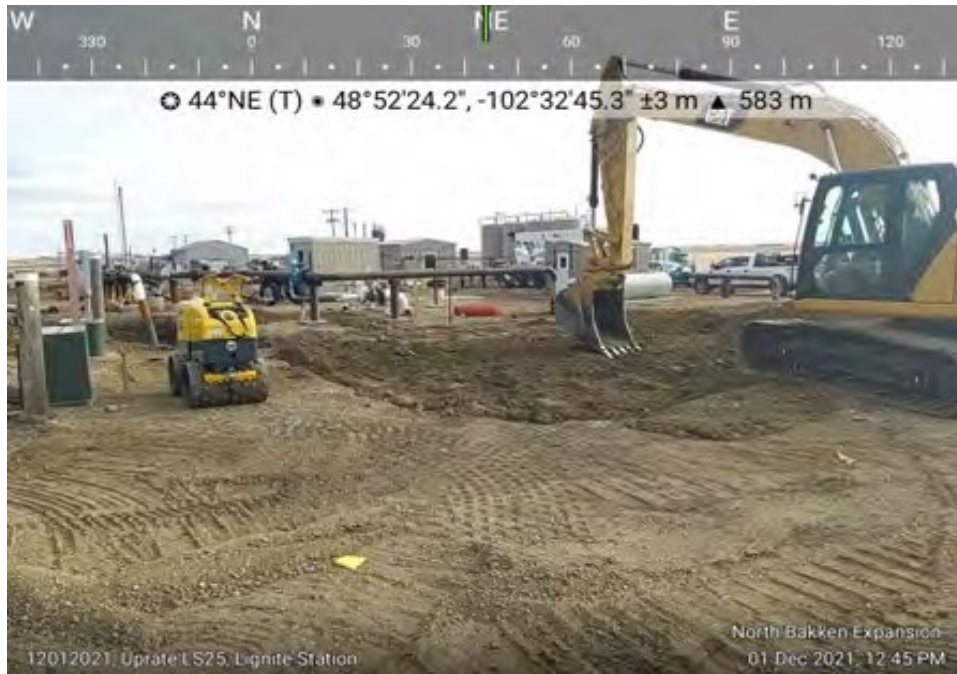
Location: Lignite Plant Receipt Station

Notes: Backfilling activities after the tie-in of the pig launcher/receiver.

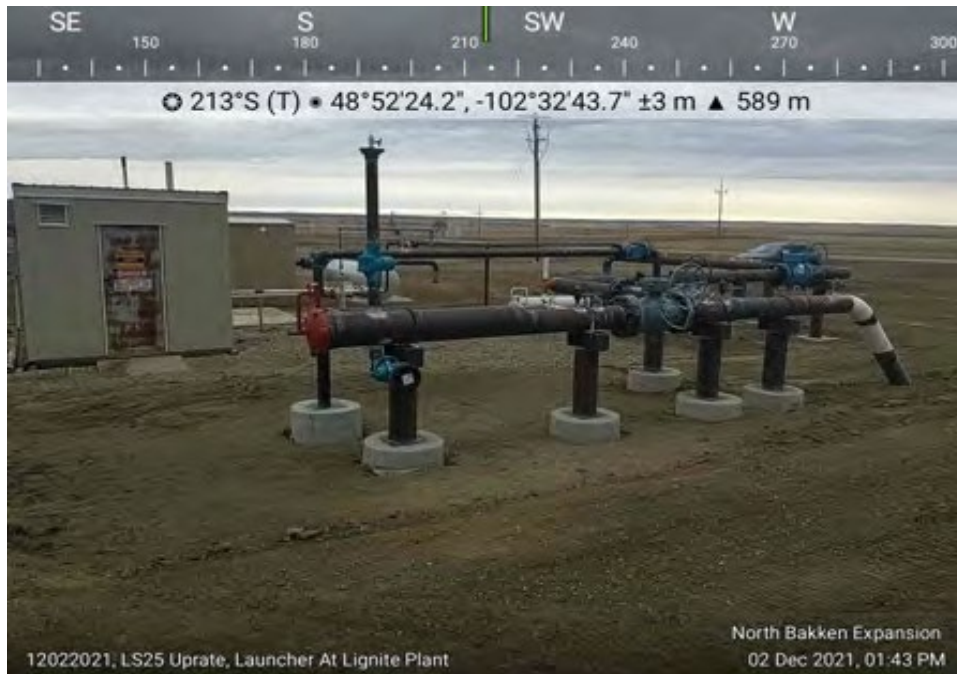
Location: Lignite Plant Receipt Station

Notes: Completed pig launcher/receiver.

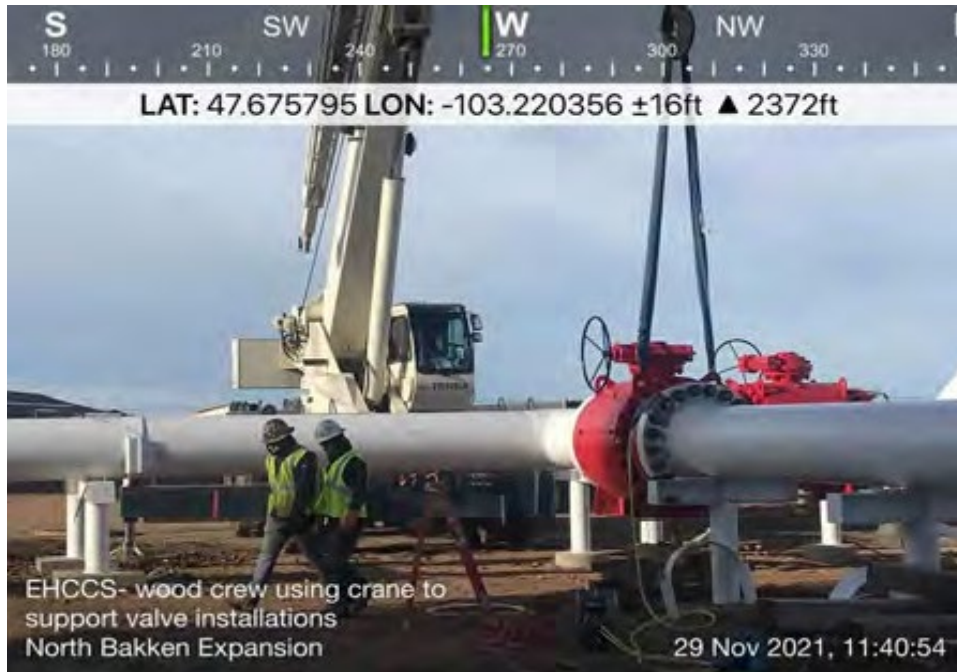
Location: Elkhorn
Creek Compressor
Station

Notes: Installation of
valve.

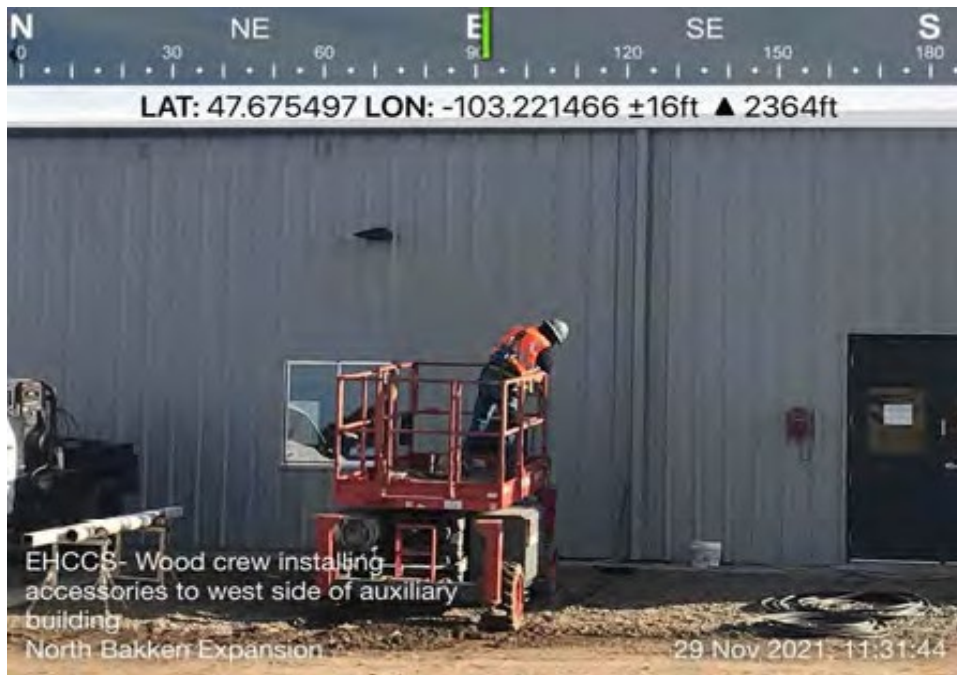
Location: Elkhorn
Creek Compressor
Station

Notes: New facilities.

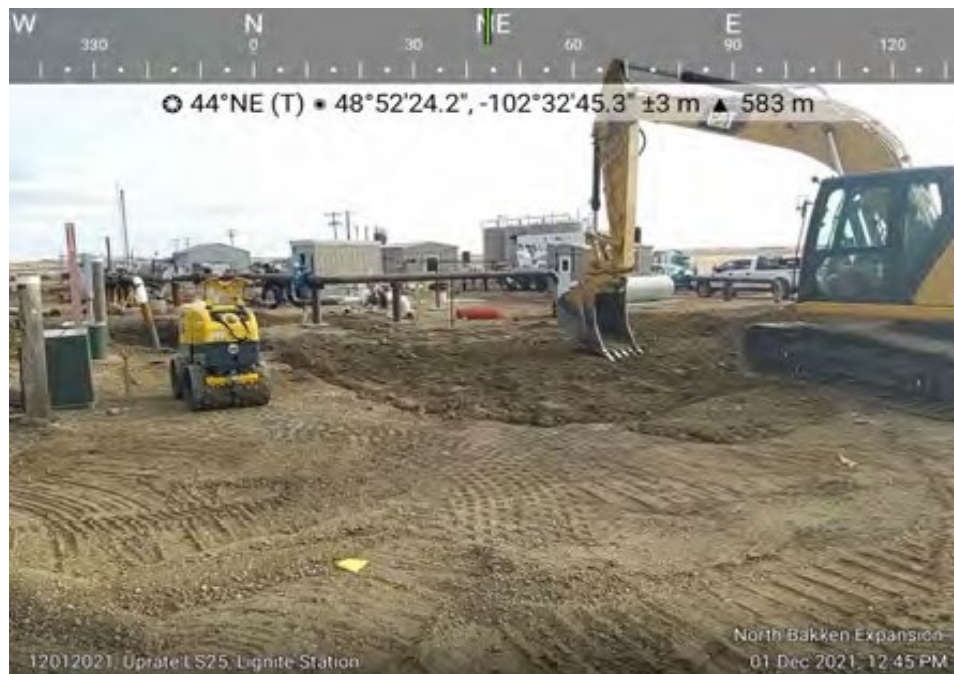
Location: Lignite Plant Receipt Station

Notes: Backfilling activities completed after the tie-in of the pig launcher/receiver.

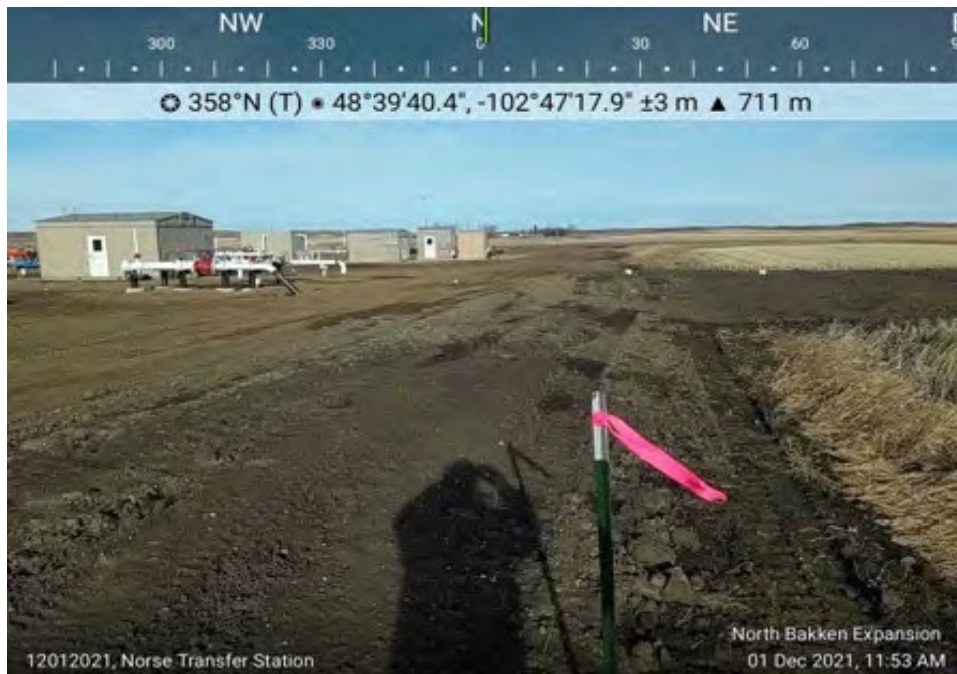
Location: Norse Plant
Receipt and Norse
Transfer Stations

Notes: Surveyed
fence line for new
security fence around
stations.

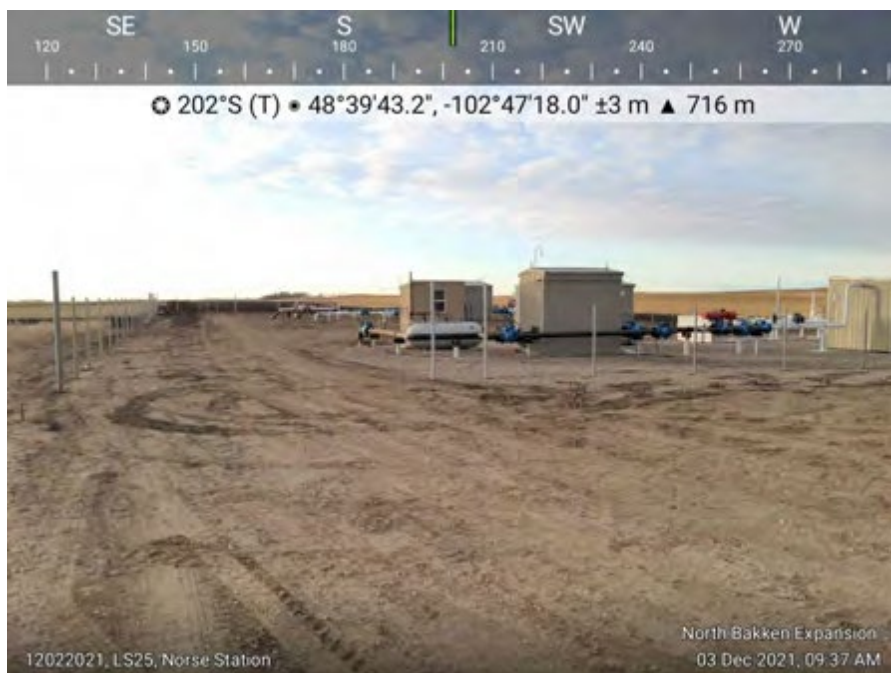
Location: Norse Plant
Receipt and Transfer
Stations

Notes: Began installation
of security fence around
stations.
