Re: WBI Energy Transmission, Inc.
Docket Nos. CP20-52-000 and CP20-52-001
North Bakken Expansion Project
Weekly Status Report No. 28

WBI Energy Transmission, Inc.
North Bakken Expansion Project Status Report No. 28
FERC Docket Nos. CP20-52-000
CP20-52-001

Reporting Period: December 06, 2021 through December 12, 2021

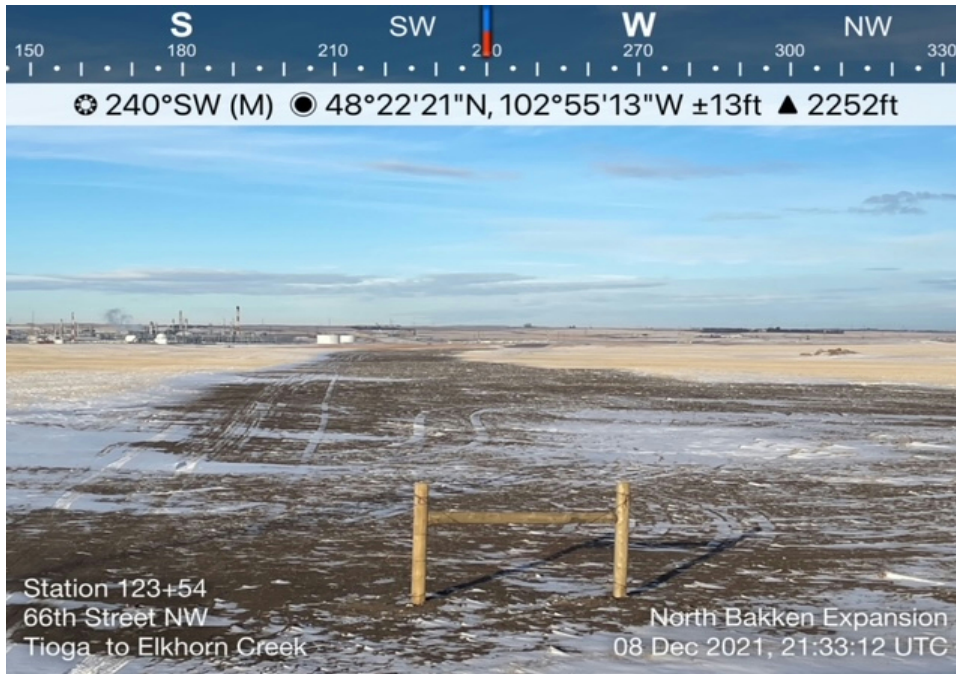
Location:
Sta. No. 123+54

Notes: Restored right-of-way in cultivated field on the Tioga-Elkhorn Creek Pipeline.

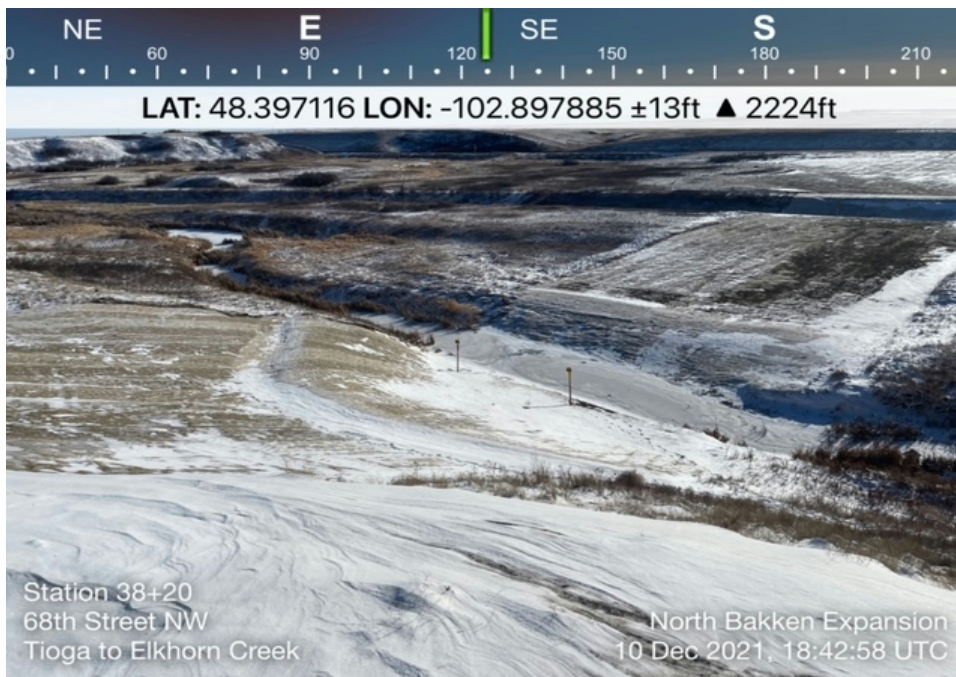
Location:
Sta. No. 38+20

Notes: Erosion control devices in place and properly functioning at waterbody s-mk-eb-002 on the Tioga-Elkhorn Creek Pipeline.

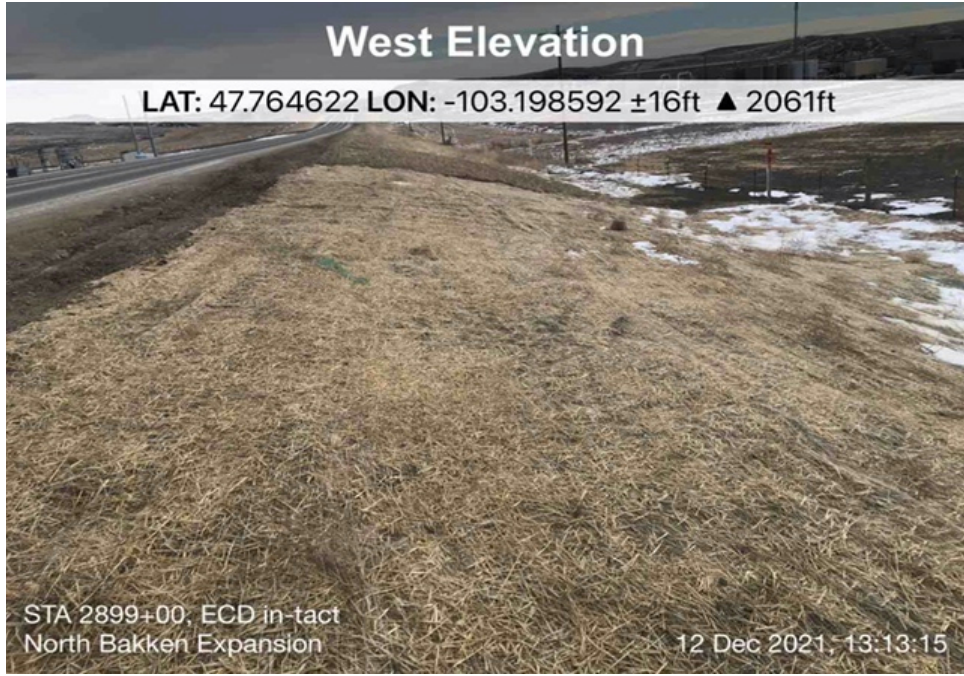
Location:
Sta. No. 2899+00

Notes: Erosion control devices in place and properly functioning in bar ditch on the Tioga-Elkhorn Creek Pipeline.

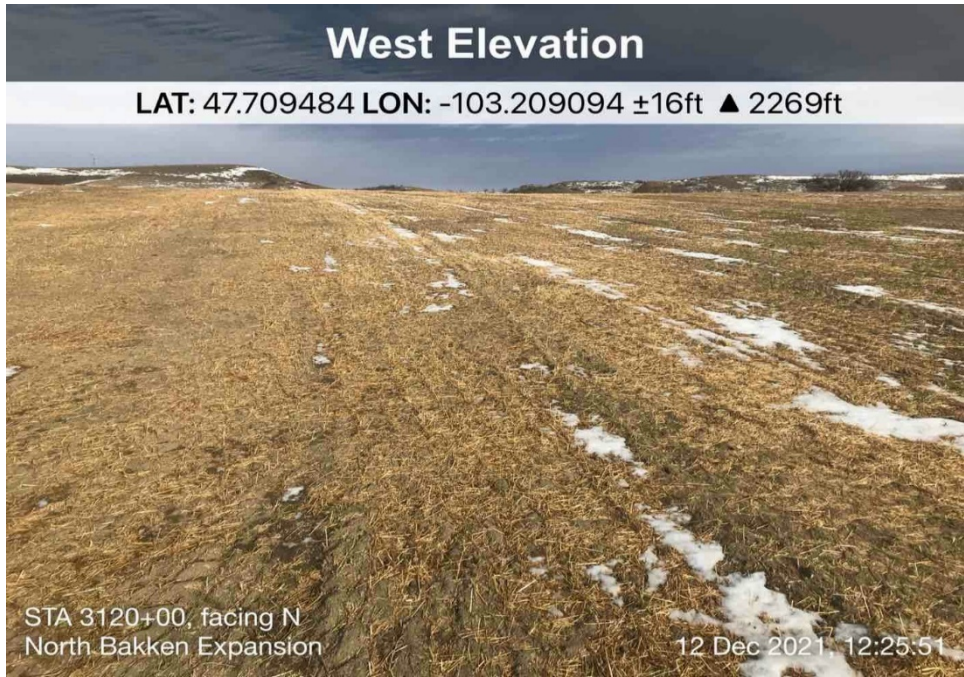
Location:
Sta. No. 3120+00

Notes: Restored right-of-way on the Tioga-Elkhorn Creek Pipeline.

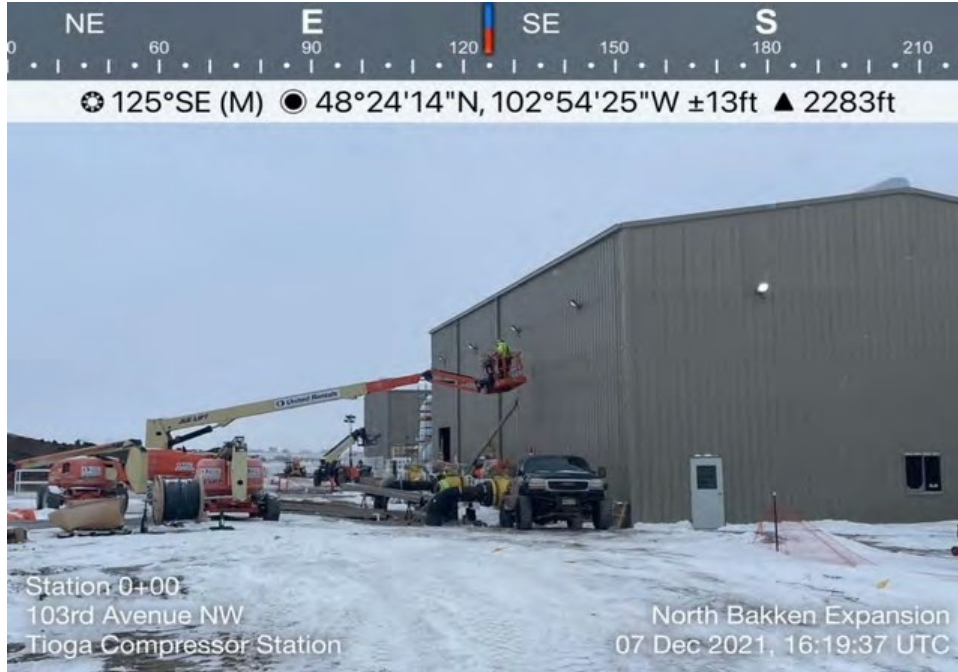
Location: Tioga Compressor Station

Notes: Installation of lights on compressor building.

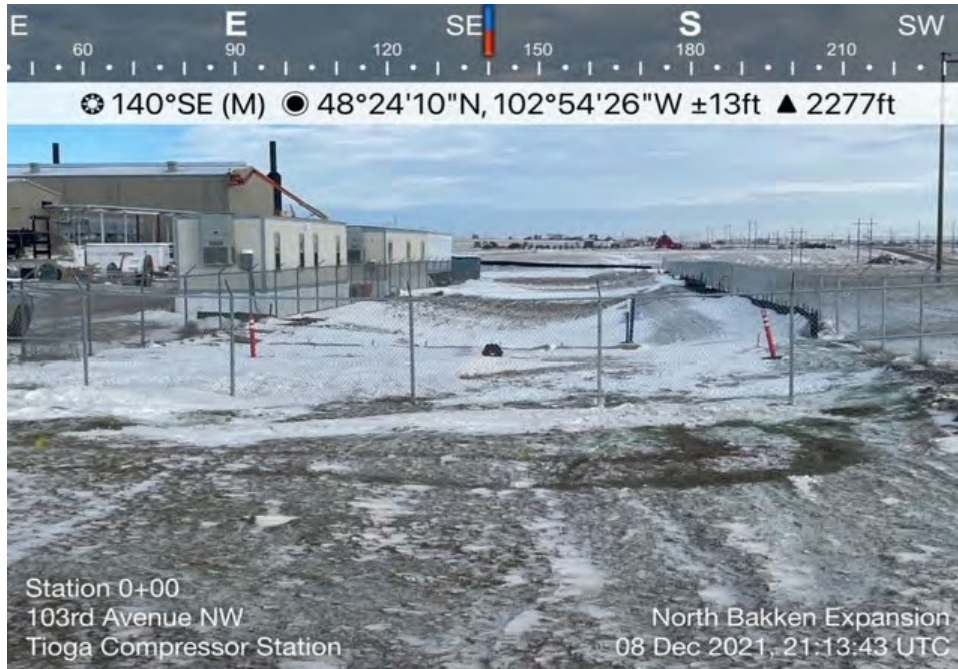
Location: Tioga Compressor Station

Notes: Erosion control devices are in place and properly functioning.

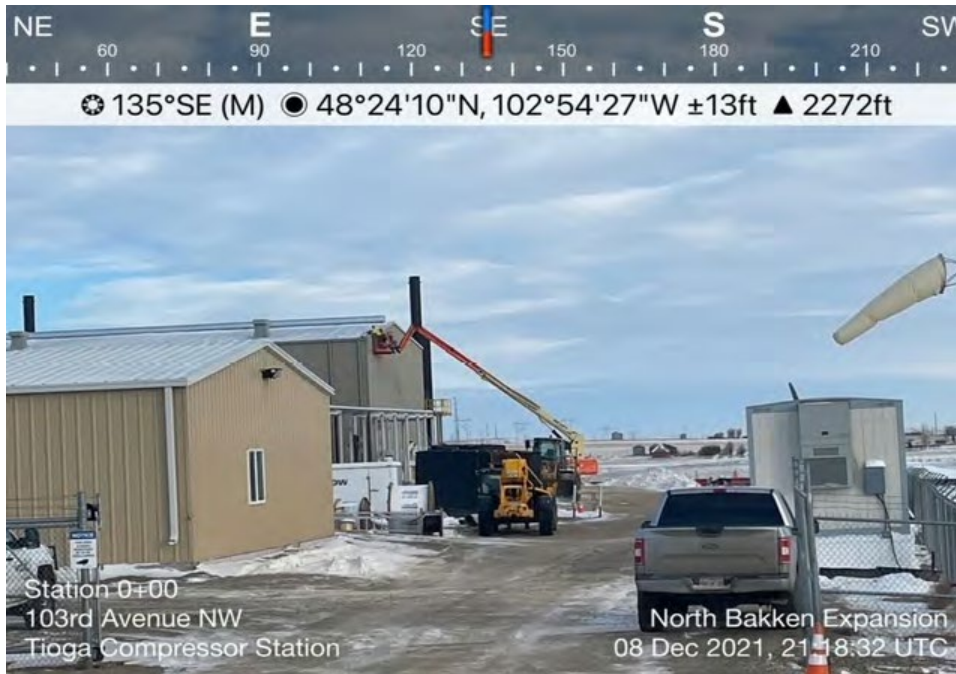
Location: Tioga Compressor Station

Notes: Completing installation of roof.

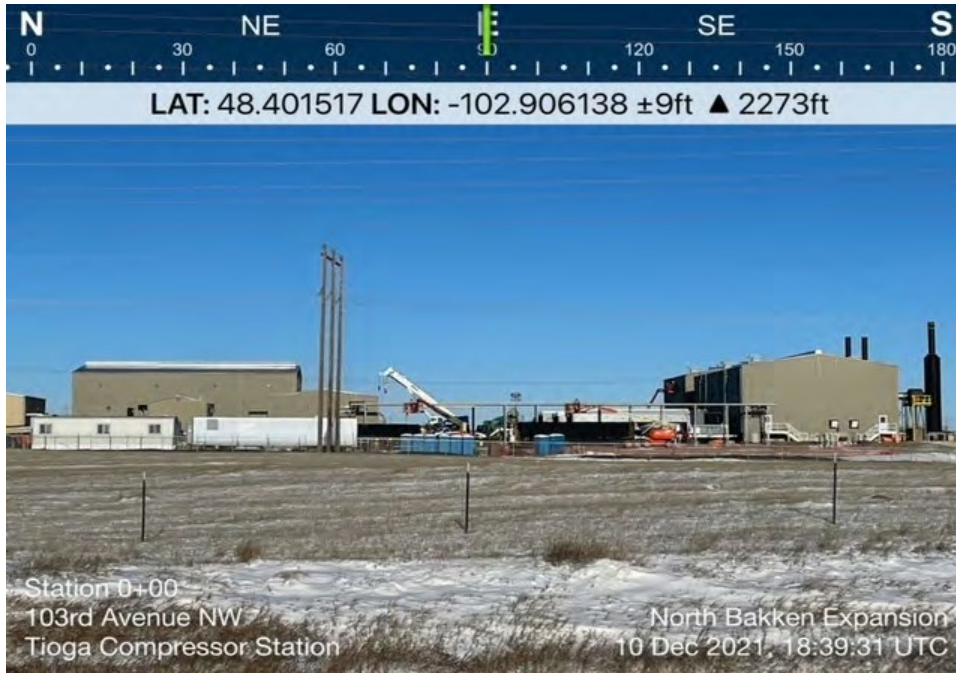
Location: Tioga Compressor Station

Notes: New facilities.

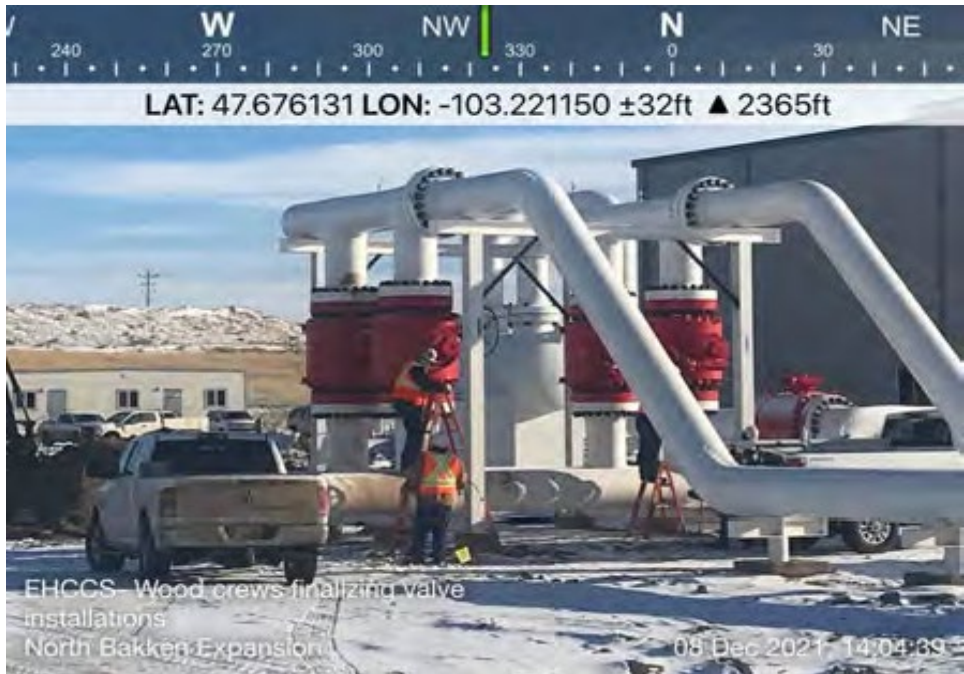
Location: Elkhorn Creek Compressor Station

Notes: Installation of valve.

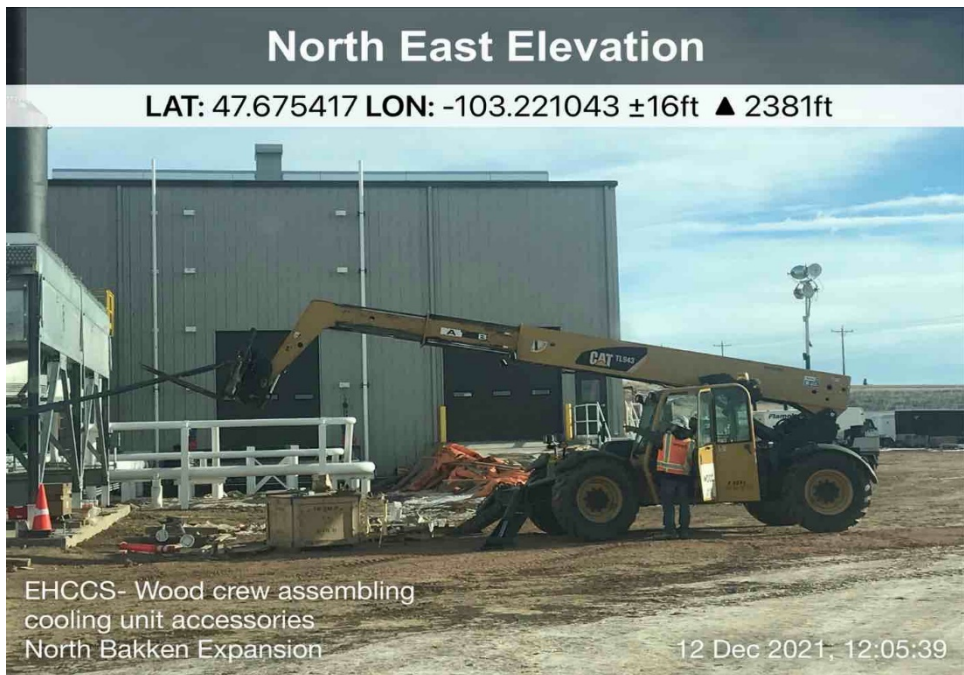
Location: Elkhorn Creek Compressor Station

Notes: New facilities.

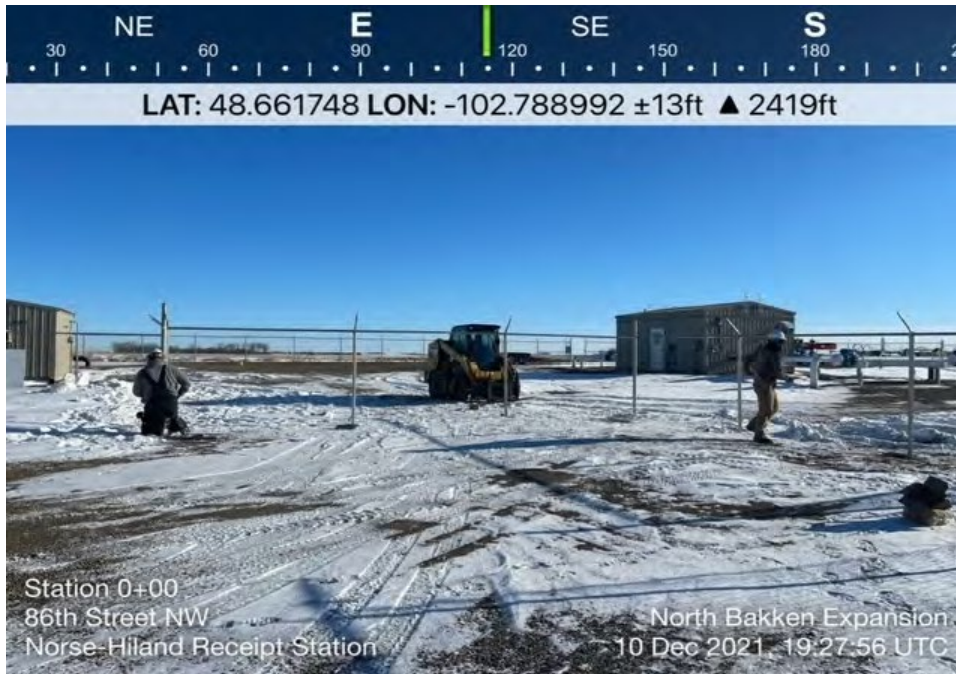
Location: Norse Plant
Receipt and Norse
Transfer Stations

Notes: Installation of
security fence around
stations.
