WBI ENERGY TRANSMISSION, INC.

North Bakken Expansion Project

Appendix

Docket Nos. CP20-52-000 CP20-52-001

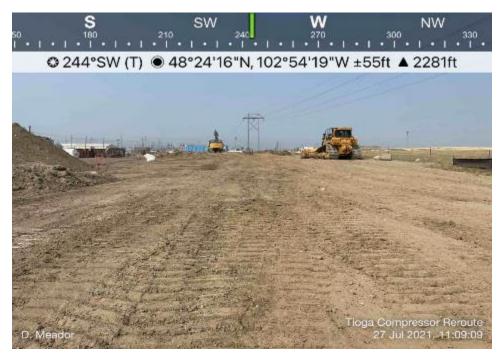
Location: Tioga Compressor Station – Williston- Tioga-Minot 12-inch Mainline Reroute.

Notes: Completed backfilling and grading of the rerouted 12-inch mainline.

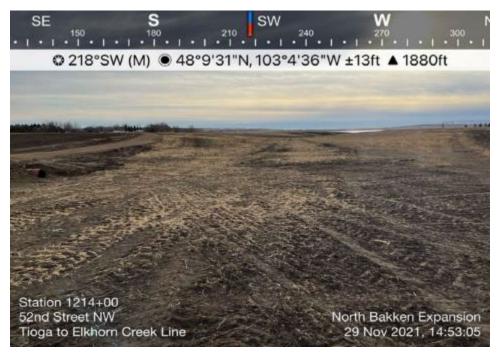
Location: Sta. No. 1214+00

Notes: Status of restored right-of-way and North Spread HDD bore site.

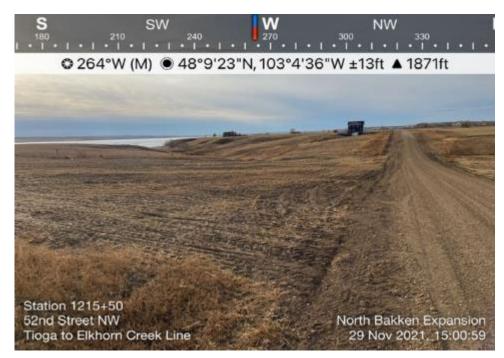
Location: Sta. No. 1215+50

Notes: Status of restored right-of-way and North Spread HDD bore site.

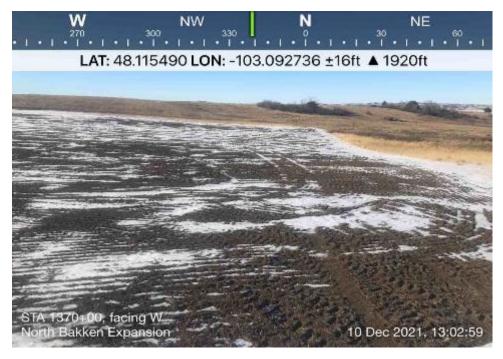
Location: Sta. No. 1370+00

Notes: Status of restored right-of-way and South Spread HDD bore site.

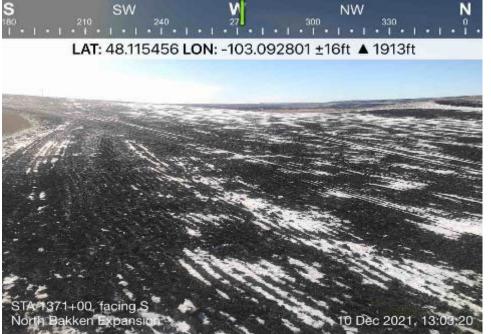
Location: Sta. No. 1371+00

Notes: Status of restored right-of-way and South Spread HDD bore site.

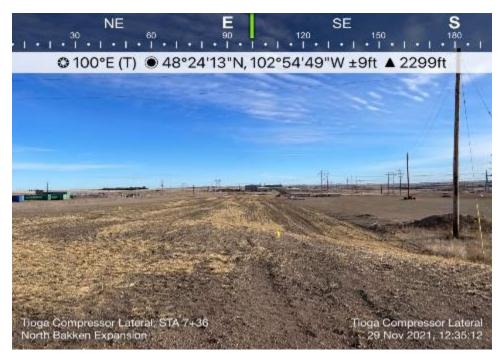
Location: Sta. No. 7+36

Notes: Status of restored right-of-way.

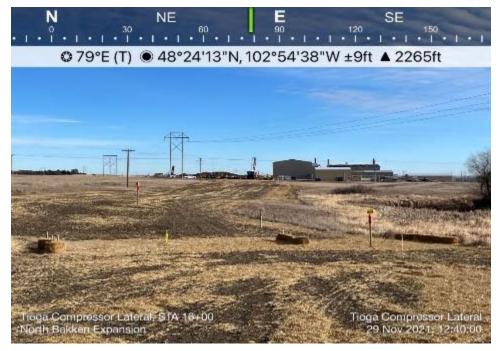
Location: Sta. No. 16+00

Notes: Status of restored right-of-way.

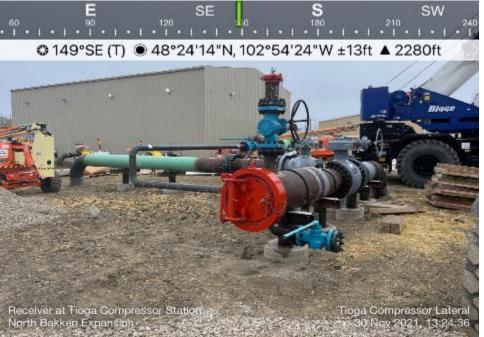
Location: Tioga Compressor Station

Notes: New Tioga Compressor Lateral pig launcher/receiver.

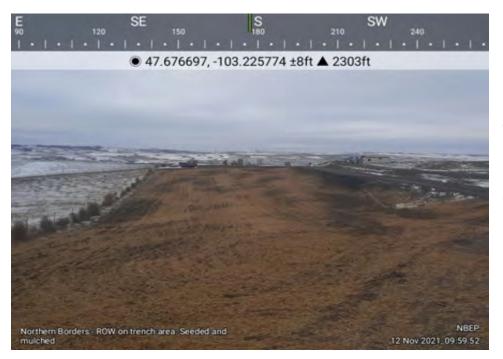
Location: Elkhorn Creek to Northern Border Interconnect Pipeline

Notes: Status of rightof-way. The Elkhorn Creek Compressor Station is in the background and to the right.

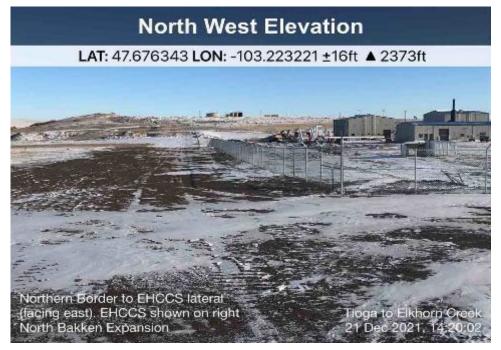
Location: Elkhorn Creek to Northern Border Interconnect Pipeline

Notes: Status of restored right-of-way. Elkhorn Creek Compressor Station to the right.

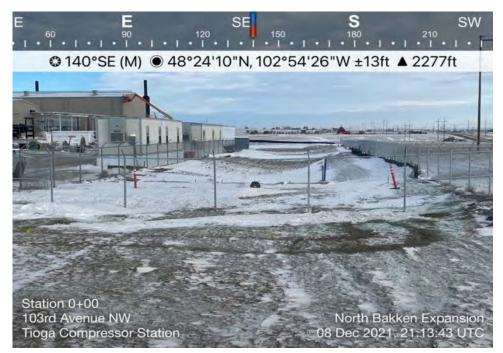
Location: Tioga Compressor Station

Notes: Erosion control devices are in place and properly functioning.

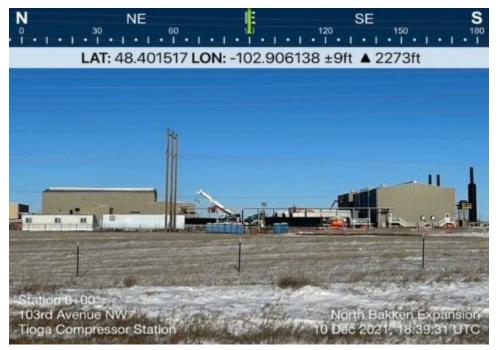
Location: Tioga Compressor Station

Notes: New Units 2 and 3, and Unit 4 compressor buildings (right), new transfer building (tall building to the left), new auxiliary building (front and right of transfer building).

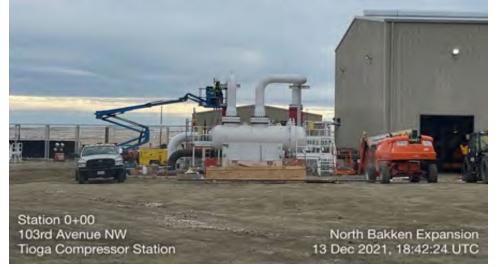
Location: Tioga Compressor Station

Notes: New suction scrubbers and discharge coalescer (center) and new transfer building (right).

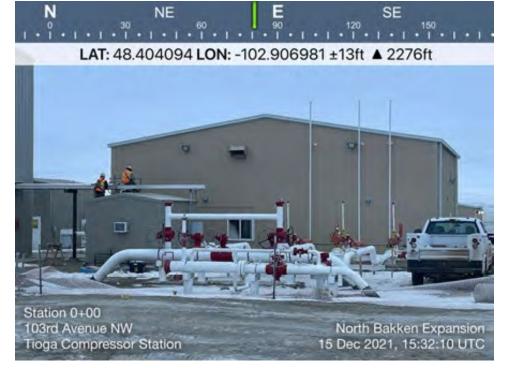
Location: Tioga Compressor Station

Notes: New gas chromatograph building (front left.

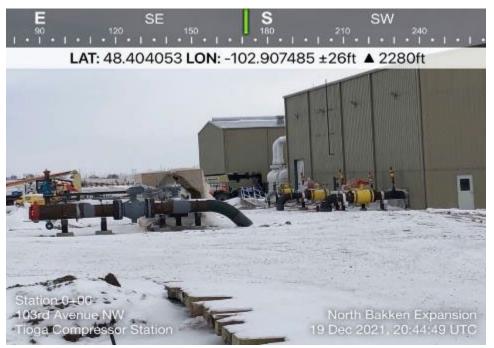
Location: Tioga Compressor Station

Notes: New Tioga Compressor Lateral pig launcher/receiver (left), transfer building and station ESD valves (right) and Unit 4 compressor building (background).

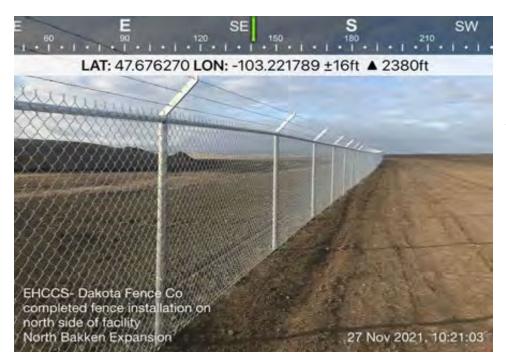
Location: Elkhorn Creek Compressor Station

Notes: Completed installation of security fence on the north side of station yard.

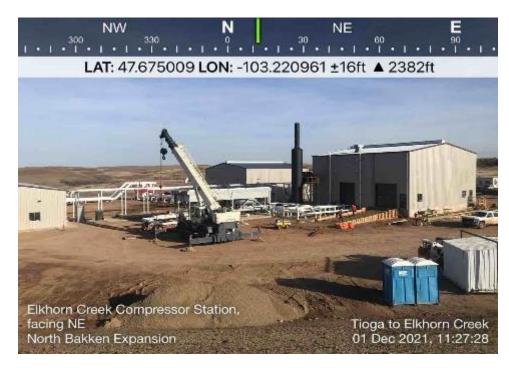
Location: Elkhorn Creek Compressor Station

Notes: New Unit 1 compressor building (right), transfer building (background), auxiliary building (left) and associated station piping.

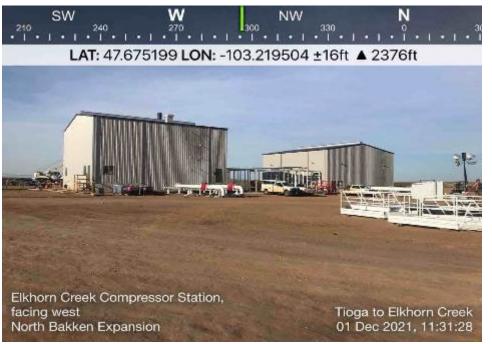
Location: Elkhorn Creek Compressor Station

Notes: New Unit 1 compressor building (left), and transfer building (right).

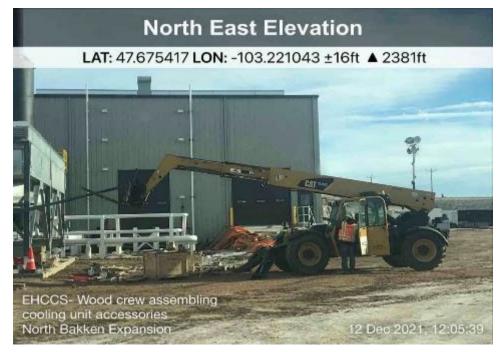
Location: Elkhorn Creek Compressor Station

Notes: New combination gas and engine jacket water cooler (left) and Unit 1 compressor building (center).

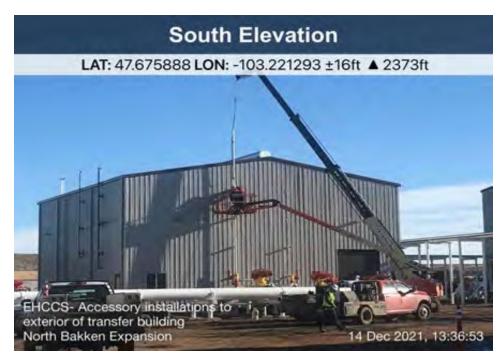
Location: Elkhorn Creek Compressor Station

Notes: West wall of new transfer building with suction and discharge headers, ESD block valves and ESD blowdown valves.

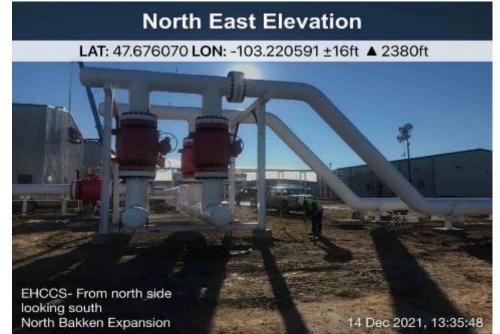
Location: Elkhorn Creek Compressor Station

Notes: New station piping and valves, transfer building (left), Unit 1 compressor building (background left), and auxiliary building (background right).

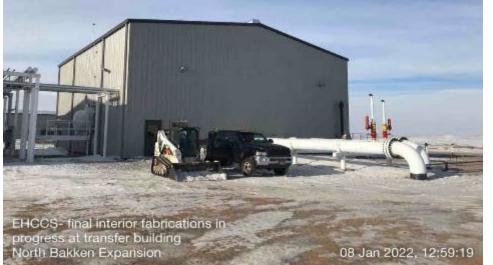
Location: Elkhorn Creek Compressor Station

Notes: East wall of transfer building with suction scrubber to the left of building

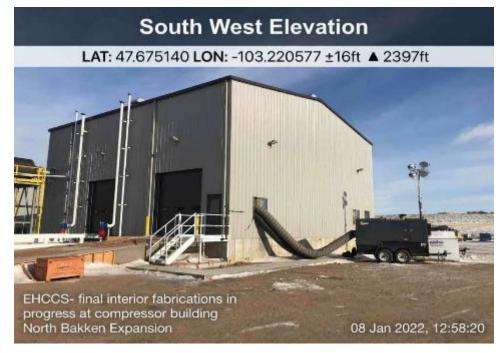
Location: Elkhorn Creek Compressor Station

Notes: New Unit 1 compressor building.

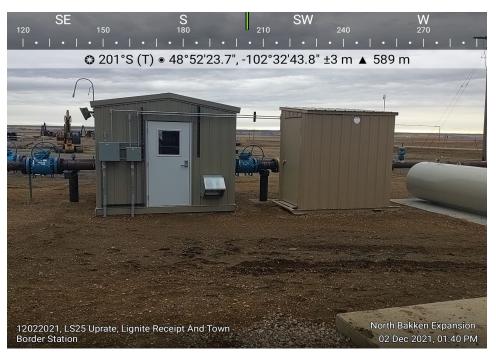
Location: Lignite Plant Receipt Station

Notes: A new meter building (left), odorization facilities (right) and associated station piping.

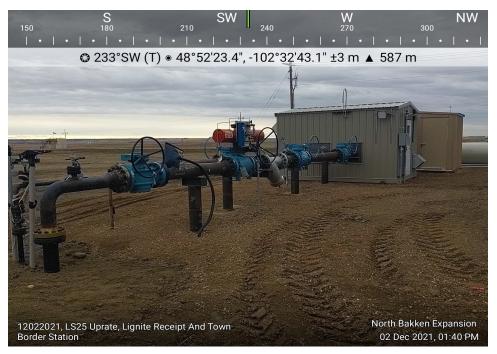
Location: Lignite Plant Receipt Station

Notes: New meter building and associated station piping.

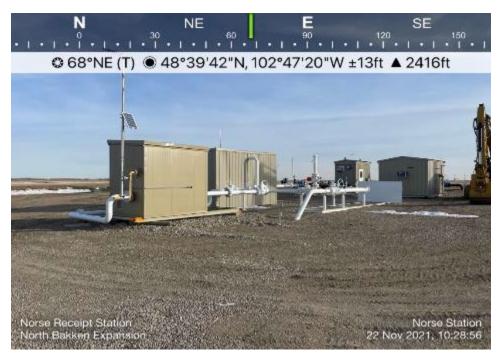
Date: 11/22/2021 Location: Norse Plant Receipt Station

Notes: New meter building and associated station piping.

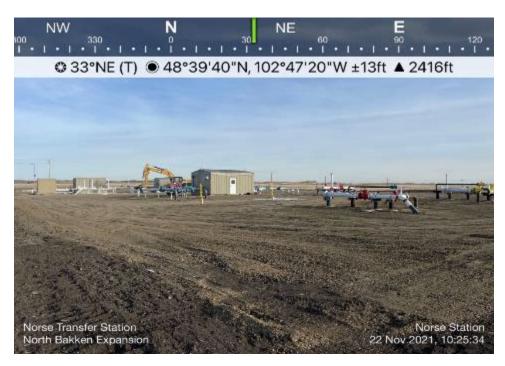
Location: Norse Transfer Station

Notes: New transfer building and associated station piping. The upgraded Norse Plant Receipt Station meter building is in background. Completed the installation of the security fence the week of December 13, 2021.

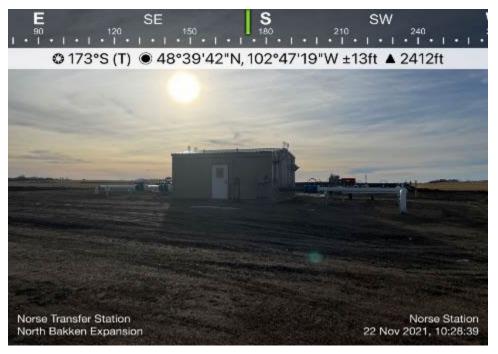
Location: Norse Transfer Station

Notes: New transfer building and associated station piping.

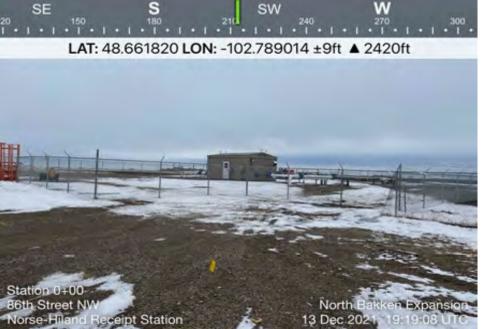
Location: Norse Plant Receipt and Norse Transfer Stations

Notes: Completed installation of a security fence around both stations.

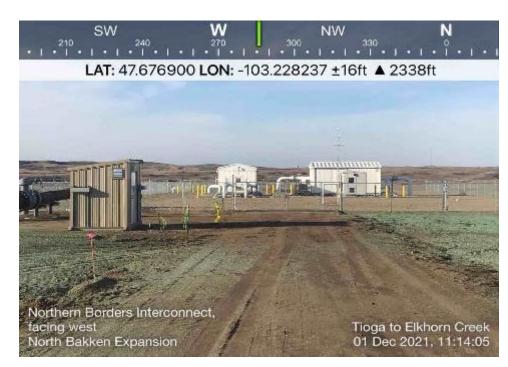
Location: Northern Border Interconnect

Notes: New RTU building (left) and pipeline (left).

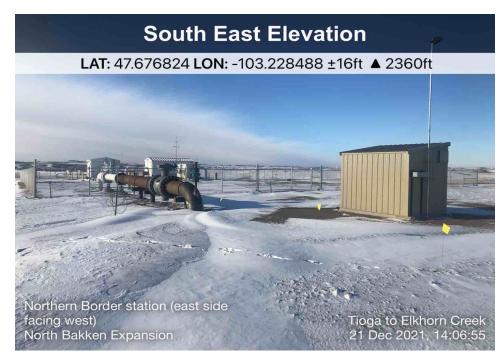
Location: Northern Border Interconnect

Notes: New facilities.

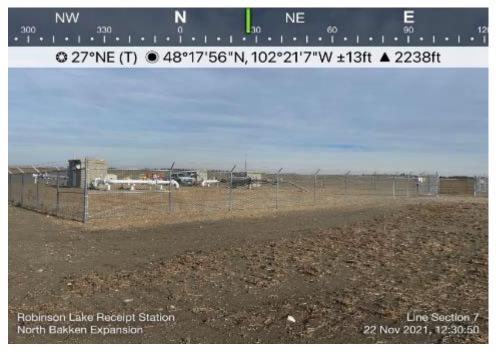
Location: Robinson Lake Plant Receipt Station.

Notes: New meter building (far left) and associated station piping.

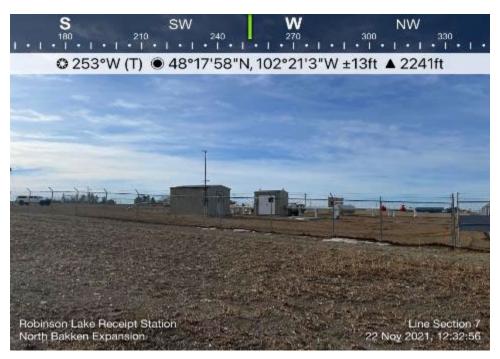
Location: Robinson Lake Plant Receipt Station.

Notes: New security fence and spread gravel around facilities.

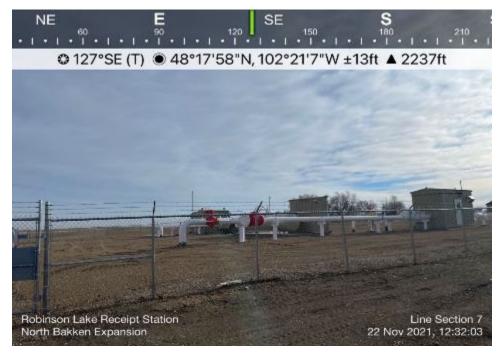
Location: Robinson Lake Plant Receipt Station.

Notes: New security fence and spread gravel around facilities.

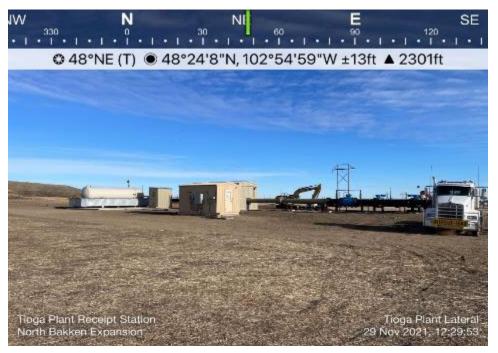
Location: Tioga Plant Receipt Station.

Notes: New odorant system (left), communications (middle) and meter (background) buildings, and associated station piping.

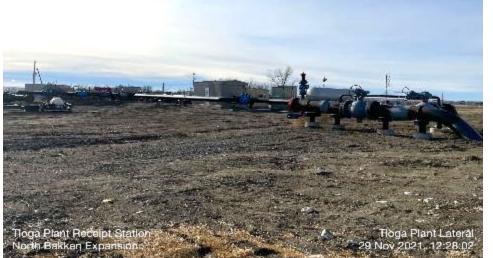
Location: Tioga Plant Receipt Station.

Notes: New pig launcher/receiver (right) meter building (center background), and associated station piping.
