FEDERAL ENERGY REGULATORY COMMISSION
ENVIRONMENTAL COMPLIANCE MONITORING PROGRAM
WEEKLY SUMMARY REPORT NO. 16
NORTH BAKKEN EXPANSION PROJECT
DOCKET NOS.: CP 20-52-000 AND CP 20-52-001
FOR THE PERIOD: NOVEMBER 14 THROUGH 20, 2021

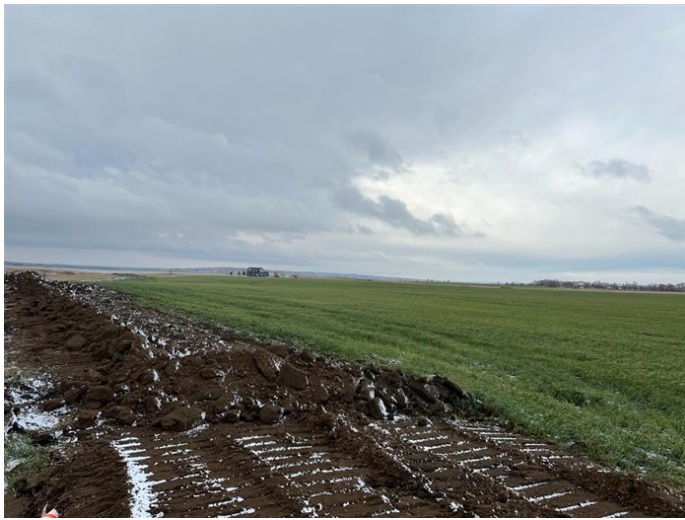
Lake Sakakawea HDD North – In progress removal and restoration of a temporary road that was constructed for landowner access to bypass the HDD site during construction (November 15, 2021) – Acceptable – MP 22.9

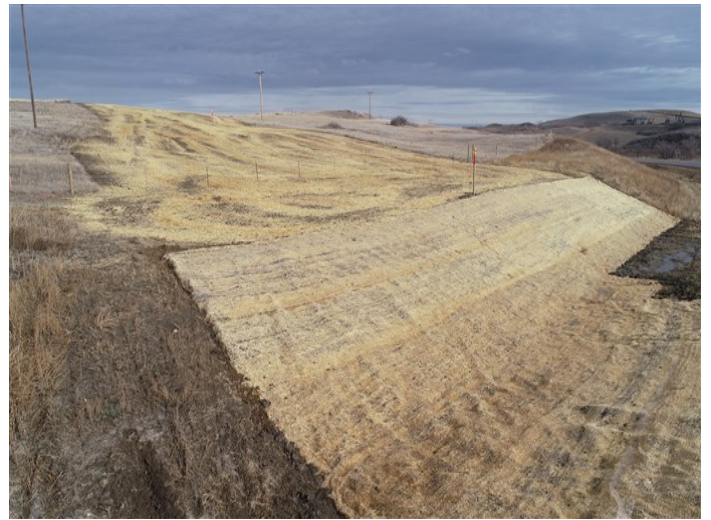
Tioga Elkhorn Creek PL Spread 2 – Curlex installed at the north side of Highway 37 ditch area. (November 15, 2021) – Acceptable – MP 59.6

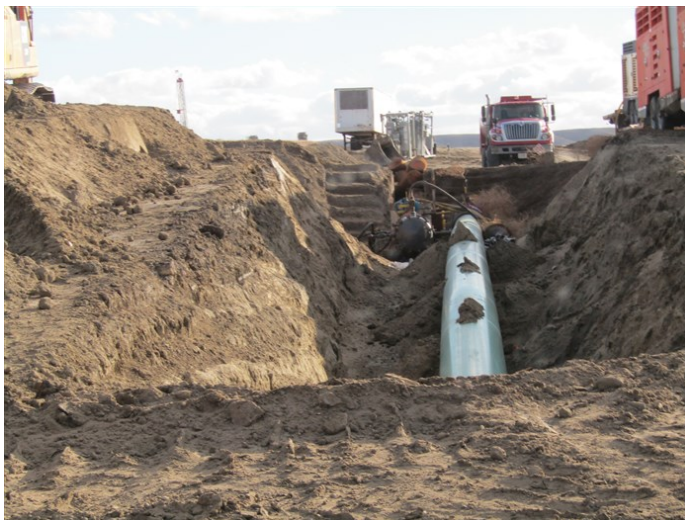
Lake Sakakawea HDD South – Ditch open and crews running pigs and drying lines with heaters after hydro-testing activities were completed (November 16, 2021) – Acceptable – MP 26.0

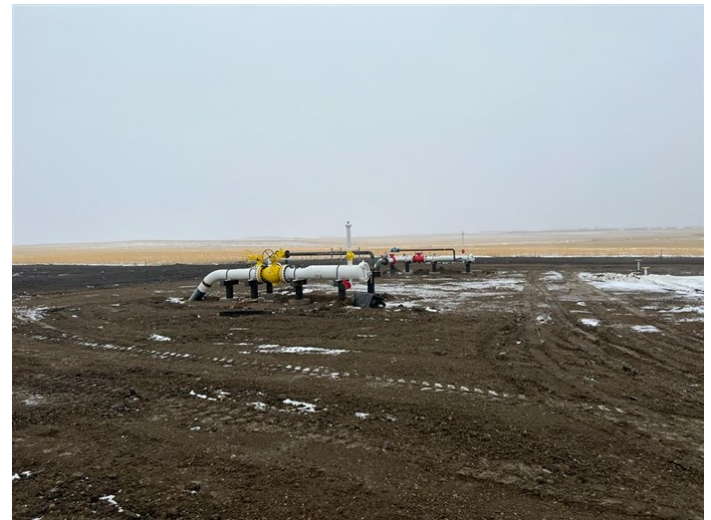
Uprates to Line Section 25 – Finished grade around new pig launcher. Receiver has been restored (November 16, 2021) – Acceptable – MP 0.0

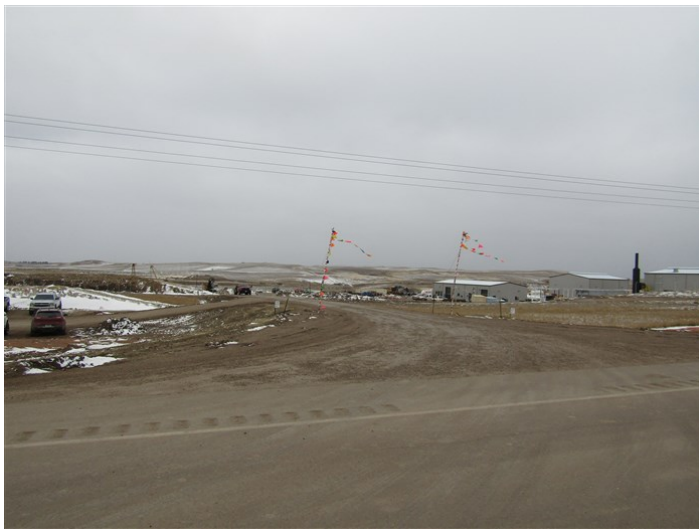
Elkhorn Creek Compressor Station – Entrance to the Elkhorn Creek Compressor Station roadway is clean. Goal posts and flagging installed at overhead lines (November 17, 2021) – Acceptable – MP 61.7

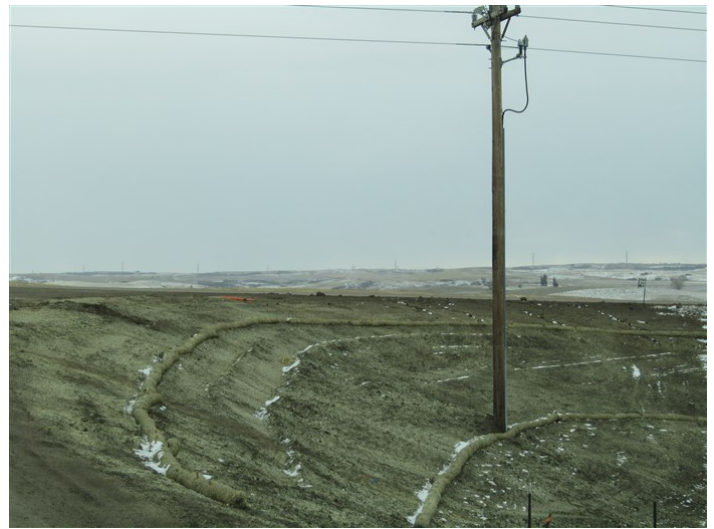
Northern Border Interconnect – Erosion control devices installed at the western bank of the access road entrance to the site (November 17, 2021) – Acceptable – MP 0.3

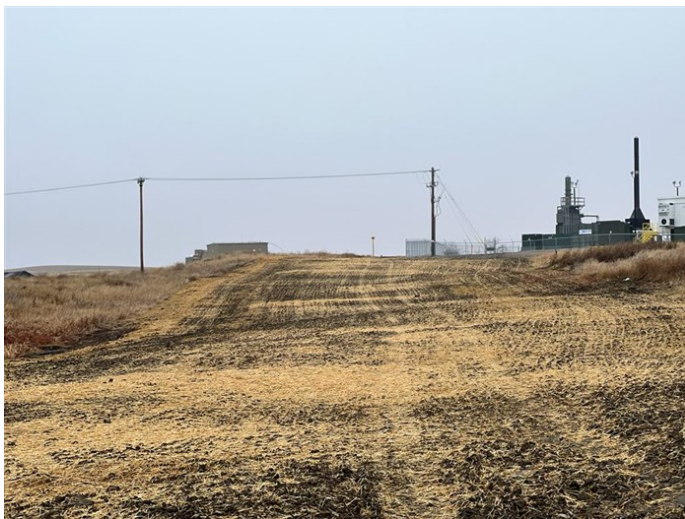
Line Section 30 Loop – Mulched and seeded right-of-way (November 18, 2021) – Acceptable – MP 0.0

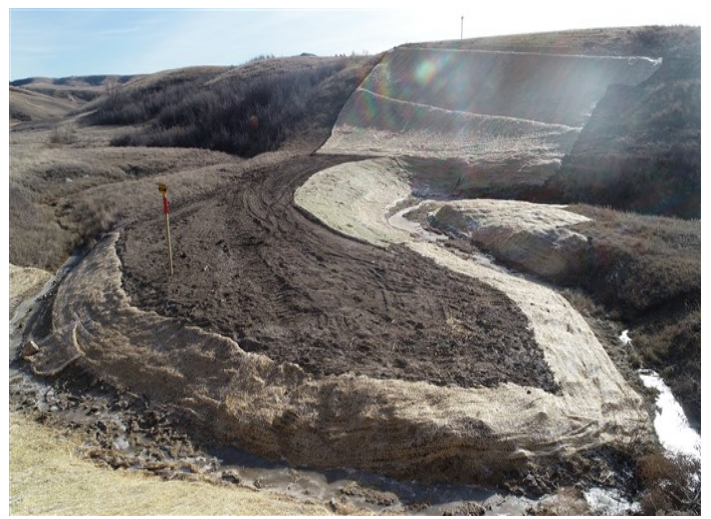
Tioga Elkhorn Creek PL Spread 2 – Final clean-up and restoration completed up to wetland w-mk-ea-001e. Curlex was installed at the steep slope area north of the wetland and Curlex was installed at the banks of both sides of the wetland. Banks were restored and contours put back. (November 18, 2021) – Acceptable – MP 28.0

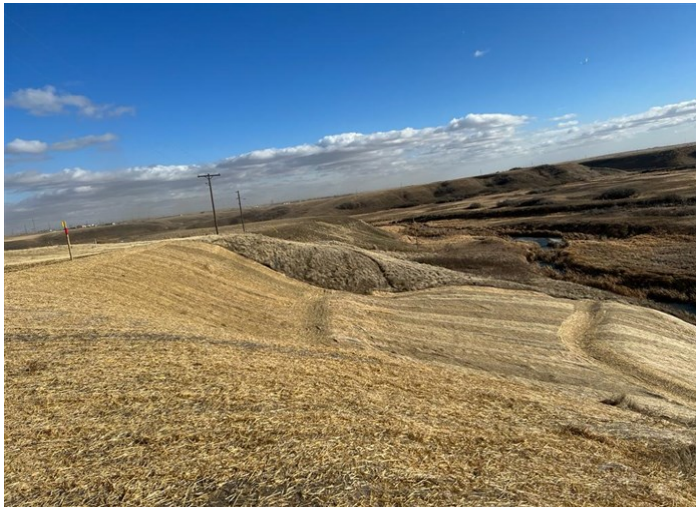
Tioga Elkhorn Creek PL Spread 1 – Stable slopes (November 19, 2021) – Acceptable – MP 0.6

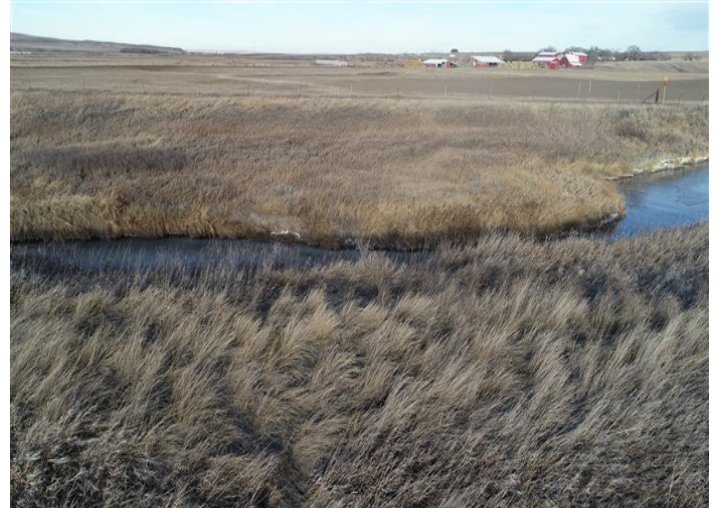
Tioga Elkhorn Creek PL Spread 2 – Tobacco Garden Creek (s-mk-eb-003), after boring activities and final clean-up. (November 19, 2021) – Acceptable – MP 30.2

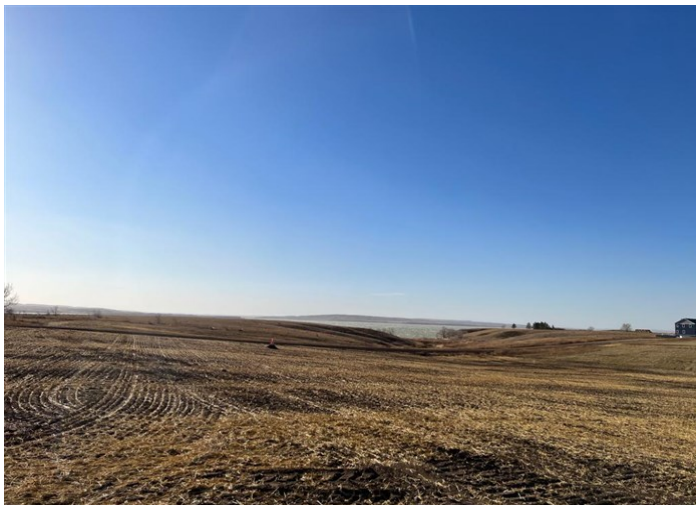
Tioga Elkhorn Creek PL Spread 1 – Completed clean-up, restoration, seeding, and mulching of all workspaces utilized for the assembly and installation of the pipeline under Lake Sakakawea (November 20, 2021) – Communication – MP 23.0

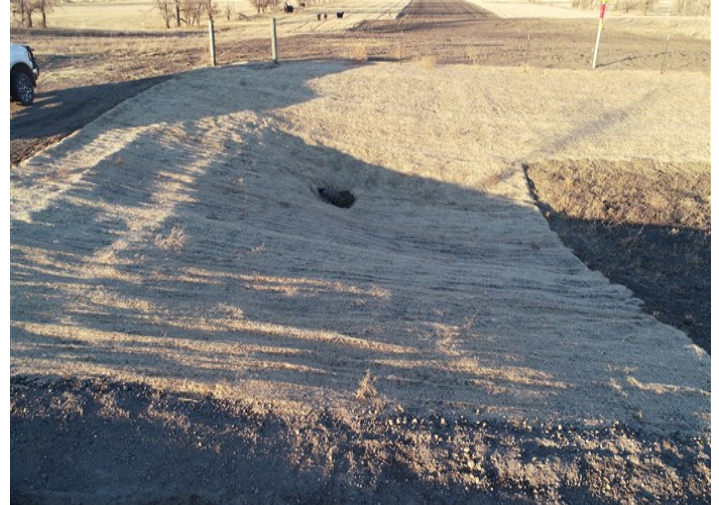
Tioga Elkhorn Creek PL Spread 2 – All construction activities including final clean-up are complete. Curlex was installed at ditch banks along Highway 10 (November 20, 2021) – Acceptable – MP 36.8
