Re: WBI Energy Transmission, Inc.
Docket Nos. CP20-52-000 and CP20-52-001
North Bakken Expansion Project
Weekly Status Report No. 30

WBI Energy Transmission, Inc.
North Bakken Expansion Project Status Report No. 30
FERC Docket Nos. CP20-52-000
CP20-52-001

Reporting Period: December 20, 2021 through December 26, 2021

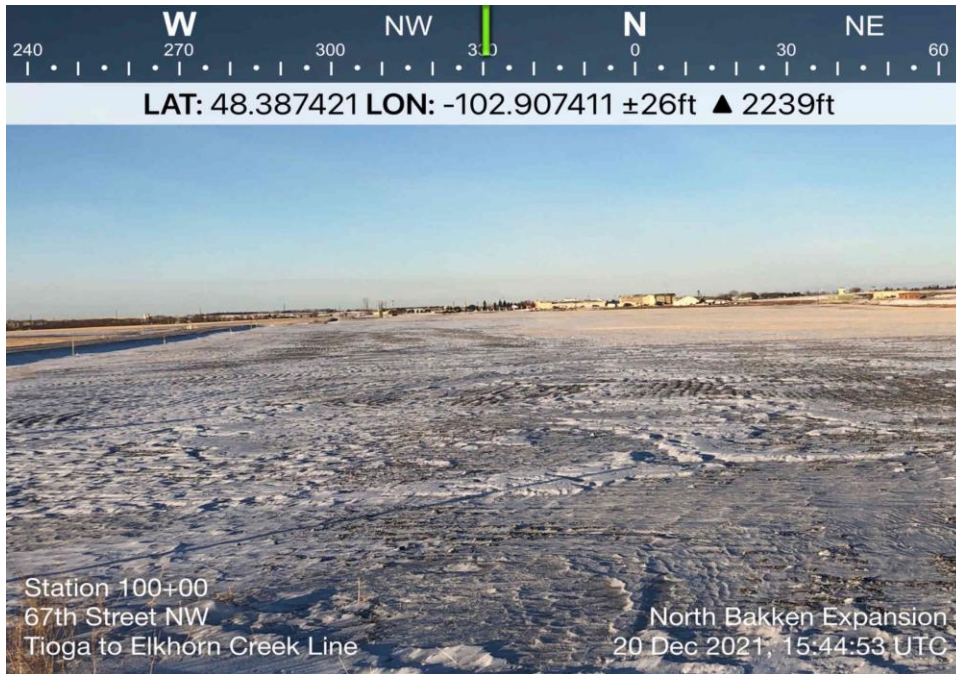
Location:
Sta. No. 100+00

Notes: Restored right-of-way remained frozen and stabilized.

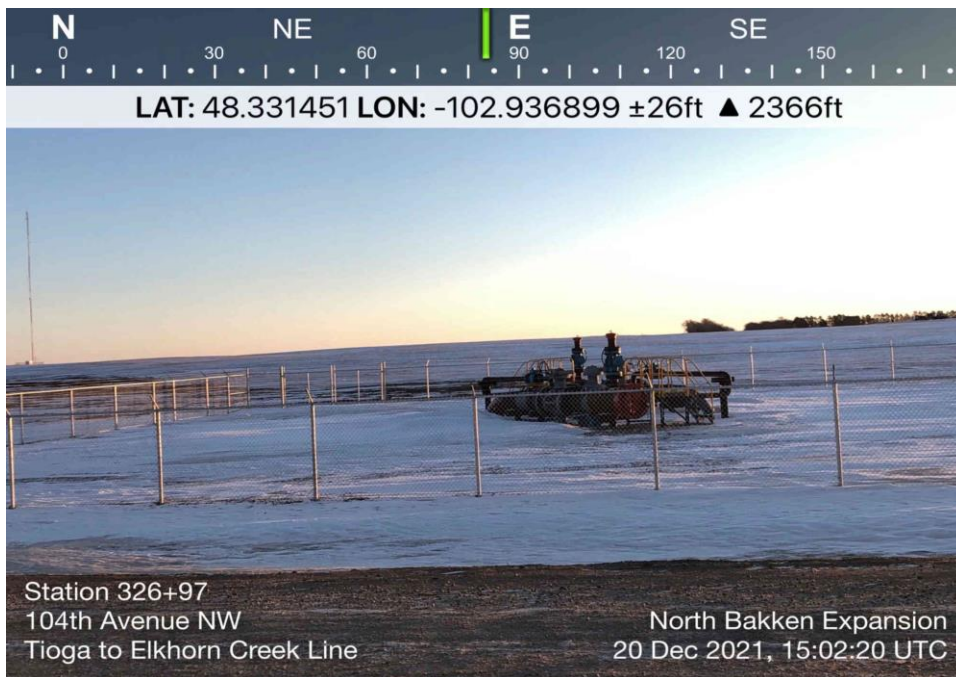
Location:
Sta. No. 326+97

Notes: Pig launcher/receiver site remained frozen and stabilized.

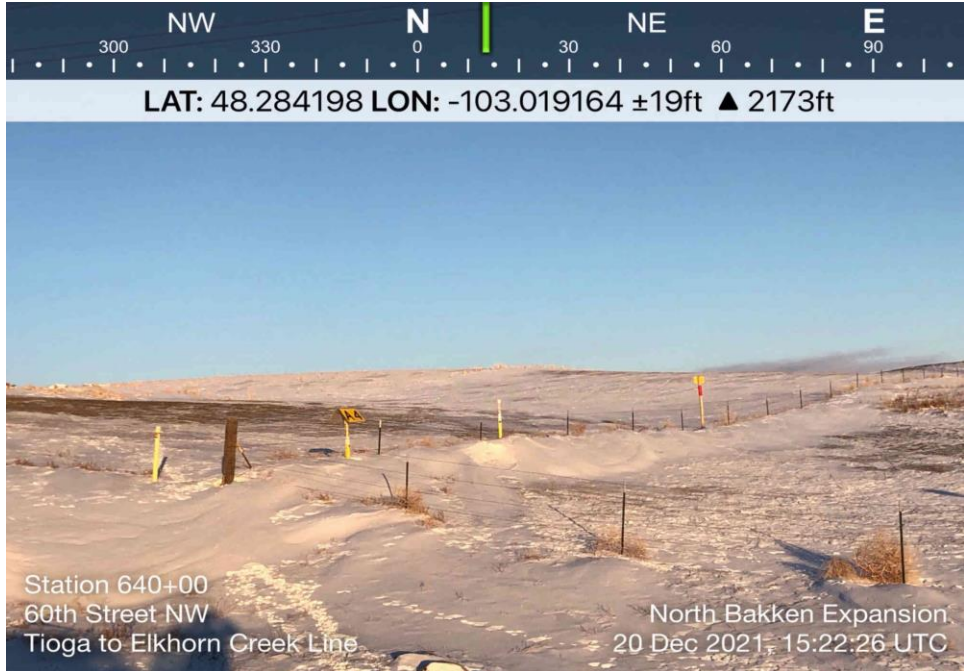
Location:
Sta. No. 640+00

Notes: Restored right-of-way remained frozen and stabilized.

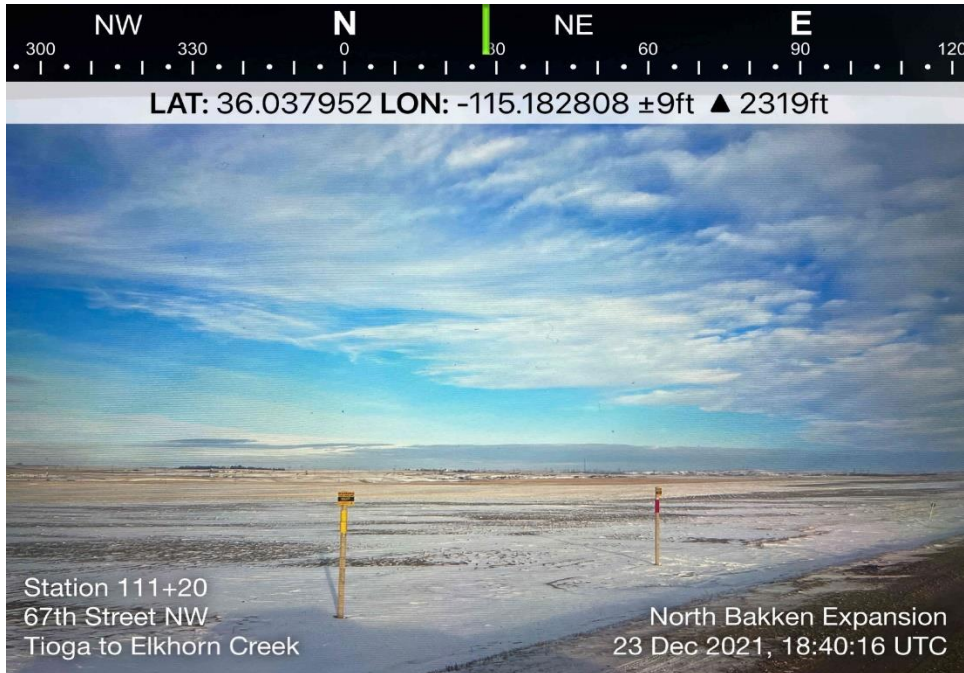
Location:
Sta. No. 111+20

Notes: Restored right-of-way remained frozen and stabilized.

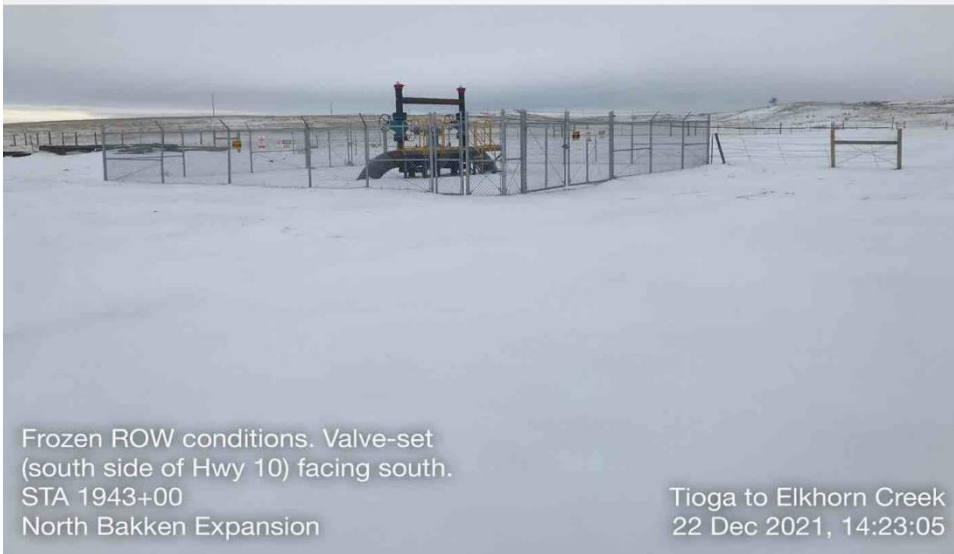
Location:
Sta. No. 1943+00

Frozen ROW conditions. Valve-set
(south side of Hwy 10) facing south.
STA 1943+00
North Bakken Expansion

Notes: Block valve
site remained frozen
and stabilized.

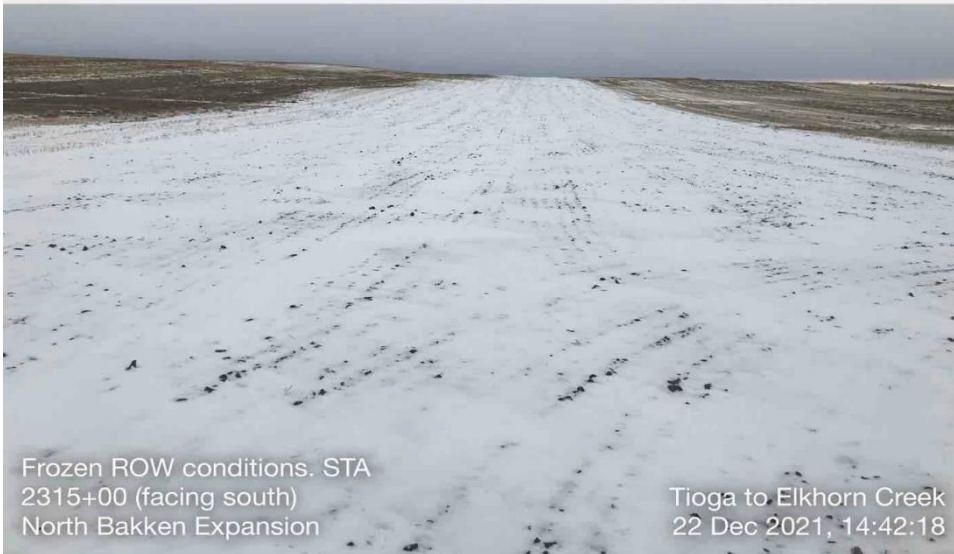
Location:
Sta. No. 2315+00

Frozen ROW conditions. STA
2315+00 (facing south)
North Bakken Expansion

Notes: Restored right-
of-way remained
frozen and stabilized.

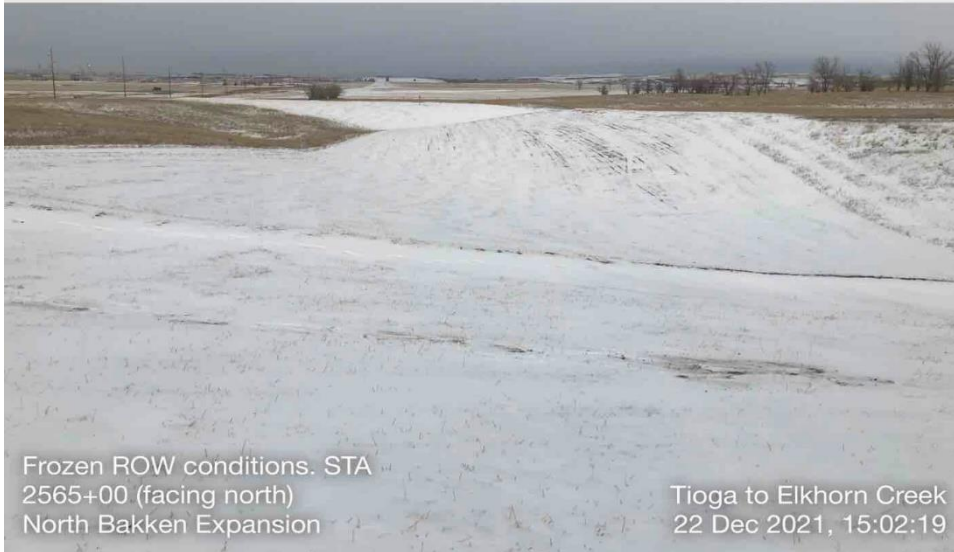
Location:
Sta. No. 2565+00

Frozen ROW conditions. STA
2565+00 (facing north)
North Bakken Expansion

Notes: Restored
right-of-way
remained frozen and
stabilized.

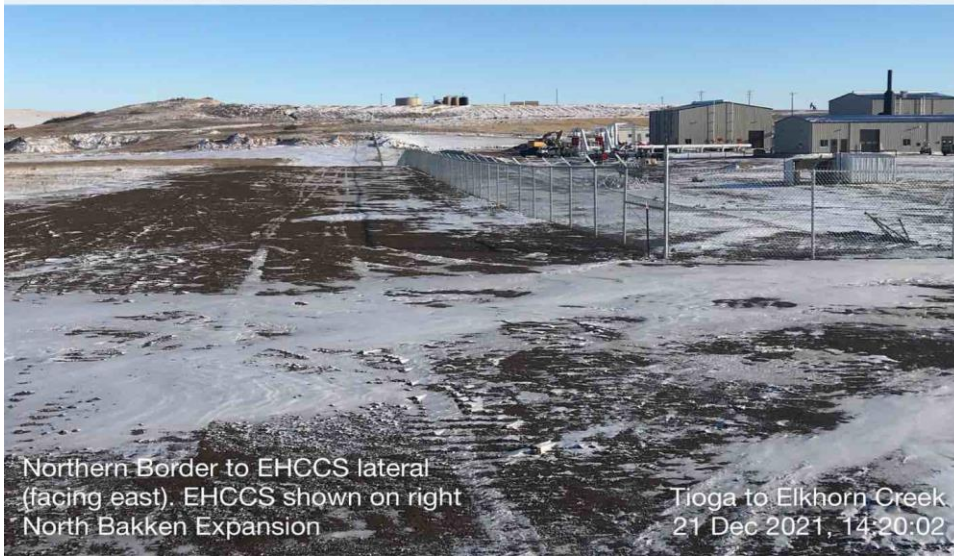
Location: Elkhorn Creek to Northern Border Pipeline.

Notes: Restored right-of-way remained frozen and stabilized. The Elkhorn Creek Compressor Station is to the right.

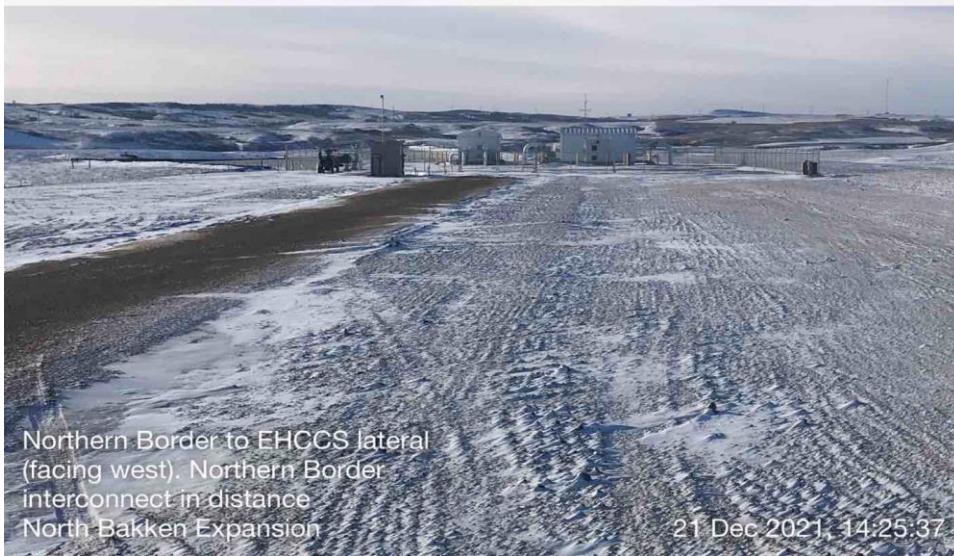
Location: Elkhorn Creek to Northern Border Pipeline.

Notes: Restored right-of-way remained frozen and stabilized. The Northern Border Interconnect RTU building is on the left.
