Re: WBI Energy Transmission, Inc.
Docket Nos. CP20-52-000 and CP20-52-001
North Bakken Expansion Project
Weekly Status Report No. 33

WBI Energy Transmission, Inc.
North Bakken Expansion Project Status Report No. 33
FERC Docket Nos. CP20-52-000
CP20-52-001

Reporting Period: January 10, 2021 through January 16, 2022

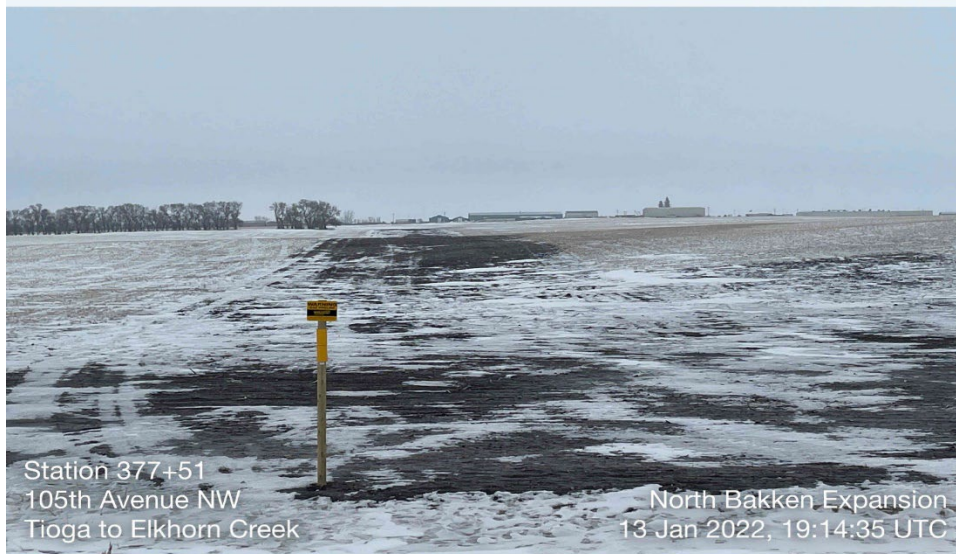
Location:
Sta. No. 377+51

Station 377+51
105th Avenue NW
Tioga to Elkhorn Creek

Notes: Restored right-of-way remains frozen and stabilized.

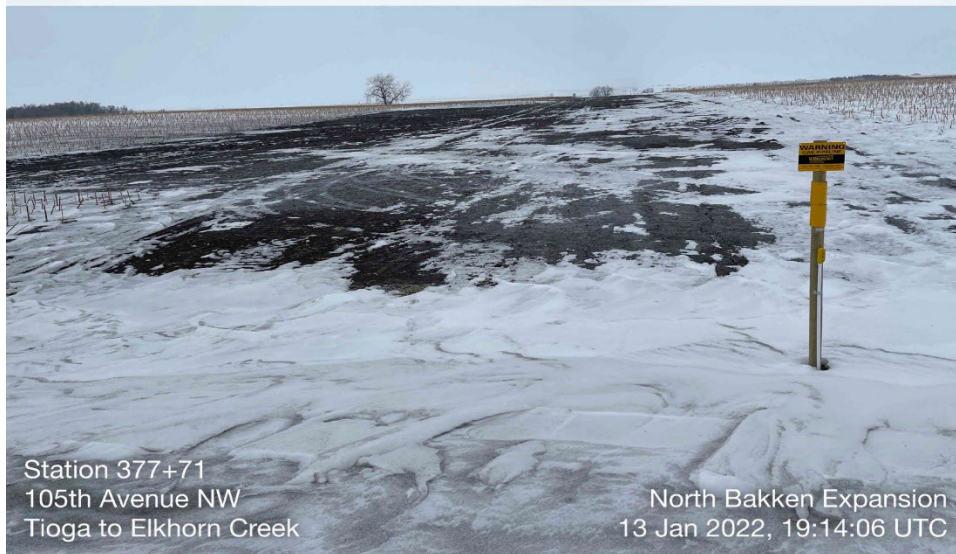
Location:
Sta. No. 377+71

Station 377+71
105th Avenue NW
Tioga to Elkhorn Creek

Notes: Restored right-of-way remains frozen and stabilized.

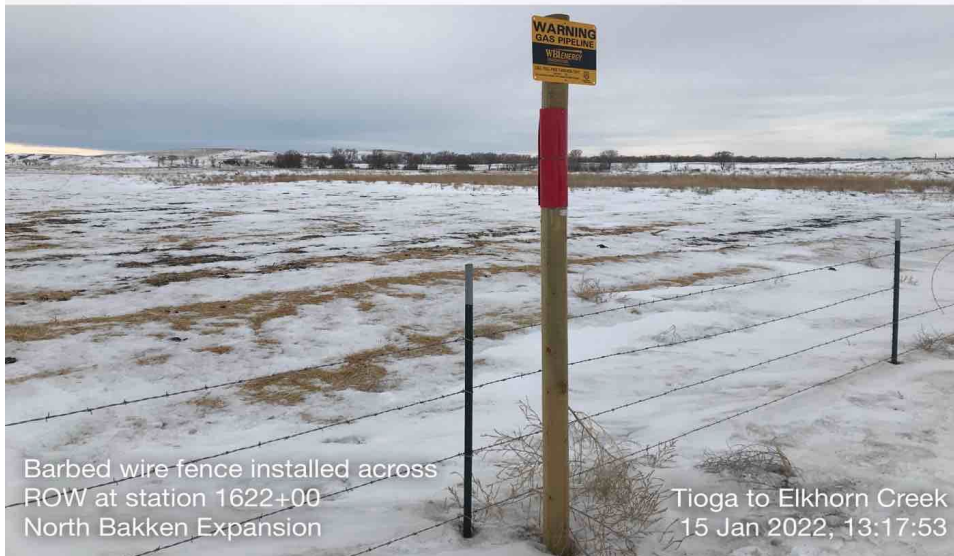
Location:
Sta. No. 1622+00

Barbed wire fence installed across
ROW at station 1622+00
North Bakken Expansion

Notes: Restored right-of-way remains frozen and stabilized.

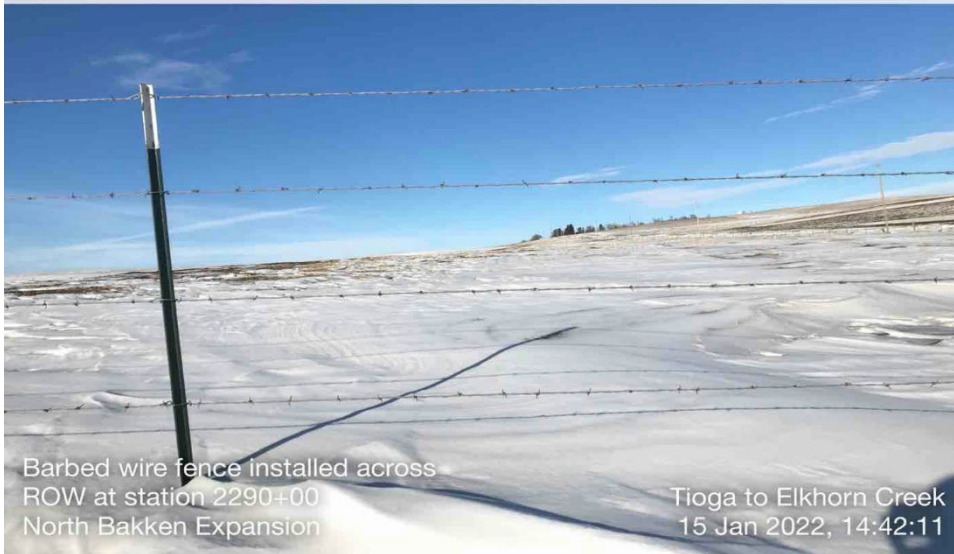
Location:
Sta. No. 2290+00

Barbed wire fence installed across
ROW at station 2290+00
North Bakken Expansion

Notes: Restored right-of-way remains frozen and stabilized.

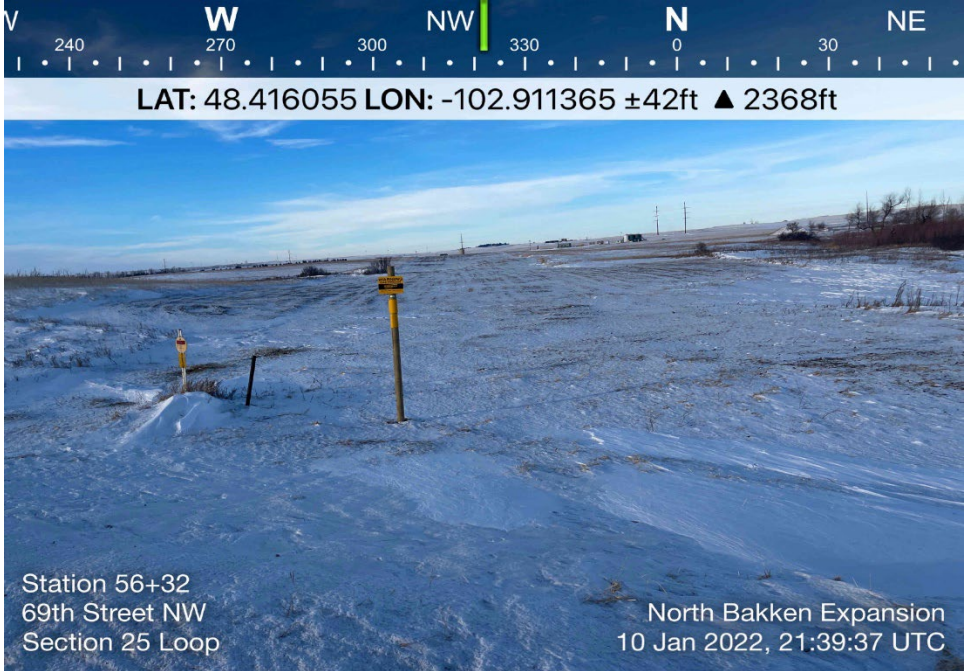
Location:
Sta. No. 56+32

Notes: Restored
right-of-way remains
frozen and stabilized.

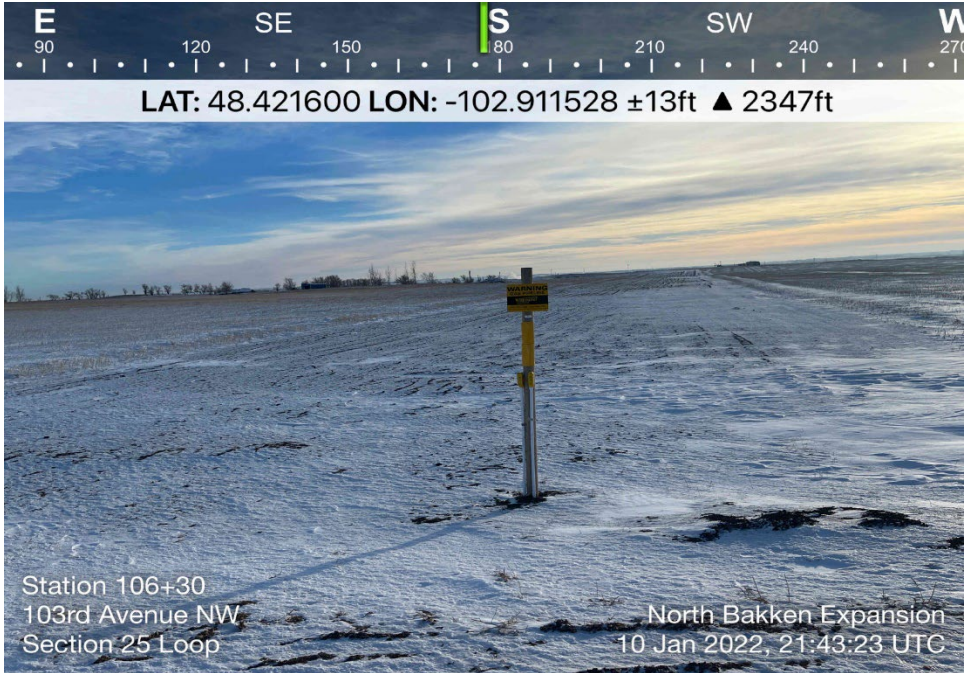
Location:
Sta. No. 106+30

Notes: Restored
right-of-way remains
frozen and stabilized.

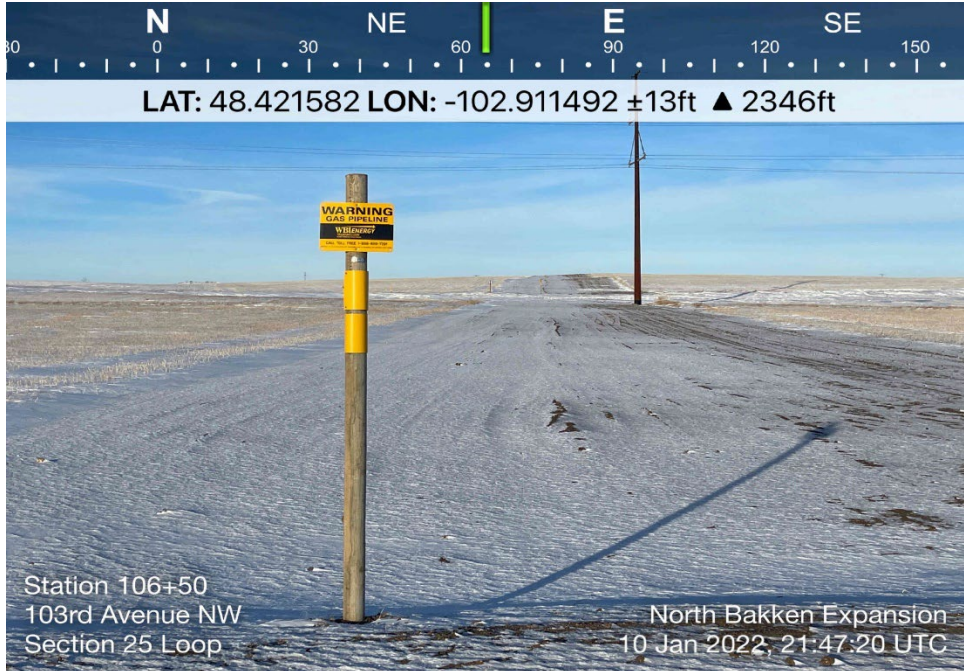
Location:
Sta. No. 106+50

Notes: Restored right-of-way remains frozen and stabilized.

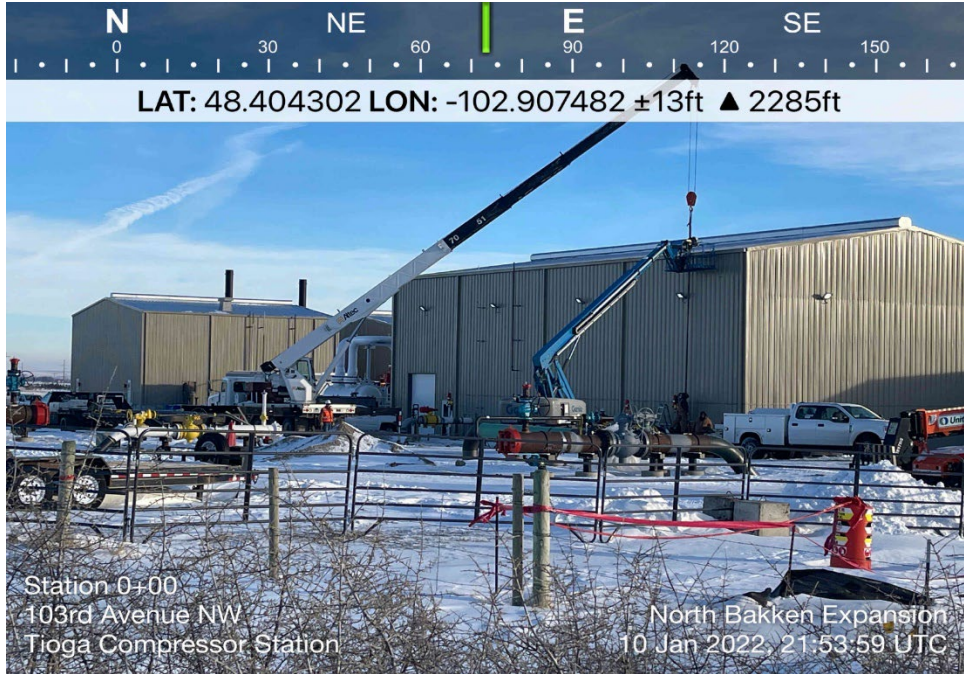
Location: Tioga Compressor Station

Notes: Continued construction activities.

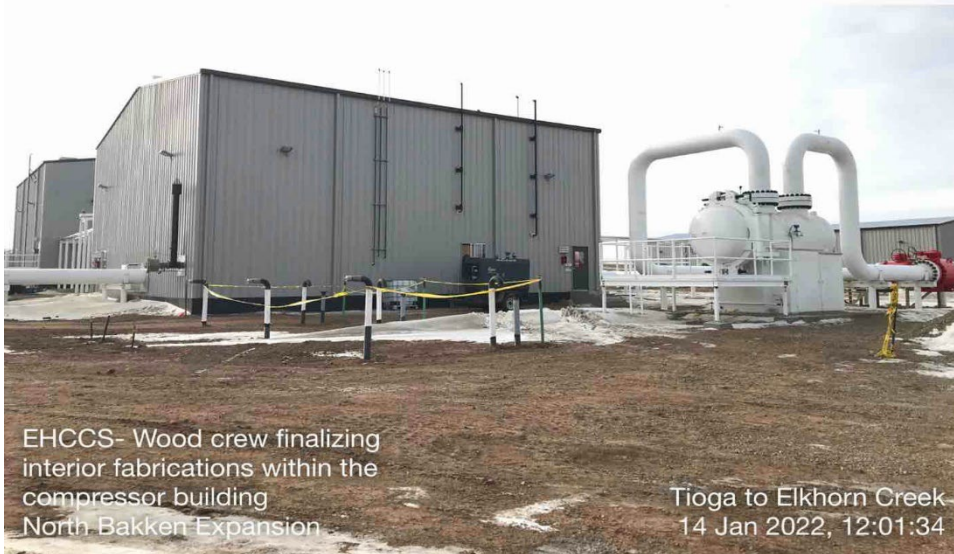
Location:
Elkhorn Creek
Compressor Station

EHCCS- Wood crew finalizing interior fabrications within the compressor building
North Bakken Expansion

Notes: Continued construction activities within the compressor building.

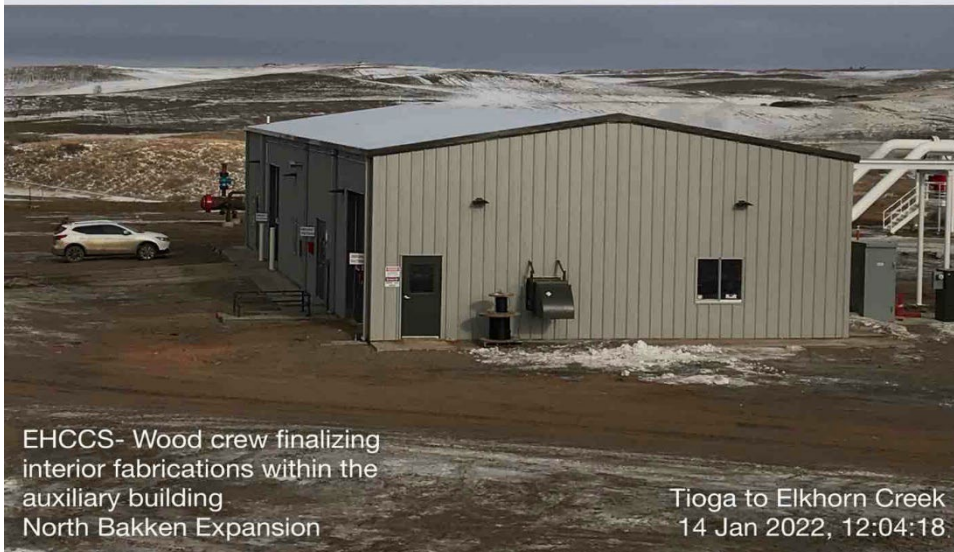
Location:
Elkhorn Creek
Compressor Station

EHCCS- Wood crew finalizing interior fabrications within the auxiliary building
North Bakken Expansion

Notes: Continued construction activities within the auxiliary building.

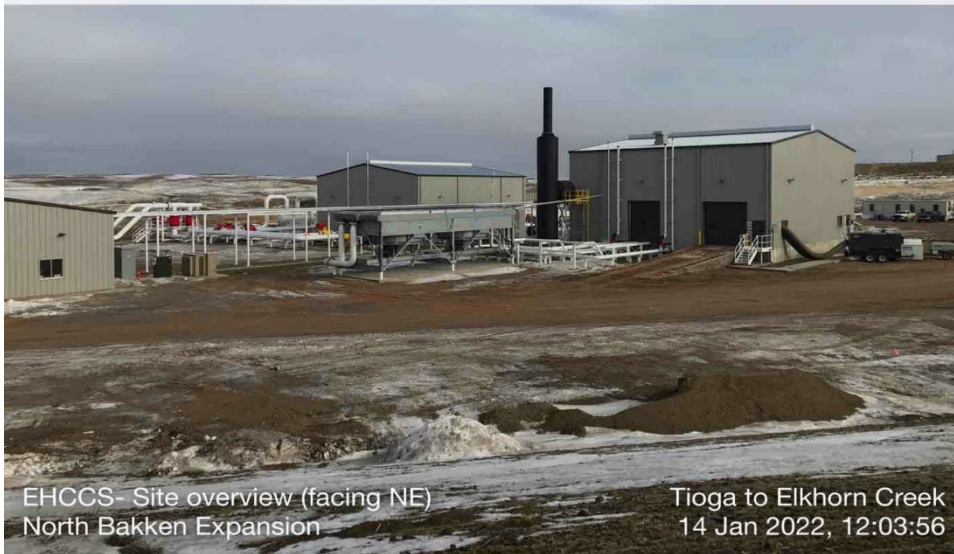
Location:
Elkhorn Creek
Compressor Station

EHCCS - Site overview (facing NE)
North Bakken Expansion

Notes: Overview of
station.
