Re: WBI Energy Transmission, Inc.
Docket Nos. CP20-52-000 and CP20-52-001
North Bakken Expansion Project
Weekly Status Report No. 34

WBI Energy Transmission, Inc.
North Bakken Expansion Project Status Report No. 34
FERC Docket Nos. CP20-52-000
CP20-52-001

Reporting Period: January 17, 2022 through January 23, 2022

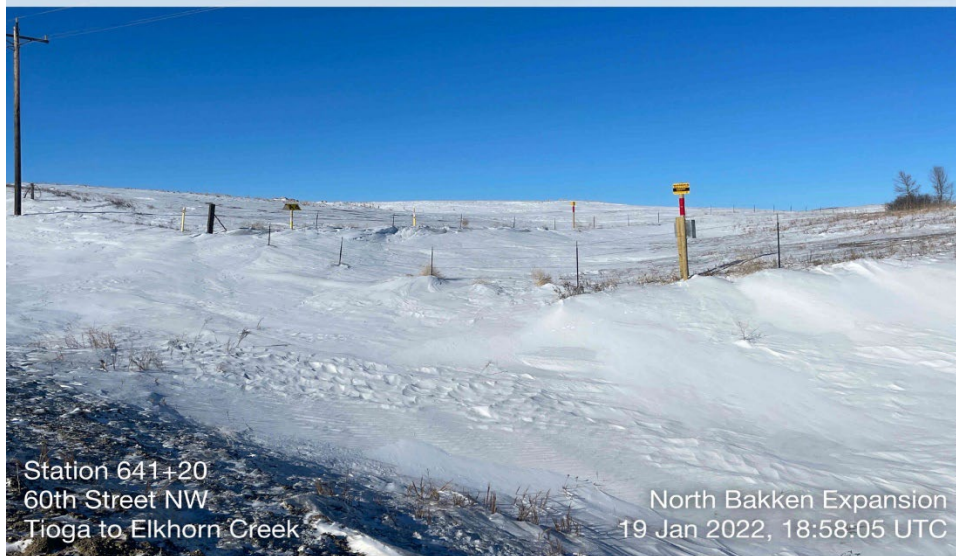
Location:
Sta. No. 641+20

Notes: Restored right-of-way remains frozen and stabilized.

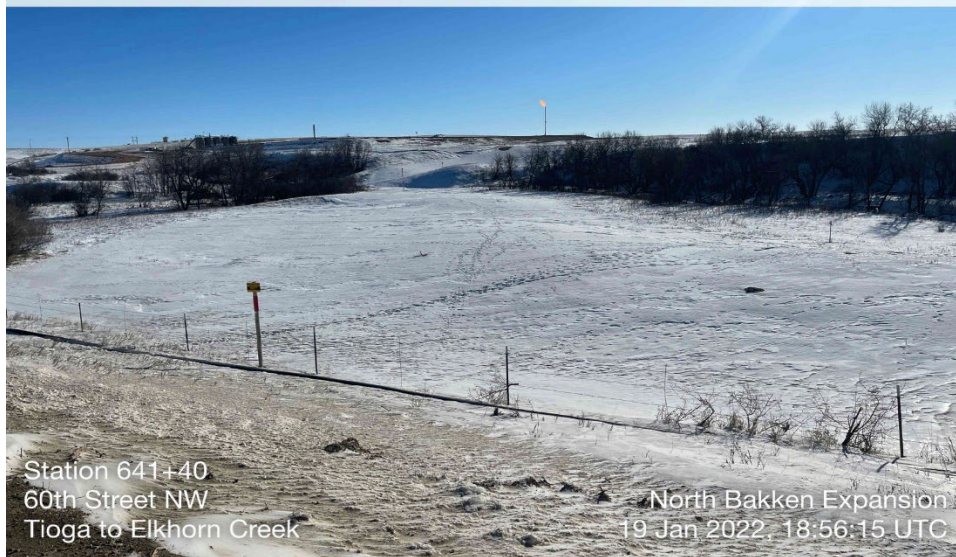
Location:
Sta. No. 641+40

Notes: Restored right-of-way remains frozen and stabilized.
