Re: WBI Energy Transmission, Inc.  
Docket Nos. CP20-52-000 and CP20-52-001  
North Bakken Expansion Project  
Status Report No. 35

**WBI Energy Transmission, Inc.**  
**North Bakken Expansion Project Status Report No. 35**  
**FERC Docket Nos. CP20-52-000**  
**CP20-52-001**

**Reporting Period:** January 24, 2022 through February 28, 2022

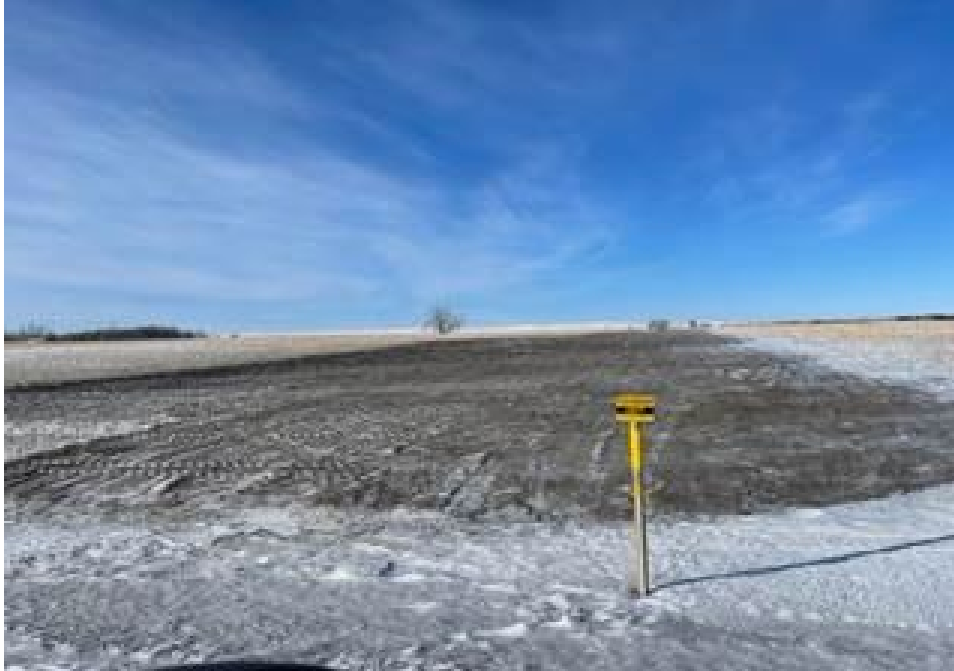
Location:  
Sta. No. 220+95

Notes: Restored right-of-way remains frozen and stabilized on the Line Section 30 Loop Pipeline.

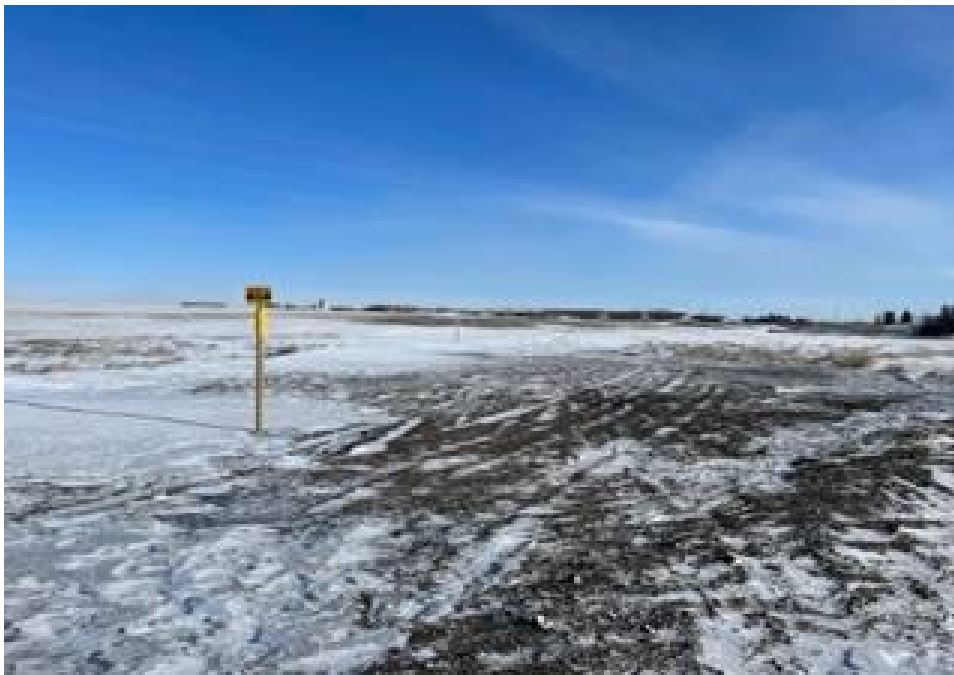
Location:  
Sta. No. 300+10

Notes: Restored right-of-way remains frozen and stabilized on the Line Section 30 Loop Pipeline.

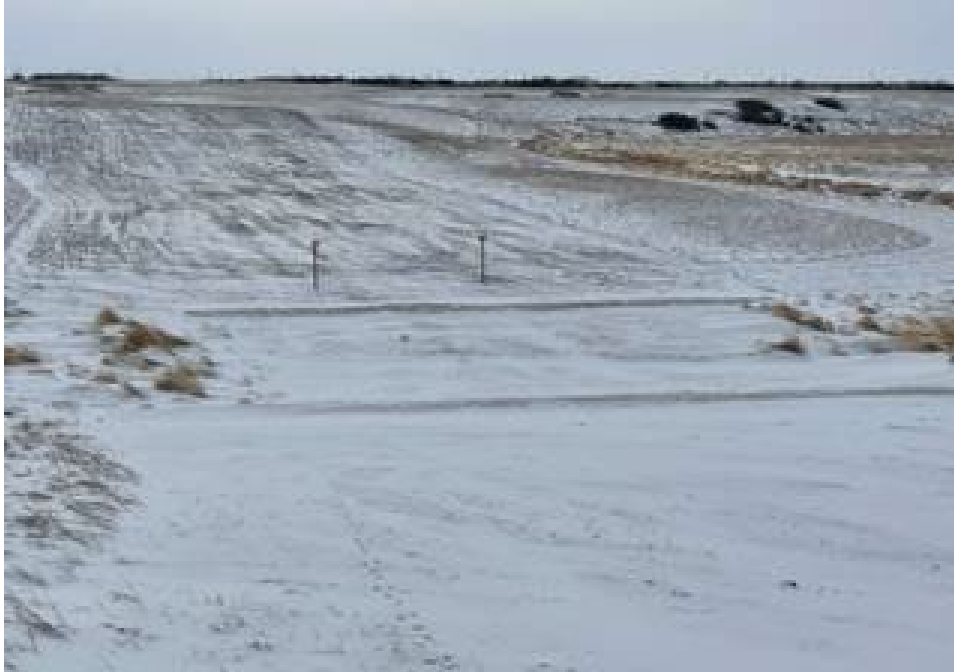
Location: Sta. Nos.  
383+50 to 385+50

Notes: Restored right-of-way remains frozen and stabilized with slope breakers in place and functioning on the Line Section 30 Loop Pipeline.

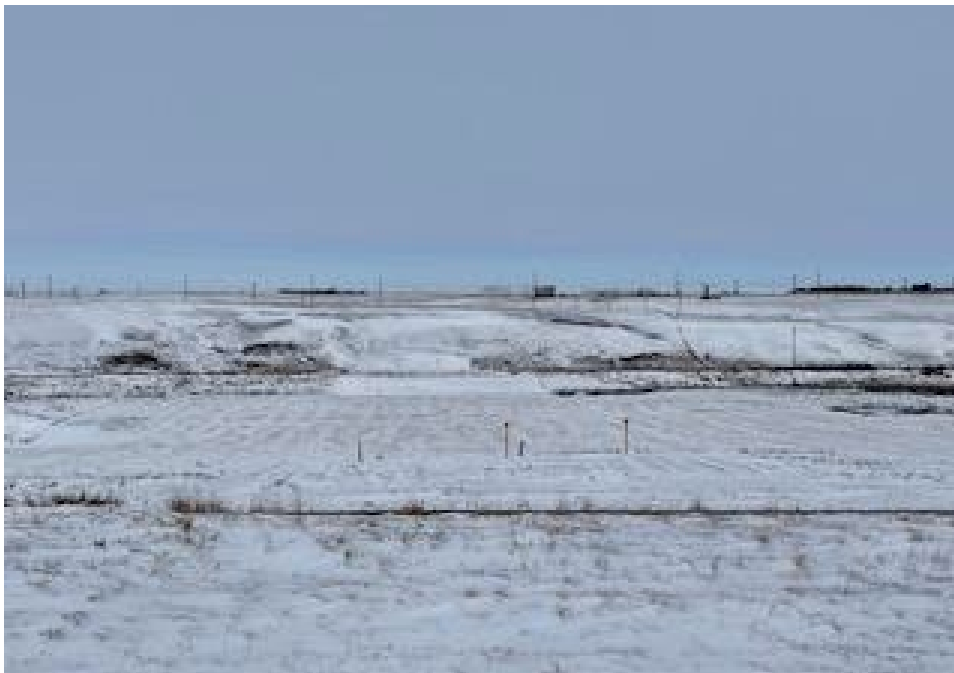
Location: Sta. Nos.  
464+25 to 464+61

Notes: Restored right-of-way and wetland 2-wm-ea-006 remain frozen and stabilized on the Line Section 30 Loop Pipeline.

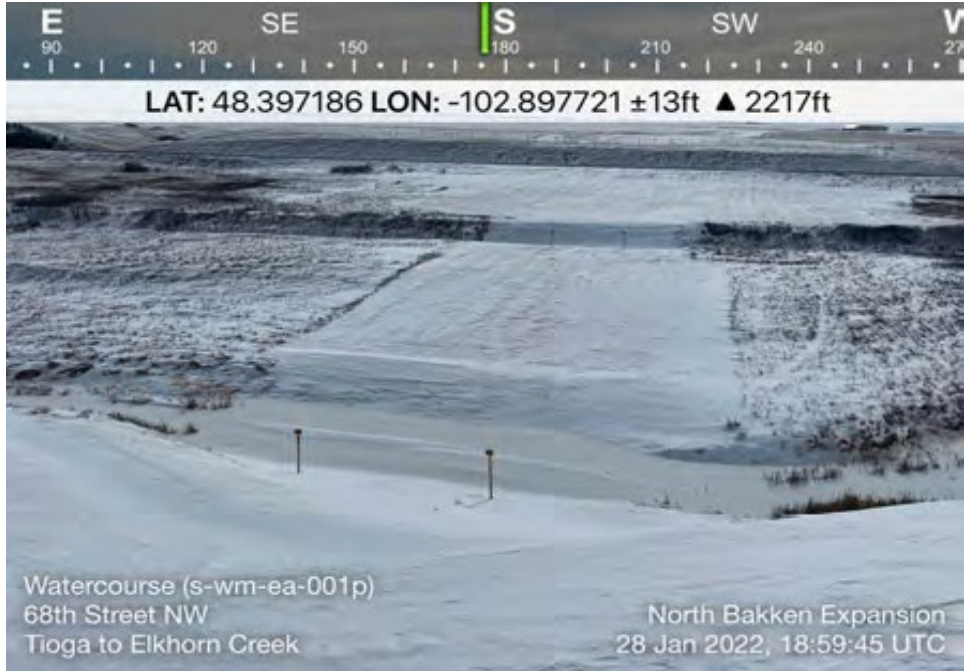
Location:  
Sta. No. 35+52

Notes: Restored right-of-way remains frozen and stabilized on the Tioga-Elkhorn Creek Pipeline.

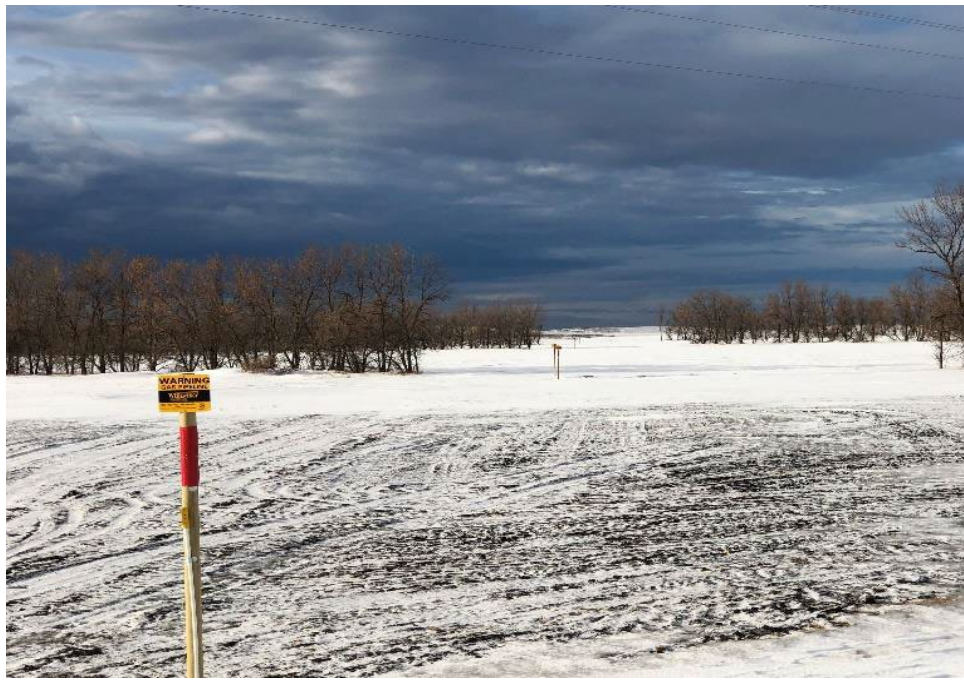
Location:  
Sta. No. 487+09

Notes: Restored right-of-way remains frozen and stabilized on the Tioga-Elkhorn Creek Pipeline.

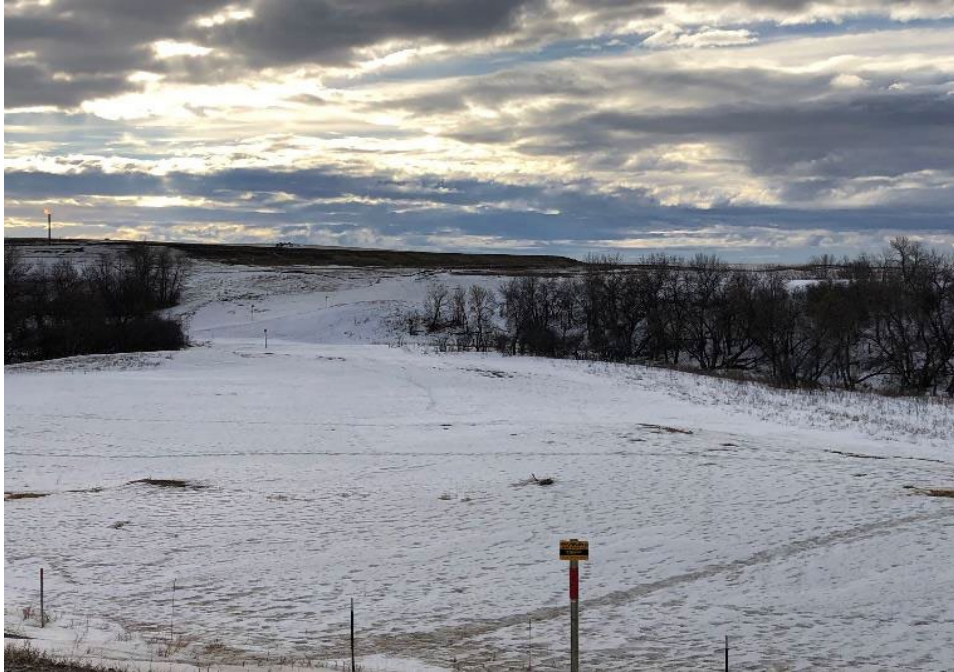
Location:  
Sta. No. 646+89

Notes: Restored right-of-way remains frozen and stabilized on the Tioga-Elkhorn Creek Pipeline.

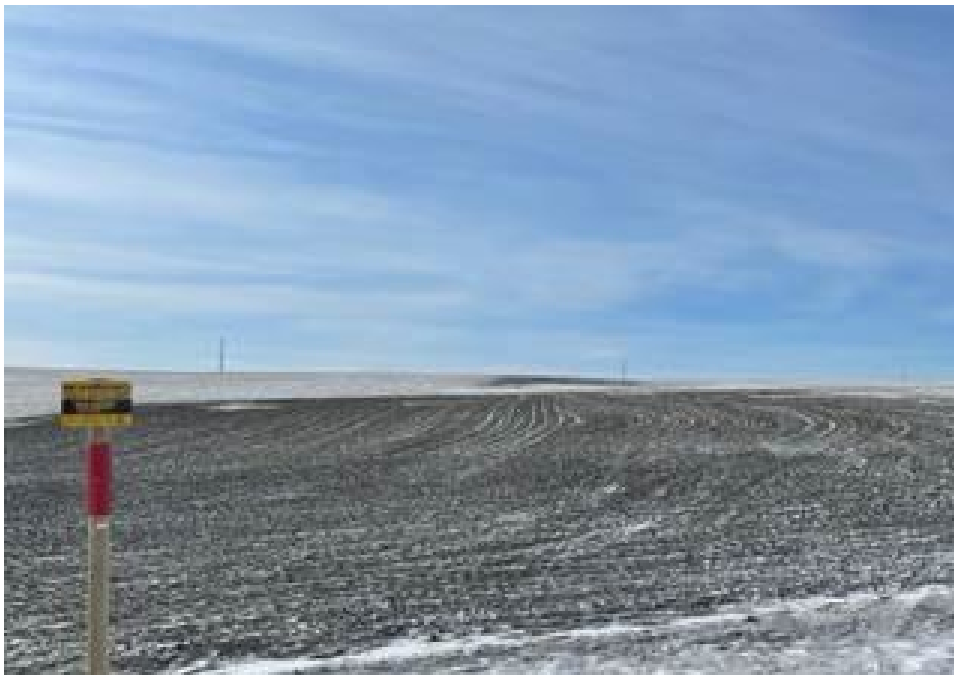
Location:  
Sta. No. 378+64

Notes: Restored right-of-way remains frozen and stabilized on the Tioga-Elkhorn Creek Pipeline.

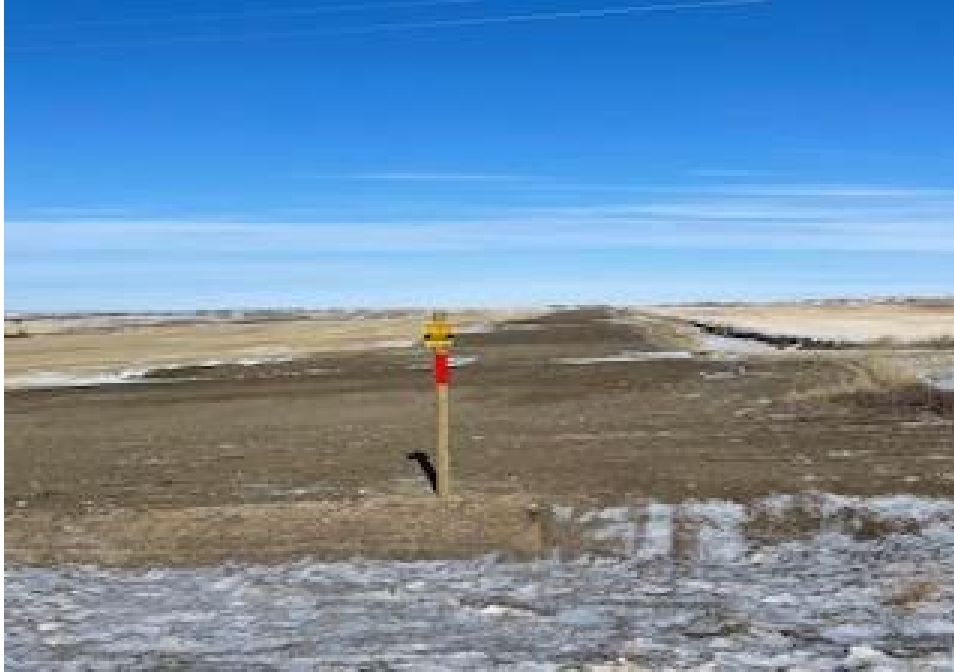
Location:  
Sta. No. 855+01

Notes: Restored right-of-way and bar ditch remains frozen and stabilized on the Tioga-Elkhorn Creek Pipeline.

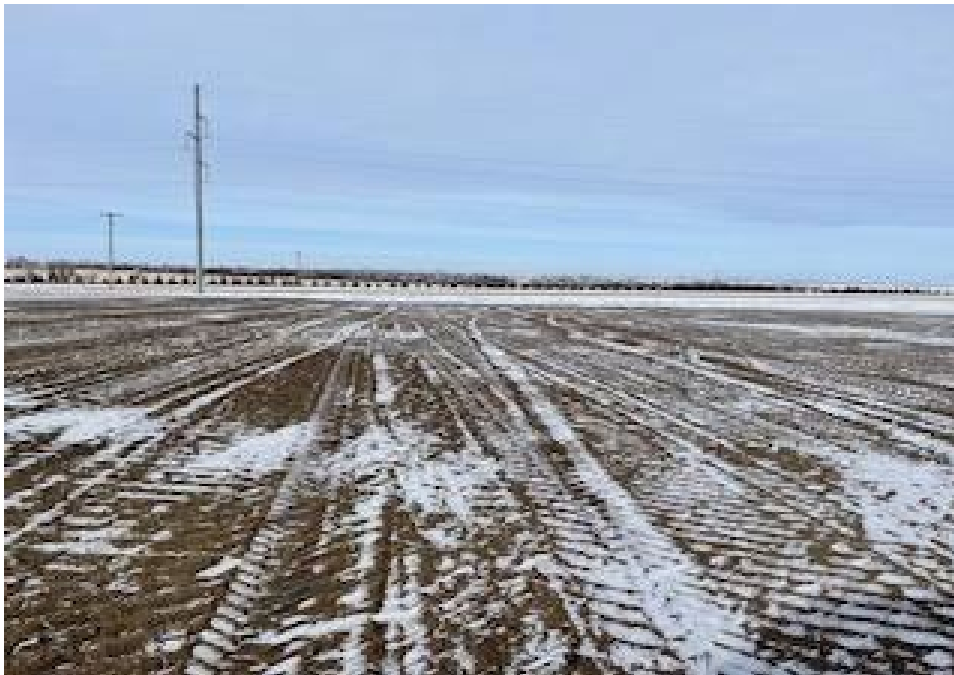
Location:  
Sta. No. 286+21

Notes: Restored right-of-way remains frozen and stabilized on the Tioga-Elkhorn Creek Pipeline.

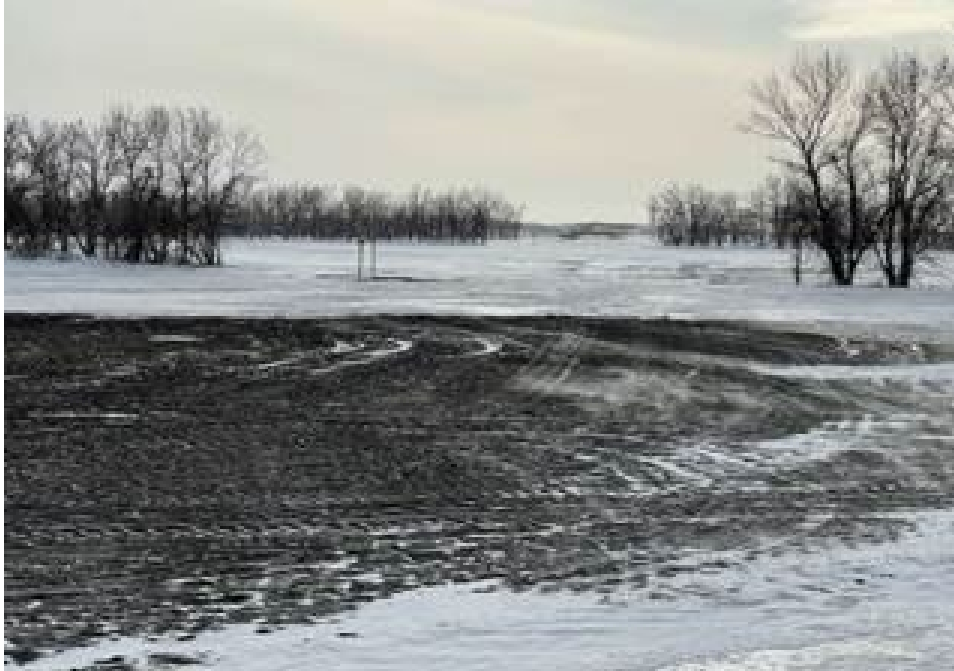
Location:  
Sta. No. 487+09

Notes: Restored right-of-way remains frozen and stabilized on the Tioga-Elkhorn Creek Pipeline.

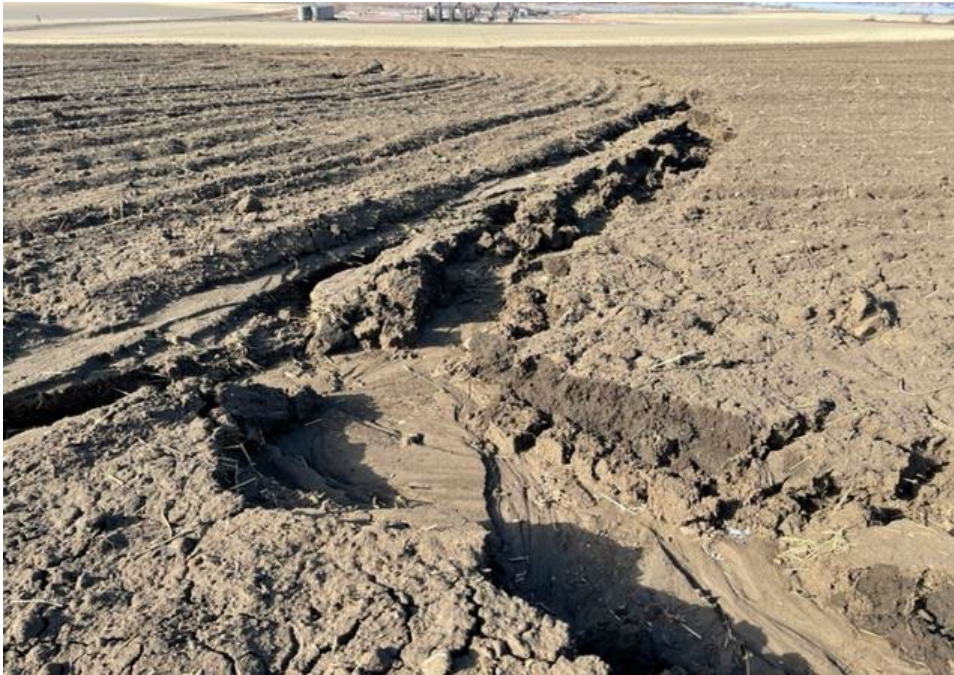
Location:  
Sta. No. 1379+00

Notes: Minor  
rill/small channel  
erosion on the Tioga-  
Elkhorn Creek  
Pipeline right-of-way.  
This area will be  
addressed when  
conditions allow.

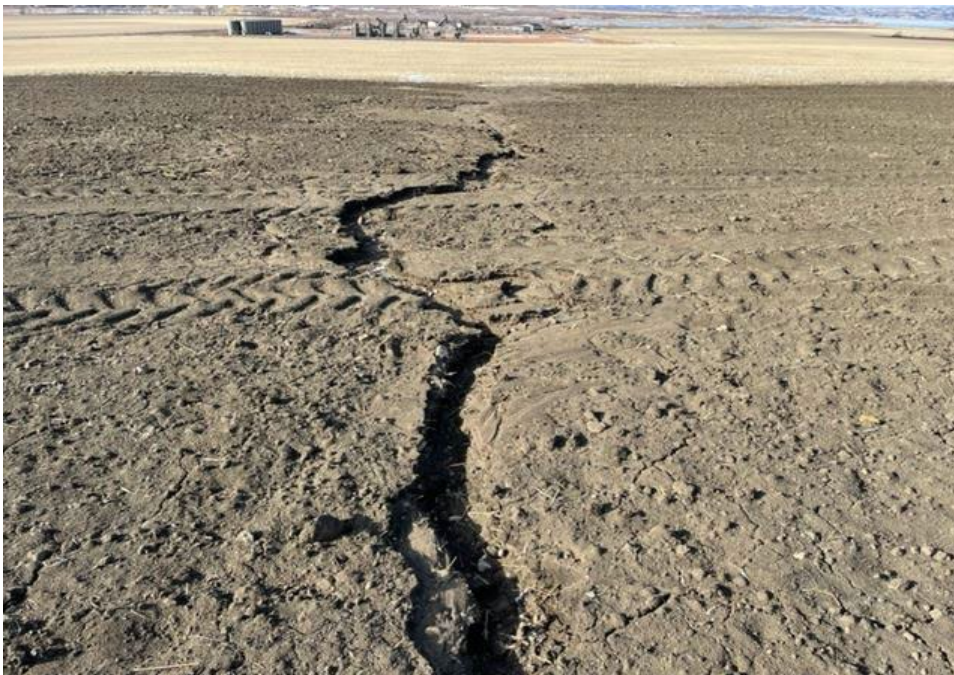
Location:  
Sta. No. 1386+00

Notes: Minor  
rill/small channel  
erosion on the Tioga-  
Elkhorn Creek  
Pipeline right-of-way.  
This area will be  
addressed when  
conditions allow.

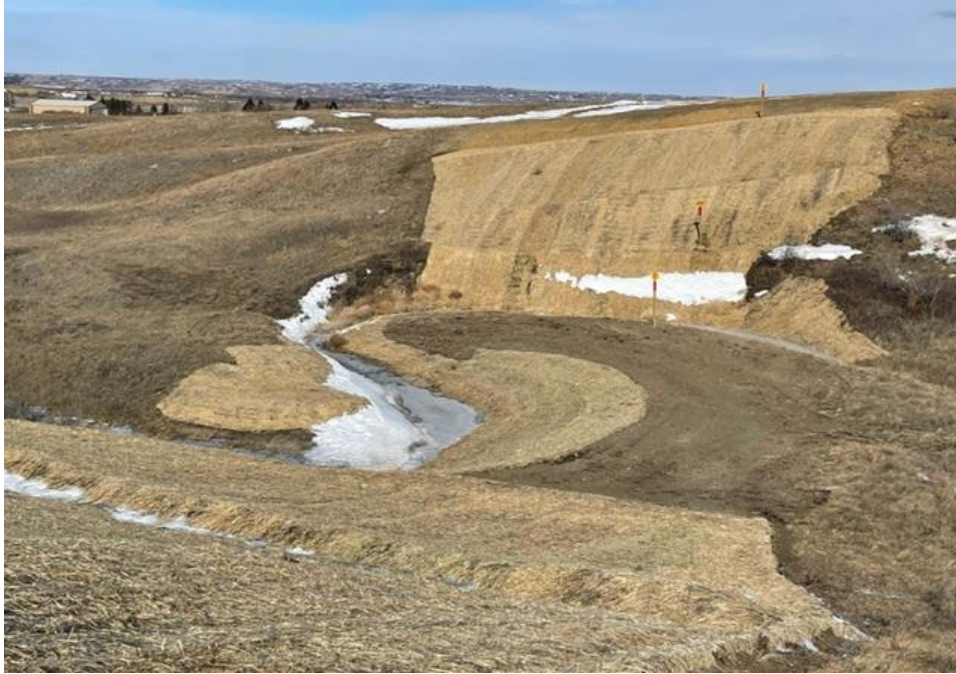
Location: Sta. Nos.  
1544+25 to 1544+85

Notes: Erosion control blankets and slope breakers remain in place and functioning on the Tioga-Elkhorn Creek Pipeline.

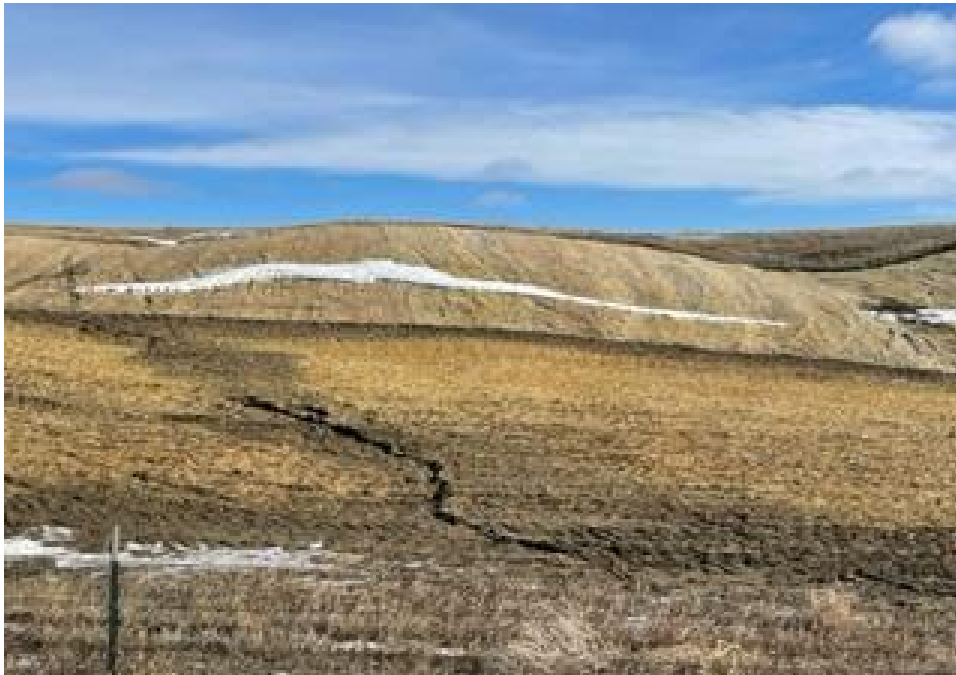
Location:  
Sta. No. 1571+00

Notes: Minor rill/small channel erosion on the Tioga-Elkhorn Creek Pipeline right-of-way. This area will be addressed when conditions allow.

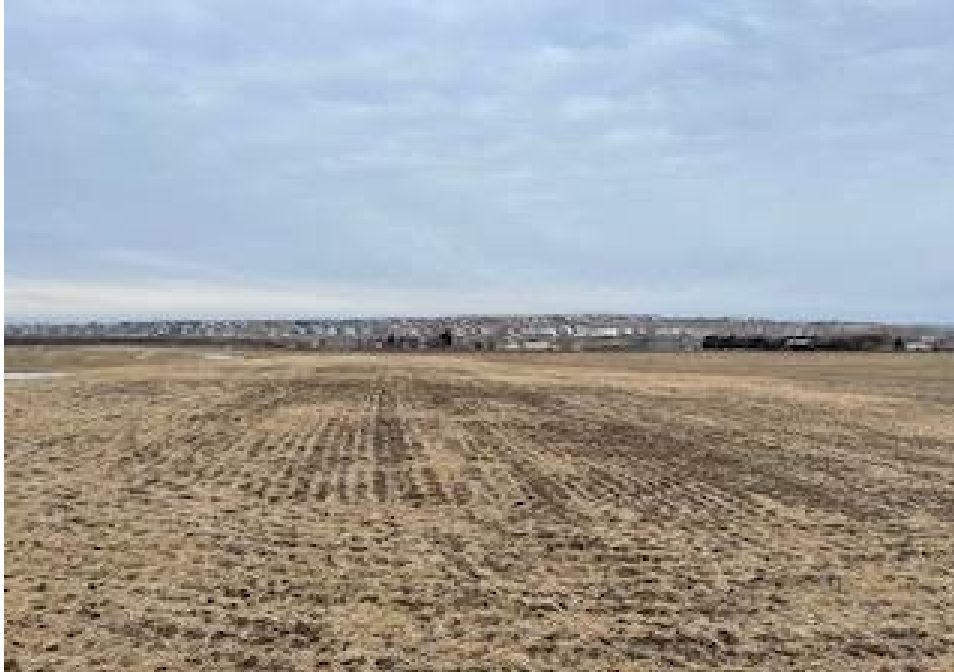
Location:  
Sta. No. 1458+00

Notes: Restored right-of-way remains properly mulched and crimped on the Tioga-Elkhorn Creek Pipeline.

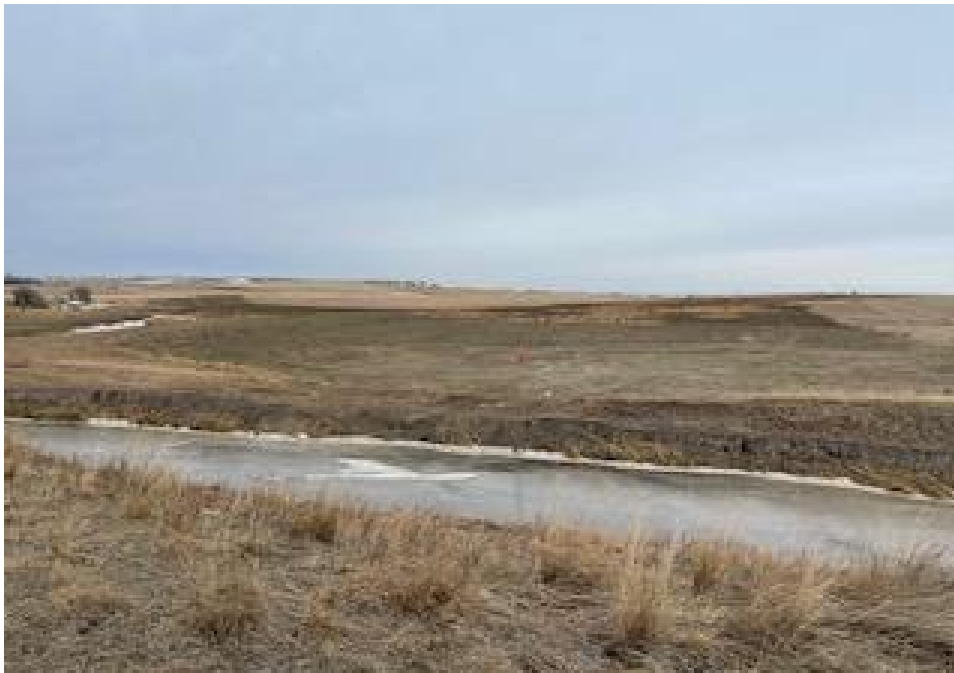
Location:  
Sta. No. 1914+65

Notes: Restored right-of-way remains frozen and stabilized on the Tioga-Elkhorn Creek Pipeline.

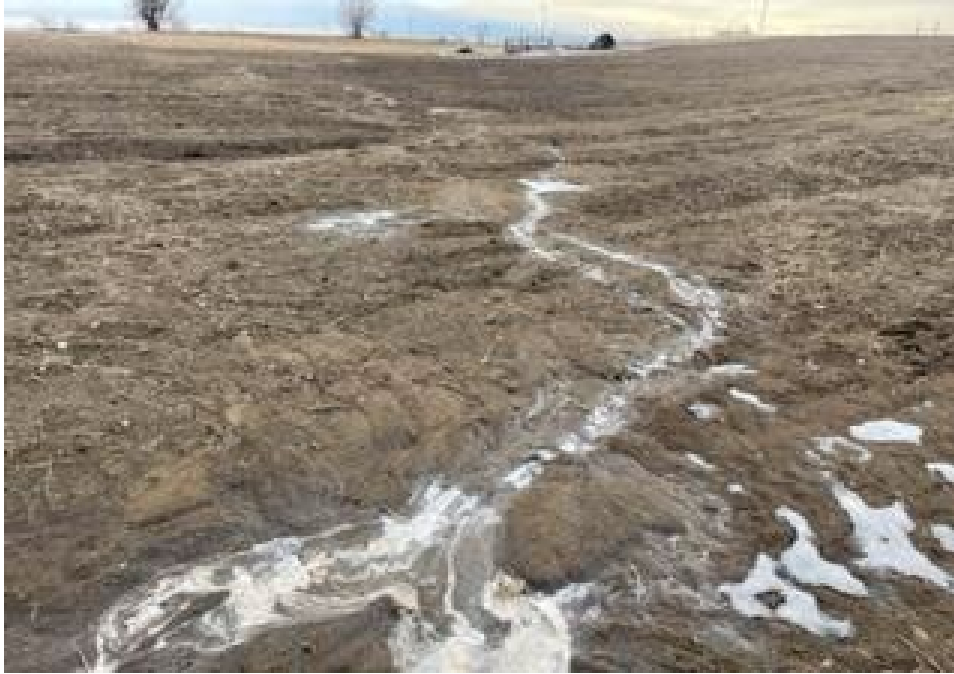
Location:  
Sta. No. 1935+00

Notes: Minor rill/small channel erosion on the Tioga-Elkhorn Creek Pipeline right-of-way. This area will be addressed when conditions allow.

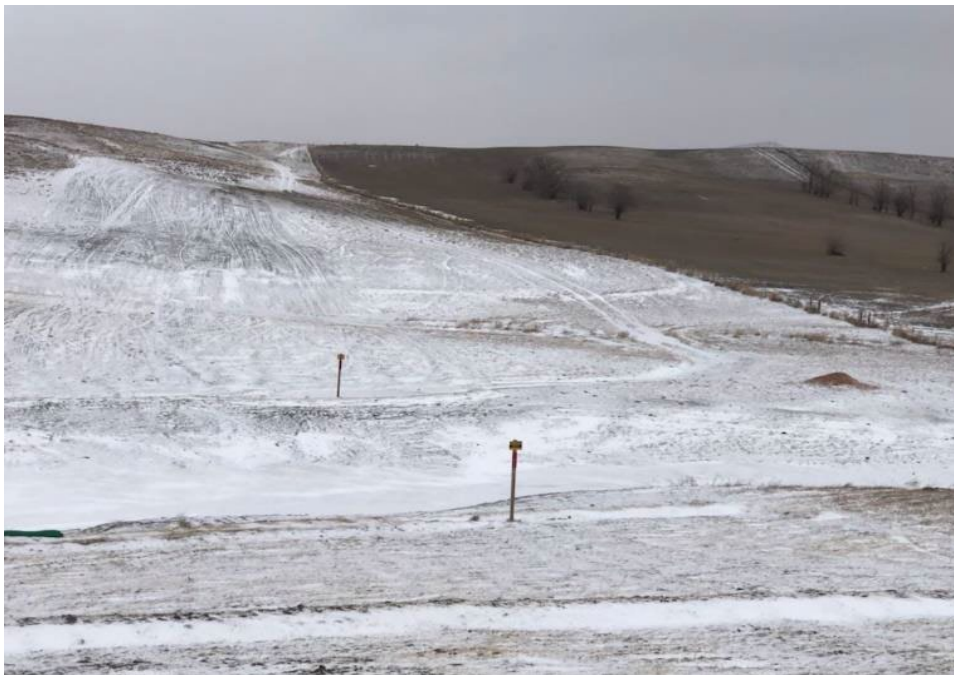
Location:  
Sta. No. 2884+00

Notes: Restored right-of-way remains frozen and stabilized, with the slope breakers in place and functioning on the Tioga-Elkhorn Creek Pipeline.

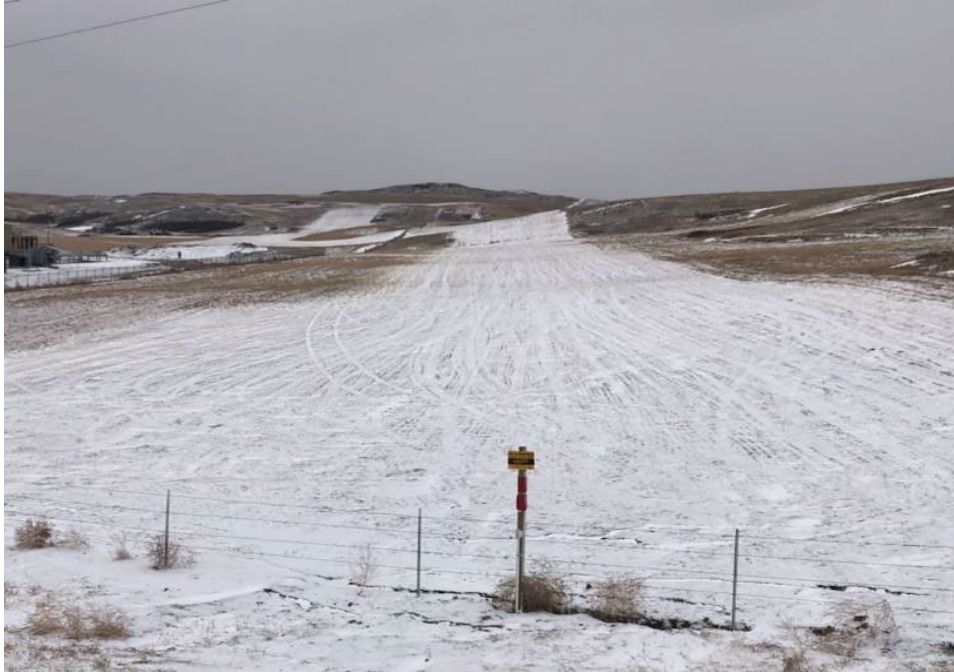
Location:  
Sta. No. 2890+90

Notes: Restored right-of-way remains frozen and stabilized on the Tioga-Elkhorn Creek Pipeline.

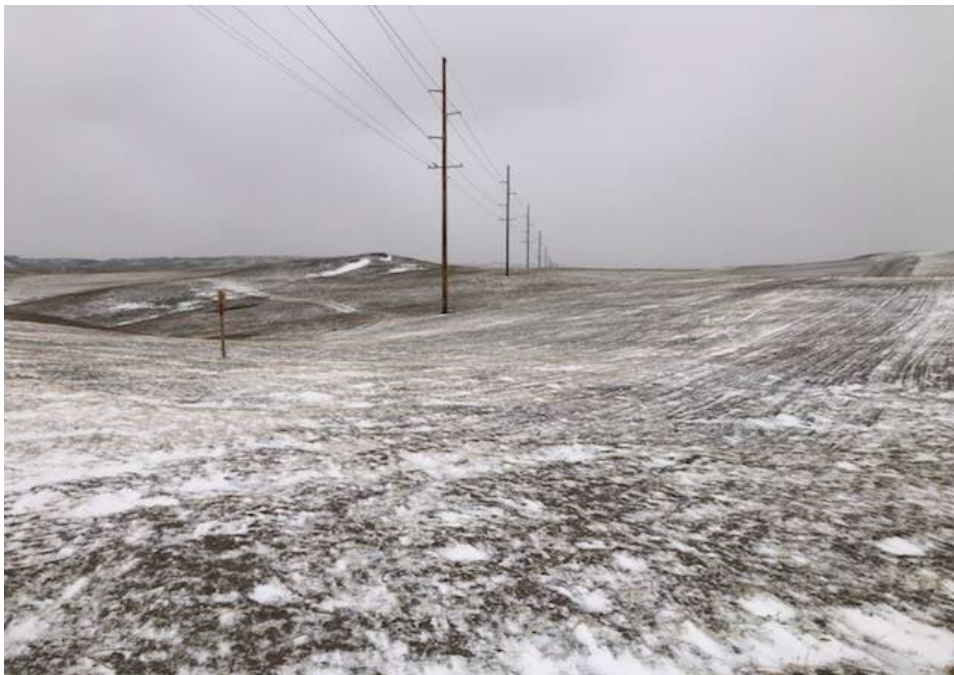
Location:  
Sta. No. 2993+90

Notes: Restored right-of-way remains frozen and stabilized on the Tioga-Elkhorn Creek Pipeline.

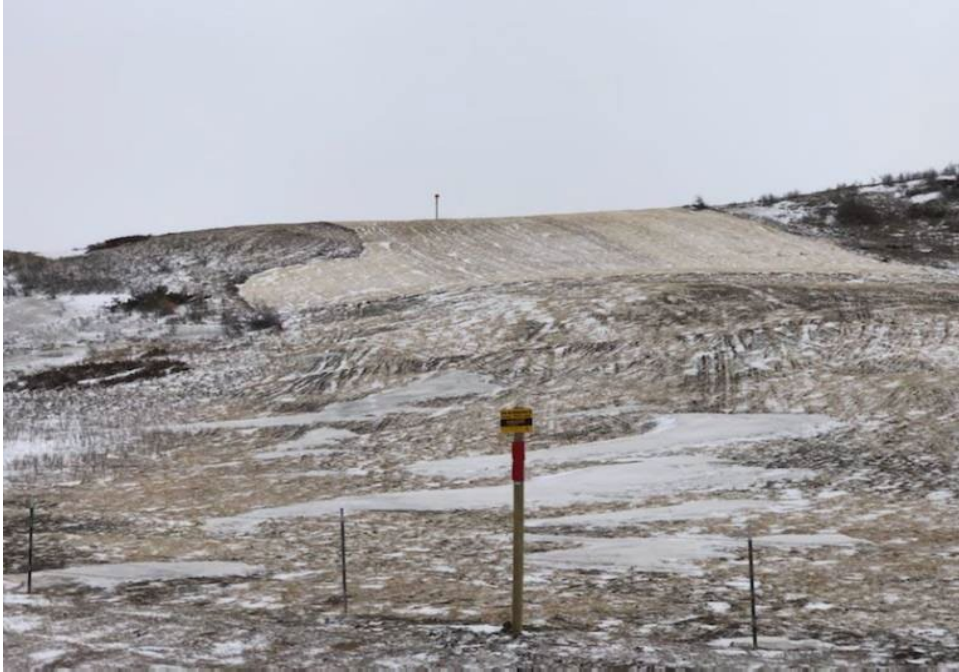
Location:  
Sta. No. 3066+80

Notes: Restored right-of-way remains frozen and stabilized with erosion control blankets in place and functioning on the Tioga-Elkhorn Creek Pipeline.

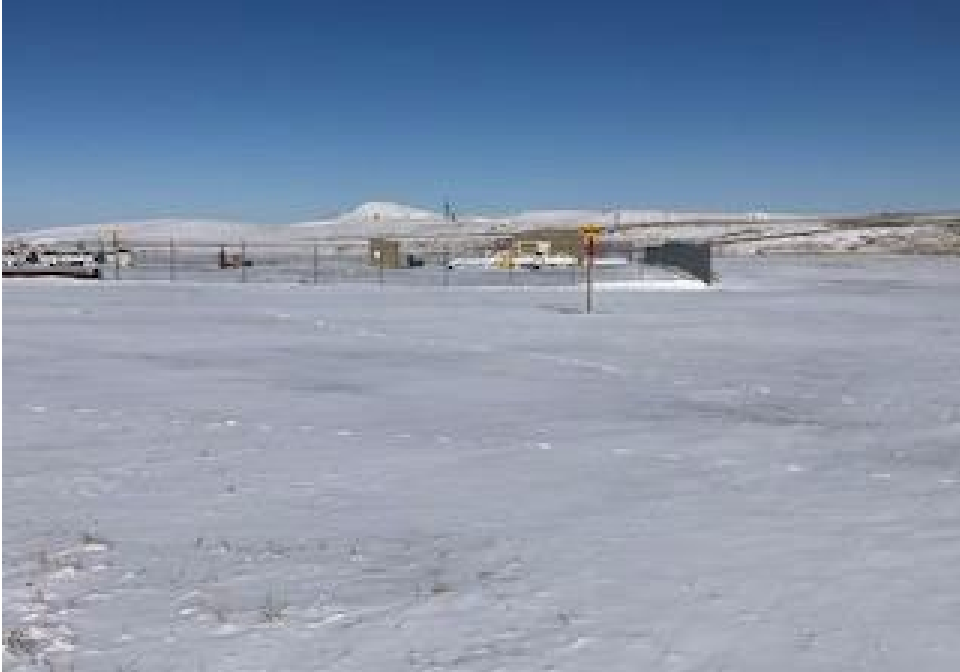
Location:  
Sta. No. 2693+69

Notes: Restored right-of-way and Cherry Creek block valve site remain frozen and stabilized on the Tioga-Elkhorn Creek Pipeline.

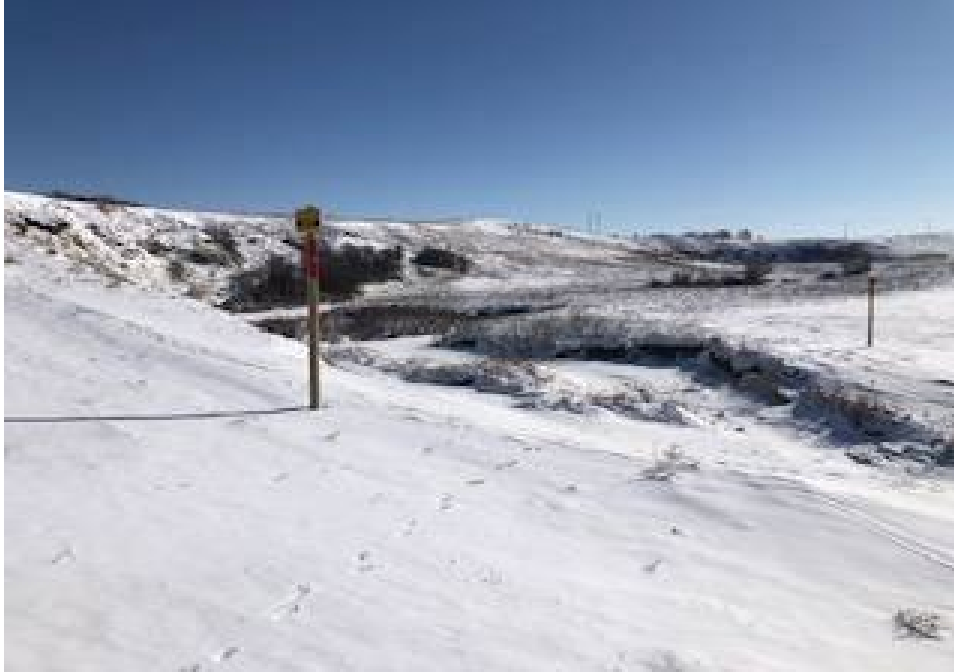
Location:  
Sta. No. 2693+69

Notes: Watercourse s-mk-eb-005 (Cherry Creek) remains frozen and stabilized on the Tioga-Elkhorn Creek Pipeline.

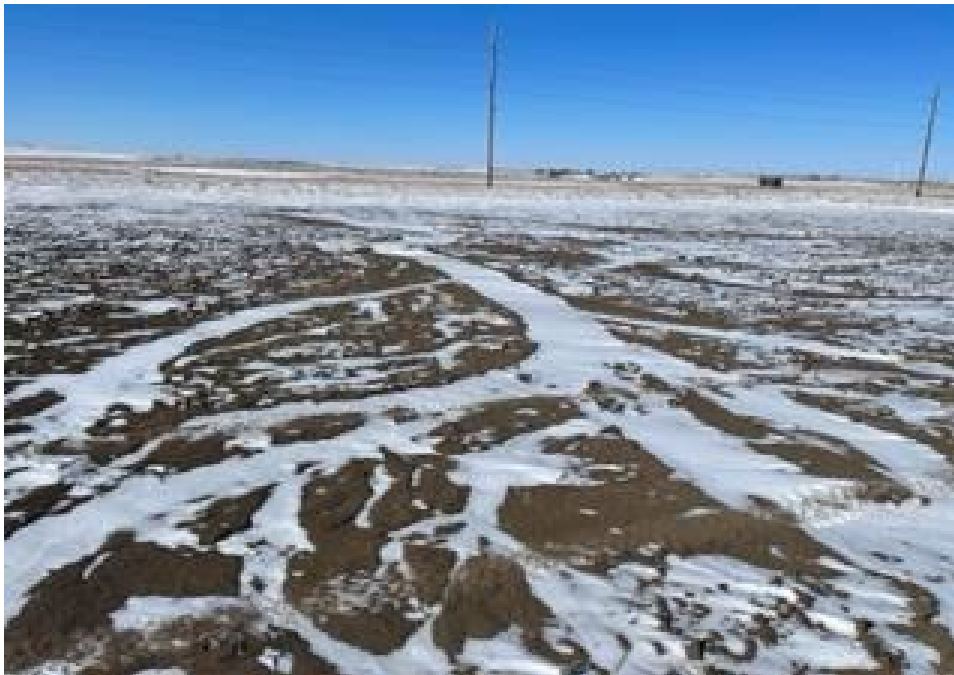
Location:  
Sta. No. 2549+00

Notes: Minor rill/small channel erosion on the Tioga-Elkhorn Creek Pipeline right-of-way. This area will be addressed when conditions allow.

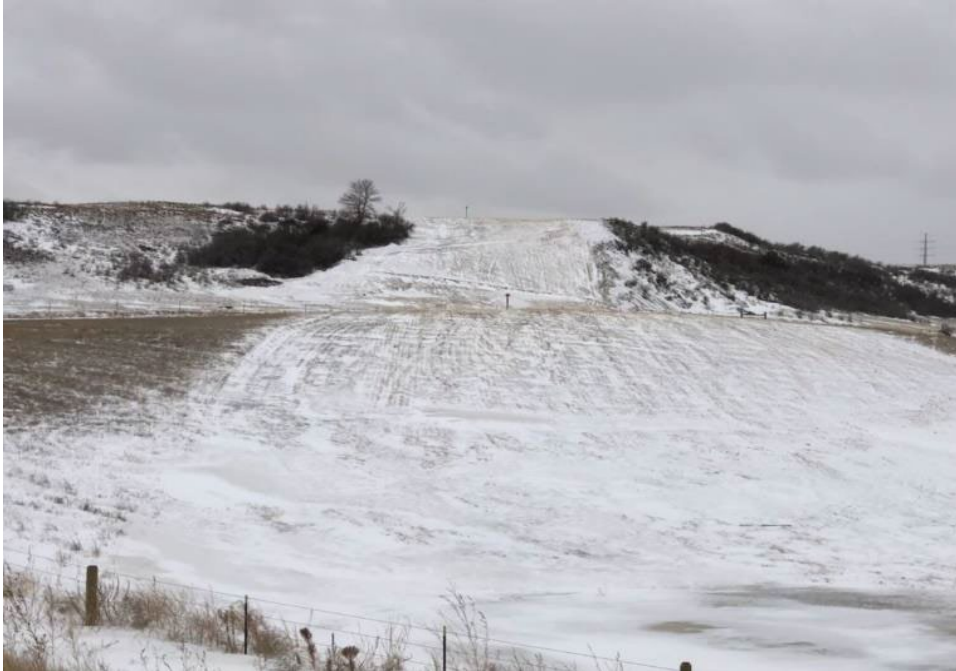
Location:  
Sta. No. 3130+00

Notes: Restored right-of-way remains frozen and stabilized with erosion control blankets in place and functioning on the Tioga-Elkhorn Creek Pipeline.

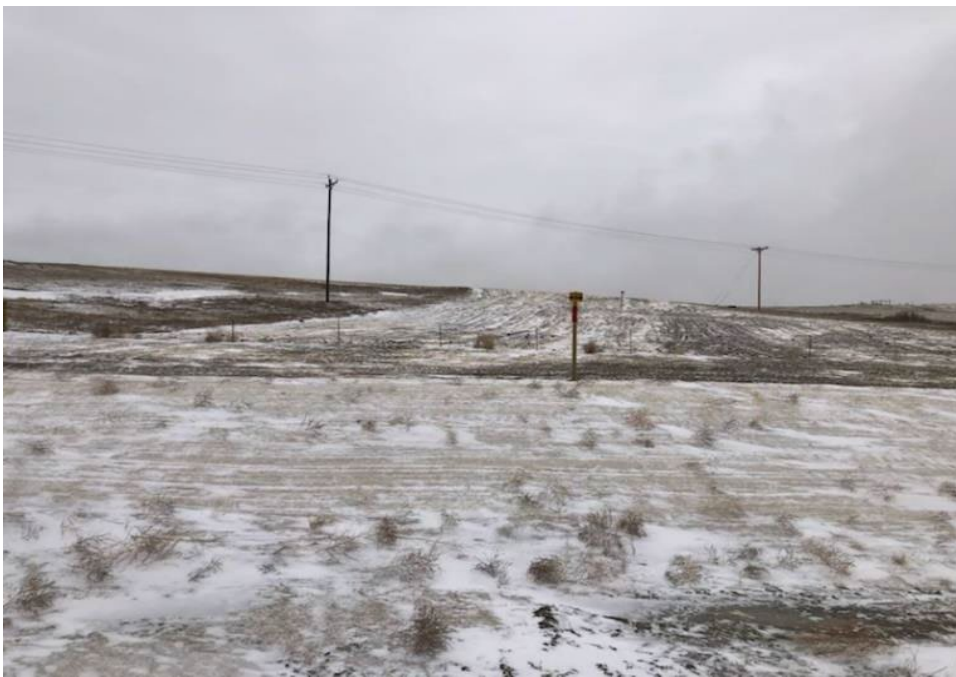
Location:  
Sta. No. 3144+73

Notes: Restored right-of-way remains frozen and stabilized with erosion control blankets in place and functioning on the Tioga-Elkhorn Creek Pipeline.

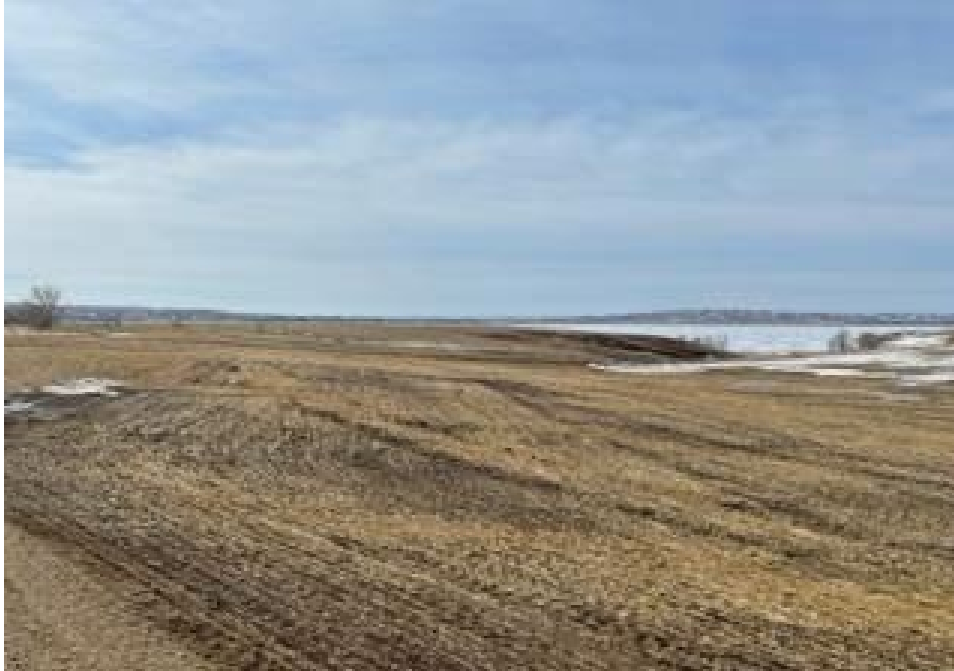
Location: North HDD  
Drill Site

Notes: Restored right-of-way remains frozen and stabilized at former North HDD drill site.

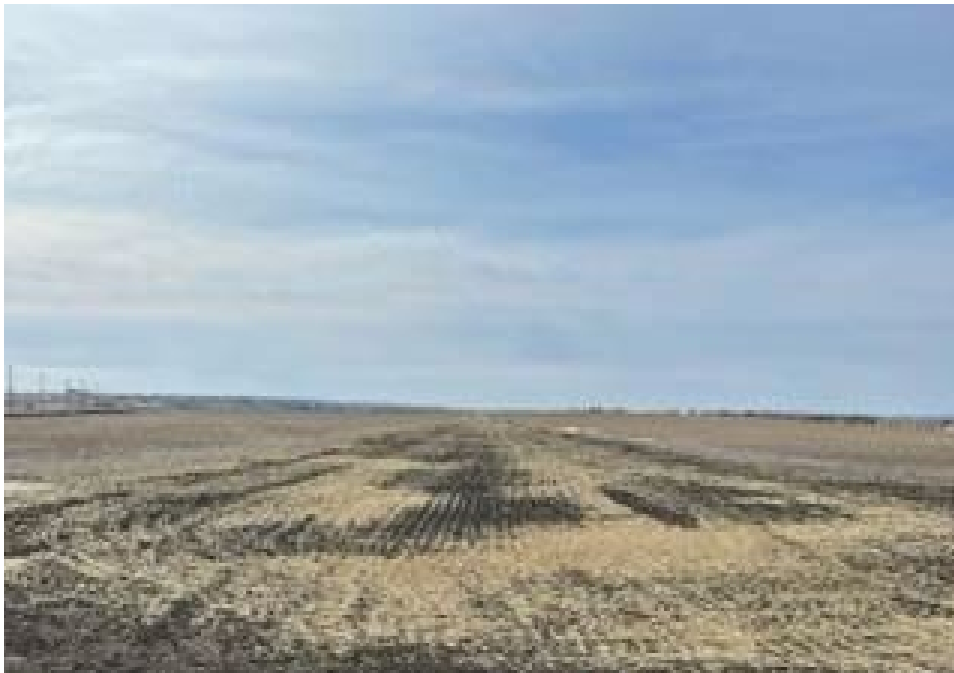
Location: North HDD  
Drill Site

Notes: Restored drill string workspace remains frozen and stabilized.

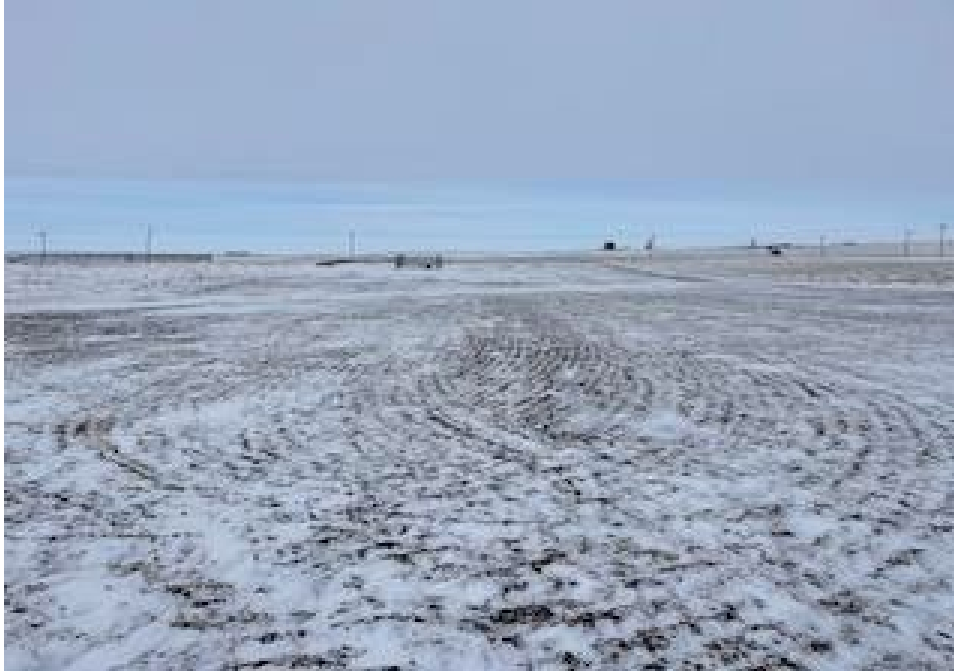
Location:  
Sta. No. 713+00

Notes: Restored right-of-way remains frozen and stabilized on the Line Section 25 Loop Pipeline.

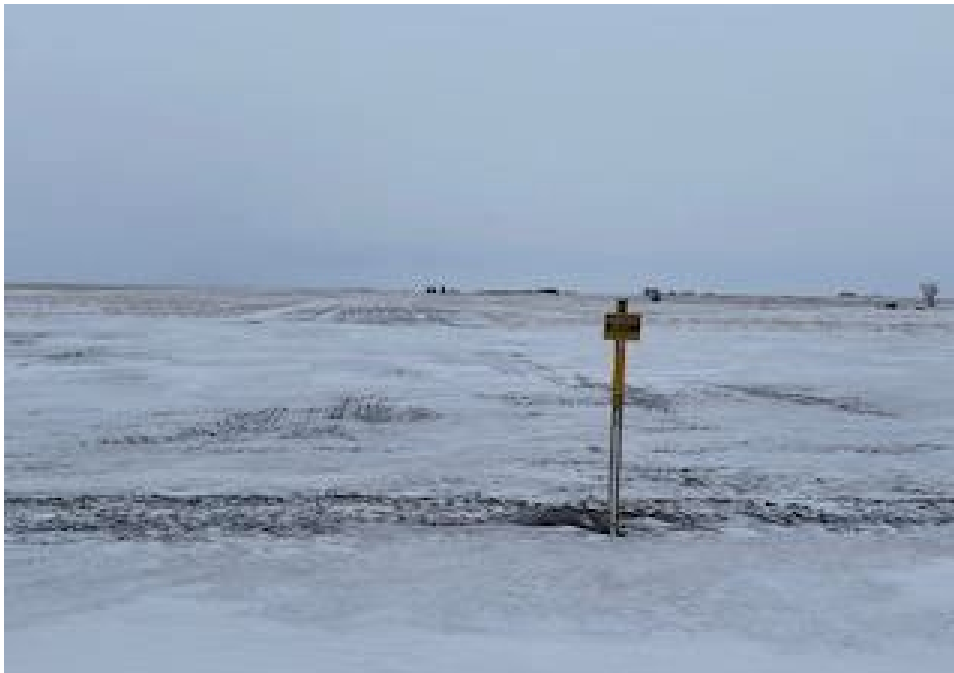
Location:  
Sta. No. 1017+30

Notes: Restored right-of-way remains frozen and stabilized on the Line Section 25 Loop Pipeline.

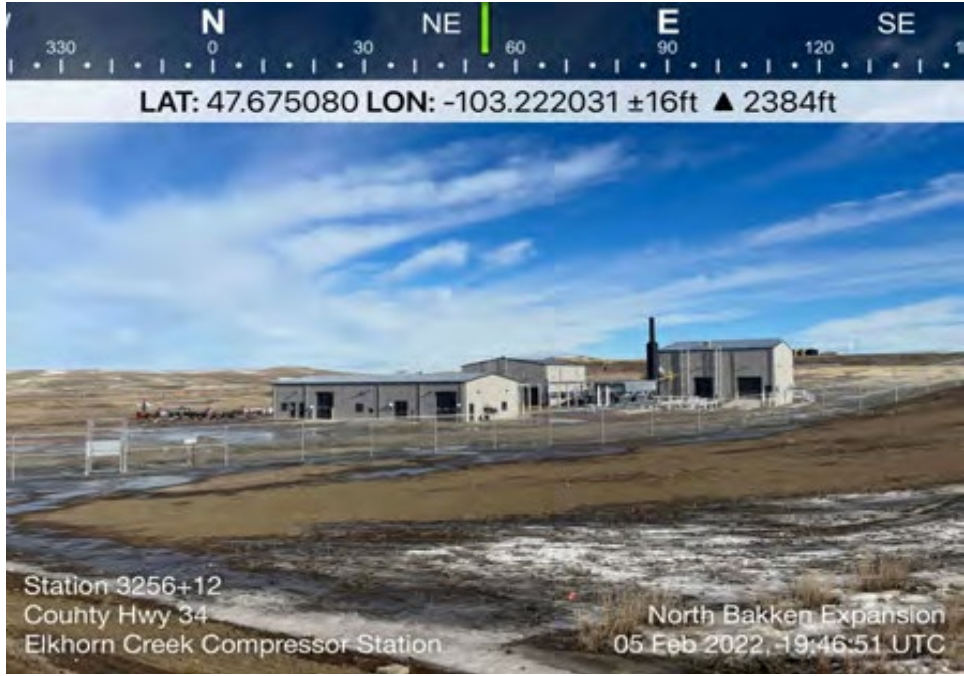
Location: Elkhorn  
Creek Compressor  
Station

Notes: No erosion  
issues or concerns  
were noted.

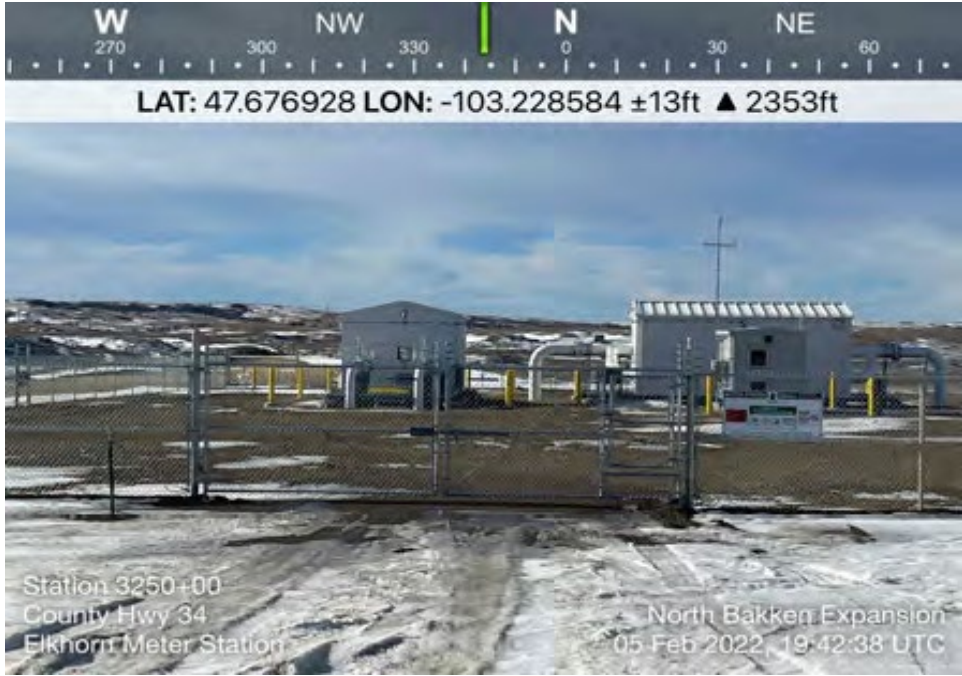
Location: Northern Border Interconnect

Notes: No erosion issues or concerns were noted.
