Re: WBI Energy Transmission, Inc.
Docket Nos. CP20-52-000 and CP20-52-001
North Bakken Expansion Project
Status Report No. 36

WBI Energy Transmission, Inc.
North Bakken Expansion Project Status Report No. 36
FERC Docket Nos. CP20-52-000
CP20-52-001

Reporting Period: March 1, 2022 through March 31, 2022

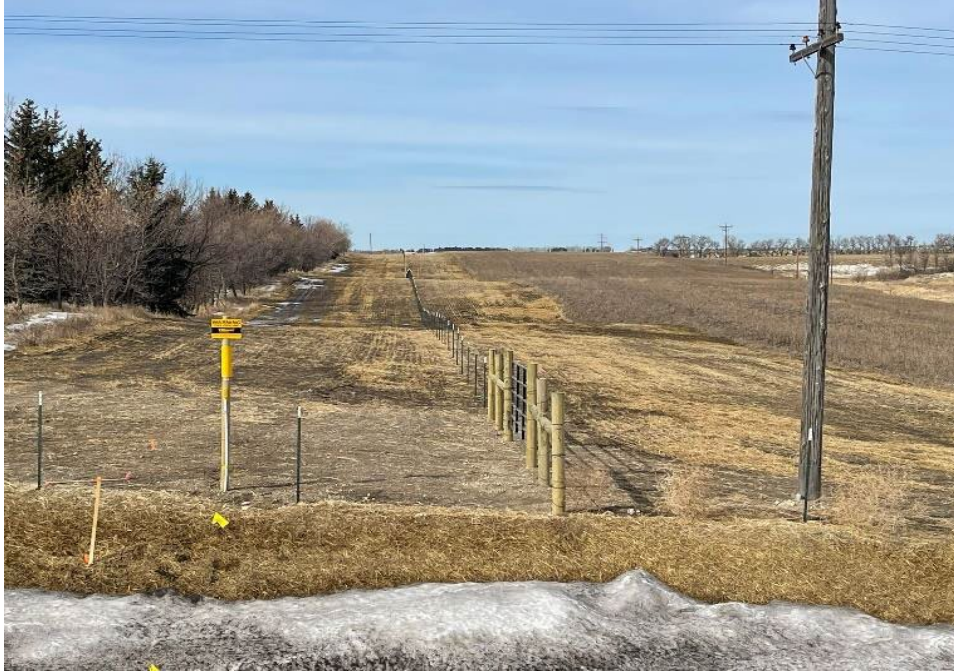
Location:
Sta. No. 333+23

Notes: Restored right-of-way and bar ditch remains frozen and stabilized on the Line Section 30 Loop Pipeline.

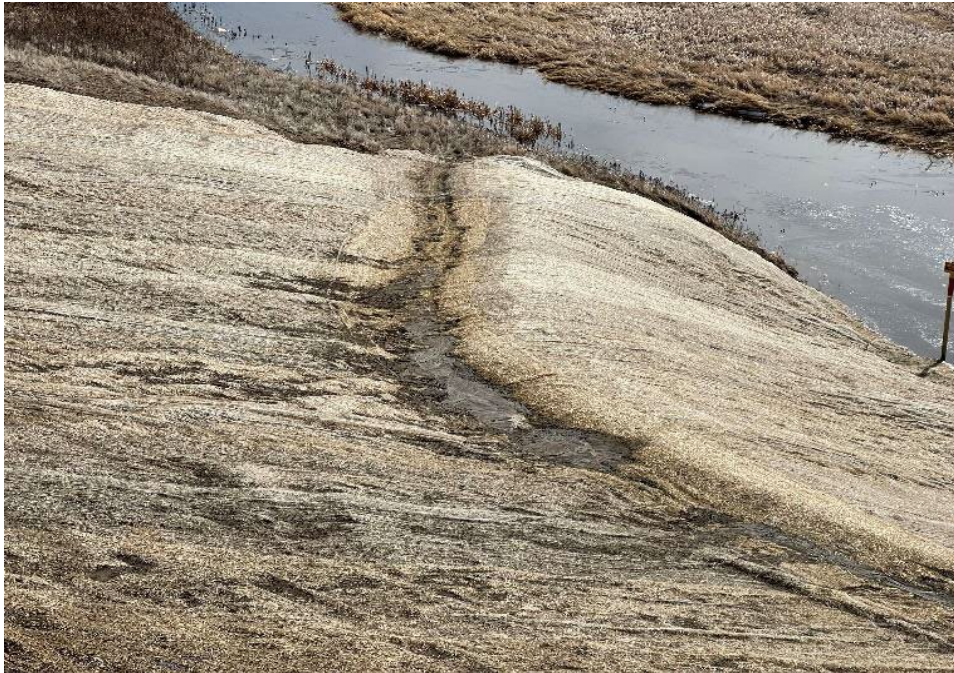
Location:
Sta. No. 468+72

Notes: Sediment eroding under an erosion control blanket due to snowmelt runoff at watercourse s-wm-ea-001p on the Line Section 30 Loop Pipeline. This area will be addressed when conditions allow.

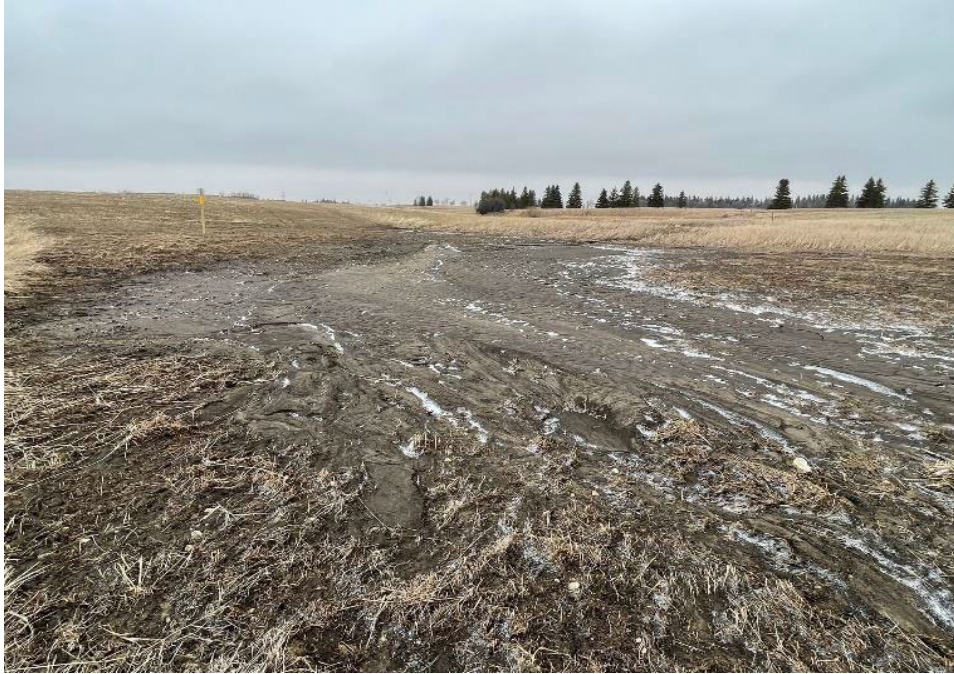
Location:
Sta. No. 300+62

Notes: Sediment discharged into wetland w-wm-ec-003e on the Line Section 30 Loop Pipeline. This area will be addressed when conditions allow.

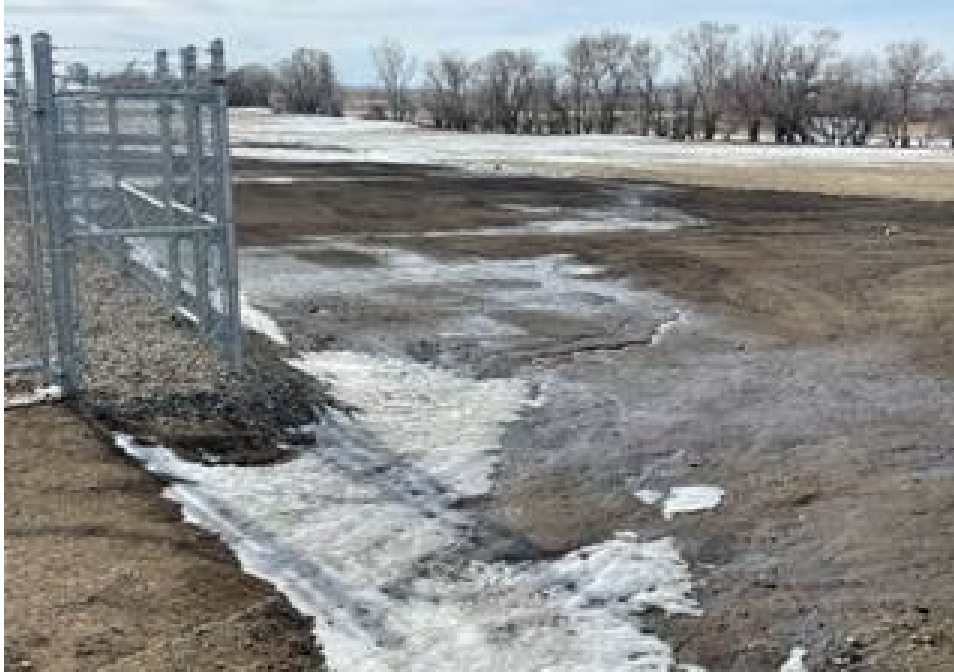
Location:
Sta. No. 855+94

Notes: Minor rill/small channel erosion on the Tioga-Elkhorn Creek Pipeline right-of-way and at the 56th Street NW block valve. This area will be addressed when conditions allow.

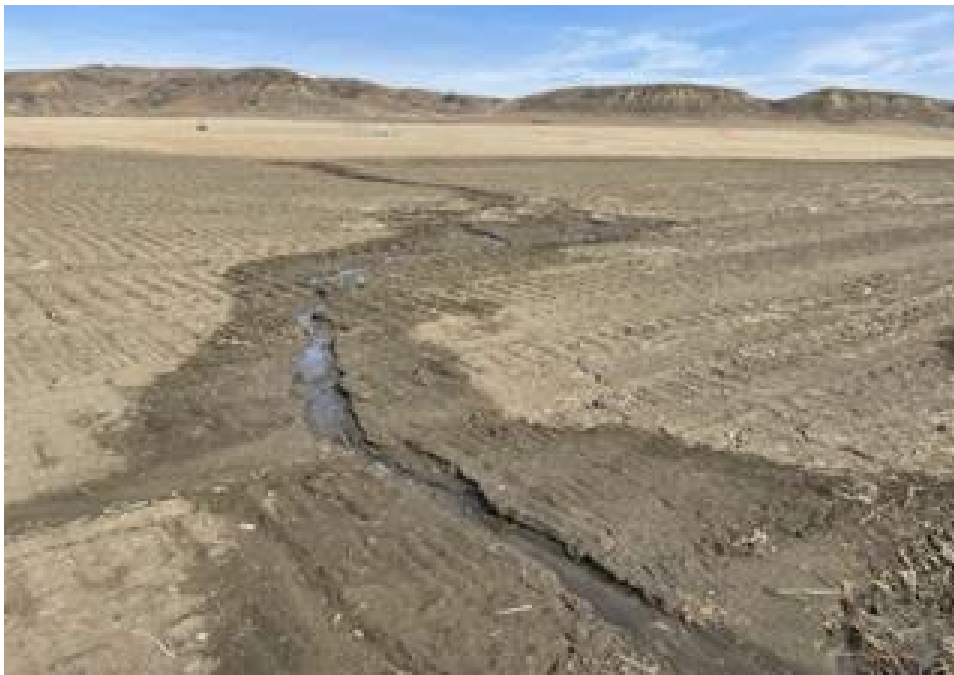
Location:
Sta. No. 1027+00

Notes: Minor rill/small channel erosion on the Tioga-Elkhorn Creek Pipeline right-of-way. This area will be addressed when conditions allow.

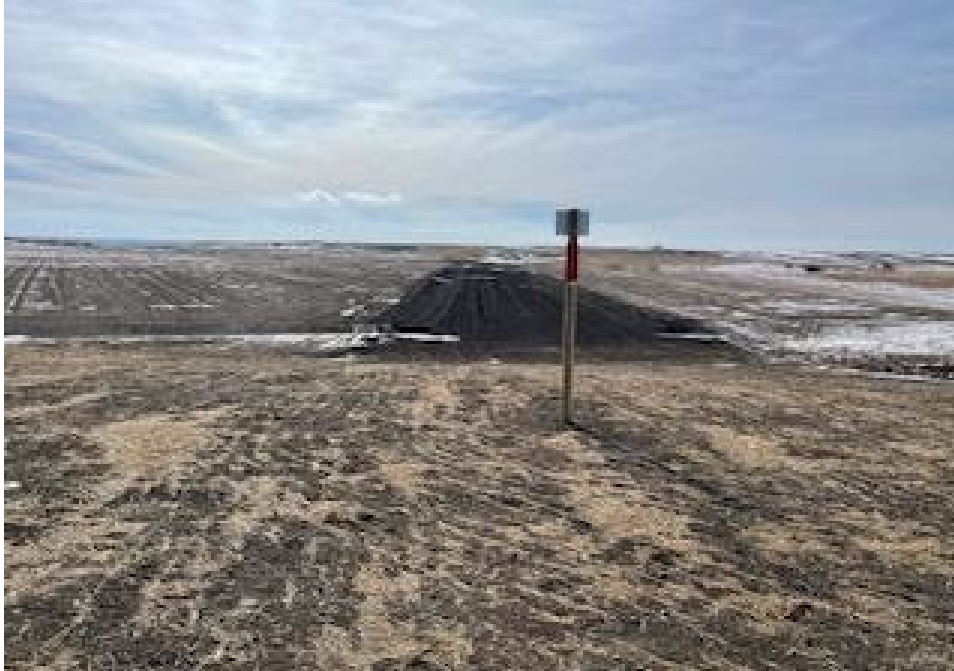
Location:
Sta. No. 755+94

Notes: Restored right-of-way remains frozen and stabilized on the Tioga-Elkhorn Creek Pipeline.

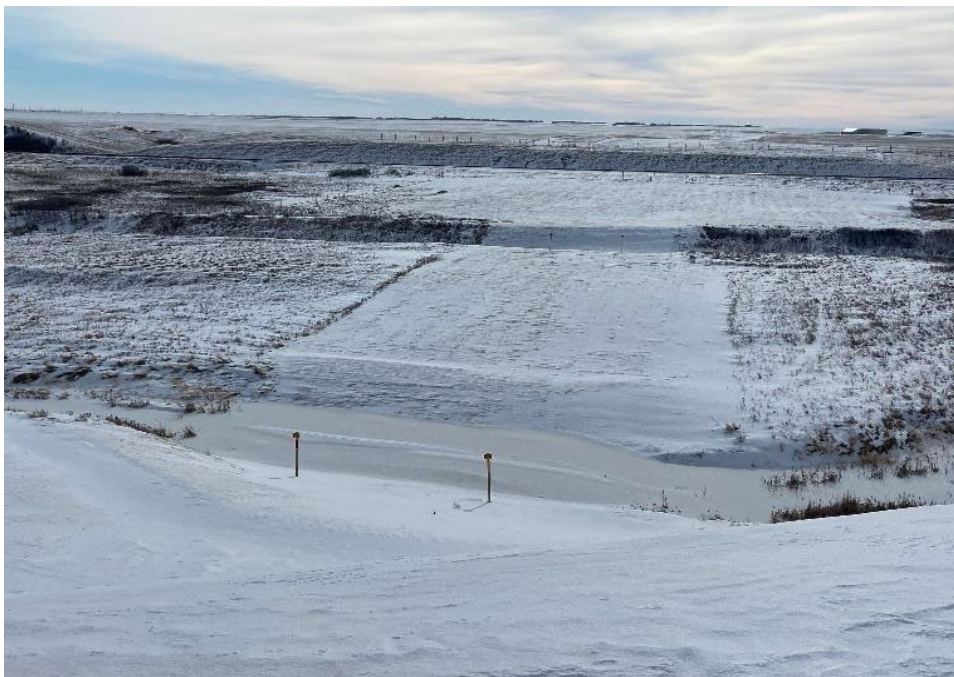
Location:
Sta. No. 35+52

Notes: Restored right-of-way remains frozen and stabilized on the Tioga-Elkhorn Creek Pipeline.

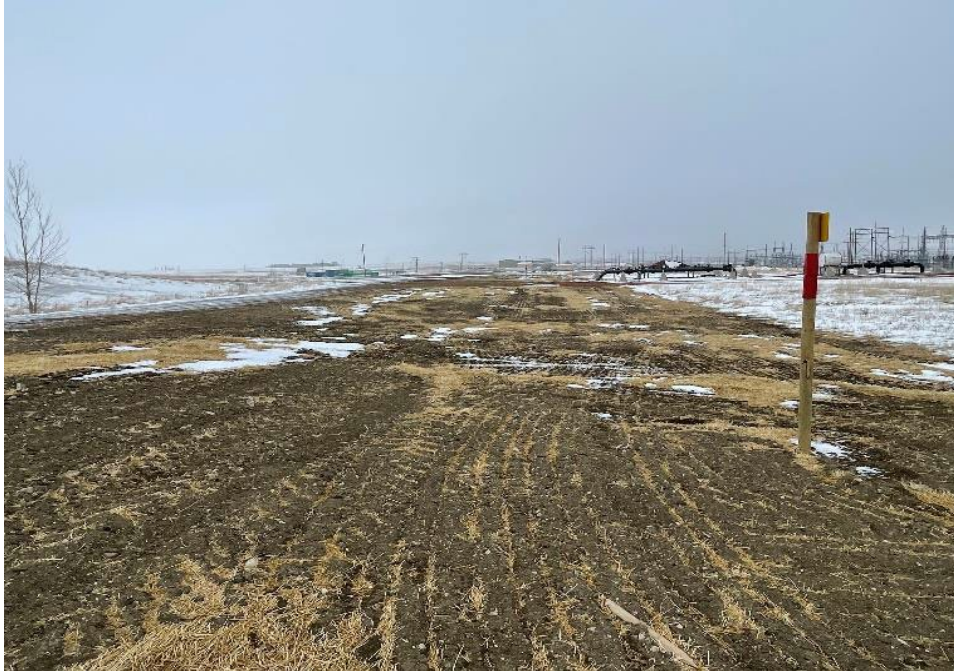
Location:
Sta. No. 5+00

Notes: Restored right-of-way on the Tioga-Elkhorn Creek Pipeline.

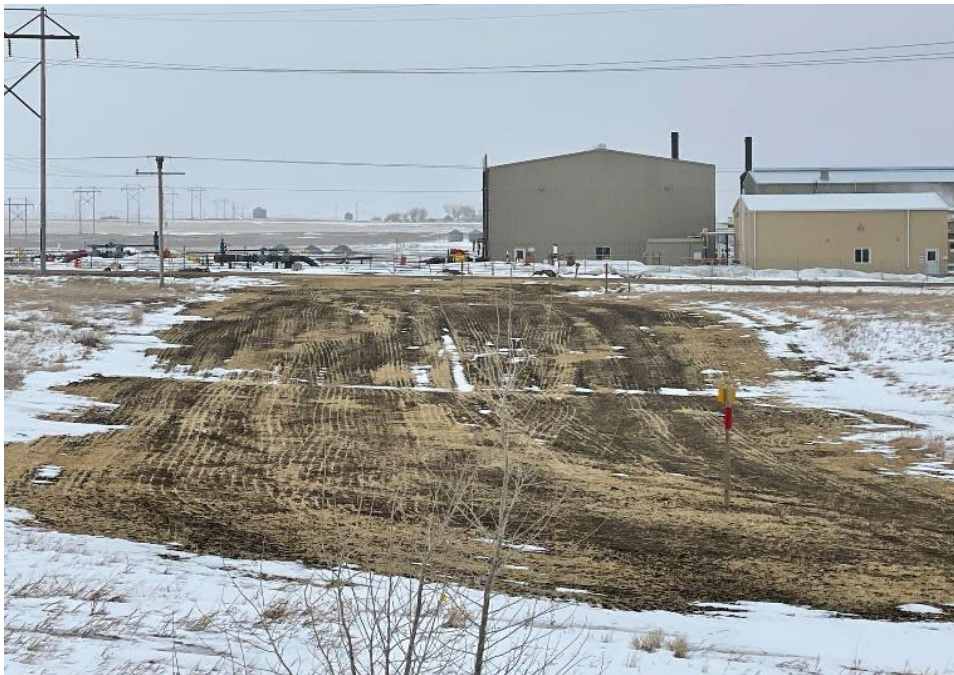
Location: Sta. Nos.
18+00 to 24+95

Notes: Restored right-of-way remains frozen and stabilized on the Tioga-Elkhorn Creek Pipeline.

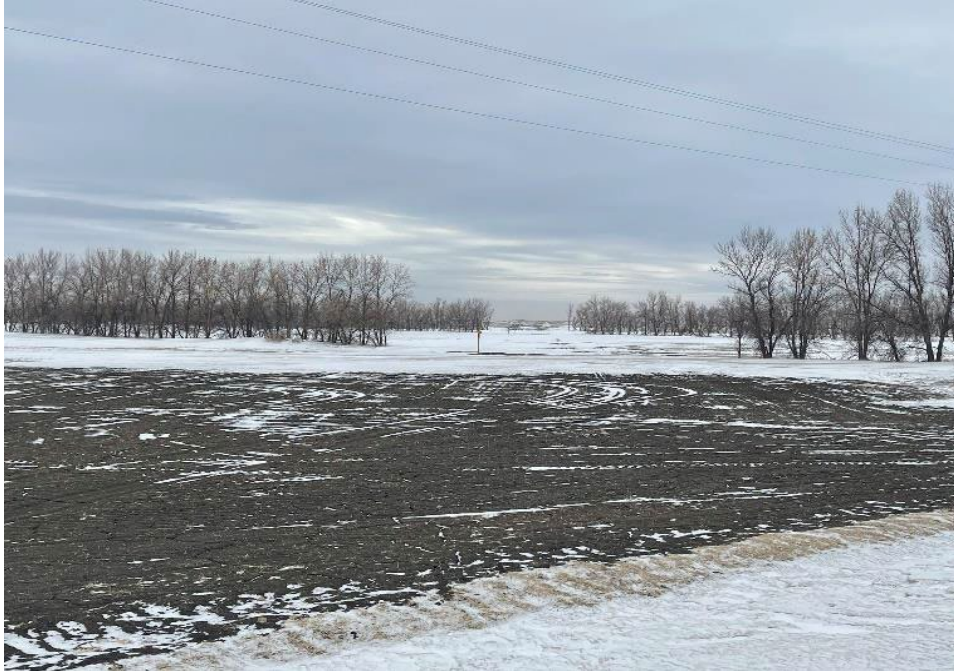
Location: Sta. Nos.
486+79 to 523+45

Notes: Restored right-of-way remains frozen and stabilized on the Tioga-Elkhorn Creek Pipeline.

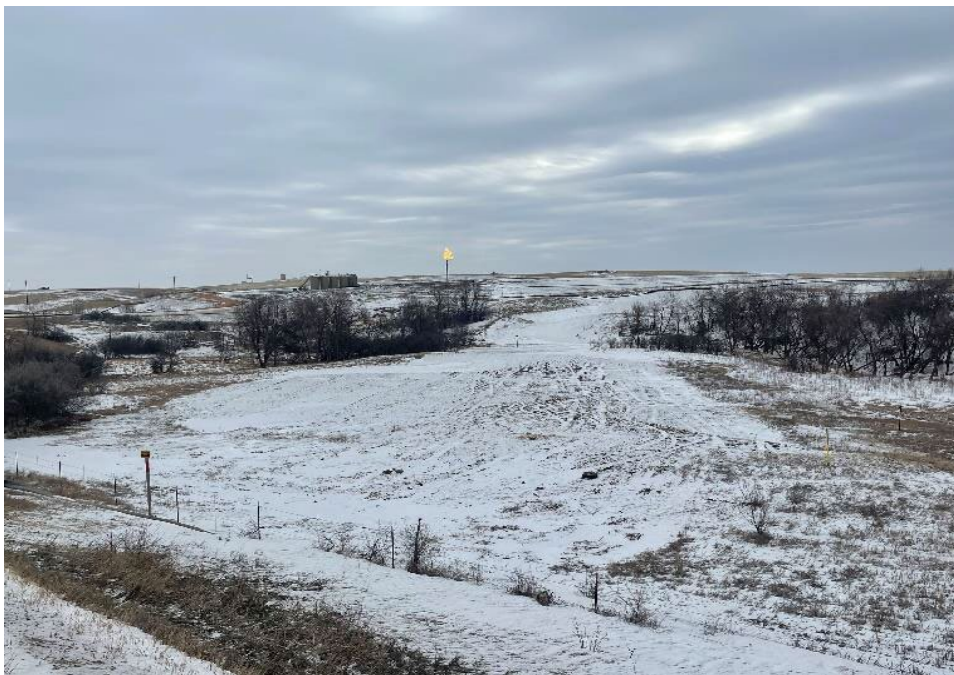
Location: Sta. Nos.
641+98 to 696+75

Notes: Restored right-of-way remains frozen and stabilized on the Tioga-Elkhorn Creek Pipeline.

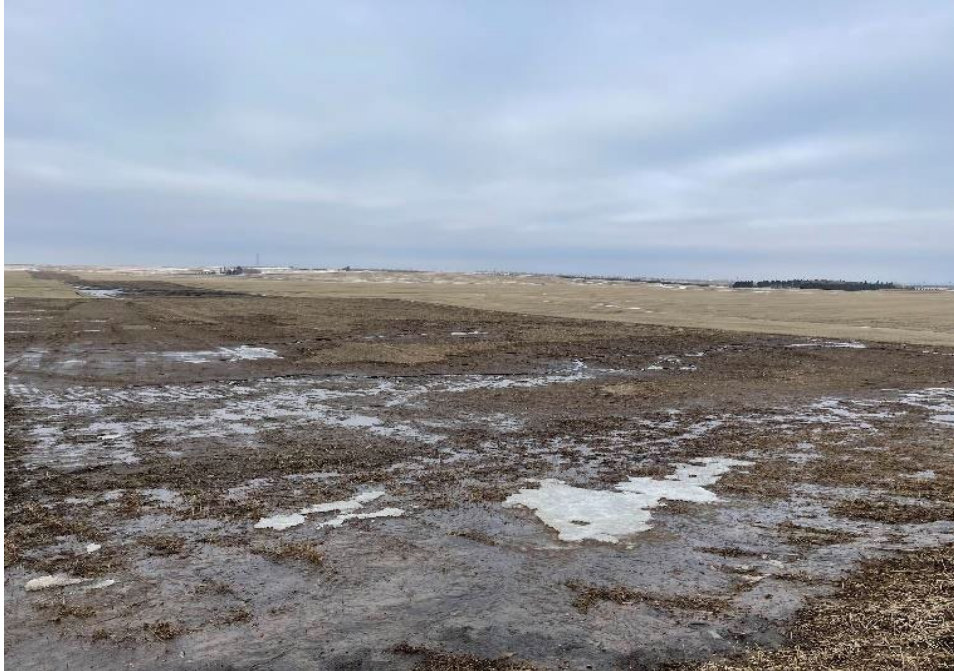
Location:
Sta. No. 329+47

Notes: Minor
rill/small channel
erosion on the Tioga-
Elkhorn Creek
Pipeline right-of-way.
This area will be
addressed when
conditions allow.

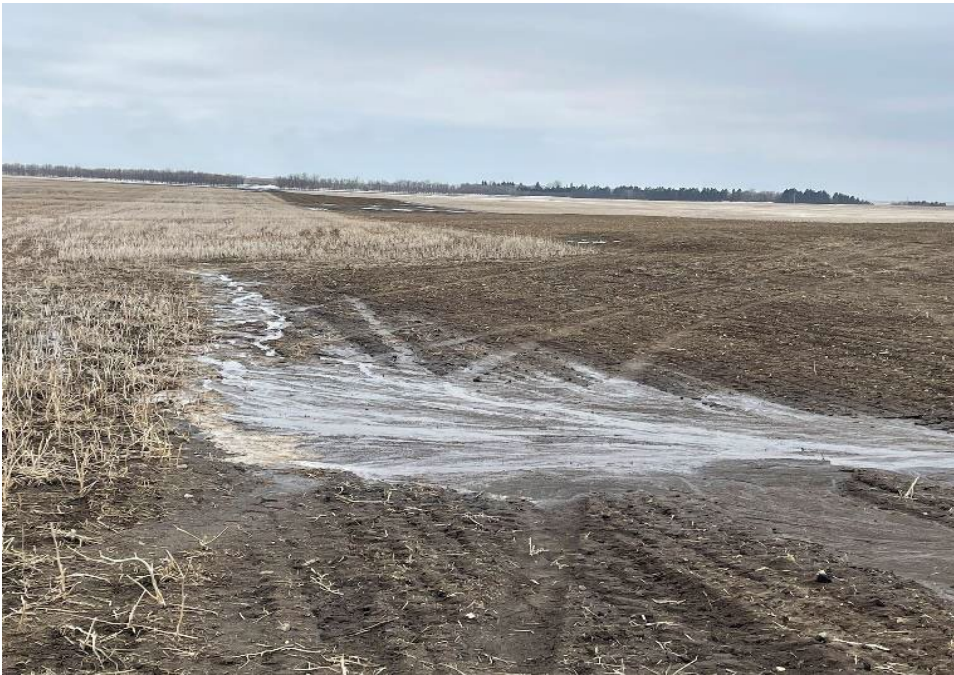
Location:
Sta. No. 449+77

Notes: Minor
rill/small channel
erosion on the Tioga-
Elkhorn Creek
Pipeline right-of-way.
This area will be
addressed when
conditions allow.

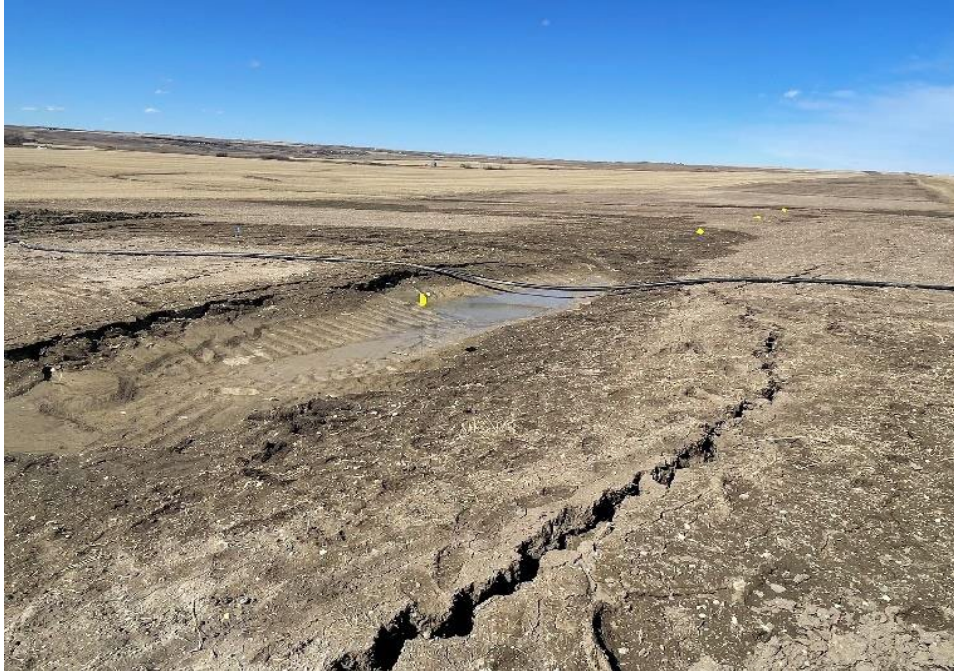
Location:
Sta. No. 853+16

Notes: A sunken area over the Tioga-Elkhorn Creek Pipeline centerline. This area will be addressed when conditions allow.

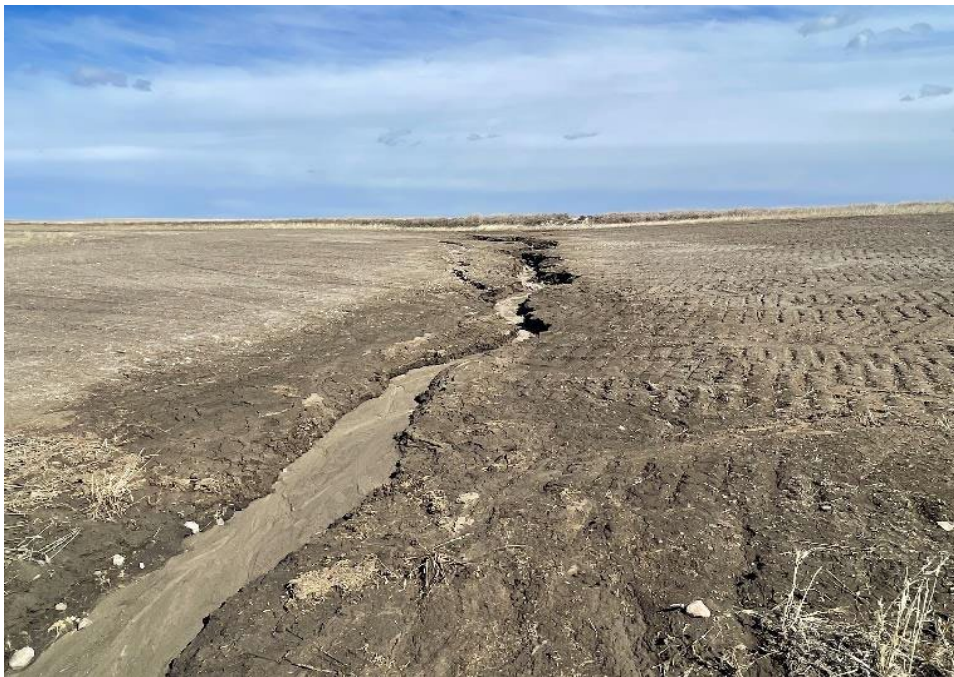
Location:
Sta. No. 838+00

Notes: Major rill/small channel erosion on the Tioga-Elkhorn Creek Pipeline right-of-way. This area will be addressed when conditions allow.

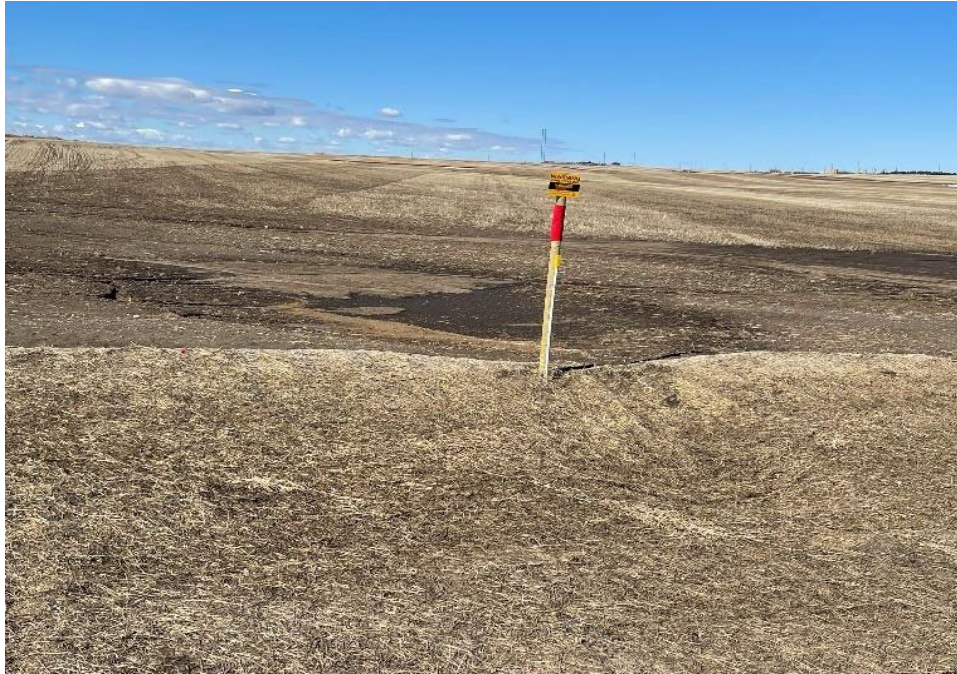
Location:
Sta. No. 377+71

Notes: A sunken area over the Tioga-Elkhorn Creek Pipeline. This area will be addressed when conditions allow.

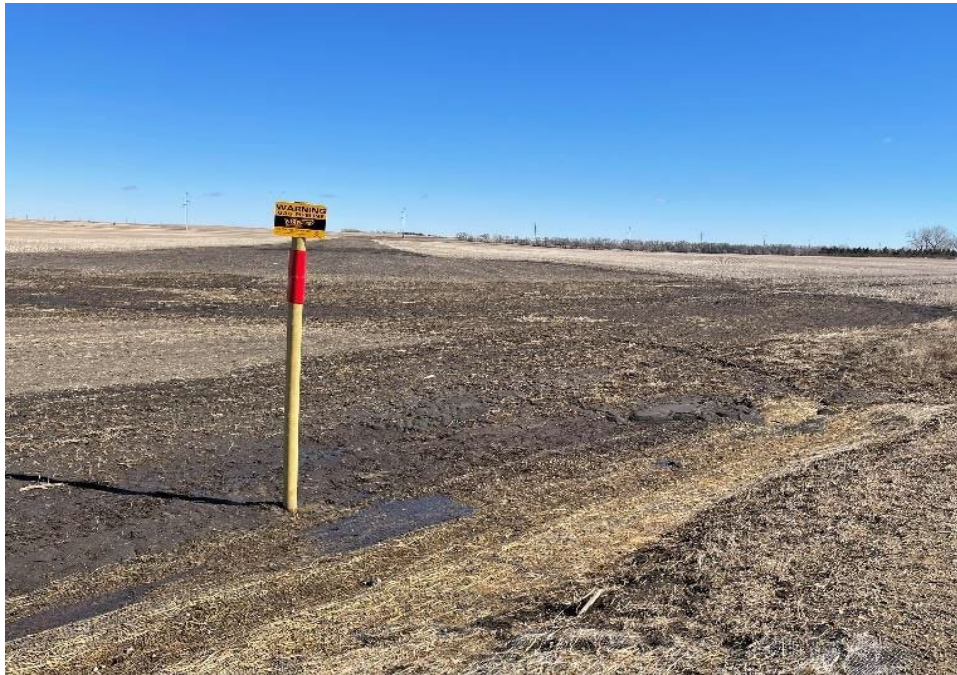
Location:
Sta. No. 486+69

Notes: Minor rill/small channel erosion on the Tioga-Elkhorn Creek Pipeline right-of-way. This area will be addressed when conditions allow.

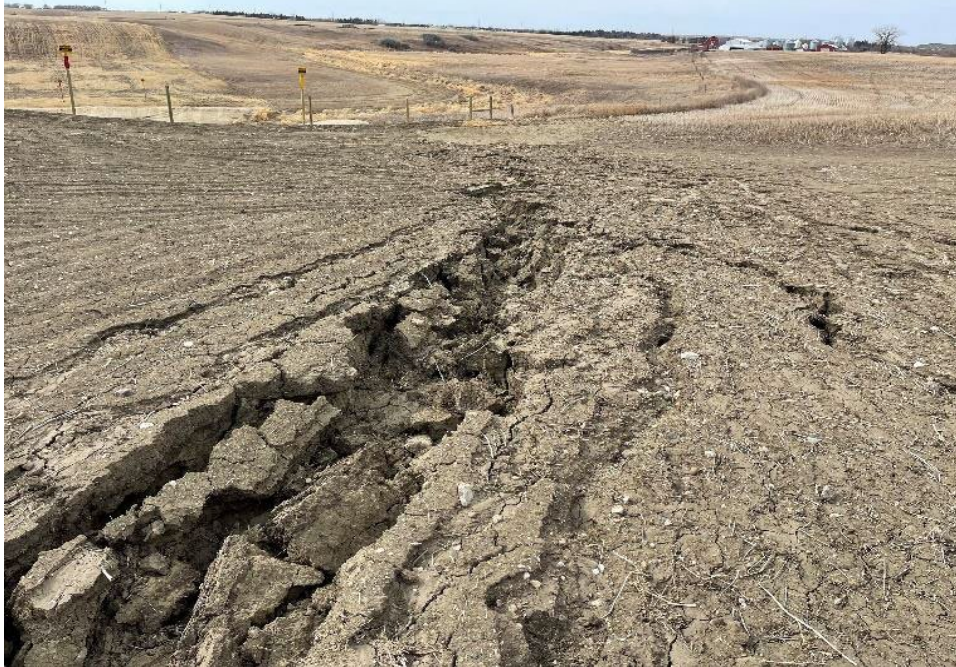
Location:
Sta. No. 122+54

Notes: Rill/channel erosion on the Tioga-Elkhorn Creek Pipeline right-of-way. This area will be addressed when conditions allow.

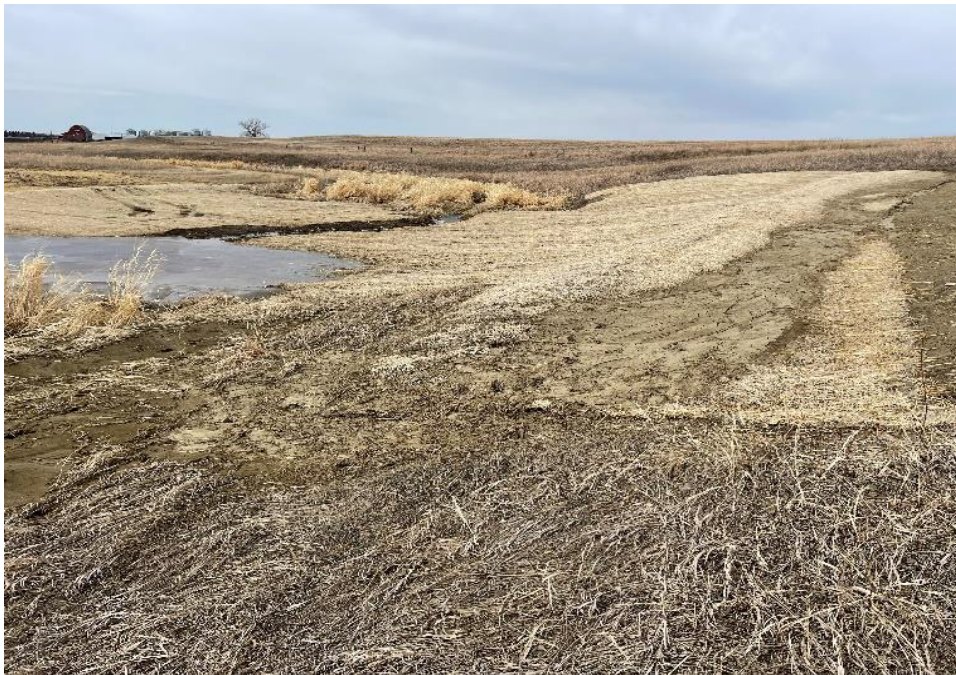
Location:
Sta. No. 385+14

Notes: Sediment discharged into watercourse s-wm-ea-00s on the Tioga-Elkhorn Creek Pipeline. This area will be addressed when conditions allow.

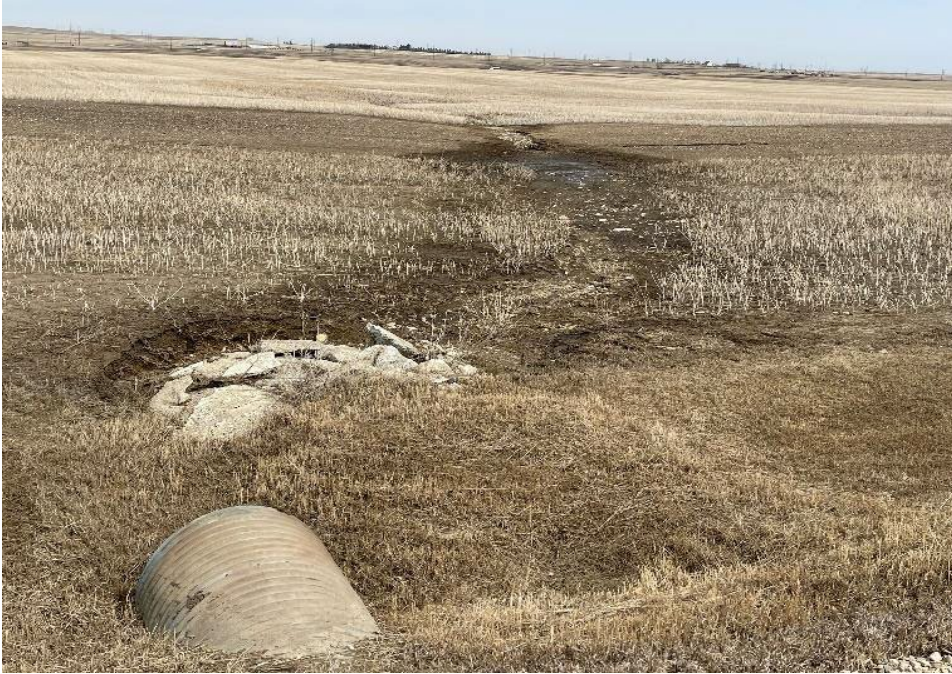
Location:
Sta. No. 95+00

Notes: Rill/channel erosion from water runoff from culvert on the Tioga-Elkhorn Creek Pipeline right-of-way. This area will be addressed when conditions allow.

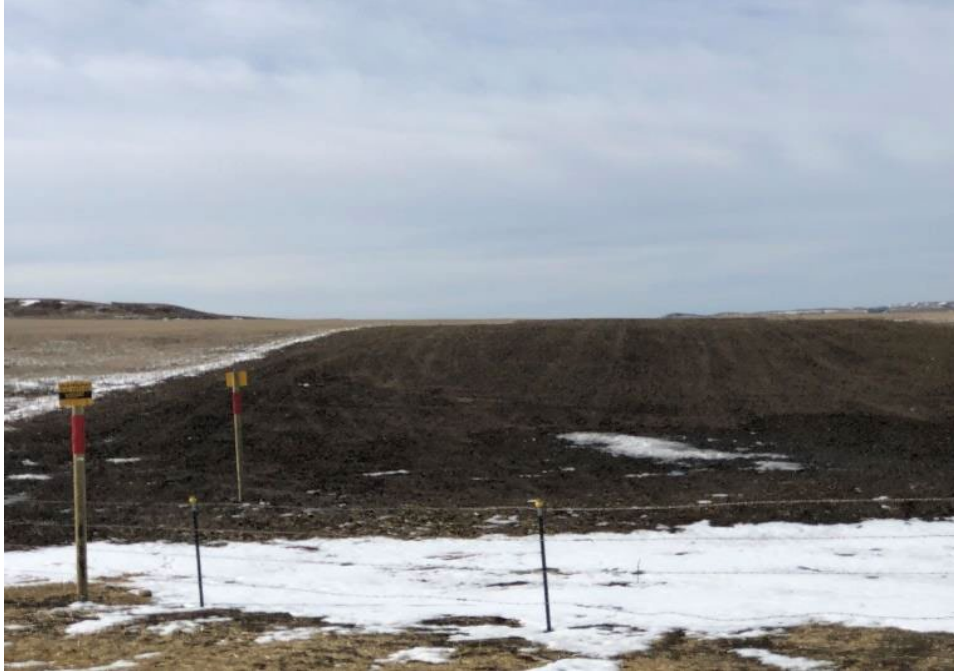
Location:
Sta. No. 1949+00

Notes: Restored right-of-way remains frozen and stabilized on the Tioga-Elkhorn Creek Pipeline.

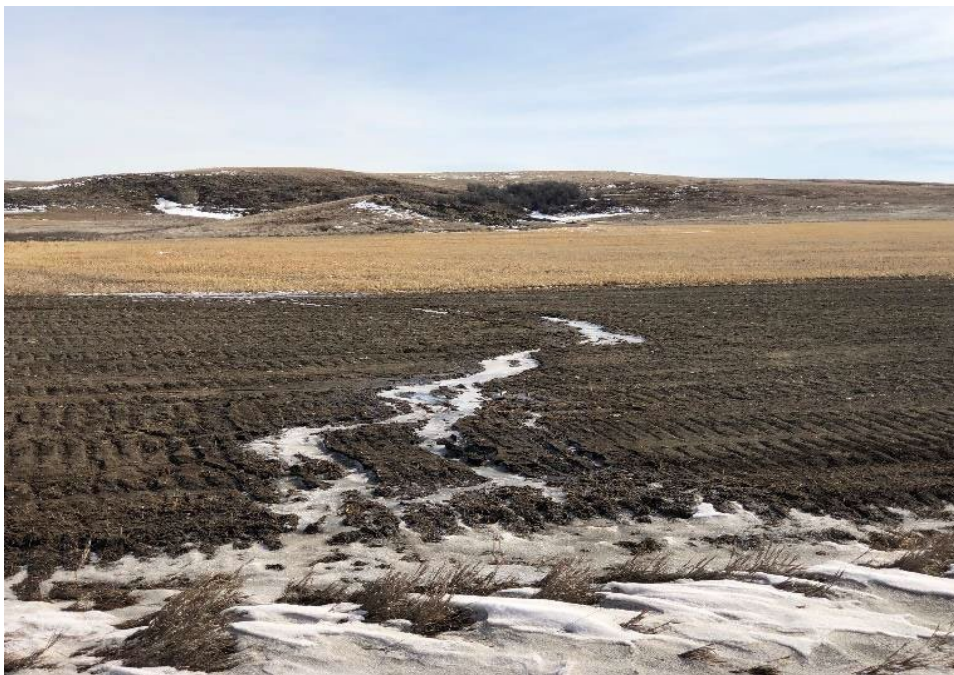
Location:
Sta. No. 2049+00

Notes: Minor rill/small channel erosion on the Tioga-Elkhorn Creek Pipeline right-of-way. This area will be addressed when conditions allow.

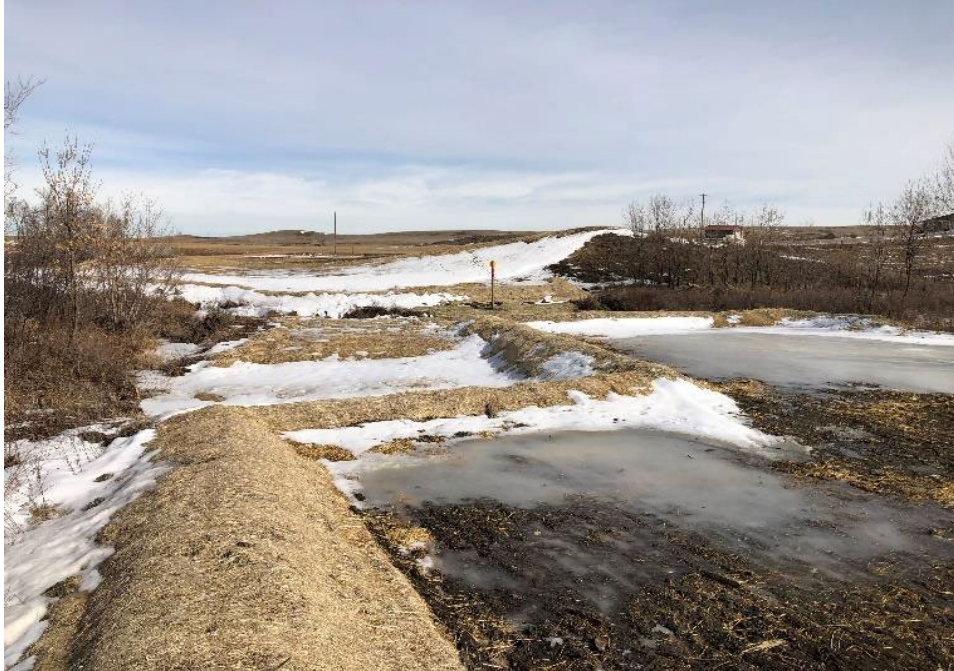
Location:
Sta. No. 2160+00

Notes: Slope breakers and erosion control blankets at watercourse s-mk-ea-002 remain in place and functioning on the Tioga-Elkhorn Creek Pipeline.

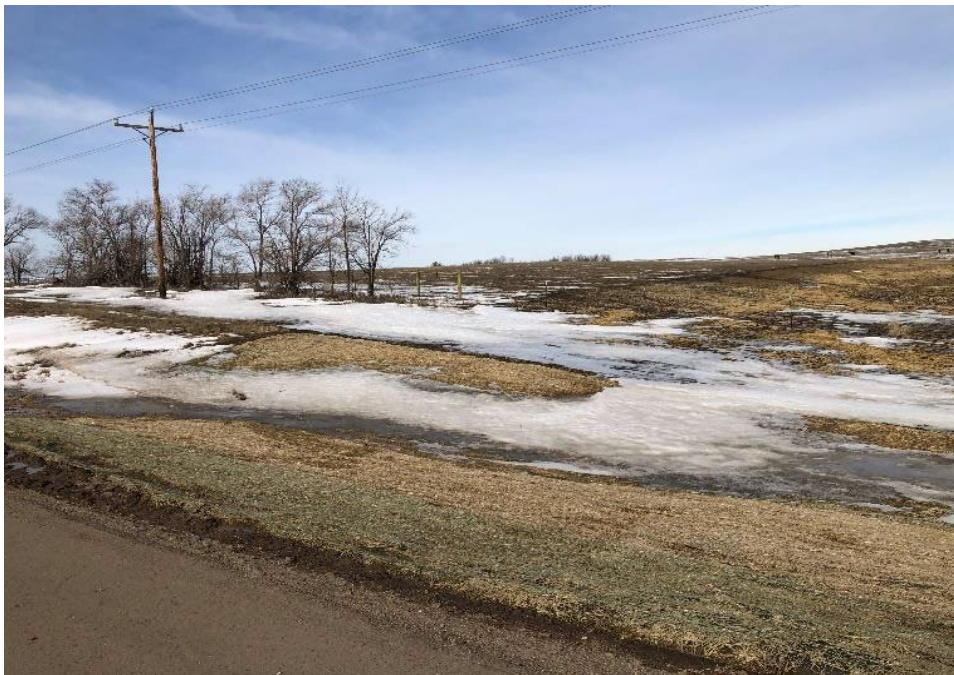
Location:
Sta. No. 2297+74

Notes: Erosion control blankets remain in place and functioning on the Tioga-Elkhorn Creek Pipeline.

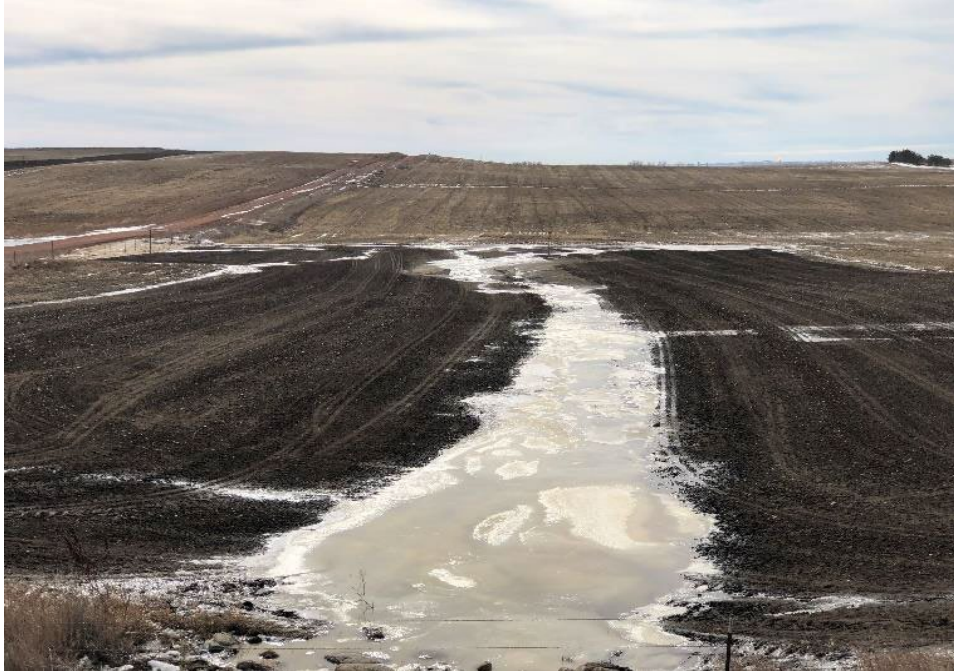
Location:
Sta. No. 2299+00

Notes: Rill/channel erosion on the Tioga-Elkhorn Creek Pipeline right-of-way due to snowmelt from a culvert under Highway 12. This area will be addressed when conditions allow.

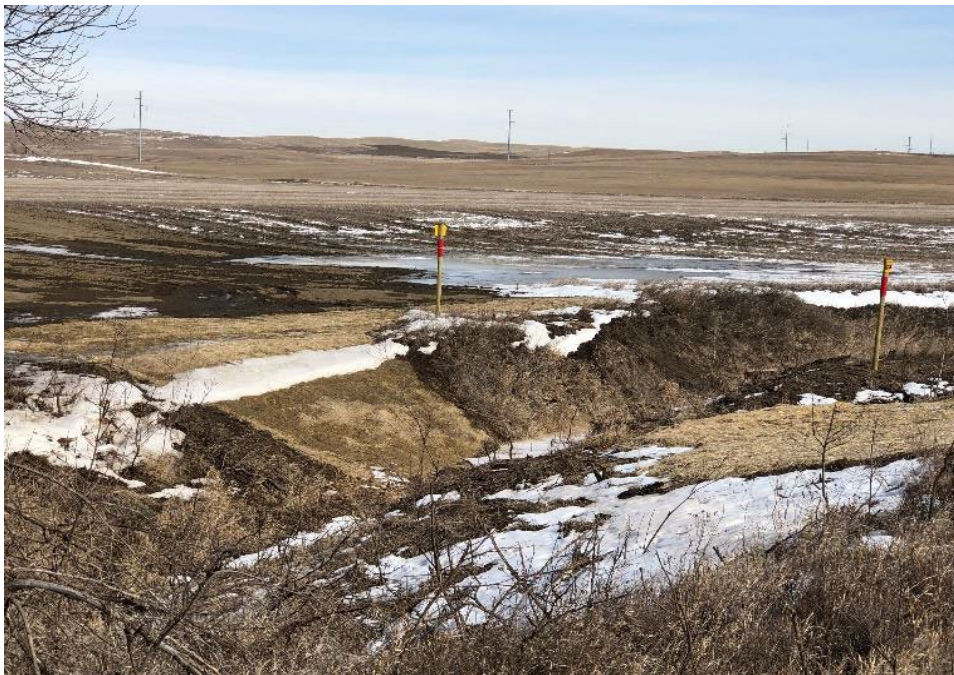
Location:
Sta. No. 2460+20

Notes: Erosion control blankets remain in place at wetland w-mk-ea-004e on the Tioga-Elkhorn Creek Pipeline.

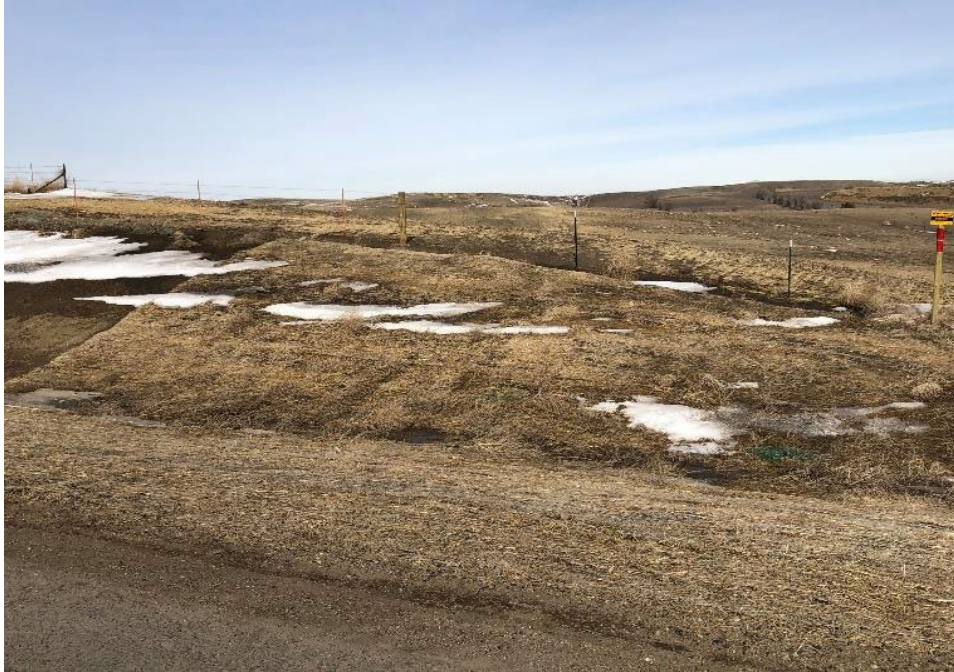
Location:
Sta. No. 2888+31

Notes: Erosion control blankets remain in place and functioning on the Tioga-Elkhorn Creek Pipeline.

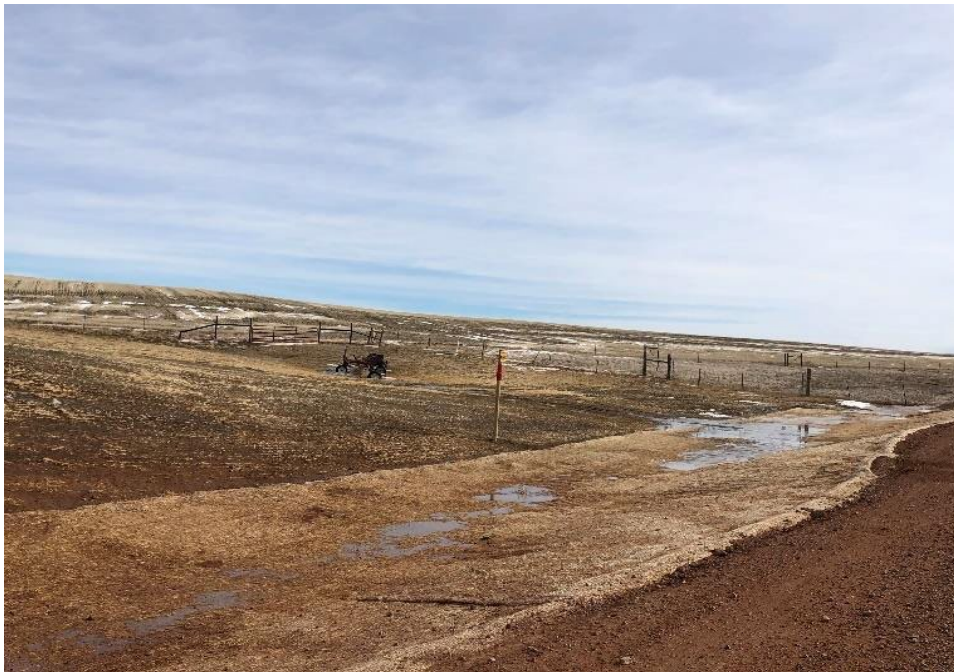
Location:
Sta. No. 2987+47

Notes: Erosion control blankets remain in place and functioning on the Tioga-Elkhorn Creek Pipeline.

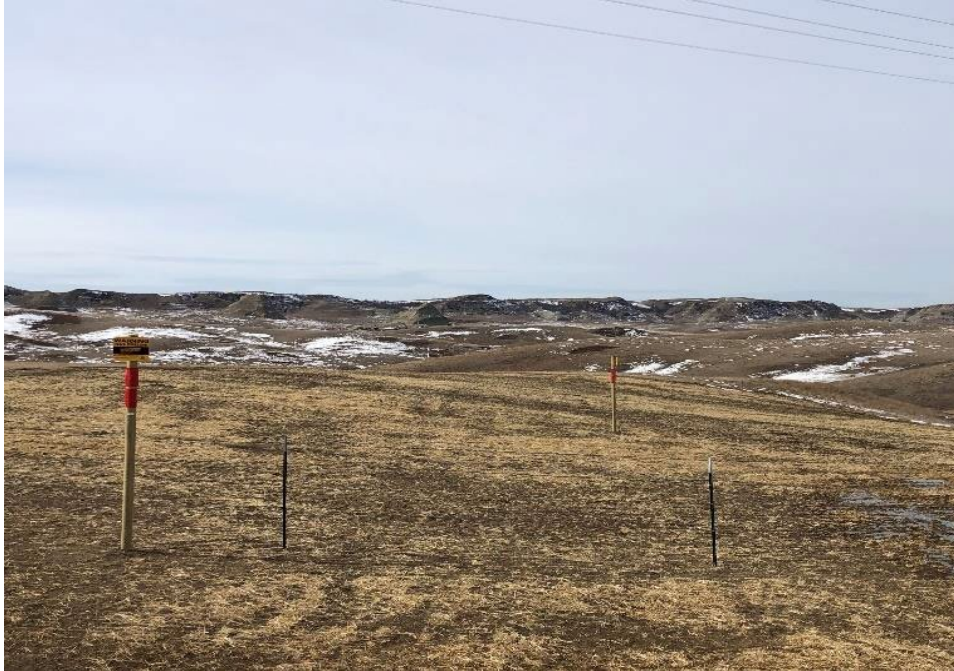
Location:
Sta. No. 2993+80

Notes: Restored right-of-way remains properly mulched and crimped on the Tioga-Elkhorn Creek Pipeline.

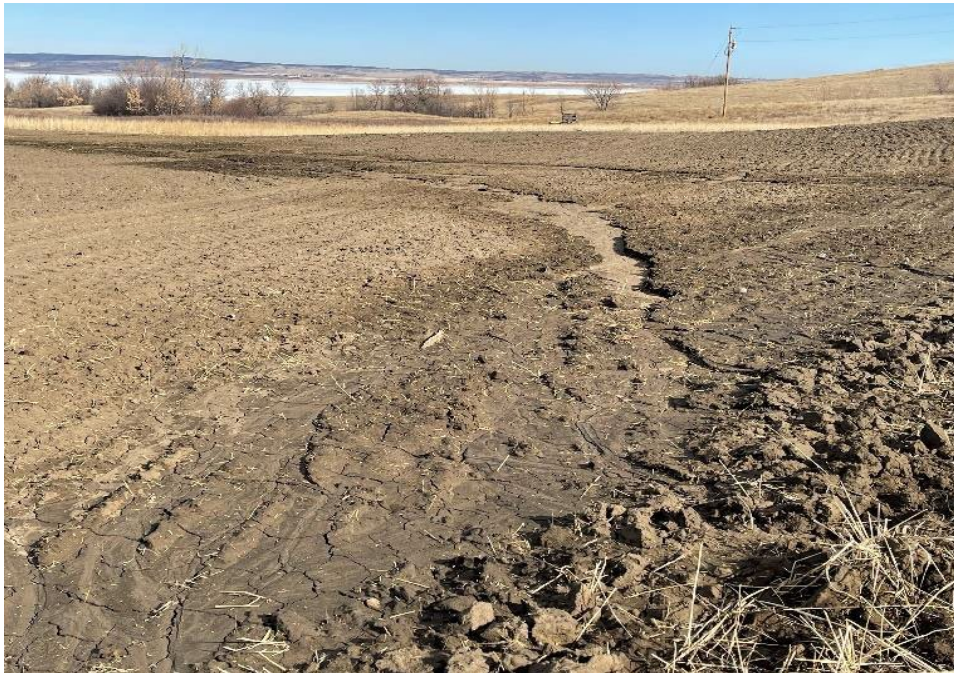
Location:
Sta. No. 1369+84

Notes: Minor rill/small channel erosion on the Tioga-Elkhorn Creek Pipeline right-of-way. This area will be addressed when conditions allow.

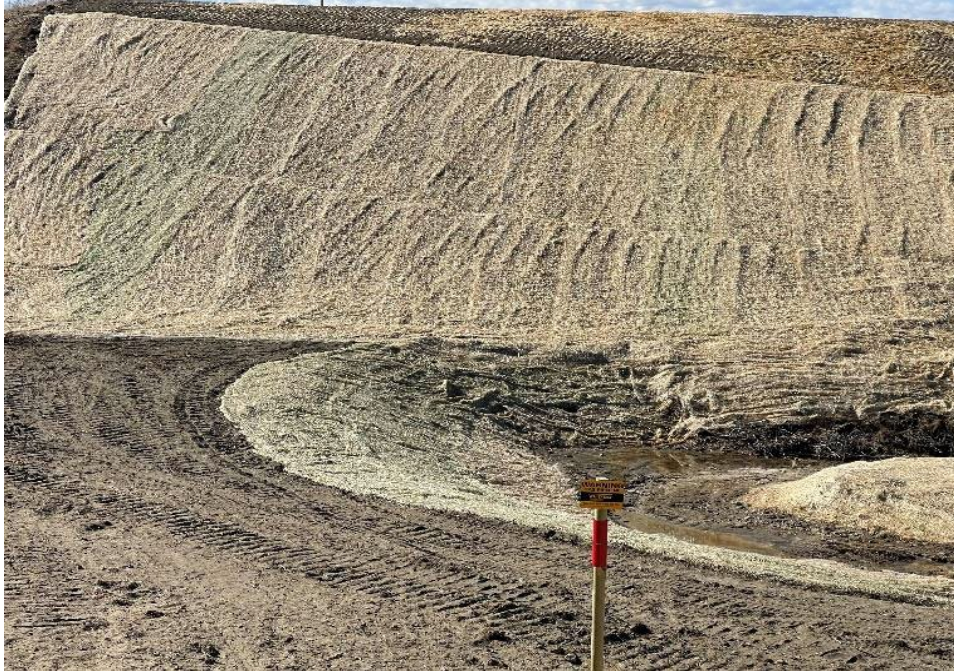
Location:
Sta. No. 1451+04

Notes: Erosion control blankets need to be restabilized on the south bank of watercourse s-mk-ea-001 on the Tioga-Elkhorn Creek Pipeline. This area will be addressed when conditions allow.

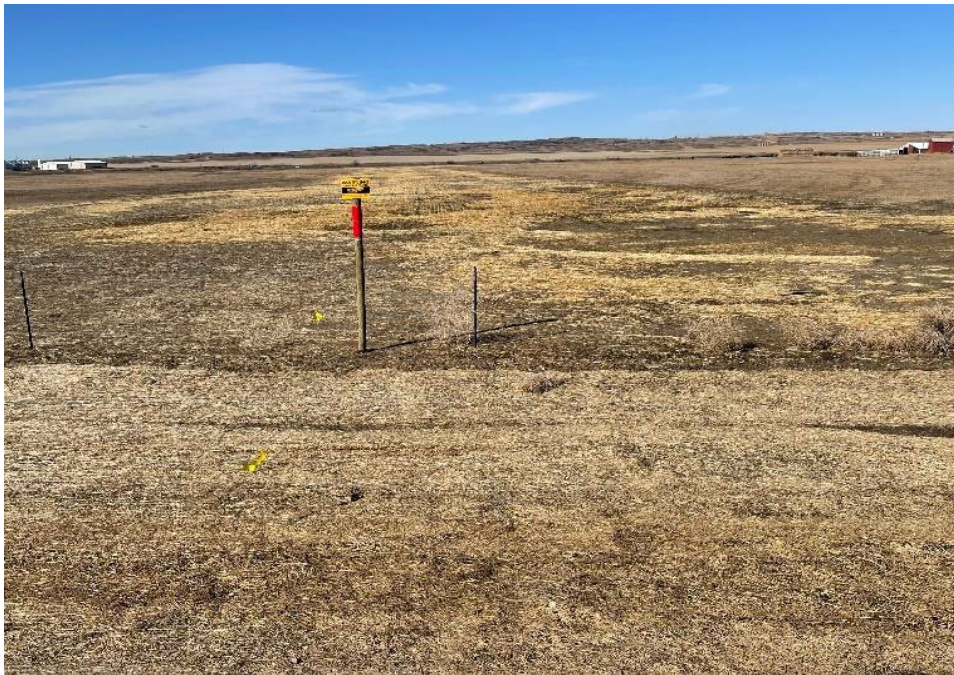
Location:
Sta. No. 1573+67

Notes: Restored right-of-way remains properly mulched and crimped on the Tioga-Elkhorn Creek Pipeline.

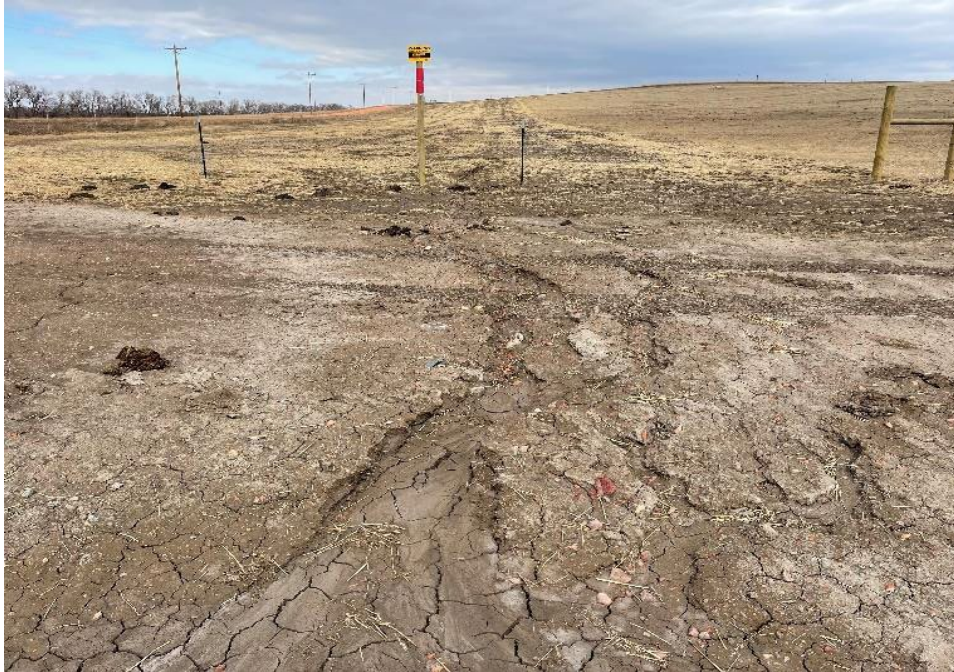
Location:
Sta. No. 1888+22

Notes: Minor rill/small channel erosion on the Tioga-Elkhorn Creek Pipeline right-of-way. This area will be addressed when conditions allow.
