Re: WBI Energy Transmission, Inc.
Docket Nos. CP20-52-000 and CP20-52-001
North Bakken Expansion Project
Status Report No. 36

WBI Energy Transmission, Inc.
North Bakken Expansion Project Status Report No. 36
FERC Docket Nos. CP20-52-000
CP20-52-001

Reporting Period: March 1, 2022 through March 31, 2022

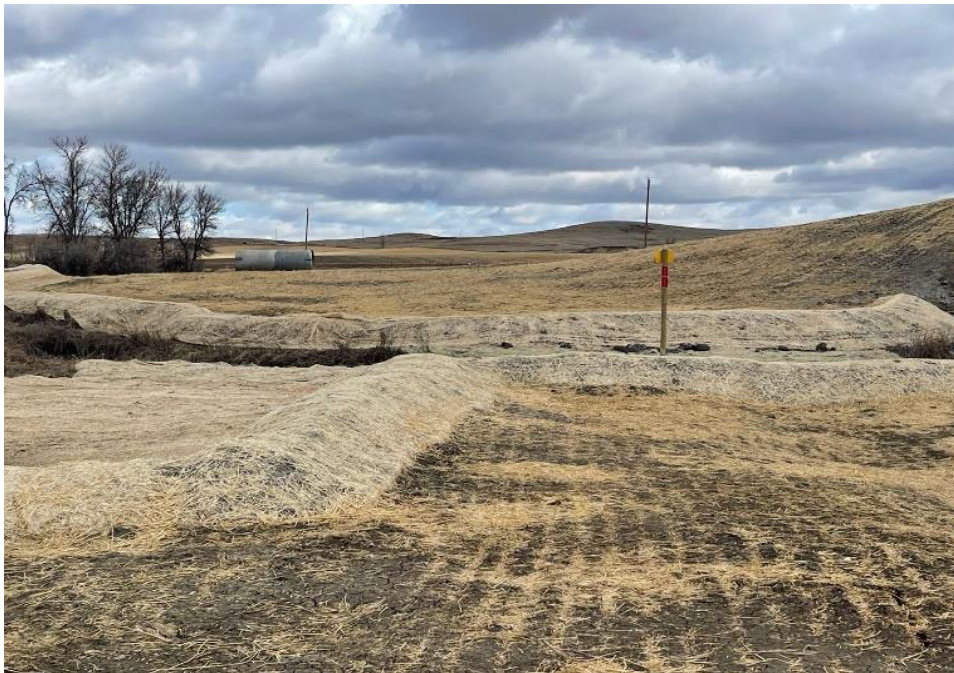
Location:
Sta. No. 2059+76

Notes: Slope breakers and erosion control blankets at watercourse s-mk-ea-002 remain in place and functioning on the Tioga-Elkhorn Creek Pipeline.

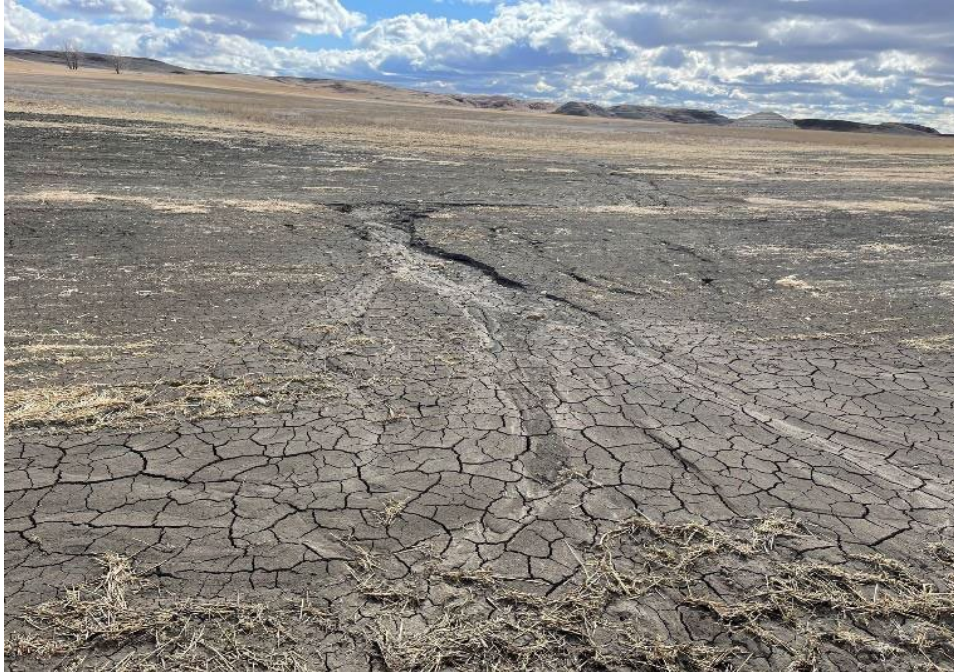
Location:
Sta. No. 2192+00

Notes: Rill/channel erosion on the Tioga-Elkhorn Creek Pipeline right-of-way. This area will be addressed when conditions allow.

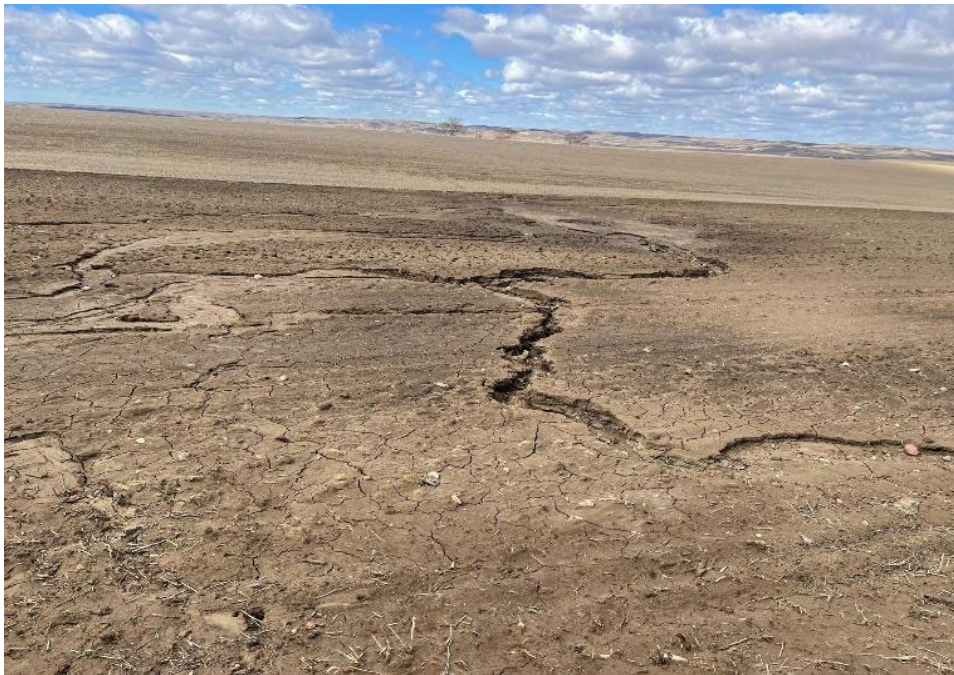
Location:
Sta. No. 2340+00

Notes: Minor rill/small channel erosion on the Tioga-Elkhorn Creek Pipeline right-of-way. This area will be addressed when conditions allow.

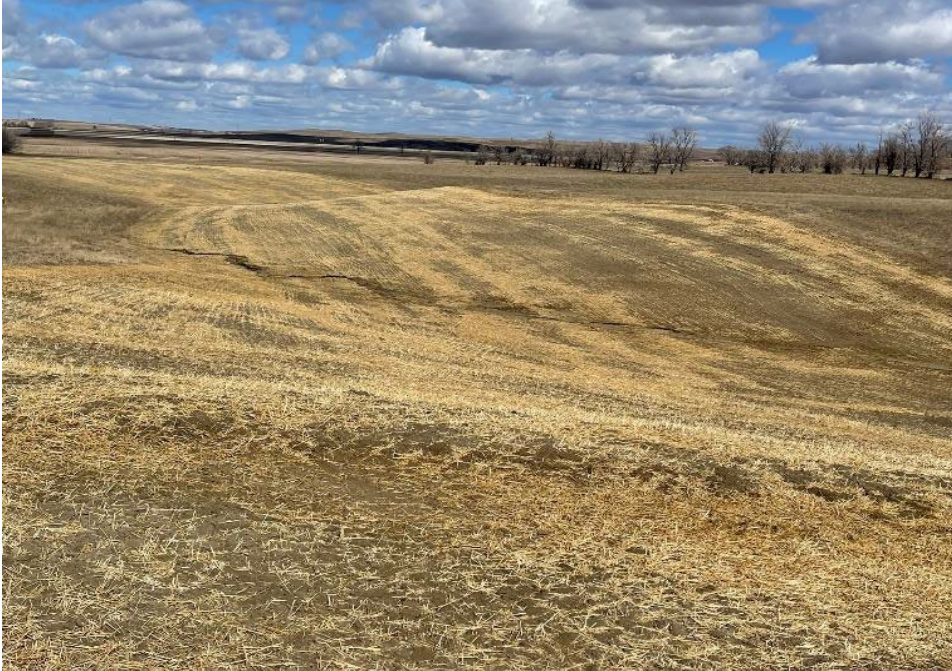
Location:
Sta. No. 2562+80

Notes: Minor
rill/small channel
erosion on the Tioga-
Elkhorn Creek
Pipeline right-of-way.
This area will be
addressed when
conditions allow.

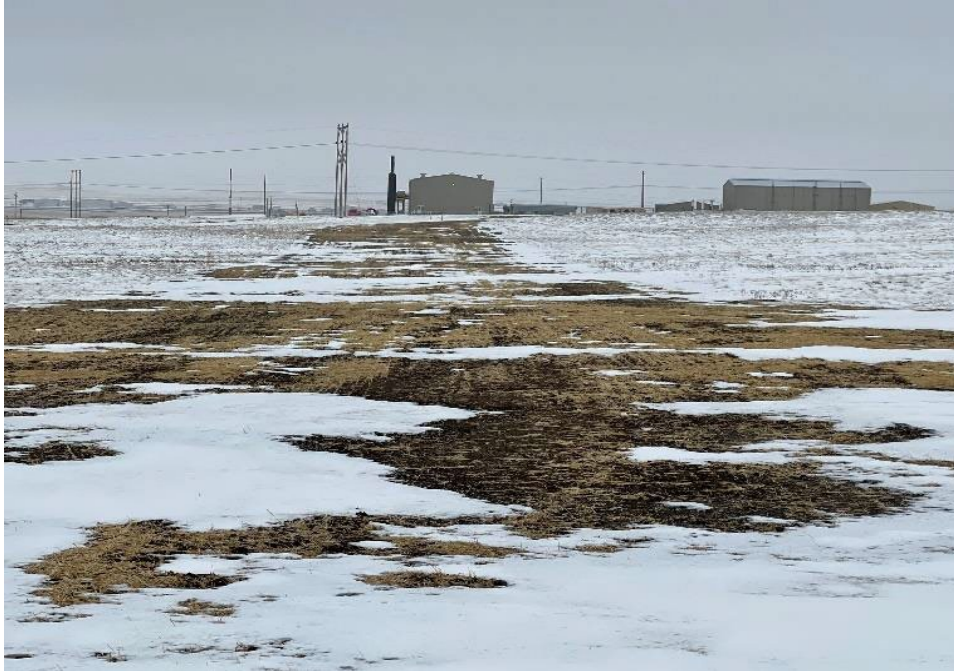
Location:
Sta. No. 19+06

Notes: Restored right-of-way remains frozen and stabilized on the Line Section 25 Loop Pipeline.

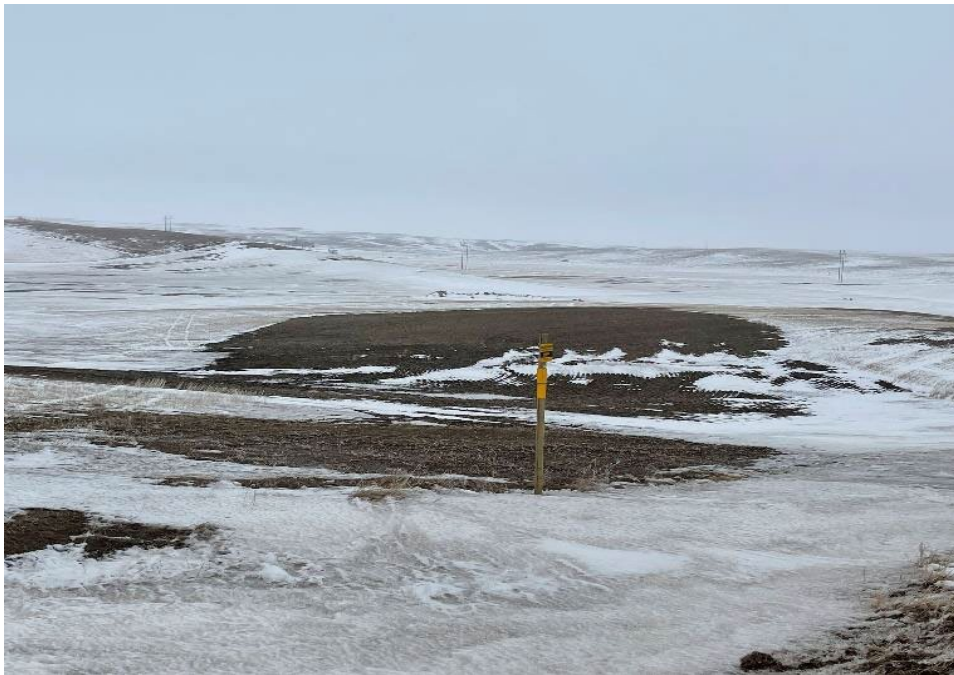
Location:
Sta. No. 107+24

Notes: Restored right-of-way remains frozen and stabilized on the Line Section 25 Loop Pipeline.

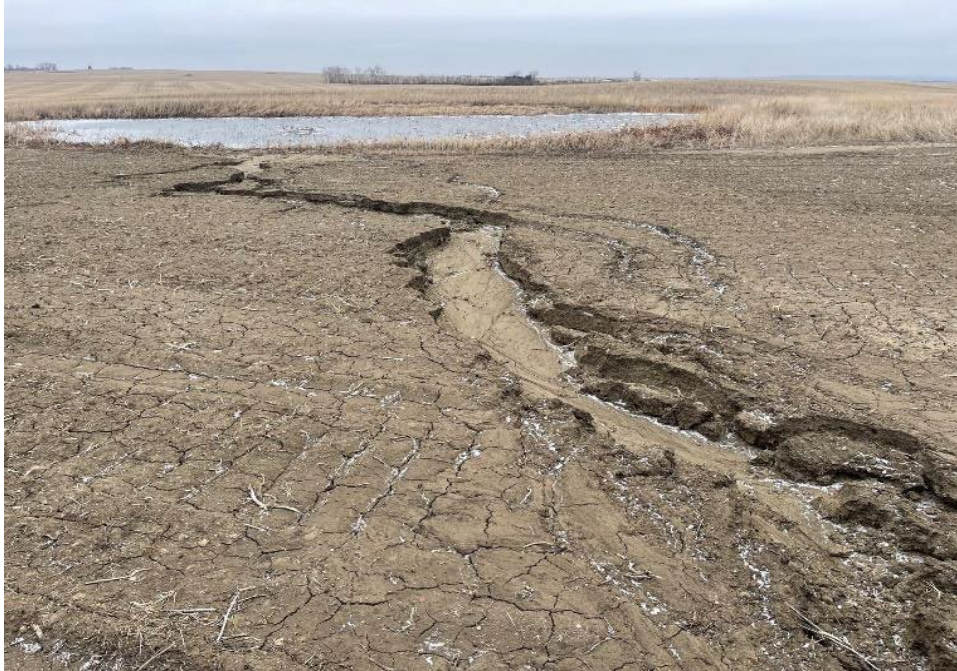
Location:
Sta. No. 832+00

Notes: Sediment discharged in wetland w-bk-ea-004e on the Line Section 25 Loop Pipeline. This area will be addressed when conditions allow.

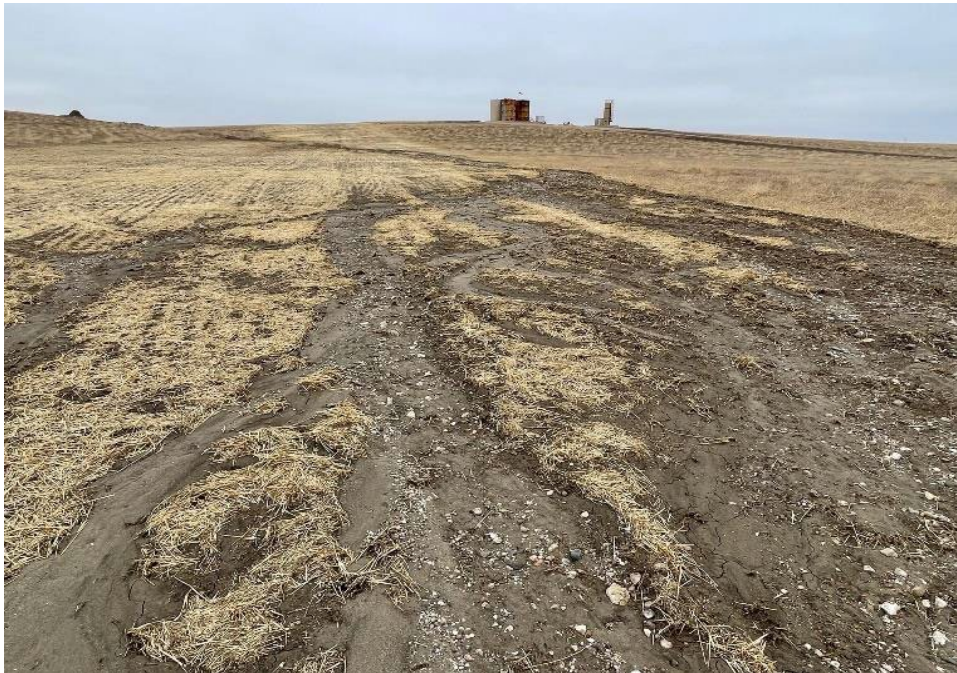
Location: Sta. Nos.
720+62 to 735+00

Notes: Rill/channel erosion on the Line Section 25 Loop Pipeline. This area will be addressed when conditions allow.

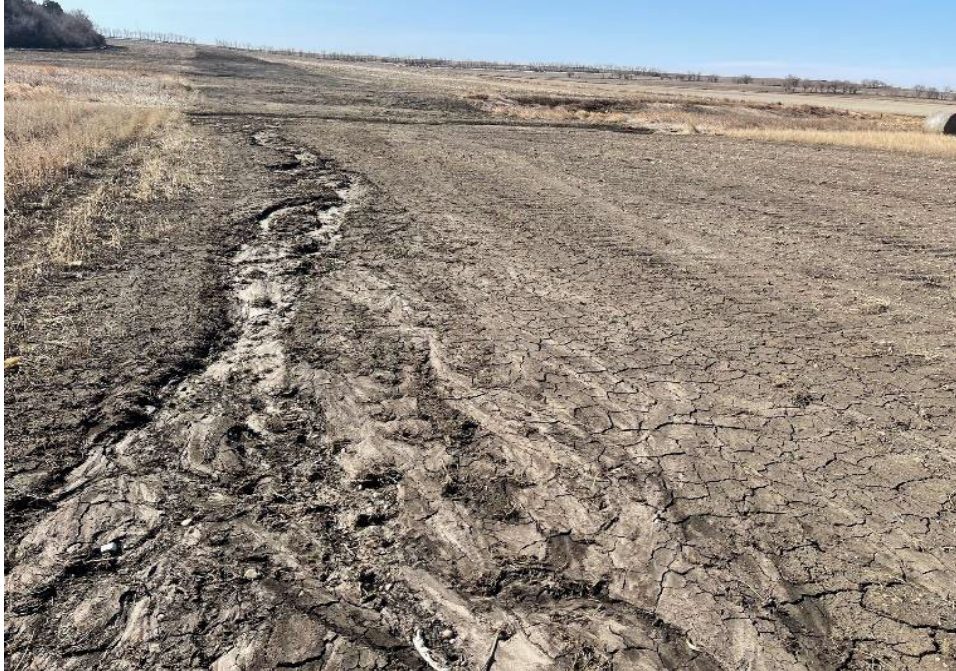
Location:
Sta. No. 583+22

Notes: Minor
rill/small channel
erosion on the Line
Section 25 Loop
Pipeline. This area
will be addressed
when conditions
allow.

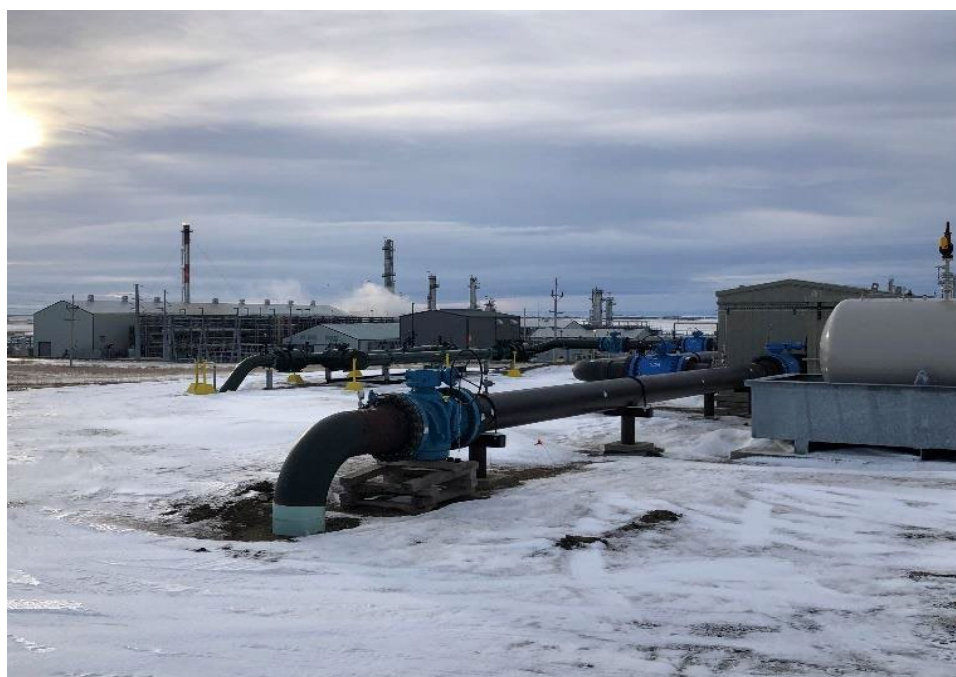
Location: Tioga Plant Receipt Station

Notes: No erosion issues or concerns were noted.
