**FEDERAL ENERGY REGULATORY COMMISSION
 ENVIRONMENTAL COMPLIANCE MONITORING PROGRAM
 SUMMARY REPORT NO. 25
 NORTH BAKKEN EXPANSION PROJECT
 DOCKET NOS.: CP 20-52-000 AND CP 20-52-001
 FOR THE PERIOD: MAY 9 THROUGH 13, 2022**

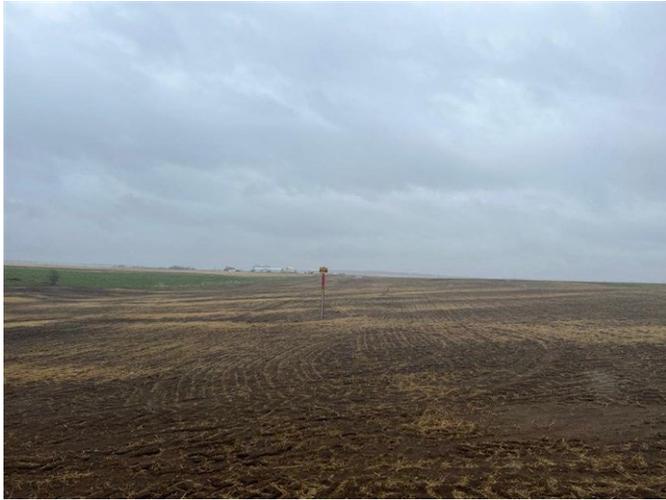
Tioga Elkhorn Creek PL Spread 1 – Restored field north of Lake Sakakawea (May 9, 2022) Communication – MP 22.9

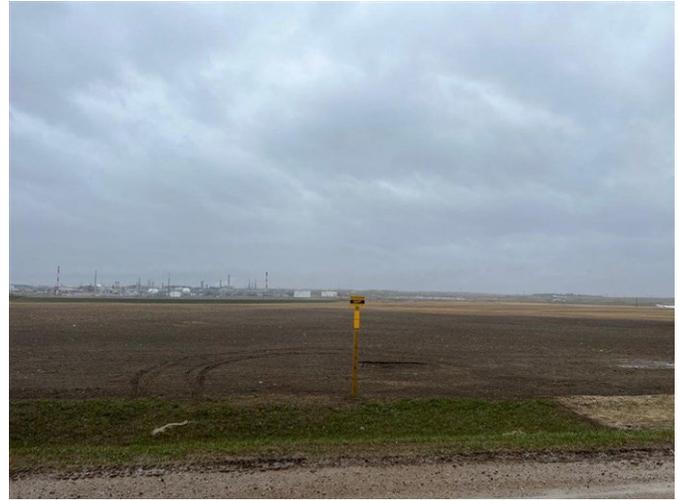
Tioga Elkhorn Creek PL Spread 1 – Minor subsidence over centerline (May 9, 2022) – Communication – MP 1.8

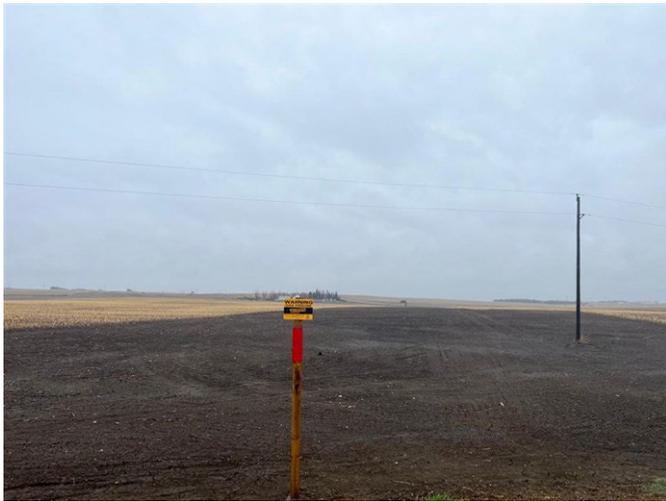
Tioga Elkhorn Creek PL Spread 1 – Restored agricultural lands (May 9, 2022) – Communication – MP 9.3

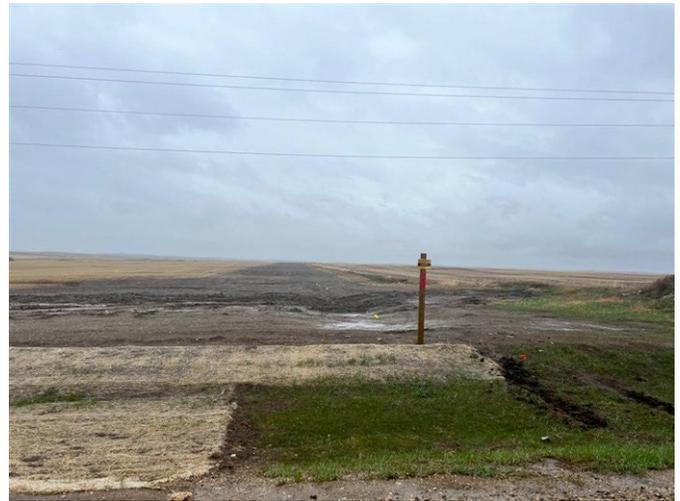
SUMMARY OF COMMUNICATION REPORTS FOR THE NORTH BAKKEN EXPANSION PROJECT				
Compliance Level/Report Number	Date Issued	Location (Spread/Facility/Milepost [MP]/County/State)	Follow-up Required (Yes or No)	Description
Other_09May2022_HT1	5/9/2022	(Mostly) Tioga-Elkhorn Cr PL Spread 1 MP 0.0 to 23.1	No	The Compliance Monitor joined by the Compliance Manager performed an inspection of multiple areas focusing mostly on the Tioga to Elkhorn Creek Spread 1 (North Spread). Access to the right-of-way was mostly limited to public roads and areas of stable access since recent heavy rain events through the region resulted in impassable access roads. The mainline right-of-way was saturated and the thawing process was mostly over, although a few small areas of accumulated snow remained. Agricultural lands near the edge of Lake Sakakawea were largely stable and suitable restoration was observed. Slopes north and south of MP 19.0 were stable and erosion controls were in good and functional condition. Slopes and hills north of Beaver Creek were also stable and restoration progress was observed. The access road to the Valve Set yard south of 56 Street NW and the surrounding areas were wet, but stable. Similar conditions were also noted through the pipeline reroute between MPs 12.0 and 12.3. A segment of right-of-way crossed by a guided bore at MPs 5.3 and 5.4 to protect a private driveway and to preserve two tree lines was in satisfactory condition. A few areas requiring repair were noted along with minor settling over the test leads of the pipeline, west of 103 Avenue NW (MP 1.9). A low depression at the crossing of an agricultural land drain near the road was also observed. Further south, ponding from rain was observed between the Valve Site and 104th Avenue NW. The Line Section 30 Loop at the crossing of Highway 40 was stable. Rutting, possibly caused by unauthorized persons, and subsidence at the pipeline were noted near the crossing of 56th Street NW (MP 16.2). A stretch of approximately 150 feet of subsidence over the centerline of the pipeline was observed

Tioga Elkhorn Creek PL Spread 1 – Minor subsidence (May 9, 2022) – Communication – MP 16.1

SUMMARY OF COMMUNICATION REPORTS FOR THE NORTH BAKKEN EXPANSION PROJECT				
Compliance Level/Report Number	Date Issued	Location (Spread/Facility/Milepost [MP]/County/State)	Follow-up Required (Yes or No)	Description
				immediately west of 109th Avenue NW. Minor subsidence was also reported over the Tioga Lateral pipeline near the crossing of 106th Avenue NW near the WBI Tioga Compressor Station. The items of needed repairs and maintenance were reported to the WBI EI. The EI indicated that the areas were already identified and added to a punch list to be addressed when conditions are suitable to access the right-of-way and implement repairs.
TiogaElkhornCr PL Spread 2_10May2022_HT1	5/10/2022	Tioga-Elkhorn Cr PL Spread 2 MP 25.9 to MP 61.7	No	The Compliance Monitor and Compliance Manager continued a post-construction inspection, focusing on the Tioga to Elkhorn Creek Spread 2. Most areas in general were stable and satisfactory progress of restoration was observed. A few small and minor signs of erosion and scour marks within the right-of-way were observed, such as at MPs 29.8, 43.6, 45.6 (temporary access road 31), and at the Northern Border Interconnect site. Subsidence over the centerline of the pipeline was visible in several locations. No instances of subsidence were severe. Agricultural lands, hay fields, and pastures were mostly stable. Private and public roads were in good condition and were safe accessing the right-of-way. The EI confirmed the arrival of a contractor crew to commence repairs and maintenance. The EI anticipated that repairs may be completed within the next three weeks.

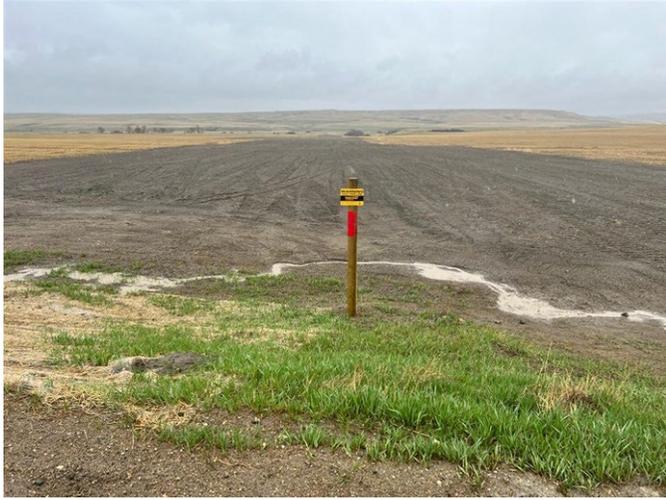
Tioga Elkhorn Creek PL Spread 1 – Erosion channel on right-of-way (May 9, 2022) – Communication – MP 18.4

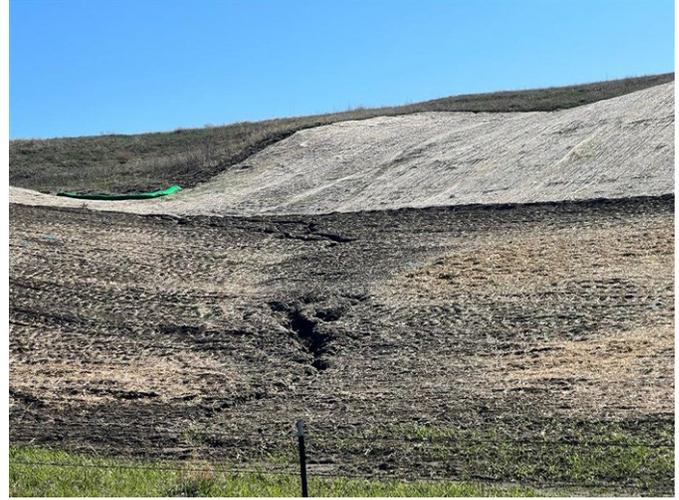
Tioga Elkhorn Creek PL Spread 2 – Erosion channel on right-of-way (May 10, 2022) – Communication – MP 29.8

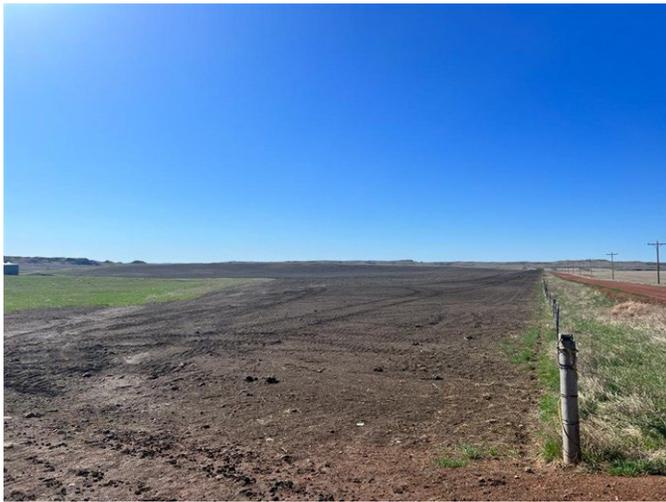
Tioga Elkhorn Creek PL Spread 2 – Stable agricultural lands (May 10, 2022) – Communication – MP 35.0

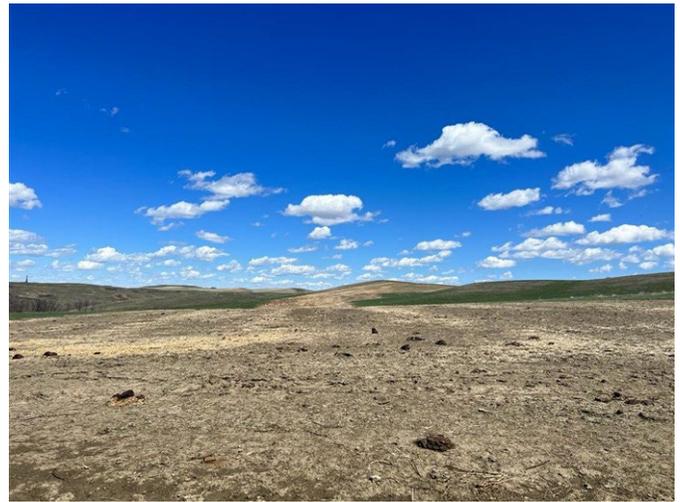
Tioga Elkhorn Creek PL Spread 2 – Stable agricultural / grazing lands (May 10, 2022) – Communication – MP 58.0

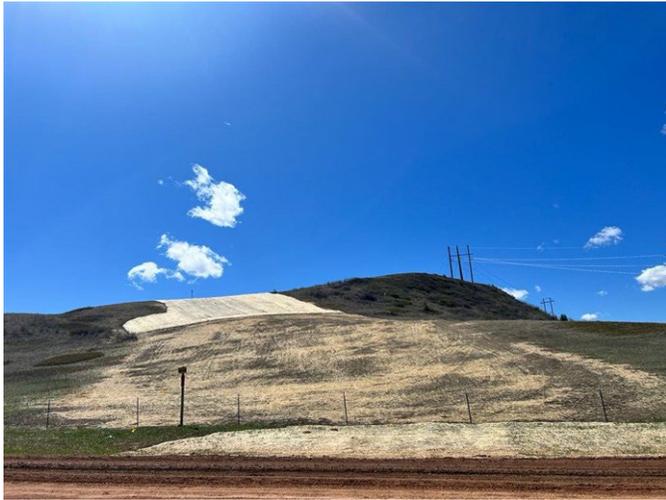
Tioga Elkhorn Creek PL Spread 2 – Stable slopes (May 10, 2022) – Communication – MP 58.0

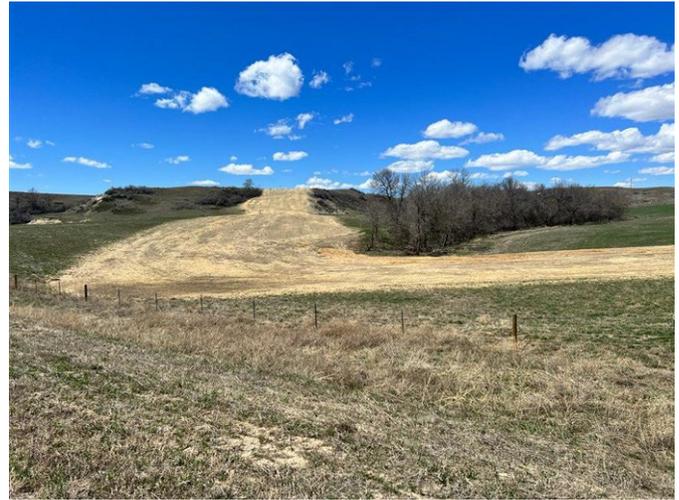
Tioga Elkhorn Creek PL Spread 2 – Mulched and stable right-of-way (May 10, 2022) – Communication – MP 61.7

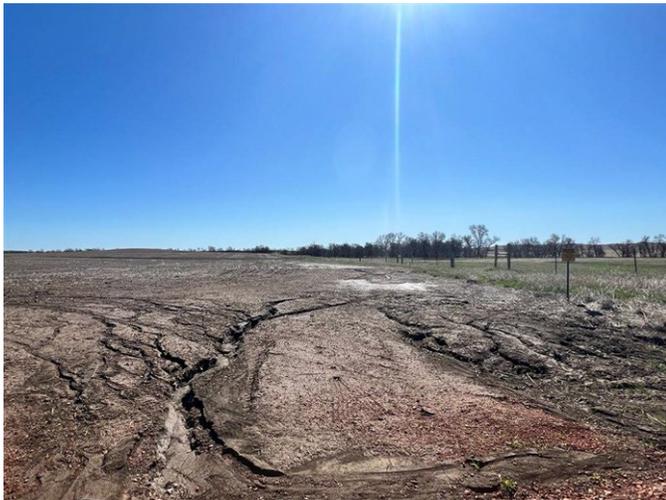
Tioga Elkhorn Creek PL Spread 2 – Erosion channels near Access Road 31 (May 10, 2022) – Communication – MP 45.6

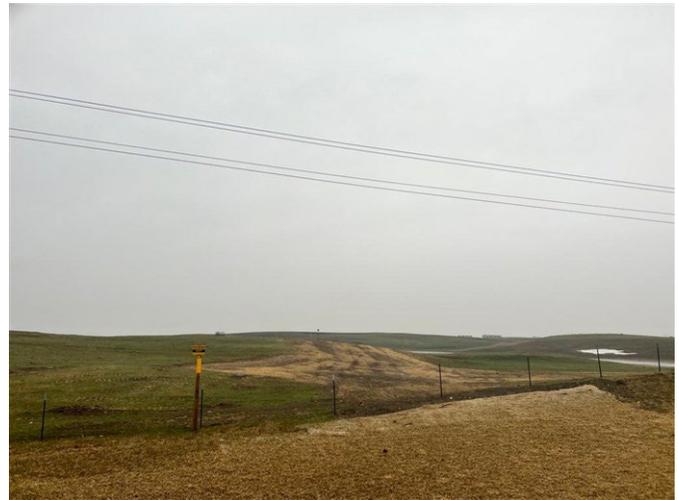
Line Section 25 Loop – Stable hay fields (May 11, 2022) – Communication – MP 1.7

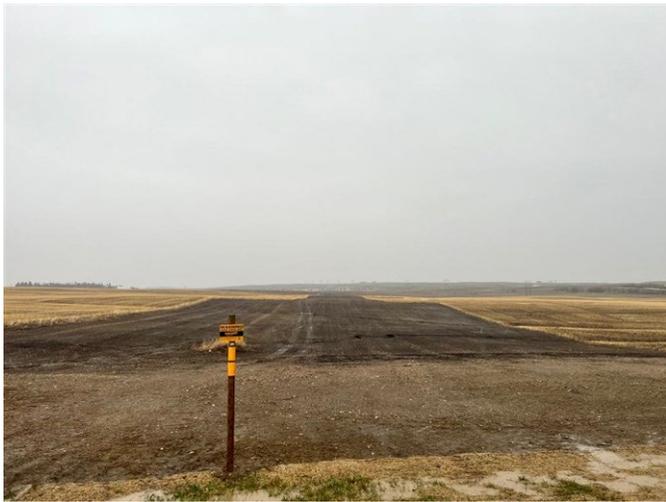
Line Section 25 Loop – Stable agricultural lands (May 11, 2022) – Communication – MP 2.6

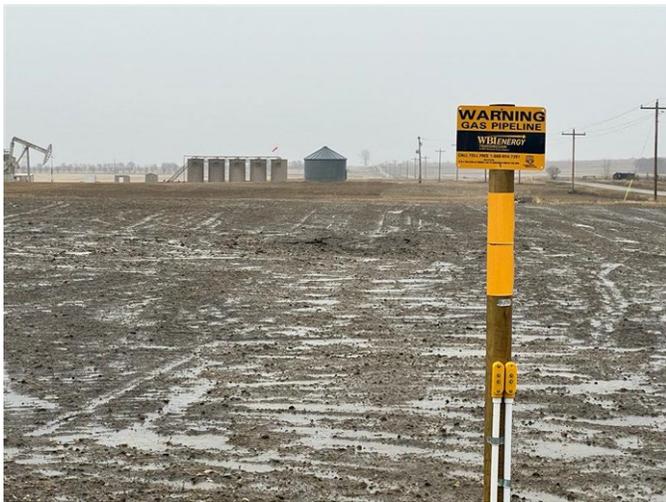
SUMMARY OF COMMUNICATION REPORTS FOR THE NORTH BAKKEN EXPANSION PROJECT				
Compliance Level/Report Number	Date Issued	Location (Spread/Facility/Milepost [MP]/County/State)	Follow-up Required (Yes or No)	Description
				Loop. Minor subsidence over the centerline of the pipeline was also noted near the Williams / Mountrail County line. These observations and areas of needed maintenance had already been incorporated into a punch list by WBI to be repaired as conditions allowed as confirmed by discussions with the EI. The installation of permanent fences at new facilities at the northern-most end of the Line Section 25 Loop at MP 20.2, at the Norse Meter and Transfer Station, and at a new launcher / receiver device were completed. The EI indicated that maintenance crews were on standby on May 11 as result of complicated access caused by rain. Maintenance activities will resume when conditions are suitable to continue working.

Line Section 25 Loop – Minor subsidence in background (May 11, 2022) – Communication – MP 7.7

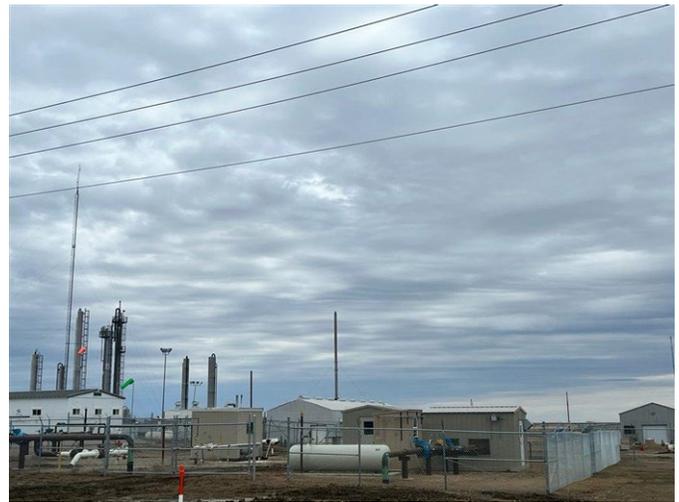
Lignite Meter Station – Upgrades completed and fences installed (May 12, 2022) – Communication – MP 0.0

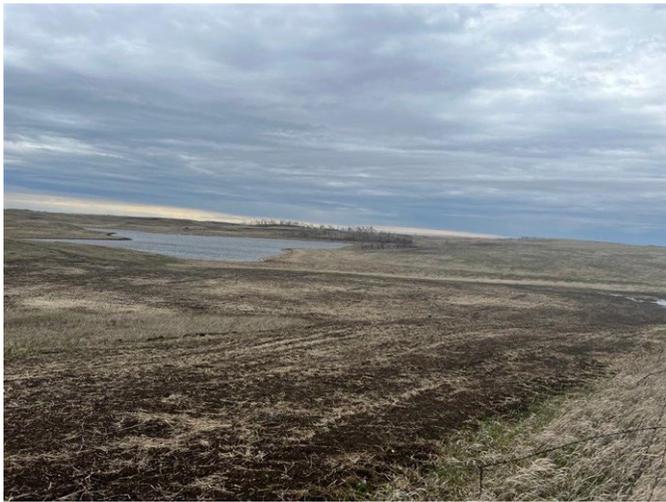
Uprates to Line Section 25 – Stable and restored area at the north side of 89th Street NW (May 12, 2022) – Communication – MP 0.0

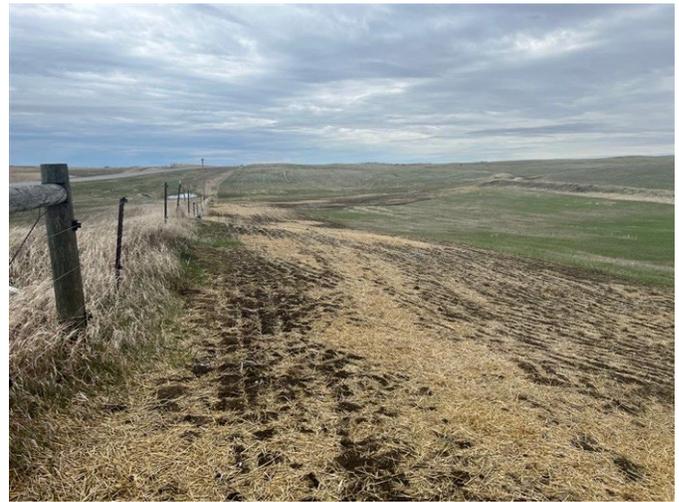
Uprates to Line Section 25 – Stable hay fields at the west side of Highway 40 (May 12, 2022) – Communication – MP 0.0

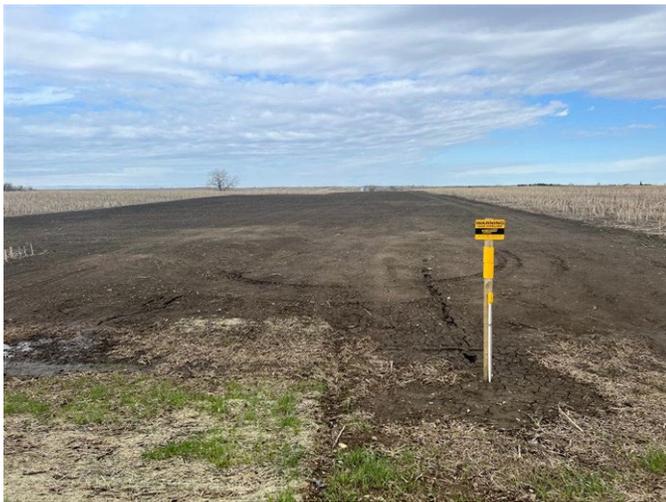
Compliance Level/Report Number	Date Issued	Location (Spread/Facility/Milepost [MP]/County/State)	Follow-up Required (Yes or No)	Description
				was noted along the pad of the pipeline test lead cables. Test leads are used to verify their pipeline system and integrity is protected. Restoration was satisfactory overall. The findings were communicated to the EI.

Line Section 30 Loop – Minor subsidence at test leads (May 13, 2022) – Communication – MP 4.2

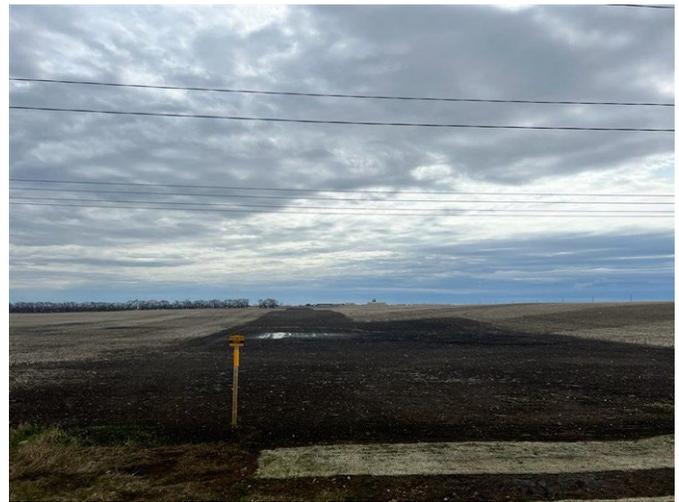
Line Section 30 Loop – Saturated right-of-way and functional ECDs (May 13, 2022) – Communication – MP 6.4
