Re: WBI Energy Transmission, Inc.  
Docket Nos. CP20-52-000 and CP20-52-001  
North Bakken Expansion Project  
Status Report No. 39

**WBI Energy Transmission, Inc.**  
**North Bakken Expansion Project Status Report No. 39**  
**FERC Docket Nos. CP20-52-000**  
**CP20-52-001**

**Reporting Period:** June 1, 2022 through June 5, 2022

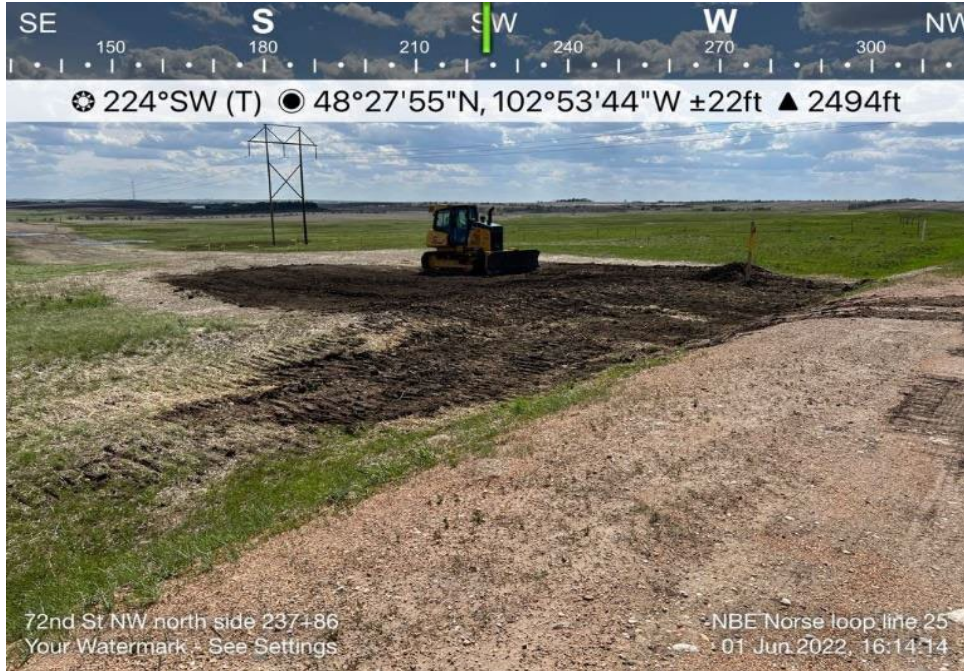
Location:  
Sta. No. 237+86

Notes: Repairing  
trench settling on the  
Line Section 25 Loop  
Pipeline right-of-way.

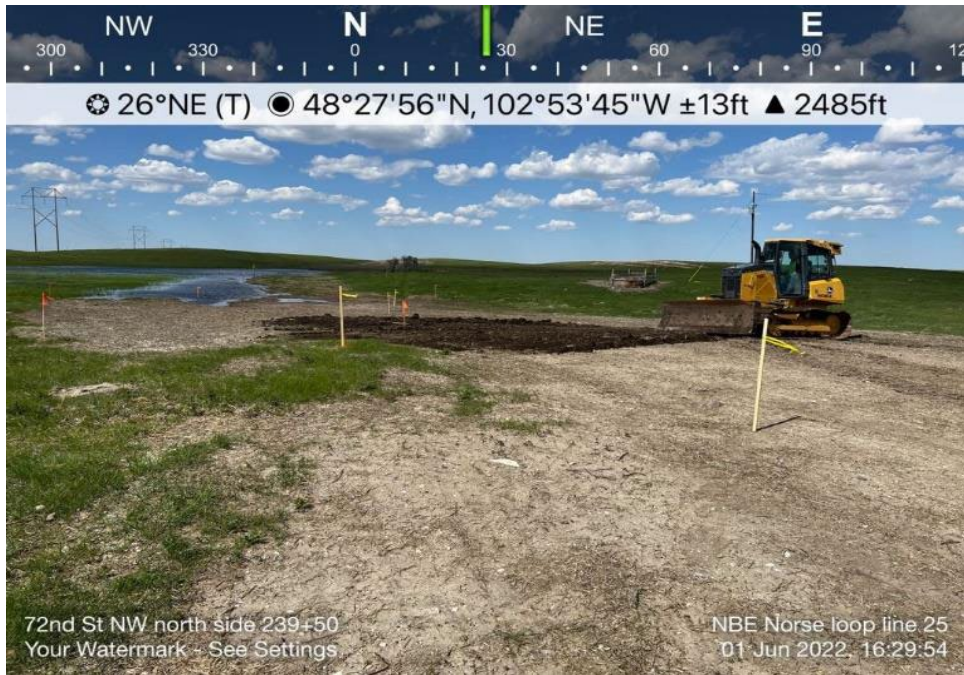
Location:  
Sta. No. 239+50

Notes: Repairing  
trench settling on the  
Line Section 25 Loop  
Pipeline right-of-way.

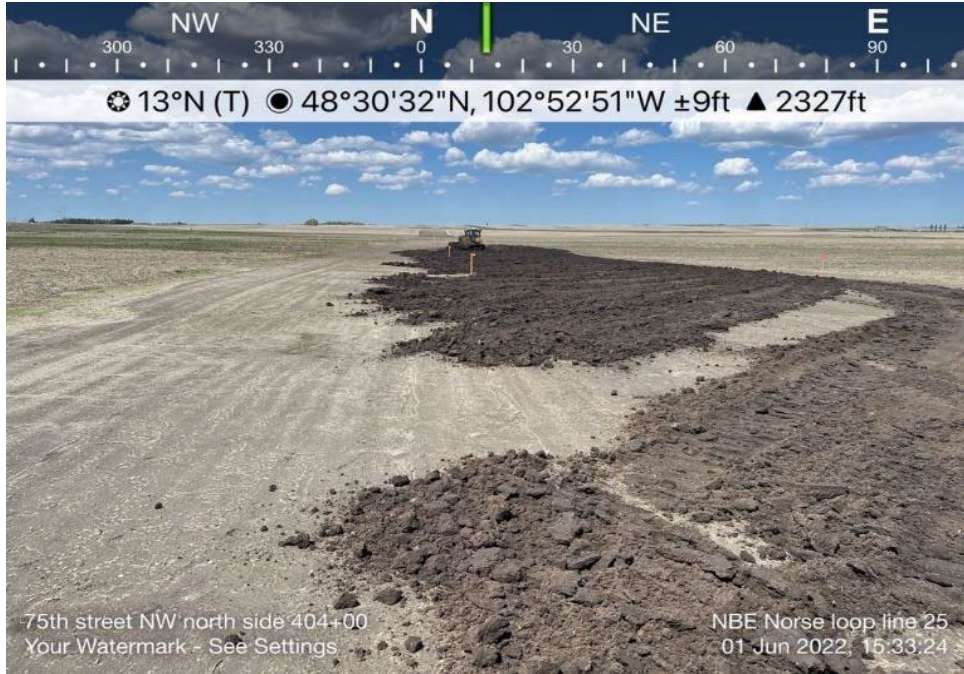
Date: 6/1/2022  
Location:  
Sta. No. 404+00

Notes: Repairing  
trench settling on the  
Line Section 25 Loop  
Pipeline right-of-way.

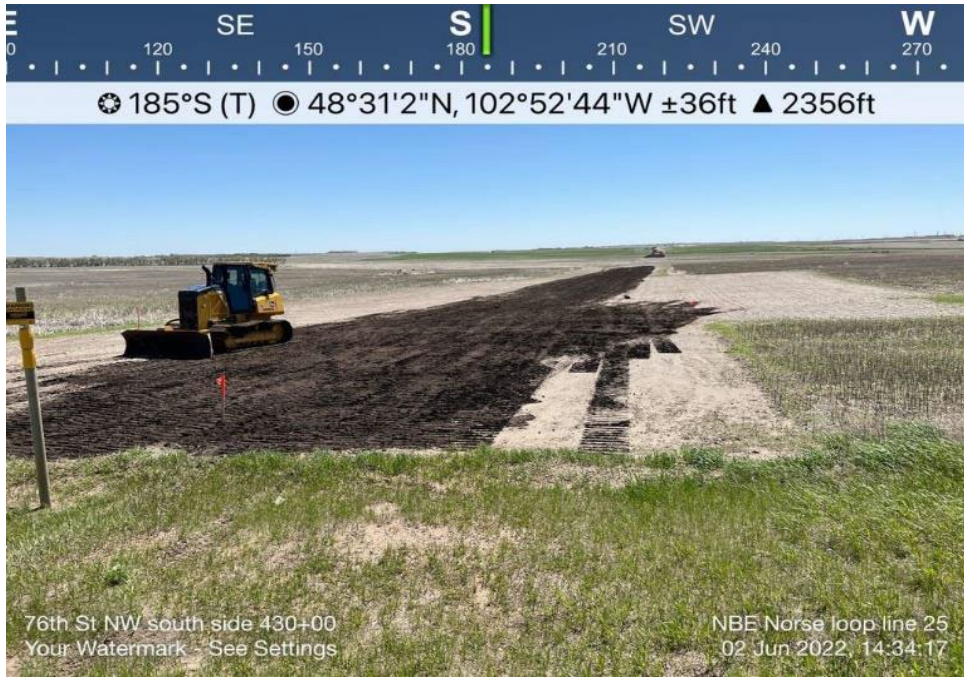
Date: 6/2/2022  
Location:  
Sta. No. 430+00

Notes: Repairing  
trench settling on the  
Line Section 25 Loop  
Pipeline right-of-way.

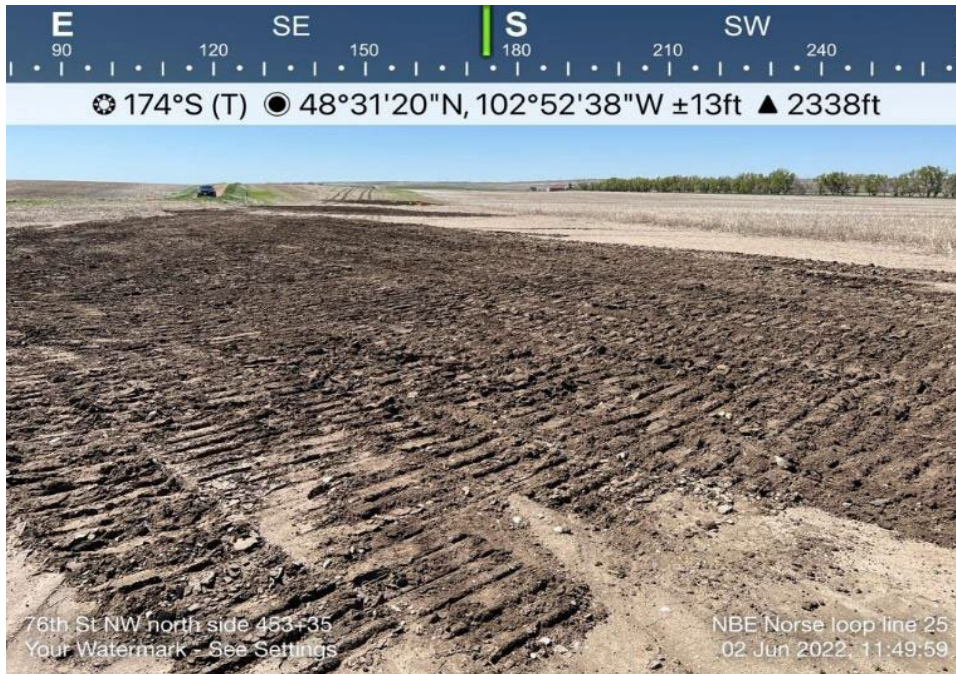
Location:  
Sta. No. 453+35

Notes: Repaired  
trench settling on the  
Line Section 25 Loop  
Pipeline right-of-way.

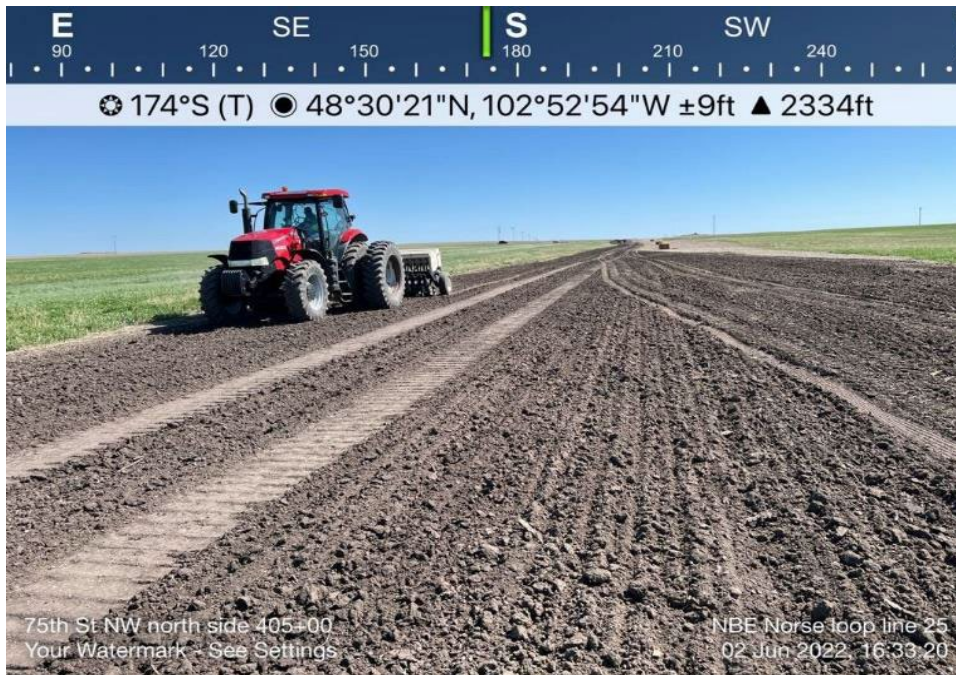
Location: Sta. Nos.  
381+90 to 405+00

Notes: Reseeding the  
repaired Line Section  
25 Loop Pipeline  
right-of-way with an  
alfalfa and oat seed  
mix that had been  
used in Fall 2021.

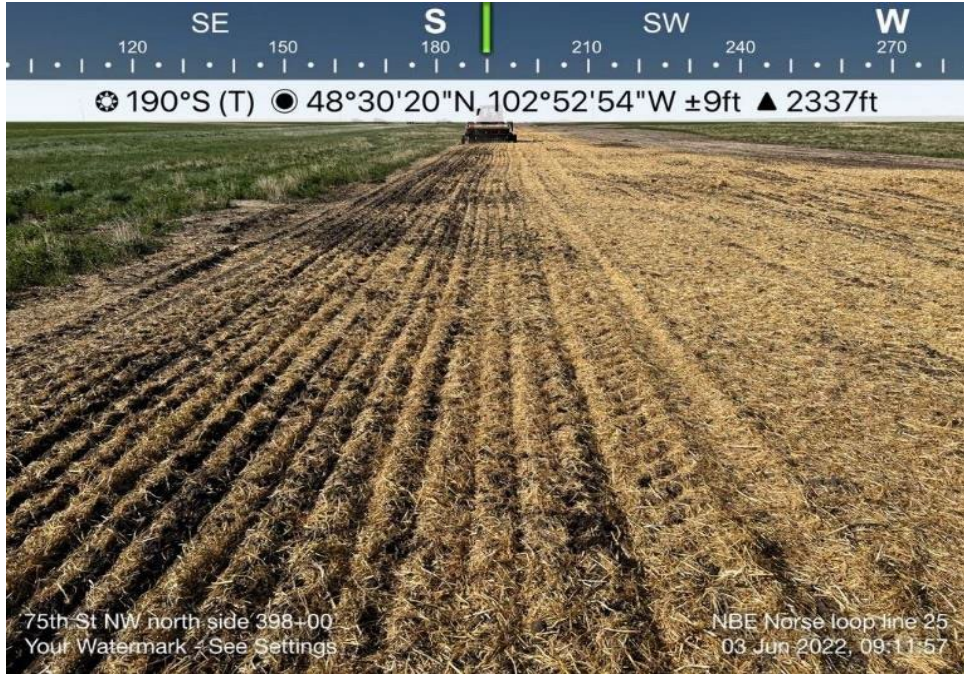
Location:  
Sta. No. 398+00

Notes: Crimping straw mulch into reseeded right-of-way to anchor mulch on the Line Section 25 Loop Pipeline.

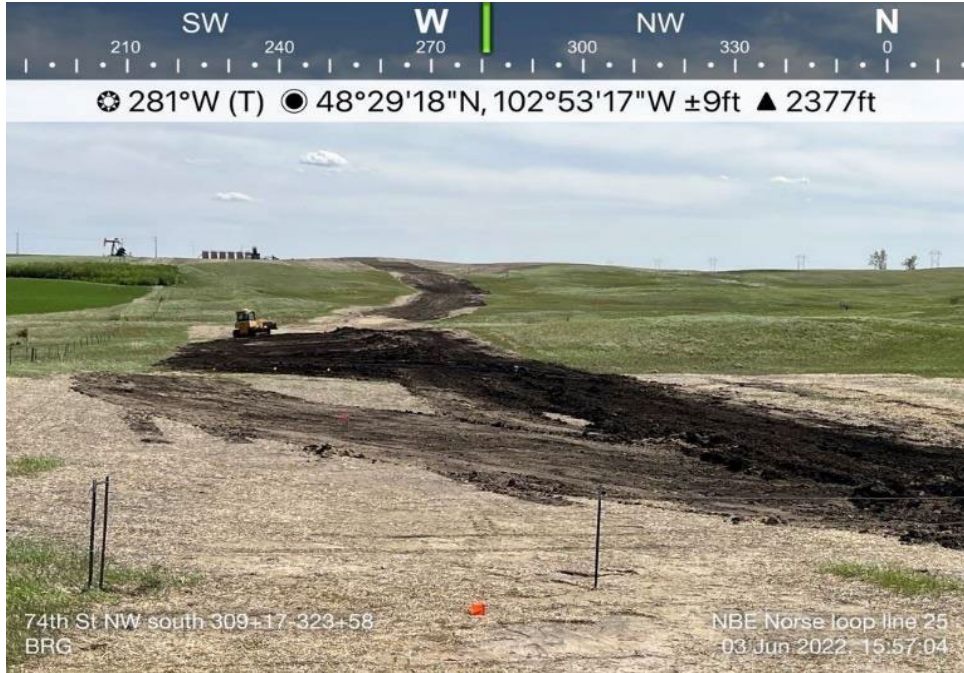
Location: Sta. Nos  
309+17 to 323+58

Notes: Repairing trench settling on the Line Section 25 Loop Pipeline right-of-way.

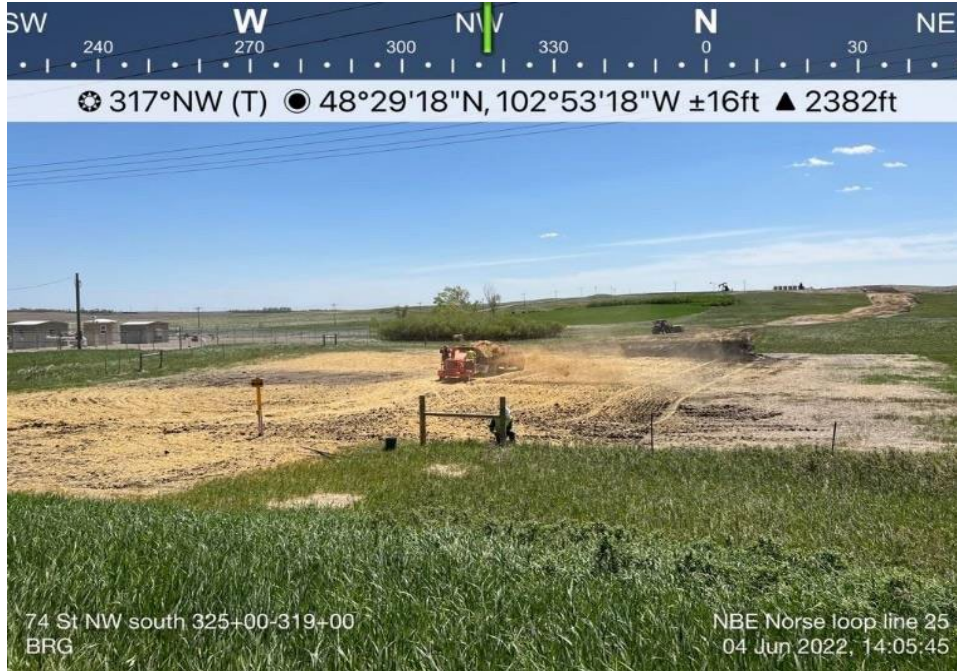
Location: Sta. Nos. 309+00 to 325+00

Notes: Crimping straw mulch into reseeded right-of-way to anchor mulch on the Line Section 25 Loop Pipeline.

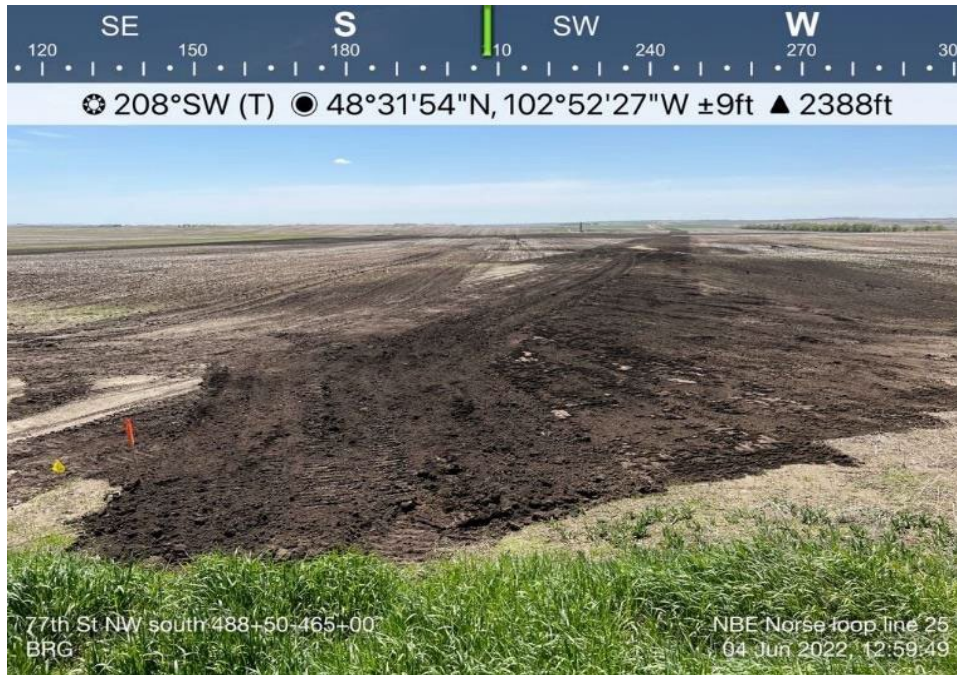
Location: Sta. Nos. 465+00 to 488+50

Notes: Repaired rill/channel erosion on the Line Section 25 Loop Pipeline right-of-way.
