Re: WBI Energy Transmission, Inc.  
Docket Nos. CP20-52-000 and CP20-52-001  
North Bakken Expansion Project  
Status Report No. 40

**WBI Energy Transmission, Inc.**  
**North Bakken Expansion Project Status Report No. 40**  
**FERC Docket Nos. CP20-52-000**  
**CP20-52-001**

**Reporting Period:** June 6, 2022 through June 12, 2022

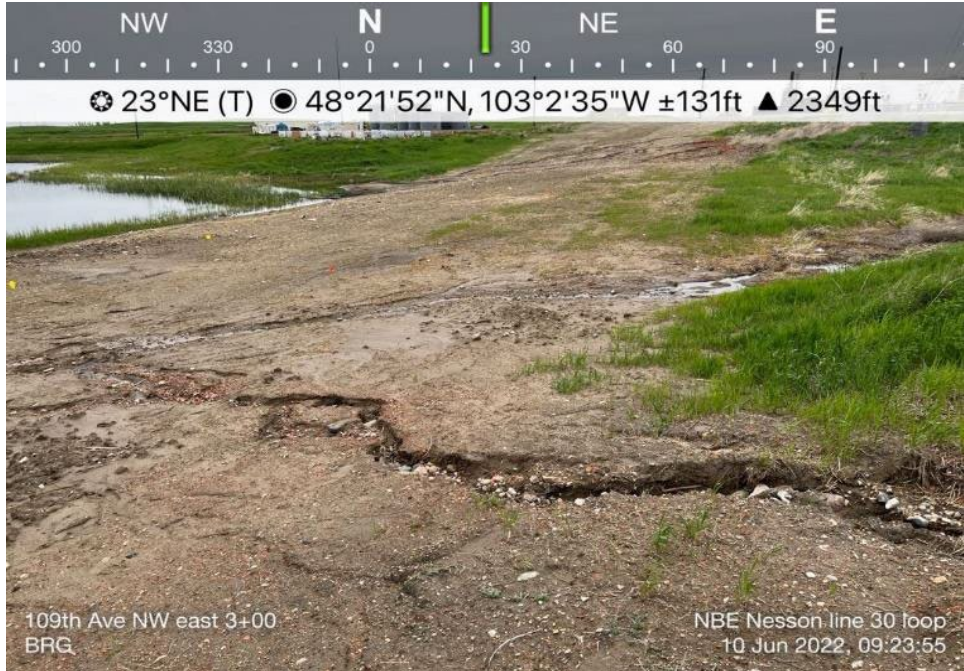
Location:  
Sta. No. 3+00

Notes: Rill/channel erosion on the Line Section 30 Loop Pipeline right-of-way. This area will be addressed when conditions allow.

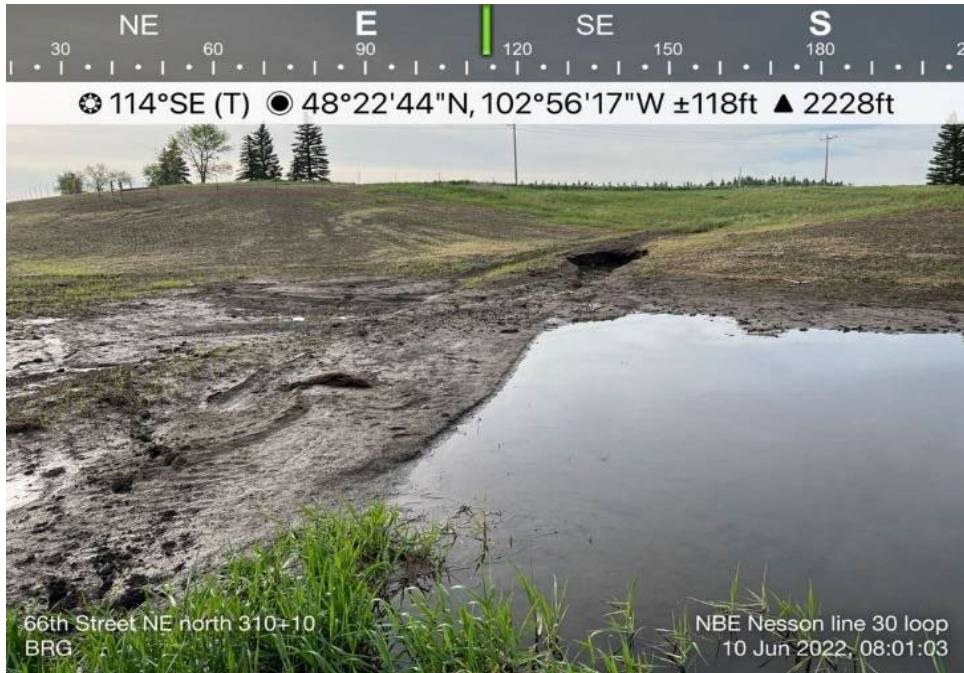
Location:  
Sta. No. 310+10

Notes: Sediment from rill/channel erosion deposited into wetland w-wm-ec-003e on the Line Section 30 Loop Pipeline. This area will be addressed when conditions allow.

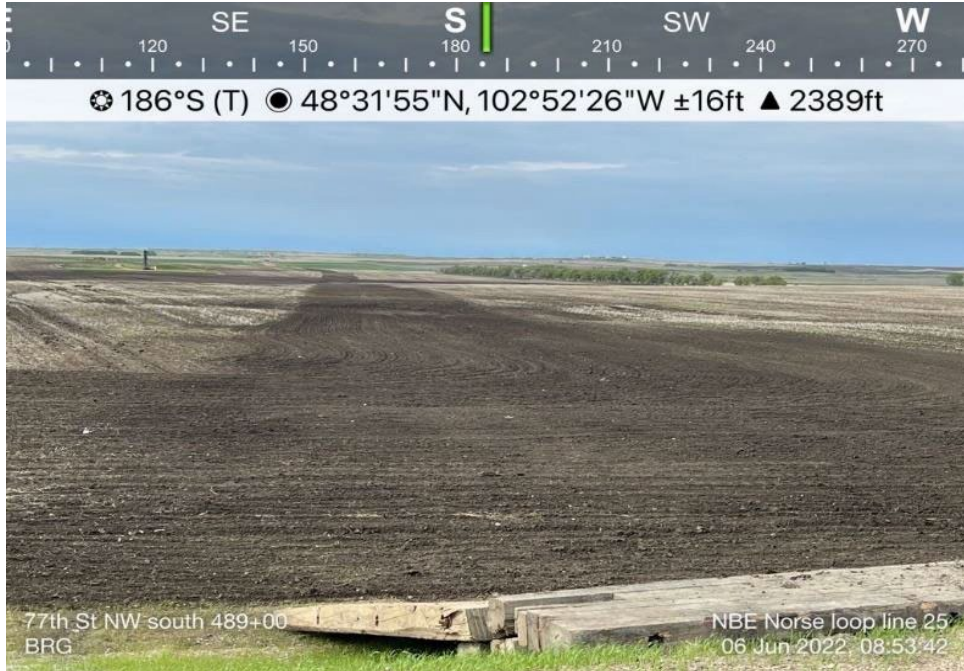
Location:  
 Sta. No. 489+00

Notes: Landowner seeded cultivated field that had been repaired the previous week on the Line Section 25 Loop Pipeline right-of-way.

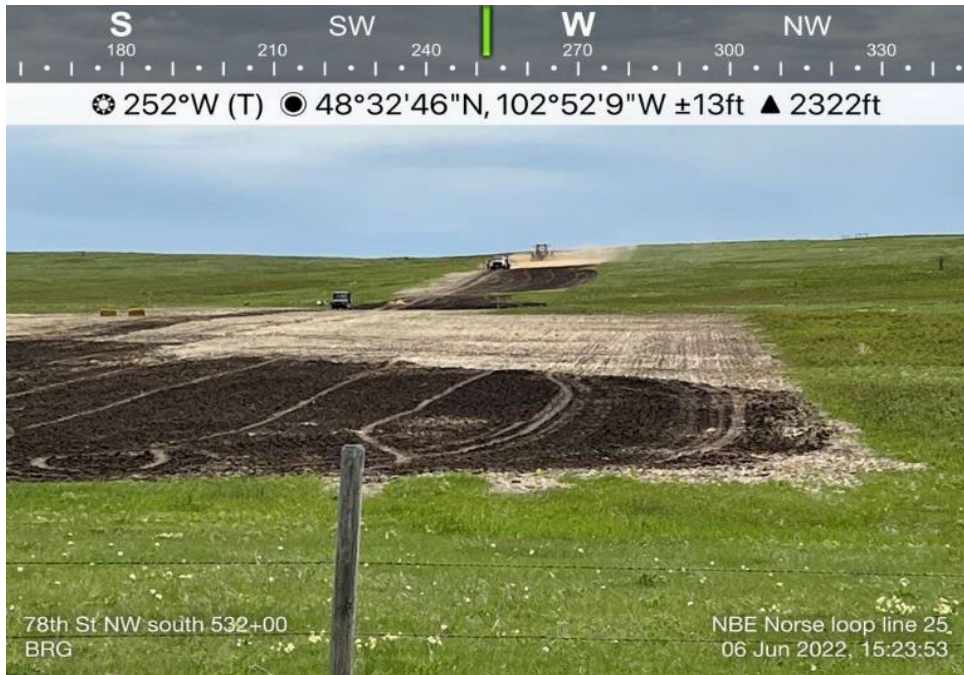
Location:  
 Sta. No. 516+51 to 543+11

Notes: Crimping straw mulch into reseeded right-of-way to anchor mulch on the Line Section 25 Loop Pipeline.

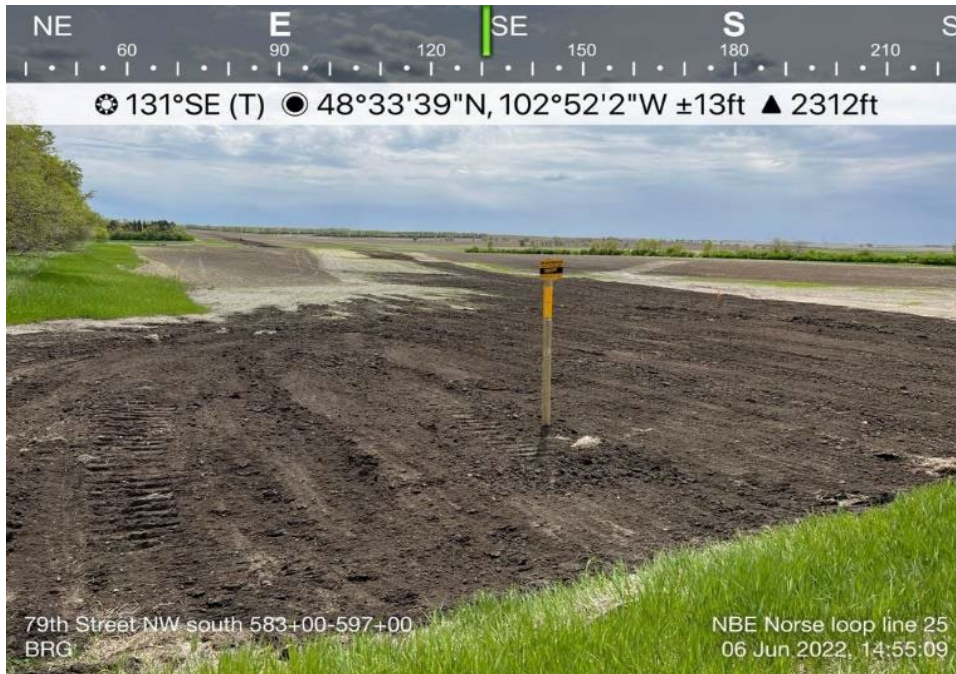
Location: Sta. Nos. 583+00 to 597+00

Notes: Repaired trench settling on the Line Section 25 Loop Pipeline right-of-way.

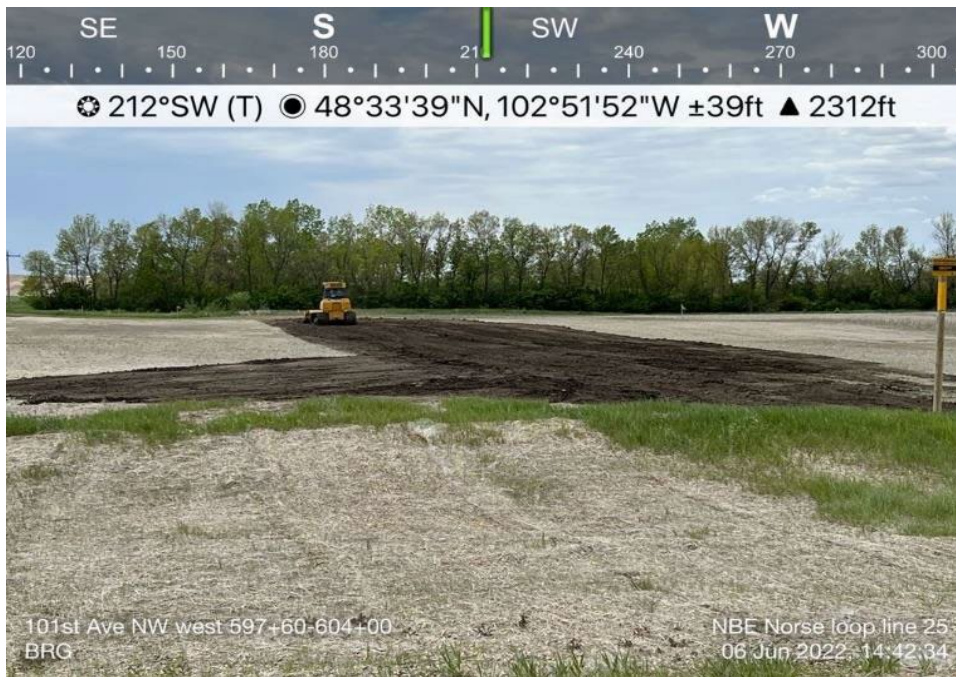
Location: Sta. Nos. 597+60 to 604+00

Notes: Repairing trench settling on the Line Section 25 Loop Pipeline right-of-way.

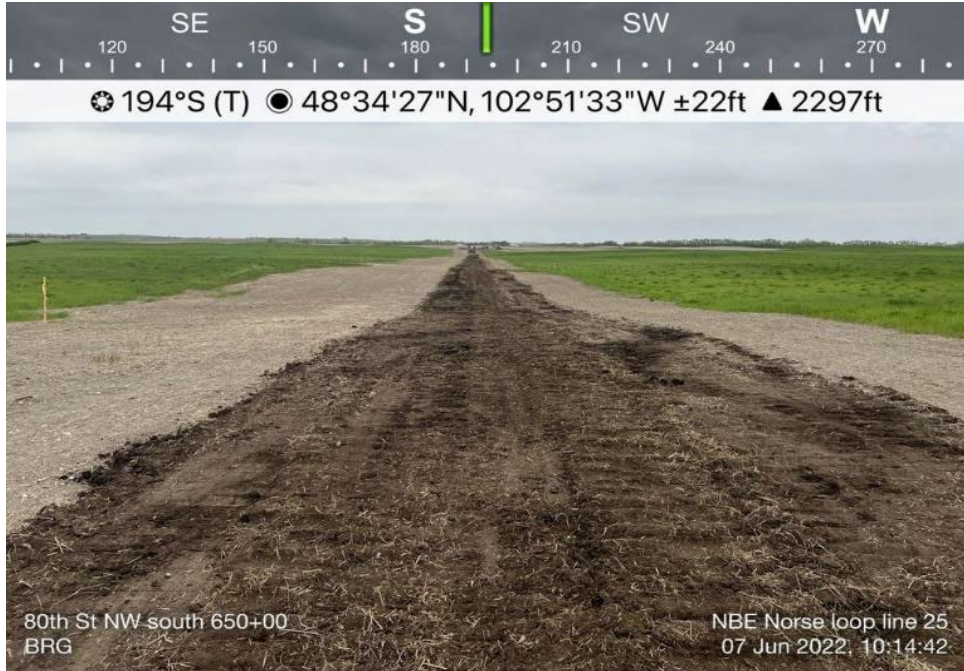
Notes: Repaired trench settling on the Line Section 25 Loop Pipeline right-of-way.

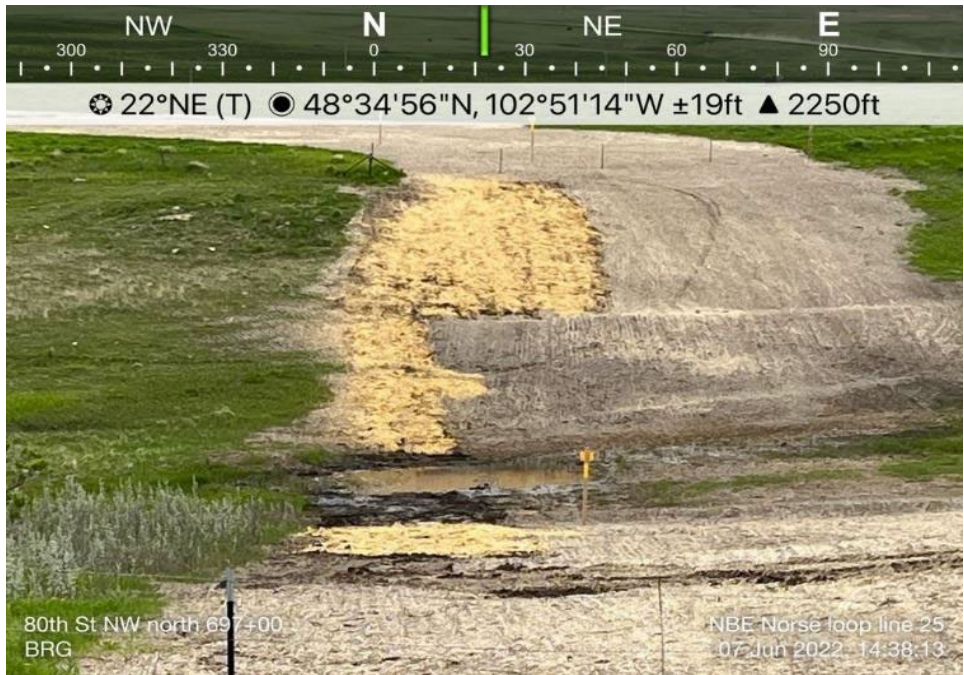
Notes: Repaired trench settling and crimped straw mulch into reseeded right-of-way and hillside of wetland w-bk-ee-002e to anchor mulch on the Line Section 25 Loop Pipeline.

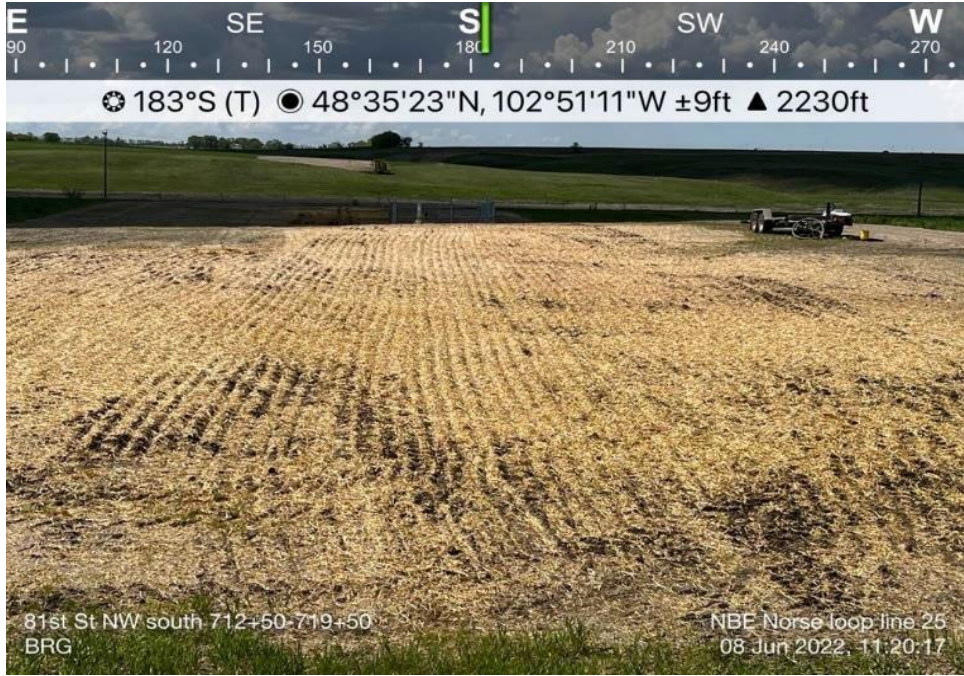
Location: Sta. Nos. 712+50 to 719+50

Notes: Crimped straw mulch into reseeded right-of-way to anchor mulch on the Line Section 25 Loop Pipeline.

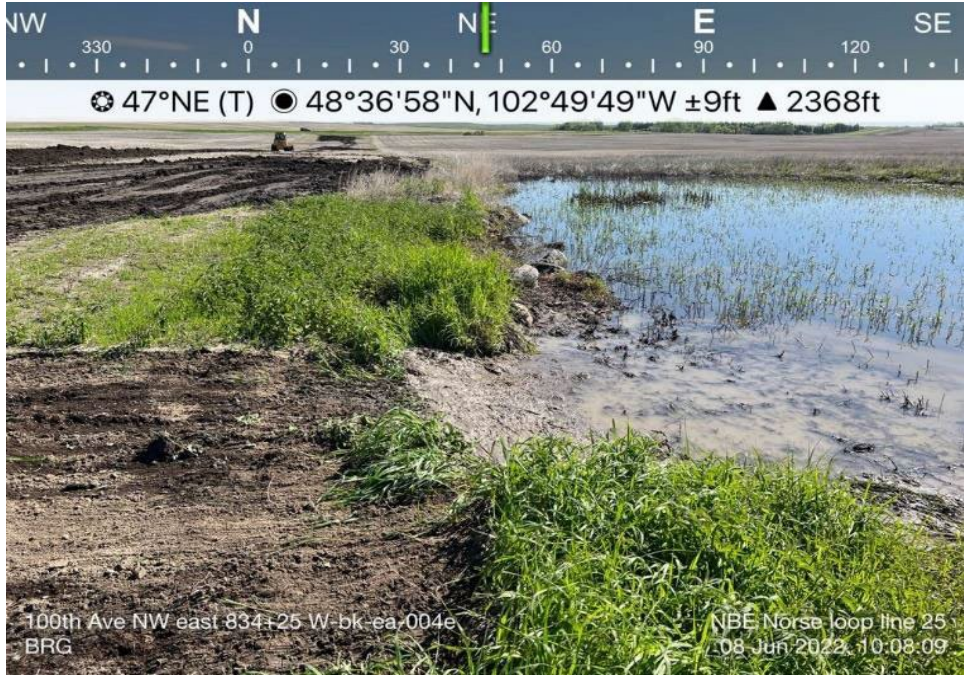
Location: Sta. No. 834+25

Notes: Removed sediment from and restored bank at wetland w-bk-ea-004e on the Line Section 25 Loop Pipeline.

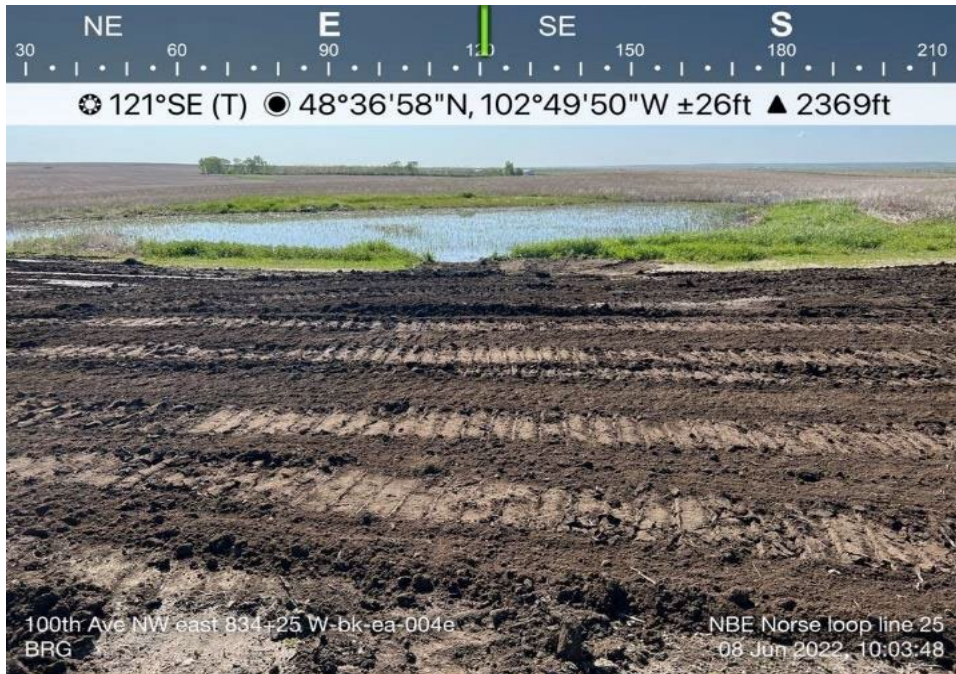
Location:  
Sta. No. 834+25

Notes: Repaired  
rill/channel erosion on  
the Line Section 25  
Loop Pipeline right-  
of-way.

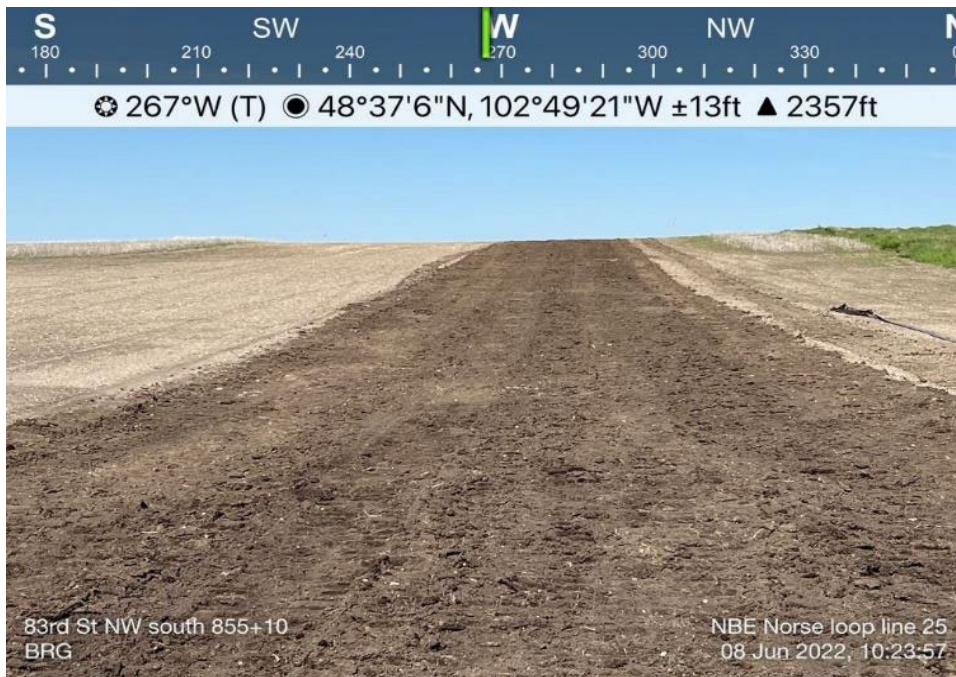
Location:  
Sta. No. 855+10

Notes: Repaired  
trench settling on the  
Line Section 25 Loop  
Pipeline right-of-way.

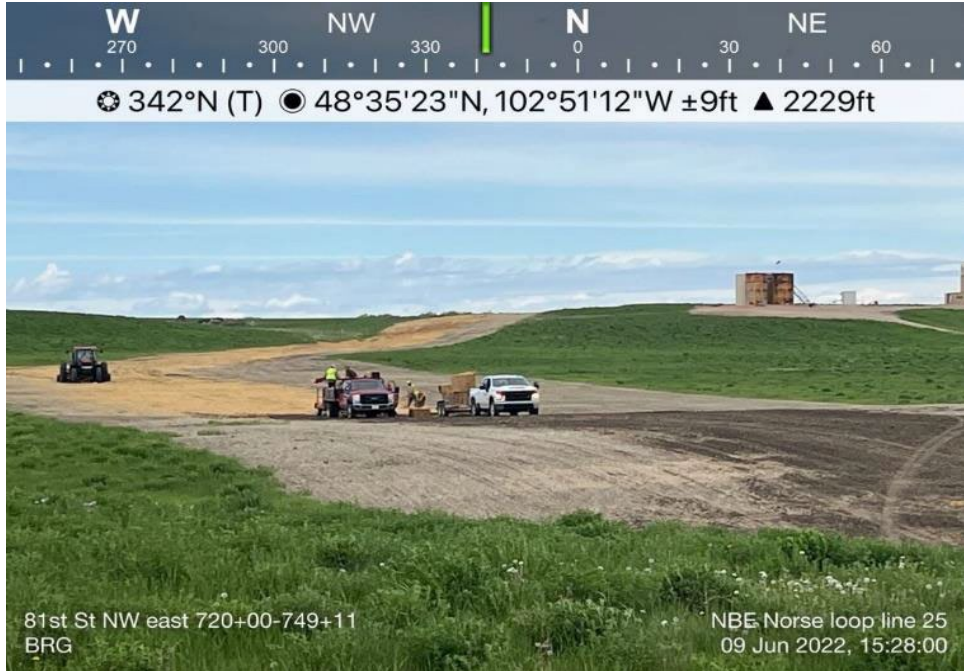
Location: Sta. Nos. 720+00 to 749+11

Notes: Crimping straw mulch into reseeded right-of-way to anchor mulch on the Line Section 25 Loop Pipeline.

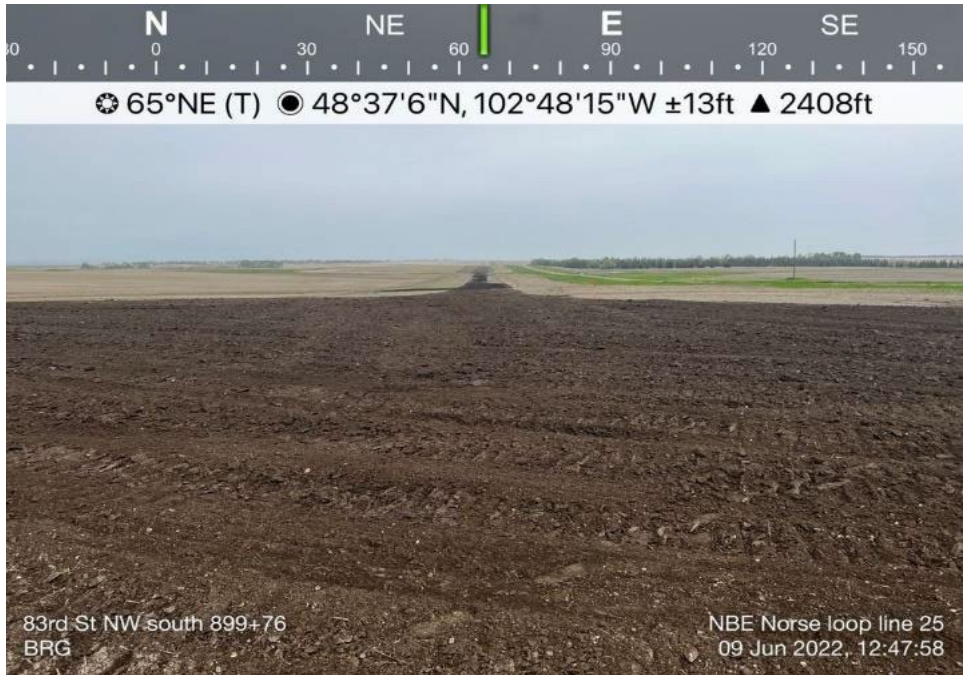
Location: Sta. No. 899+76

Notes: Repaired trench settling on the Line Section 25 Loop Pipeline right-of-way.

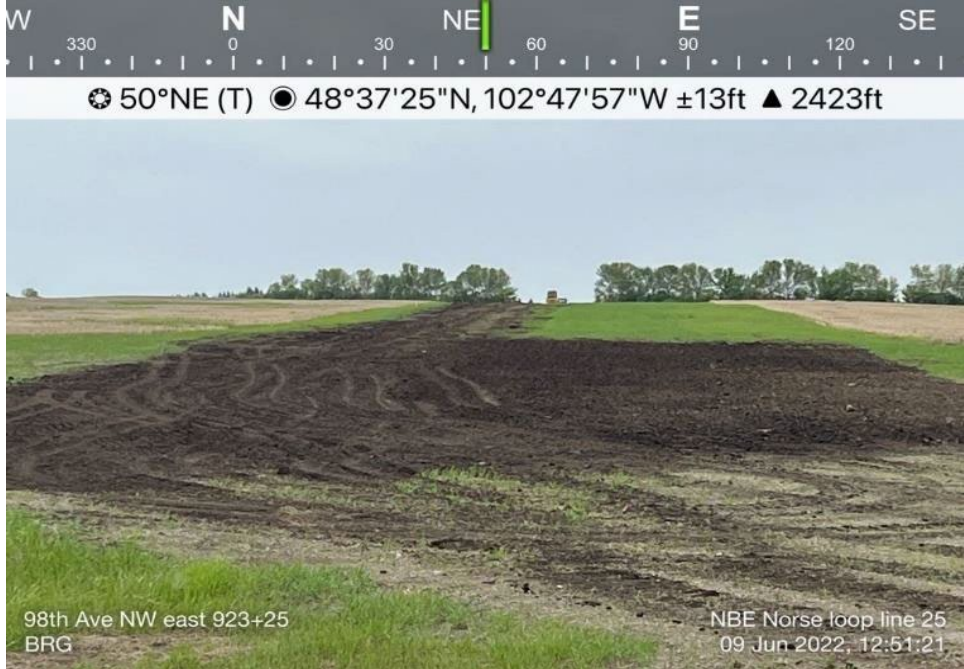
Notes: Repaired  
 trench settling on the  
 Line Section 25 Loop  
 Pipeline right-of-way.

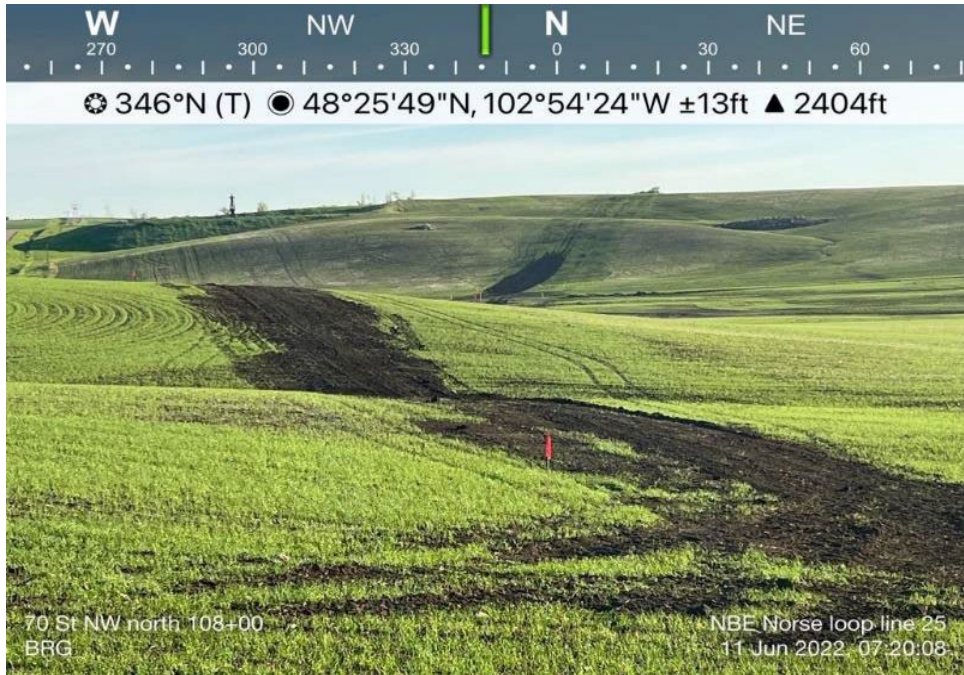
Notes: Repaired  
 trench settling on the  
 Line Section 25 Loop  
 Pipeline right-of-way.

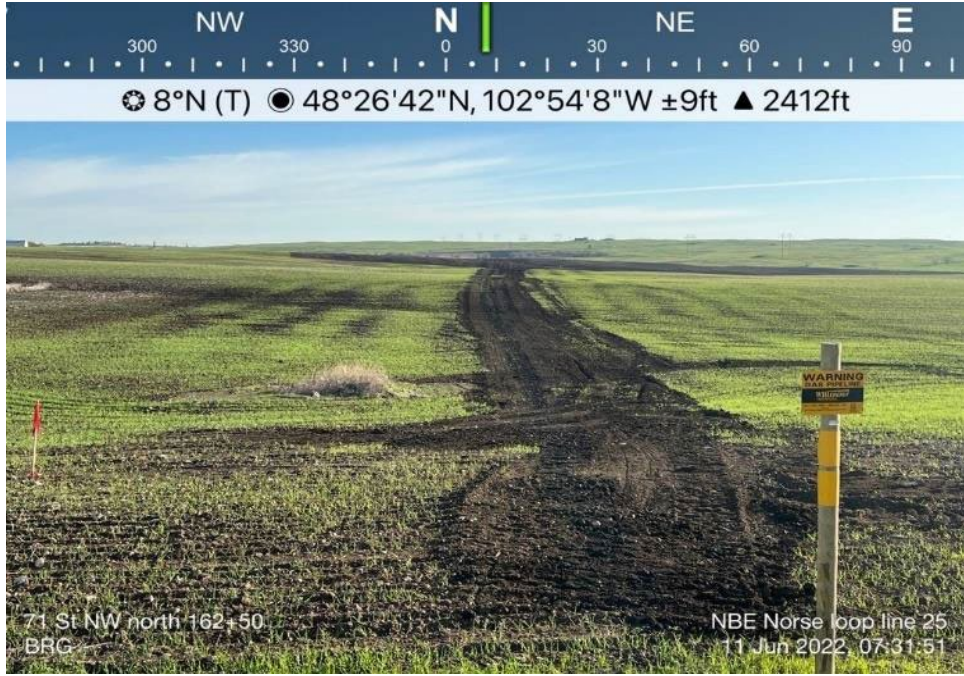
Location: Sta. Nos.  
162+50 to 188+09

Notes: Repaired  
trench settling on the  
Line Section 25 Loop  
Pipeline right-of-way.

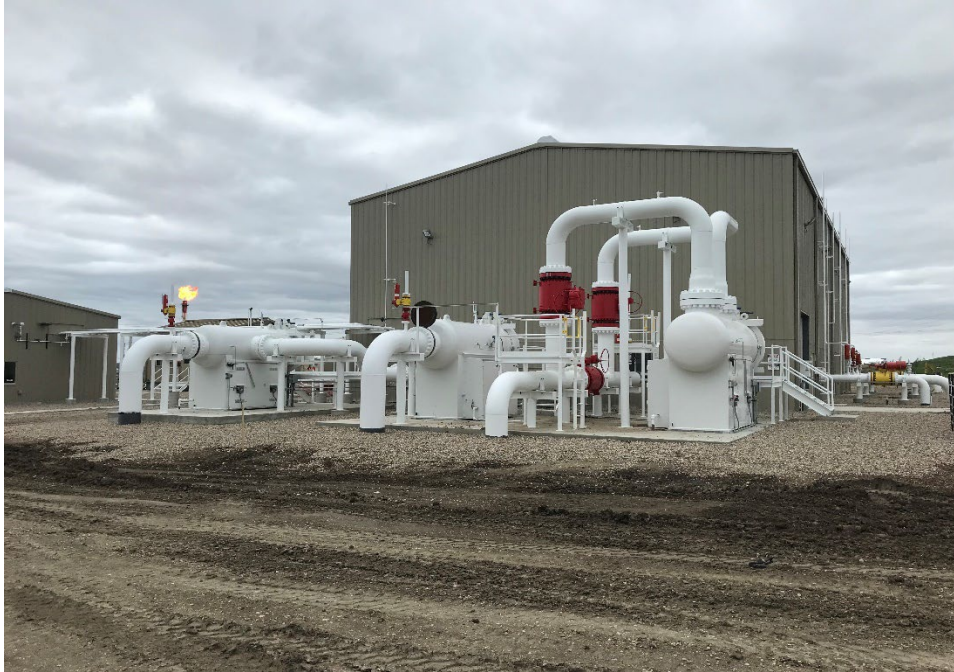
Location: Tioga  
Compressor Station

Notes: Painted station  
piping.

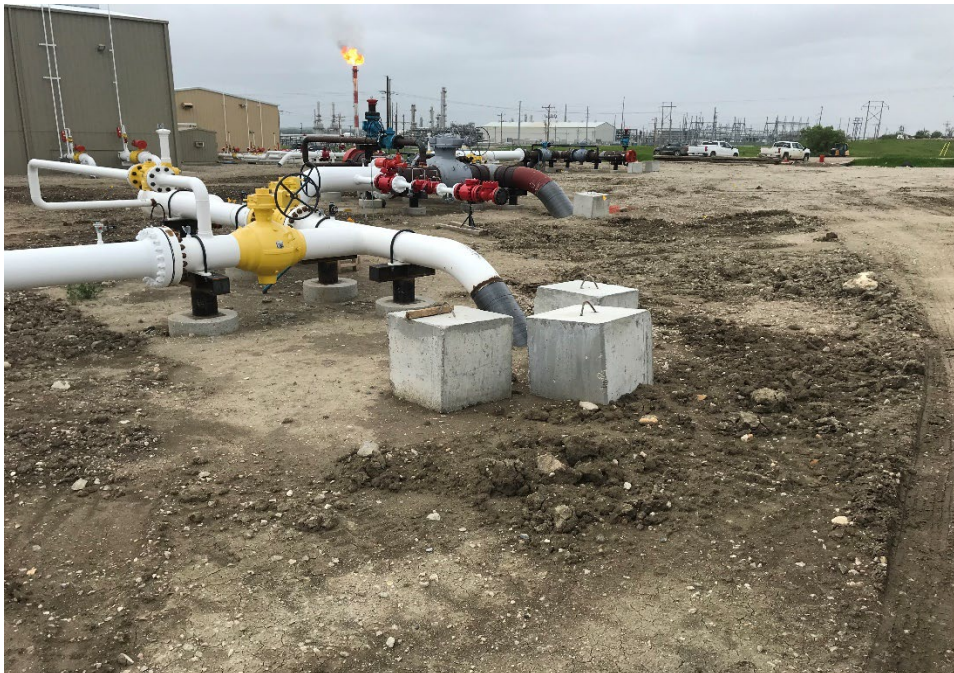
Location: Tioga  
Compressor Station

Notes: Painted station  
piping.
