Re: WBI Energy Transmission, Inc.
Docket Nos. CP20-52-000 and CP20-52-001
North Bakken Expansion Project
Status Report No. 41

WBI Energy Transmission, Inc.
North Bakken Expansion Project Status Report No. 41
FERC Docket Nos. CP20-52-000
CP20-52-001

Reporting Period: June 13, 2022 through June 19, 2022

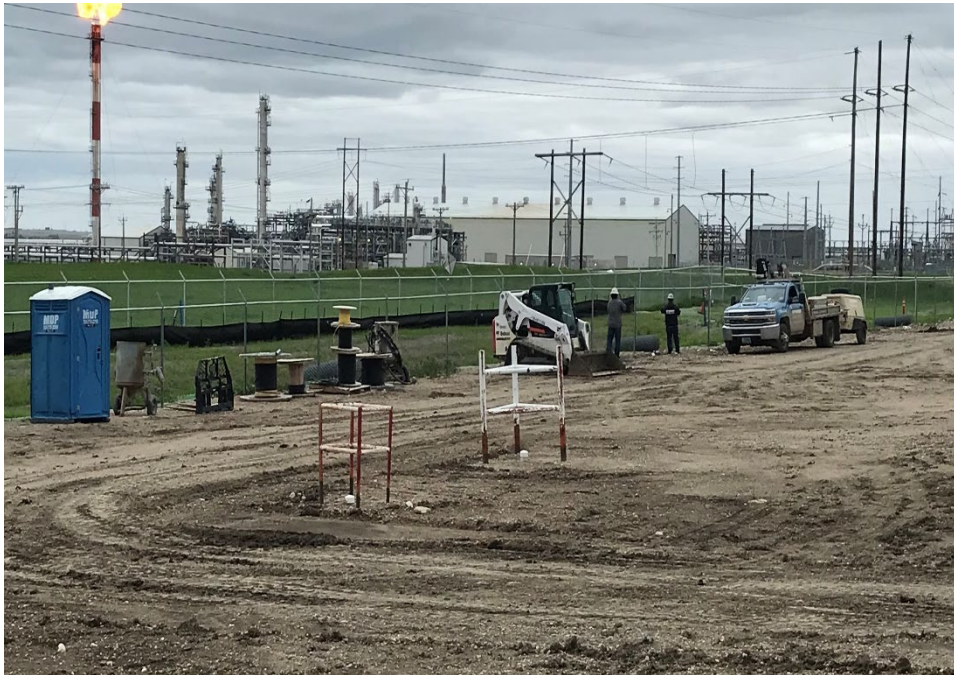
Location: Tioga Compressor Station

Notes: Began re-installing the security fence.

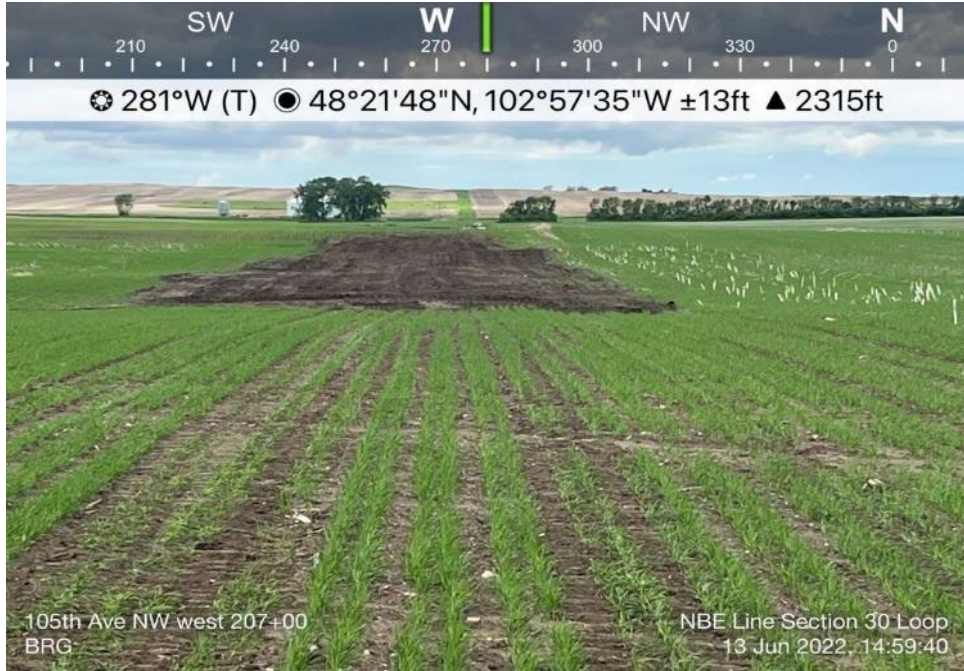
Location:
Sta. No. 207+00

Notes: Repaired trench settling on the Line Section 30 Loop Pipeline right-of-way.

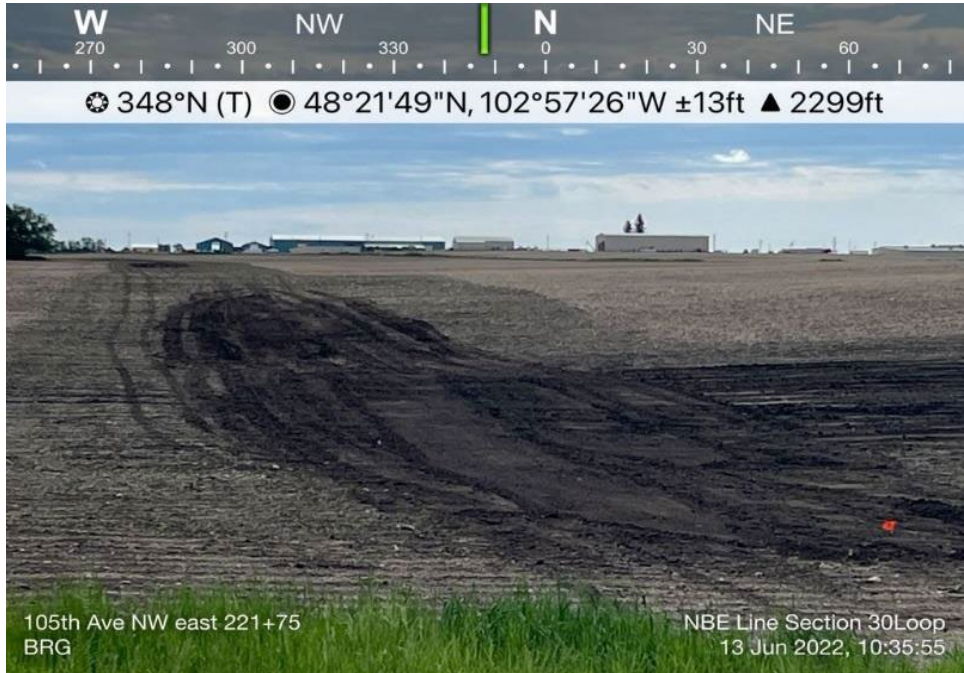
Location:
Sta. No. 221+75

Notes: Repaired trench settling on the Line Section 30 Loop Pipeline right-of-way.

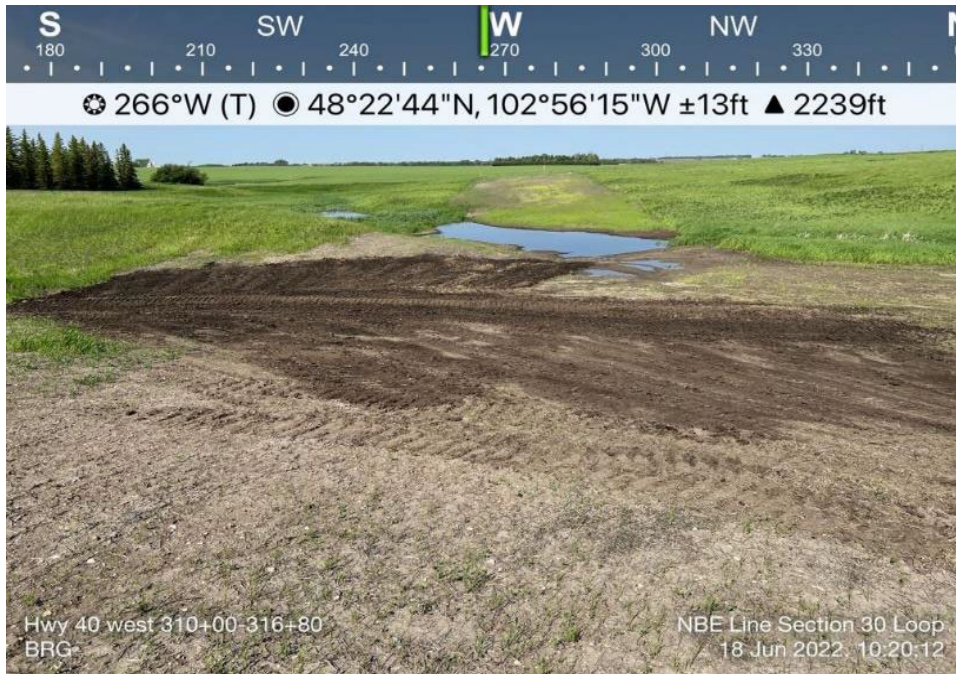
Location:
Sta. No. 311+00

Notes: Repaired
water bar on the
Line Section 30
Loop Pipeline right-
of-way.

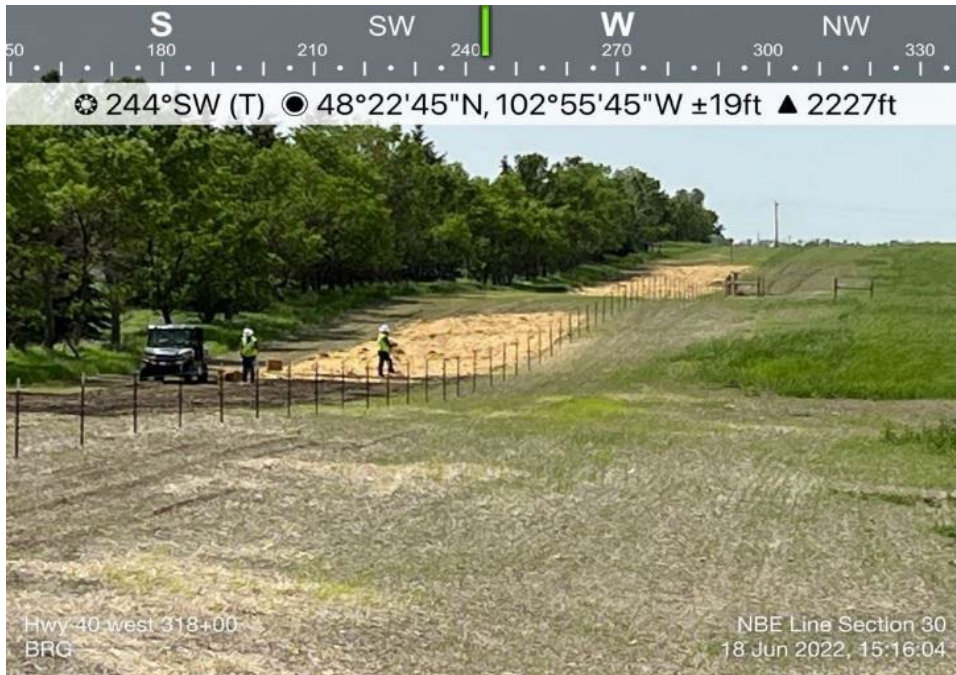
Location:
Sta. No. 318+00

Notes: Spreading
straw mulch onto
reseeded right-of-
way on the Line
Section 30 Loop
Pipeline.

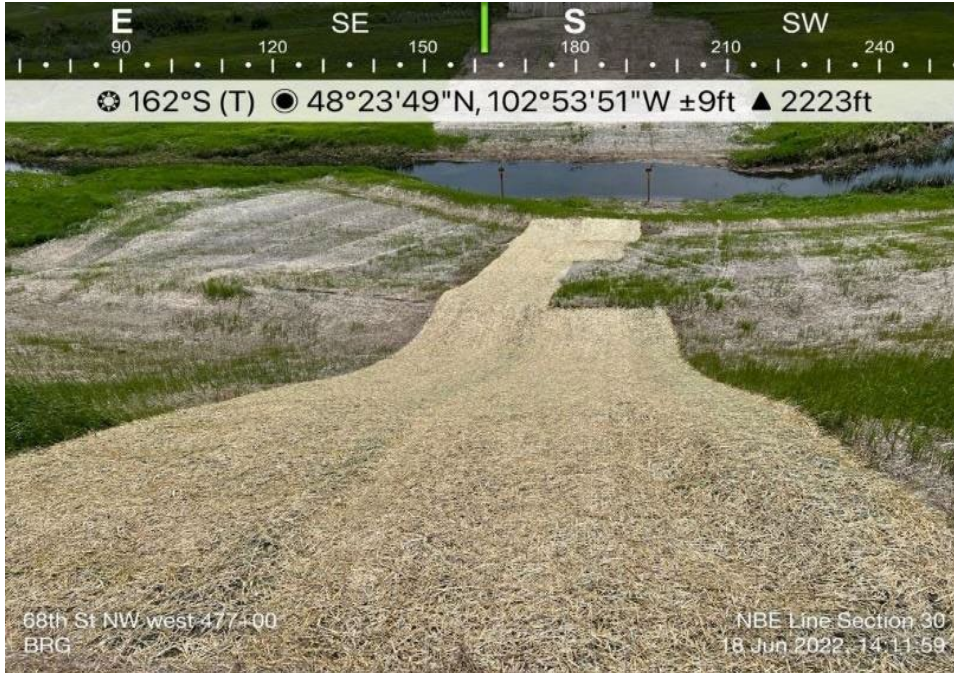
Location:
Sta. No. 477+00

Notes: Repaired
rill/channel erosion
on hillside and
removed sediment
deposits at water
bar on the Line
Section 30 Loop
Pipeline right-of-
way.

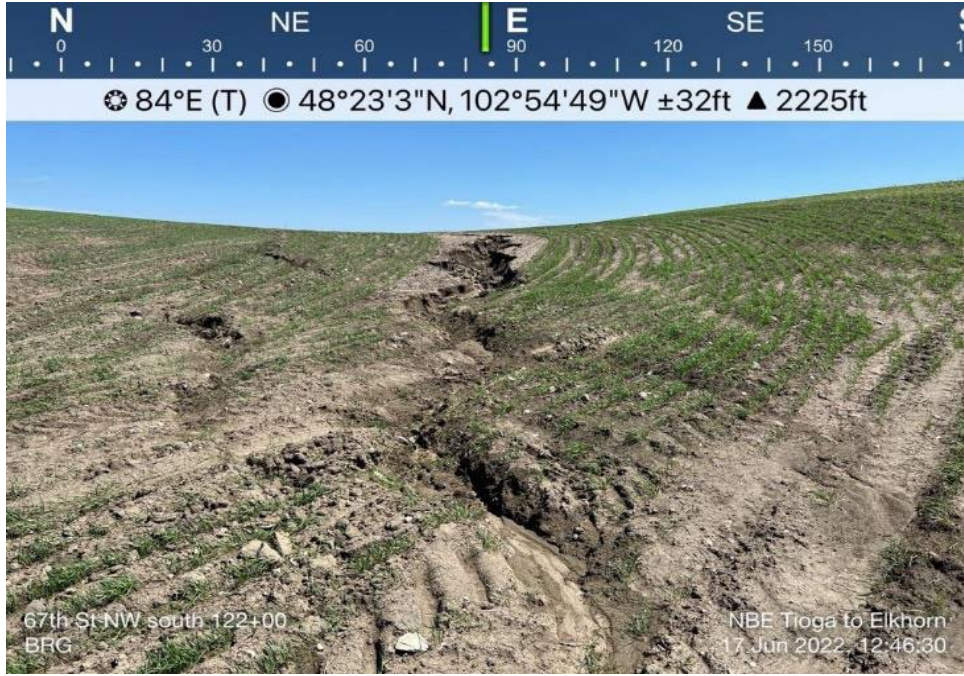
Location:
Sta. No. 122+00

Notes: Severe rill/
channel erosion on
the Tioga-Elkhorn
Creek Pipeline right-
of-way. This area
will be addressed.

- Begin to address areas that require follow-up restoration work.

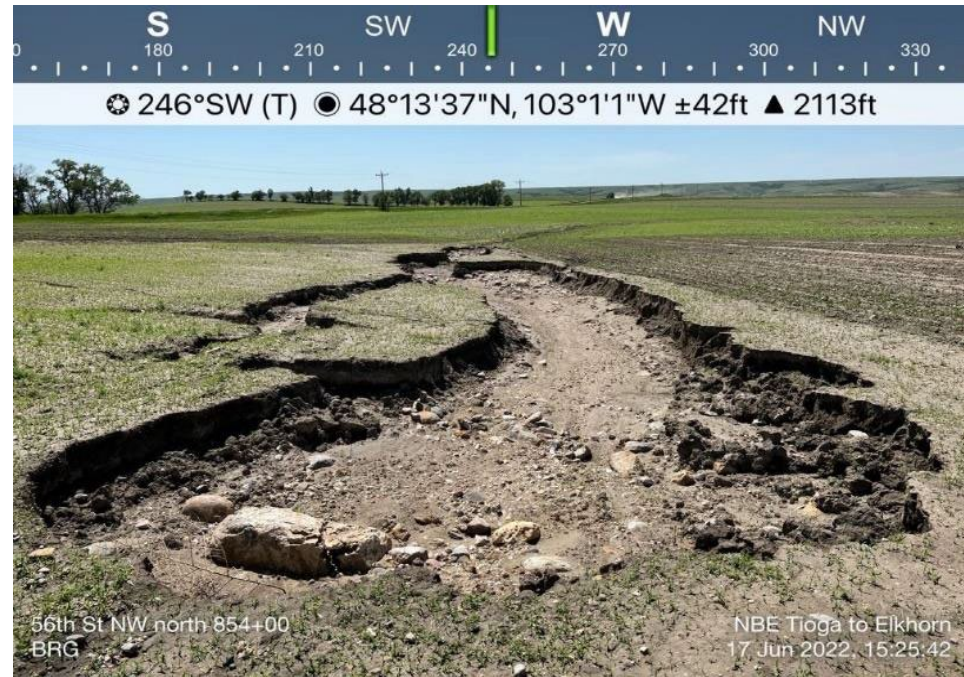
Location:
Sta. No. 854+00

Notes: Severe rill/
channel erosion on
the Tioga-Elkhorn
Creek Pipeline right-
of-way. This area
will be addressed.

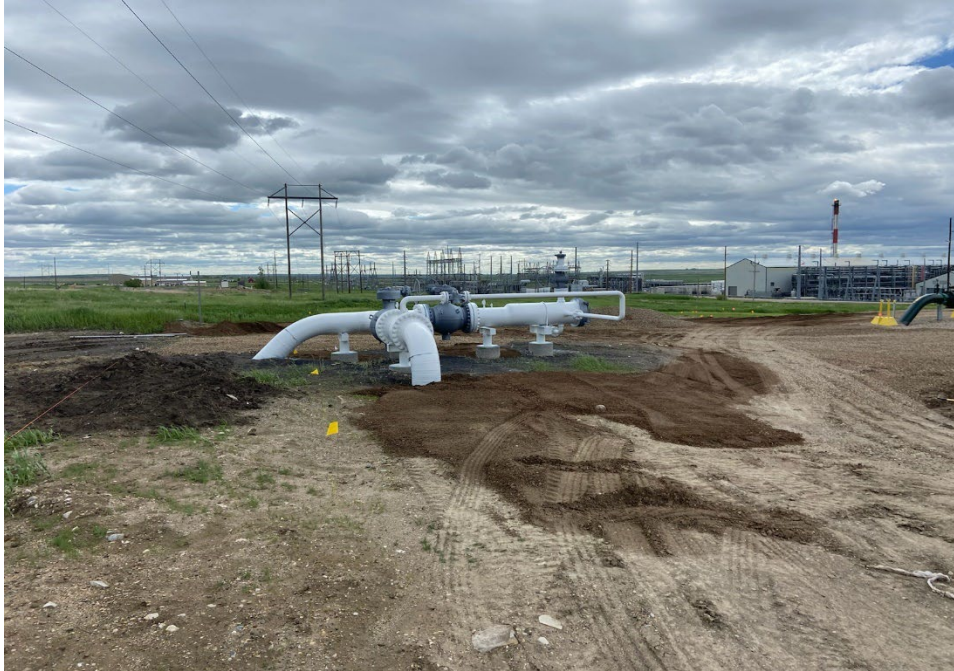
Location: Tioga
Plant Receipt
Station

Notes: Painted pig
launcher/receiver
for the Tioga
Compressor Lateral.

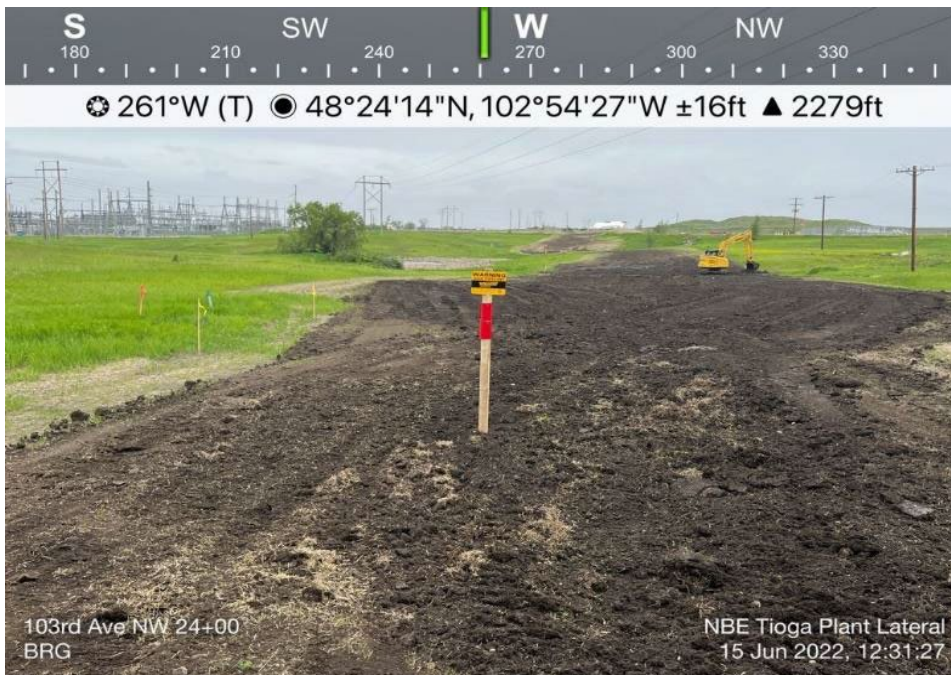
Location:
Sta. No. 24+00

Notes: Repaired
rill/channel erosion
on the Tioga
Compressor Lateral
right-of-way.

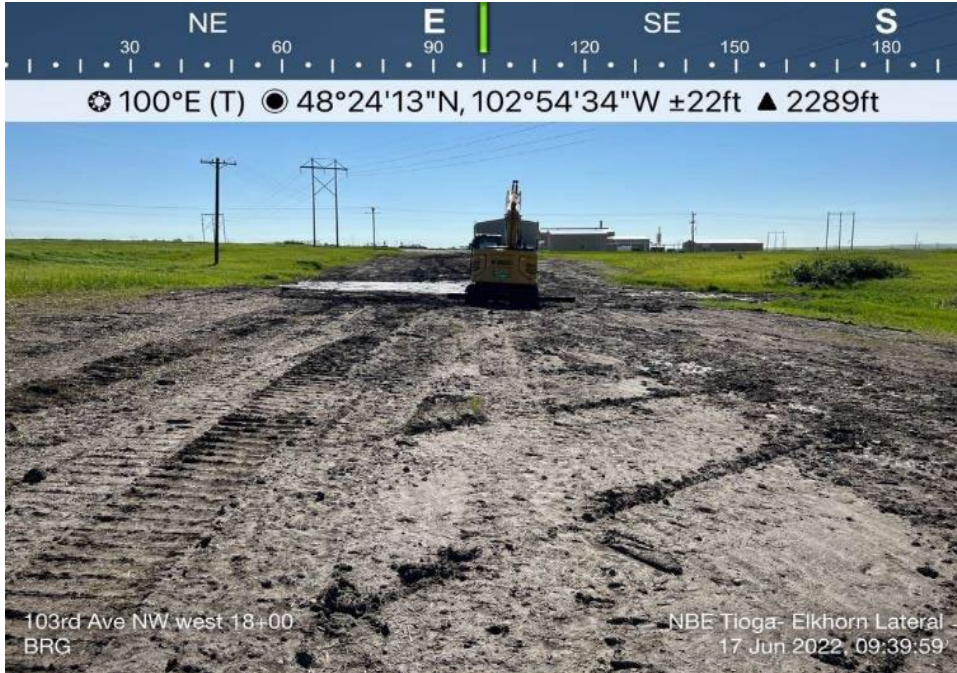
Location:
Sta. No. 18+00

Notes: Repairing
rill/channel erosion
on the Tioga
Compressor Lateral
right-of-way.

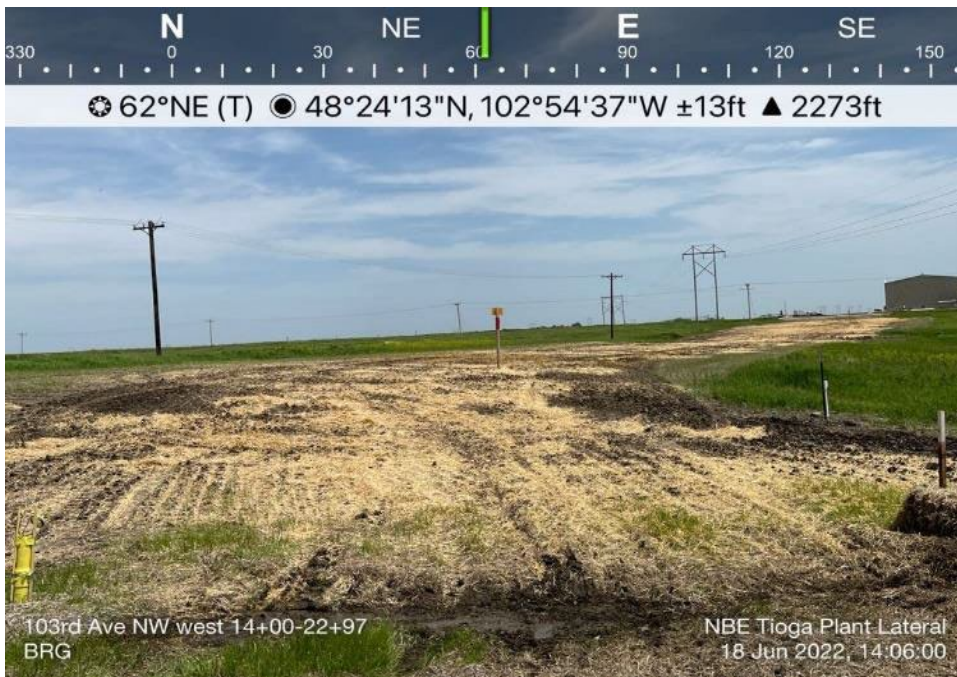
Location: Sta. Nos.
14+00 to 22+97

Notes: Crimped
straw mulch into
reseeded right-of-
way to anchor
mulch on the Tioga
Compressor Lateral
right-of-way.

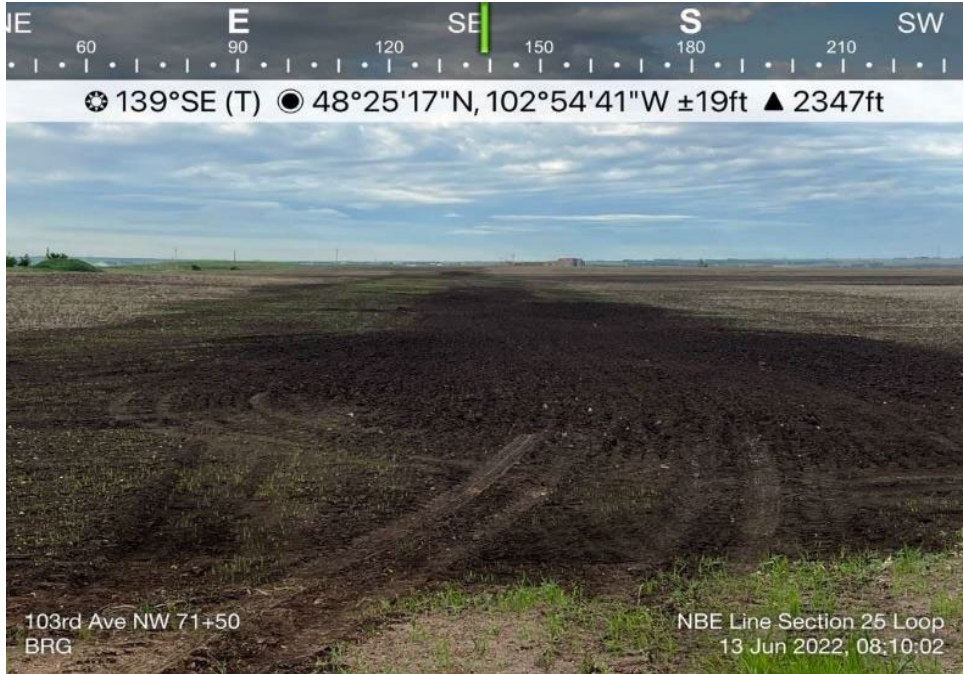
Location:
Sta. No. 71+50

Notes: Repaired
trench settling on
the Line Section 25
Loop Pipeline right-
of-way.

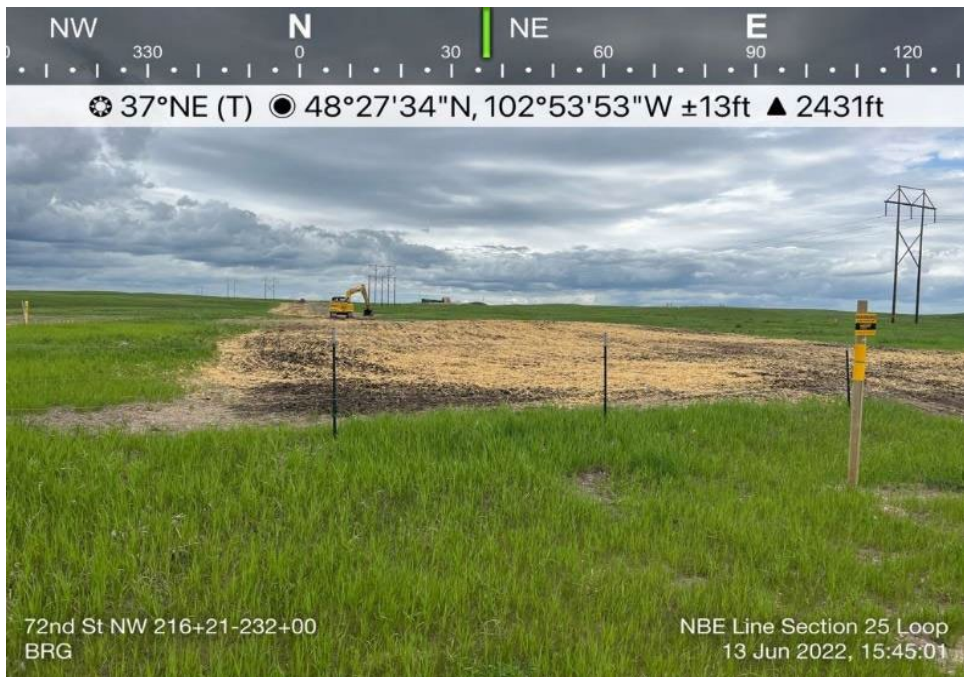
Location: Sta. Nos.
216+21 to 232+00

Notes: Crimped
straw mulch into
reseeded right-of-
way to anchor
mulch on the Line
Section 25 Loop
Pipeline.

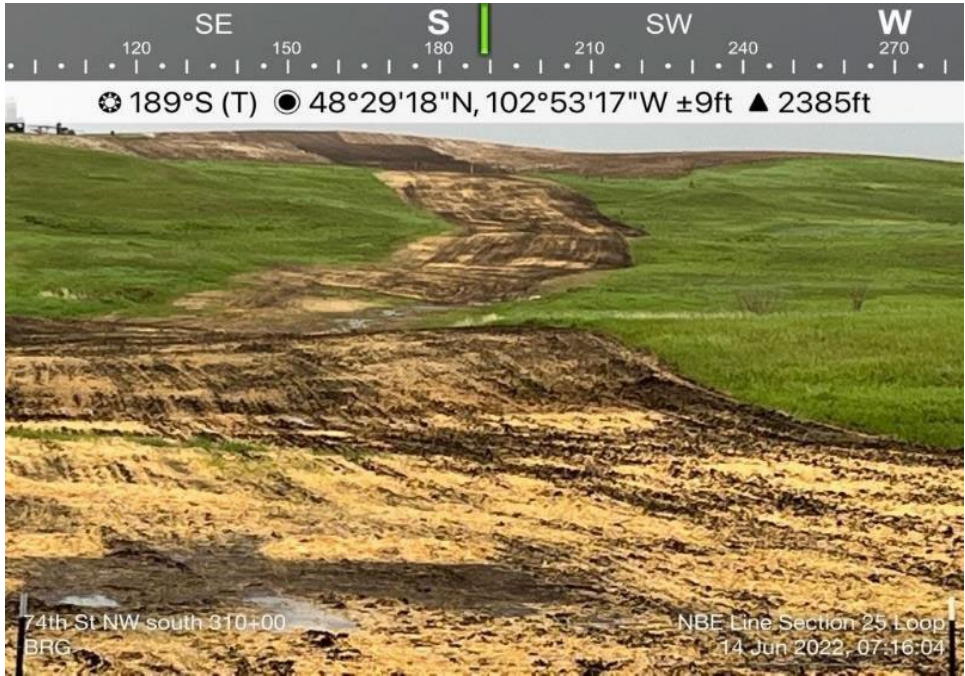
Location:
Sta. No. 310+00

Notes: Repaired
right-of-way on the
Line Section 25
Loop Pipeline
remains stable.

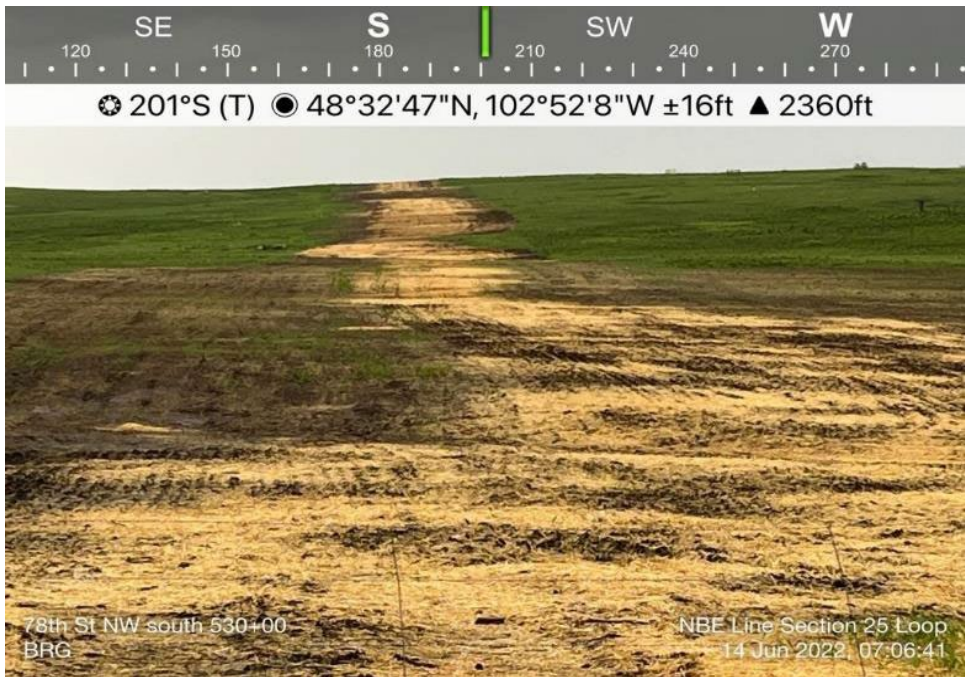
Location:
Sta. No. 530+00

Notes: Repaired
right-of-way on
Line Section 25
Loop Pipeline
remains stable.

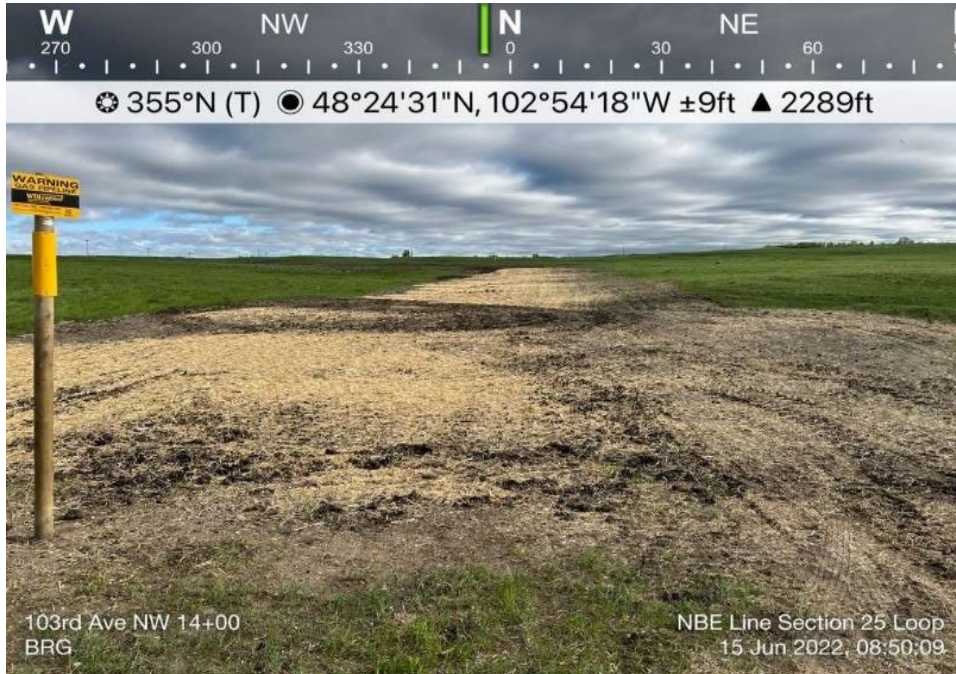
Location:
Sta. No. 14+00

Notes: Crimped straw mulch into reseeded right-of-way to anchor mulch on the Line Section 25 Loop Pipeline.

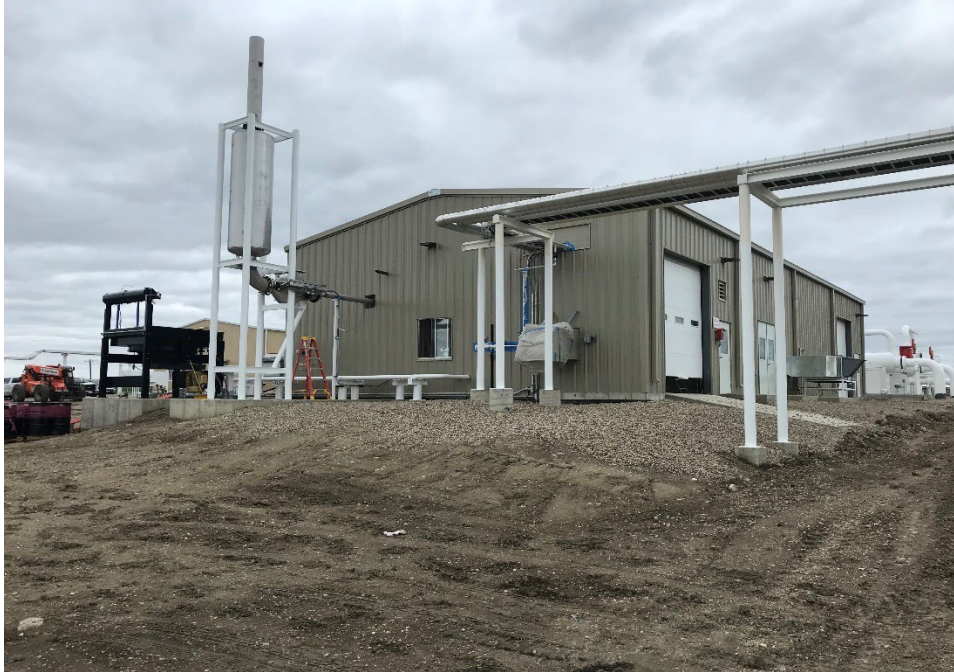
Location: Tioga
Compressor Station

Notes: Dirt work.

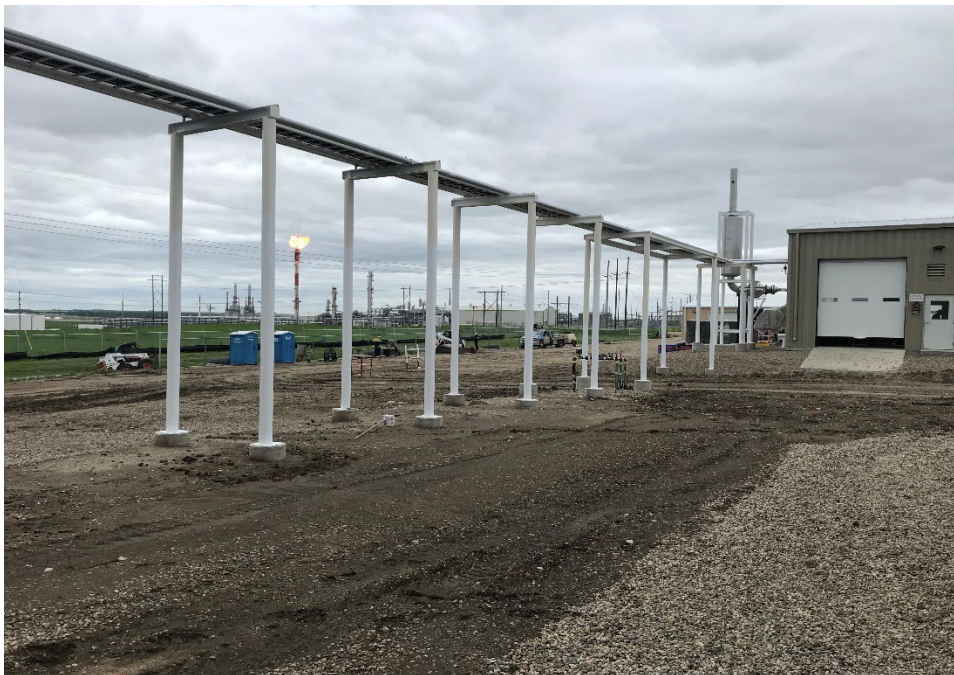
Location: Tioga
Compressor Station

Notes: Began re-
installing the
security fence
(background) and
dirt work.
