Re: WBI Energy Transmission, Inc.
Docket Nos. CP20-52-000 and CP20-52-001
North Bakken Expansion Project
Status Report No. 42

WBI Energy Transmission, Inc.
North Bakken Expansion Project Status Report No. 42
FERC Docket Nos. CP20-52-000
CP20-52-001

Reporting Period: June 20, 2022 through June 26, 2022

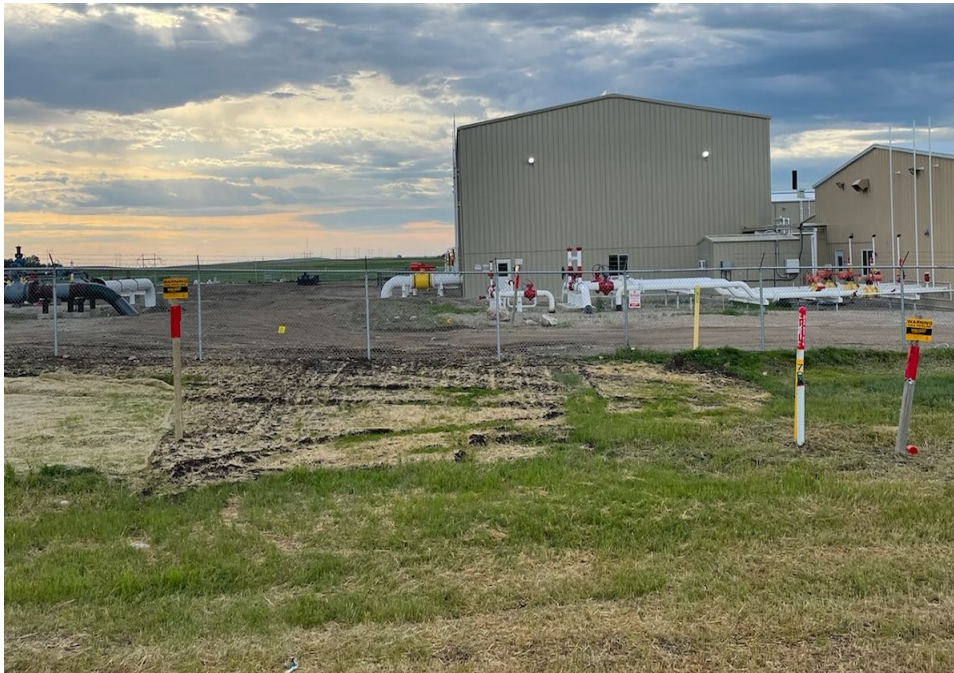
Location: Tioga Compressor Station

Notes: Re-installed security fence and reseeded fence line.

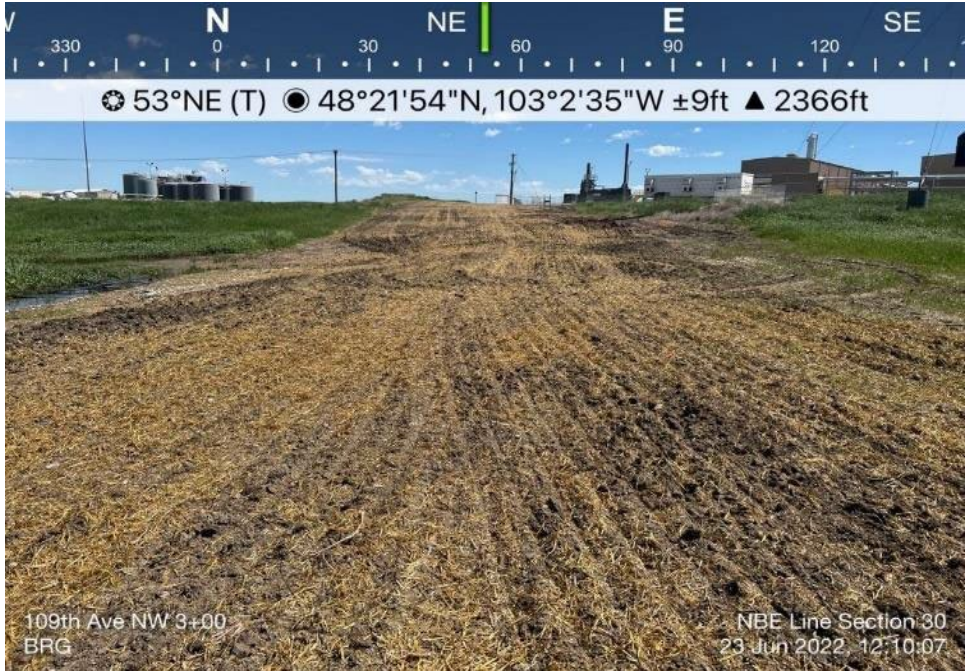
Location:
Sta. No. 3+00

Notes: Crimped straw mulch into reseeded right-of-way to anchor mulch on the Line Section 30 Loop Pipeline right-of-way.

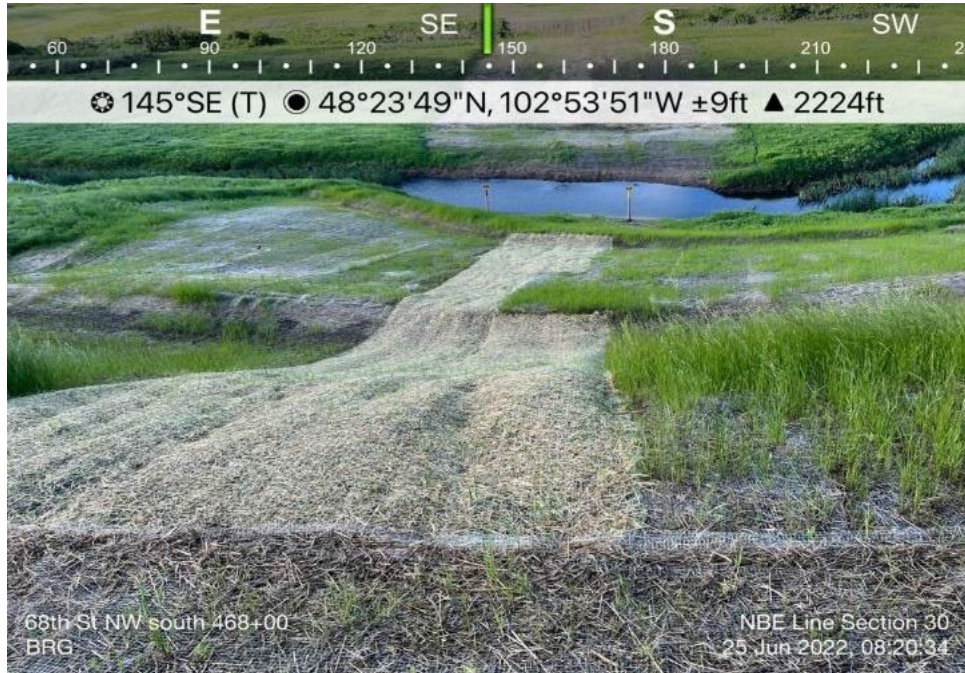
Location:
Sta. No. 468+00

Notes: Repaired right-of-way on the Line Section 30 Loop Pipeline remains stable.

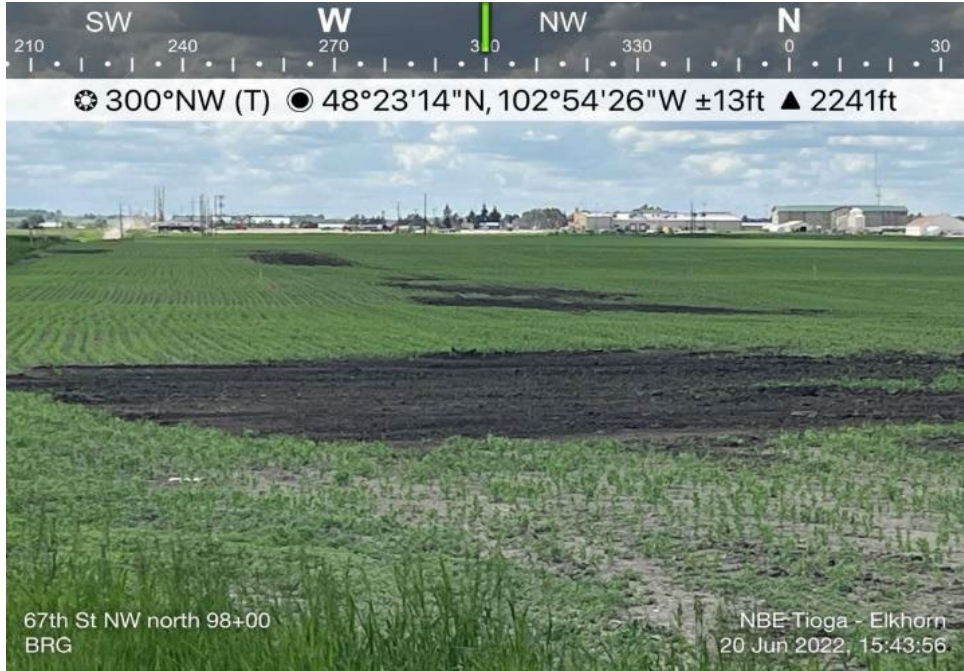
Location:
Sta. No. 98+00

Notes: Repaired
trench settling on
the Tioga-Elkhorn
Creek Pipeline
right-of-way.

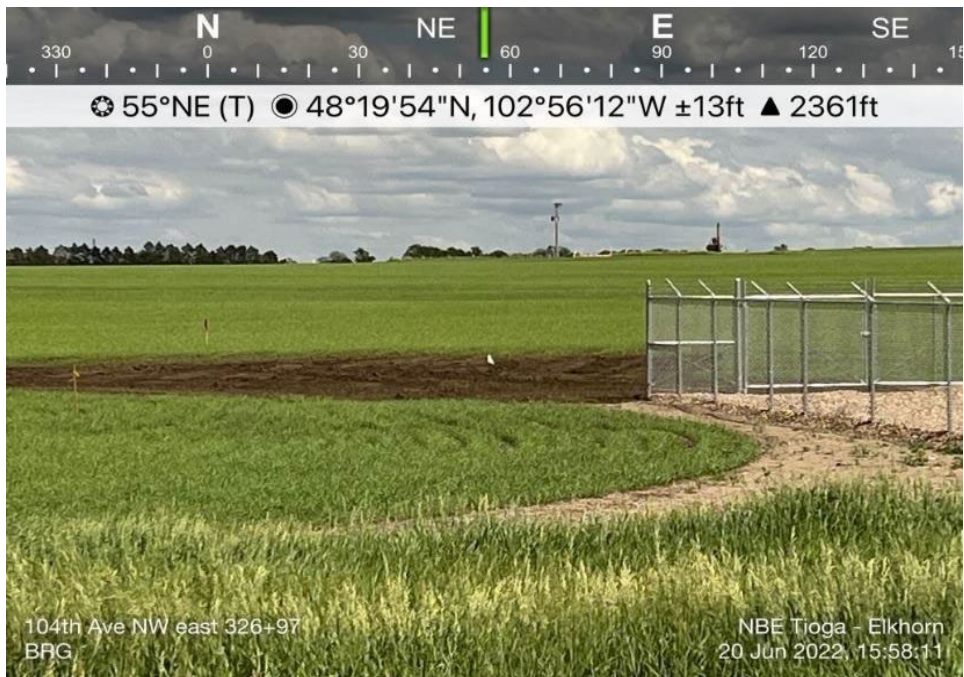
Location:
Sta. No. 326+97

Notes: Repaired
trench settling
outside of the 104th
Avenue NW pig
launcher/receiver
facilities on the
Tioga-Elkhorn
Creek Pipeline
right-of-way.

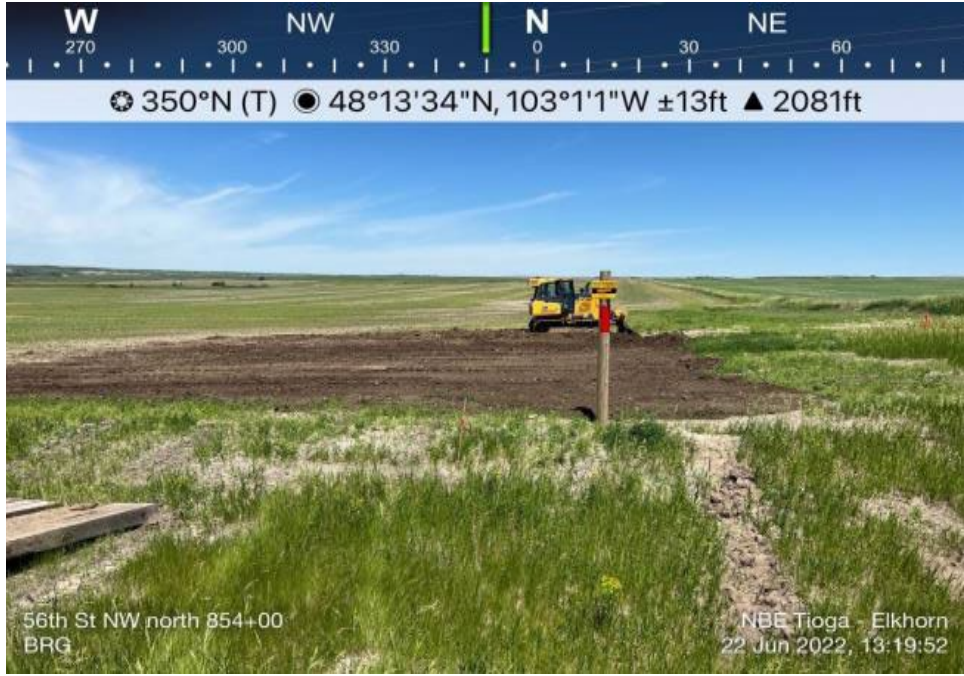
Location:
Sta. No. 854+00

Notes: Repaired
rill/channel erosion
on the Tioga-
Elkhorn Creek
Pipeline right-of-
way.

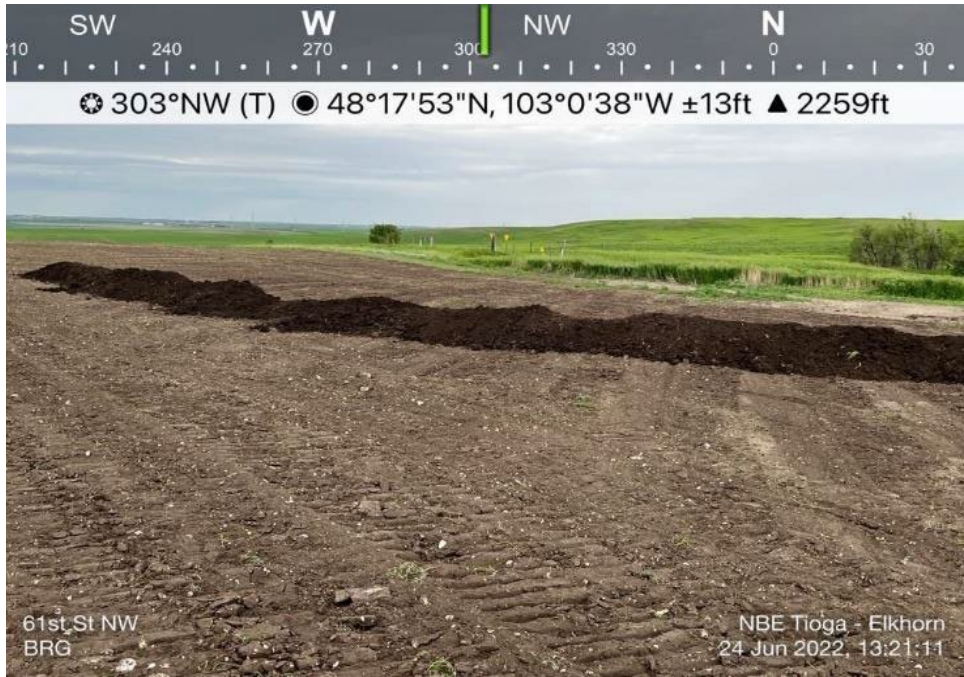
Location:
Sta. No. 680+00

Notes: Topsoil was
added to repair
trench settling on
the Tioga-Elkhorn
Creek Pipeline
right-of-way.

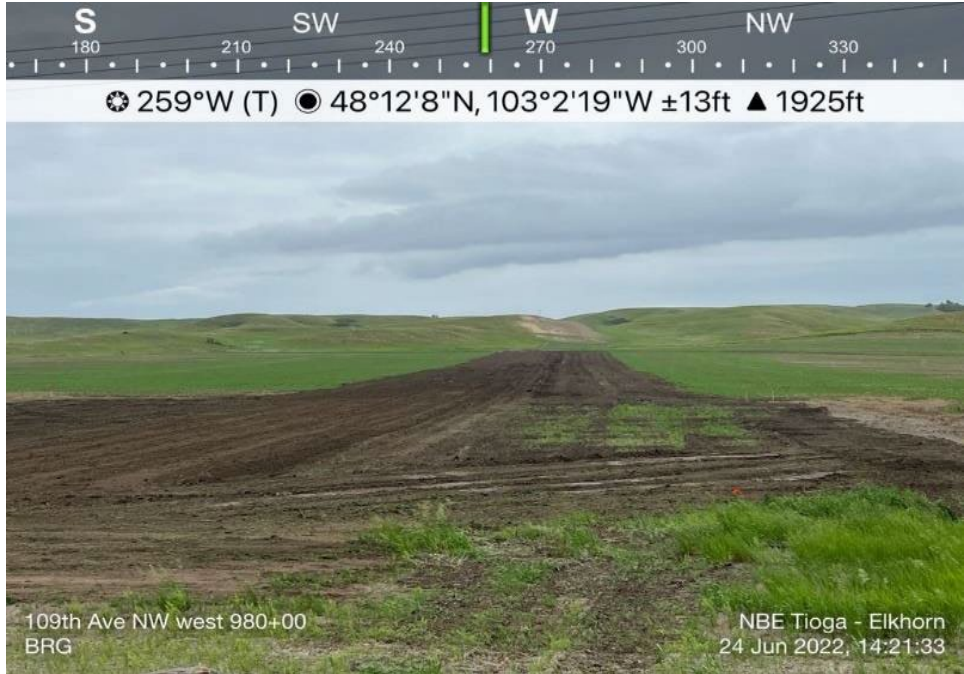
Location:
Sta. No. 980+00

Notes: Repaired
trench settling on
the Tioga-Elkhorn
Creek Pipeline
right-of-way.

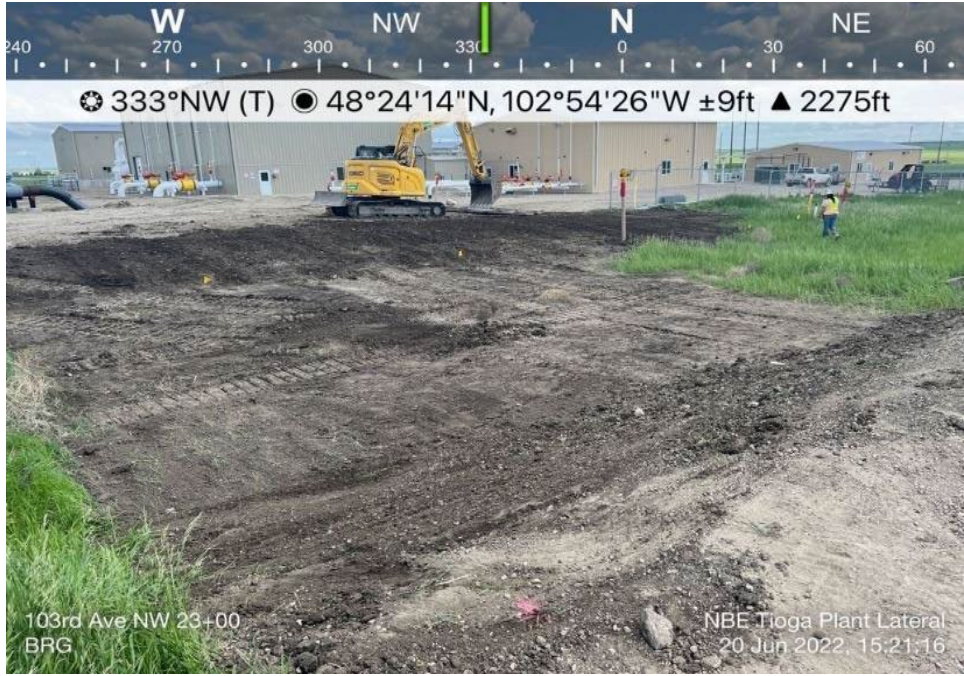
Location:
Sta. No. 23+00

Notes: Repaired trench settling on the Tioga Compressor Lateral right-of-way, removed previous construction entrance mats and restored bar ditch adjacent to the Tioga Compressor Station.

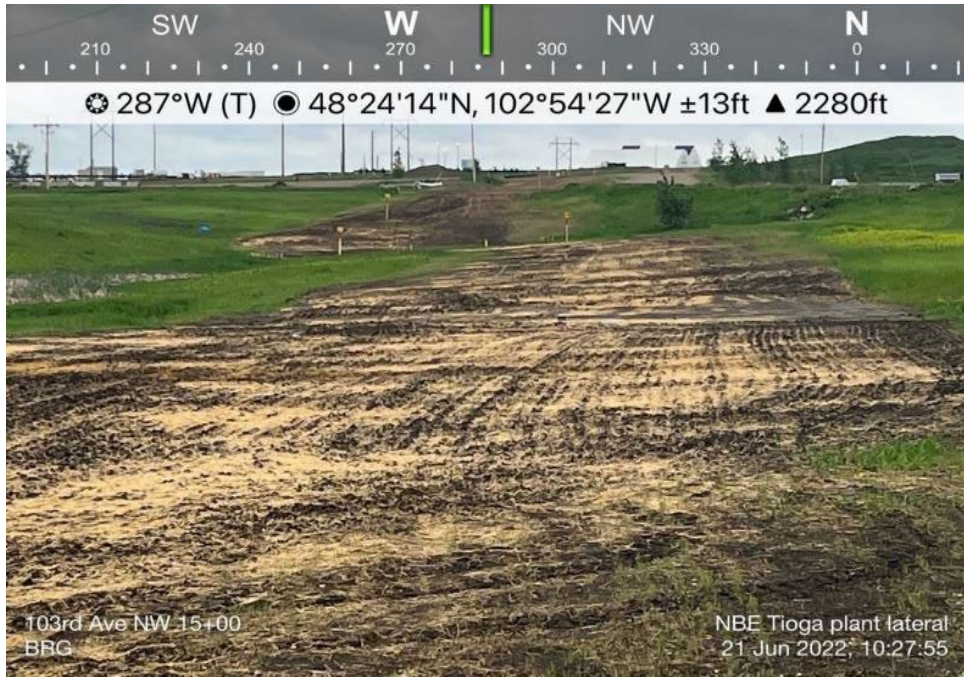
Location:
Sta. No. 15+00

Notes: Repaired Tioga Compressor Lateral right-of-way remains stable.

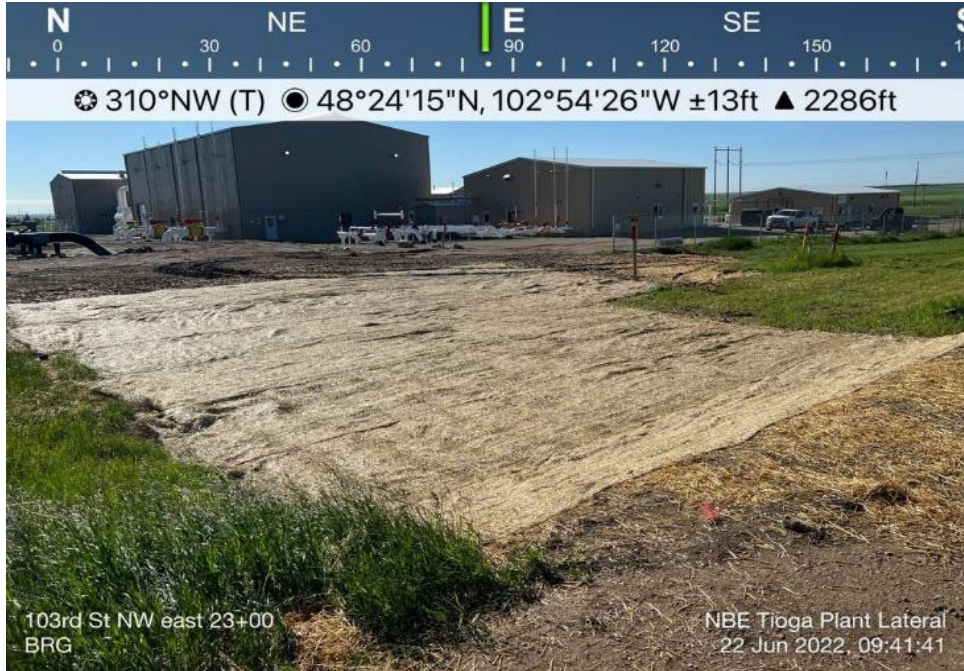
Location:
Sta. No. 23+00

Notes: Installed erosion control blankets in restored bar ditch on the Tioga Compressor Lateral right-of-way adjacent to the Tioga Compressor Station.

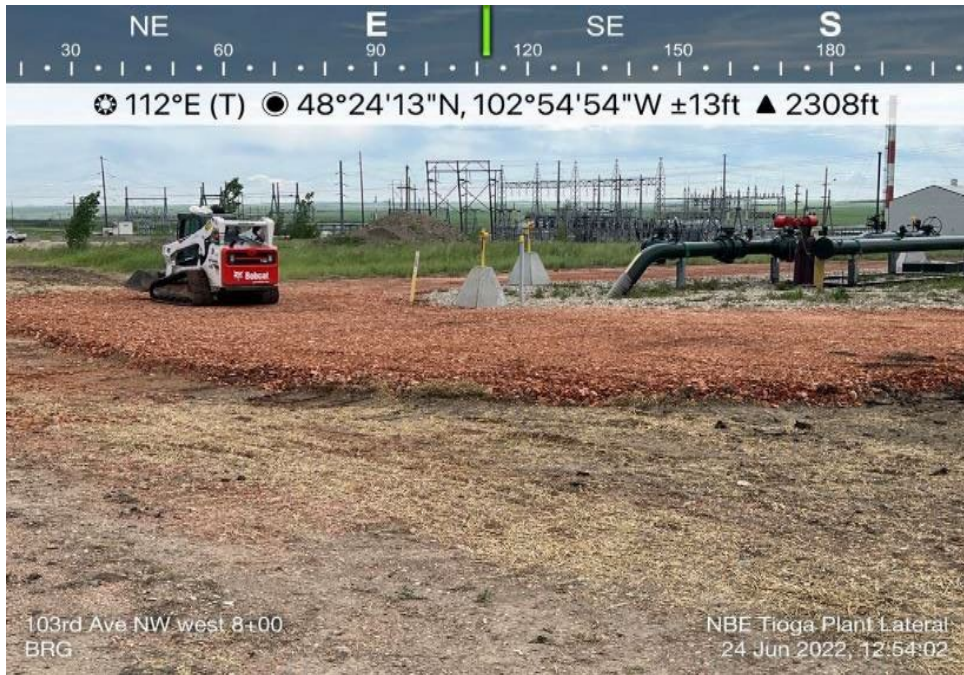
Location:
Sta. No. 8+00

Notes: Spread additional gravel around the Tioga Plant Receipt Station pig launcher/receiver facilities on the Tioga Compressor Lateral right-of-way.

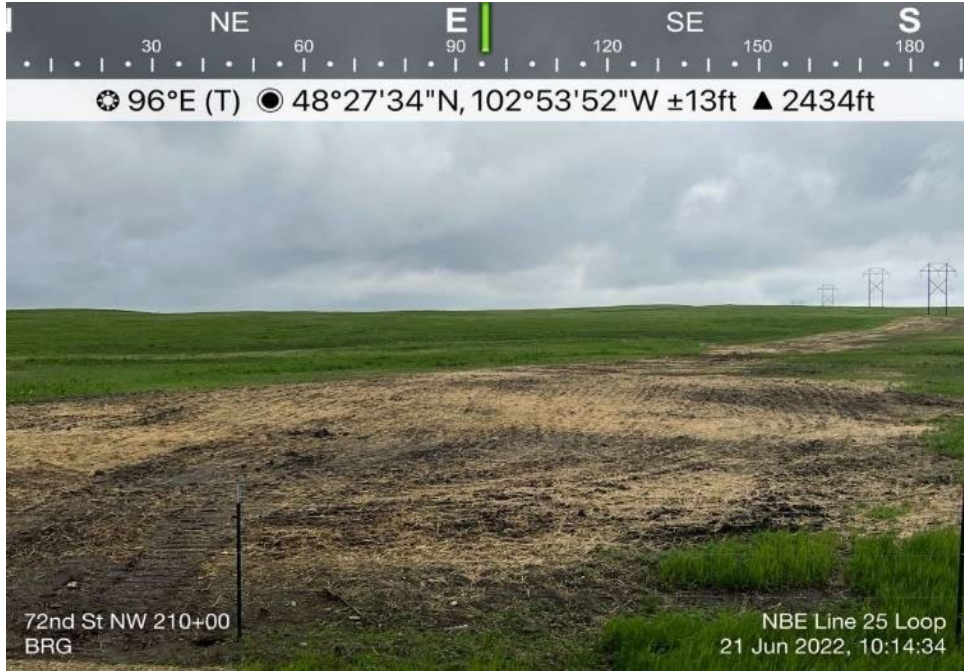
Location:
Sta. No. 210+00

Notes: Repaired
right-of-way on the
Line Section 25
Loop Pipeline
remains stable.

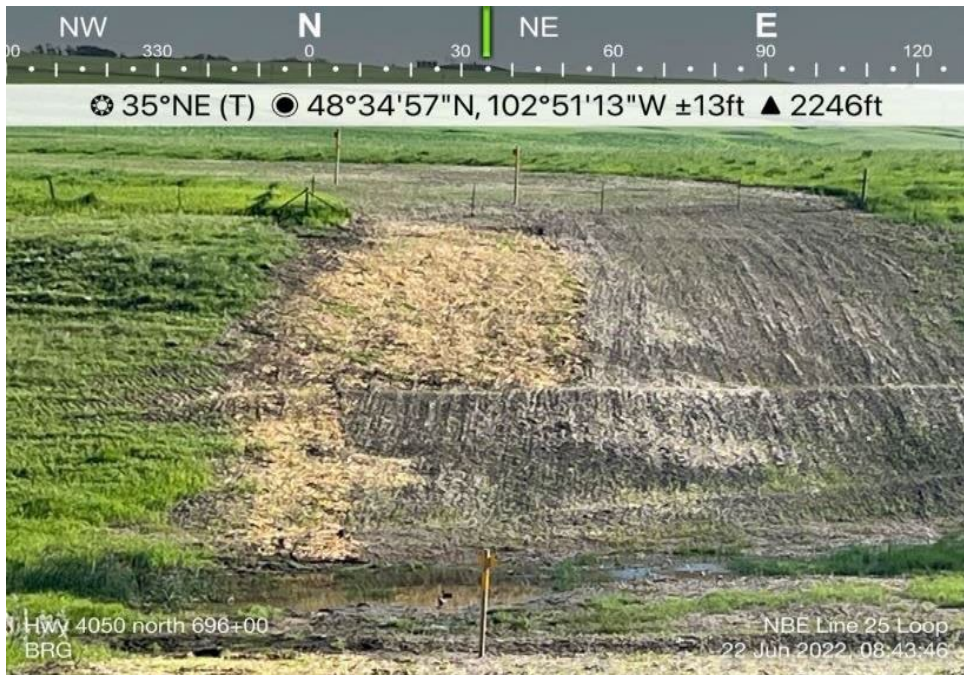
Location:
Sta. No. 696+00

Notes: Repaired
right-of-way on the
Line Section 25
Loop Pipeline
remains stable.

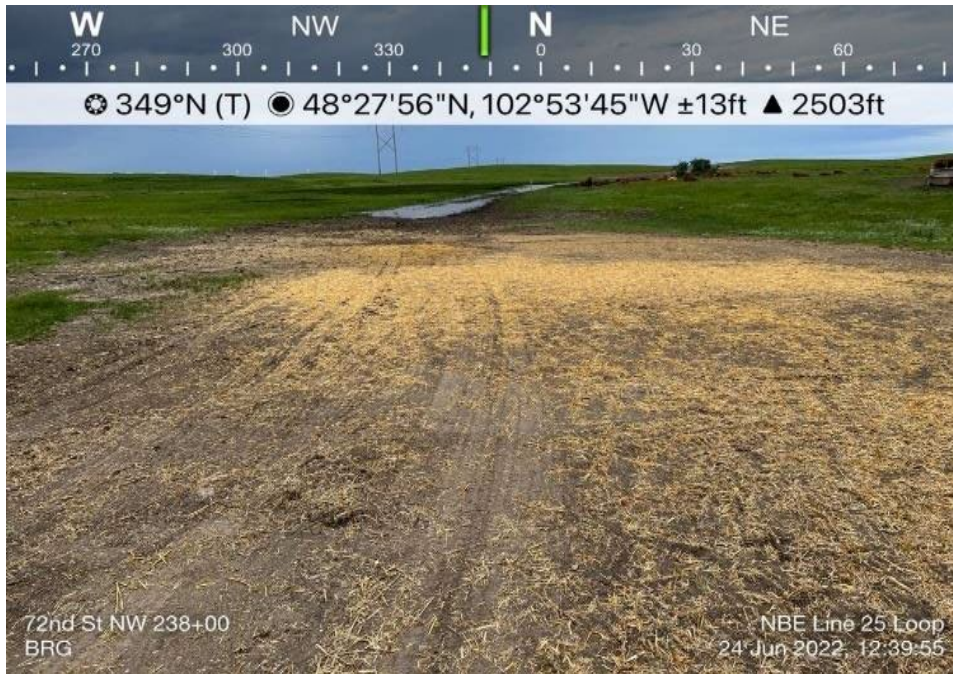
Location:
Sta. No. 238+00

Notes: Repaired
trench settling on
the Line Section 25
Loop Pipeline right-
of-way.

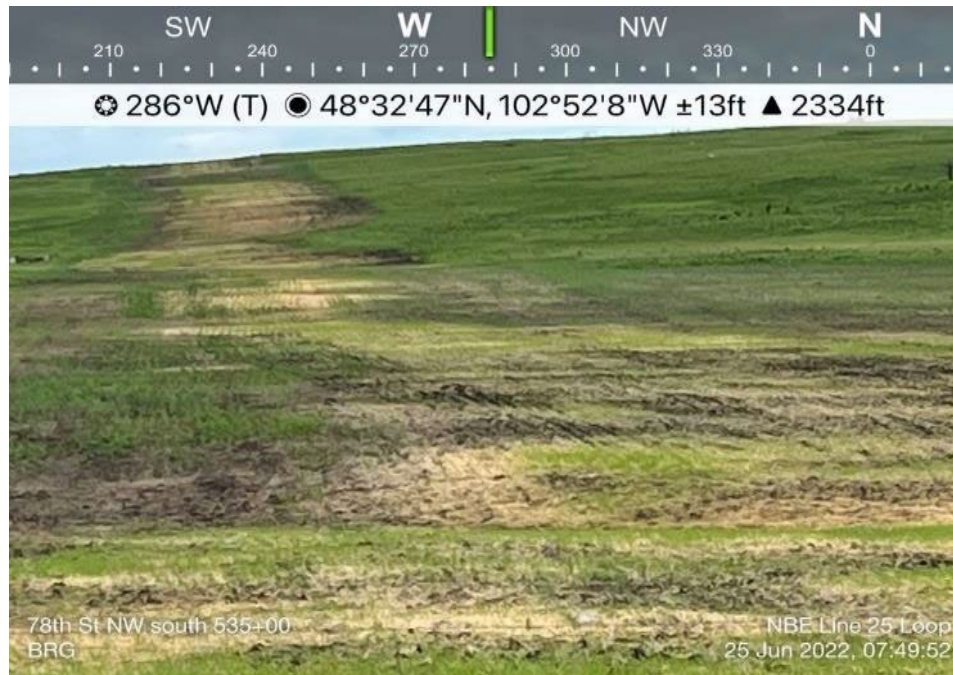
Location:
Sta. No. 535+00

Notes: Repaired
right-of-way on the
Line Section 25
Loop Pipeline
remains stable.

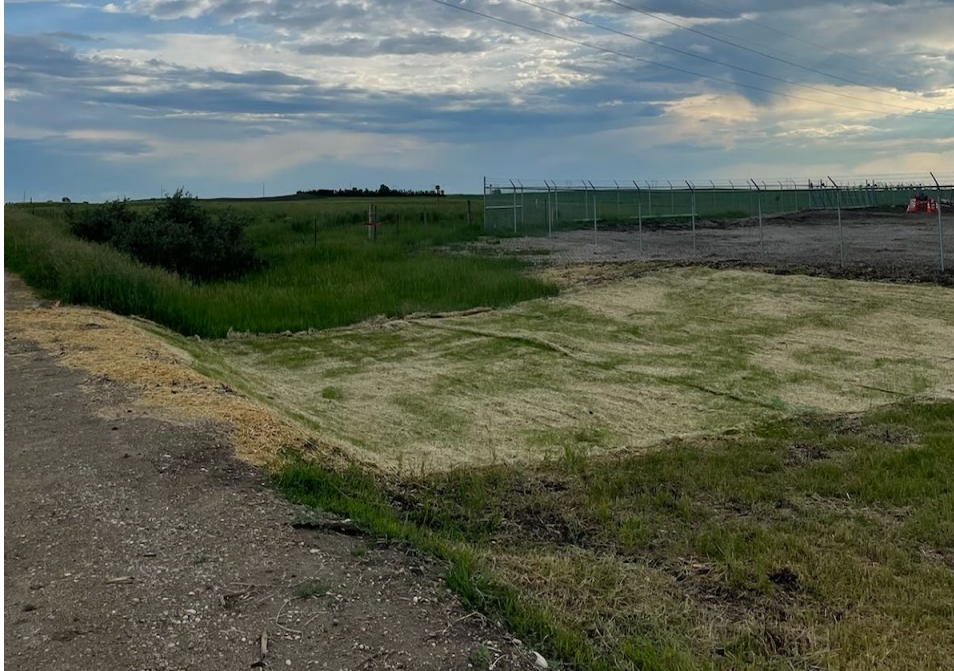
Location: Tioga
Compressor Station

Notes: Removed
construction
entrance mats,
restored bar ditch,
installed erosion
control blankets, re-
installed security
fence and reseeded
along fence line at
the Tioga
Compressor Station.

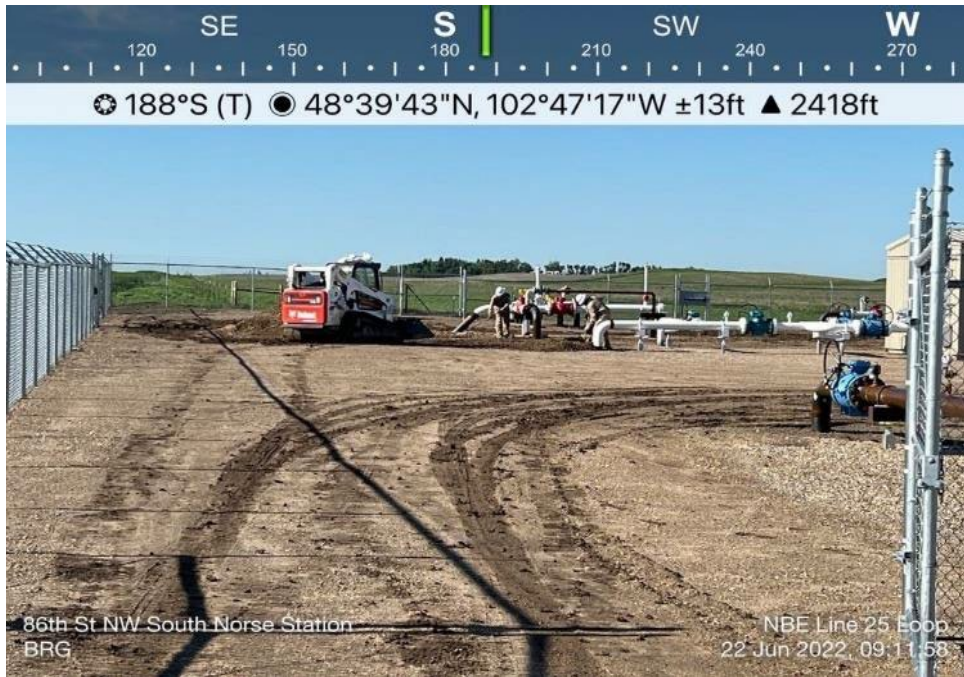
Location: Norse Transfer Station

Notes: Spread gravel around valve settings to repair trench settling.
