Re: WBI Energy Transmission, Inc.
Docket Nos. CP20-52-000 and CP20-52-001
North Bakken Expansion Project
Status Report No. 43

WBI Energy Transmission, Inc.
North Bakken Expansion Project Status Report No. 43
FERC Docket Nos. CP20-52-000
CP20-52-001

Reporting Period: June 27, 2022 through July 3, 2022

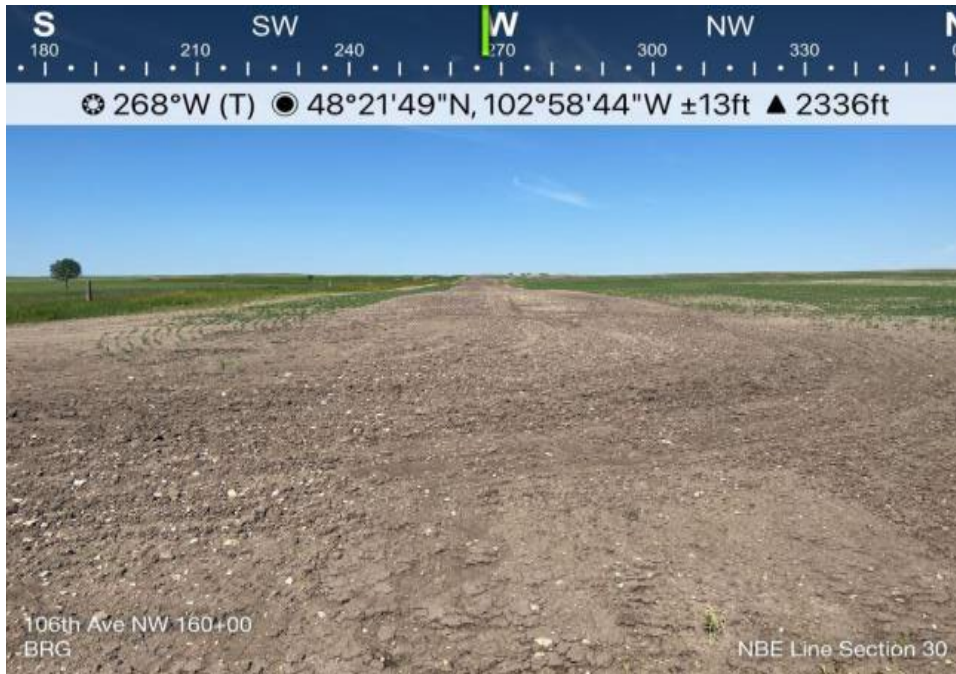
Location:
Sta. No. 160+00

Notes: Repaired
right-of-way on the
Line Section 30
Loop Pipeline
remains stable.

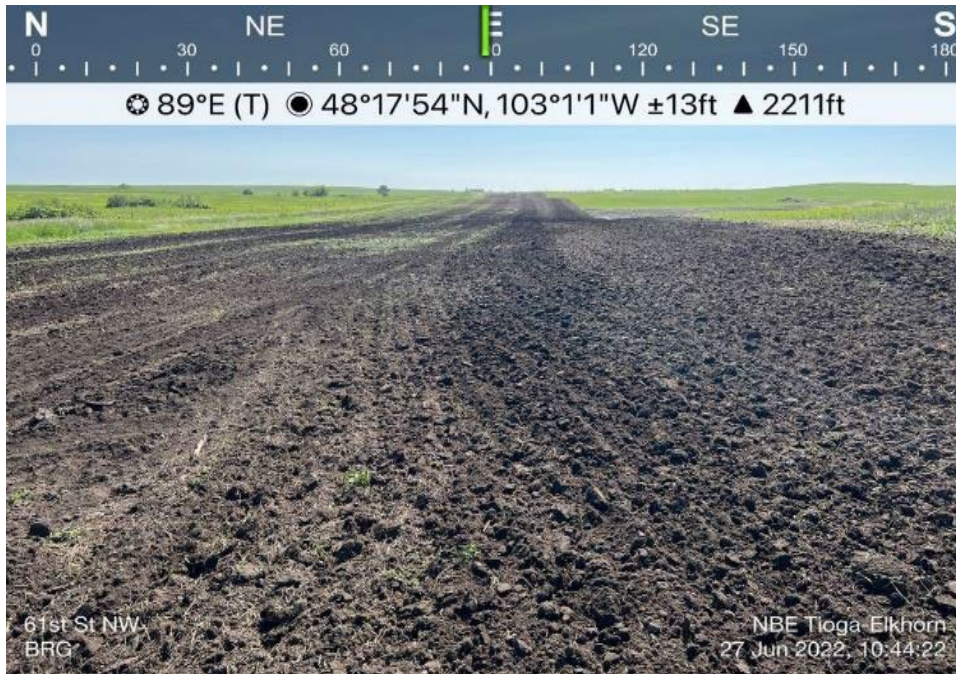
Location: Sta. Nos. 579+96 to 626+95

Notes: Repaired trench settling on the Tioga-Elkhorn Creek Pipeline right-of-way.

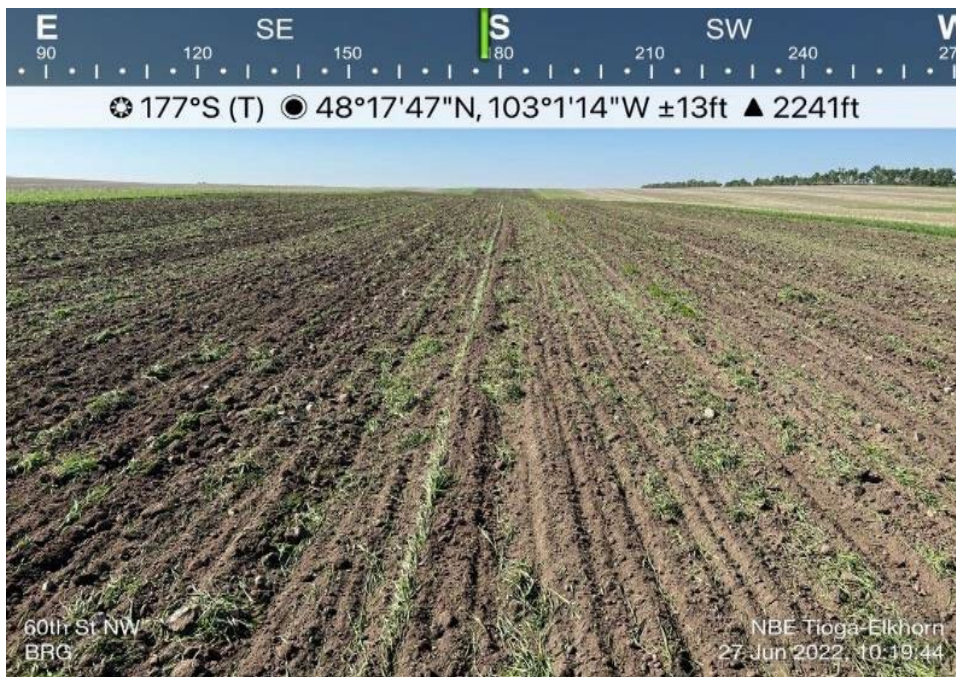
Location: Sta. Nos. 655+00 to 677+00

Notes: Reseeded the repaired Tioga-Elkhorn Creek Pipeline right-of-way with a landowner approved rye cover crop.

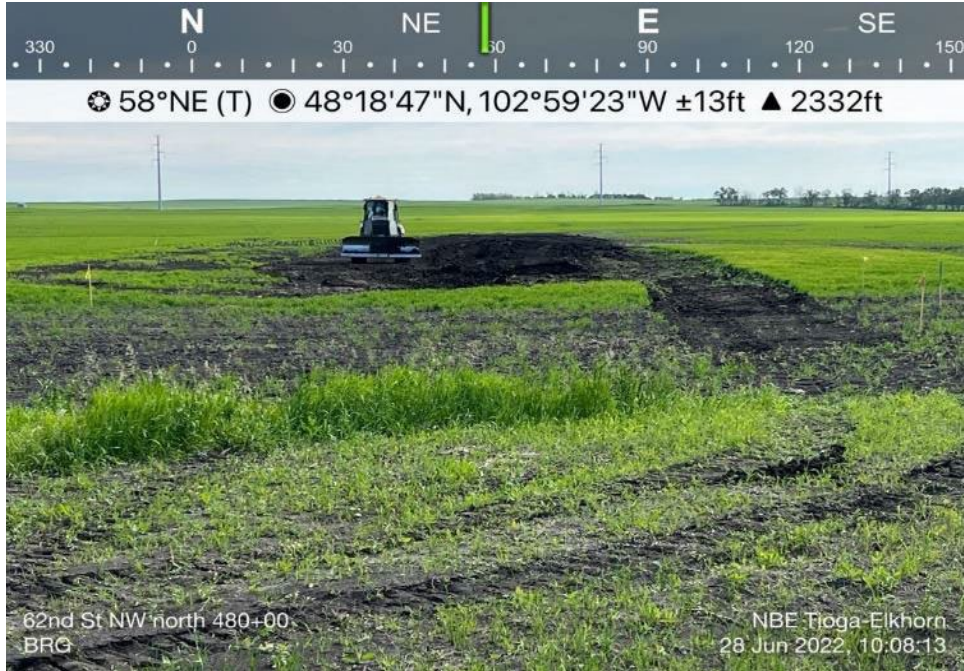
Location:
Sta. No. 480+00

Notes: Repaired
trench settling on
the Tioga-Elkhorn
Creek Pipeline
right-of-way.

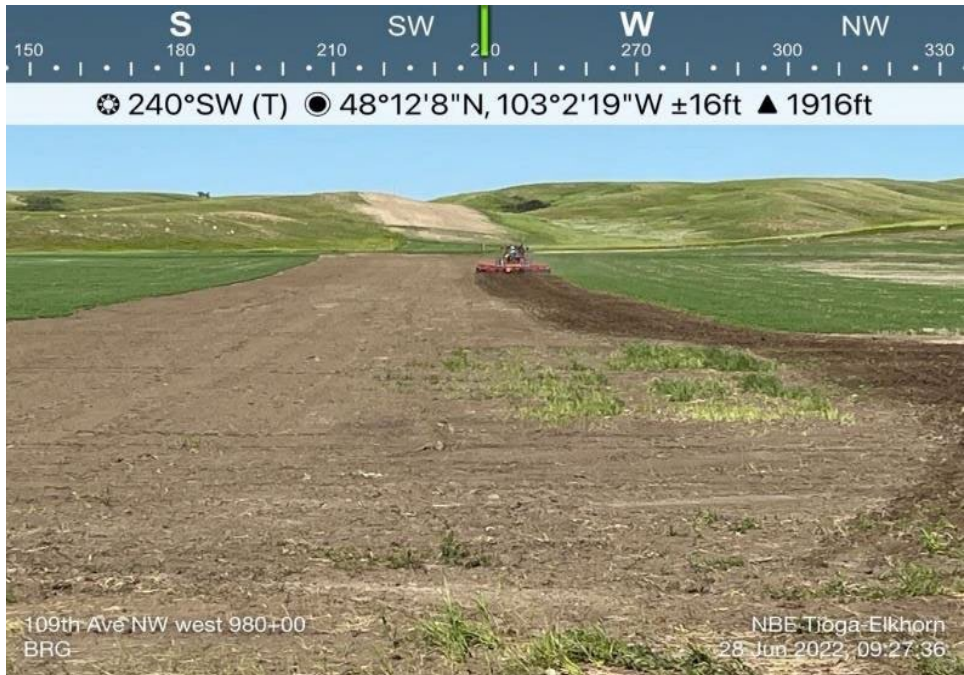
Location:
Sta. No. 980+00

Notes: Utilizing a
disc to smooth the
Tioga-Elkhorn
Creek Pipeline
right-of-way.

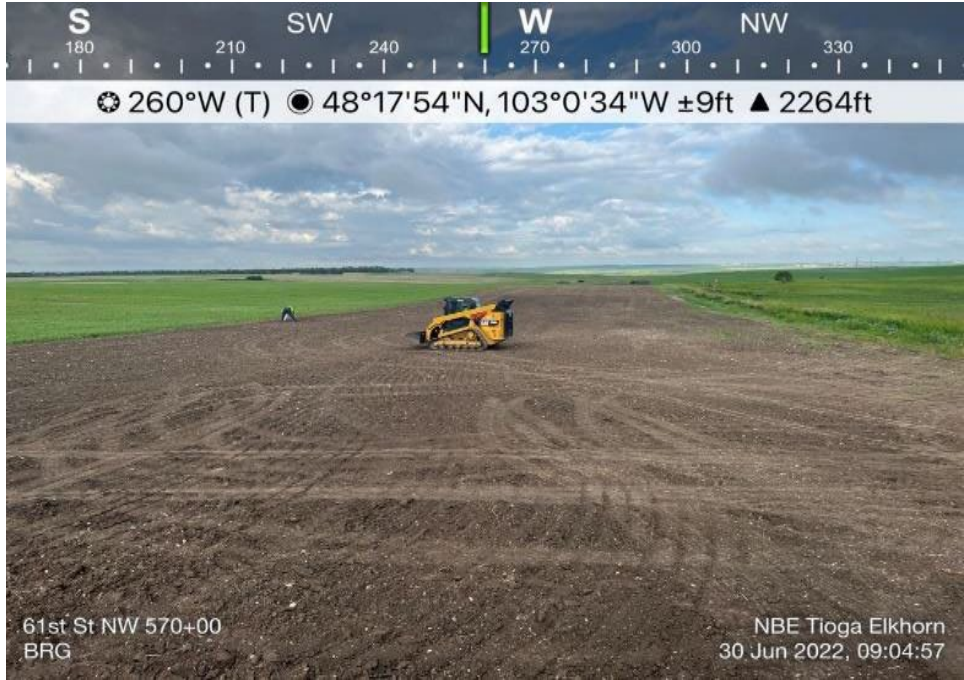
Location:
Sta. No. 570+00

Notes: Rock picking
after the repair of
Tioga-Elkhorn
Creek Pipeline
right-of-way.

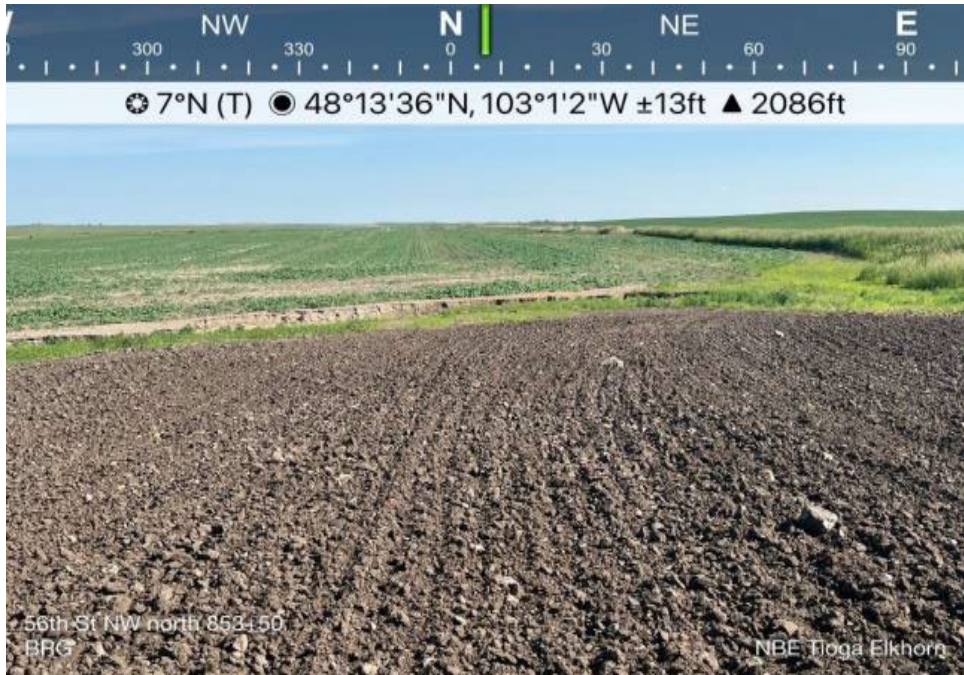
Location:
Sta. No. 853+50

Notes: The Tioga-
Elkhorn Creek
Pipeline right-of-
way remains stable.

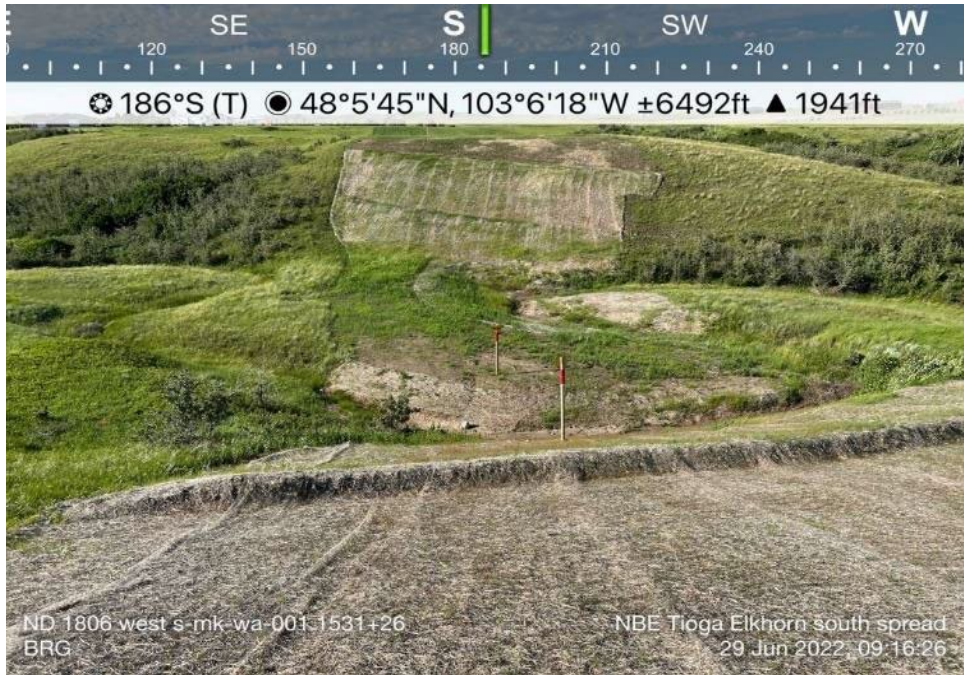
Location:
Sta. No. 1531+26

Notes: The Tioga-
Elkhorn Creek
Pipeline right-of-
way and waterbody
s-mk-wa-001 (an
unnamed tributary
to Tobacco
Garden Creek)
remains stable.

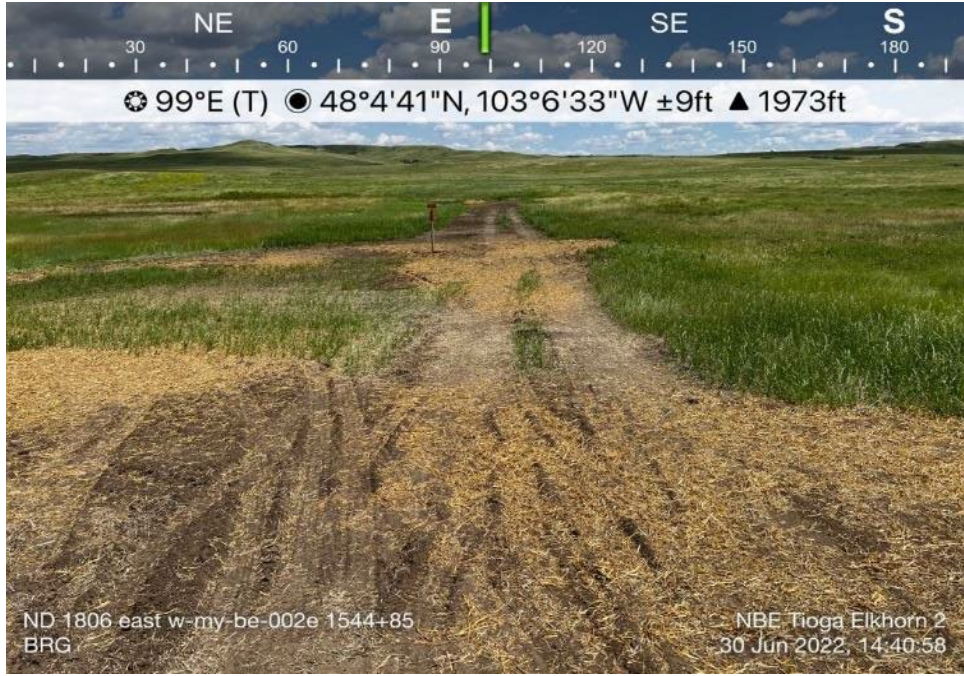
Location:
Sta. No. 1544+85

Notes: Repaired and
reseeded trench
settling on the
Tioga-Elkhorn
Creek Pipeline
right-of-way.

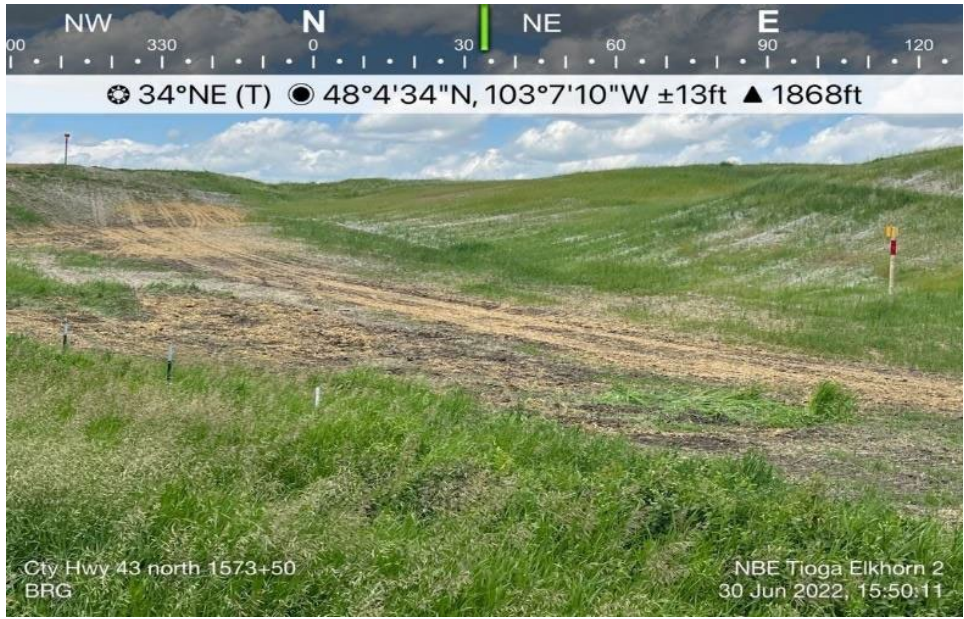
Location:
Sta. No. 1573+50

Notes: Repaired and
reseeded trench
settling on the
Tioga-Elkhorn
Creek Pipeline
right-of-way.

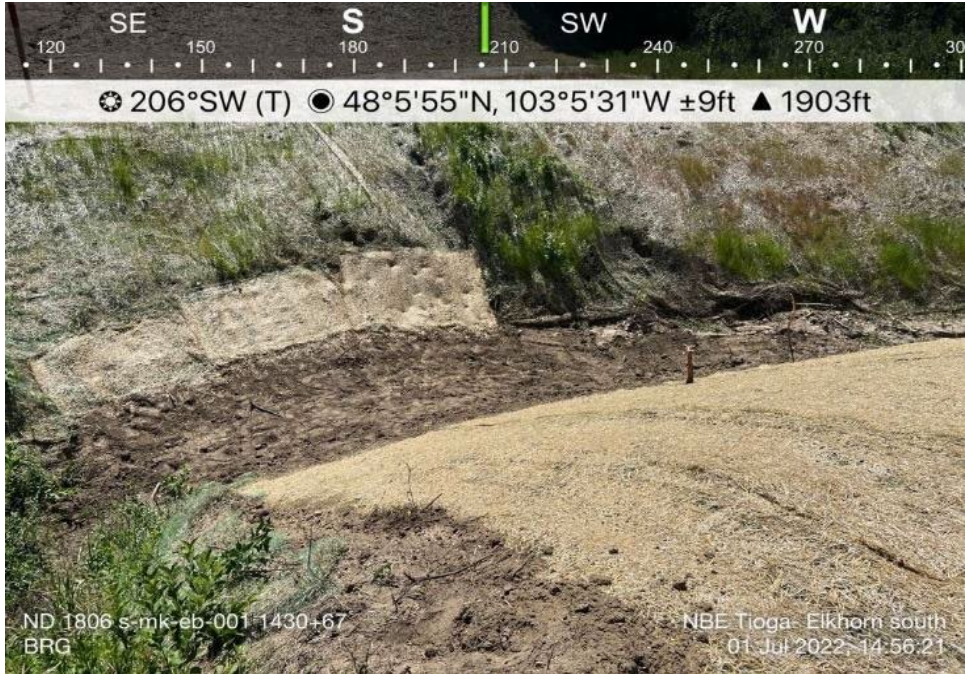
Location:
Sta. No. 1430+67

Notes: Repaired and restored the banks and channel of waterbody s-mk-eb-001 (an unnamed tributary to Sand Garden Creek) on the Tioga-Elkhorn Creek Pipeline right-of-way.

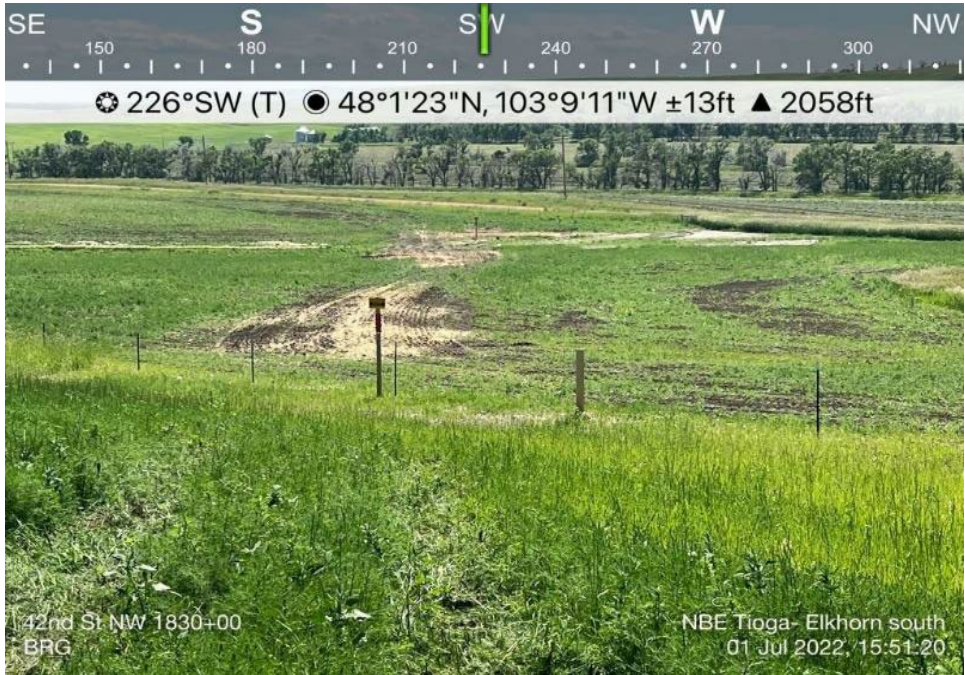
Location:
Sta. No. 1830+00

Notes: Repaired and reseeded trench settling on the Tioga-Elkhorn Creek Pipeline right-of-way.

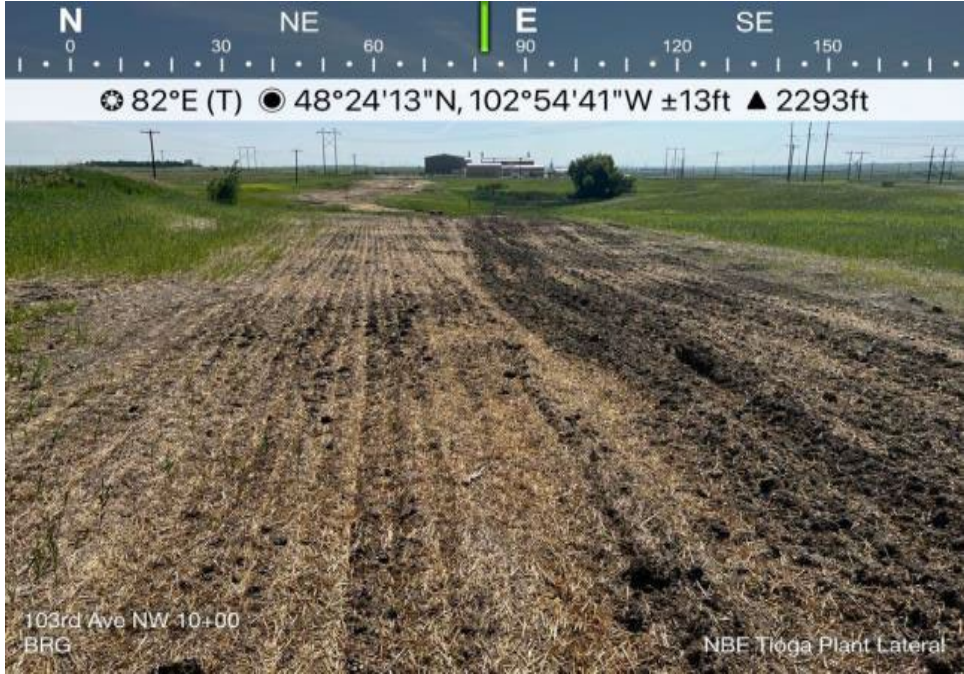
Location:
Sta. No. 10+00

Notes: Repaired
right-of-way on the
Tioga Compressor
Lateral remains
stable.

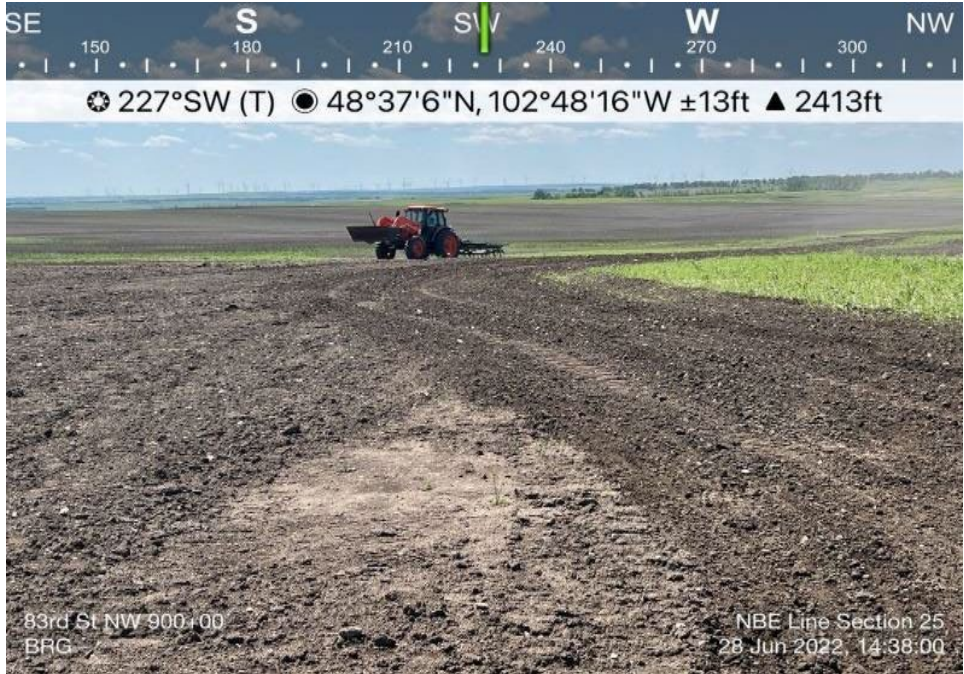
Location:
Sta. No. 900+00

Notes: Utilizing a drag to smooth the repaired right-of-way on the Line Section 25 Loop Pipeline.

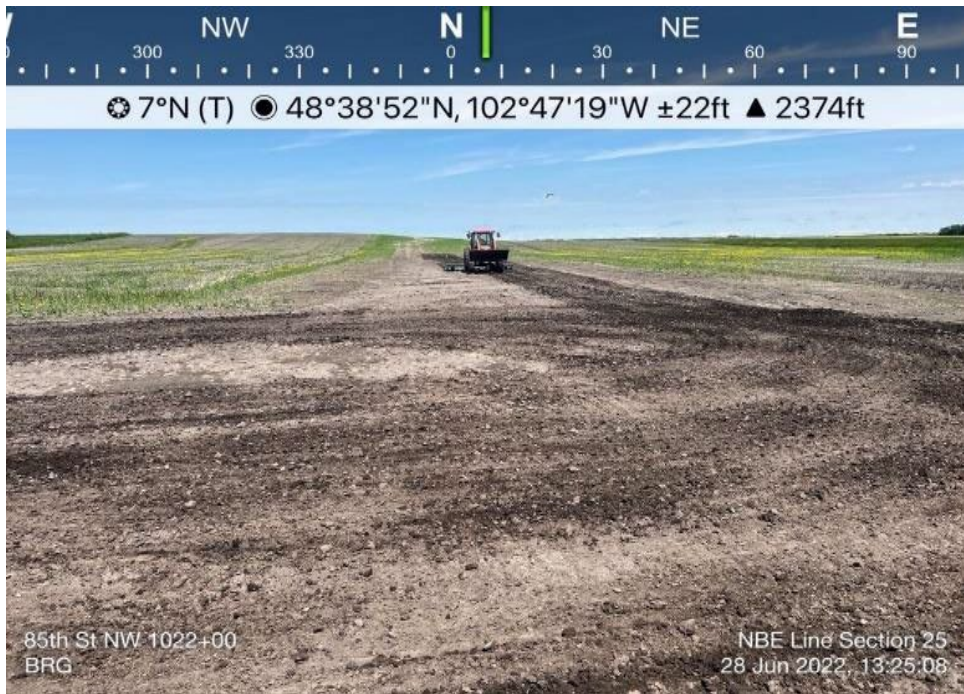
Location:
Sta. No. 1022+00

Notes: Utilizing a drag to smooth the repaired right-of-way on the Line Section 25 Loop Pipeline.

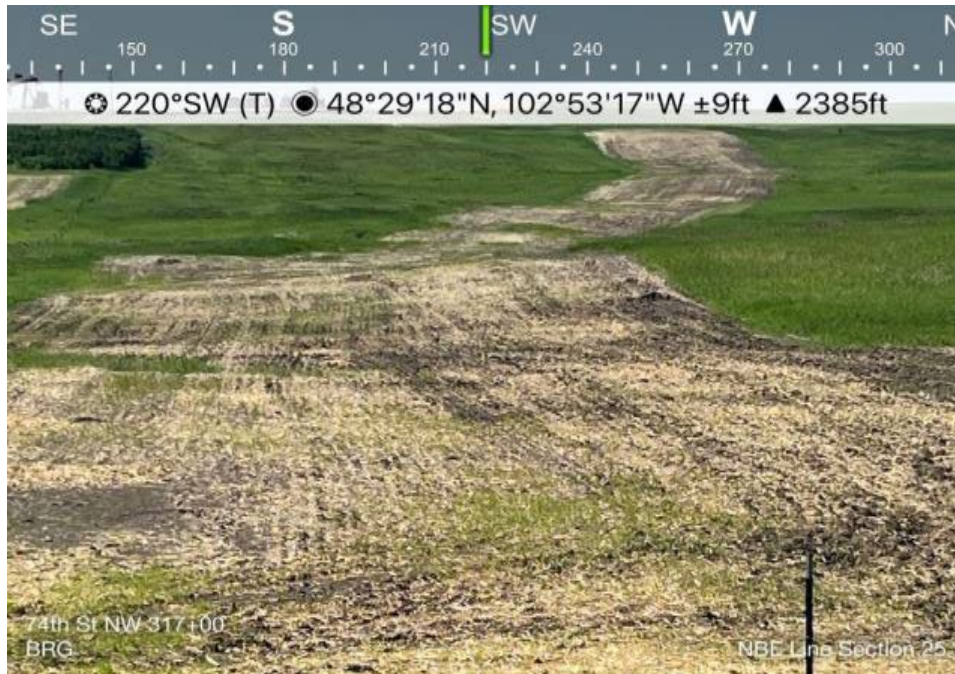
Location:
Sta. No. 317+00

Notes: Repaired
right-of-way on the
Line Section 25
Loop Pipeline
remains stable.

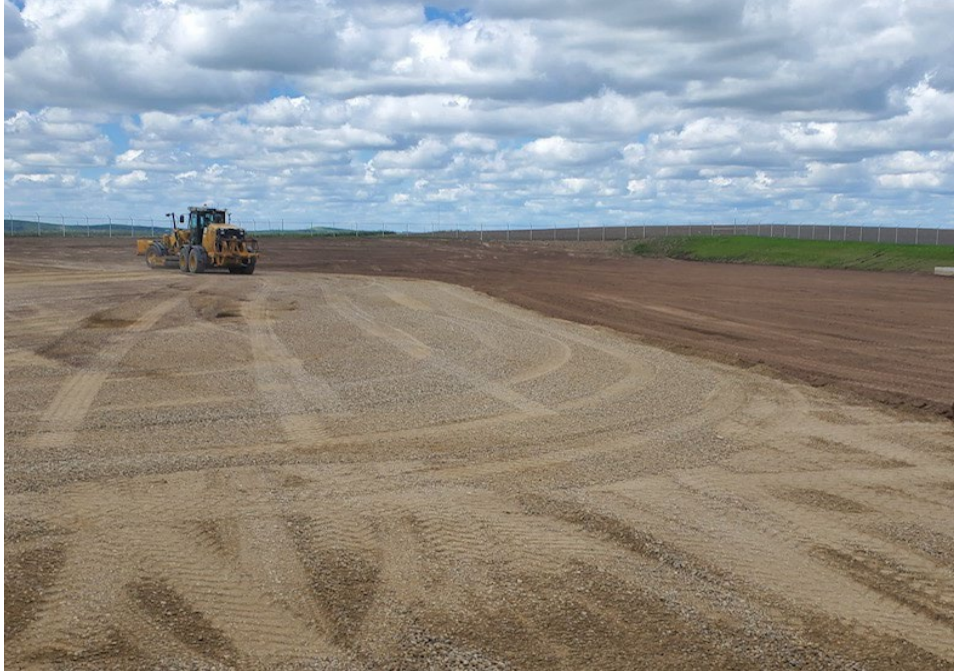
Location: Elkhorn
Creek Compressor
Station

Notes: Dirt work
and spreading
gravel at the
Elkhorn Creek
Compressor Station.

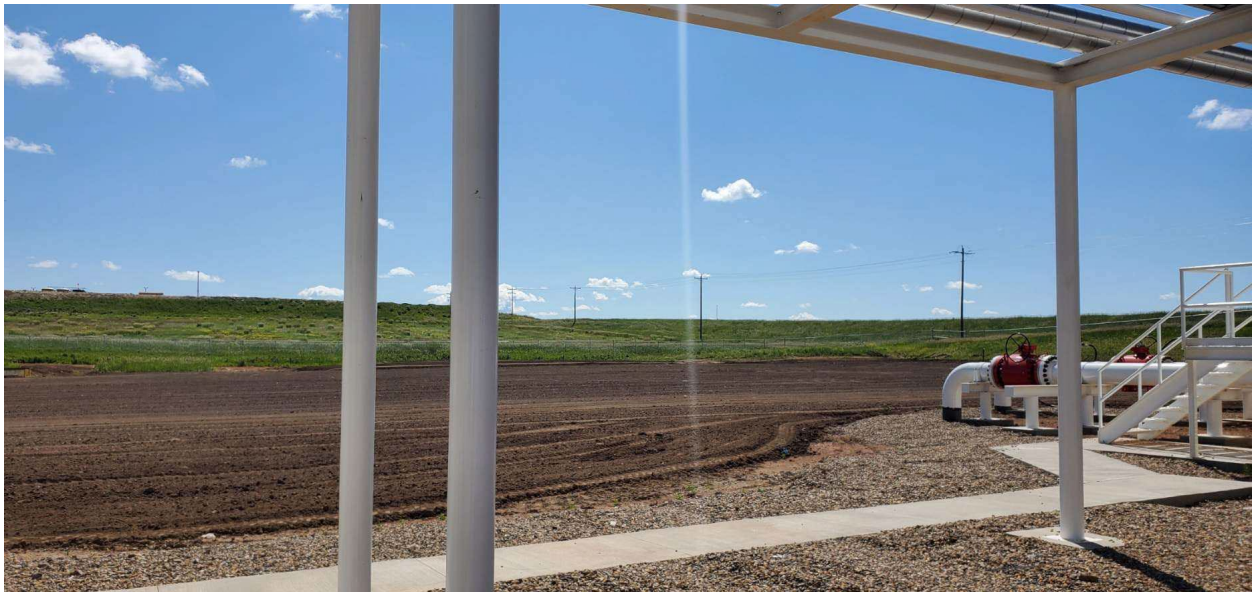
Location: Elkhorn Creek Compressor Station

Notes: Dirt work.

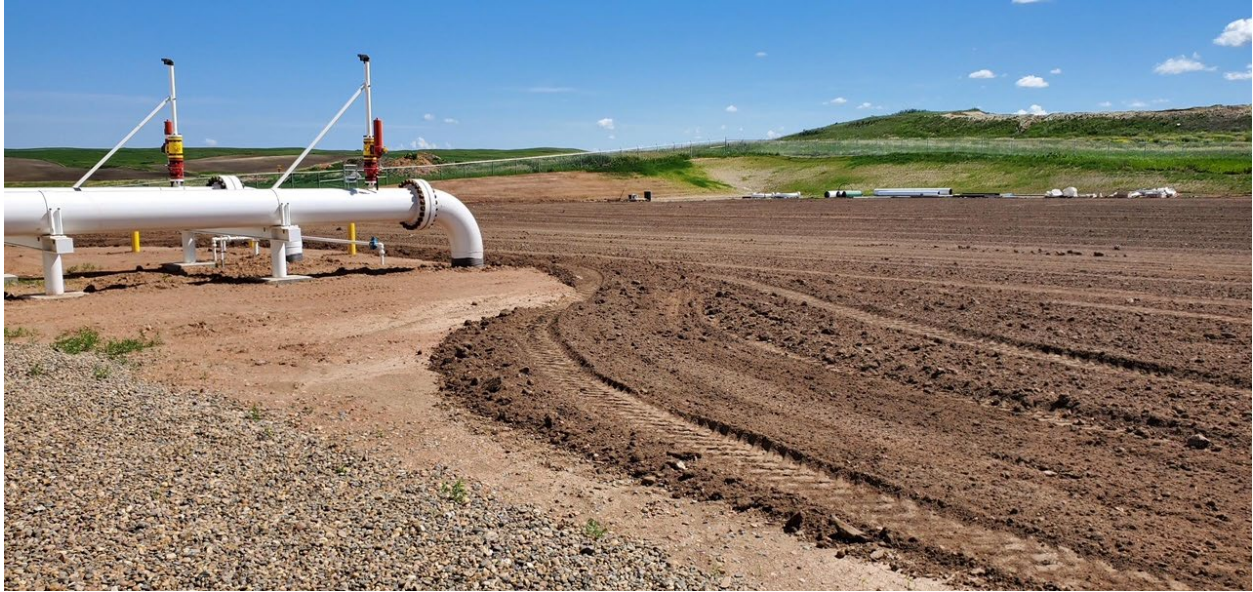
Location: Elkhorn Creek Compressor Station

Notes: Dirt work.

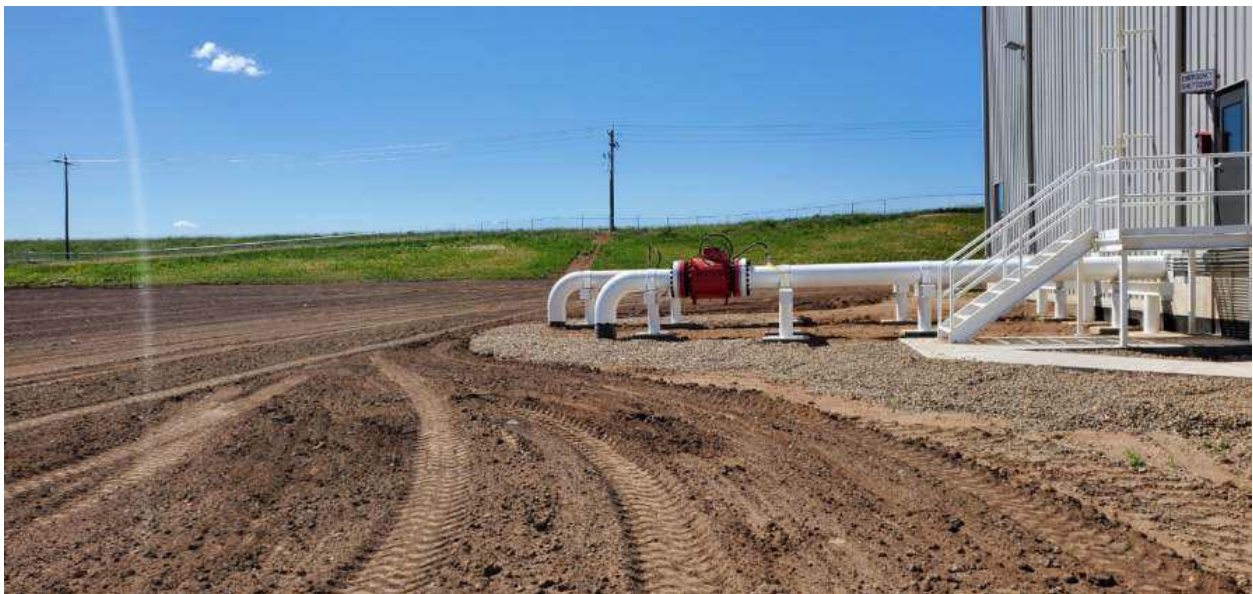
Location: Elkhorn Creek Compressor Station

Notes: Dirt work.
