Re: WBI Energy Transmission, Inc.
Docket Nos. CP20-52-000 and CP20-52-001
North Bakken Expansion Project
Status Report No. 44

WBI Energy Transmission, Inc.
North Bakken Expansion Project Status Report No. 44
FERC Docket Nos. CP20-52-000
CP20-52-001

Reporting Period: July 4, 2022 through July 10, 2022

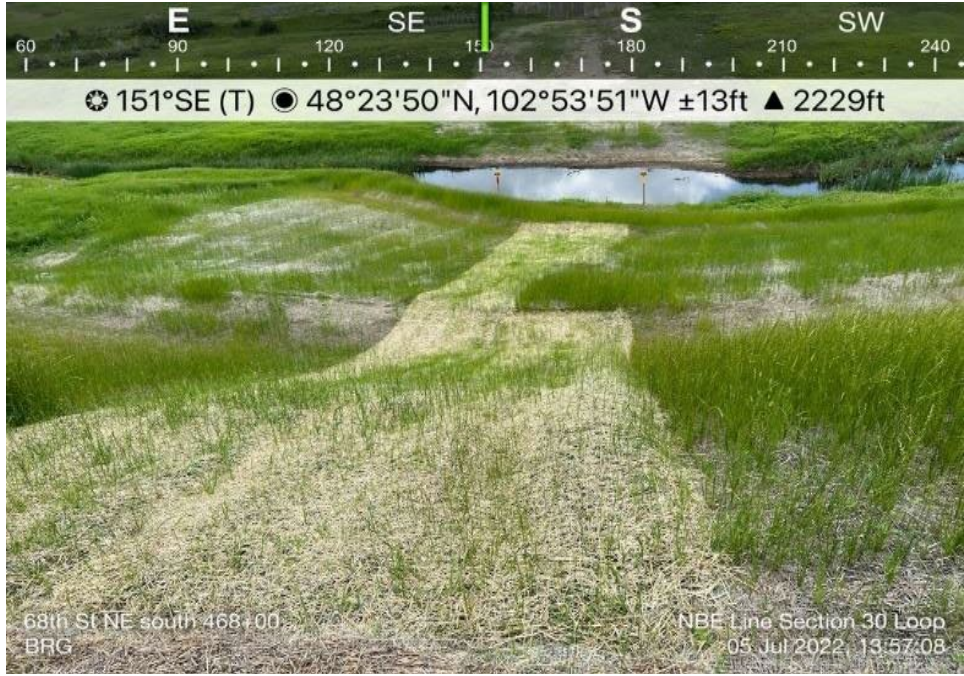
Location:
Sta. No. 468+00

Notes: Repaired
right-of-way on the
Line Section 30
Loop Pipeline
remains stable.

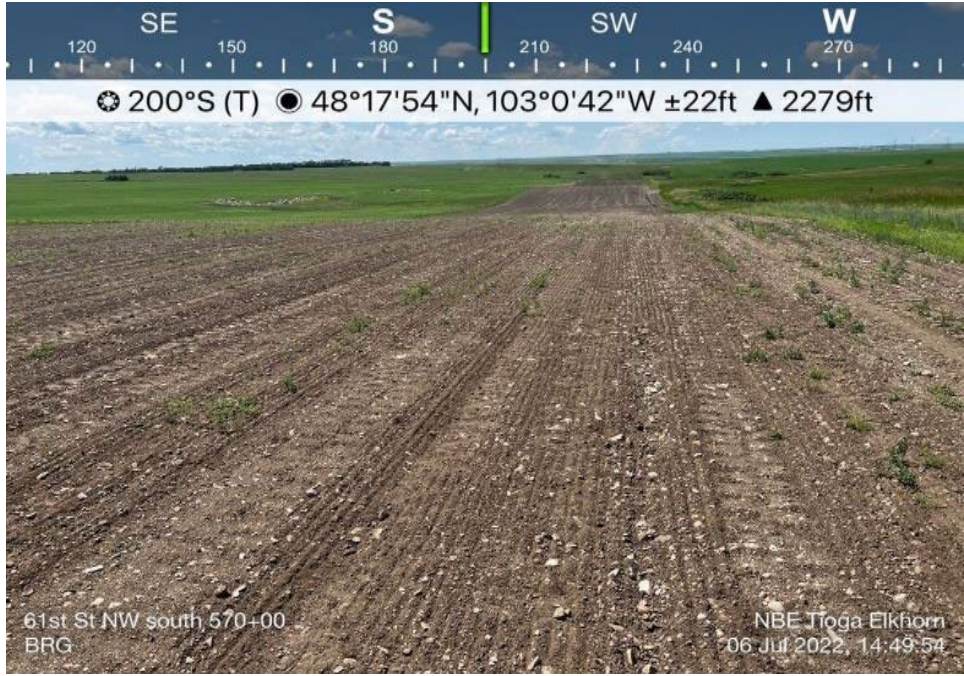
Location:
Sta. No. 570+00

Notes: Reseeded the repaired Tioga-Elkhorn Creek Pipeline right-of-way with a landowner approved rye cover crop.

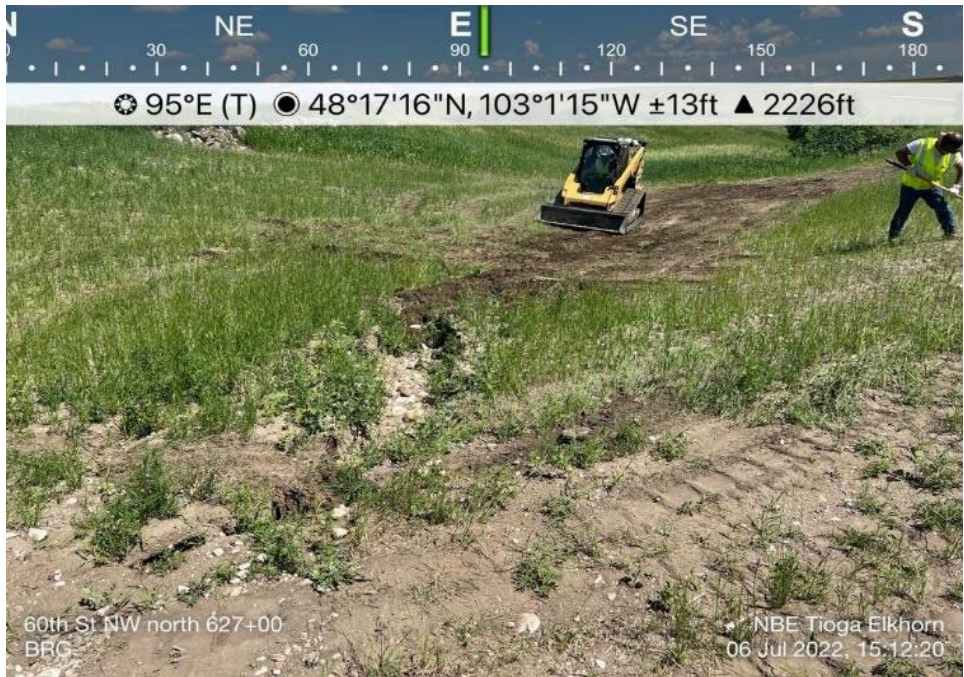
Location:
Sta. No. 627+00

Notes: Repairing rill/channel erosion on the Tioga-Elkhorn Creek Pipeline right-of-way.

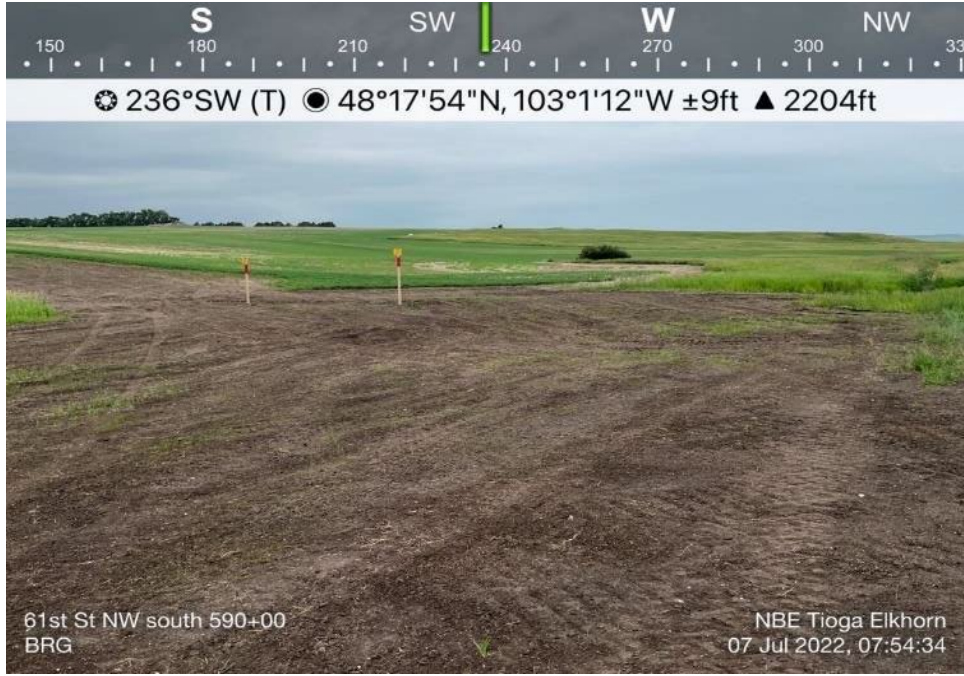
Location:
Sta. No. 590+00

Notes: Repaired
trench settling on
the Tioga-Elkhorn
Creek Pipeline
right-of-way.

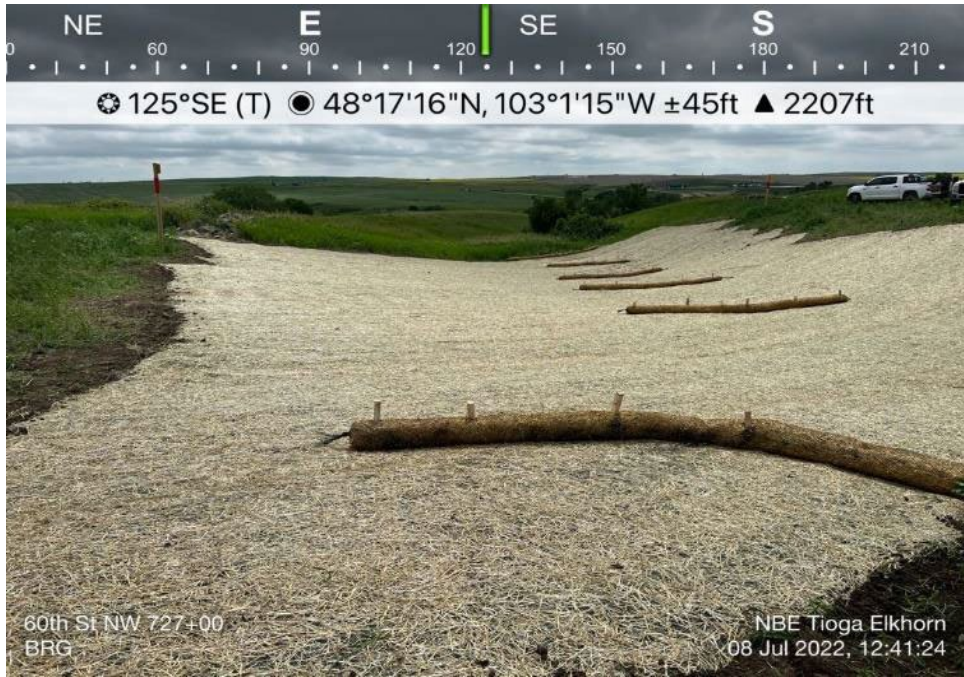
Location:
Sta. No. 727+00

Notes: Installed
erosion control
devices in restored
drainage on the
Tioga-Elkhorn
Creek Pipeline
right-of-way.

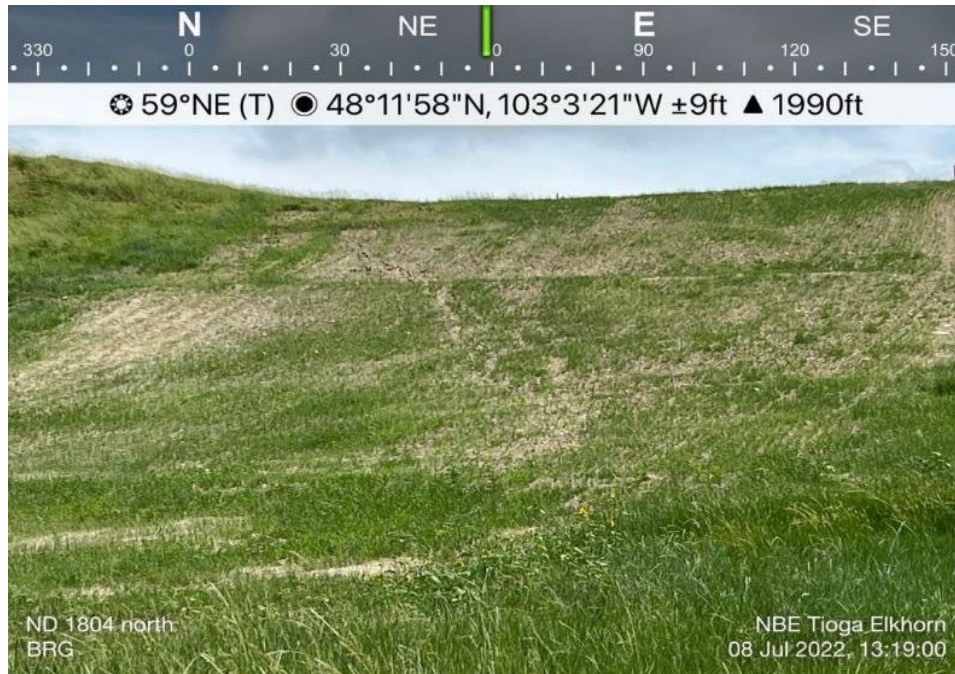
Location:
Sta. No. 1017+00

Notes: The Tioga-
Elkhorn Creek
Pipeline right-of-
way remains stable.

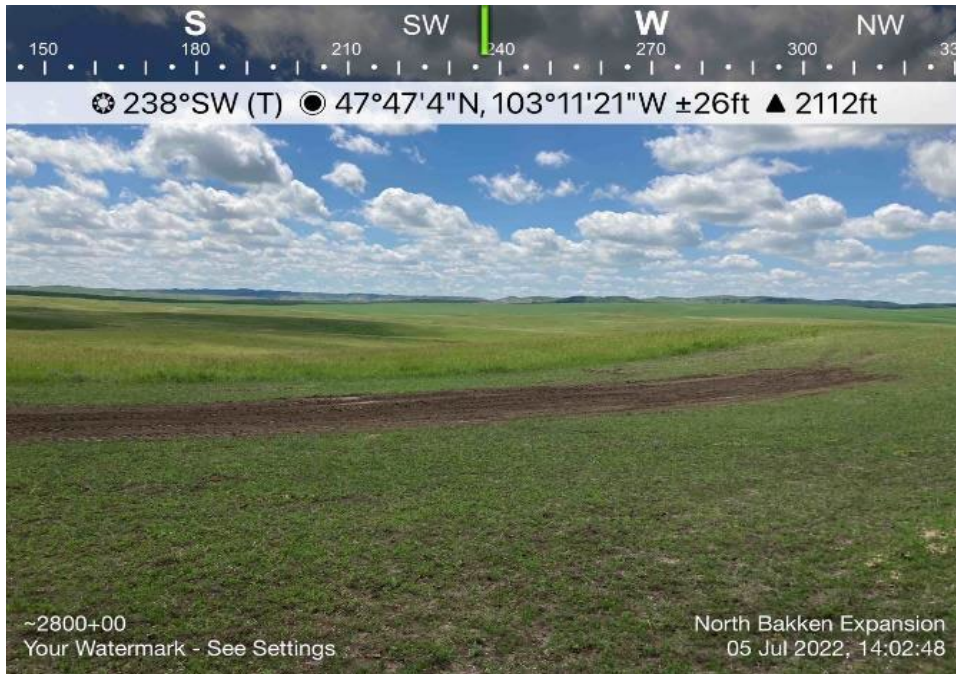
Location:
Sta. No. 2800+00

Notes: Repaired
Tioga-Elkhorn
Creek Pipeline
right-of-way.

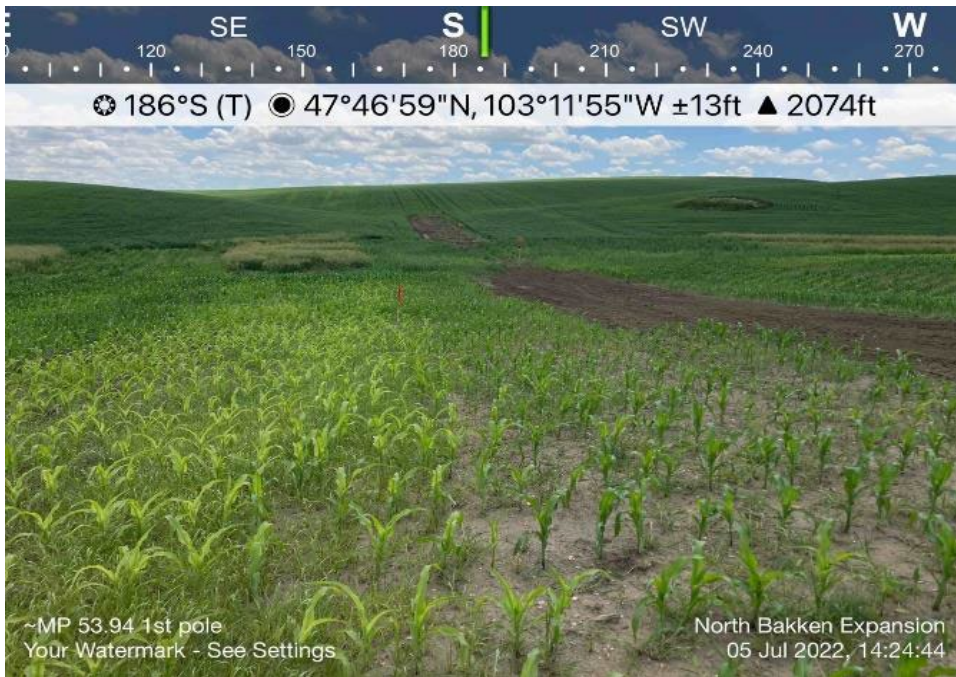
Location:
Sta. No. 2840+00

Notes: Repaired
Tioga-Elkhorn
Creek Pipeline
right-of-way.

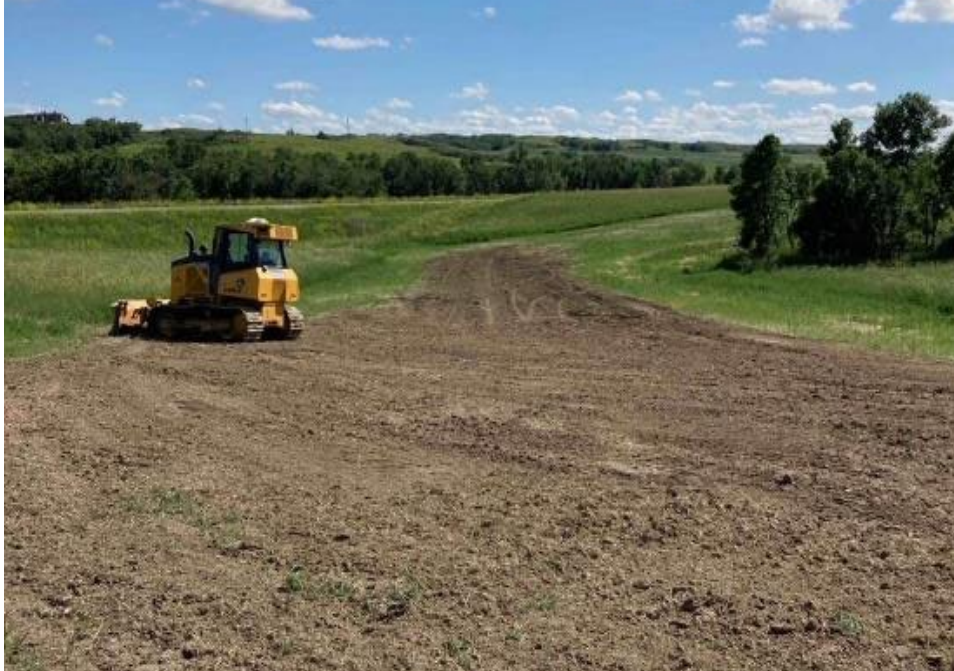
Location:
Sta. No. 3114+00

Notes: Repairing
trench settling on
the Tioga-Elkhorn
Creek Pipeline
right-of-way.

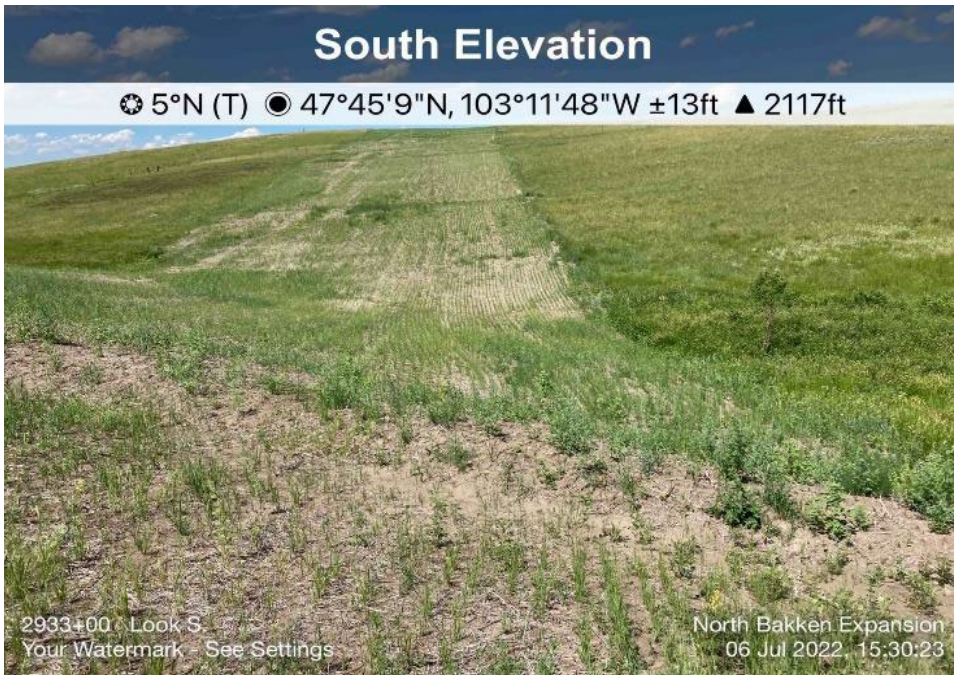
Location:
Sta. No. 2933+00

Notes: The Tioga-
Elkhorn Creek
Pipeline right-of-
way remains stable.

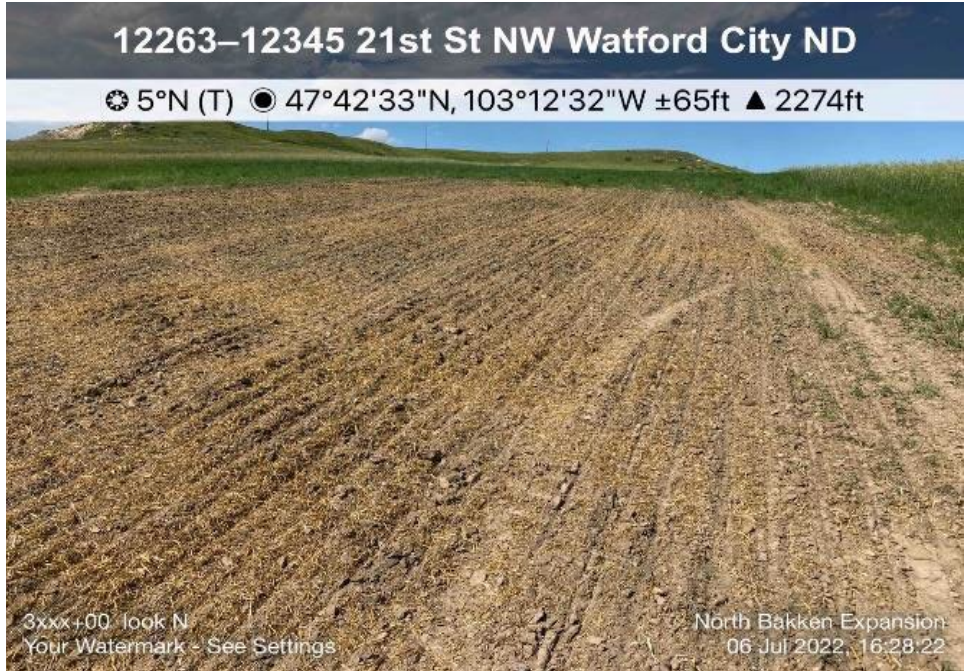
Location:
Sta. No. 3118+00

Notes: Crimped straw mulch into reseeded right-of-way to anchor mulch on the Tioga-Elkhorn Creek Pipeline.

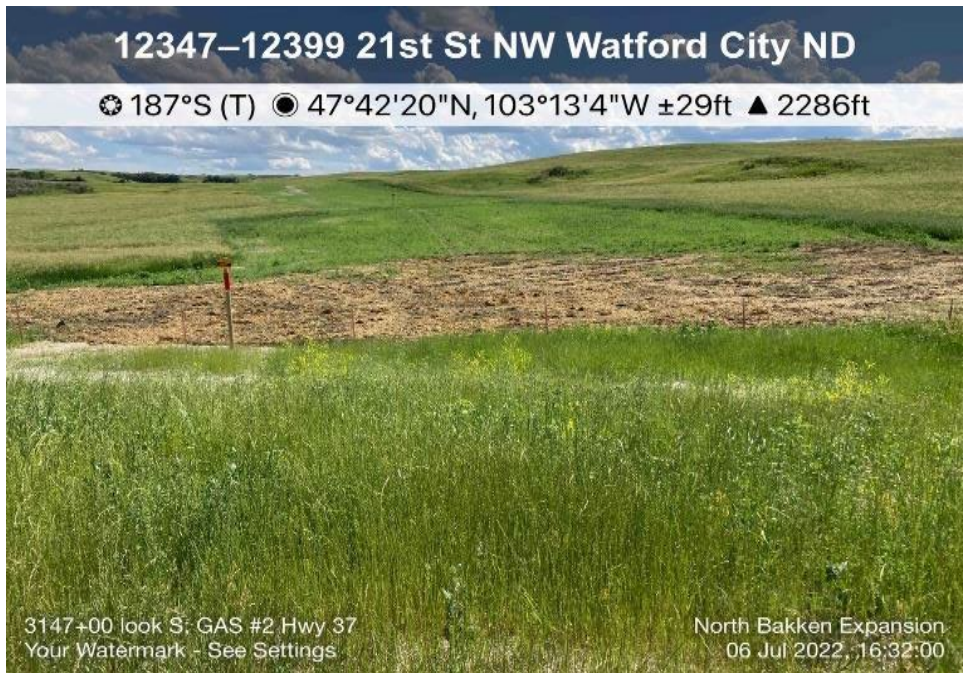
Location:
Sta. No. 3147+00

Notes: Crimped straw mulch into reseeded right-of-way to anchor mulch on the repaired Tioga-Elkhorn Creek Pipeline.

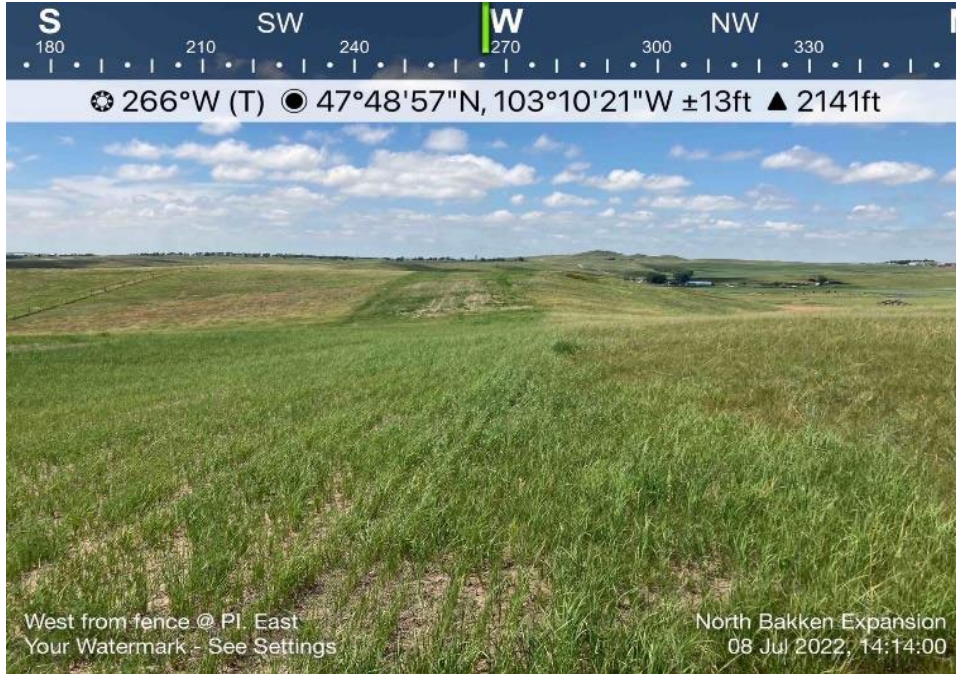
Location: Sta. Nos. 2670+00 to 2685+00

Notes: The Tioga-Elkhorn Creek Pipeline right-of-way remains stable.

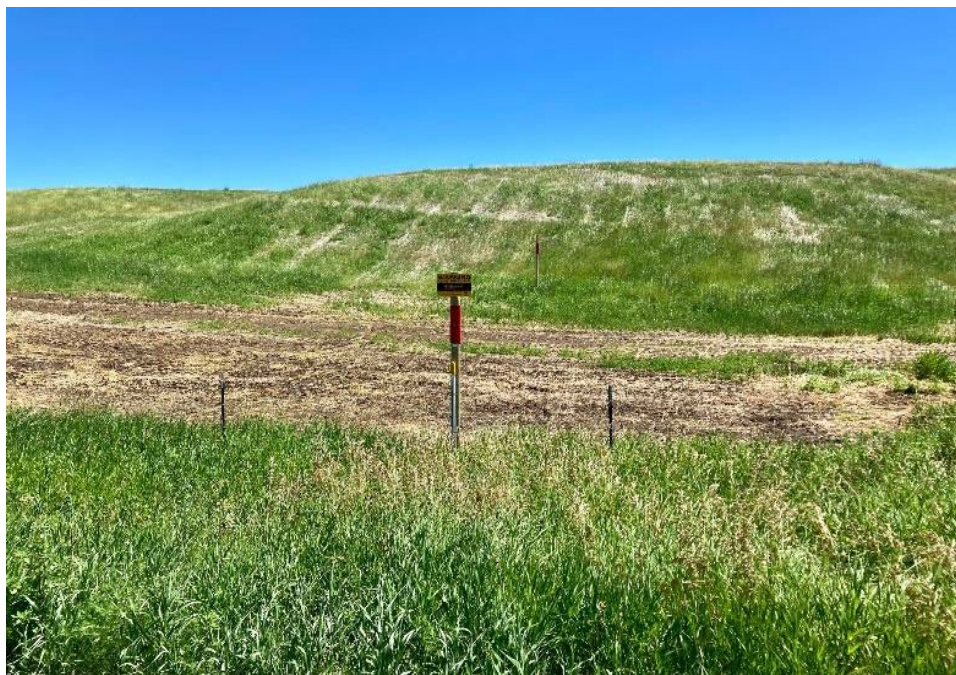
Location: Sta. No. 1572+90

Notes: Reseeded the repaired right-of-way on the Tioga-Elkhorn Creek Pipeline.

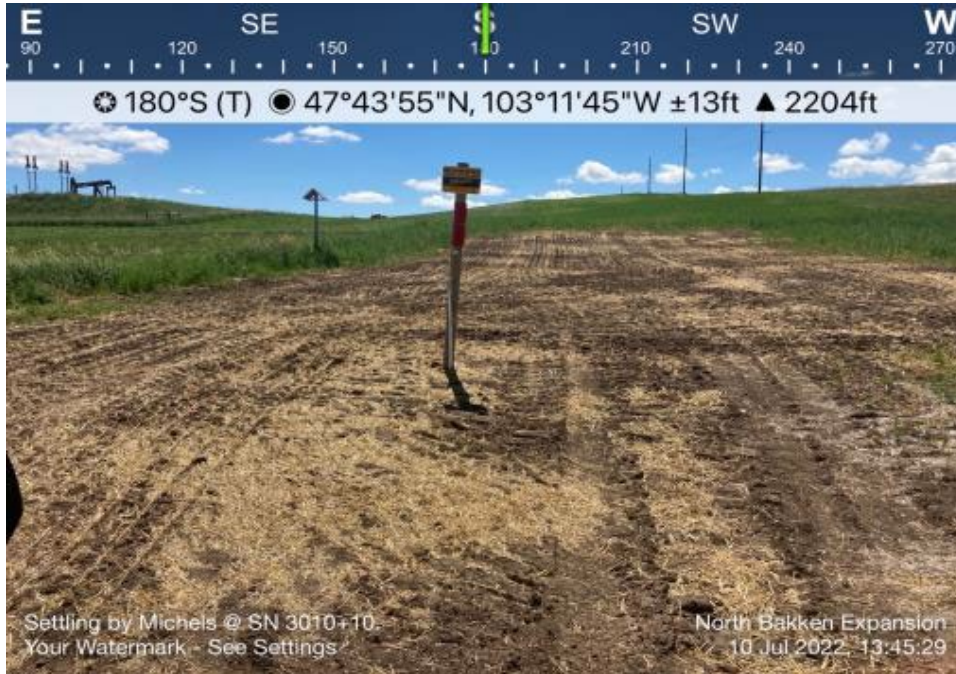
Location:
Sta. No. 3010+00

Notes: Repaired and
reseeded trench
settling on the
Tioga-Elkhorn
Creek Pipeline
right-of-way.

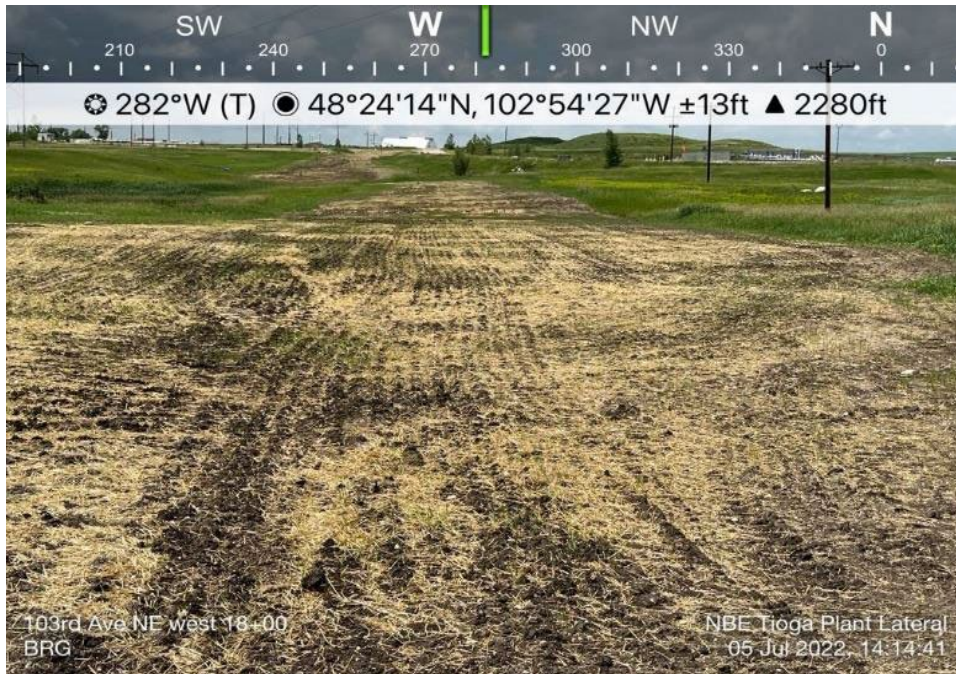
Location:
Sta. No. 18+00

Notes: Repaired
right-of-way on the
Tioga Compressor
Lateral remains
stable.

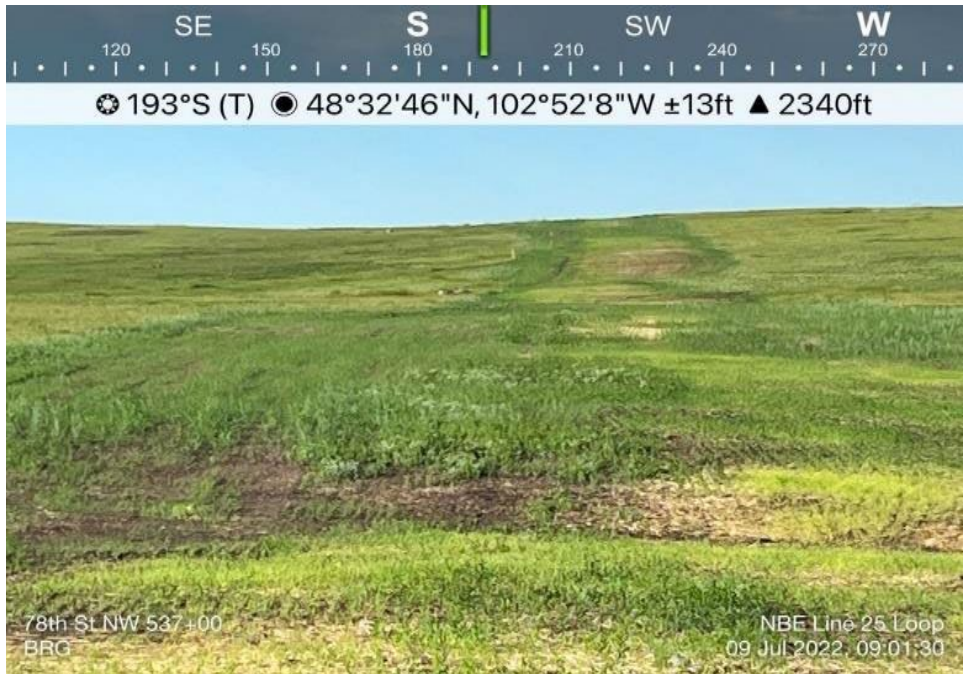
Location:
Sta. No. 537+00

Notes: Right-of-way
on the Line Section
25 Loop Pipeline
remains stable.

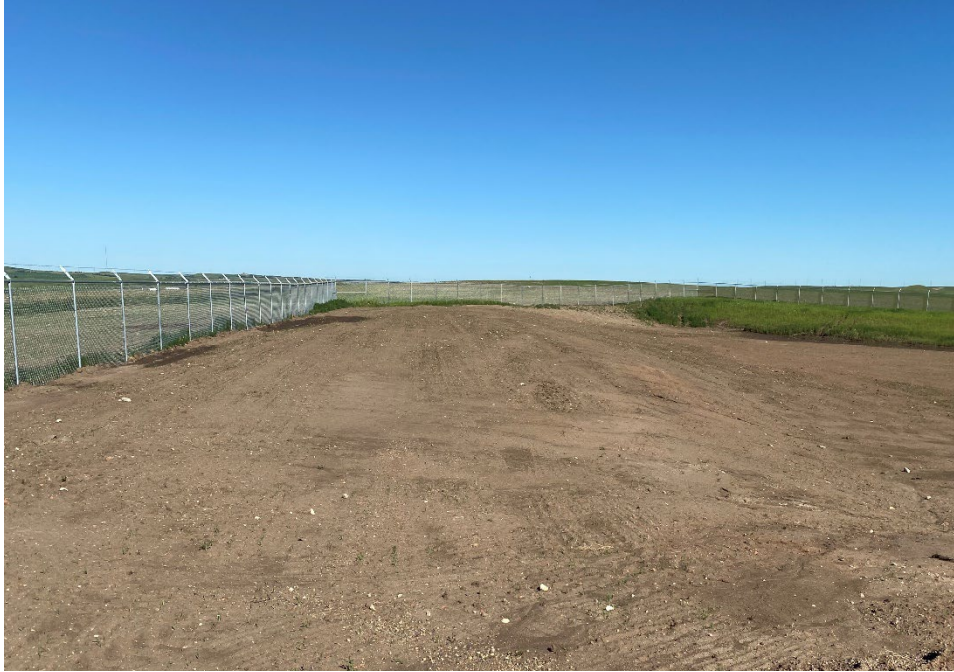
Location: Elkhorn
Creek Compressor
Station

Notes: Completed
spreading topsoil at
the Elkhorn Creek
Compressor Station.
