Re: WBI Energy Transmission, Inc.
Docket Nos. CP20-52-000 and CP20-52-001
North Bakken Expansion Project
Status Report No. 45

WBI Energy Transmission, Inc.
North Bakken Expansion Project Status Report No. 45
FERC Docket Nos. CP20-52-000
CP20-52-001

Reporting Period: July 11, 2022 through July 17, 2022

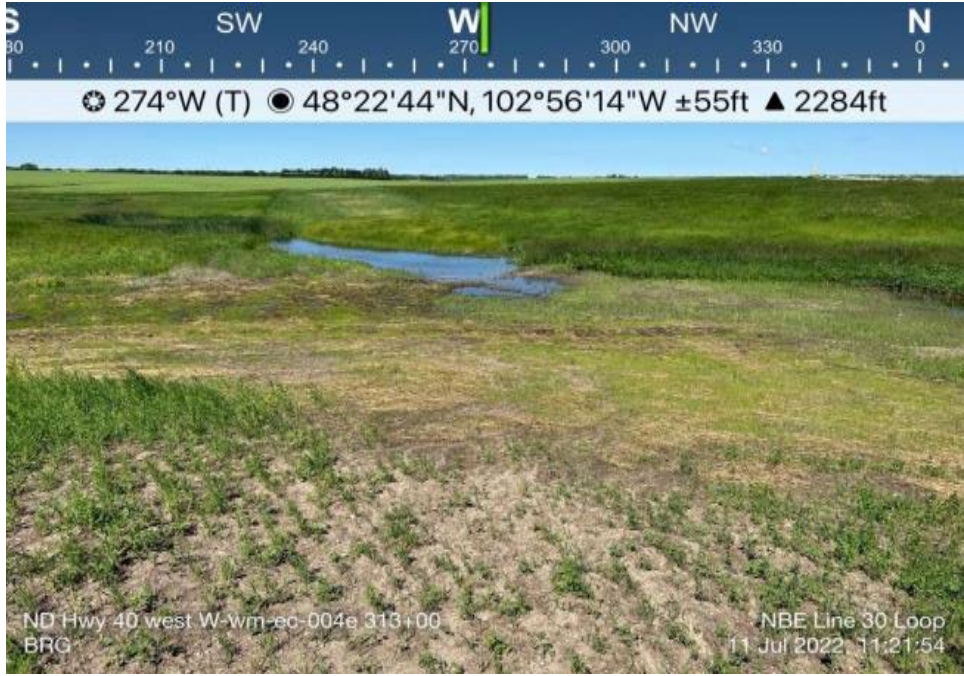
Location:
Sta. No. 313+00

Notes: Repaired
right-of-way on the
Line Section 30
Loop Pipeline
remains stable.

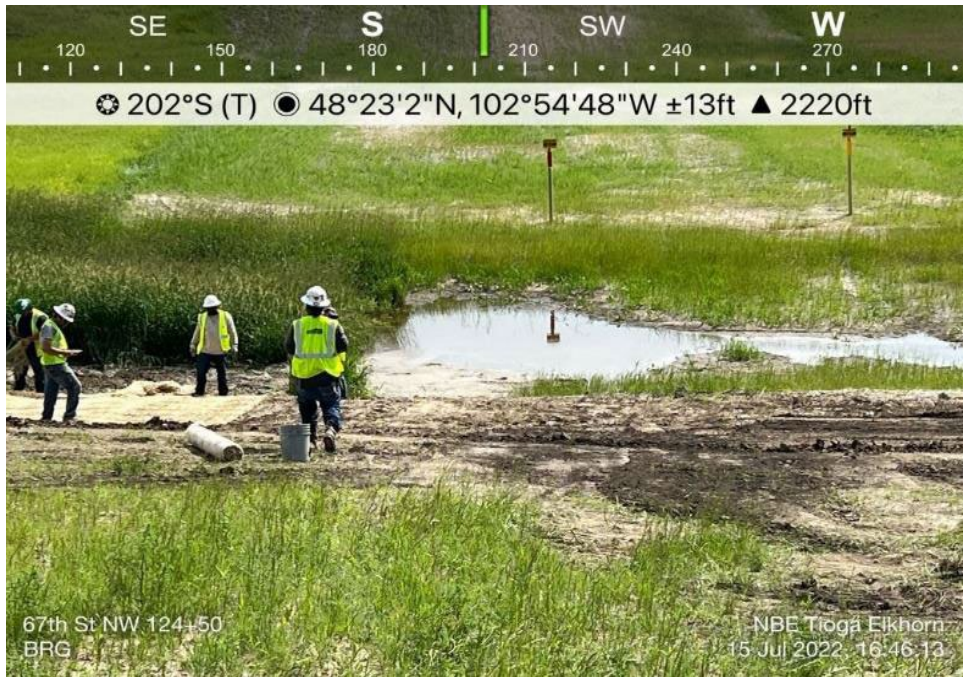
Location:
Sta. No. 124+50

Notes: Installing
erosion control
devices on restored
bank of waterbody
s-wm-ea-002
(unnamed tributary
to Dry Fork Creek)
on the collocated
Tioga-Elkhorn
Creek and Line
Section 30 Loop
Pipelines.

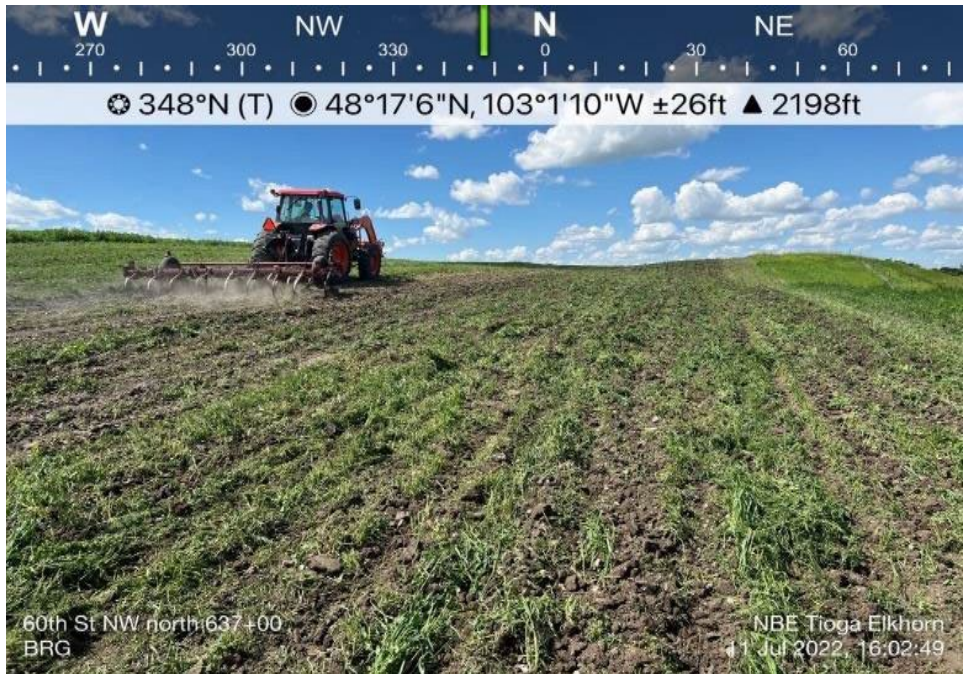
Location:
Sta. No. 637+00

Notes: Utilizing a chisel plow prior to reseeding the repaired Tioga-Elkhorn Creek Pipeline right-of-way.

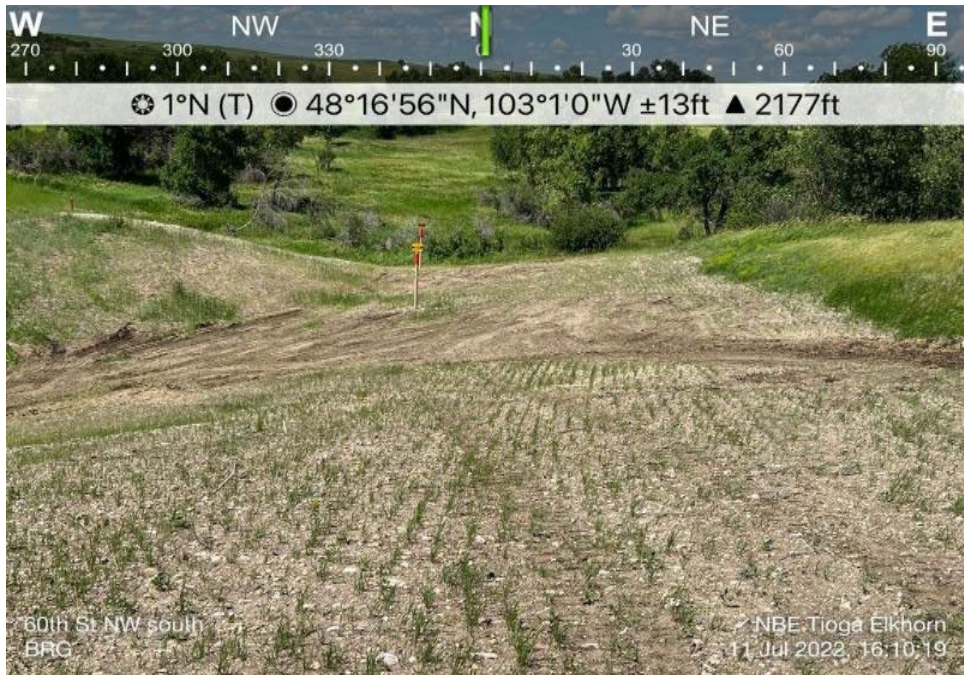
Location:
Sta. No. 650+00

Notes: Repaired rill/channel erosion on the Tioga-Elkhorn Creek Pipeline right-of-way.

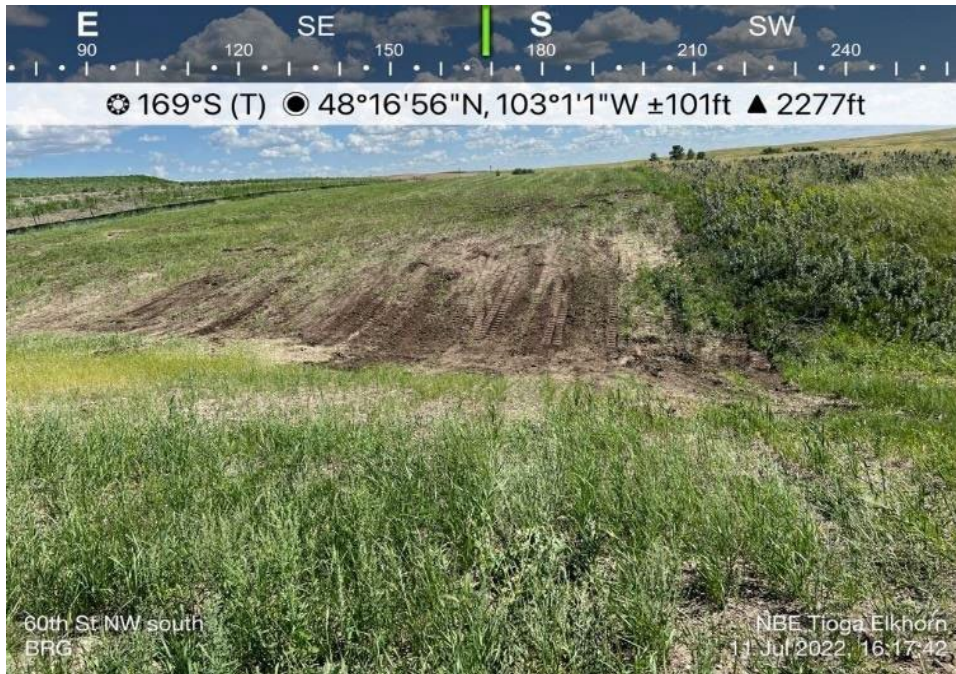
Location:
Sta. No. 660+00

Notes: Repaired
rill/channel erosion
on the Tioga-
Elkhorn Creek
Pipeline right-of-
way.

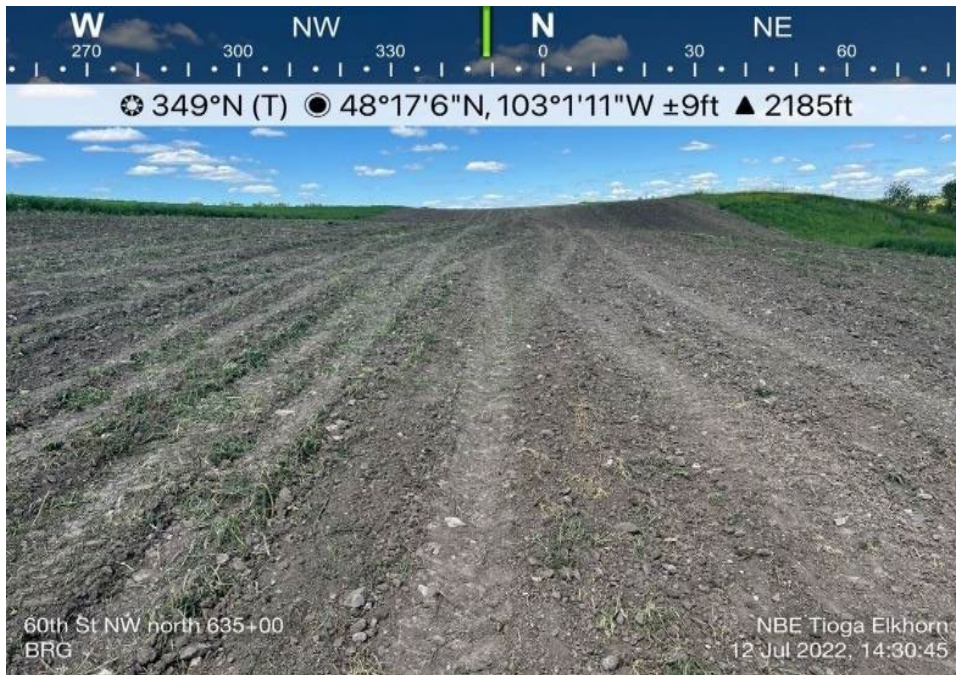
Location:
Sta. No. 635+00

Notes: Utilized a
drag to level field
and picked rocks
prior to reseeding
the repaired Tioga-
Elkhorn Creek
Pipeline right-of-
way.

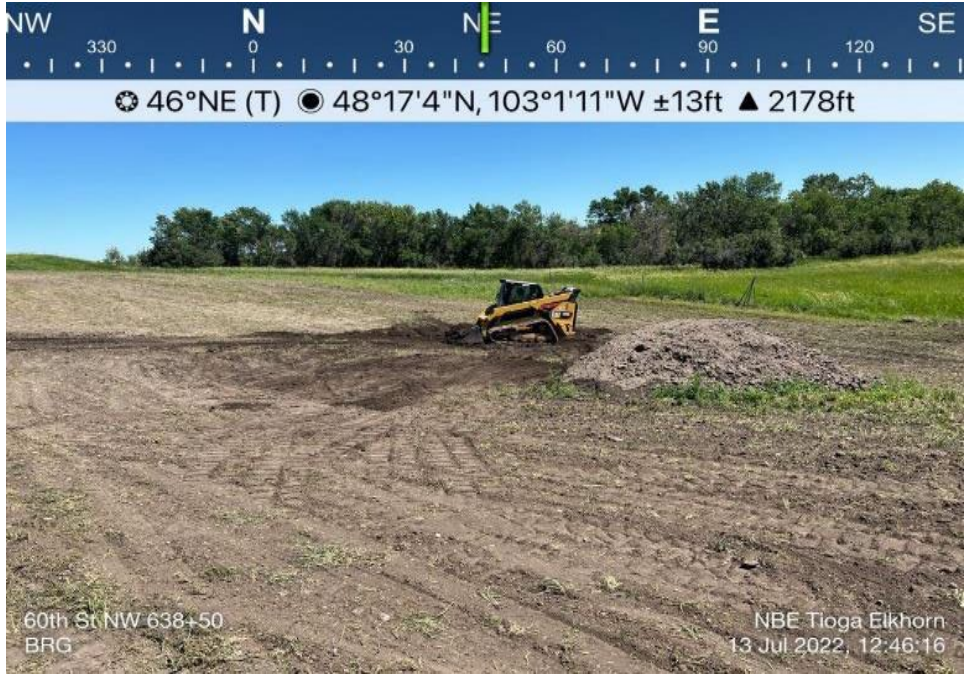
Location:
Sta. No. 638+50

Notes: Repairing trench settling with additional topsoil on the Tioga-Elkhorn Creek Pipeline right-of-way.

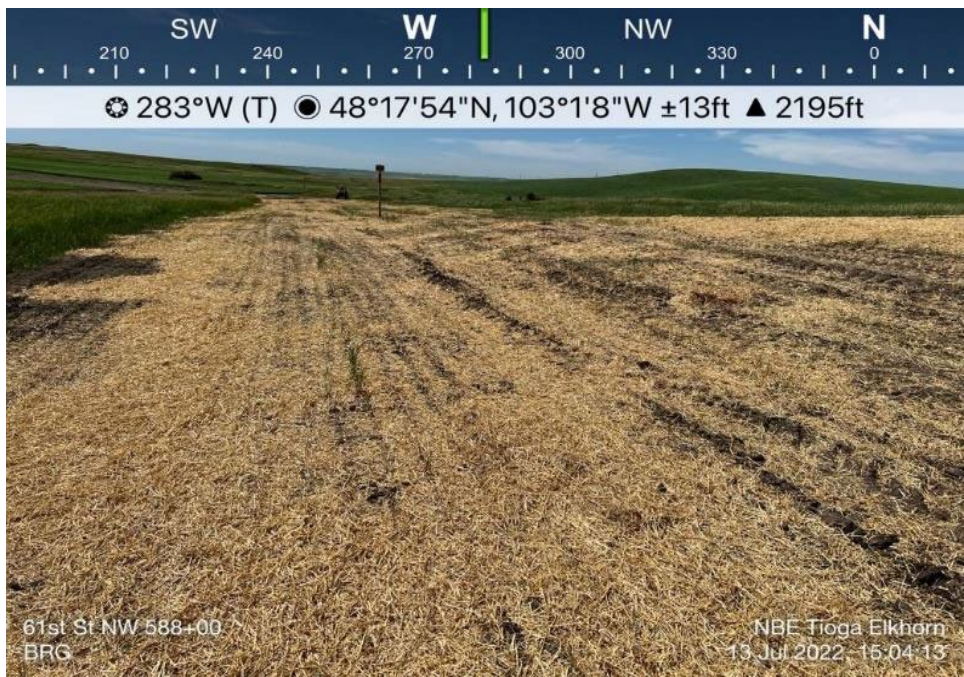
Location:
Sta. No. 588+00

Notes: Crimped straw mulch into reseeded right-of-way to anchor mulch on the Tioga-Elkhorn Creek Pipeline.

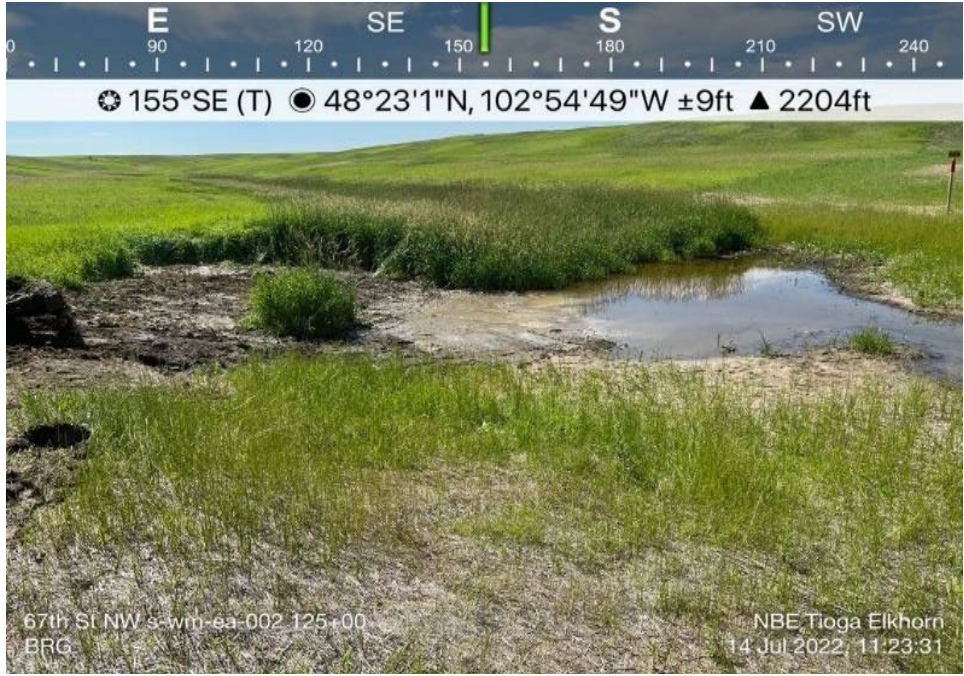
Location:
Sta. No. 125+00

Notes: Removed sediment deposited into waterbody s-wm-ea-002 (unnamed tributary to Dry Fork Creek) on the collocated Tioga-Elkhorn Creek and Line Section 30 Loop Pipelines.

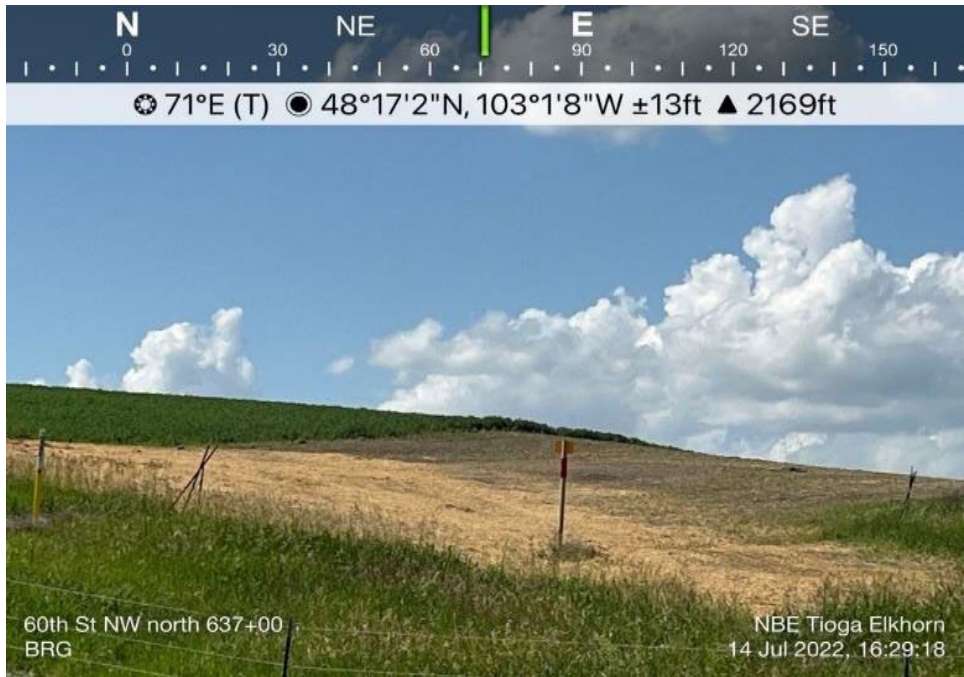
Location:
Sta. No. 637+00

Notes: Crimped straw mulch into reseeded right-of-way to anchor mulch on the Tioga-Elkhorn Creek Pipeline.

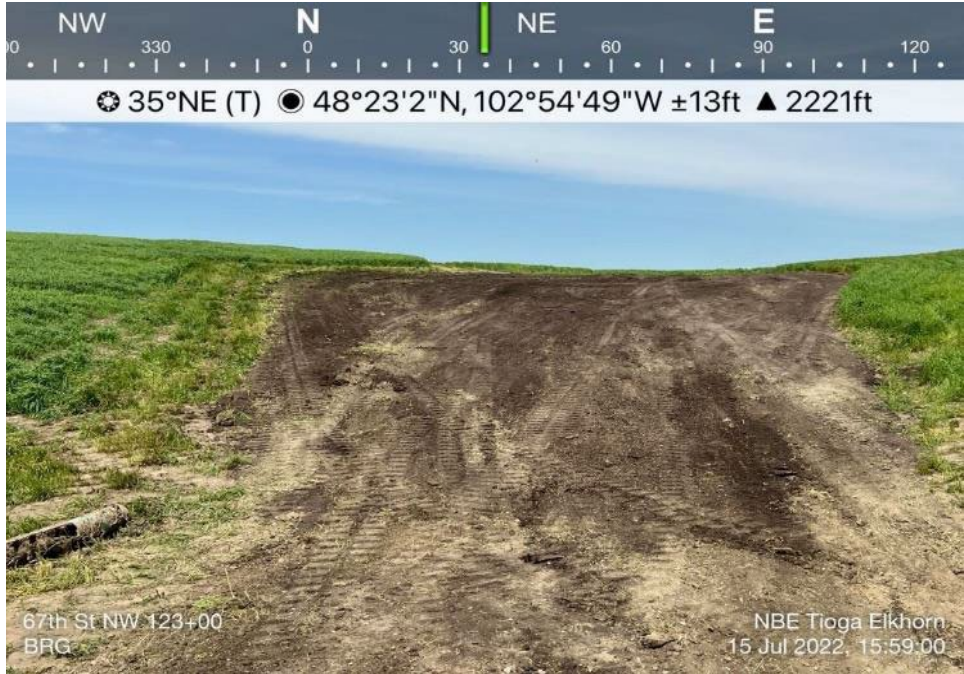
Location:
Sta. No. 123+00

Notes: Repaired
rill/channel erosion
on the Tioga-
Elkhorn Creek
Pipeline right-of-
way.

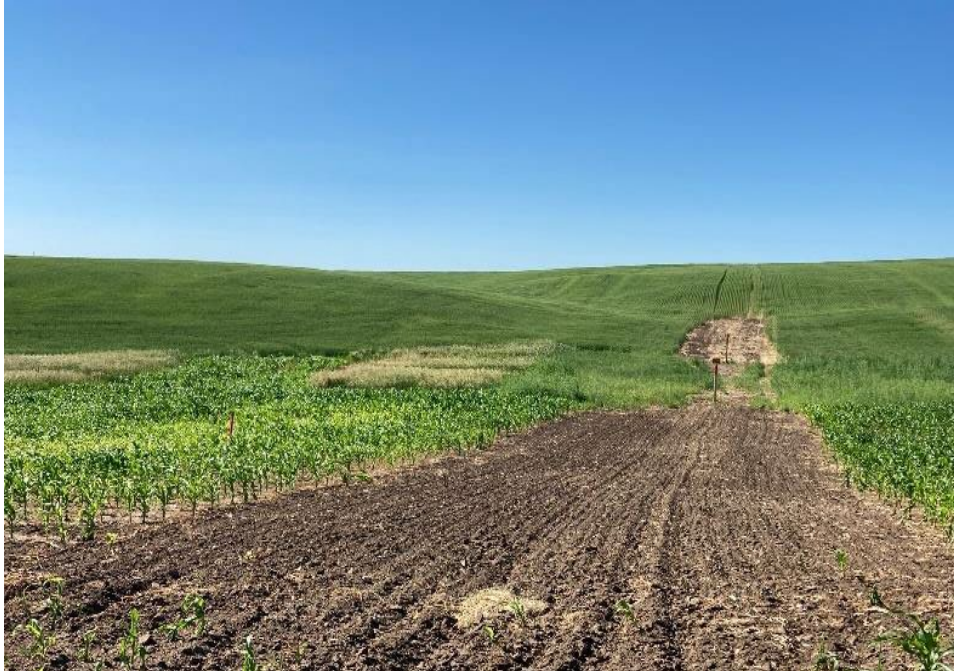
Location: Sta. Nos.
2817+83 to
2848+15

Notes: Repaired
Tioga-Elkhorn
Creek Pipeline
right-of-way.

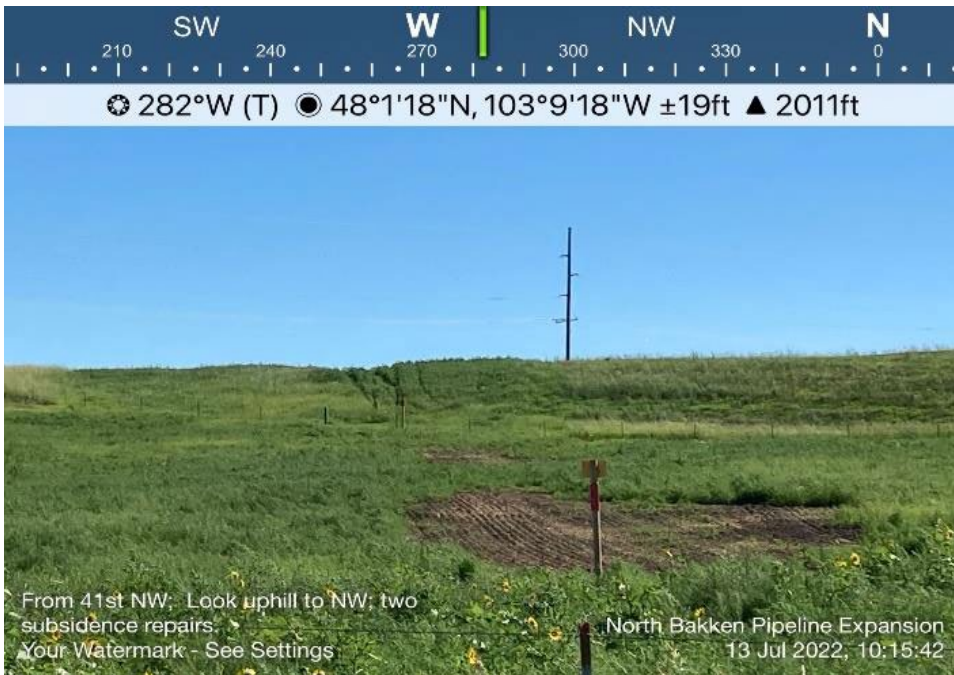
Location:
Sta. No. 1830+00

Notes: Repaired
trench settling on
the Tioga-Elkhorn
Creek Pipeline
right-of-way.

From 41st NW: Look uphill to NW; two
subsidence repairs.
Your Watermark - See Settings

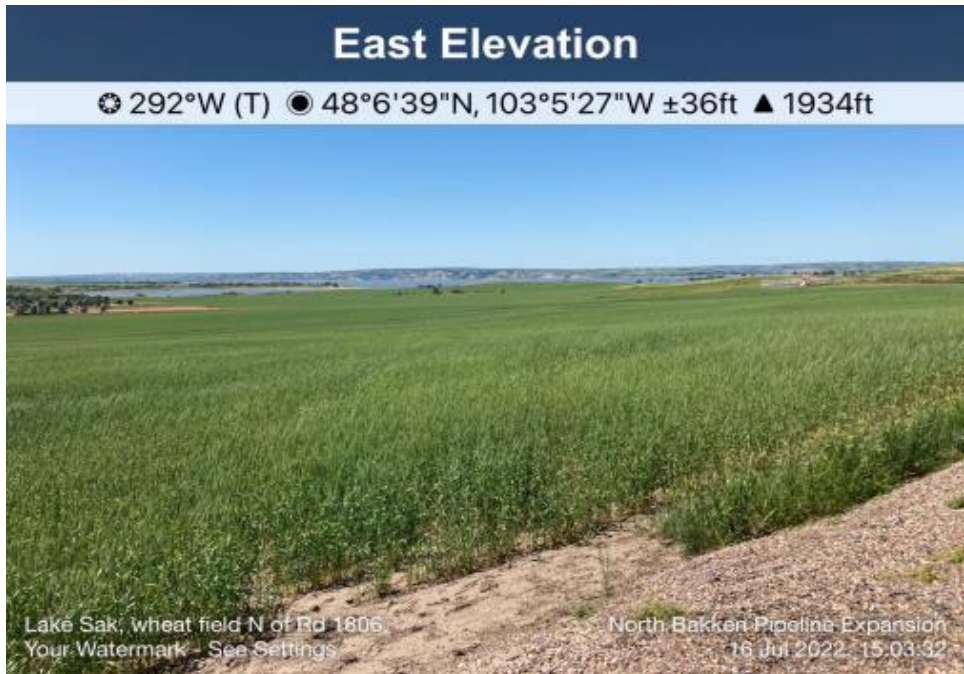
Location:
Sta. No. 1386+00

Notes: The Tioga-Elkhorn Creek Pipeline right-of-way remains stable.

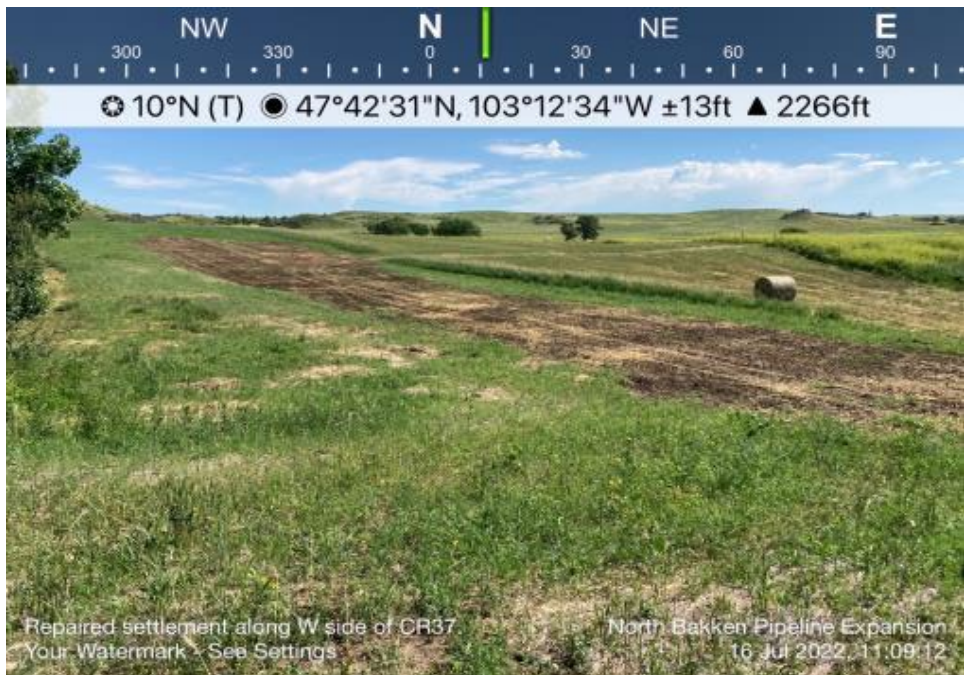
Location:
Sta. No. 3120+00

Notes: Repaired trench settling on the Tioga-Elkhorn Creek Pipeline right-of-way.

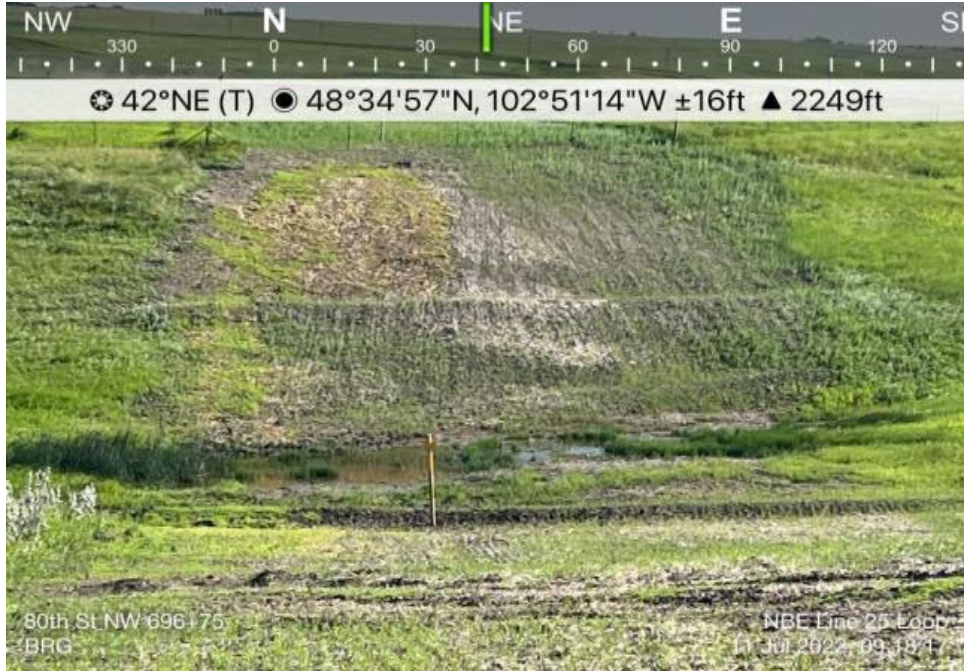
Location:
Sta. No. 696+75

Notes: The repaired
hillside of wetland w-
bk-ee-002e on the
Line Section 25 Loop
Pipeline right-of-way
remains stable.
