Re: WBI Energy Transmission, Inc.
Docket Nos. CP20-52-000 and CP20-52-001
North Bakken Expansion Project
Status Report No. 46

WBI Energy Transmission, Inc.
North Bakken Expansion Project Status Report No. 46
FERC Docket Nos. CP20-52-000
CP20-52-001

Reporting Period: July 18, 2022 through July 24, 2022

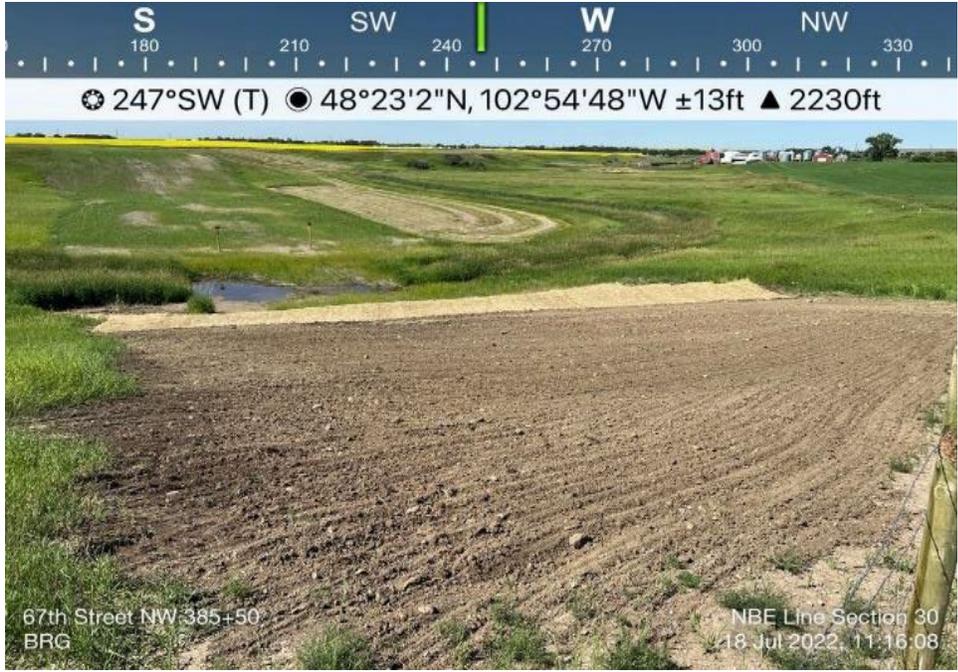
Location: Sta. Nos.
385+25 to 386+15

Notes: Chisel
plowed, dragged
and reseeded the
repaired right-of-
way on collocated
Line Section 30
Loop.

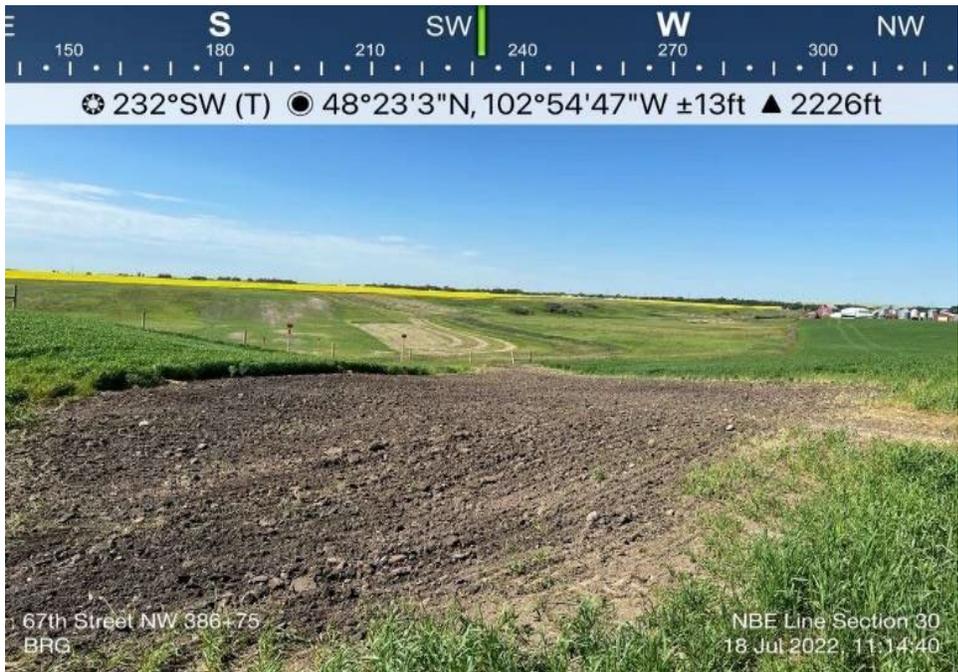
Location: Sta. Nos.
386+15 to 386+75

Notes: Chisel
plowed, dragged
and reseeded the
right-of-way on
collocated Line
Section 30 Loop.

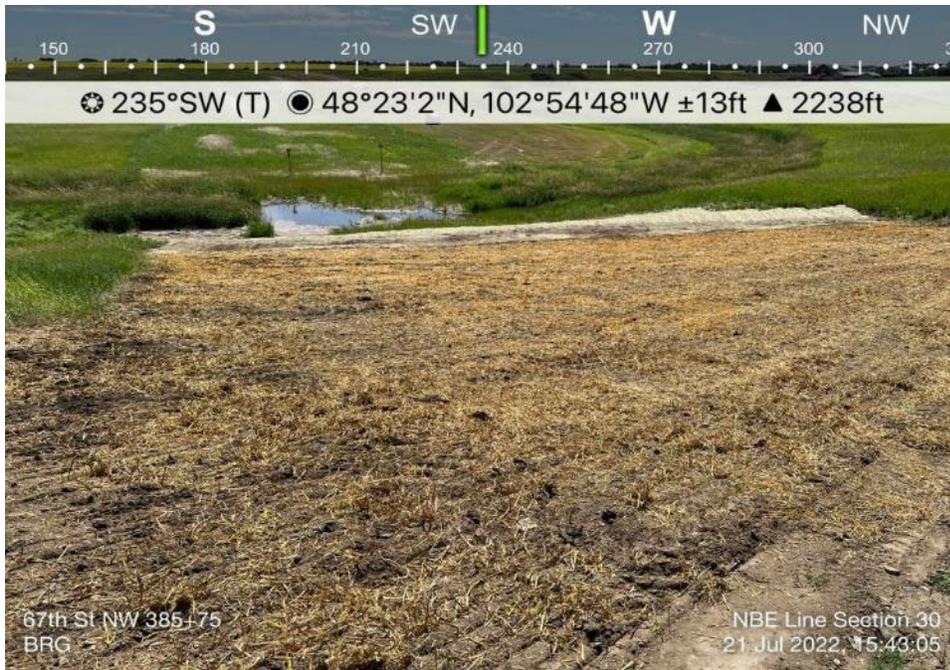
Location:
Sta. No. 385+75

Notes: Crimped straw mulch into reseeded right-of-way to anchor mulch on the Line Section 30 Loop.

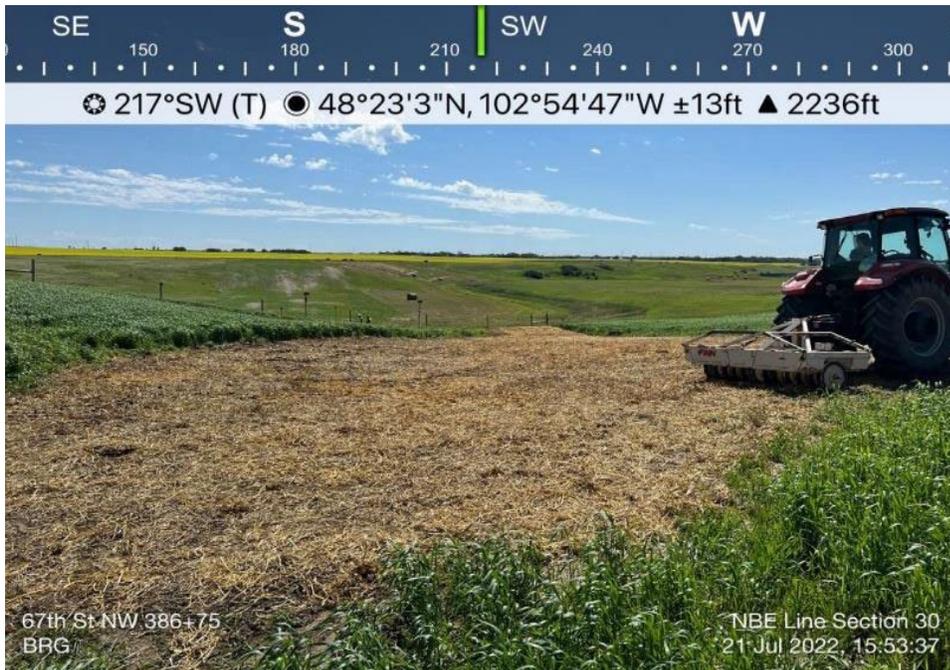
Location:
Sta. No. 386+75

Notes: Crimping straw mulch into reseeded right-of-way to anchor mulch on the Line Section 30 Loop.

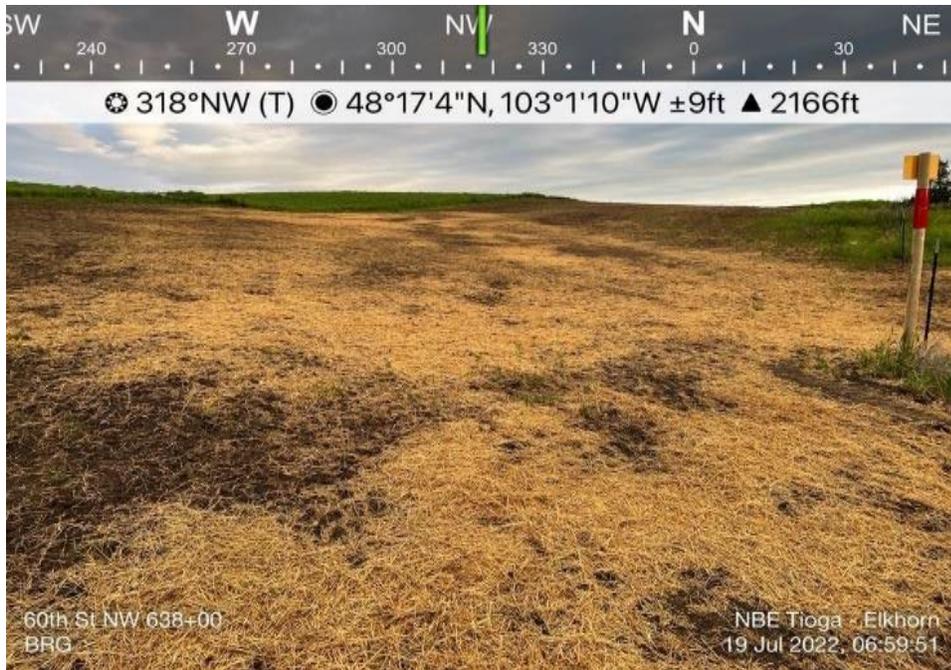
Location:
Sta. No. 638+00

Notes: Crimped straw mulch into reseeded right-of-way to anchor mulch on the Tioga-Elkhorn Creek Pipeline.

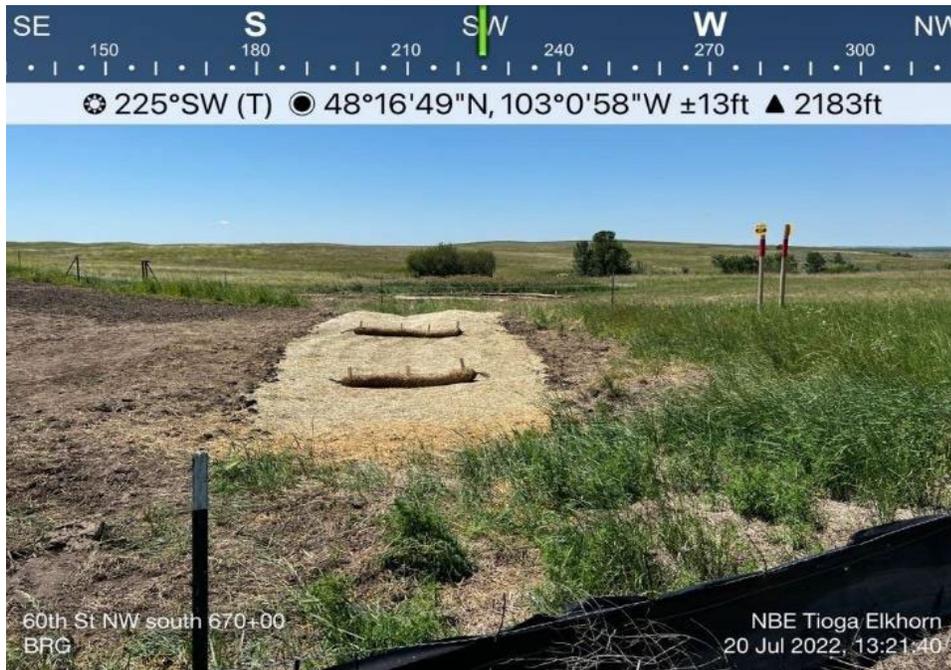
Location:
Sta. No. 670+00

Notes: Installed erosion control devices on the reseeded drainage area on the Tioga-Elkhorn Creek Pipeline right-of-way.

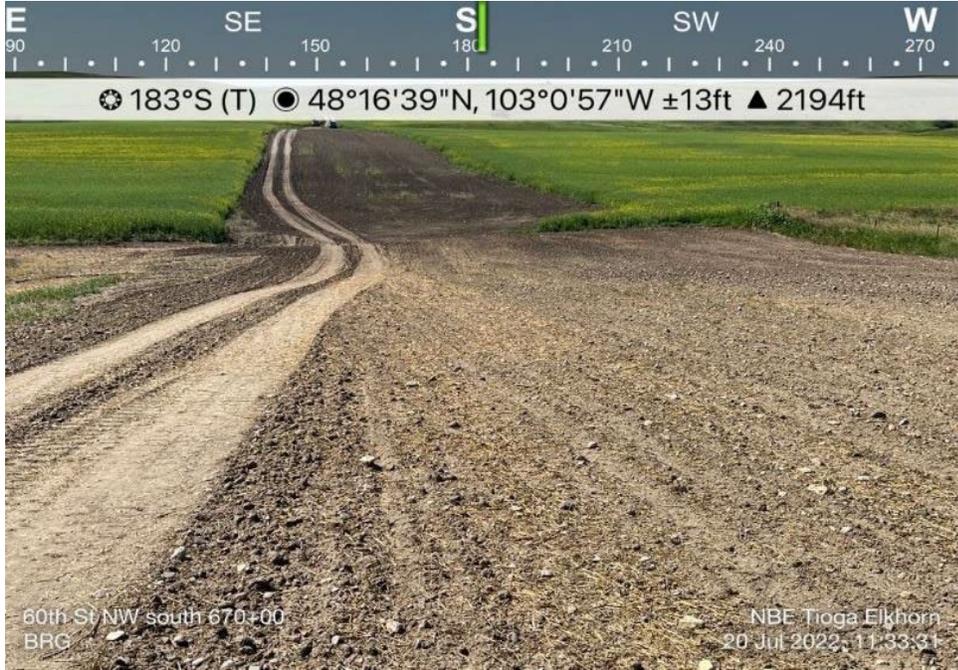
Location:
Sta. No. 670+00

Notes: Picked rocks prior to reseeding the repaired Tioga-Elkhorn Creek Pipeline right-of-way.

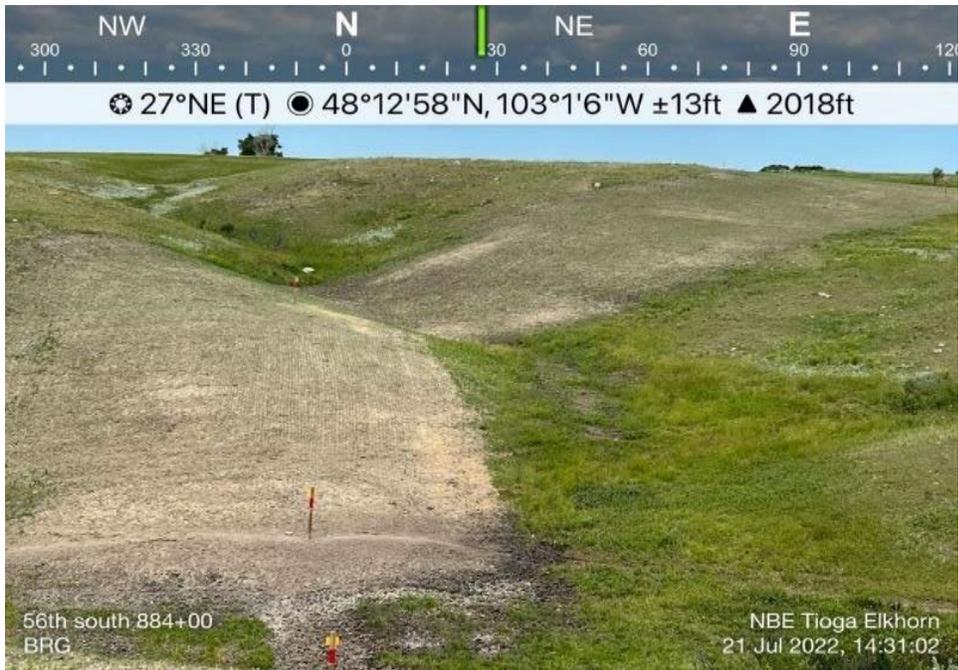
Location:
Sta. No. 884+00

Notes: The Tioga-Elkhorn Creek Pipeline right-of-way remains stable.

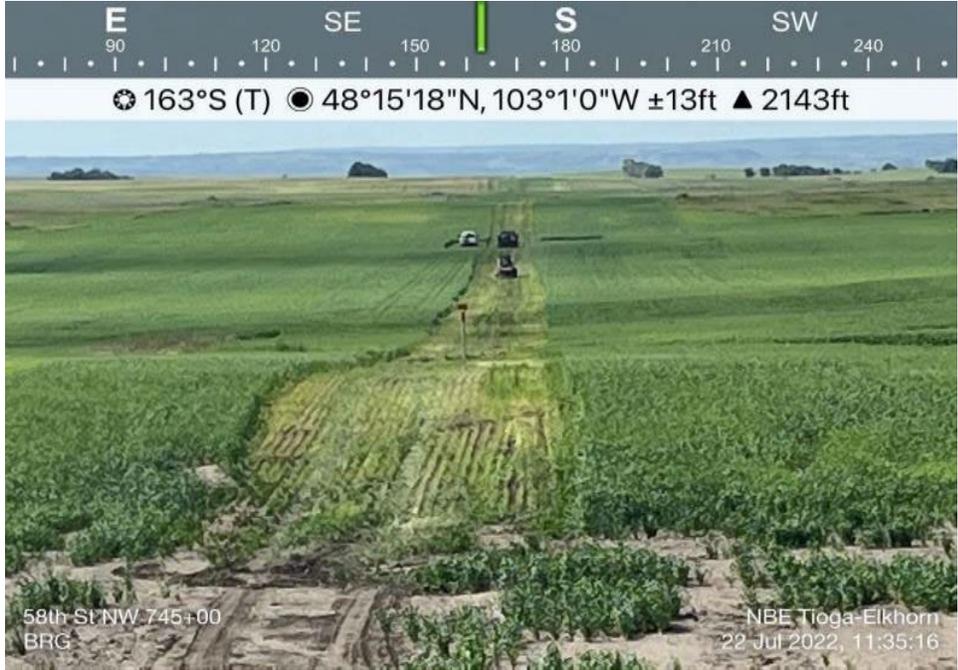
Location:
Sta. No. 745+00

Notes: Mowing the
Tioga-Elkhorn
Creek Pipeline
right-of-way for
weed control.

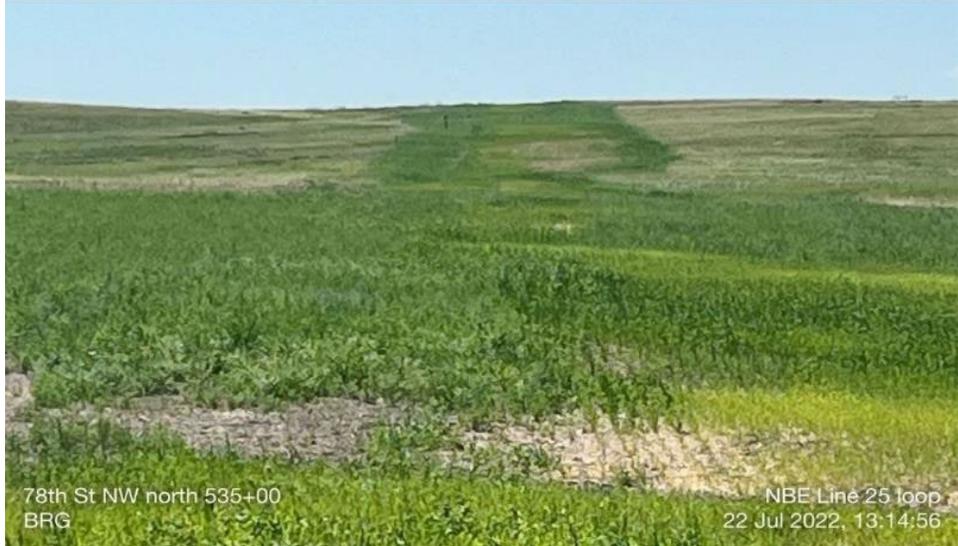
Location:
Sta. No. 535+00

Notes: The Line
Section 25 Loop
Pipeline right-of-way
remains stable.
