Re: WBI Energy Transmission, Inc.  
Docket Nos. CP20-52-000 and CP20-52-001  
North Bakken Expansion Project  
Status Report No. 47

**WBI Energy Transmission, Inc.**  
**North Bakken Expansion Project Status Report No. 47**  
**FERC Docket Nos. CP20-52-000**  
**CP20-52-001**

**Reporting Period:** July 25, 2022 through July 31, 2022

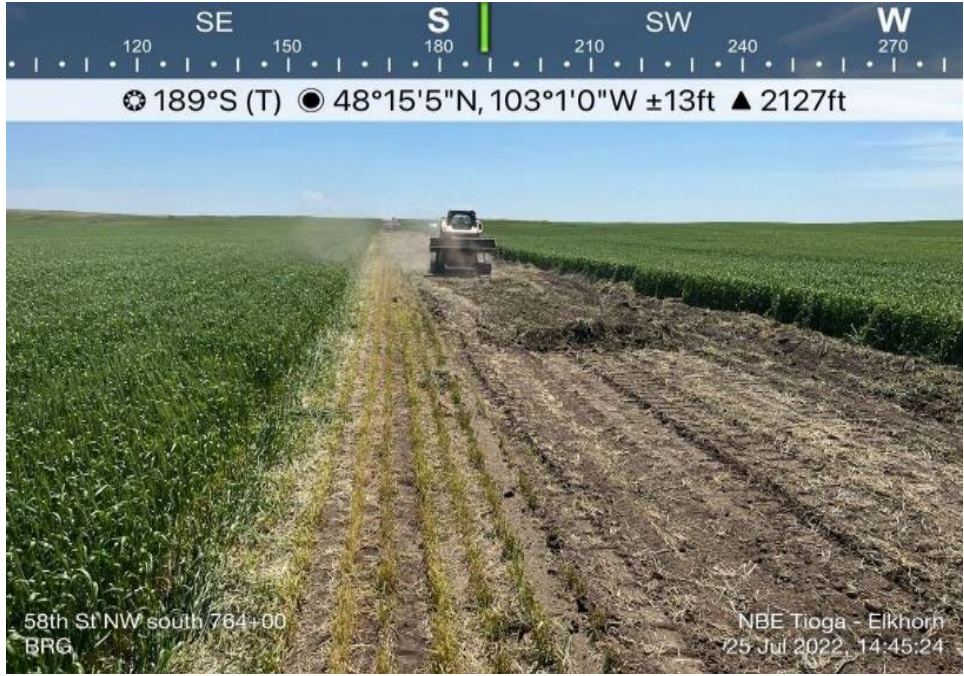
Location:  
Sta. No. 784+50

Notes: Repairing  
rill/channel erosion  
on the Tioga-  
Elkhorn Creek  
Pipeline right-of-  
way.

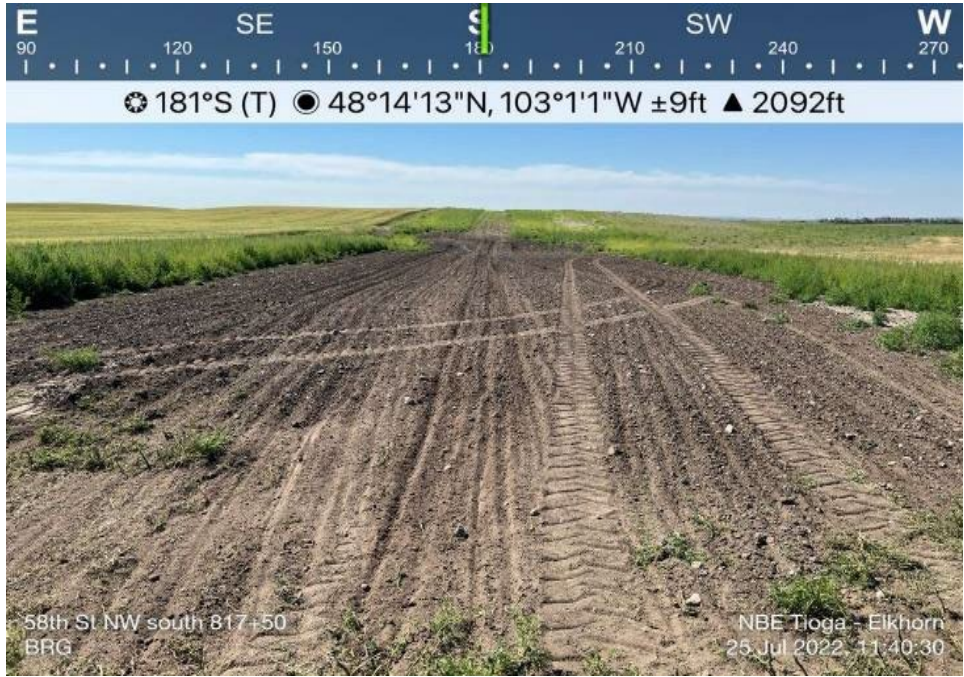
Location:  
Sta. No. 817+50

Notes: Repaired  
right-of-way prior  
to reseeding the  
Tioga-Elkhorn  
Creek Pipeline  
right-of-way.

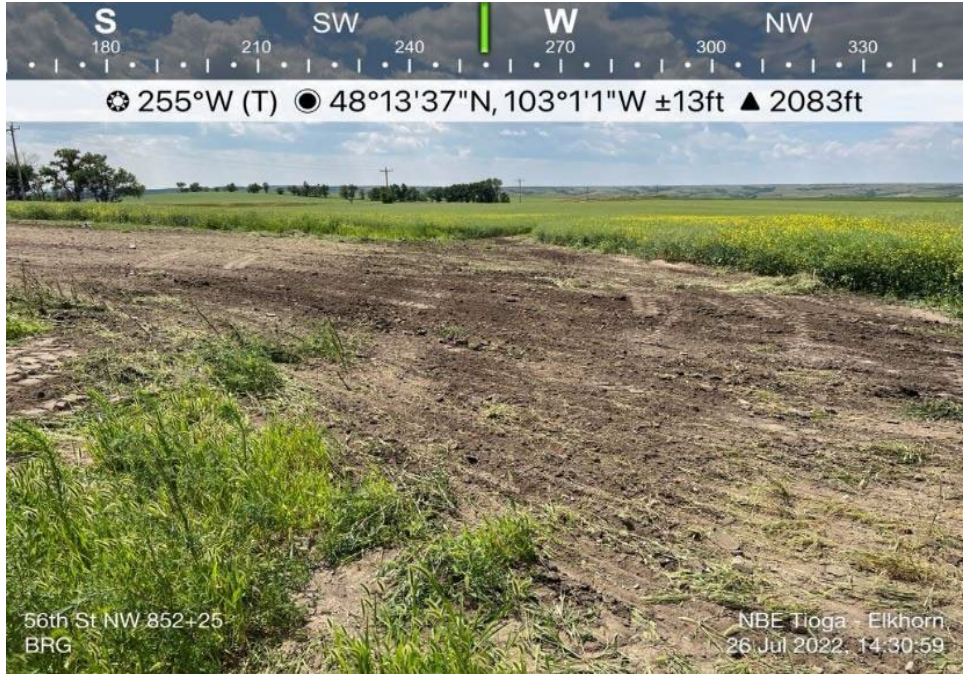
Location:  
Sta. No. 852+25

Notes: Repaired  
rill/channel erosion  
on the Tioga-  
Elkhorn Creek  
Pipeline right-of-  
way.

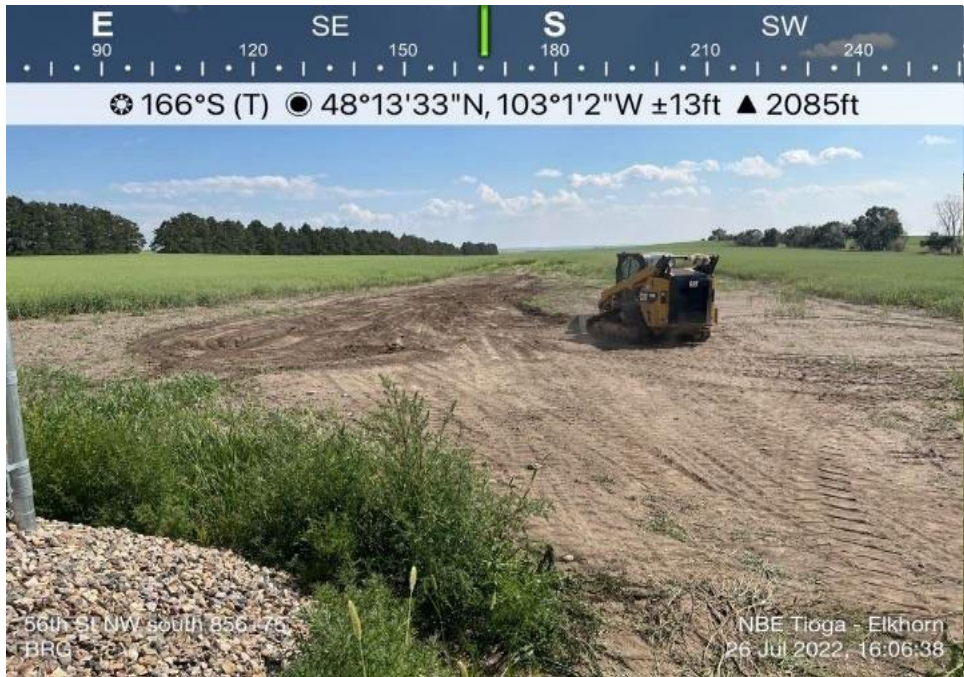
Location:  
Sta. No. 856+75

Notes: Repairing  
trench settling on  
the Tioga-Elkhorn  
Creek Pipeline  
right-of-way.

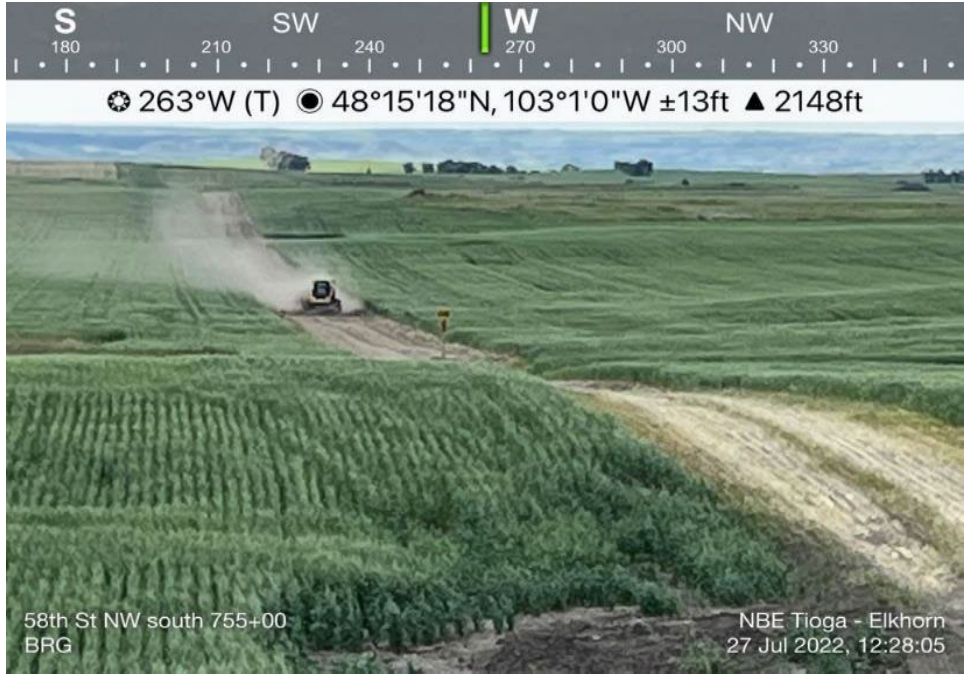
Location:  
Sta. No. 755+00

Notes: Repairing  
trench settling on  
the Tioga-Elkhorn  
Creek Pipeline  
right-of-way.

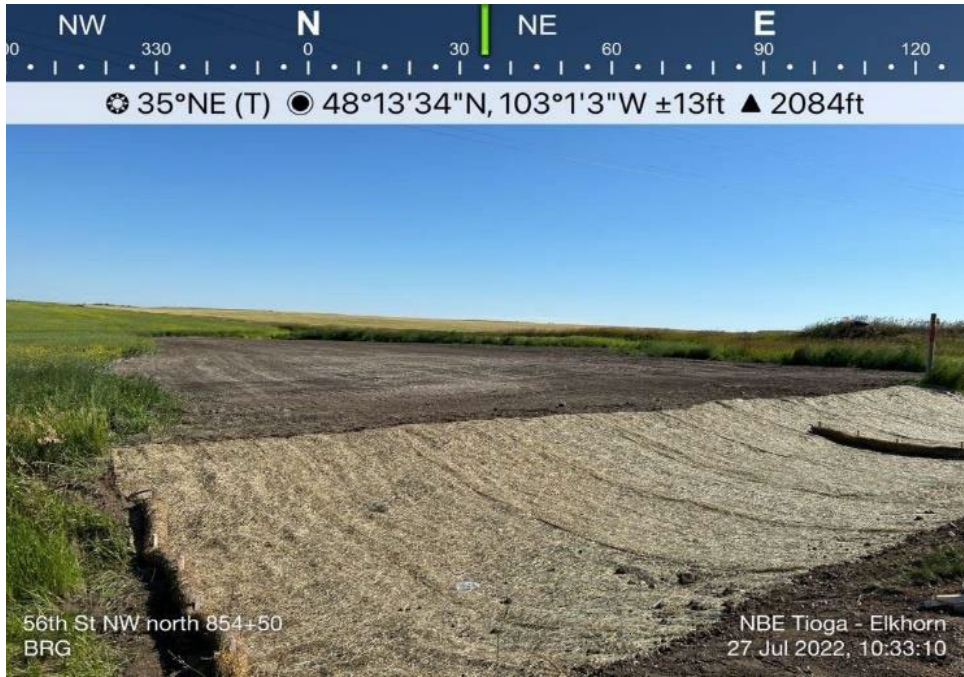
Location:  
Sta. No. 854+50

Notes: Installed  
erosion control  
devices in a bar  
ditch on the Tioga-  
Elkhorn Creek  
Pipeline.

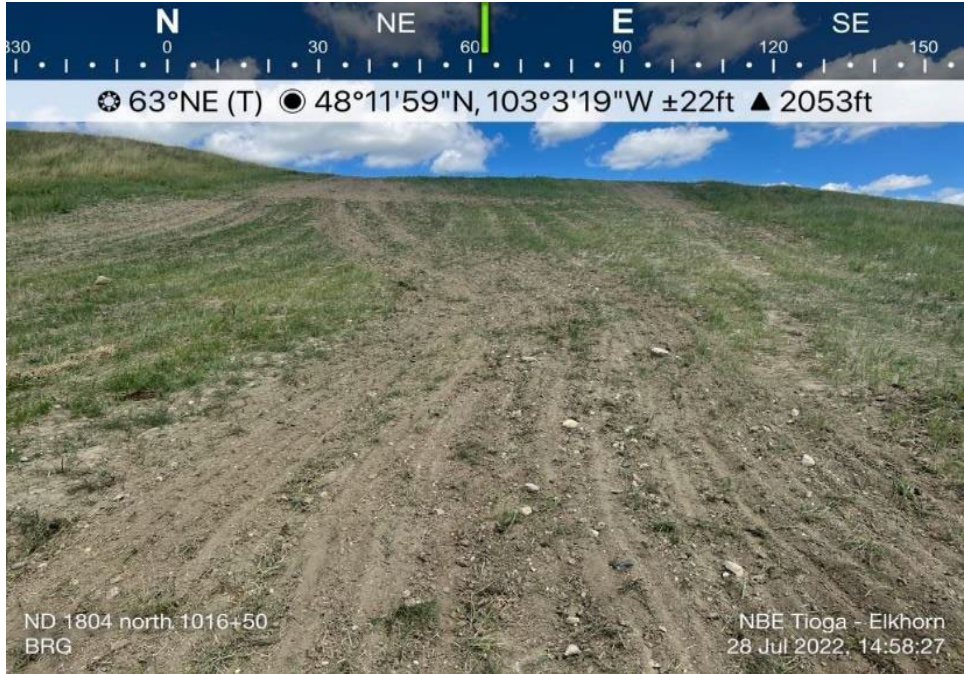
Location:  
Sta. No. 1016+50

Notes: Repaired  
rill/channel erosion  
on the Tioga-  
Elkhorn Creek  
Pipeline right-of-  
way.

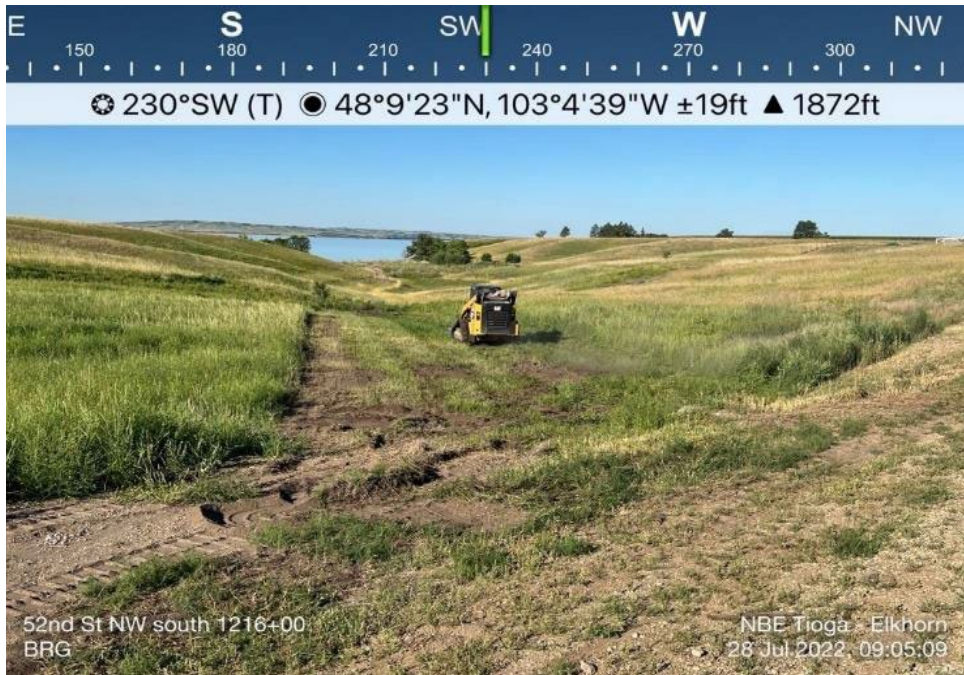
Location:  
Sta. No. 1216+00

Notes: Mowing  
prior to repairing  
rill/channel erosion  
on the Tioga-  
Elkhorn Creek  
Pipeline right-of-  
way.

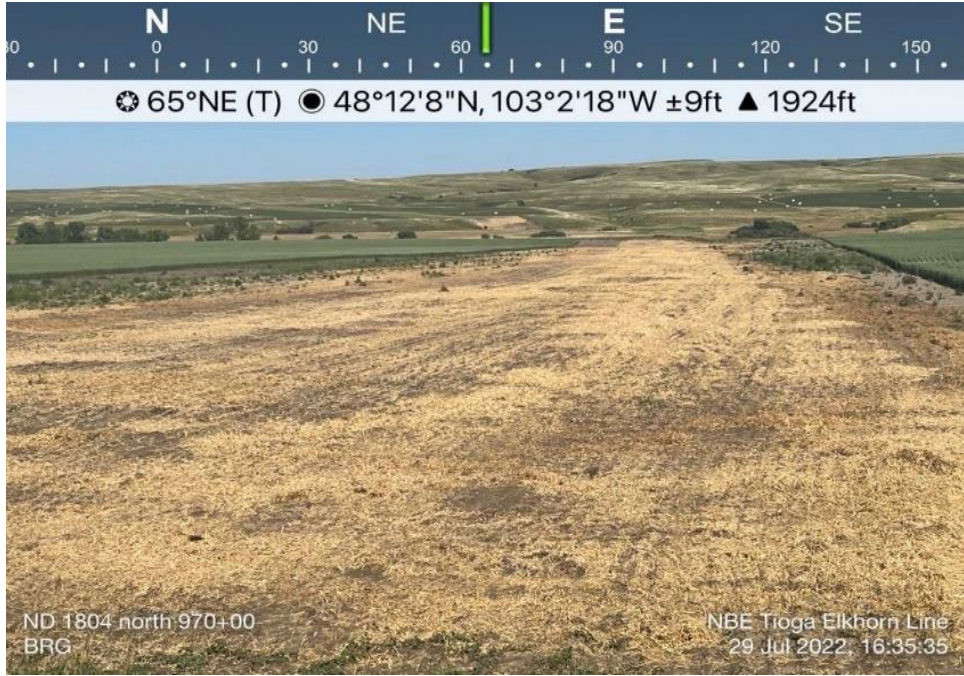
Location: Sta. Nos.  
963+60 to 975+50

Notes: Crimped  
straw mulch into  
reseeded right-of-  
way to anchor  
mulch on the Tioga-  
Elkhorn Creek  
Pipeline.

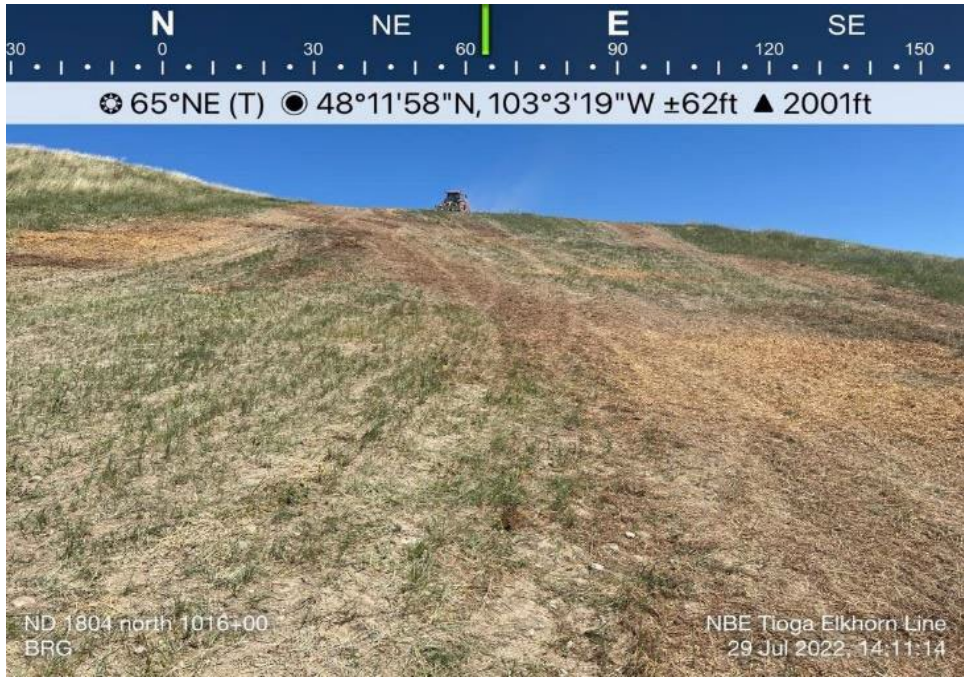
Location:  
Sta. No. 1016+00

Notes: Crimping  
straw mulch into  
reseeded right-of-  
way to anchor  
mulch on the Tioga-  
Elkhorn Creek  
Pipeline.

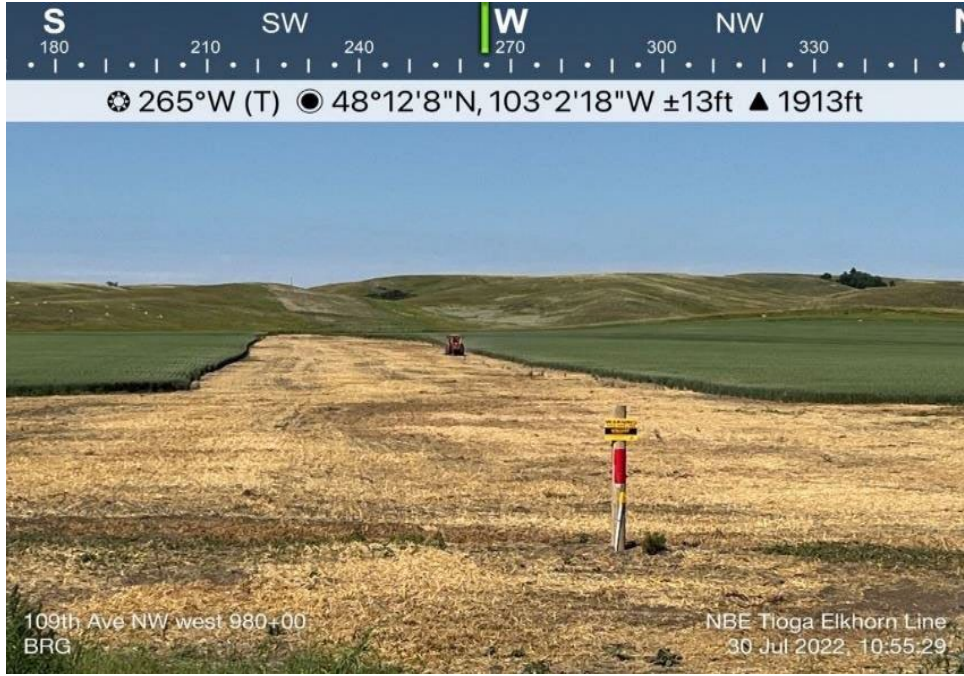
Location:  
Sta. No. 980+00

Notes: Crimping straw mulch into reseeded right-of-way to anchor mulch on the Tioga-Elkhorn Creek Pipeline.

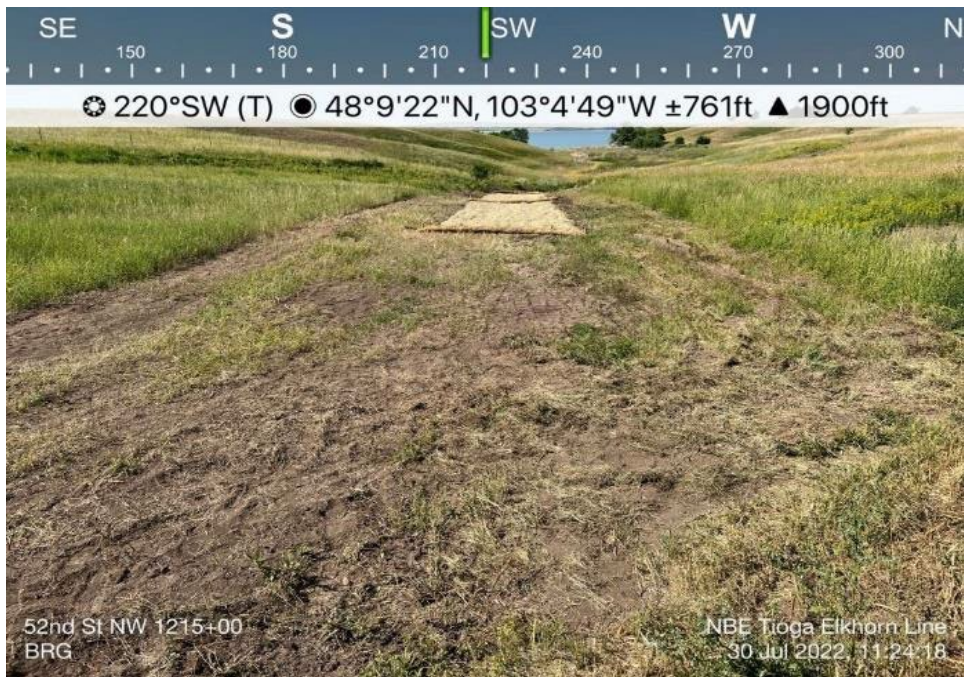
Location:  
Sta. No. 1215+00

Notes: Installed erosion control devices on repaired Tioga-Elkhorn Creek Pipeline right-of-way.
