## FEDERAL ENERGY REGULATORY COMMISSION FIELD INSPECTION REPORT

**Date** July 22, 2025

**Project** WBI Energy Transmission, Inc.  
Wahpeton Expansion Project  
Cass and Richland Counties, North Dakota  
Docket No.: CP22-466-000  
Authority: Section 7(c)

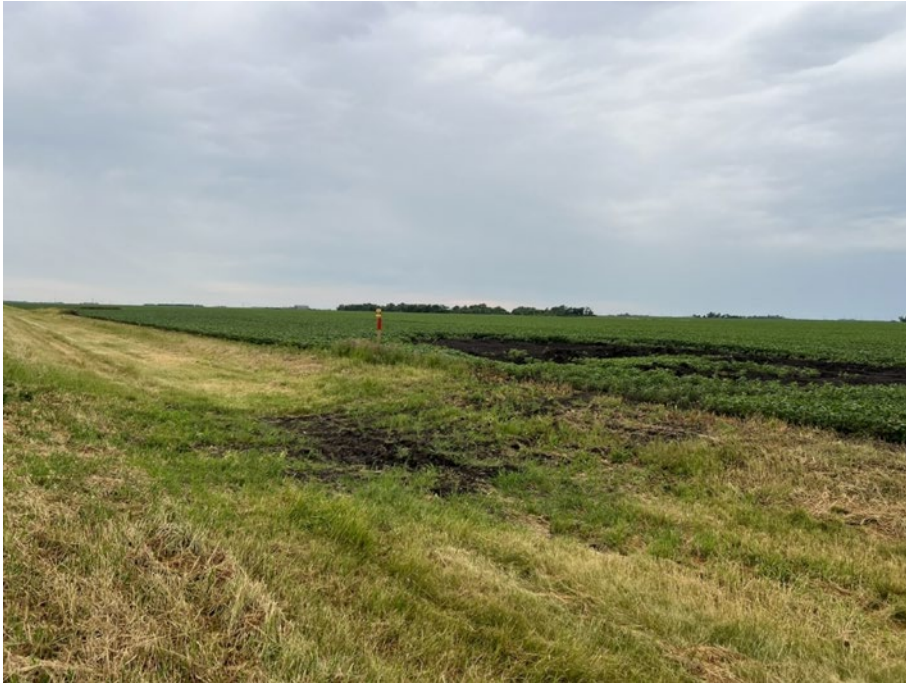
**Photo No.:** 1

**Comments:** Agricultural ROW, Bore #10 Site. The ROW and temporary workspaces were restored, and pipeline markers were in place. Restored areas were free of rutting, erosion, and large rocks; however, crop coverage was generally sparse. WBI reported that planting was likely delayed due to anomaly repairs and that the site would be monitored, with additional repairs to be made if requested by the landowner.

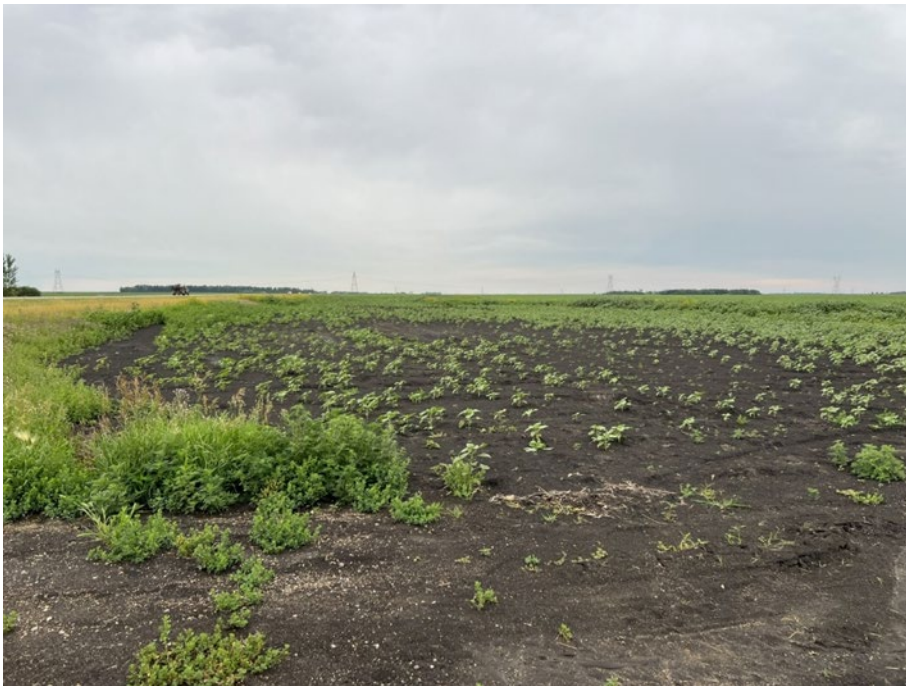
**Photo No.:** 2

**Comments:** Agricultural ROW. The ROW was restored, with no signs of rutting, large rocks, or construction debris. The site was stable; however, crop coverage was generally sparse. WBI reported that planting was likely delayed due to anomaly repairs and that the site would be monitored, with additional repairs to be made if requested by the landowner.

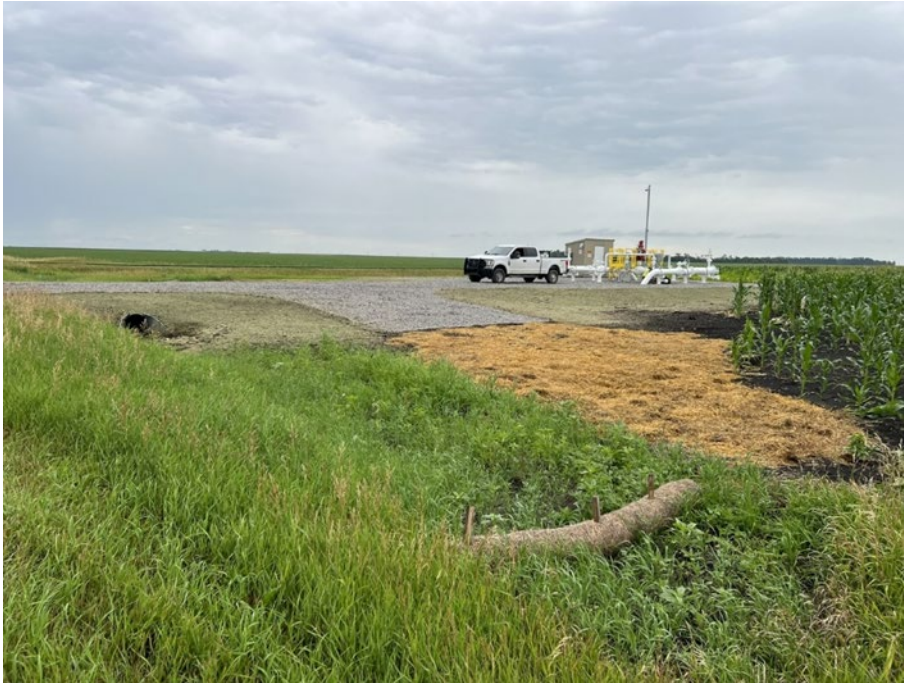
**Photo No.:** 3

**Comments:** Aboveground Facility, Valve #2 Site. The valve site, permanent access road, and adjacent temporary workspaces were restored; stabilized with gravel, mulch, or hydroseed; and were free of rutting and erosion. Facility fencing was not required at this valve site, according to WBI. Stormwater management measures were installed, and the outlet was stabilized with rock to prevent scouring. Temporary ECDs remained in place in some areas pending revegetation of the site.

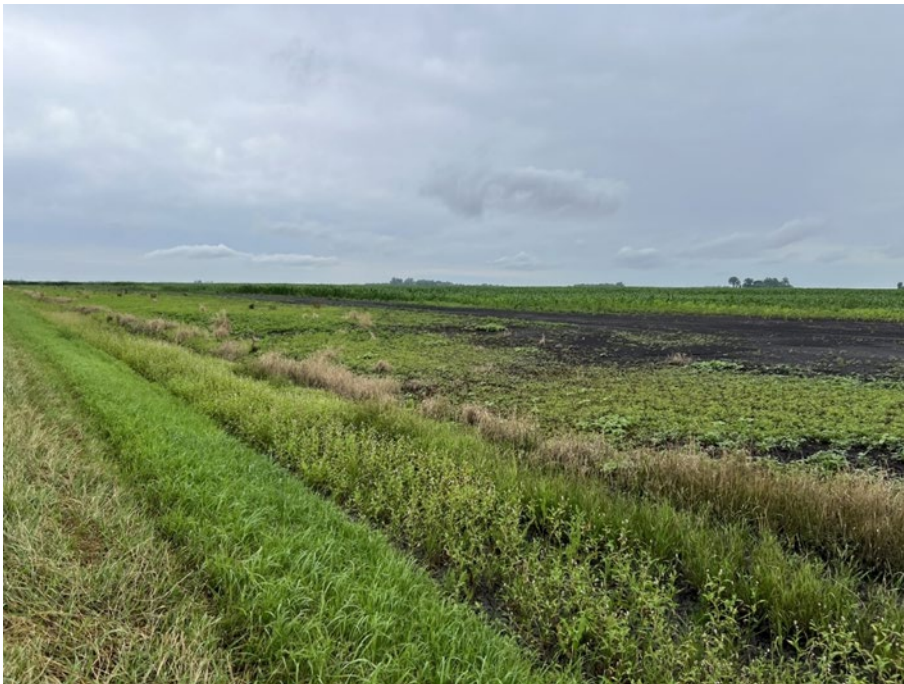
**Photo No.:** 4

**Comments:** Agricultural ROW, Bore #24 Site. The ROW and temporary workspaces were restored; with no signs of rutting, large rocks, or construction debris. The site was stable; however, low-lying areas were noted, and crop coverage was generally sparse from approximately MP 15.6 through MP 16.0. WBI reported that planting was likely delayed due to flooding of the ROW through June and that the site would be monitored, with additional repairs to be made if requested by the landowner.

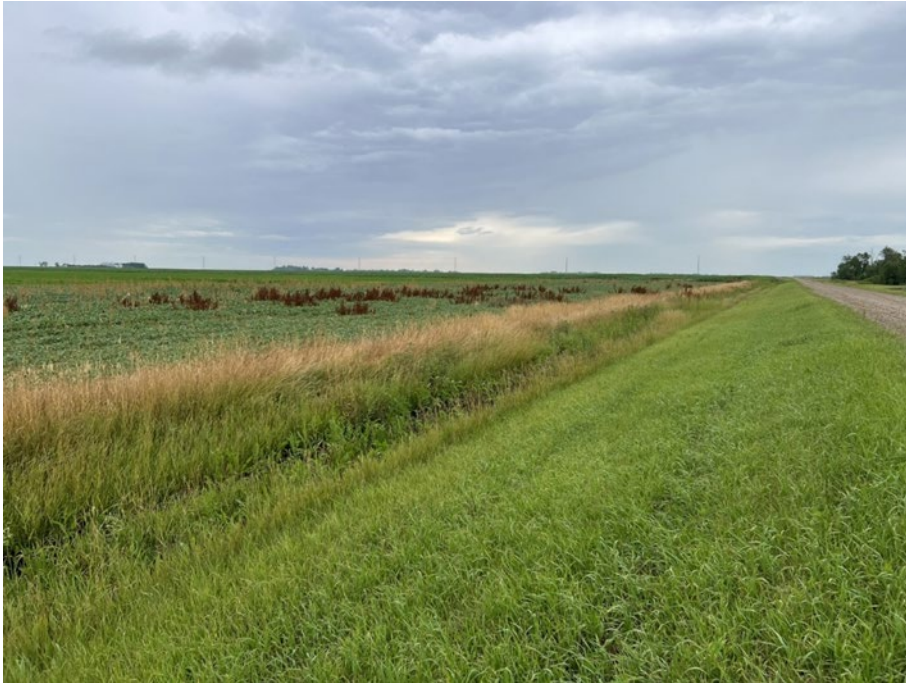
**Photo No.:** 5

**Comments:** Agricultural ROW. The ROW was restored; with no signs of rutting, large rocks, or construction debris. The site was stable and well vegetated; however, noxious weeds were common along the ROW from approximately MP 16.2 through MP 16.7. WBI reported that the noxious weed issue would likely be resolved once the landowner disked and replanted spring crops.

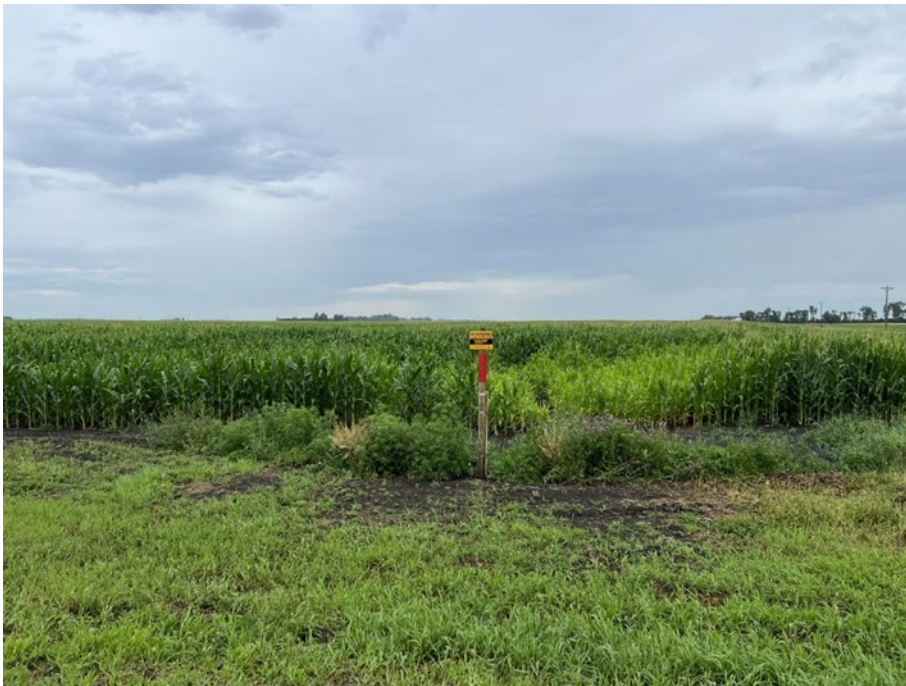
**Photo No.:** 6

**Comments:** Agricultural ROW, Bore #30 Site. Restored areas of the ROW and temporary workspaces were free of rutting, erosion, and large rocks; however, crop coverage was generally sparse in what appeared to be an area of subsidence. WBI noted that some subsidence repairs were completed in the spring of 2025 and may have included this location. WBI also stated that the site would be monitored, with additional repairs made if requested by the landowner.

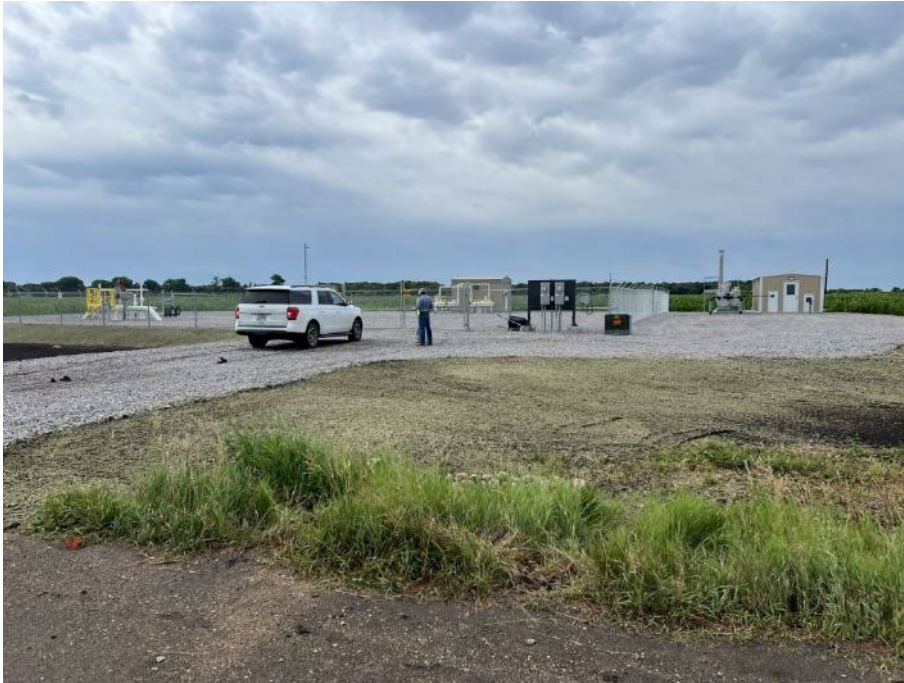
**Photo No.:** 7

**Comments:** Aboveground Facility, Valve #3 Site. Temporary workspaces were restored and stabilized with mulch or hydroseed. The station was stabilized with gravel and was free of ruts and excessive erosion. Perimeter fencing was in place per Project plans, according to WBI. Stormwater control measures were installed, and outlets were stabilized with large rock.

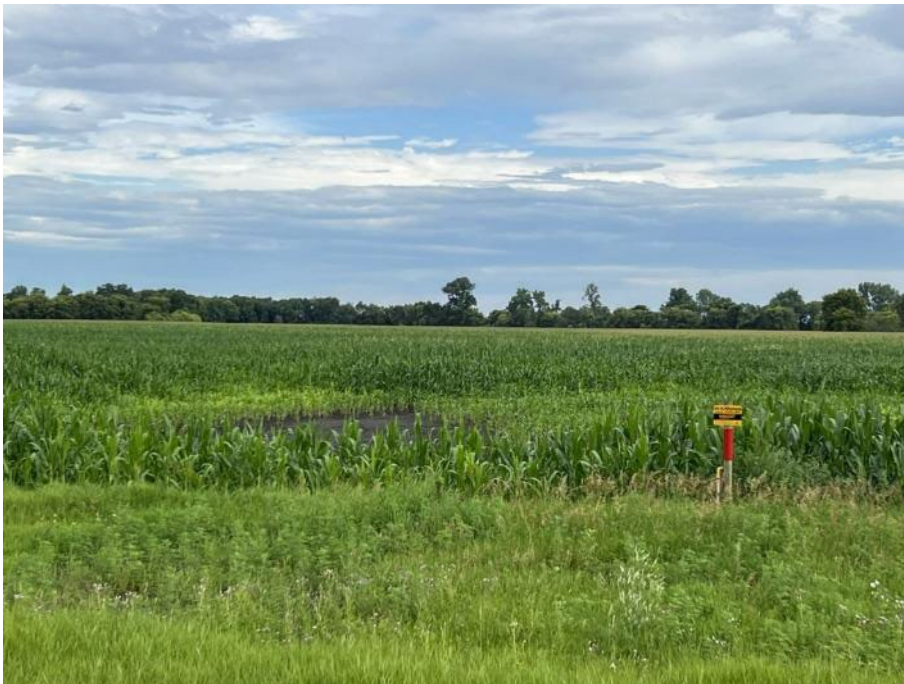
**Photo No.:** 8

**Comments:** Agricultural ROW, Bore #33 Site. The ROW was restored with no signs of rutting, large rocks, or construction debris. However, sparse vegetation and possible subsidence were observed within restored areas of the ROW and temporary workspaces. WBI noted that the site would be monitored, with additional repairs made if requested by the landowner.

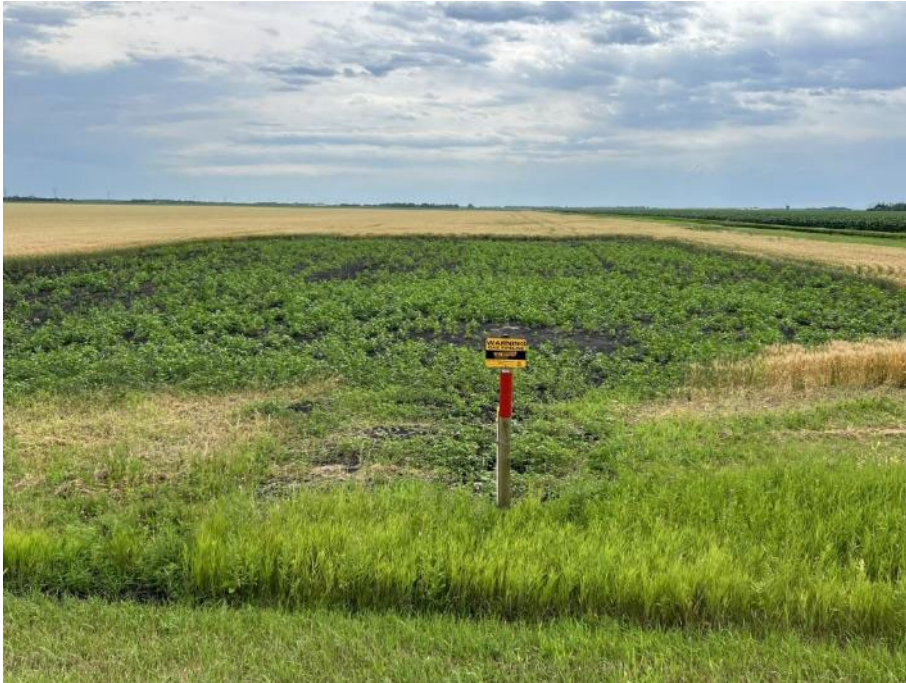
**Photo No.:** 9

**Comments:** Agricultural ROW. The ROW was restored with no signs of rutting, large rocks, or construction debris. The site was stable; however, crop coverage was generally sparse. WBI reported that planting was likely delayed due to anomaly repairs and that the site would be monitored, with additional repairs made if requested by the landowner.

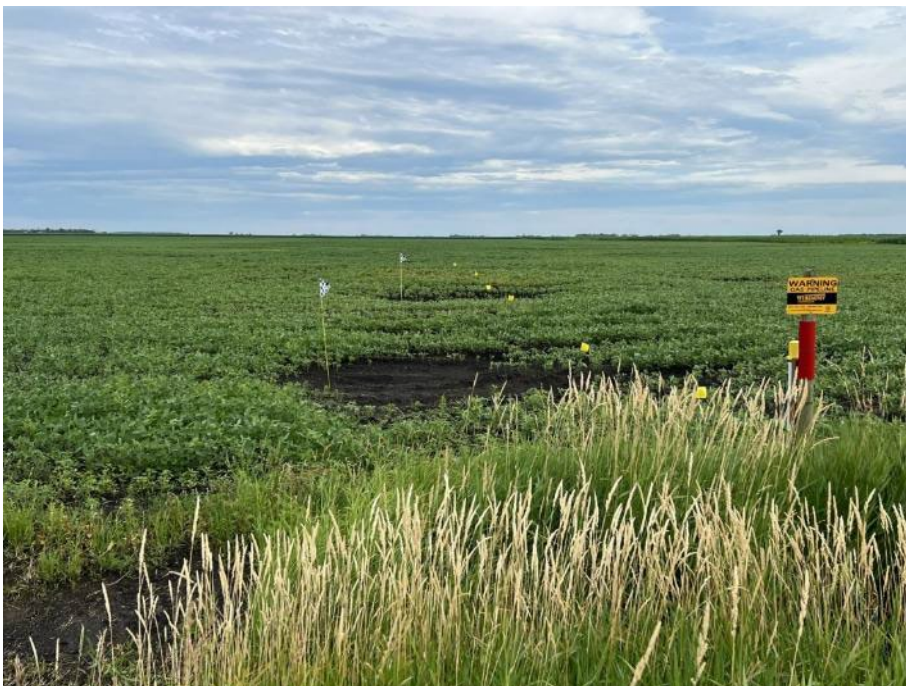
**Photo No.:** 10

**Comments:** Agricultural ROW, Bore #38 Site. The temporary workspaces were restored and free of rutting, large rocks, and construction debris. However, several sparsely vegetated low-lying areas were observed. WBI indicated that the landowner had placed flags to mark areas requiring repairs, which WBI stated would be repaired after the harvest.

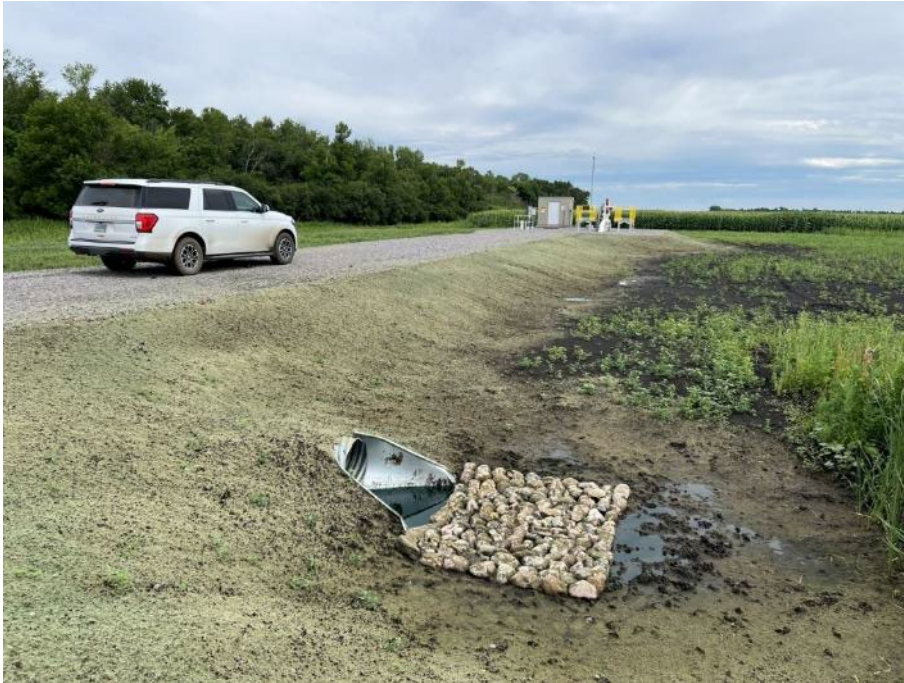
**Photo No.:** 11

**Comments:** Aboveground Facility, Valve #4 Site. The valve site, permanent access road, and adjacent temporary workspaces were restored; stabilized with gravel, mulch, or hydroseed; and were free of rutting and erosion. Facility fencing was not required at this valve, according to WBI. Stormwater management measures were installed, and the outlet was stabilized with rock to prevent scouring.

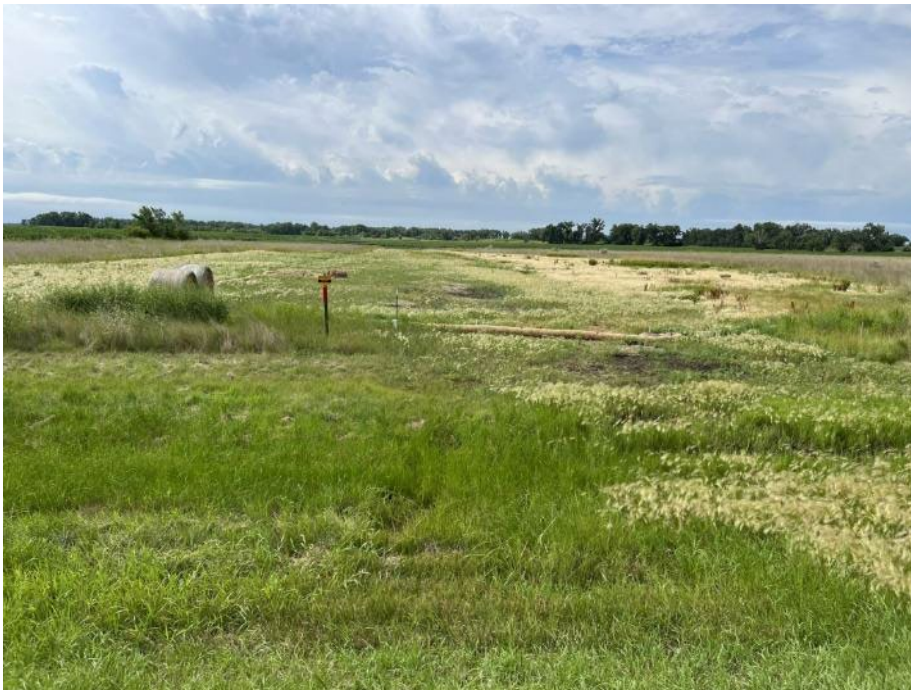
**Photo No.:** 12

**Comments:** Open ROW, Wetland wrib007e. Wetland contours appeared to be adequately restored, and the wetland was densely revegetated. The adjacent upland ROW was well vegetated and free of rutting, erosion, and construction debris. Temporary ECDs remained in place along the wetland boundary.

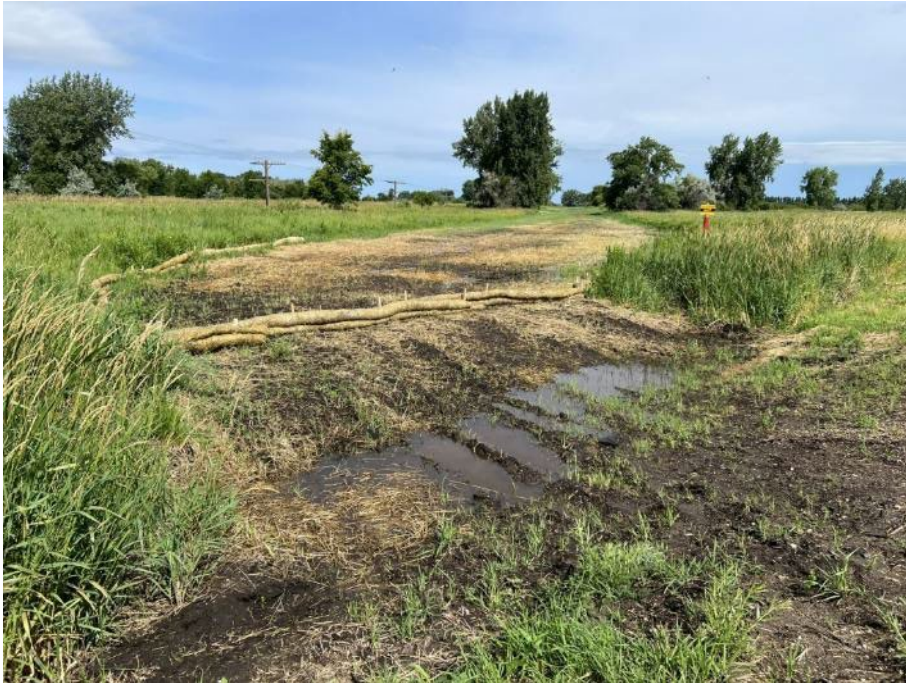
**Photo No.:** 13

**Comments:** Open ROW, Wetland wrib019e. Wetland contours appeared to be adequately restored, and the wetland was stabilized with mulch per state requirements, according to WBI. Temporary ECDs remained in place along the wetland boundary.

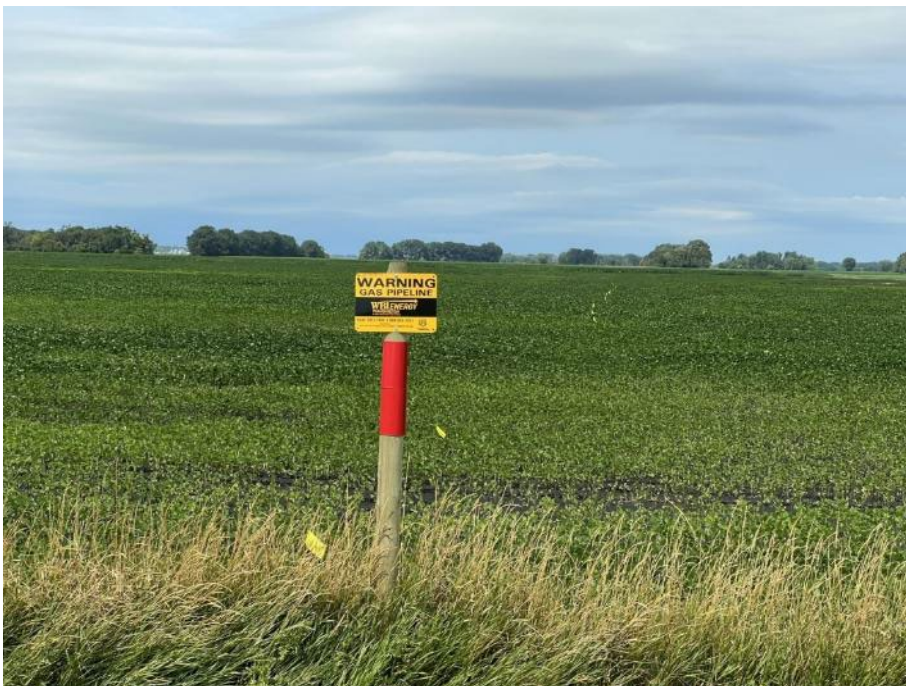
**Photo No.:** 14

**Comments:** Agricultural ROW. Agricultural crops were well established along the restored ROW and within temporary workspaces. Restored areas appeared to be stable and free of erosion and large rocks. Pipeline markers were installed. Nearby road crossings were restored to stable conditions, with no signs of construction debris or pavement damage.

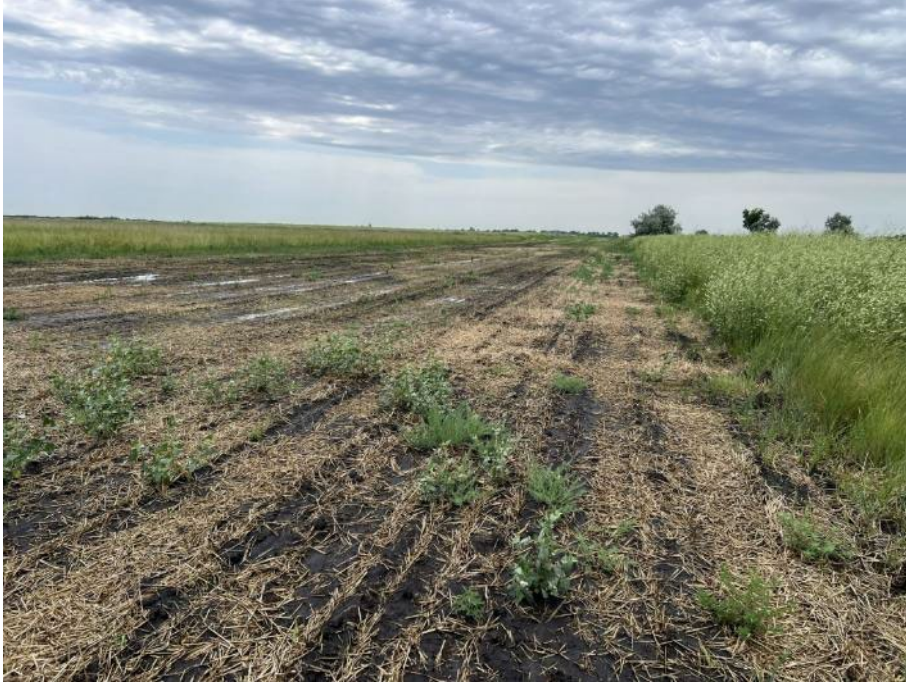
**Photo No.:** 15

**Comments:** Agricultural ROW. The ROW was restored with no signs of rutting, large rocks, or construction debris. The site was stabilized with mulch; however, vegetation coverage was sparse. WBI reported that the ROW in this general vicinity was reseeded with a special conservation seed mix, per state requirements, and that it would be reseeded in late-summer.

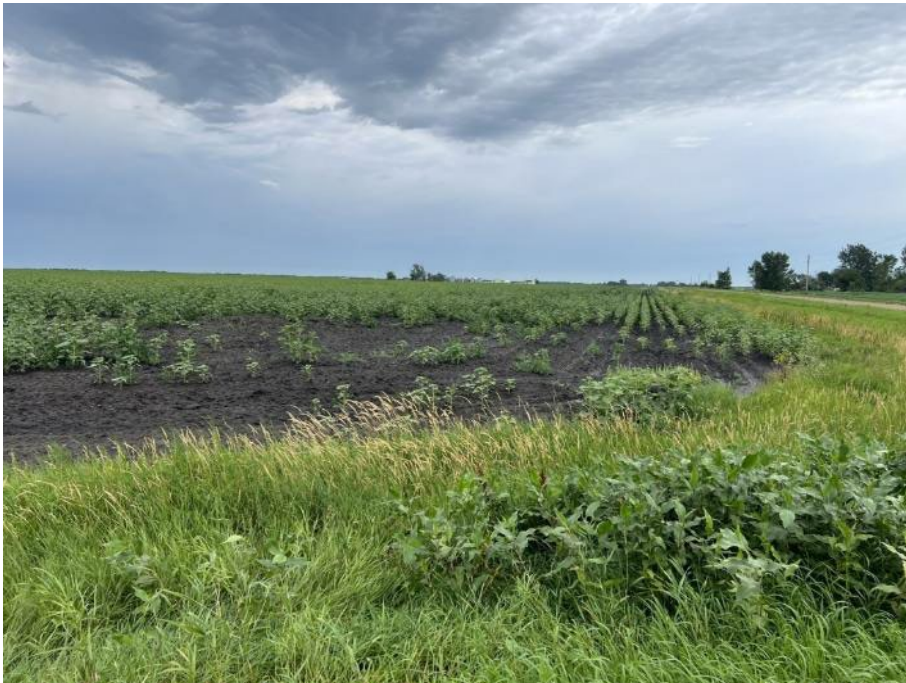
**Photo No.:** 16

**Comments:** Agricultural ROW. The ROW was restored with no signs of rutting, large rocks, or construction debris. The site was stable; however, crop coverage was generally sparse from approximately MP 46.90 through MP 47.50. WBI reported that planting was likely delayed due to anomaly repairs and that the site would be monitored, with additional repairs made if requested by the landowner.

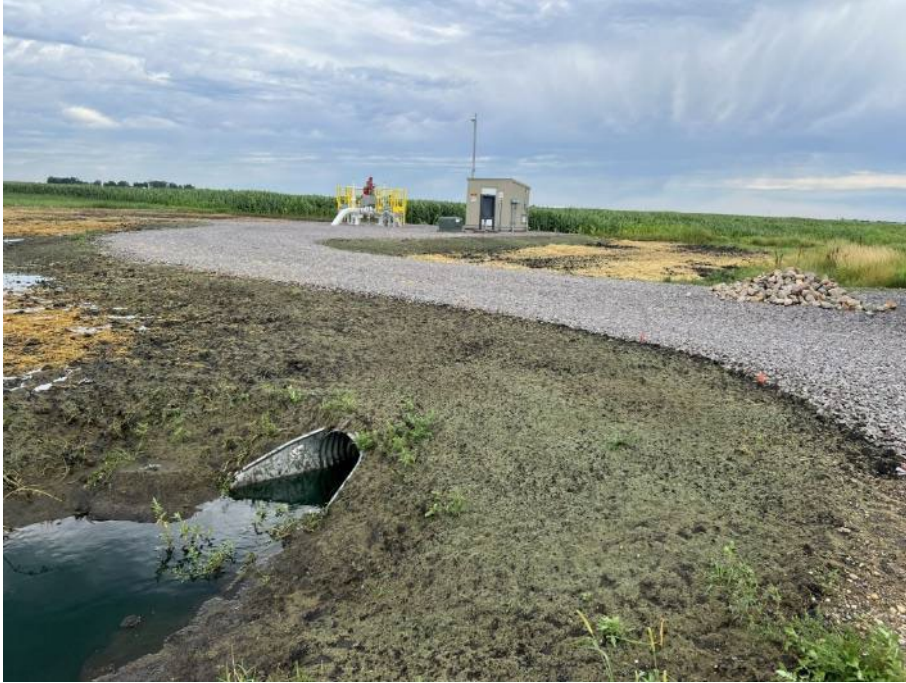
**Photo No.:** 17

**Comments:** Aboveground Facility, Valve #6 Site. Temporary workspaces were restored and stabilized with mulch or hydroseed. The station was stabilized with gravel and was free of ruts and excessive erosion. Facility fencing was not required at this valve, according to WBI. Stormwater control measures were installed. Rock staged on the permanent access road will be placed at the culvert outlet to prevent scouring, according to WBI.

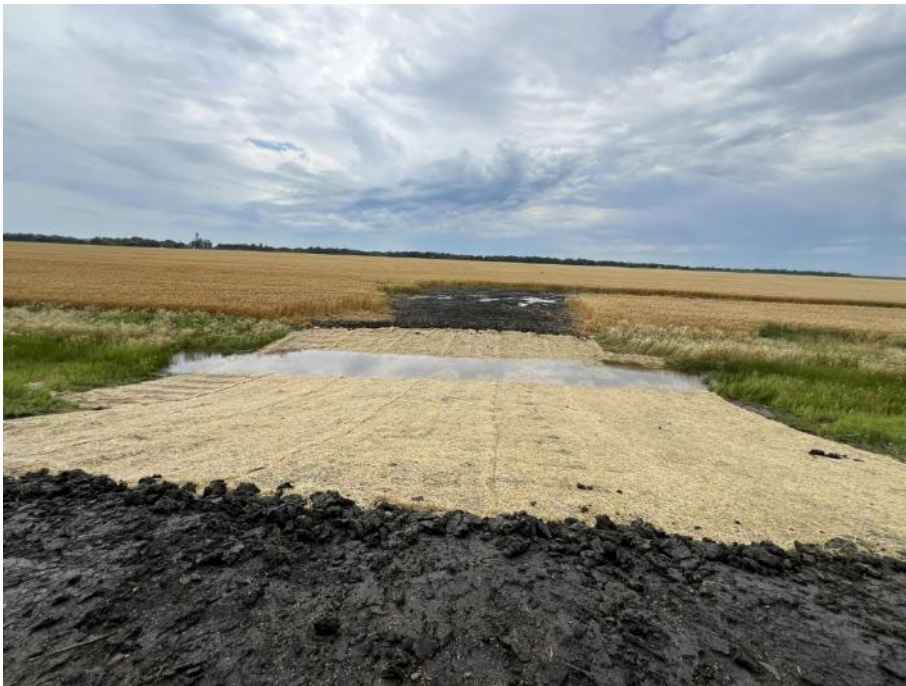
**Photo No.:** 18

**Comments:** Agricultural ROW, Temporary Access Road AR-56.1. The construction entrance and access road into the former Wild Rice River horizontal directional drilling (HDD) site were restored to original contours and slopes were stabilized with erosion control blanket. The site was free of construction debris. No pavement damage was observed on the adjacent public roadway.

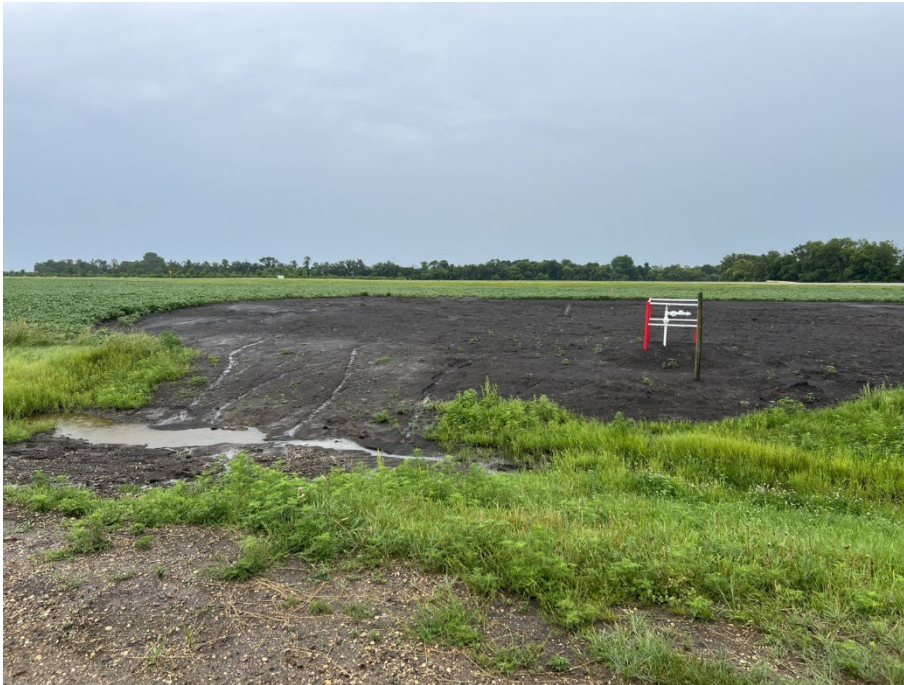
**Photo No.:** 19

However, at approximately Milepost (MP) 57.05, rill erosion had resulted in sediment transport into a densely vegetated roadside stormwater drainage swale (Photo No 19). The accumulated sediment appeared to be contained within the approved workspace limits and no protected resources were affected. Following the inspection, WBI reported that it monitored the site until a temporary straw waddle was added on or shortly before July 29, 2025 (Photo No. 20), stating that the delay in repairs was due to wet weather and saturated soil conditions. The disturbed area was later seeded and stabilized with an erosion control blanket, according to a July 31, 2025 update from WBI.

**Comments:** Agricultural ROW, Bore #69 Site. The ROW and temporary workspaces for the Bore #69 crossing were restored, with no signs of rutting, large rocks, or construction debris. However, rill erosion was observed, resulting in sediment transport into a densely vegetated roadside stormwater swale. The accumulated sediment appeared to be contained within the approved workspace limits. Following the inspection, WBI reported that it monitored the site until temporary ECDs were added on or shortly before July 29, 2025 (see Photo No. 20). WBI stated that the delay was due to wet weather and saturated soil conditions.

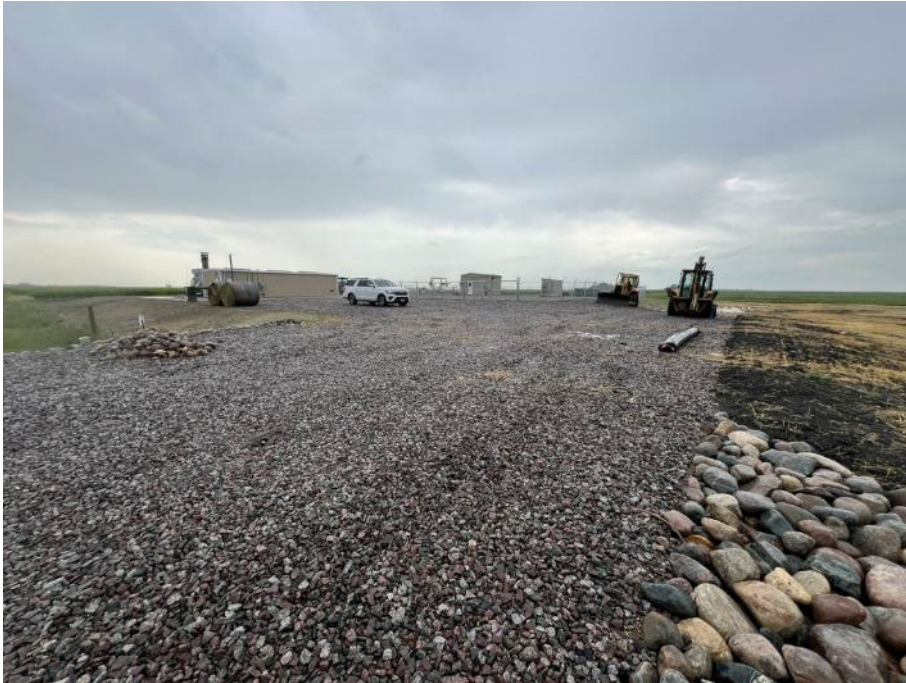
**Photo No.:** 21

**Comments:** Aboveground Facility, Valve #7 Site (Wahpeton Border Station). The valve site, permanent access road, and adjacent temporary workspaces were restored; stabilized with gravel, mulch, or hydroseed; and were free of rutting and erosion. Facility perimeter fencing was in place. Stormwater management measures were installed, and the outlets were stabilized with rocks to prevent scouring. WBI stated that the construction equipment and materials on site were being used by contractors completing final stabilization of road embankments.
