**FEDERAL ENERGY REGULATORY COMMISSION  
 ENVIRONMENTAL COMPLIANCE MONITORING PROGRAM  
 WEEKLY SUMMARY REPORT NO. 12  
 NORTH BAKKEN EXPANSION PROJECT  
 DOCKET NOS.: CP 20-52-000 AND CP 20-52-001  
 FOR THE PERIOD: OCTOBER 17 THROUGH OCTOBER 23, 2021**

On June 1, 2021, the Federal Energy Regulatory Commission (FERC) published an Order Issuing Certificate (Certificate) to WBI Energy Transmission, Inc. (WBI) to construct and operate pipeline and ancillary facilities in Burke, McKenzie, Mountrail, and Williams Counties, North Dakota for the North Bakken Expansion Project (Project).

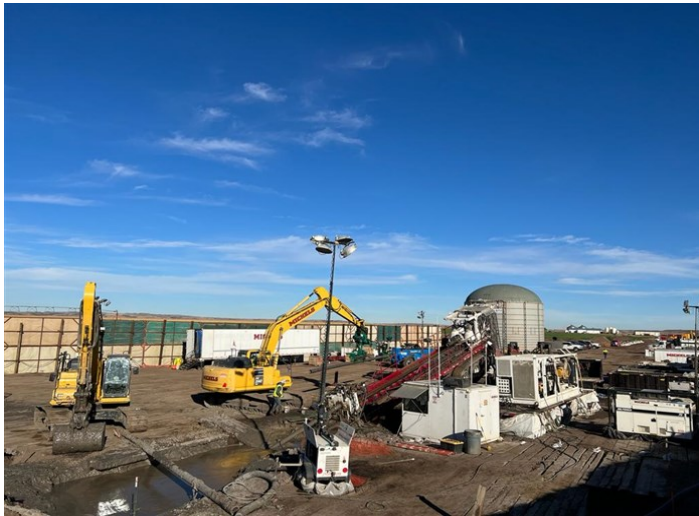
Lake Sakakawea HDD North – Ongoing drilling operations with a swab head along the pipeline pad at the Lake (October 18, 2021) – Acceptable – MP 23.0

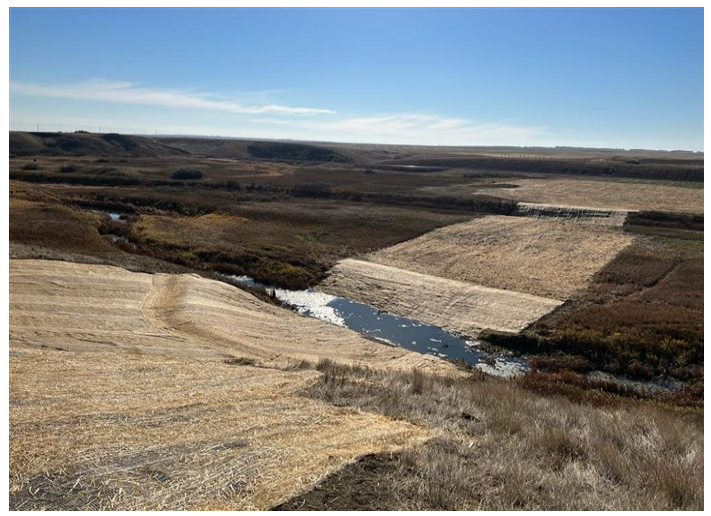
Tioga Elkhorn Creek PL Spread 1– Slope breakers and erosion blankets on both sides of stream s-wm-ea-001p (October 18, 2021) – Acceptable – MP 3.3

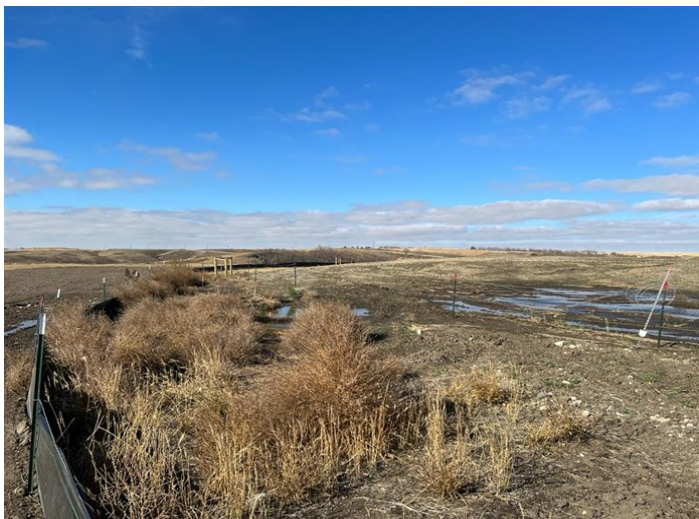
Tioga Elkhorn Creek PL Spread 1 – Faulty erosion controls at an adjacent non-Project area (October 19, 2021) – Communication – MP 12.3

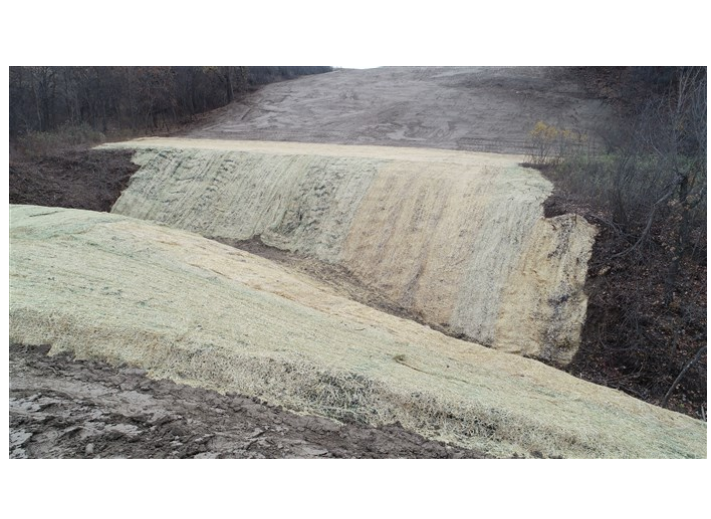
Tioga Elkhorn Creek PL Spread 2 – Curlex installed on the slope breaker at stream s-mk-eb-001. Banks of stream put back and contours restored to the original condition (October 19, 2021) – Acceptable – MP 27.1

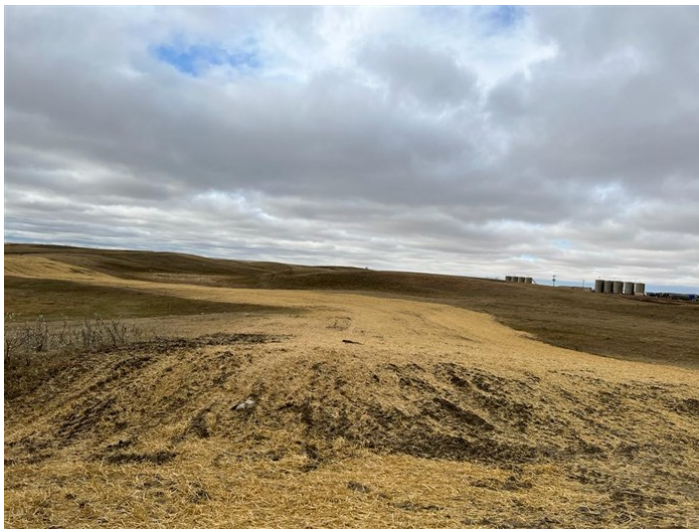
Line Section 25 Loop – Straw mulch over seeded grassland north of the WBI Tioga Compressor Station (October 20, 2021) – Acceptable – MP 1.0

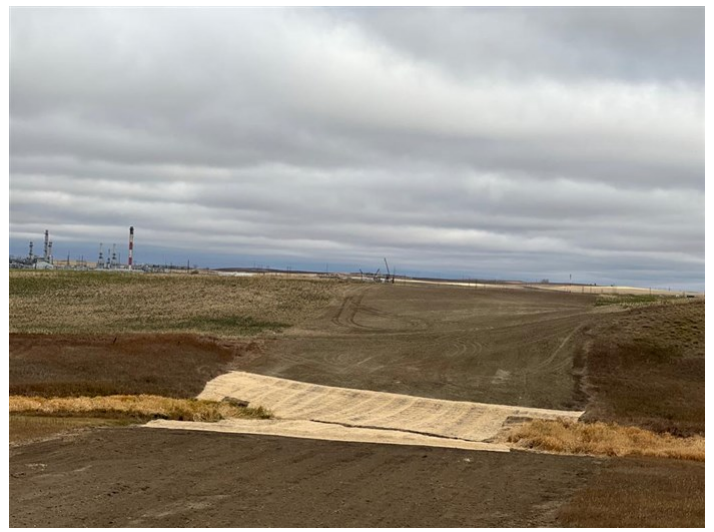
Line Section 30 Loop – Permanent erosion controls at the crossing of stream s-wm-ea-002 (October 20, 2021) – Acceptable – MP 7.3

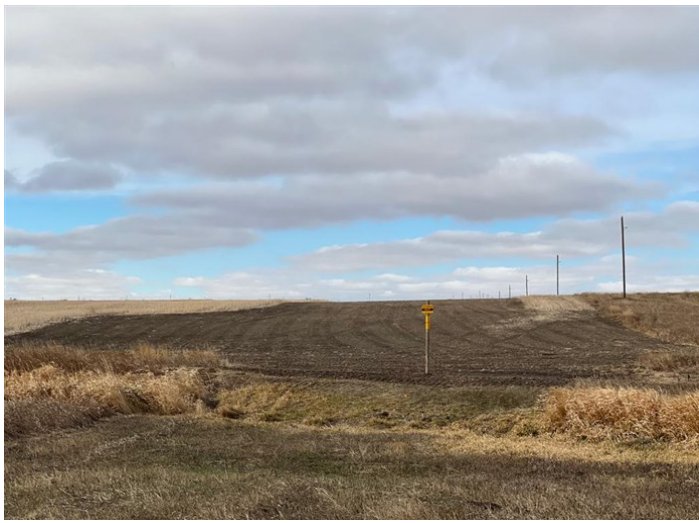
Line Section 25 Loop – Wetland w-nk-ea-001e (October 21, 2021) – Acceptable – MP 16.2

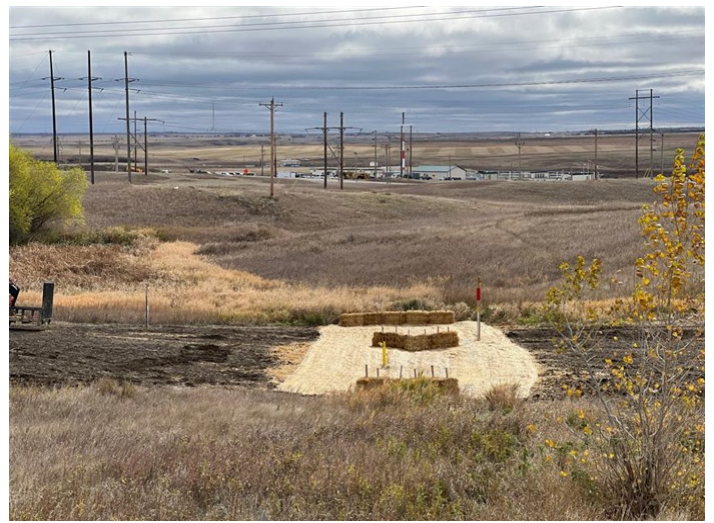
Tioga Compressor Lateral – Permanent erosion controls over a drainage swale across the Tioga Lateral right-of-way (October 21, 2021) – Acceptable – MP 0.3

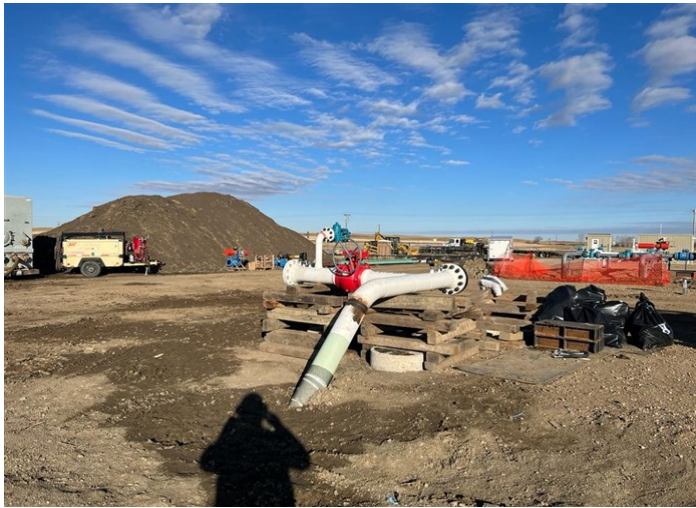
Norse Plant Receipt Station – 8-inch diameter piping headers to replace the existing 6-inch diameter pipeline to increase capacity and transmission (October 22, 2021) – Communication – MP 0.0

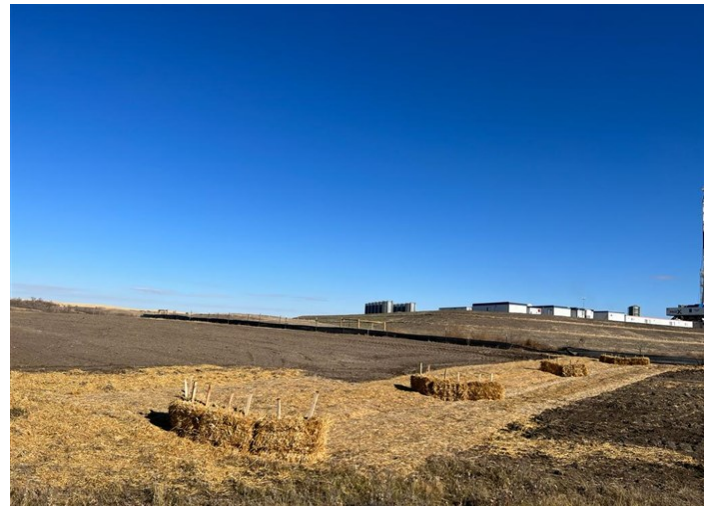
Tioga Elkhorn Creek PL Spread 1 – Environmental crews implemented corrective actions and additional measures to control erosion caused by non-Project sources (October 22, 2021) – Acceptable – MP 12.3

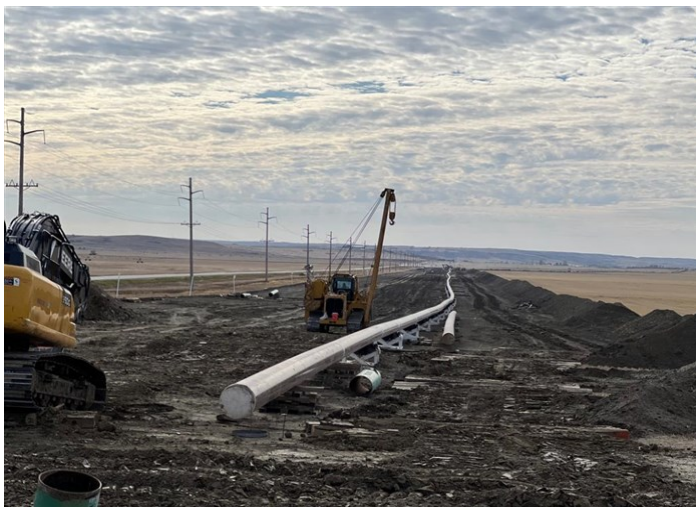
Lake Sakakawea HDD North – 235 joints of abrasion-resistant pipe welded together ready for installation (October 23, 2021) – Acceptable – MP 19.9

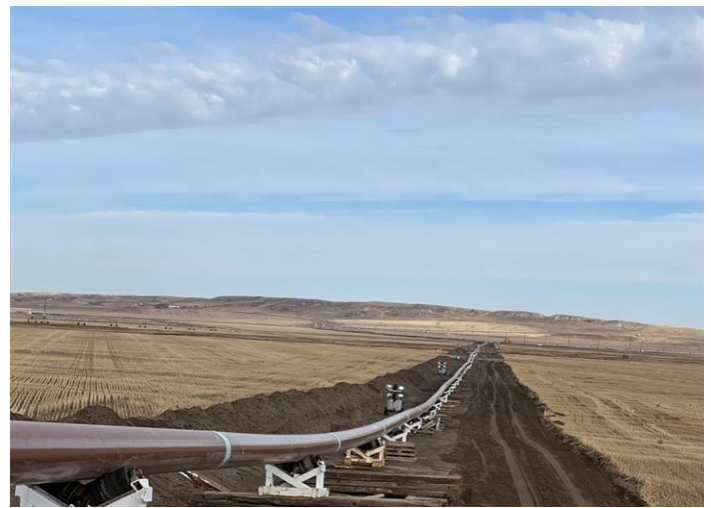
Lake Sakakawea HDD North – Approximately 600 rubber-roller skids supporting the pre-fabricated segments of pipeline (October 23, 2021) – Acceptable – MP 19.9

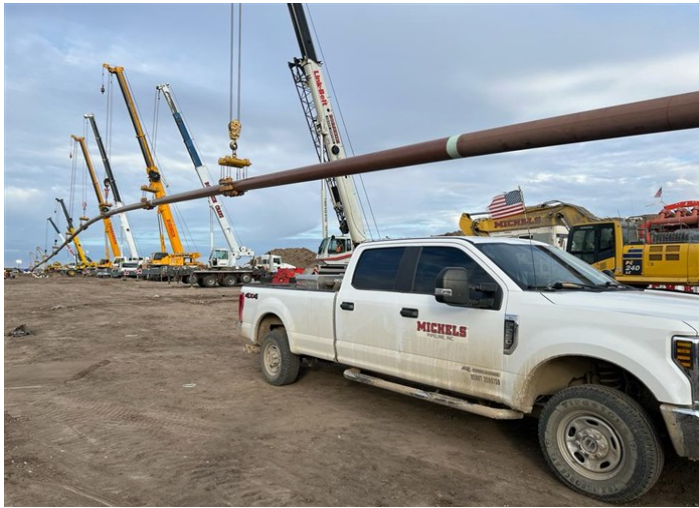
Lake Sakakawea HDD North – Elevated pipeline ready for pullback (October 23, 2021) – Acceptable – MP 23.0

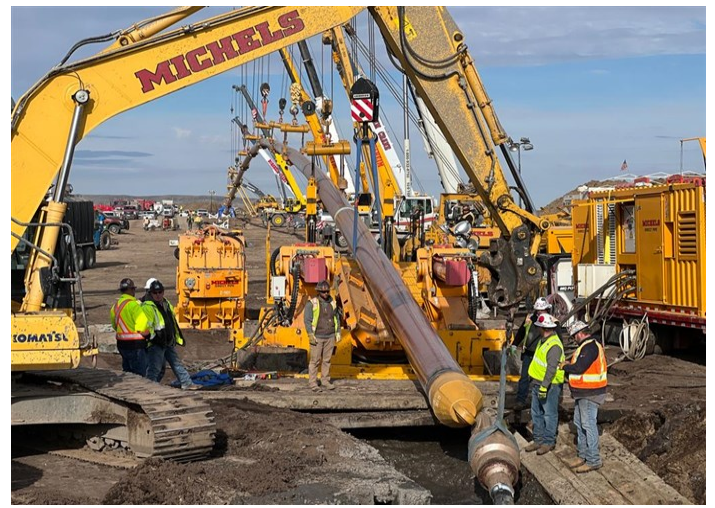
Lake Sakakawea HDD North – Pipeline alignment into the bore hole (October 23, 2021) – Acceptable – MP 23.0
