CLASS III HISTORIC ARCHITECTURAL SURVEY

WBI Energy Transmission, Inc. Wahpeton
Expansion Project, Cass and Richland
Counties, North Dakota

28 February 2022

Project No.: 0611161

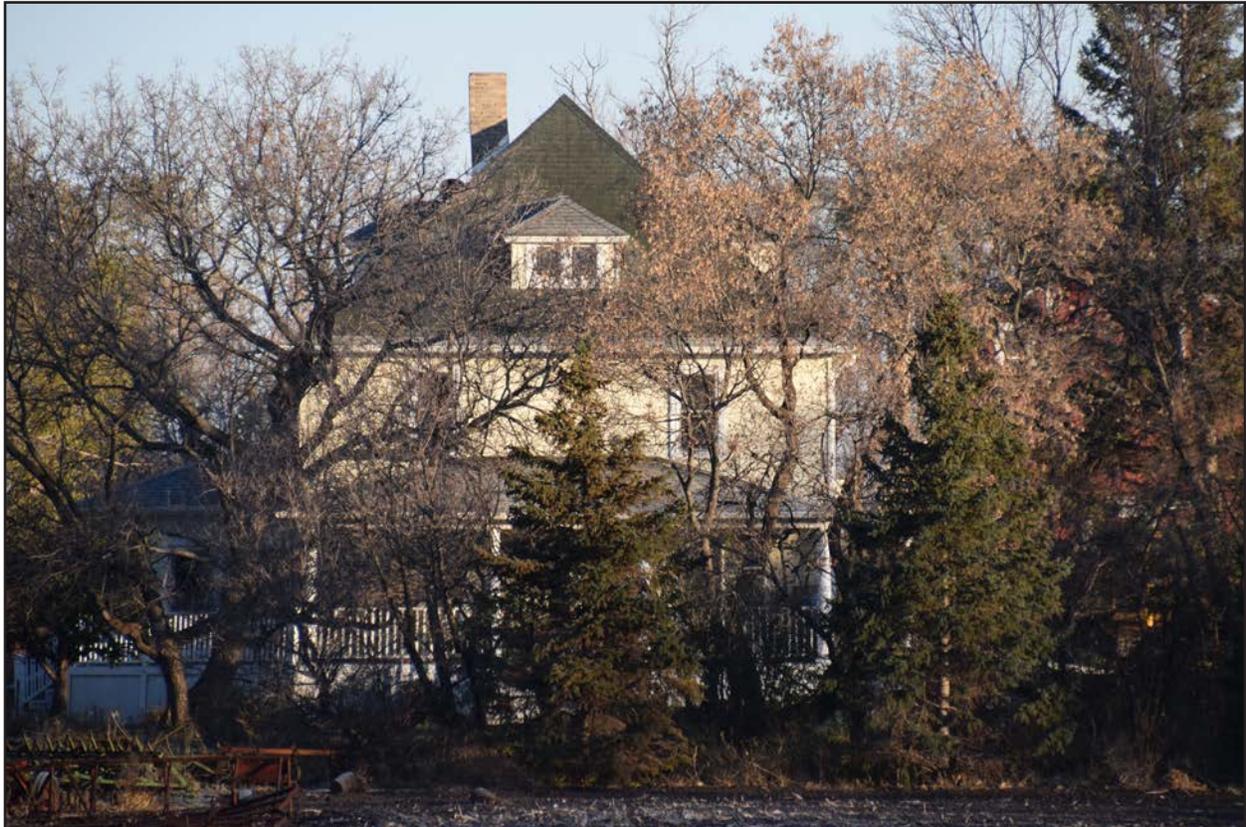
32CS5119 was previously recorded in 2012 by Lorna Meidinger, who provided information from a 1980s draft nomination form. Meidinger recorded the dwelling (Feature 1) as a circa 1900–1915 American Foursquare, two-and-a-half-story, wood frame structure, with a hipped roof and hipped dormers and a concrete foundation (Appendix B, Figure 2). She noted double-hung, two-over-two glass windows, as well as two brick chimneys. A previously screened full-width porch spanned the length of the façade, with a hipped roof supported by columns. Feature 2 was recorded as a circa 1900–1915 two-story barn with a gambrel roof with two large vents extending up from the roof peak, and small windows along the side and a large sliding door for the main entrance. Immediately above the large sliding door was a smaller sliding door; the opening to the hayloft is flanked by windows and appears to be filled with clapboard siding matching the rest of the barn's cladding.

ERM visited the site in 2021 and noted that Features 1 and 2 were built prior to 1893, based on historic atlas research. ERM also observed that Feature 1 includes modifications and additions, such as a rear attached garage and cascading hipped-roof sections. The major additions were constructed in 1980, and have drastically altered the original design and massing of the house by extending the northern elevation on both the first and second stories (Cass County Director of Tax Equalization 2021). ERM also observed that the section of the porch that wraps around from the south elevation to the west elevation was constructed sometime after 1980, at which time details of the original front porch were changed including the addition of a modern balustrade (Meidinger 2012). Both Features 1 and 2 are in good condition.

Figure 2. 32CS5119, American Foursquare dwelling, south elevation.

NRHP Assessment: Meidinger recorded the resource's NRHP eligibility as unevaluated and noted that more current information was needed to make a determination. Based on ERM's current survey, 32CS5119 includes a modified American Foursquare dwelling and two modified outbuildings. The setting and feeling of the farmstead remains similar to that of the original landscape, especially since the roughly contemporary barn and windbreak still frames the main feature. Although the resource represents a typical example of the American Foursquare style, the multiple additions and modifications, along with the extensive use of replacement materials, have greatly impacted the resource's integrity of design, materials, workmanship, and feeling. The sequence of rear additions has vastly increased the scale of the dwelling, and have yielded unbalanced massing that projects away from the neat cube of the original American Foursquare footprint. Although an effort was made to incorporate materials and design elements like dormers that echo the original block, the overall effect is a dwelling that no longer captures

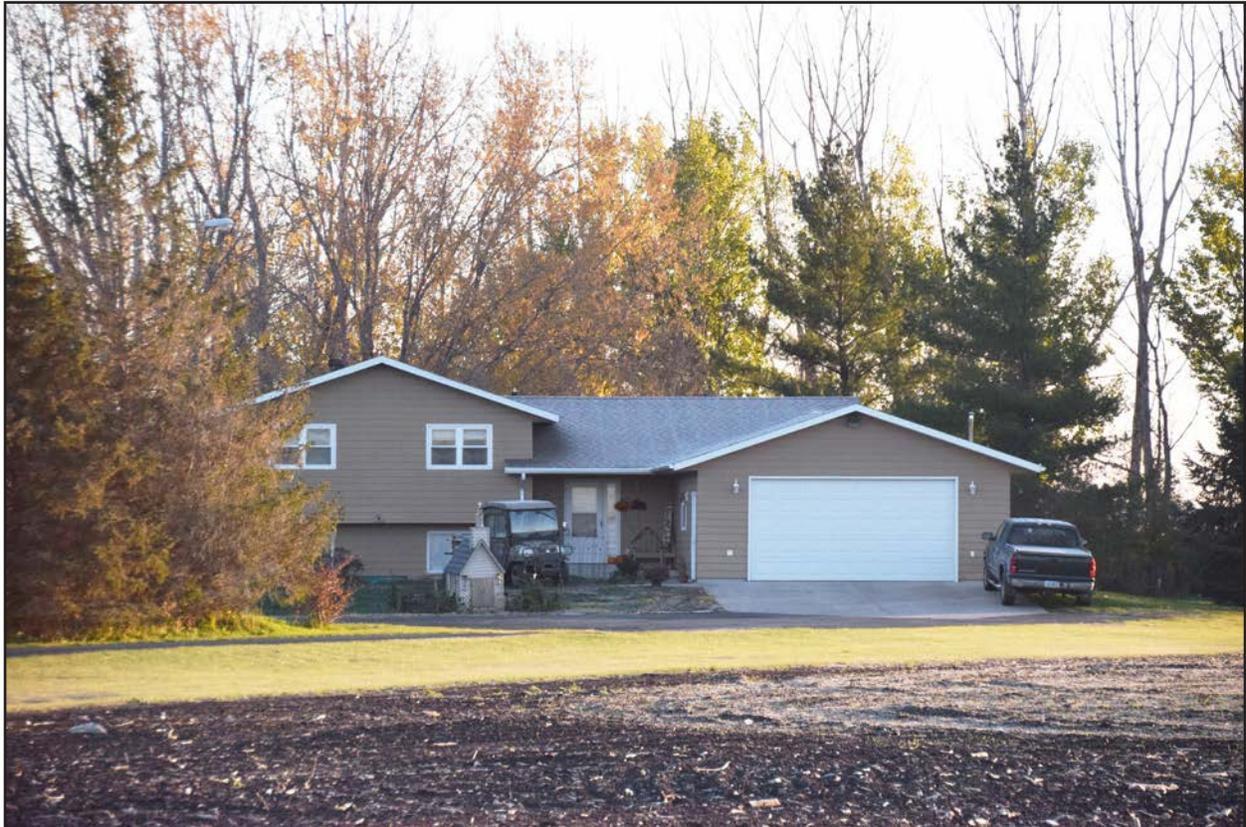
concrete block foundation (Appendix B, Figure 5). The dwelling included one-over-one double-hung vinyl windows on the first floor and vinyl casement windows on the basement level. The dwelling included a front-gable garage ell off the one-story, side-gable section. The dwelling was in good condition as of 2016. The utility building (Feature 2) was described as a front-gabled structure with a concrete slab foundation and casement windows in fair condition. ERM visited the resource in 2021 and noted no changes to the dwelling. Feature 2 was not visible from the public road, but based on aerial views, there do not appear to be any changes (Appendix B, Figure 6).

Figure 5. 32CS5283, Feature 1, southwest elevation, view to the northeast.

NRHP Assessment: Pratt recommended the resource as not eligible for the NRHP due to the dwelling's recent age and lack of historical significance. As 32CS5283 does not meet the 50-year threshold for NRHP-eligible properties, ERM also recommends the resource not eligible.

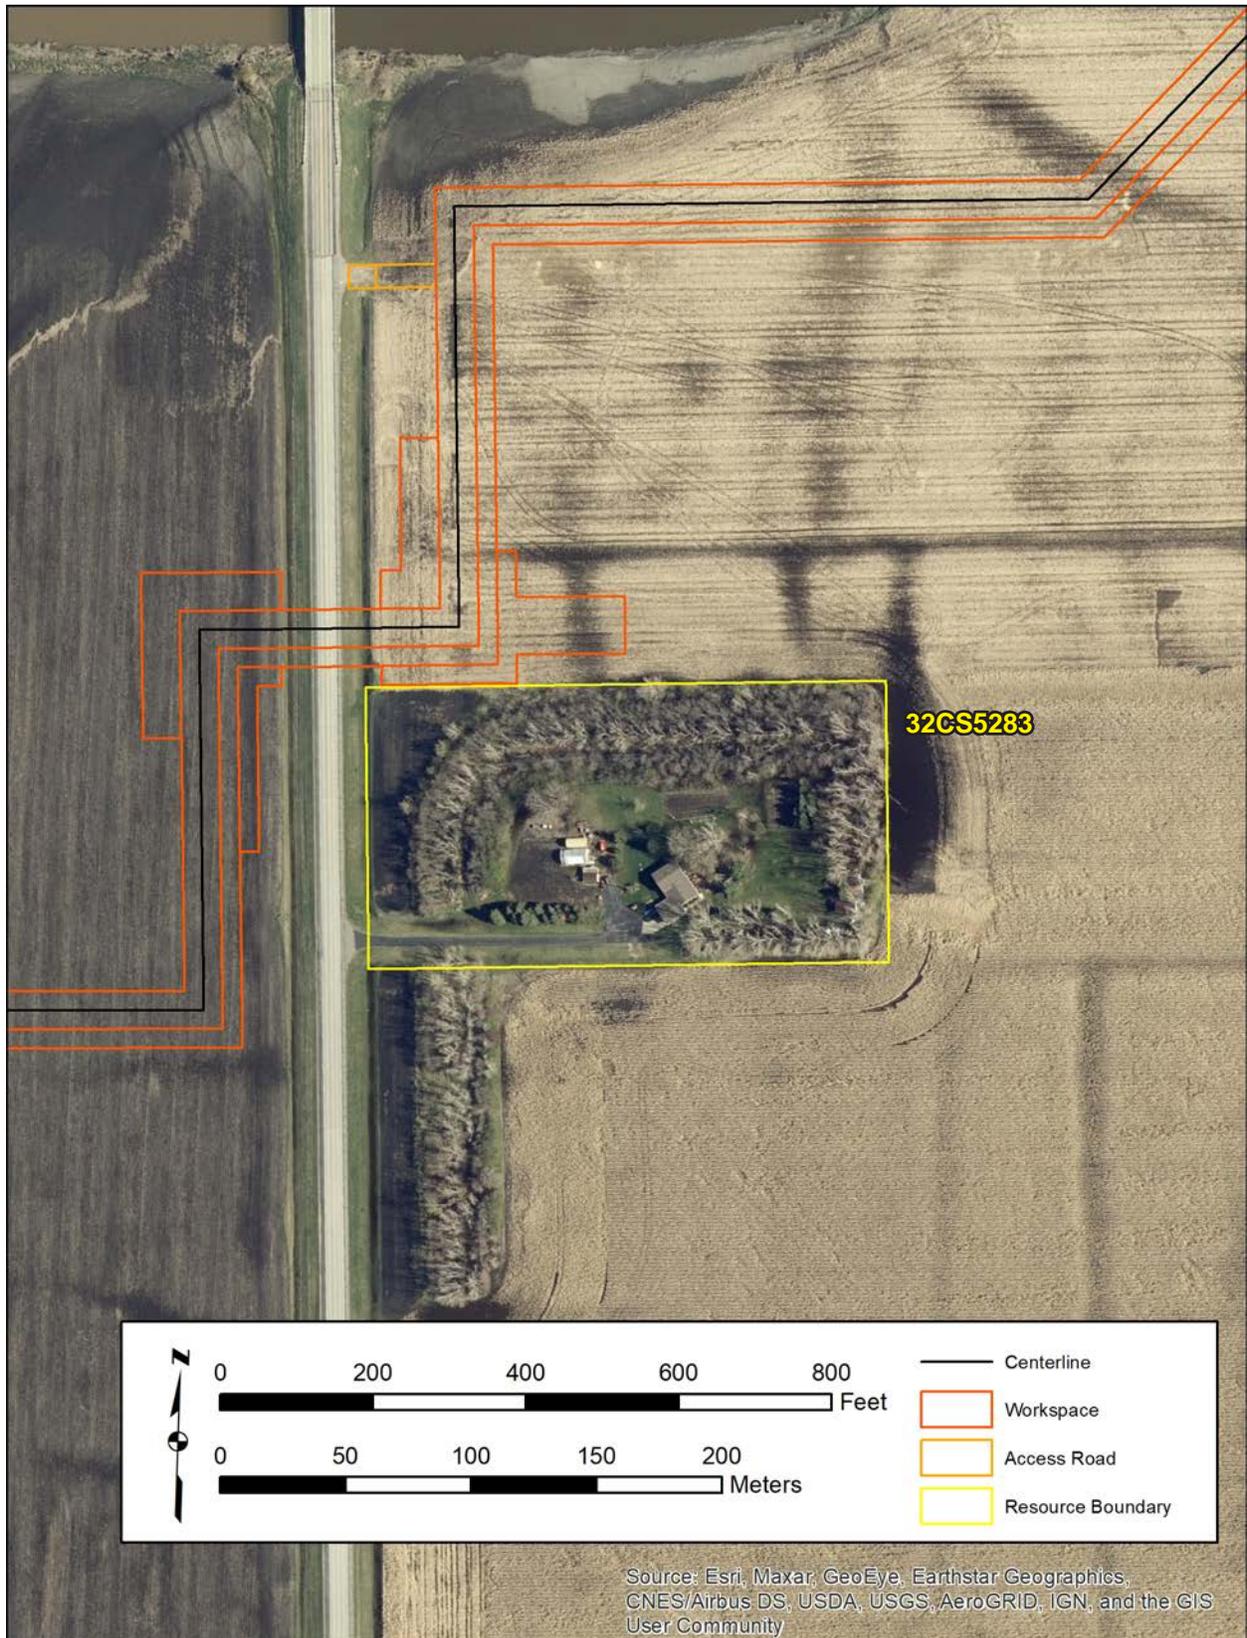
Figure 6. 32CS5283 in relation to the Project.

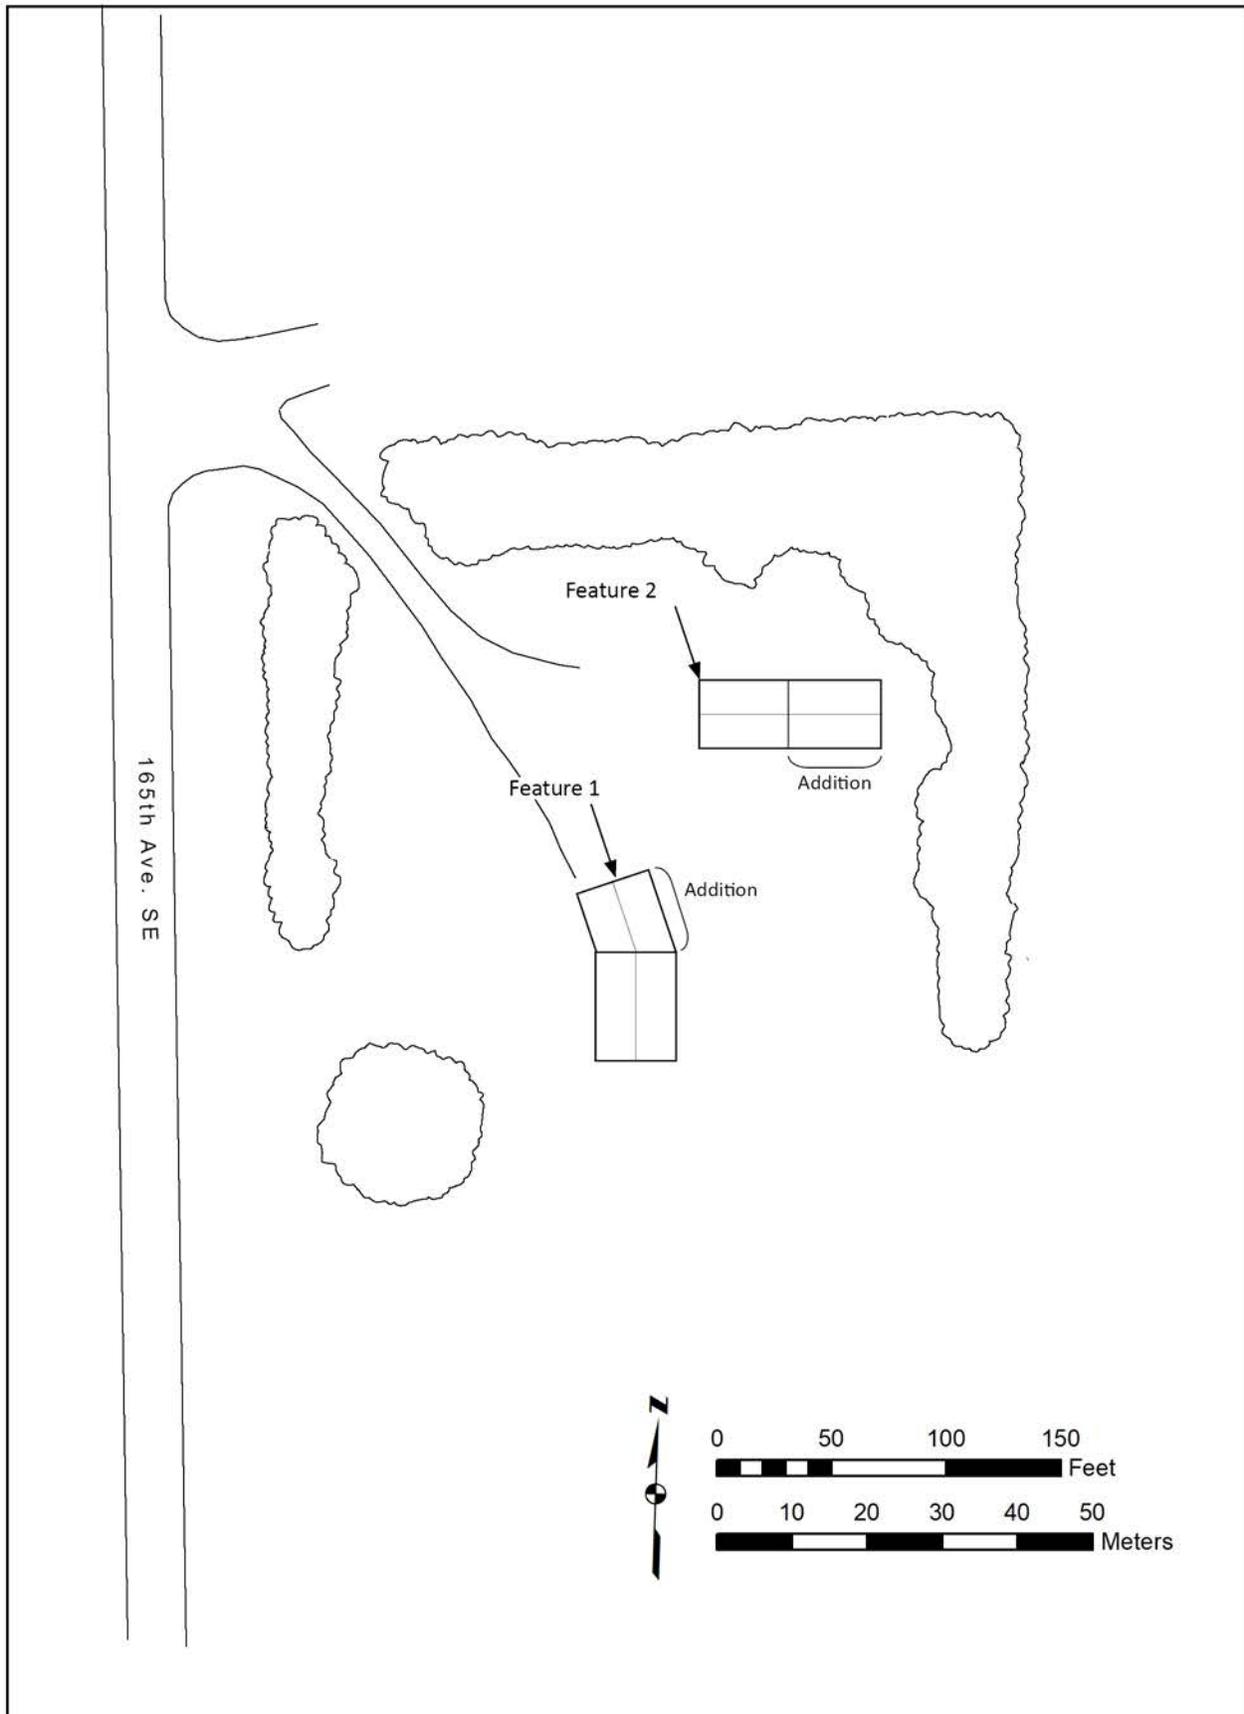
32CS5353 consists of a one-story, modified, Compact Ranch style dwelling that was constructed in 1969, and a workshop (Appendix B, Figure 14). Feature 1, the dwelling, has a side-gable, asphalt shingle roof, aluminum siding, and a continuous concrete masonry unit foundation (Appendix B, Figure 15). It also features replacement vinyl casement windows as well as large single-pane picture windows with fixed shutters. The primary entrance is located on the west elevation through a vinyl door and a metal and glass storm door. The entry is accessed via poured concrete steps that are flanked by decorative metal handrails. The attached two-car garage on the north elevation is a 1978 addition, canted slightly to the

Figure 14. 32CS5353, sketch map.

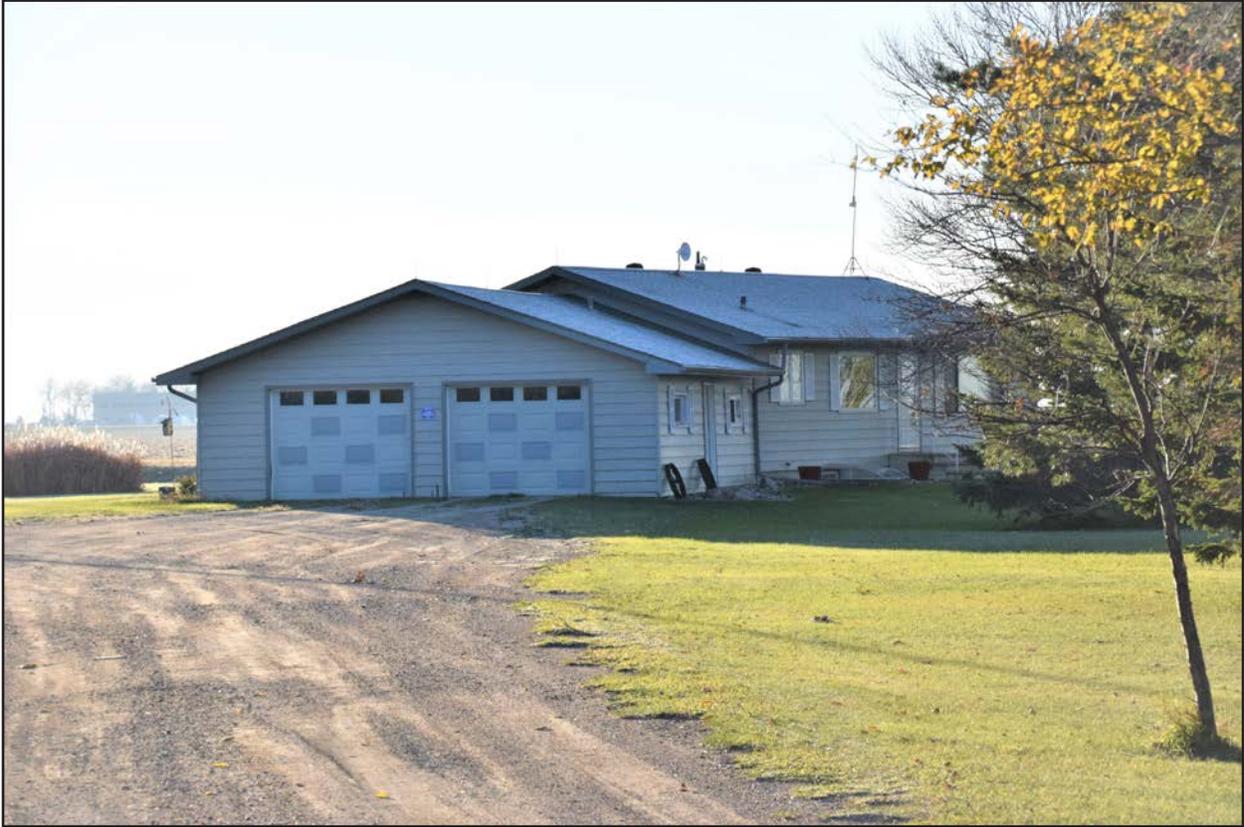
northwest. It features the same materials as the main block and has a personnel door on the west elevation and two overhead metal doors on the north elevation. The two garage doors have four fixed lights. Feature 1 and its addition are in good condition.

Figure 15. 32CS5353, Feature 1, north and west elevations, view to the southeast.

NRHP Assessment: 32CS5353 consists of a modified Compact Ranch dwelling and a modified workshop, both of which have only recently reached sufficient age to be considered for NRHP eligibility. The dwelling has common features of the ubiquitous Compact Ranch style and does not exhibit remarkable design or workmanship. Furthermore, 32CS5353 has suffered a loss of integrity with the use of replacement windows and the idiosyncratic orientation of the garage to the original block, which is out of character in the archetypically rectangular design grammar of Ranch style architecture. Therefore, ERM recommends 32CS5353 ineligible under NRHP Criterion C. Historical research for the Project did not uncover any significant events associated with the resource, so it is also recommended ineligible under NRHP Criterion A. Further deed research is needed to evaluate NRHP eligibility under Criterion B.

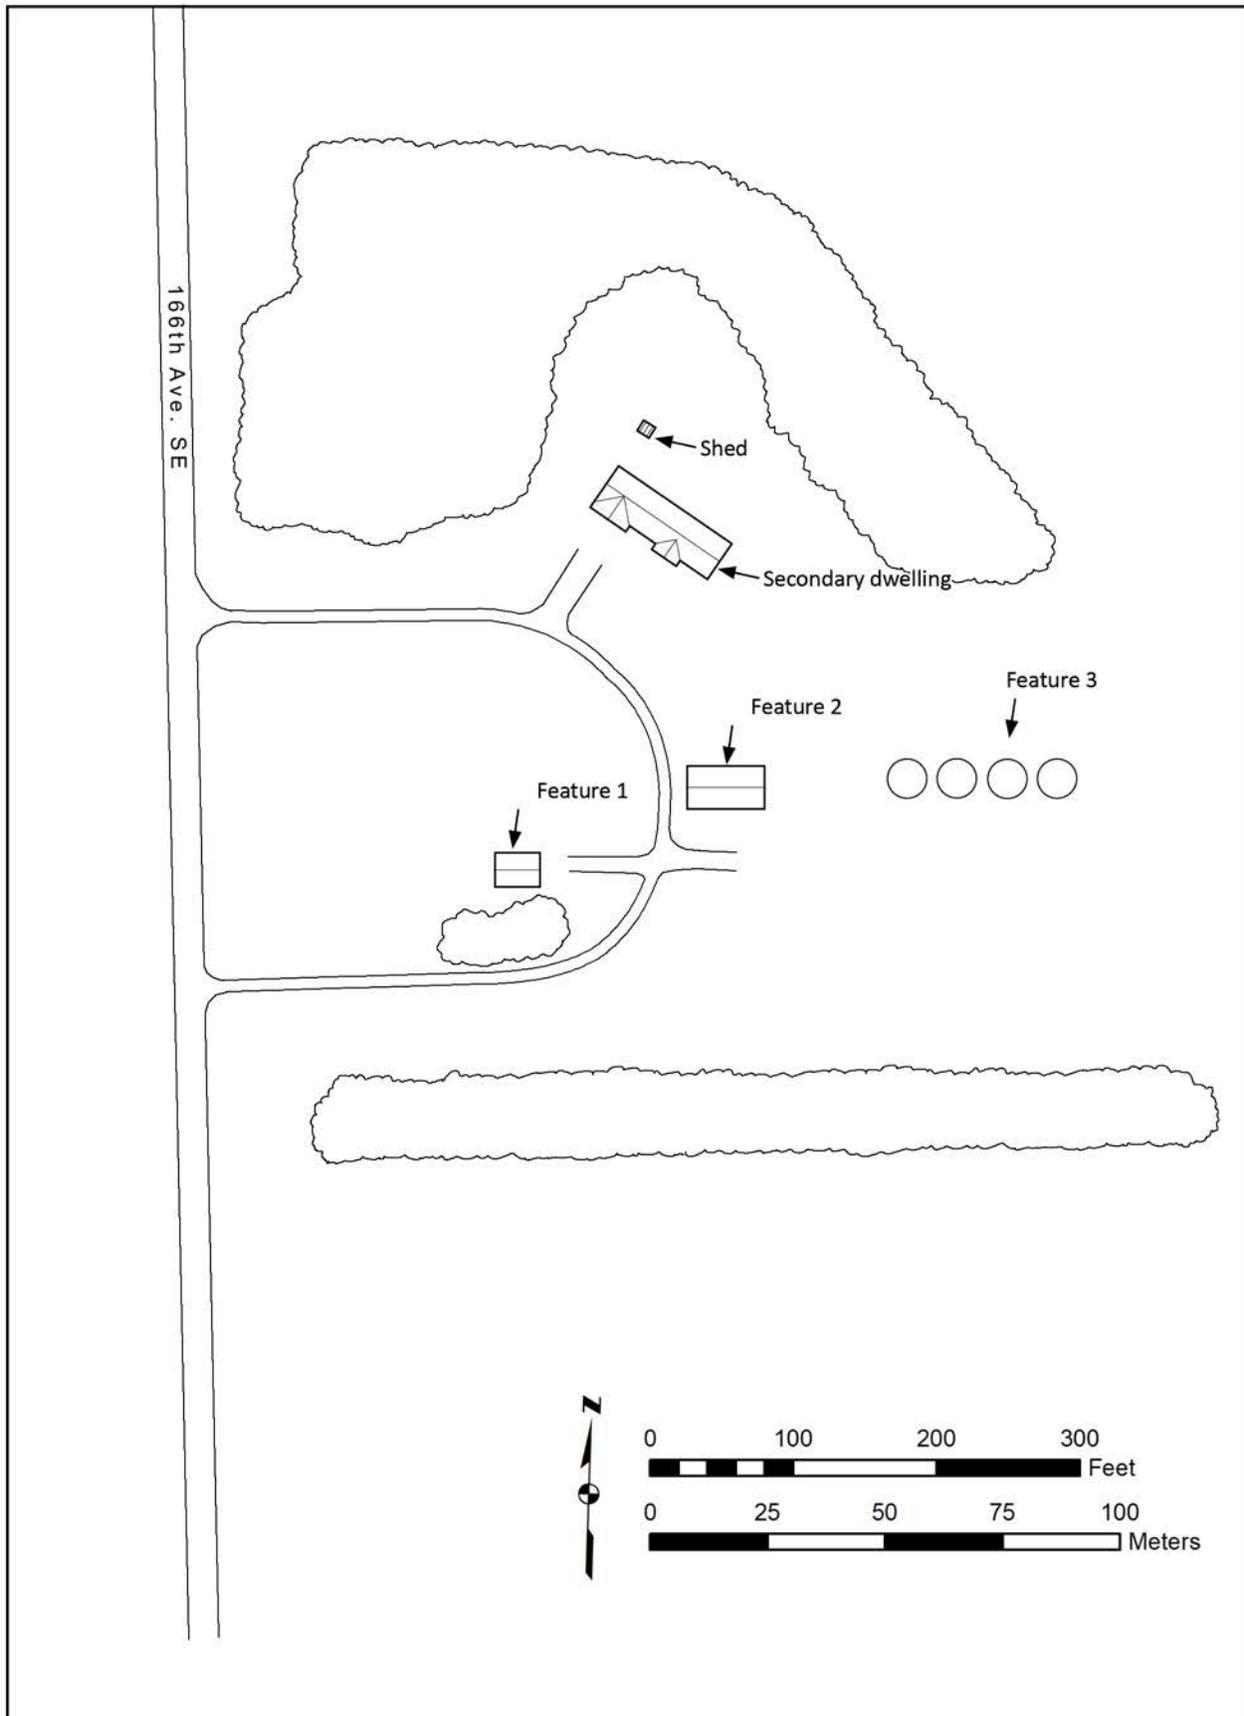
32CS5354 includes a ca. 1940 dwelling, a barn, four grain bins, a secondary modern Ranch style dwelling, and a modern shed (Appendix B, Figure 18). The primary dwelling, Feature 1, is within the semicircular drive, and has a side-gable, asphalt shingle roof, vinyl siding, and the foundation is not visible from the right of way (Appendix B, Figure 19). It also has an interior, on-peak brick chimney located closest to the west elevation, and vinyl casement windows covered by storm windows. The primary entrance is located on the north entrance through a vinyl door with a fixed two-pane light. Feature 1 has been well kept and is in good condition, but it is unclear whether it is currently occupied.

Figure 18. 32CS5354, sketch map.

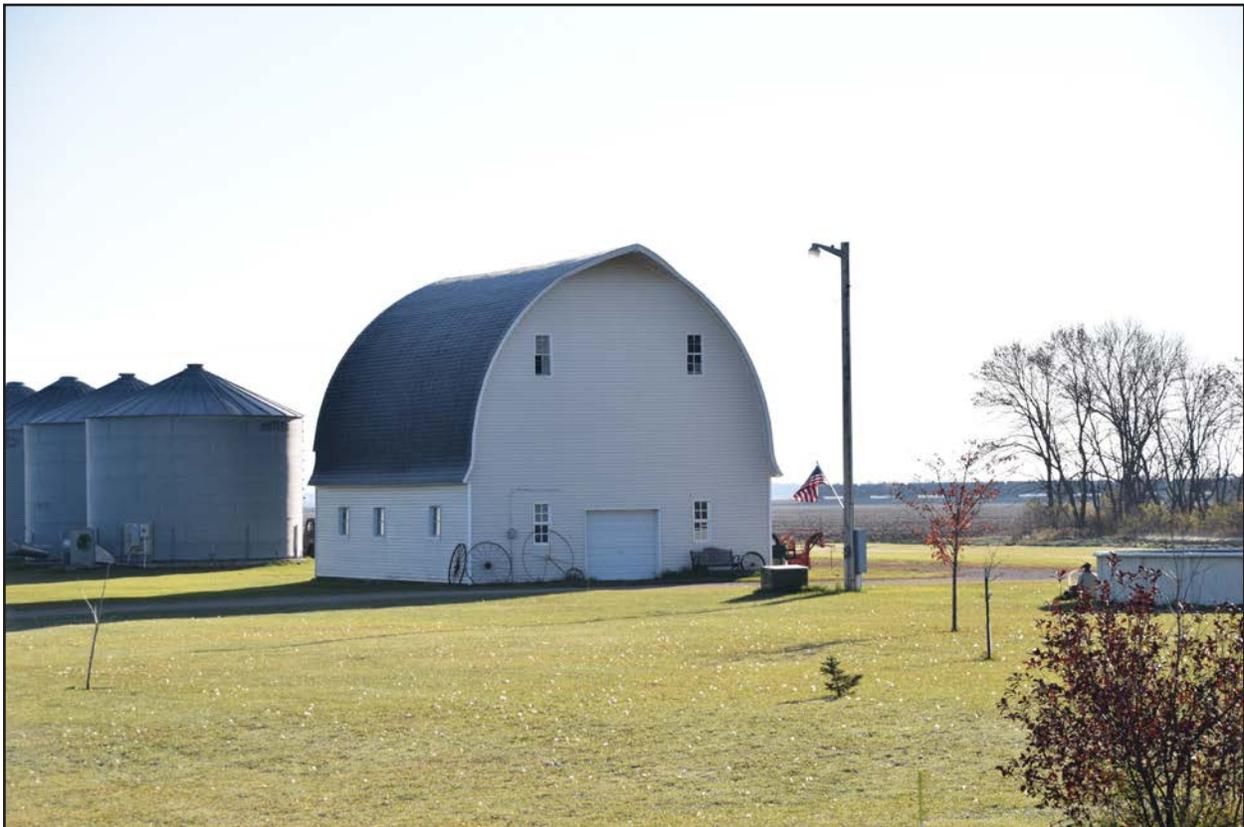
Feature 2 is a ca. 1940 barn that is located slightly northeast of Feature 1. It has a Gothic arch, asphalt shingle roof, vinyl siding, and the foundation is not visible (Appendix B, Figure 20). It also has four-over-four single-hung wood sash as well as four-light fixed windows, and an overhead metal bay door that serves as the primary entrance on the western elevation. The barn is in fair condition, as the two upper windows have lost some glazing. Next, the four large metal grain bins are designated Feature 3. They were constructed pre-1984, are in good condition, and are located in a line directly east of Feature 2 (Appendix B, Figures 21 and 22).

Figure 20. 32CS5354, Feature 2, barn, north and west elevations, view to the southeast.

NRHP Assessment: 32CS5354 includes three modified historic features and two modern features located in a rural area. The individual features display frequently used, modern replacement materials, and are otherwise well cared for in a manner that is sympathetic to the original workmanship and design. However, the generic form and updated materials of the original dwelling make it impossible to discern a specific style. Between 1984 and 1990, a building in the location of the secondary dwelling was razed; it was a large square footprint building that looks like barn in aerial imagery. As of 1984, there was another outbuilding between that barn and the barn that is still standing that was razed between 1990 and 1997, and another building within the semicircular drive that was razed between 1997 and 2003. These observations suggest that much of the farm's historic built environment has been lost and is now dominated by an architecturally incompatible modern dwelling, and thus 32CS5354 no longer retains integrity of association and feeling. That added to the loss of material integrity and lack of outstanding architectural character leads, ERM to recommend 32CS5354 ineligible for the NRHP under Criterion C. It is also considered ineligible under NRHP Criterion A because historical research for the Project did not identify any important events associated with the property. The resource also does not convey a compelling sense of the region's agricultural history, given the prominence of modern elements that have replaced earlier components of the working farm. Further deed research is still needed to evaluate NRHP eligibility under Criterion B.

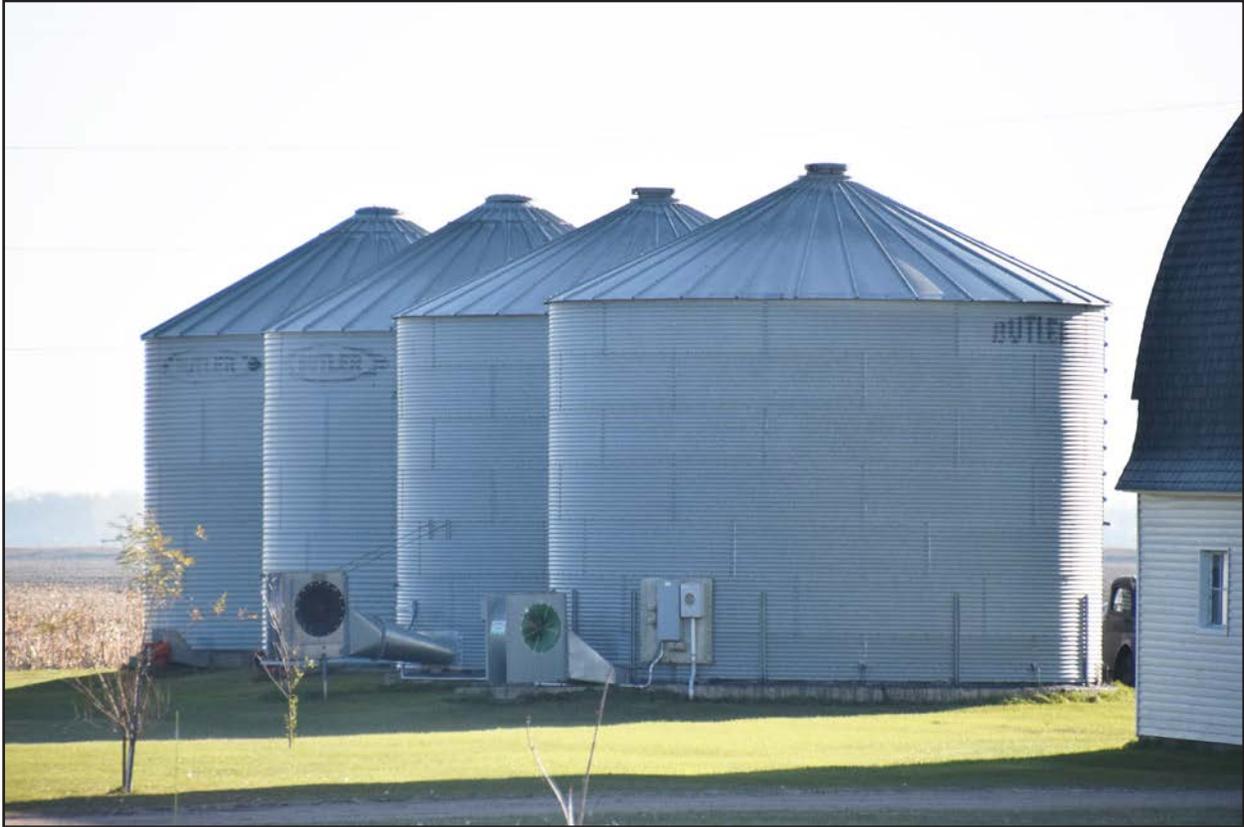
Figure 21. 32CS5354, Feature 3, view facing southeast.

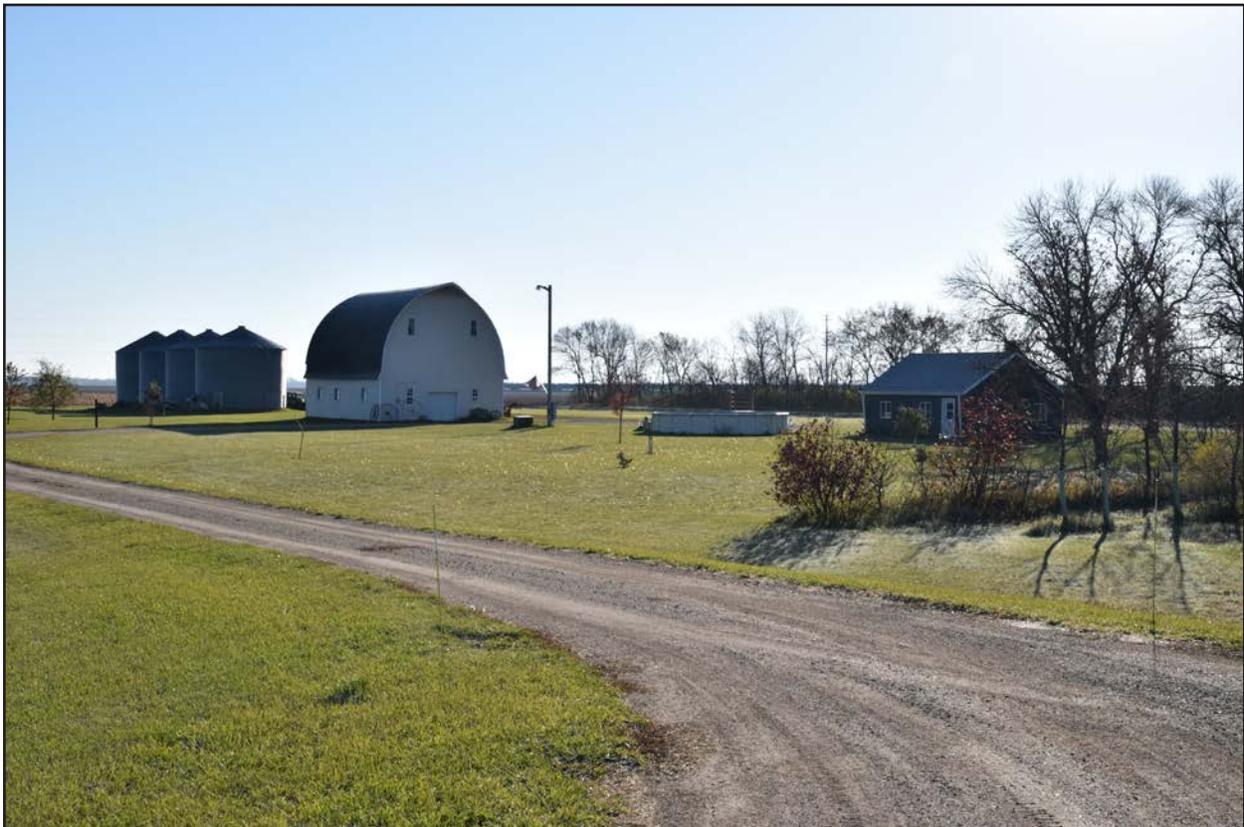
Figure 22. 32CS5354, Overview showing Features 1, 2, and 3.

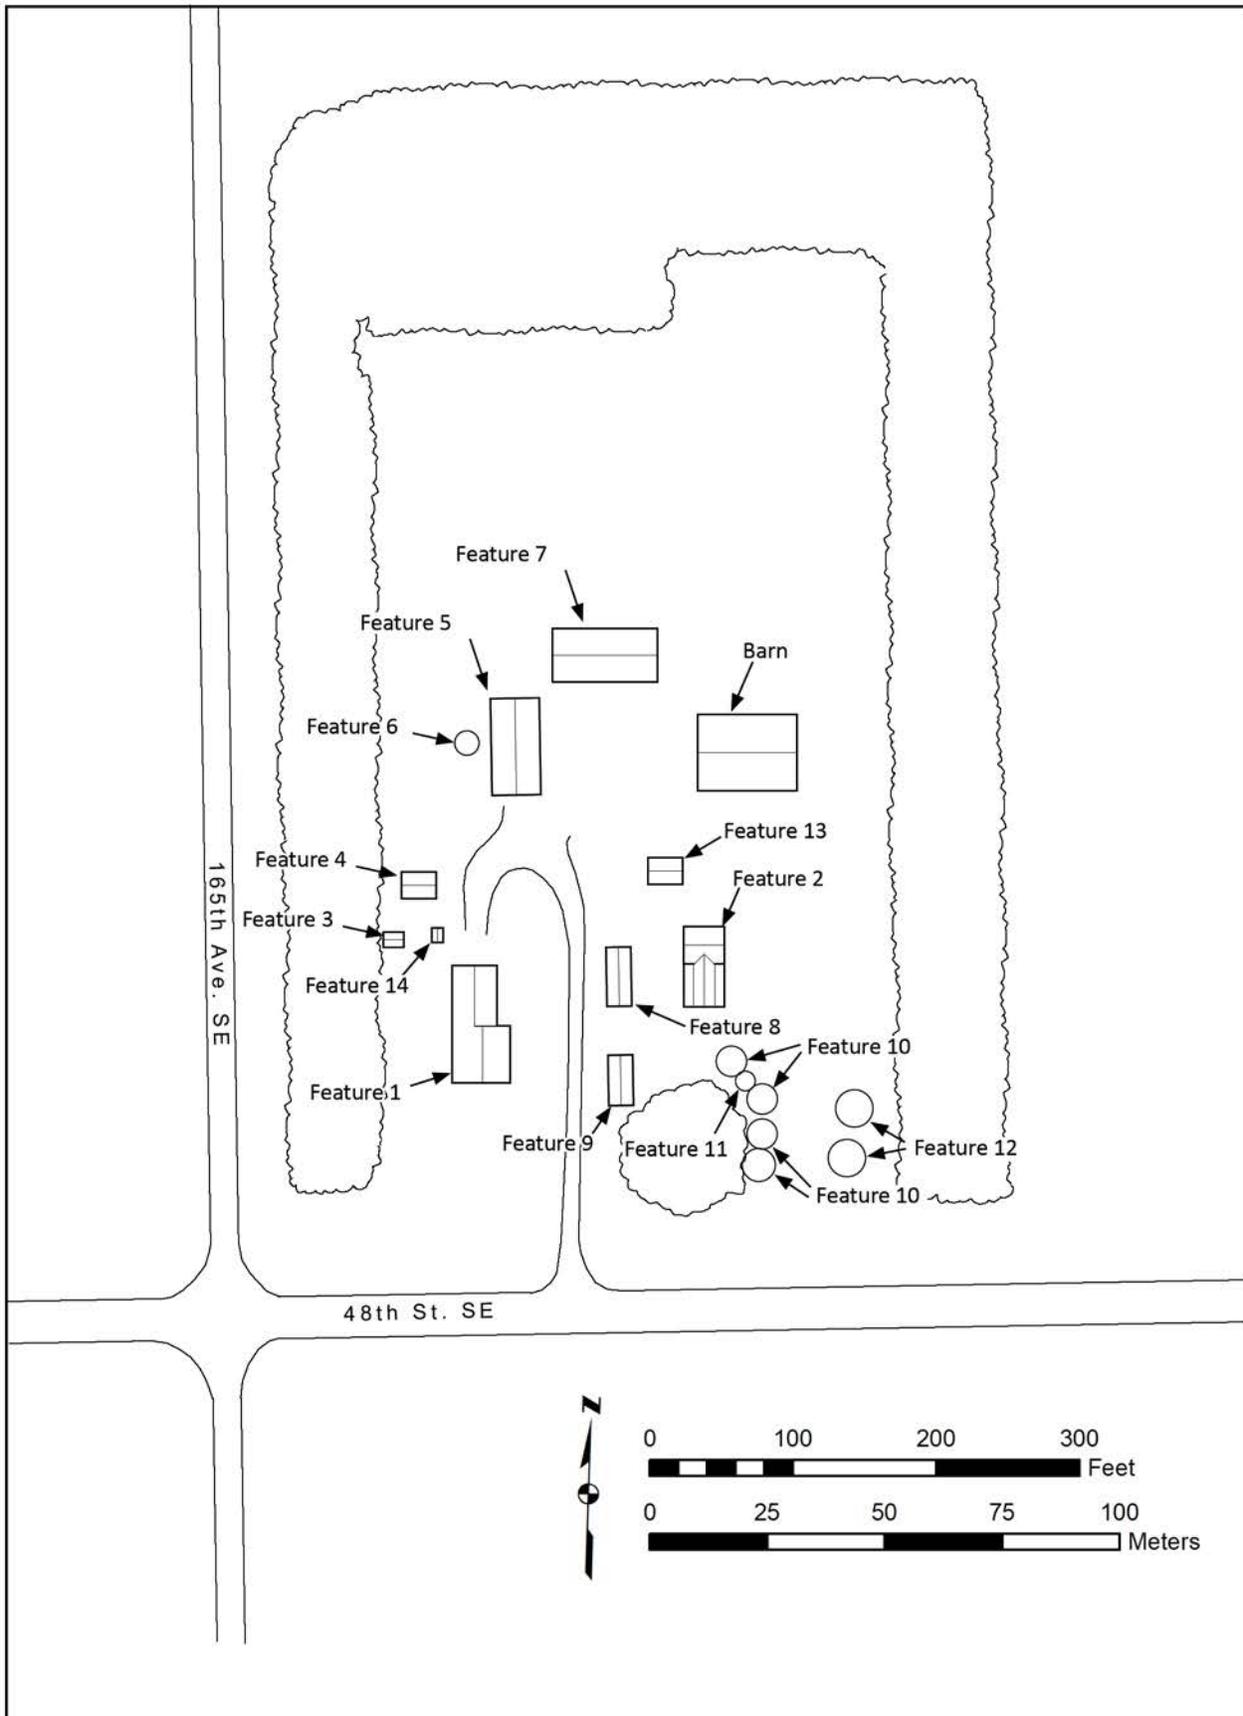
32CS5355 consists of a one-story, ca. 1960, Linear Ranch style dwelling, a ca. 1900 equipment shed that may have originated as a dwelling, nine other outbuildings, a silo, and seven grain bins (Appendix B, Figures 24 and 25). The dwelling, Feature 1, has a side-gable, standing seam metal roof, vinyl siding, and a continuous concrete masonry unit foundation (Appendix B, Figure 26). It also features a narrow three pane picture window, and a large fixed square picture window. The primary entrance is located on the eastern elevation, but it is not visible from the public right-of-way. The dwelling is in good condition.

Figure 24. 32CS5355, sketch map.

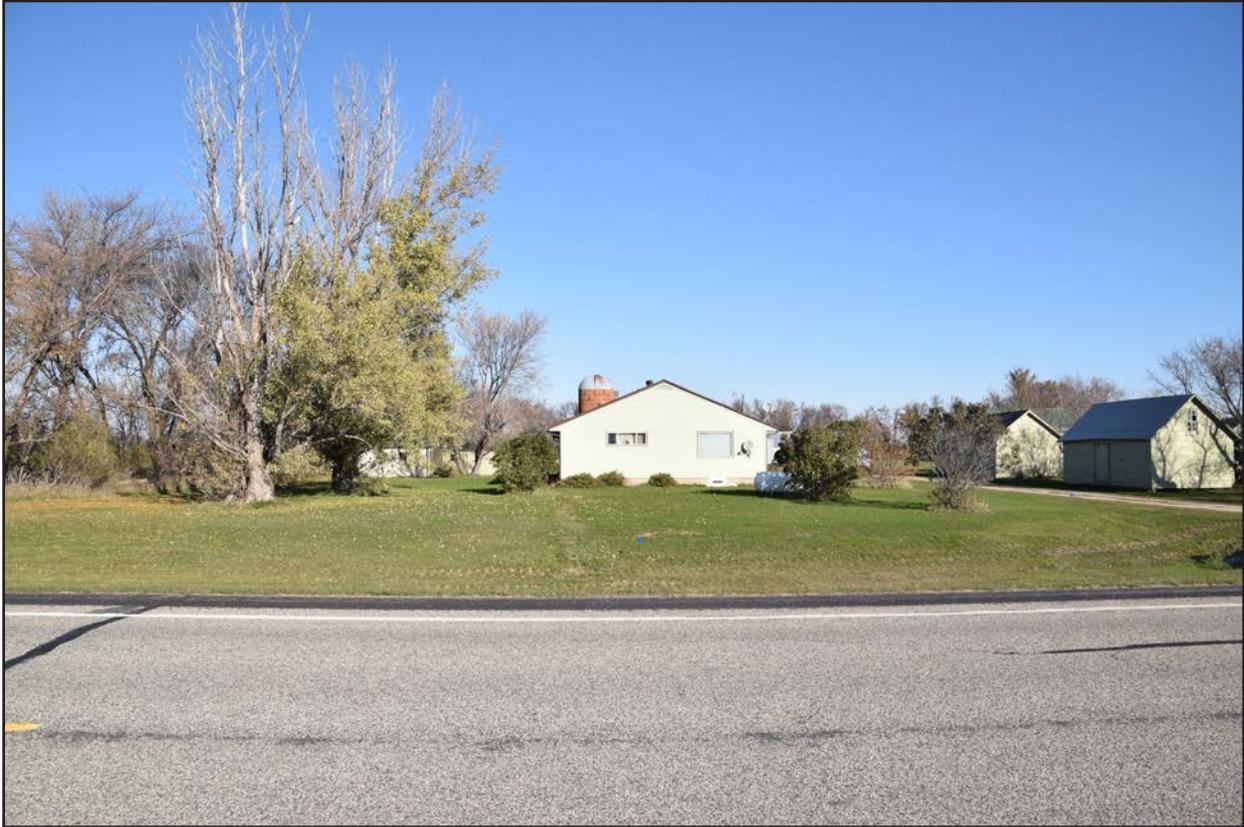
Figure 25. 32CS5355, Resource overview, view facing northeast.

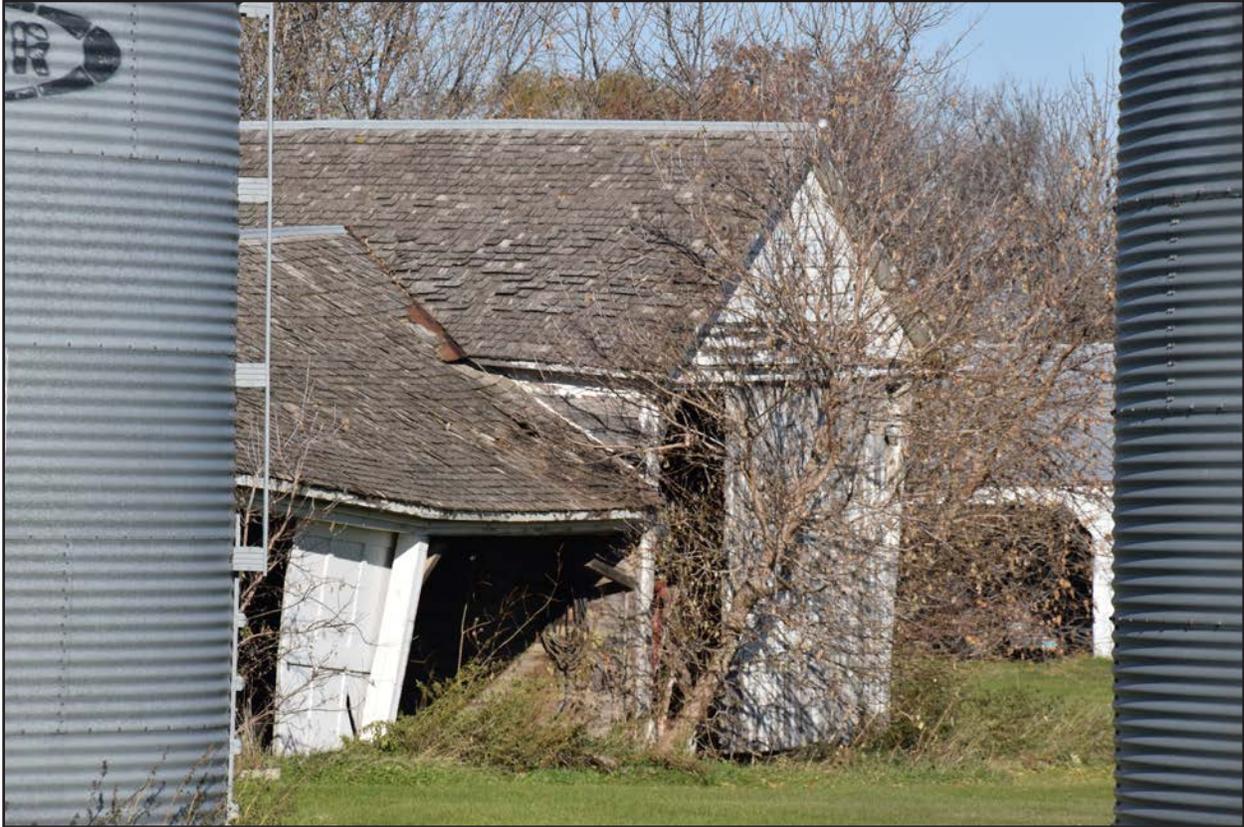
remnant of a wooden sliding door. Feature 2 is in poor condition, as some structural supports have shifted and portions of the roof are sagging, and some roofing shingles and siding have been lost.

Figure 27. 32CS5355, Feature 2, view facing northwest.

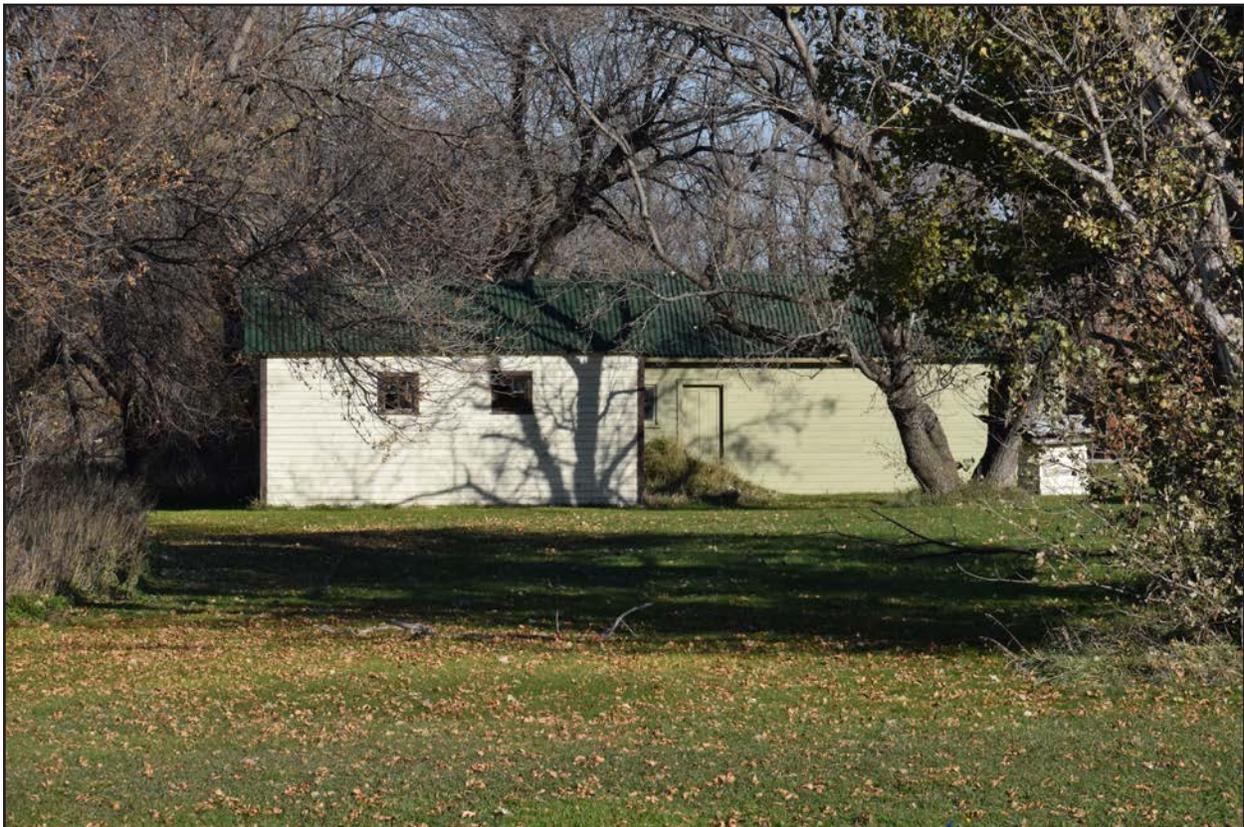
Feature 3 is a shed located to the northwest of the dwelling. It has a gabled roof clad in modern corrugated metal; it appears to retain original clapboard siding and four-light wood frame windows. Other details are not visible from the right-of-way, but the feature appears to be in good condition. Directly north of Feature 3 is Feature 4, a larger building that may serve as a shed or workshop. It has a side-gable roof clad in the same modern corrugated metal as Feature 3. Like Feature 3, Feature 4 has clapboard siding. Its primary entrance is located on the southern elevation. The entry has a wood, four-panel door, and there is a fixed four-light window to the west. It is also in good condition. Both Features 3 and 4 appear to date to the 1940s based on the appearance of the original materials (Appendix B, Figure 28).

Figure 28. 32CS5355, (from left to right) Features 3, 4, 12, view facing north.

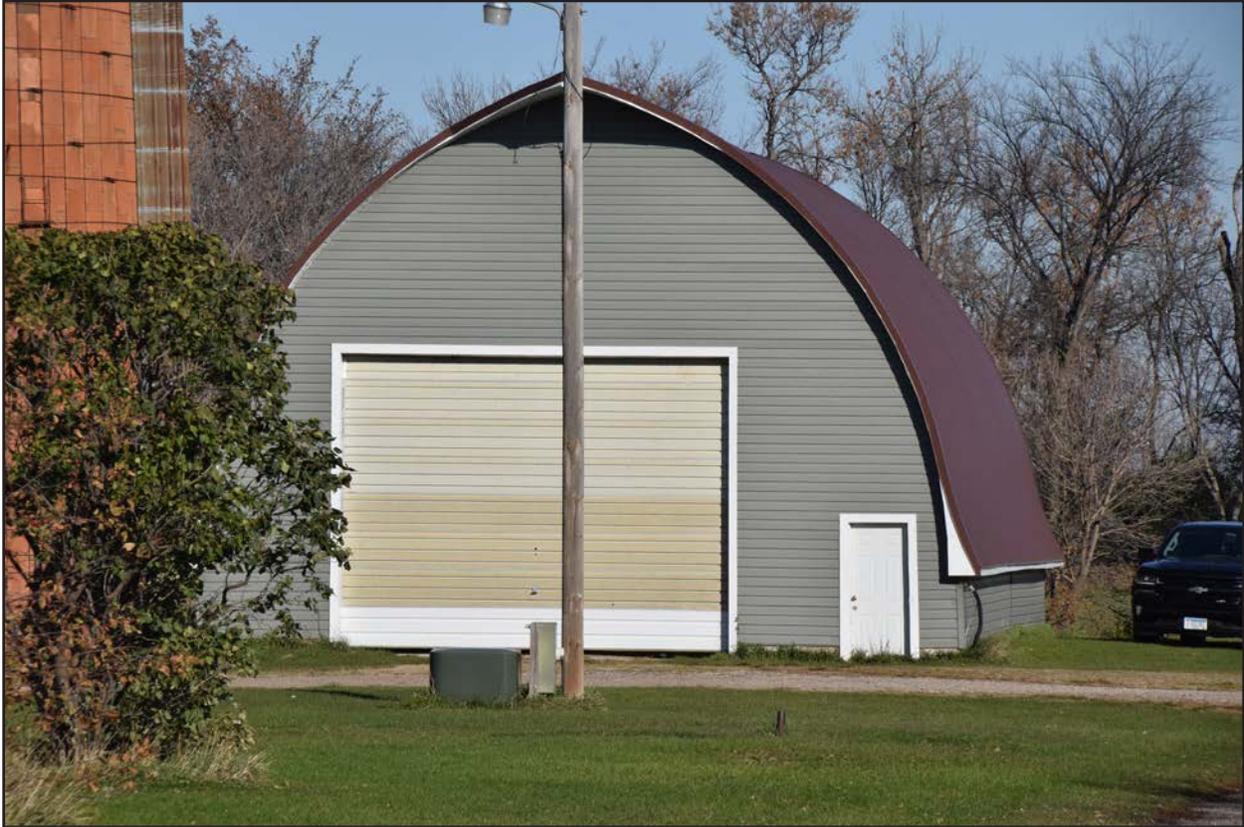
Located northeast of Features 3 and 4 is a pre-1984 garage, Feature 5, that likely dates to the 1960s. It has a Gothic arch roof, vinyl siding, metal roofing, and a poured concrete foundation (Appendix B, Figure 29). The entrance is located on the southern elevation through an overhead metal bay door and a replacement six-panel vinyl personnel door. It is in good condition. Just northwest of the garage is a tile silo, Feature 6, which dates to the early twentieth century. Its galvanized metal cap is intact, and the silo seems to be in good condition (Appendix B, Figure 30). Northeast of the garage is an equipment shed, Feature 7, which was constructed before 1984 and likely dates to the 1960s. It has a side-gable, corrugated metal roof with exposed rafter tails and corrugated metal siding (Appendix B, Figure 31). It has a two-bay opening on the southern elevation divided by a wooden support post. It is in good condition.

Figure 29. 32CS5355, Feature 5, view facing northwest.
