Re: WBI Energy Transmission, Inc. Wahpeton Expansion Project Docket No. CP22-466-000 FERC/EIS-0325D

Responses to Comments on the Draft Environmental Impact Statement

Addendum Wetland and Waterbody Delineation Report

Wahpeton Expansion Project

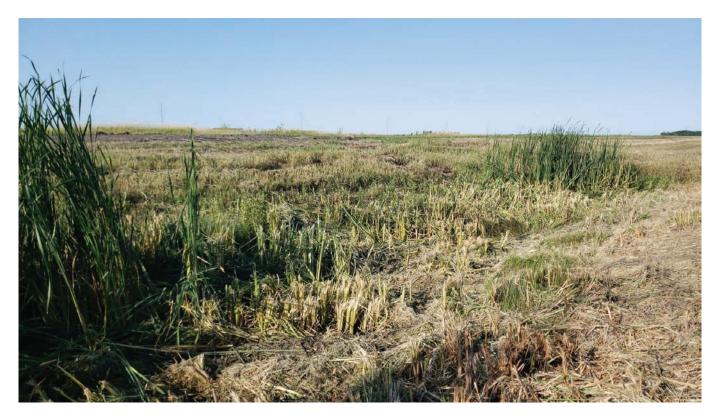
wcae001e_w, looking southwest

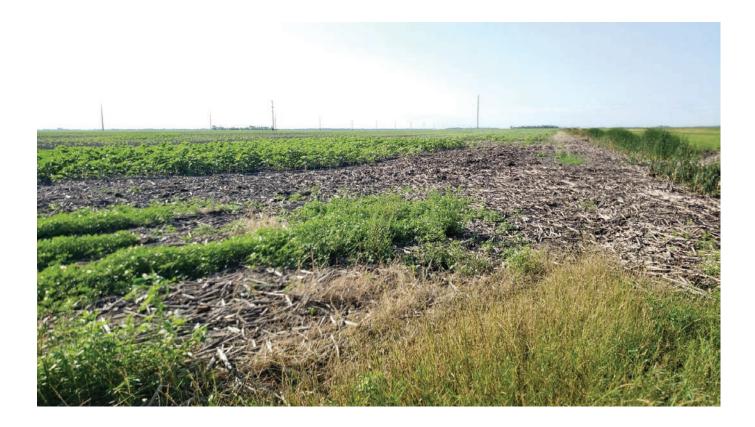
wace006e_u, looking south.

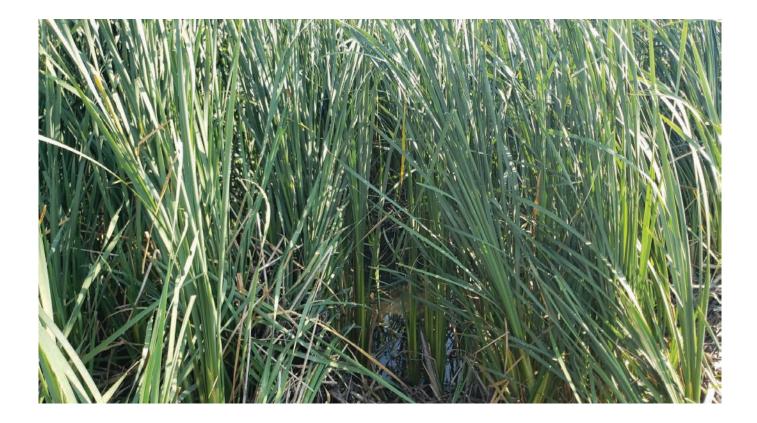
Remarks: Plot is located in the centerline of a roadside ditch.

wace006e_w, looking northeast.

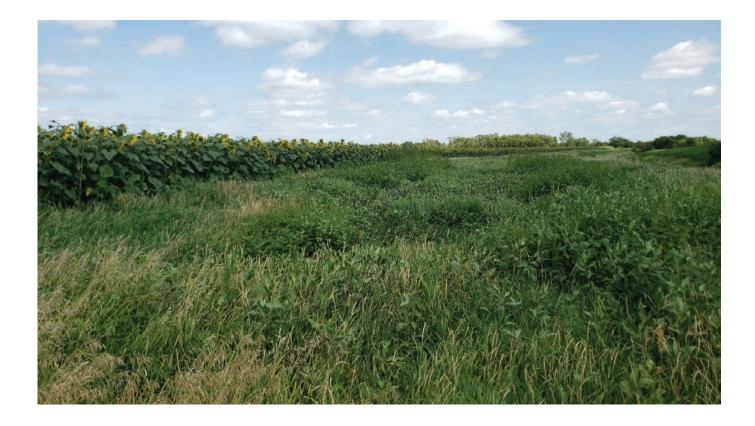
wcae007e_u, looking northeast.

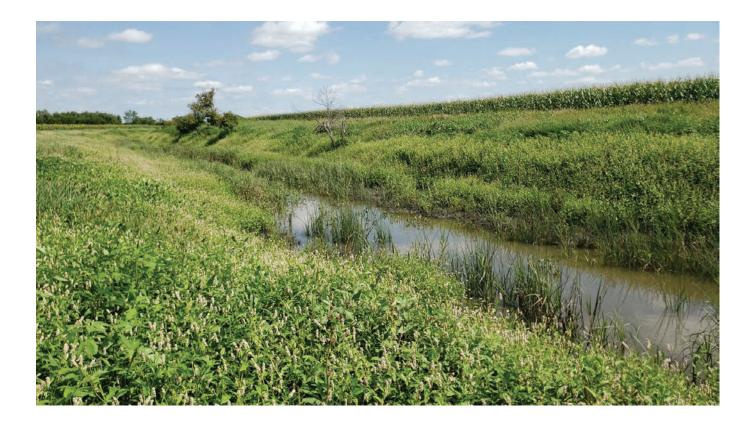
Remarks: Plot is located in the centerline of a waterway.

wcae007e_w, looking northeast.

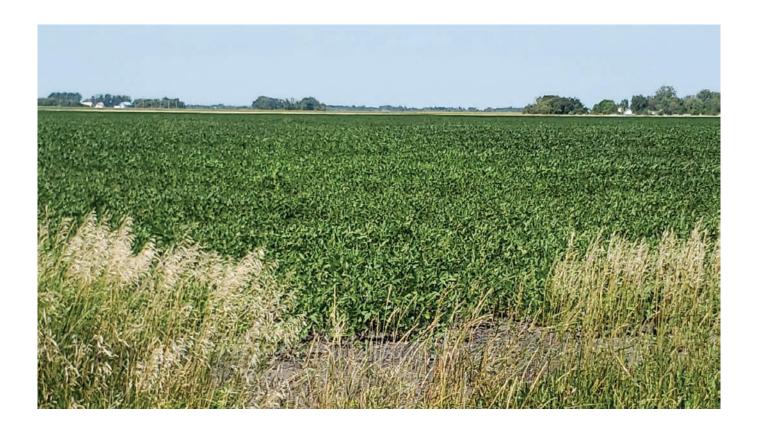
wrie009e_w, looking west.

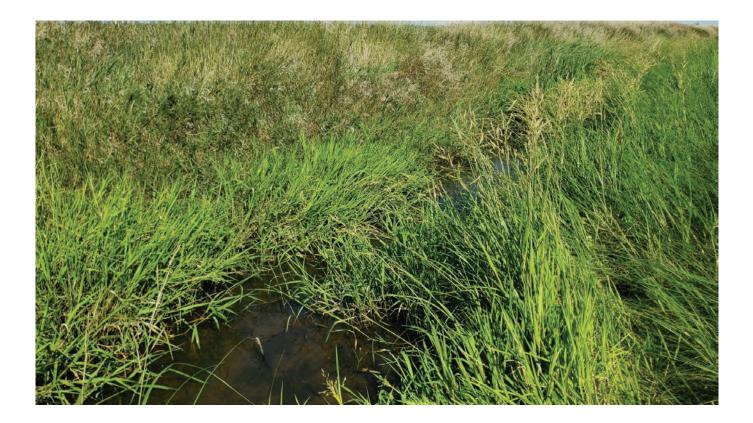
Remarks: Plot is located in the centerline of a roadside ditch.

wrie009e_w, looking northwest.

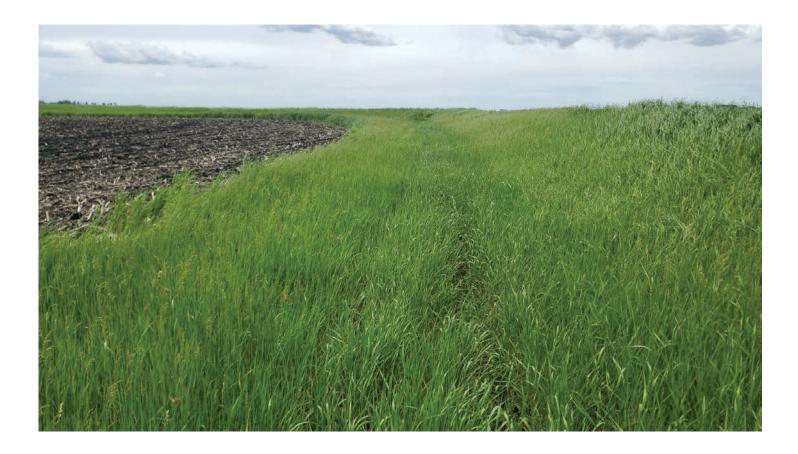
Observation Notes: Roadside ditch

Downstream, looking south.

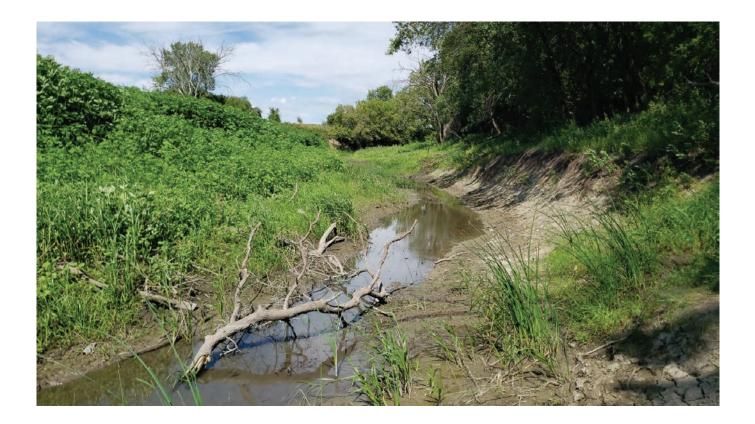
Observation Notes: Antelope River

Downstream, looking northwest.

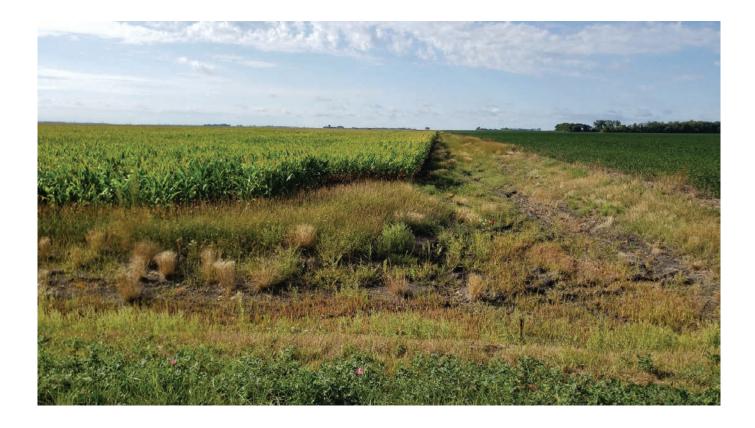
OHWM Indicator: (check all that apply)	I ⊂ C	lear line	on bank 🛛	Shelving	□Wreste	ed vegetation	Scouring		□Water	staining
		ent, matte ing vege		Wrack line	□Litter a	nd debris	d Abrupt plan Change	t commun	nity      □Soil ch change	aracteristic
Dominant Substrate: (check all that apply)	□B	edrock	□ Boulde	r 🗆 C	Cobble	Gravel	□ Sand	□ Silt/	clay 🗹	Organic
Observations										
Riparian Zone Preser (check one)	nt: 🗆 Ye	es	🗹 No							
Vegetation Layers: (check all that apply)		ees	□ Sapl	ngs/Shrub	s 🗹 He	erbs				
<b>Dominant Bank Vege</b> Reed canary grass, Ke										
Aquatic Habitats (ex:	submerged or	emerged a	equatic vegetation, o	verhanging ba	anks/roots, leaf pac	ks, large submerged	wood, riffles, deep p	ools, etc.):		
Aquatic Organisms (	Observed	(list):								
Disturbances (ex: live	stock acces	s, manure	e in waterbody, w	aste dischar	rge pipes):					
Observation Notes: Agricultural drainage c	litch

Upstream, looking southeast.

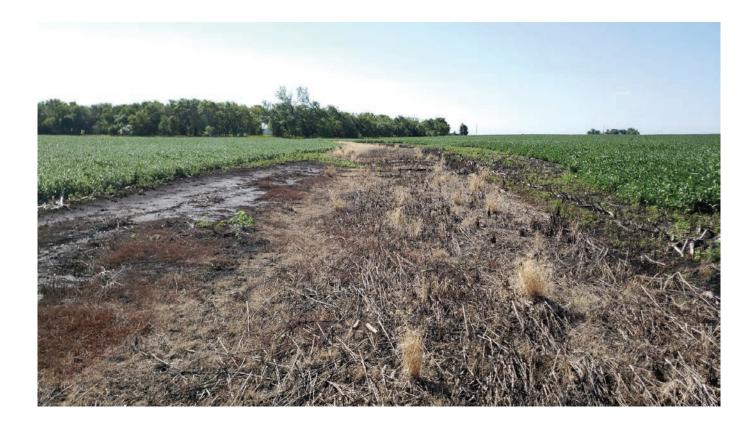
Aquatic Organisms Obs	served	(list):												
Disturbances (ex: livesto	ock acces	s, manure	in waterboo	dy, waste	discharge	e pipes):								
Observation Notes: Agricultural drainage ditcl	h

Downstream, looking southeast.

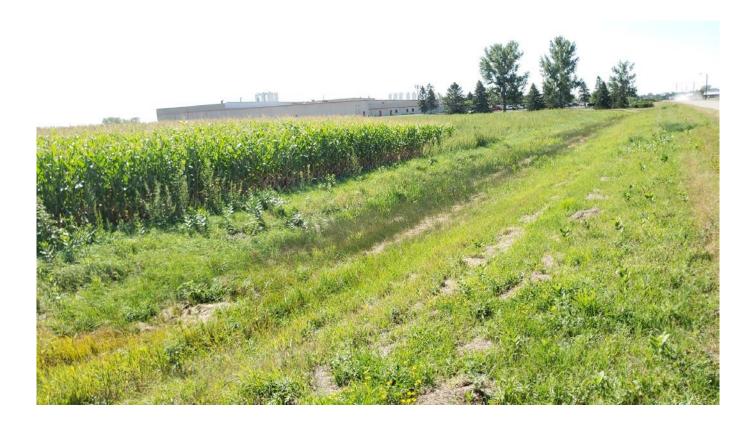
Observation Notes:											
Roadside ditch

Downstream, looking southeast.
