Re: WBI Energy Transmission, Inc.
Wahpeton Expansion Project
Docket No. CP22-466-000
Responses to the Environmental Conditions of the Order Issuing Certificate

2.0 RESPONSE TO COMMISSION ORDER ENVIRONMENTAL CONDITIONS

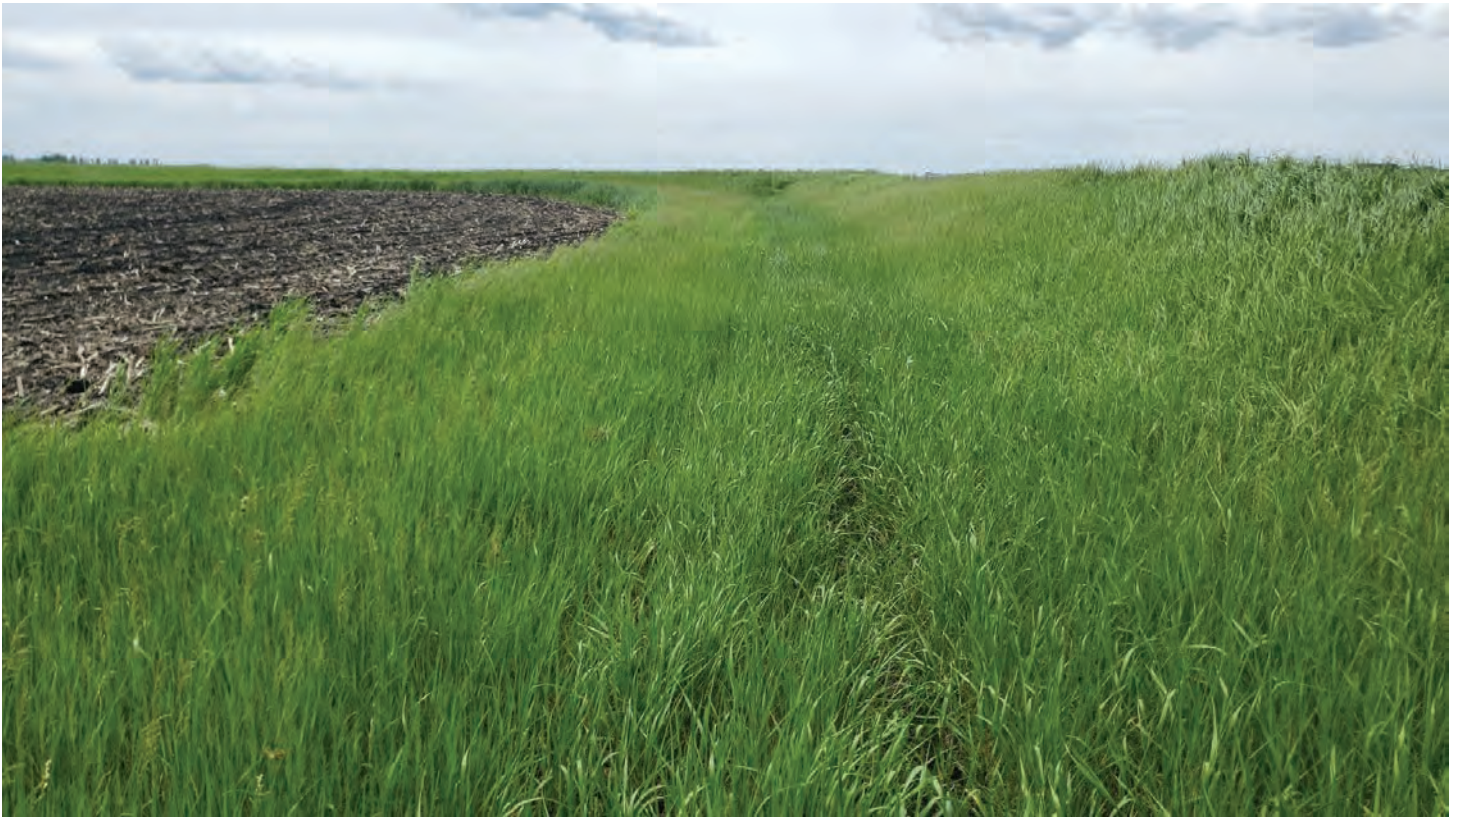
Downstream, looking south.

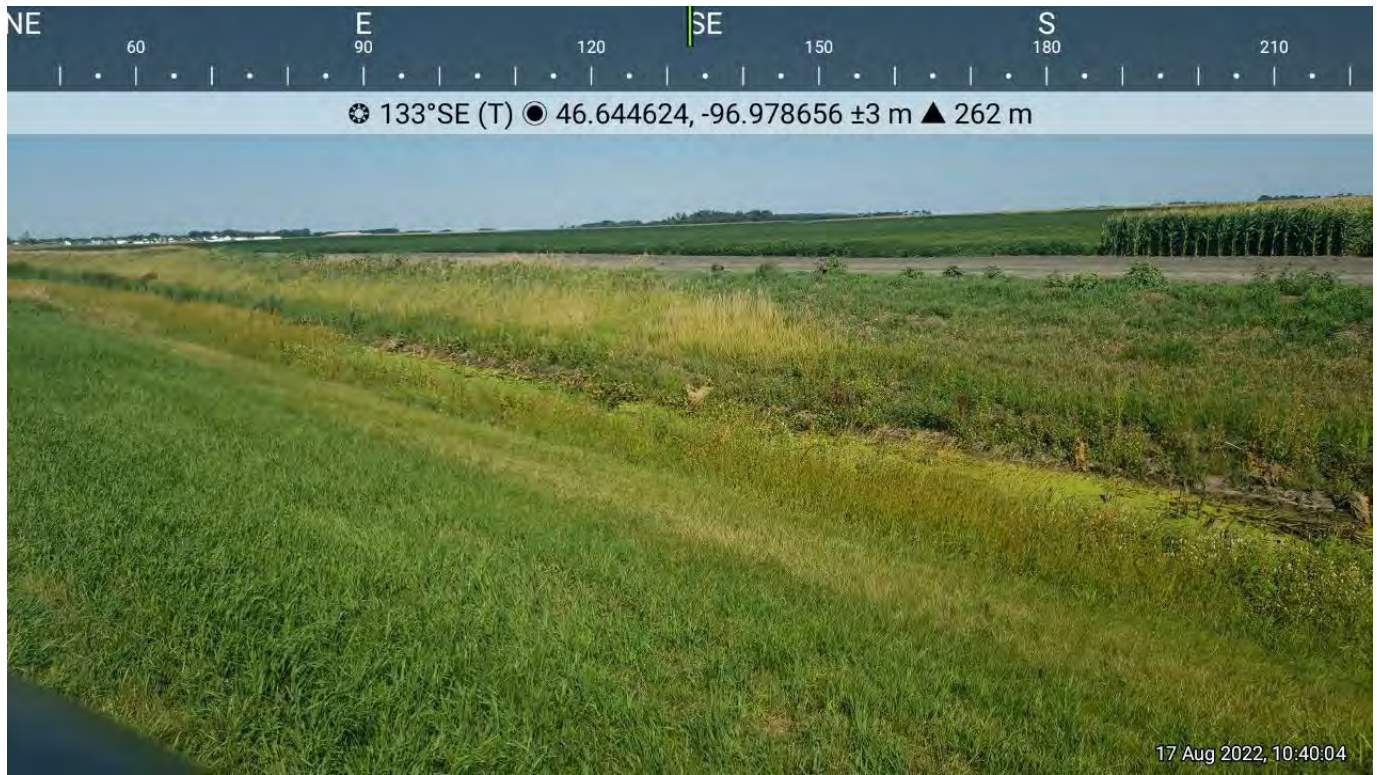
Downstream, looking southeast.

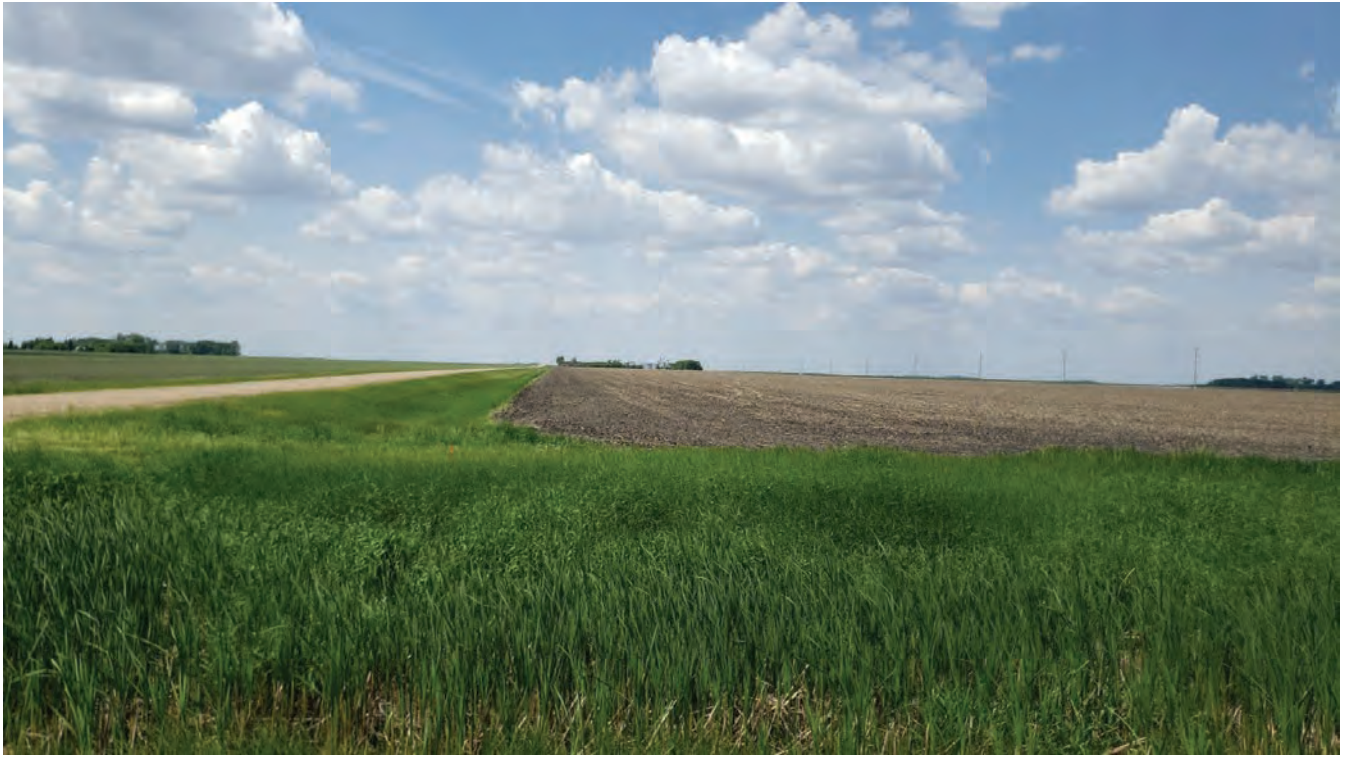
Downstream, looking west.

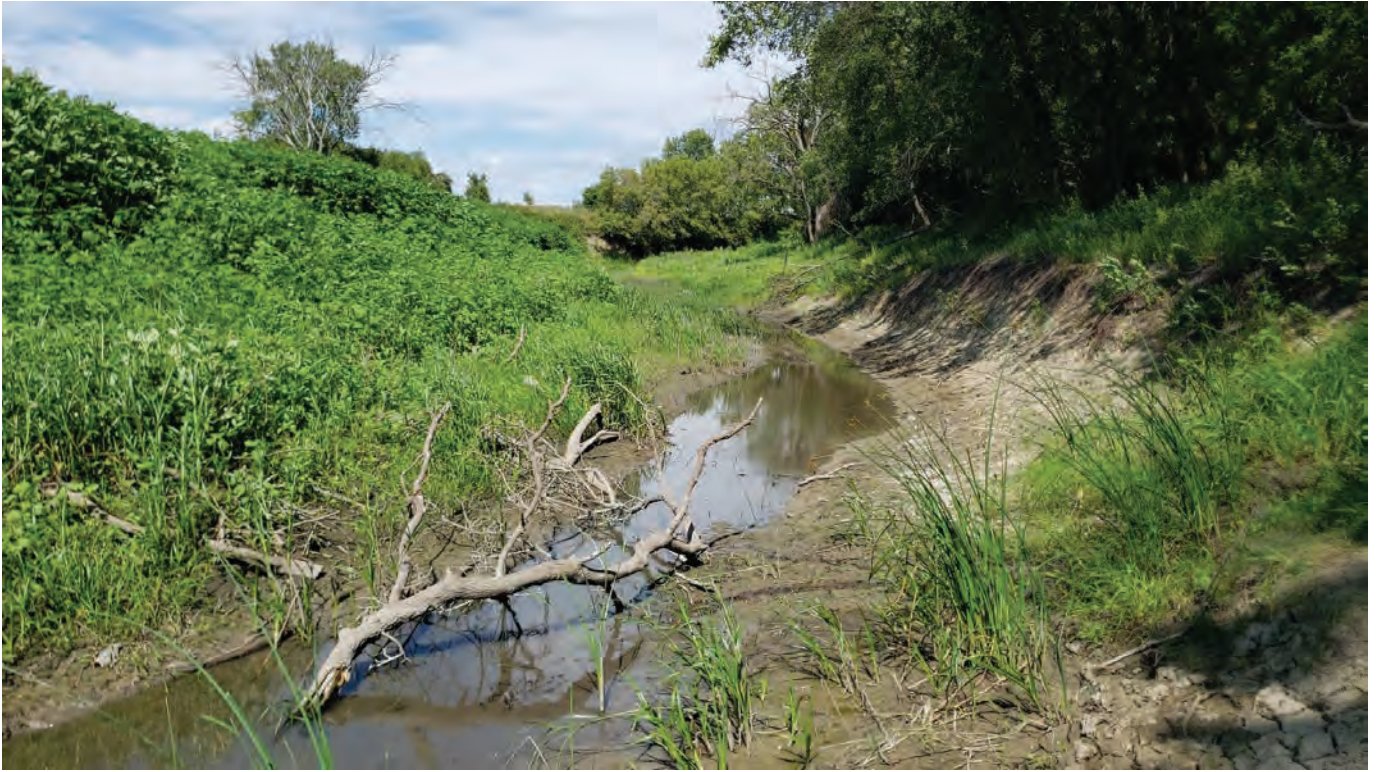
Downstream, looking northwest.

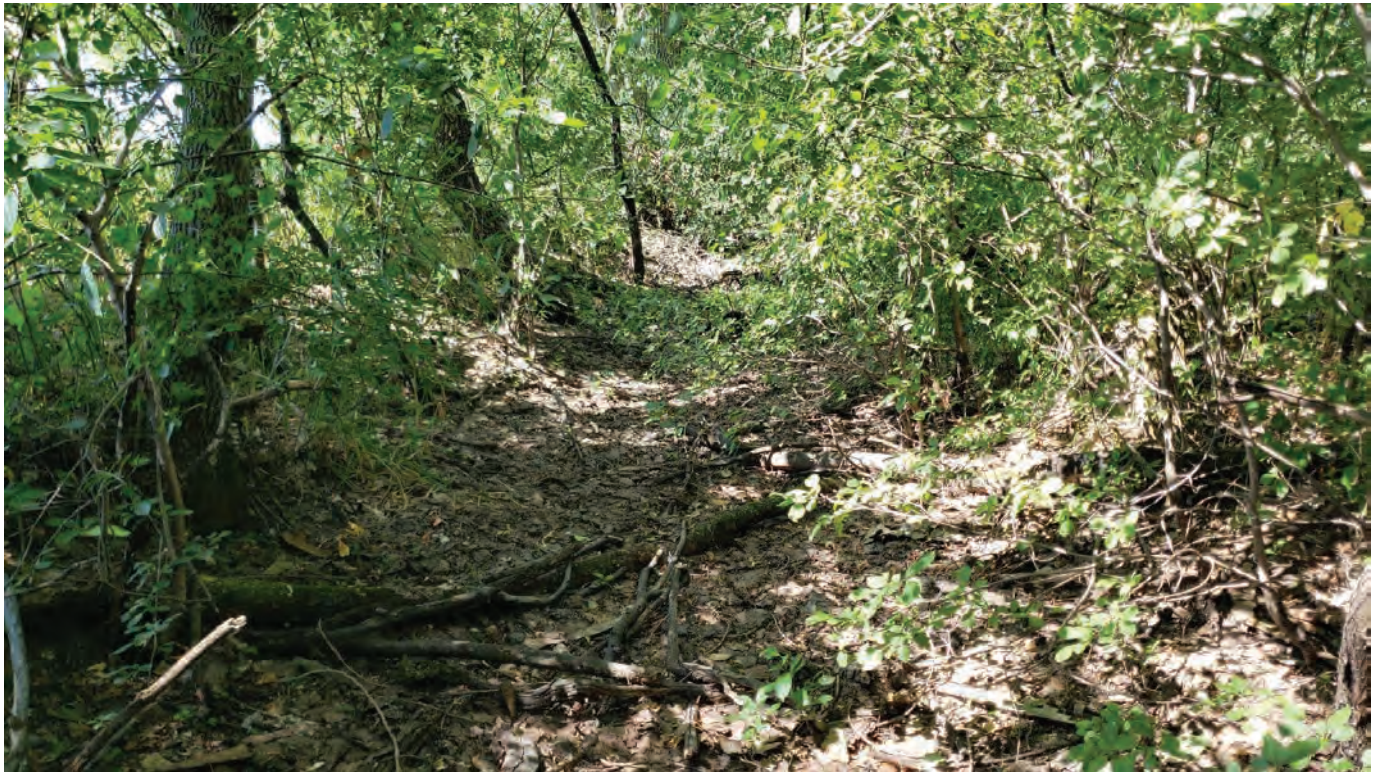
Upstream, looking west.

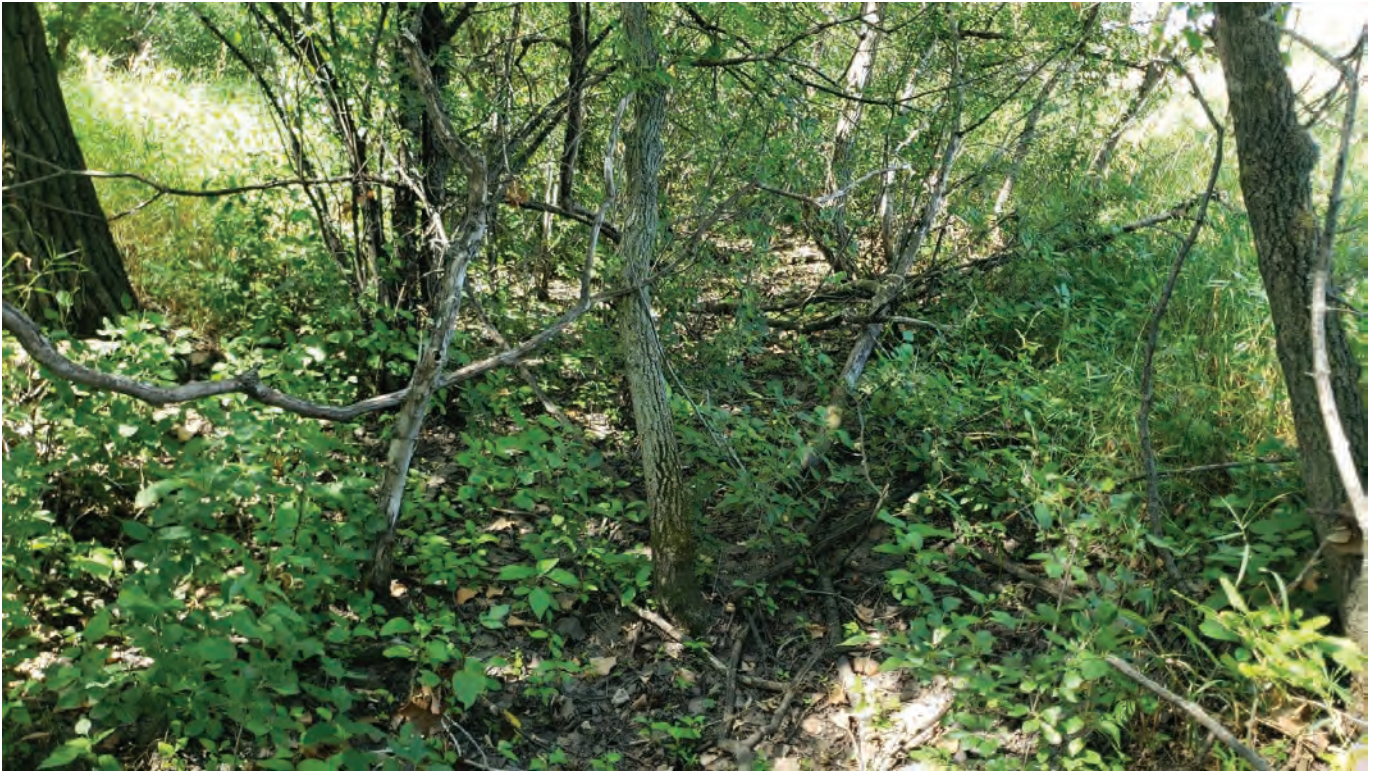
Upstream, looking west.

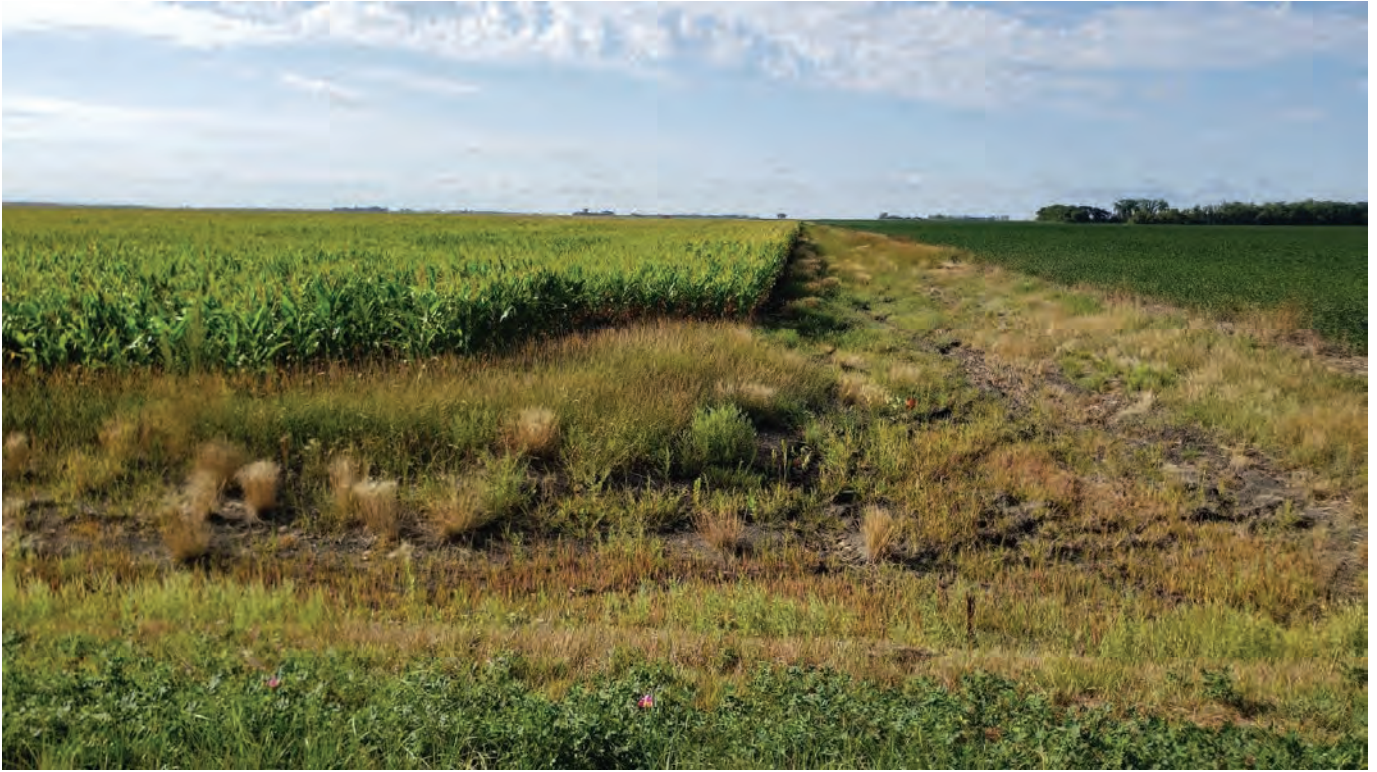
Upstream, looking southeast.

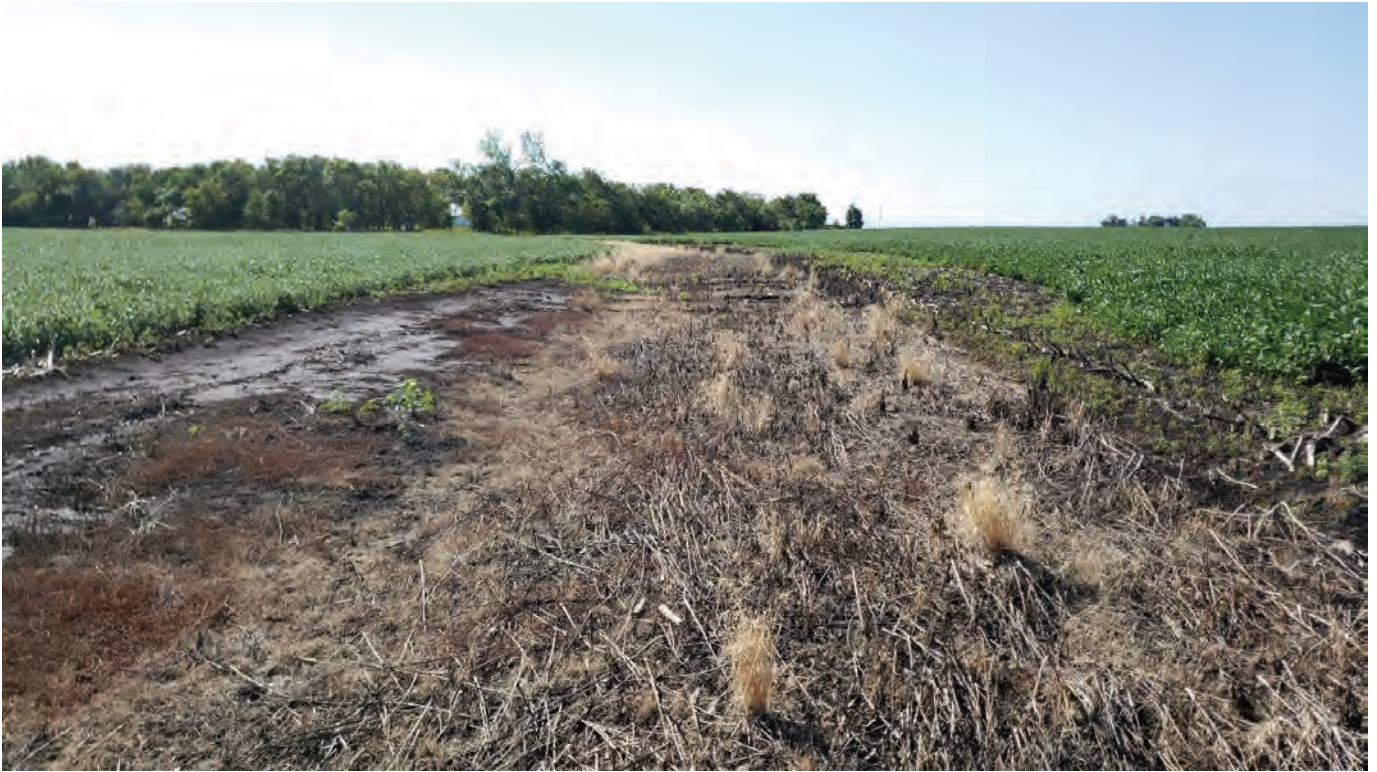
Downstream, looking southeast.

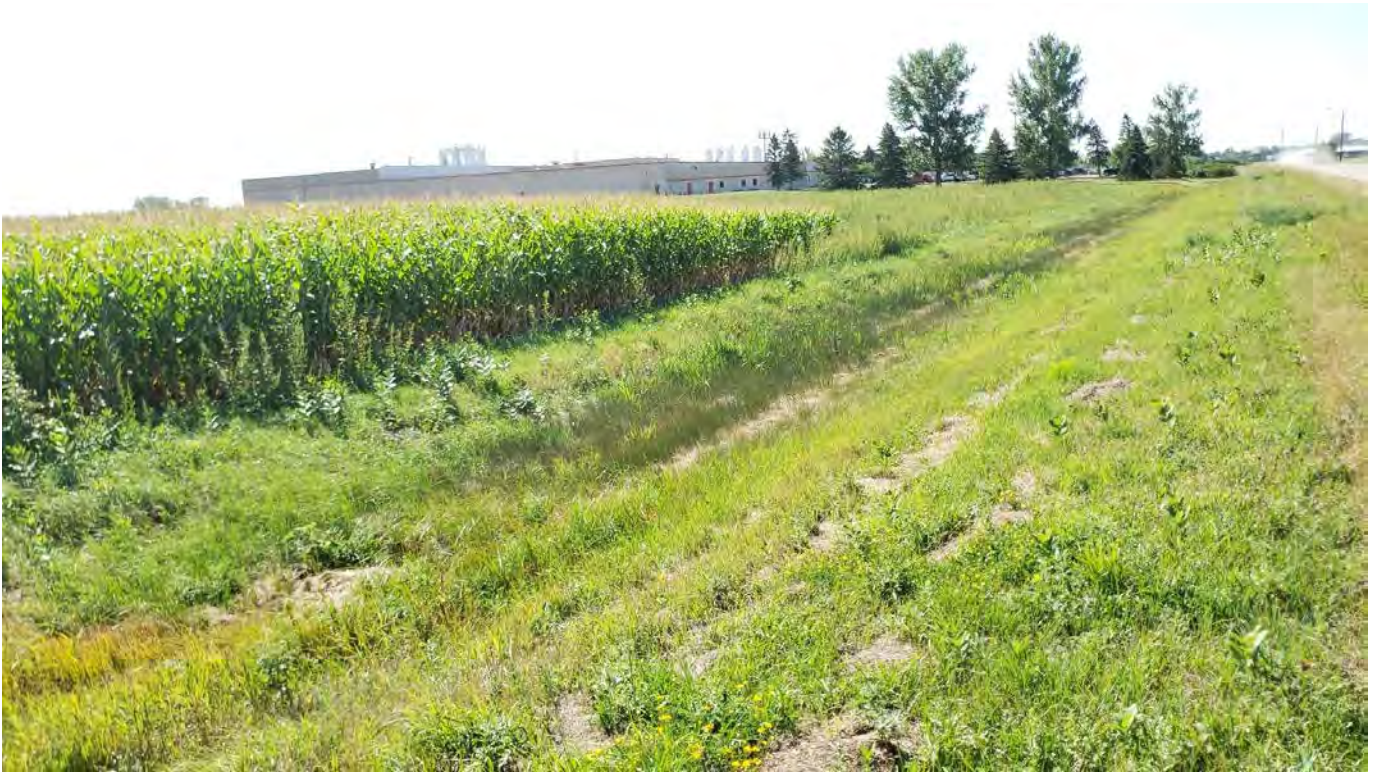
Downstream, looking southeast.
