## FEDERAL ENERGY REGULATORY COMMISSION FIELD INSPECTION REPORT

**Date** December 10 and 11, 2024

**Project** WBI Energy Transmission, Inc.  
Wahpeton Expansion Project  
Cass and Richland Counties, North Dakota  
Docket No.: CP22-466-000  
Authority: Section 7(c)

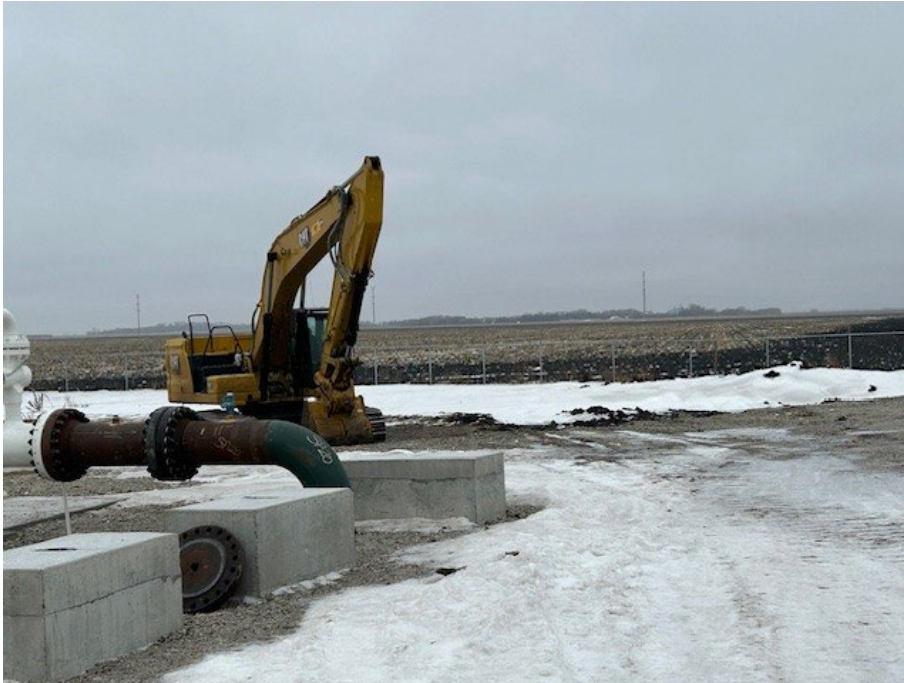
**Photo No.:** 1

**Comments:** Aboveground Facility, Valve #1 Site. Construction of the valve was complete, with painting planned for the spring of 2025. The adjacent ROW and temporary workspaces were restored and free of rutting, large rocks, and construction debris. The adjacent Wahpeton Station was mechanically complete. The site was stable, with no environmental concerns identified.

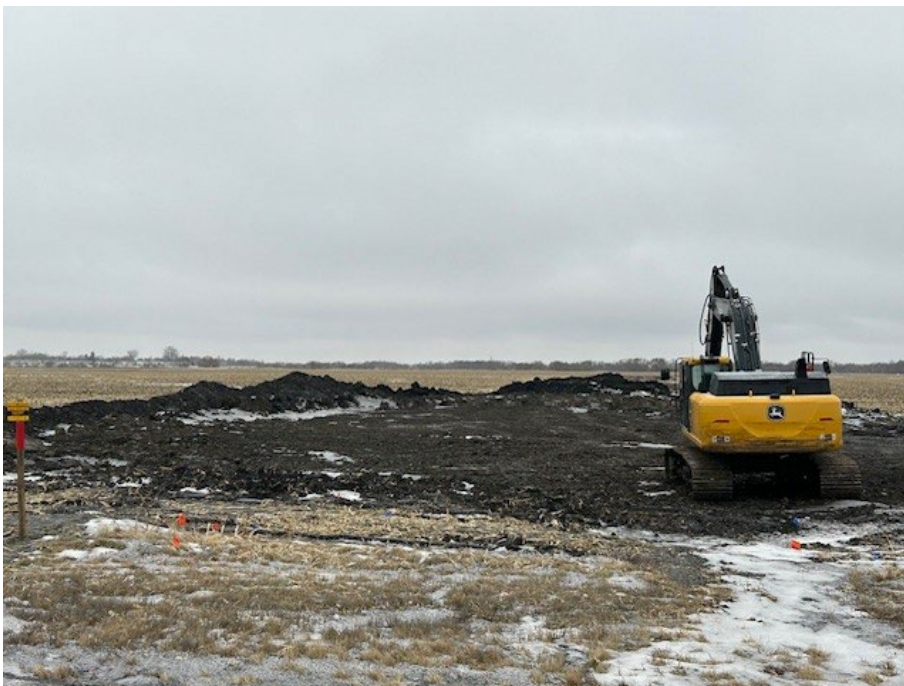
**Photo No.:** 2

**Comments:** Agricultural ROW. Final cleanup (equipment mat removal) and final grading were underway after the area was re-disturbed to address an anomaly. No environmental concerns were identified.

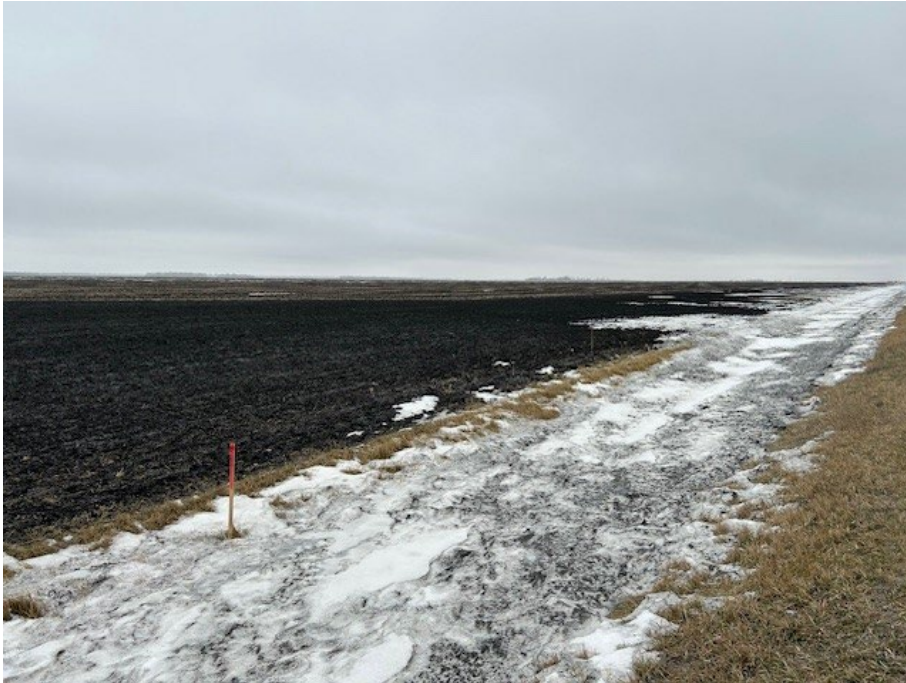
**Photo No.:** 3

**Comments:** Agricultural ROW. The ROW was restored, with no signs of rutting, large rocks, or construction debris. The site was stable, with no environmental concerns identified.

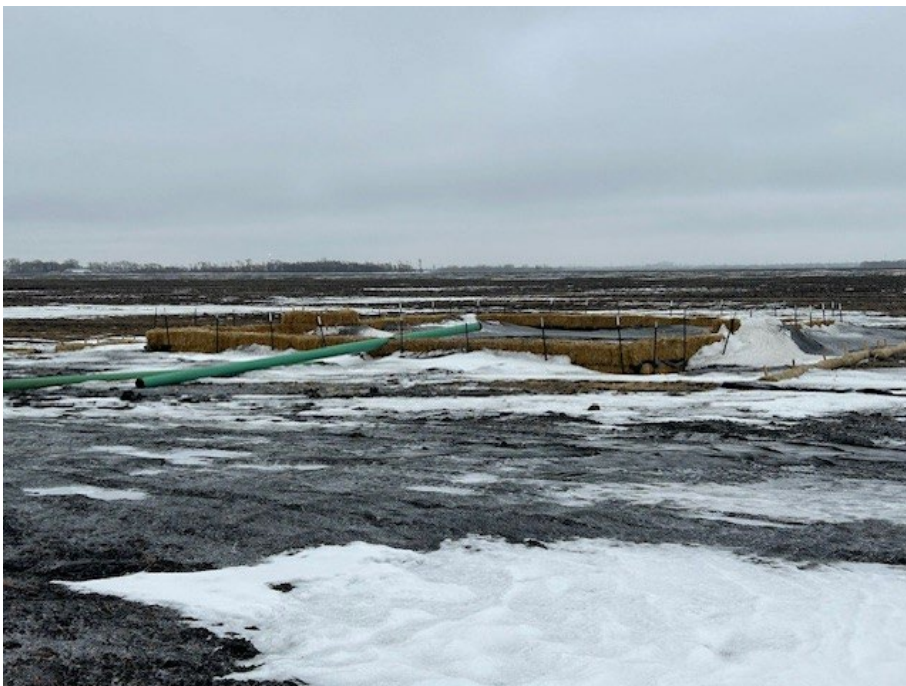
**Photo No.:** 4

**Comments:** Aboveground Facility, Valve #2 Site. The dewatering structure, used as part of last month's hydrostatic pressure testing, appeared to be adequately designed, with no evidence of sediment release outside of the approved workspace. Removal of the structure was planned for the following week. No environmental concerns were identified.

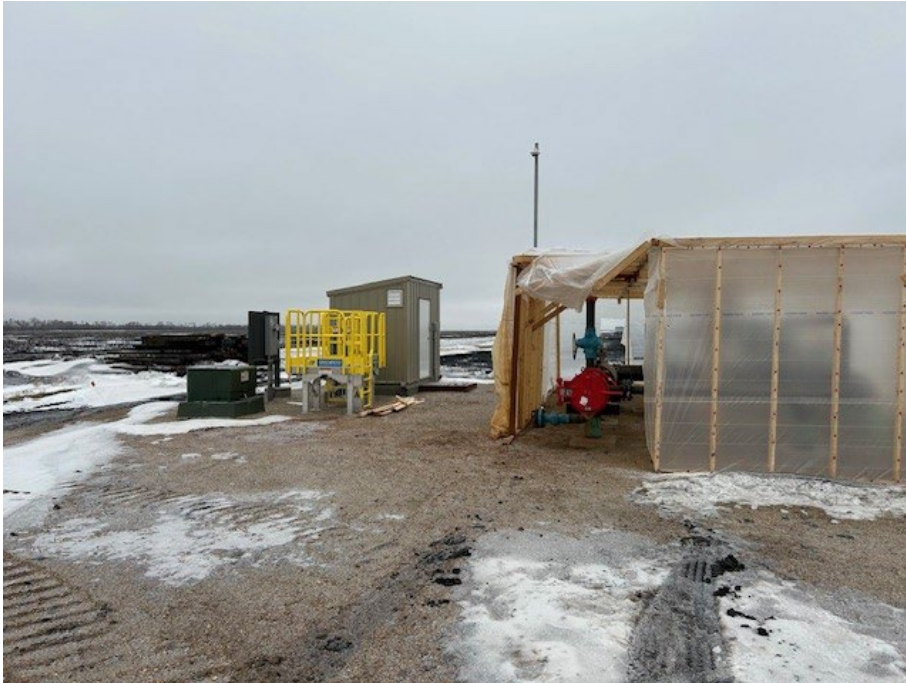
**Photo No.:** 5

**Comments:** Aboveground Facility, Valve #2 Site. Final cleanup and restoration within and around the site (i.e. pad construction, perimeter fence installation, valve settings and equipment painting) will be completed in the spring of 2025. The site was stable, with no environmental concerns identified.

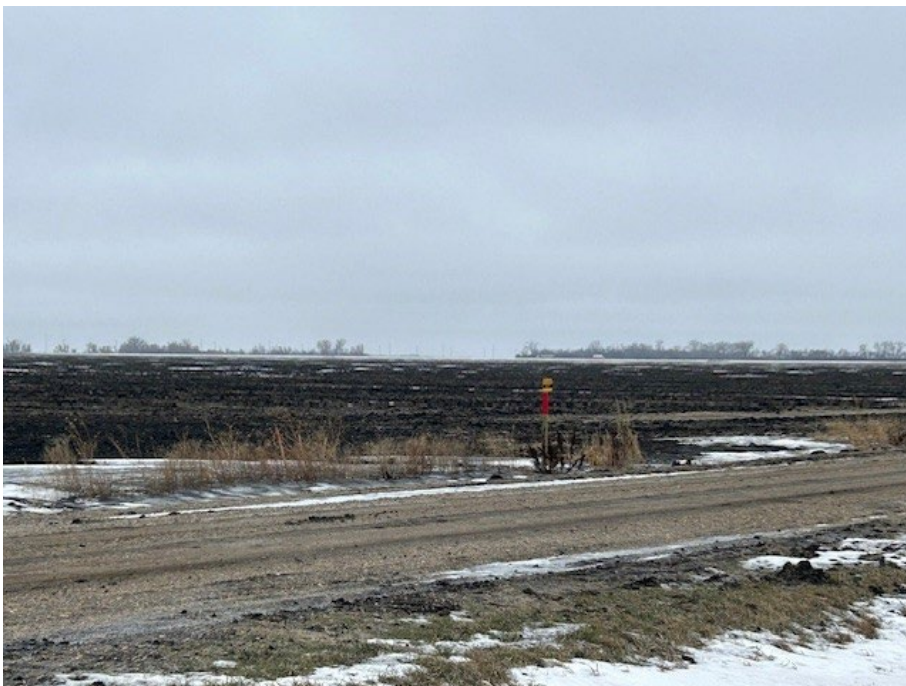
**Photo No.:** 6

**Comments:** Agricultural ROW, Bore #20 Site. The ROW and temporary workspaces were restored and free of rutting, large rocks, and construction debris. The site was stable, with no environmental concerns identified.

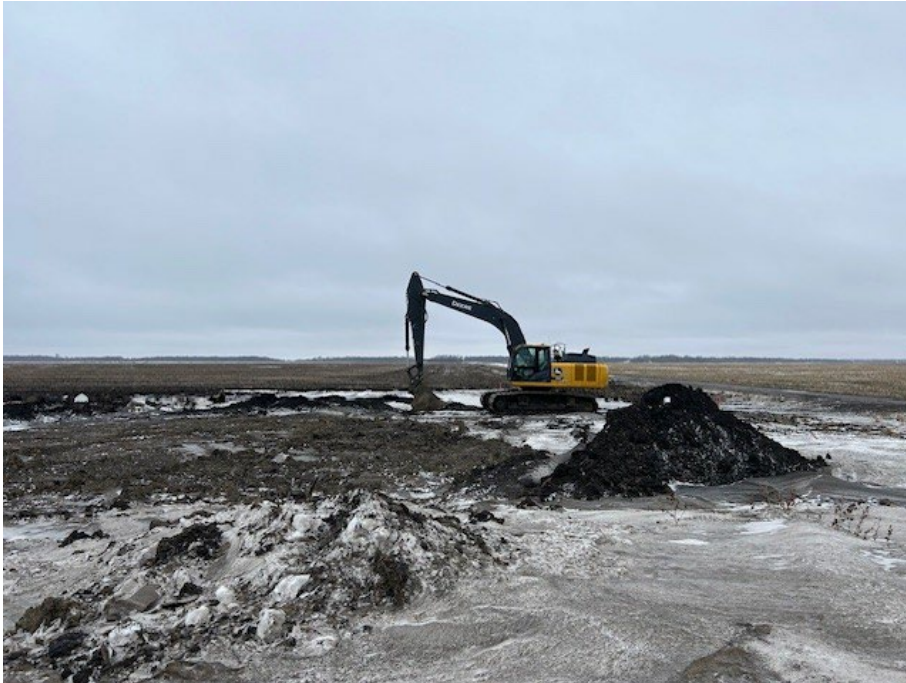
**Photo No.:** 7

**Comments:** Agricultural ROW. Final cleanup and final grading were underway after the area was re-disturbed to address an anomaly. ROW limits along active construction areas were marked with stakes and flagging. No environmental concerns were identified.

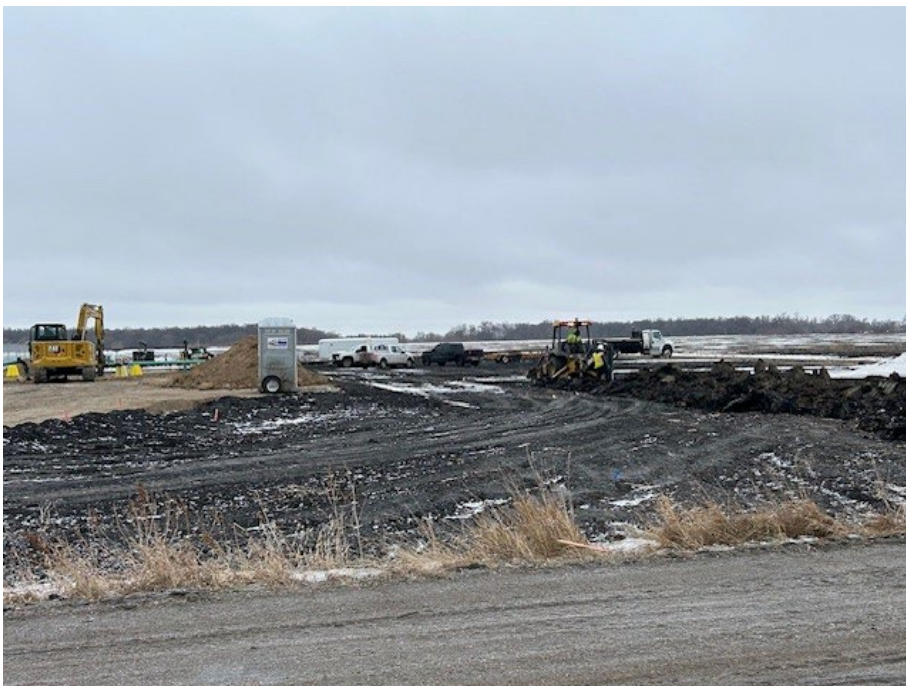
**Photo No.:** 8

**Comments:** Aboveground Facility, Valve #3 Site. Montanna-Dakota Utilities [MDU] (local gas delivery provider) was in the process of completing their tie-in. The access point to the public roadway was well maintained, with no tracked mud or debris was present on the road. No environmental concerns were identified.

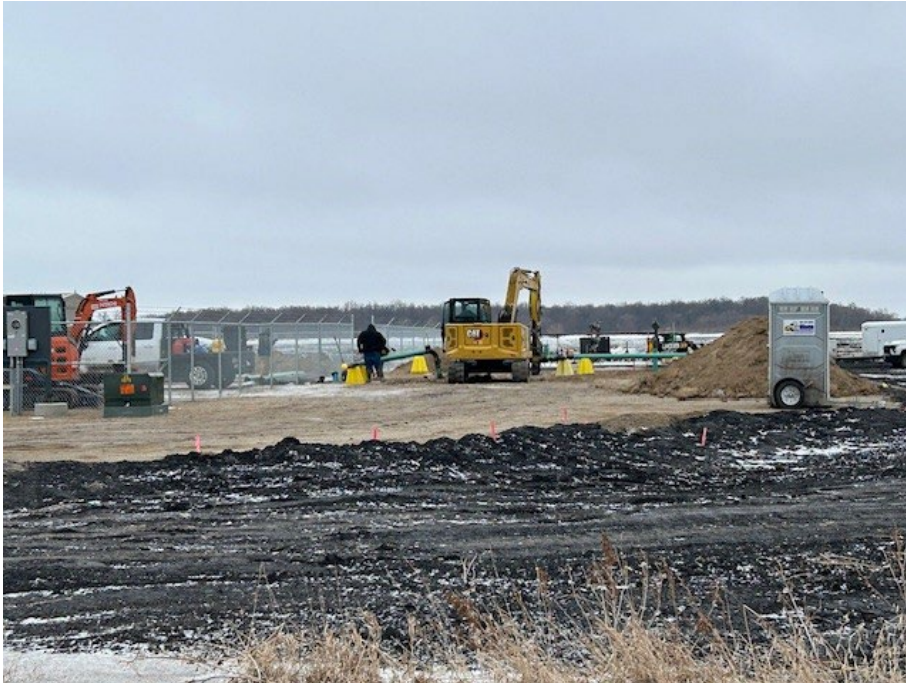
**Photo No.:** 9

**Comments:** Aboveground Facility, Valve #3 Site. WBI work at the valve site was complete. MDU was completing their tie-in. No environmental concerns were identified.

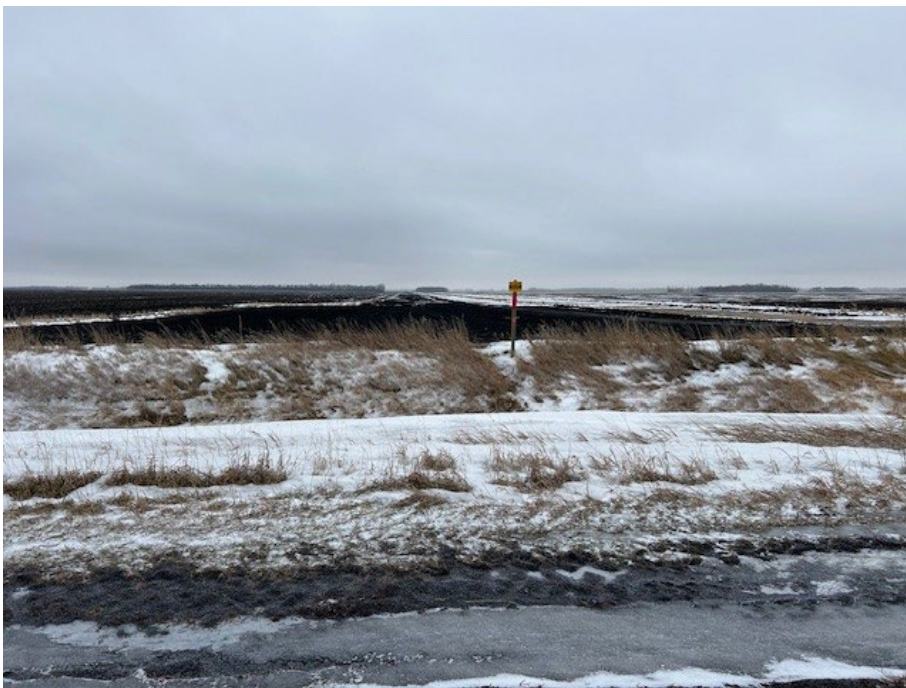
**Photo No.:** 10

**Comments:** Agricultural ROW, Bore # 36 Site. The temporary workspaces were restored, and free of rutting, large rocks, and construction debris. The site was stable, with no environmental concerns identified.

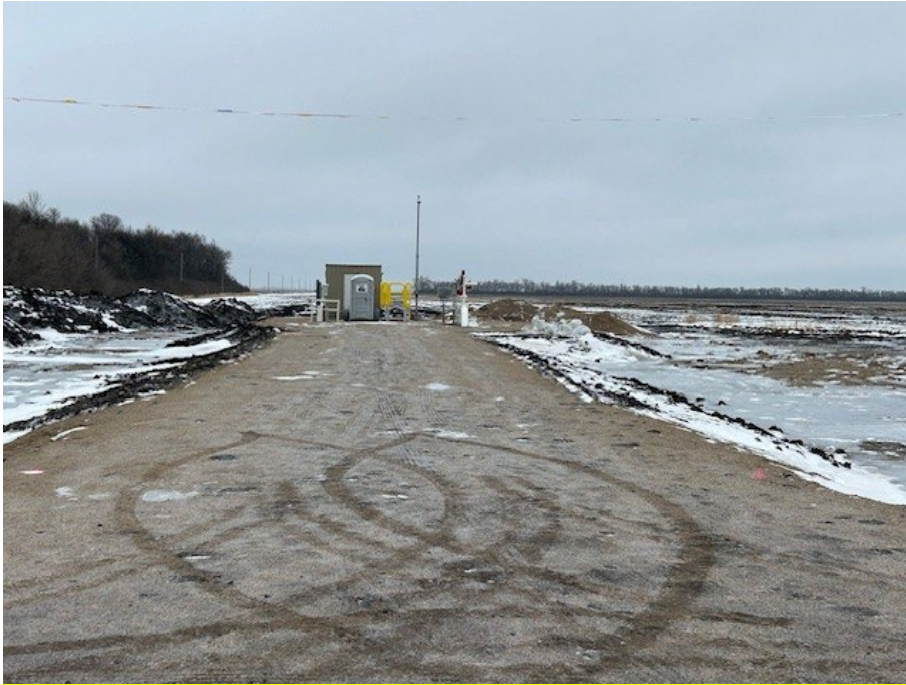
**Photo No.:** 11

**Comments:** Aboveground Facility, Valve #4 Site. WBI work at the valve site (i.e. painting and fencing) will be completed in the spring of 2025. The site was stable, with no environmental concerns identified.

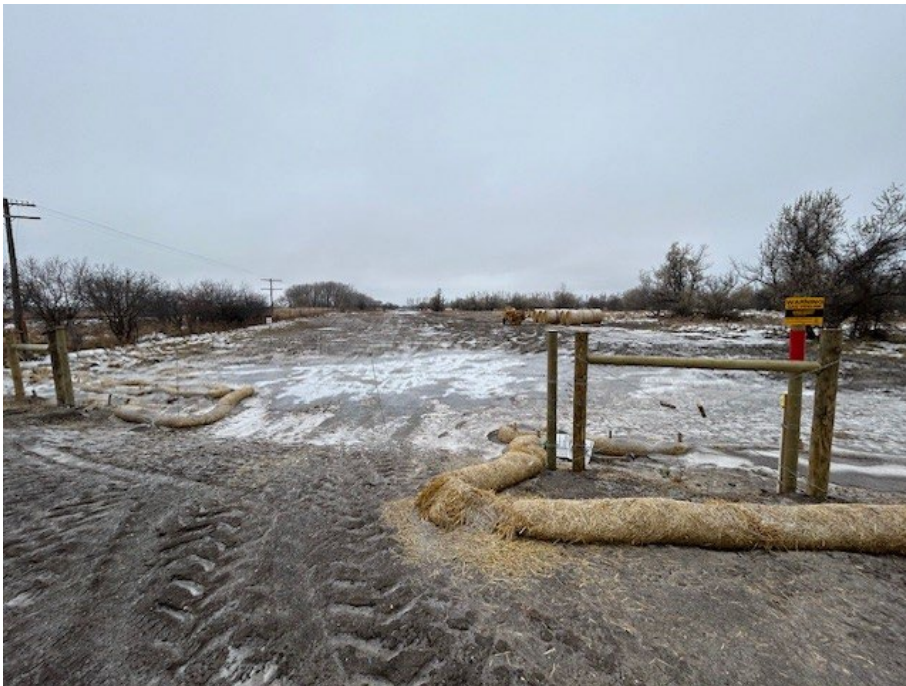
**Photo No.:** 12

**Comments:** Forested ROW, Wetland wria006e. Final cleanup and restoration were complete, and the ROW was seeded from MP 35.60 to MP 36.80; where construction had been delayed due to migratory bird restrictions. Resource identification signs and ECDs remained in place. No environmental concerns were observed.

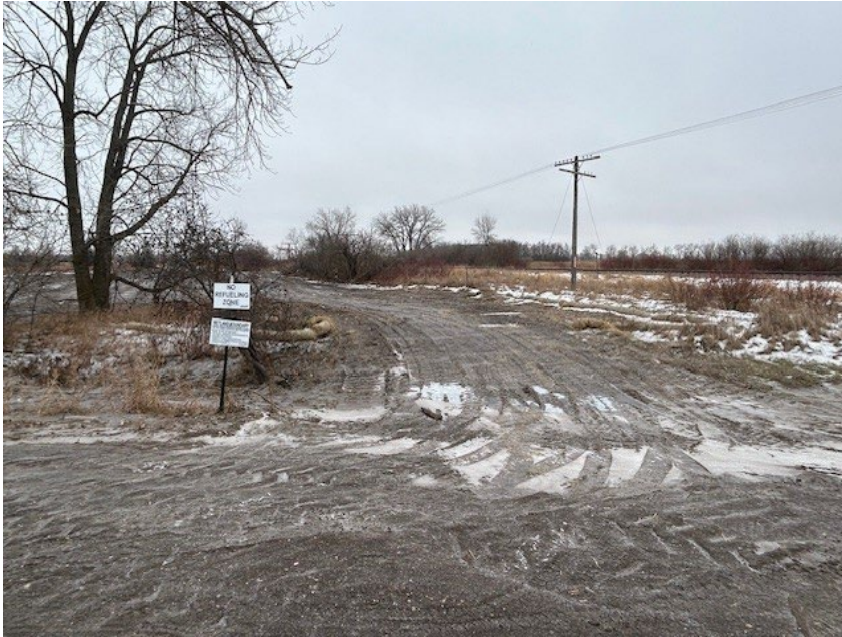
**Photo No.:** 13

**Comments:** Forested ROW, Final cleanup and restoration were complete, and the ROW was seeded from MP 35.60 to MP 36.80; where construction had been delayed due to migratory bird restrictions. ECDs remained in place. No environmental concerns were identified.

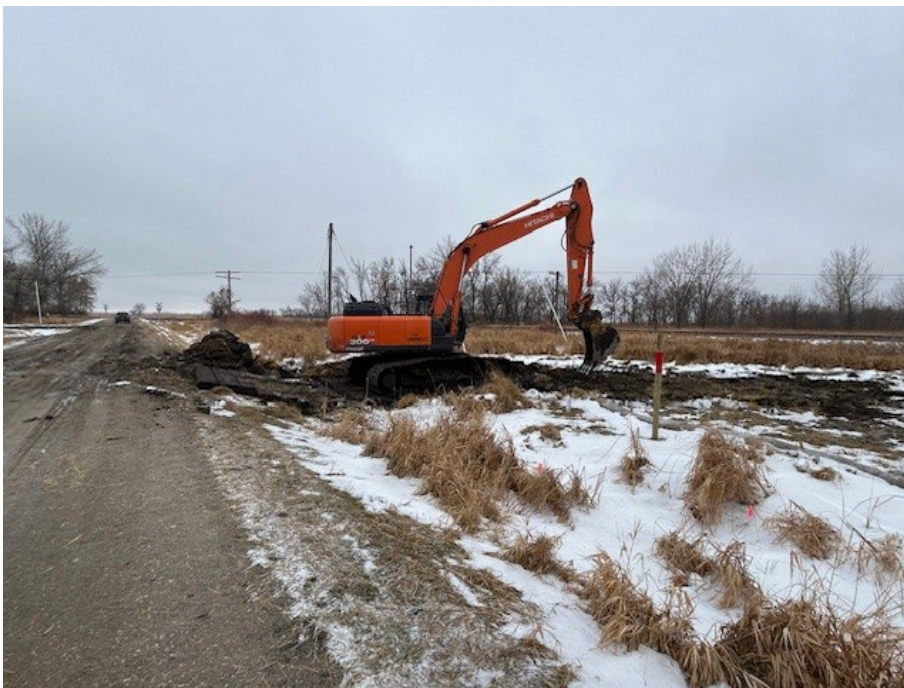
**Photo No.:** 14

**Comments:** Agricultural ROW. Final cleanup was underway after the area was re-disturbed to address an anomaly. Some tracking was present on the road, but would be cleaned up once the mat was removed from the ROW access, according to WBI. No environmental concerns were identified.

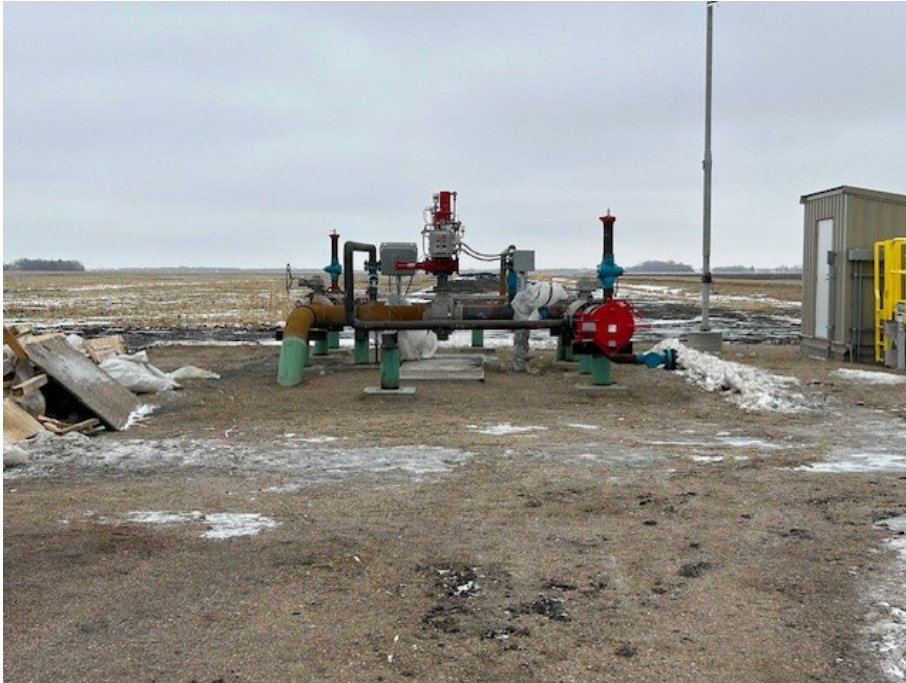
**Photo No.:** 15

**Comments:** Aboveground Facility, Valve #5 Site. The valve was mechanically complete; however, work at the valve site was delayed until spring 2025 and will include perimeter fence installation, valve settings and equipment painting, and final cleanup and restoration within and around the valve site. No off-ROW impacts or other environmental concerns were identified.

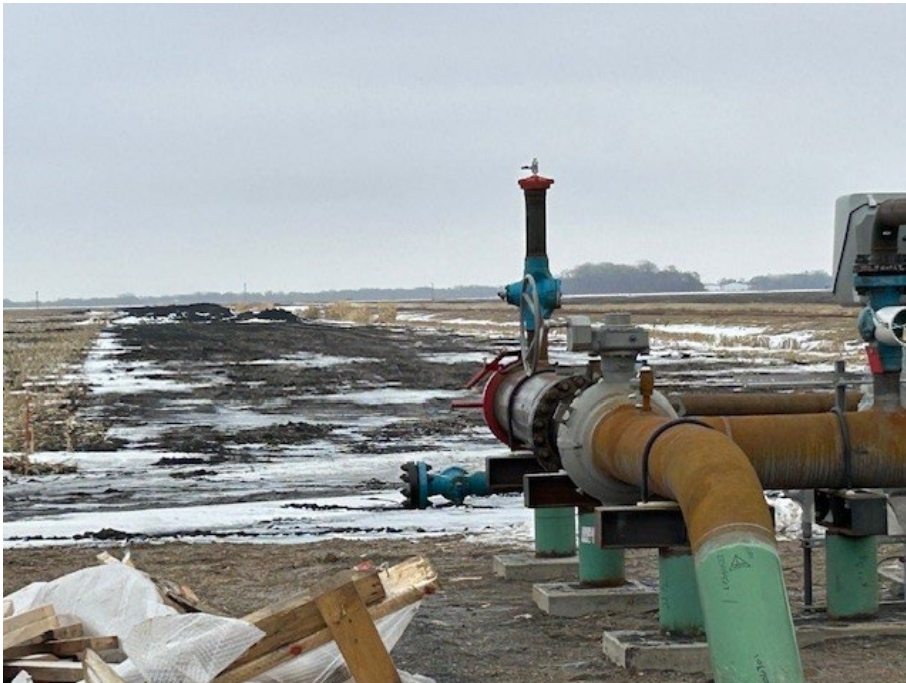
**Photo No.:** 16

**Comments:** Aboveground Facility, Valve #5 Site. Topsoil was restored along temporary workspaces. Wooden stakes remained in place to identify the workspace limits in areas of active construction. The site was stable, with no environmental concerns identified.

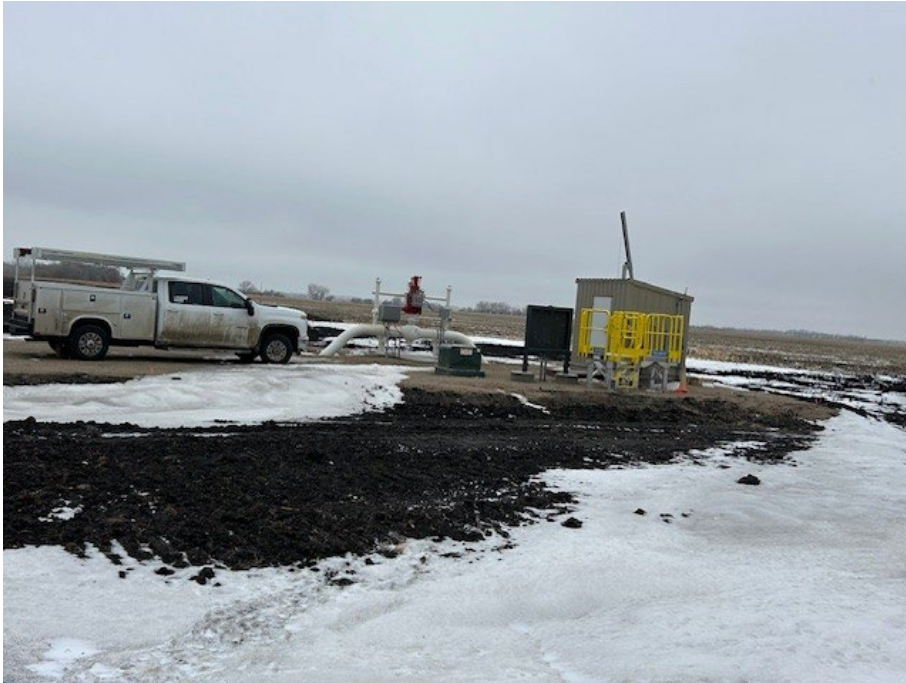
**Photo No.:** 17

**Comments:** Aboveground Facility, Valve #6 Site. The valve was mechanically complete, and only minor work remained, including perimeter fence installation and final restoration of adjacent temporary workspaces around the facility. Workspace limits in active construction areas remained well marked. The site was stable, with no environmental concerns identified.

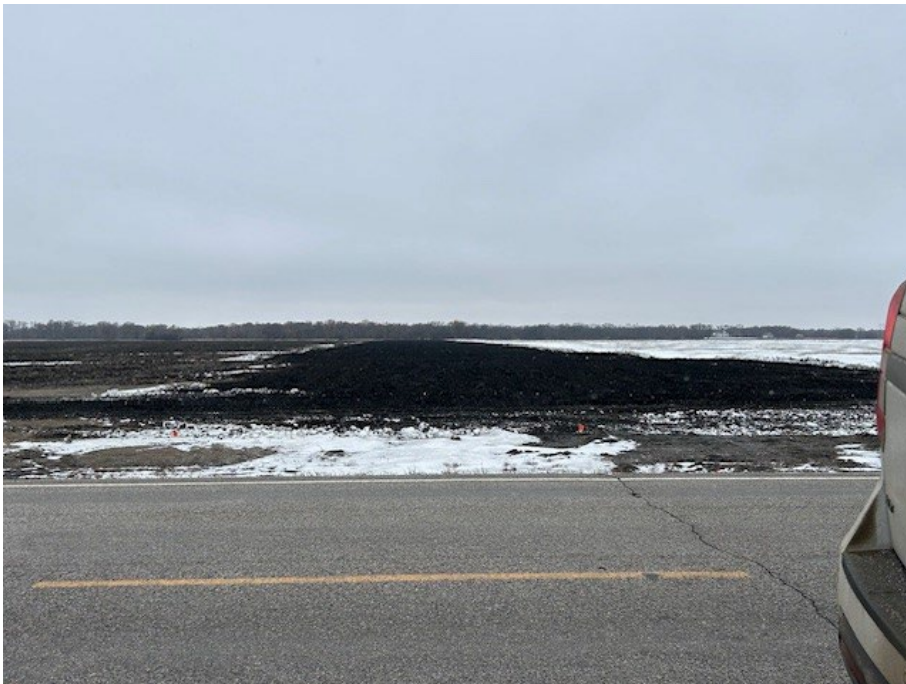
**Photo No.:** 18

**Comments:** Agricultural ROW. East of the Wild Rice River HDD site, the ROW was restored and stable. No environmental concerns were identified.

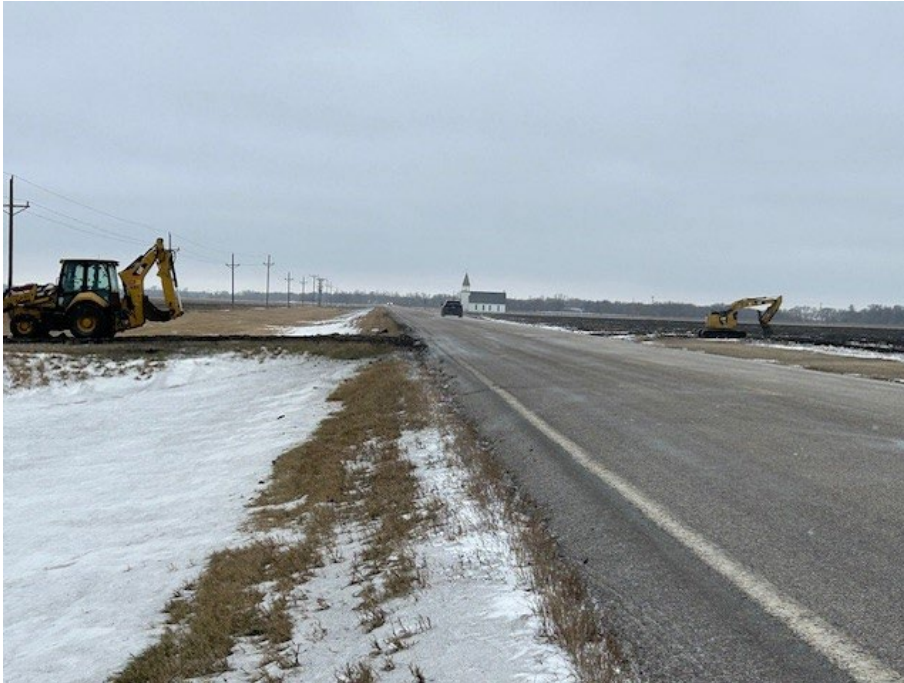
**Photo No.:** 19

**Comments:** Agricultural ROW, Final cleanup and restoration were underway but incomplete along an approximately 0.7-mile-long portion of the ROW between MP 51.30 and MP 51.92. No off-ROW impacts or environmental concerns were identified.

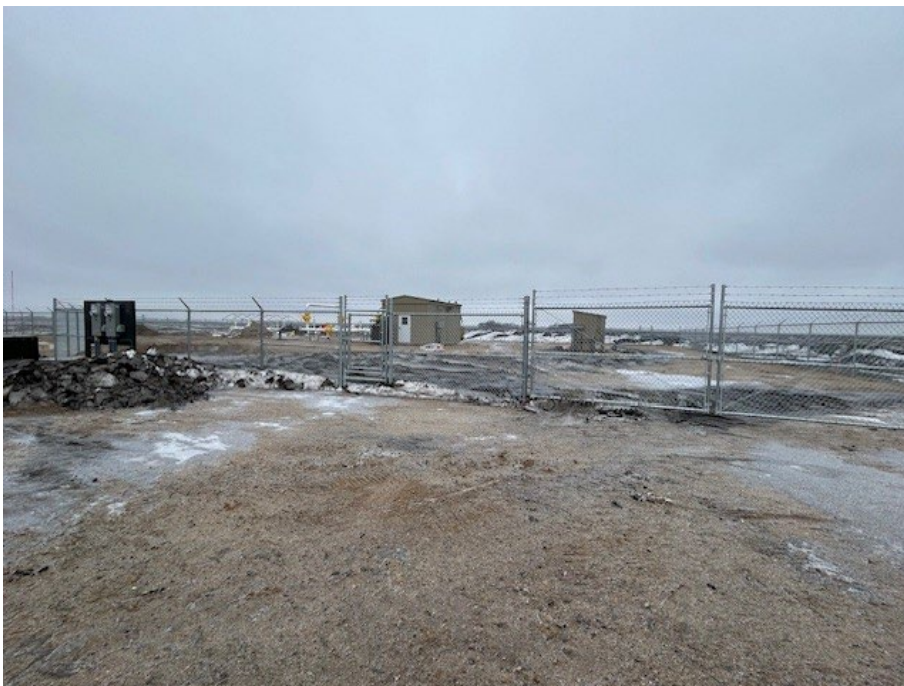
**Photo No.:** 20

**Comments:** Aboveground Facility, Valve #7 Site (Wahpeton Border Station). The valve was mechanically complete, and only minor work remained, including pad completion, painting, and final restoration of temporary workspaces. Construction along the east side of the valve site was associated with the MDU tie-in. The construction access point was well maintained, and the public road was free of tracked mud and construction debris. The site was stable, with no environmental concerns identified.
