Re: WBI Energy Transmission, Inc. Docket Nos. CP20-52-000 and CP20-52-001 North Bakken Expansion Project Weekly Status Report No. 23

WBI Energy Transmission, Inc. North Bakken Expansion Project Status Report No. 23 FERC Docket Nos. CP20-52-000 CP20-52-001

Reporting Period: November 1, 2021 through November 7, 2021

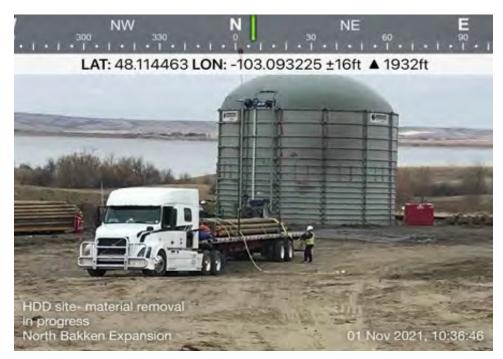
Location: South Spread HDD bore site.

Notes: Removal of equipment from the South Spread HDD bore site.

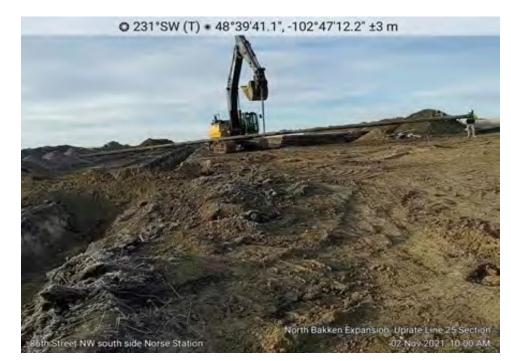
Location: Southeast of Norse Transfer Station.

Notes: The removal of 8-inch Line Section 25 pipeline that was replaced with new 8inch pipeline. The old pipeline will be cut into 40-foot sections and removed.

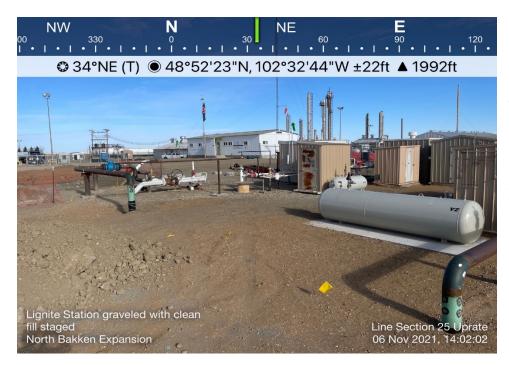
Location: Lignite Plant Receipt Station

Notes: Stockpile of fill dirt to replace removed contaminated soil.
