Re: WBI Energy Transmission, Inc.
Docket Nos. CP20-52-000 and CP20-52-001
North Bakken Expansion Project
Weekly Status Report No. 24

WBI Energy Transmission, Inc.
North Bakken Expansion Project Status Report No. 24
FERC Docket Nos. CP20-52-000
CP20-52-001

Reporting Period: November 8, 2021 through November 14, 2021

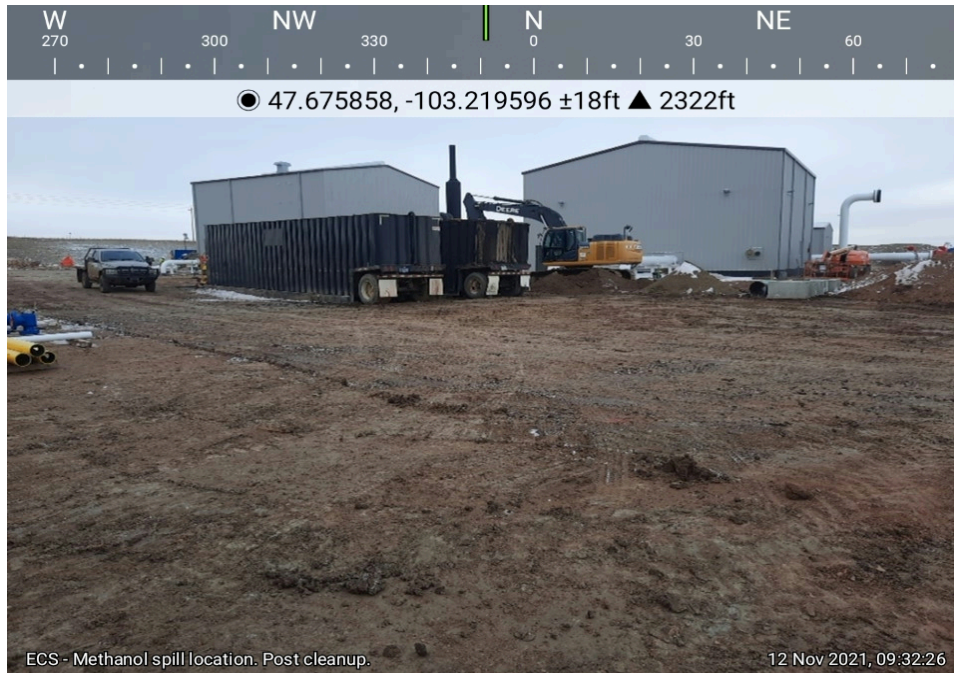
Location: Elkhorn
Creek Compressor
Station

- Completed foundation and concrete activities.
- Continued installing piping, structural supports and equipment.
- On November 11, 2021, approximately 1,260 gallons of water containing 24-gallons of methanol was spilled while stabilizing water levels between two storage frac tanks. Water was being held on site for hydrostatic testing purposes. WBI Energy quickly implemented measures identified in the Spill Prevention, Control and Countermeasure (SPCC) Plan to contain the fluid and stockpile affected soil from an area covering approximately 60 feet by 60 feet at a depth of 2-4 inches; the soil was stockpiled on plastic sheeting within the station for later disposal at an approved facility. Given the low concentration of methanol, the soil was not considered hazardous. No cultural or sensitive resources were impacted. Requisite agency and internal spill reports were filed.

Notes: Spilled
methanol-water
solution location after
clean-up efforts.
