Re: WBI Energy Transmission, Inc.
Docket Nos. CP20-52-000 and CP20-52-001
North Bakken Expansion Project
Status Report No. 36

WBI Energy Transmission, Inc.
North Bakken Expansion Project Status Report No. 36
FERC Docket Nos. CP20-52-000
CP20-52-001

Reporting Period: March 1, 2022 through March 31, 2022

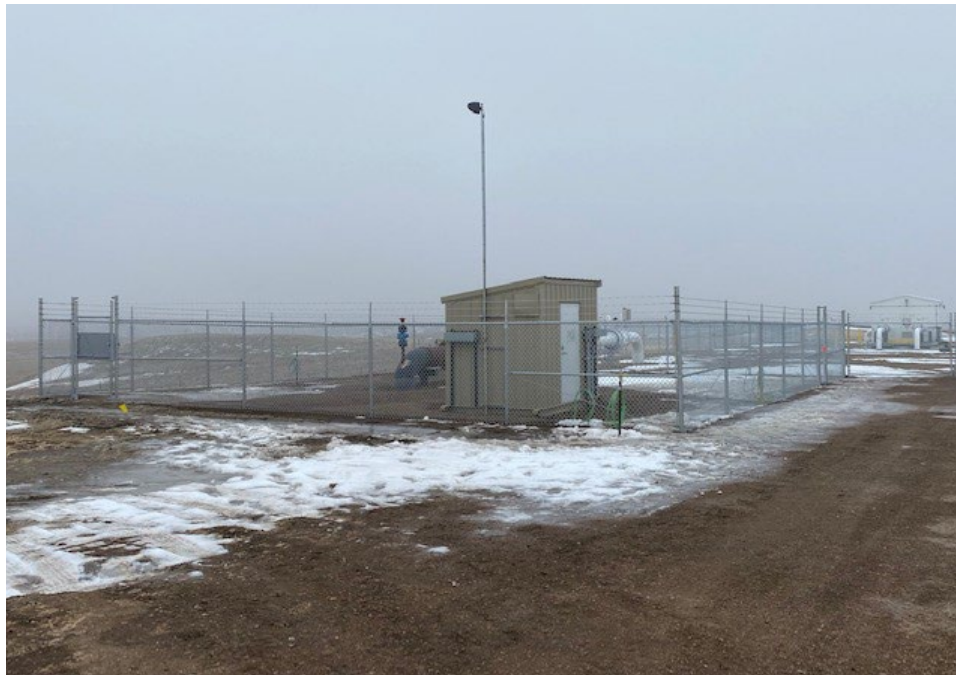
Location: Northern Border Interconnect

Work Completed during Reporting Period:				
<ul style="list-style-type: none"> Completed the installation of a security fence around WBI Energy's meter station located adjacent to Northern Border's interconnect facility. 				
Activity	Total % Completed This Period	% of Total Job Completed	Comments	
Site Preparation		100%		
Facility Installation		100%		
Cleanup	0%	99%	1/	
1/ Fifty feet of the approach from the county highway will be asphalted in Spring 2022 per the county highway requirements.				
Work Planned for next Reporting Period and Schedule Changes:				
<ul style="list-style-type: none"> No work is planned for the next reporting period. 				
Problem Areas, Corrective Actions and Effectiveness:				
<ul style="list-style-type: none"> No problem areas were identified during reporting period. 				
Non-Compliance Issues, Corrective Actions and Effectiveness:				
<ul style="list-style-type: none"> No non-compliance issues were identified during reporting period.
