Re: WBI Energy Transmission, Inc.
Docket Nos. CP20-52-000 and CP20-52-001
North Bakken Expansion Project
Status Report No. 42

WBI Energy Transmission, Inc.
North Bakken Expansion Project Status Report No. 42
FERC Docket Nos. CP20-52-000
CP20-52-001

Reporting Period: June 20, 2022 through June 26, 2022

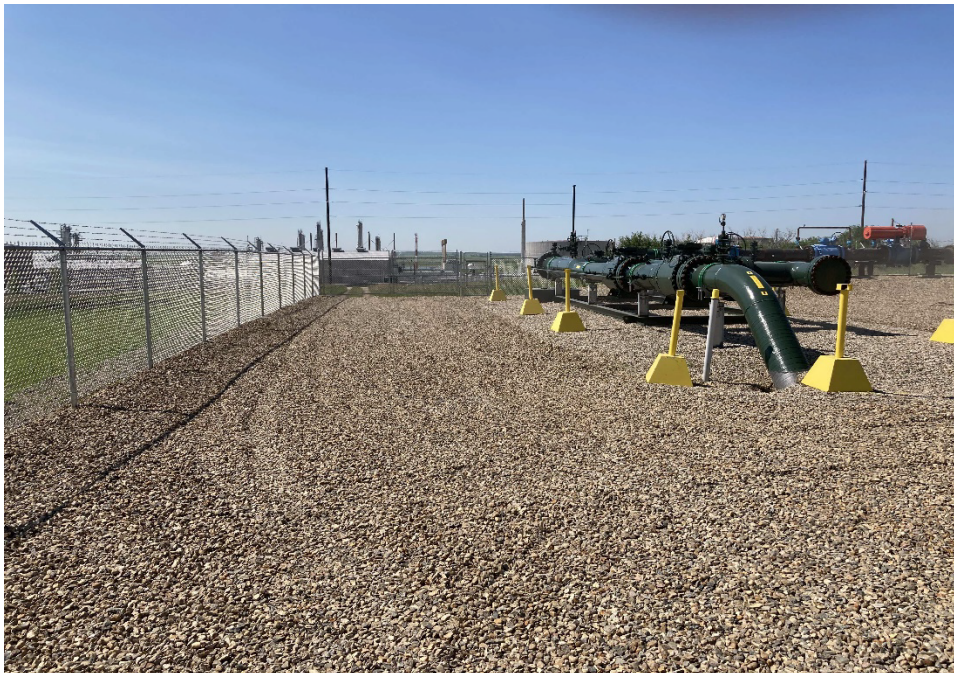
Location: Tioga Plant Receipt Station

Work Completed during Reporting Period				
<ul style="list-style-type: none"> Continued the installation of the security fence and spreading gravel. 				
Activity	Total % Completed This Period	% of Total Job Completed	Comments	
Site Preparation		100%		
Facility Installation		100%		
Cleanup	0%	99%		
Work Planned for next Reporting Period and Schedule Changes:				
<ul style="list-style-type: none"> Complete the installation of the security fence and painting station piping. 				
Problem Areas, Corrective Actions and Effectiveness:				
<ul style="list-style-type: none"> No problem areas were identified during reporting period. 				
Non-Compliance Issues, Corrective Actions and Effectiveness:				
<ul style="list-style-type: none"> No non-compliance issues were identified during reporting period. 				
Non-Compliance Issues from Federal, State or Local Permitting Agencies and Response:				
<ul style="list-style-type: none"> No non-compliance issues were identified during reporting period. Copies included: Not applicable
