## APPENDIX 4D CLASS III HISTORIC STRUCTURES SURVEY REPORT

WBI Energy Transmission, Inc. Wahpeton Expansion Project, Cass and Richland Counties, North Dakota

28 February 2022 Project No.: 0611161

## CLASS III HISTORIC ARCHITECURAL SURVEY

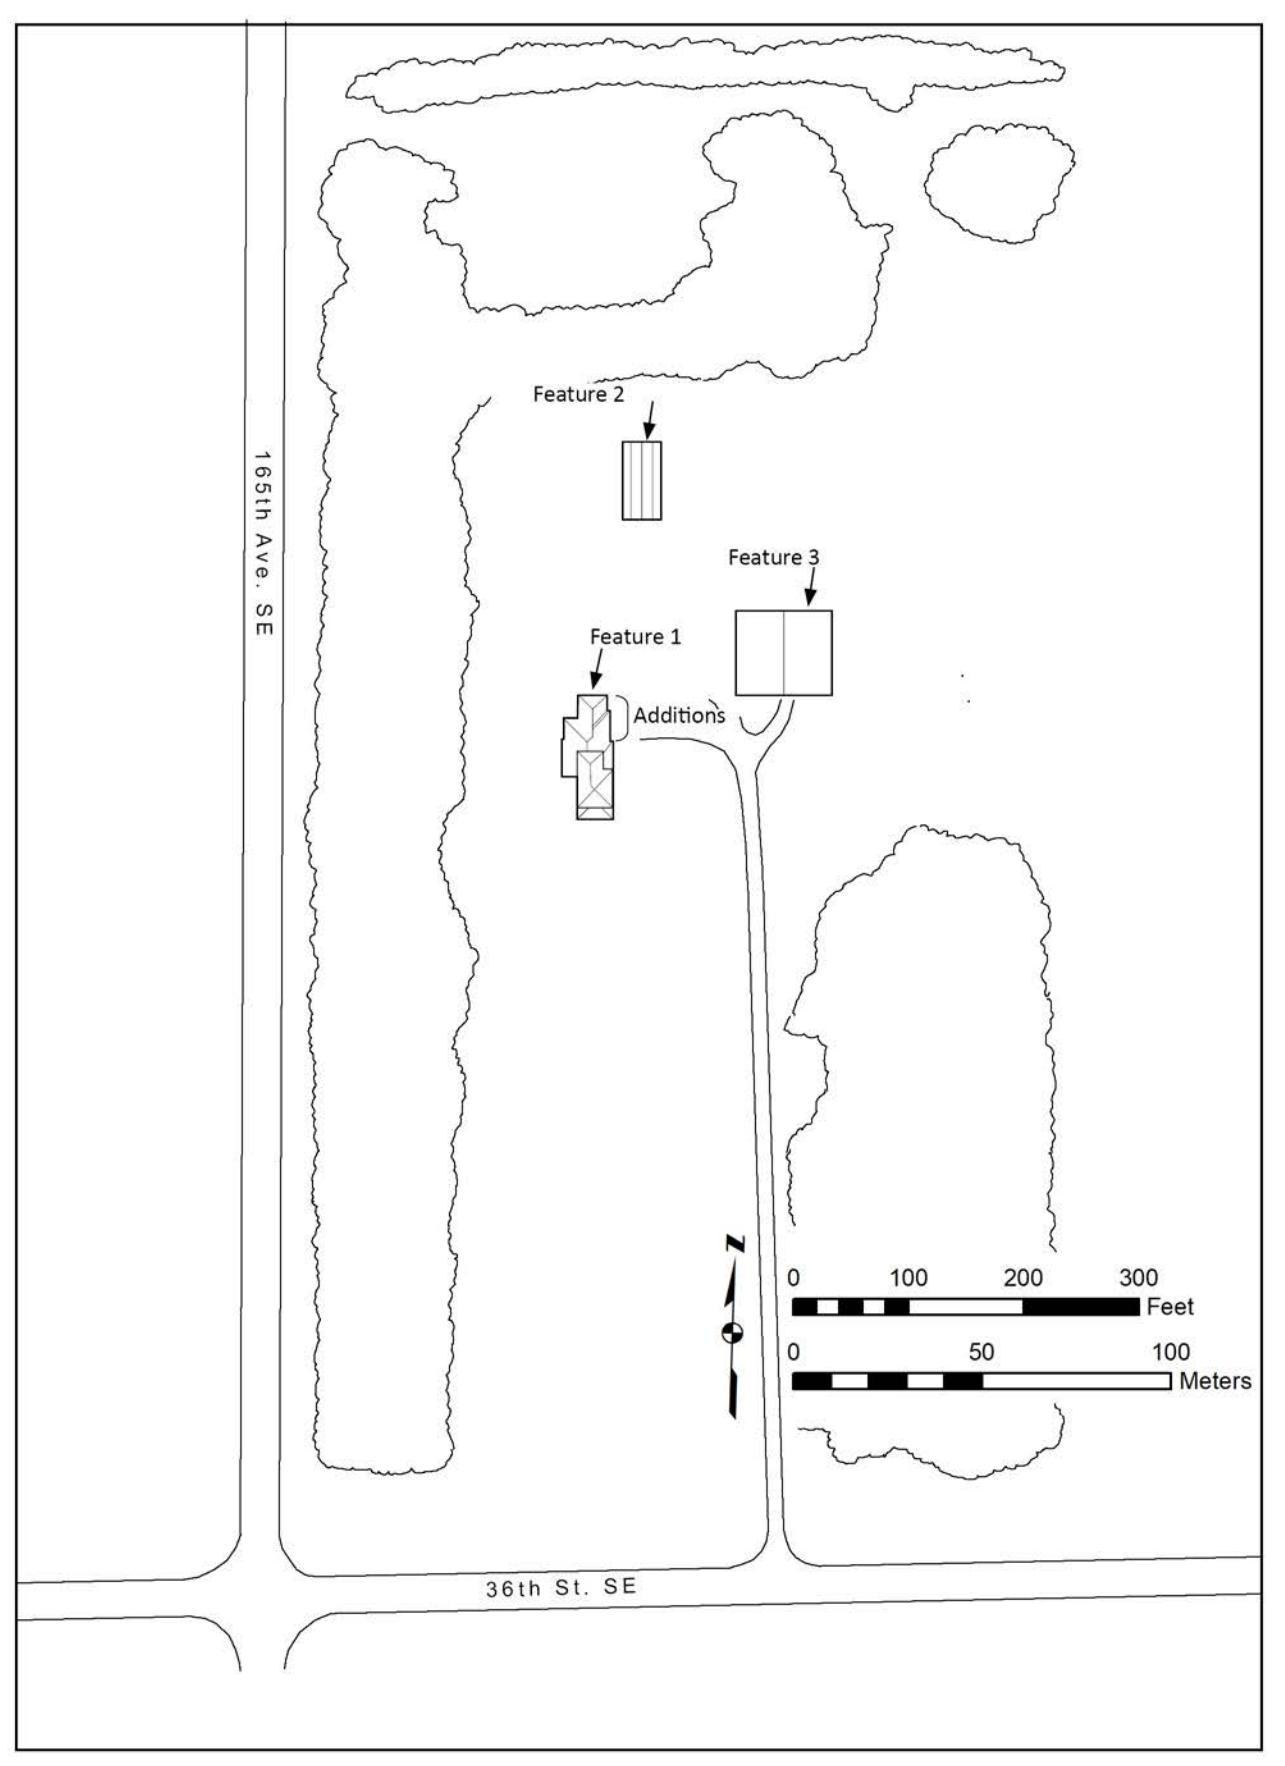
Figure 1. 32CS5119, sketch map.

32CS5119 was previously recorded in 2012 by Lorna Meidinger, who provided information from a 1980s draft nomination form. Meidinger recorded the dwelling (Feature 1) as a circa 1900–1915 American Foursquare, two-and-a-half-story, wood frame structure, with a hipped roof and hipped dormers and a concrete foundation (Appendix B, Figure 2). She noted double-hung, two-over-two glass windows, as well as two brick chimneys. A previously screened full-width porch spanned the length of the façade, with a hipped roof supported by columns. Feature 2 was recorded as a circa 1900–1915 two-story barn with a gambrel roof with two large vents extending up from the roof peak, and small windows along the side and a large sliding door for the main entrance. Immediately above the large sliding door was a smaller sliding door; the opening to the hayloft is flanked by windows and appears to be filled with clapboard siding matching the rest of the barn's cladding.

ERM visited the site in 2021 and noted that Features 1 and 2 were built prior to 1893, based on historic atlas research. ERM also observed that Feature 1 includes modifications and additions, such as a rear attached garage and cascading hipped-roof sections. The major additions were constructed in 1980, and have drastically altered the original design and massing of the house by extending the northern elevation on both the first and second stories (Cass County Director of Tax Equalization 2021). ERM also observed that the section of the porch that wraps around from the south elevation to the west elevation was constructed sometime after 1980, at which time details of the original front porch were changed including the addition of a modern balustrade (Meidinger 2012). Both Features 1 and 2 are in good condition.

Feature 3 was not previously recorded, but is a large shed located slightly to the northeast of Feature 1. It has a front-gable roof and with a shed-roof extension, and the entire building is clad in ribbed metal. It was constructed in 1970, and has two large sliding, metal doors (Cass County Director of Tax Equalization 2021). The rest of the structure is heavily obscured by foliage. Feature 3 is in good condition.

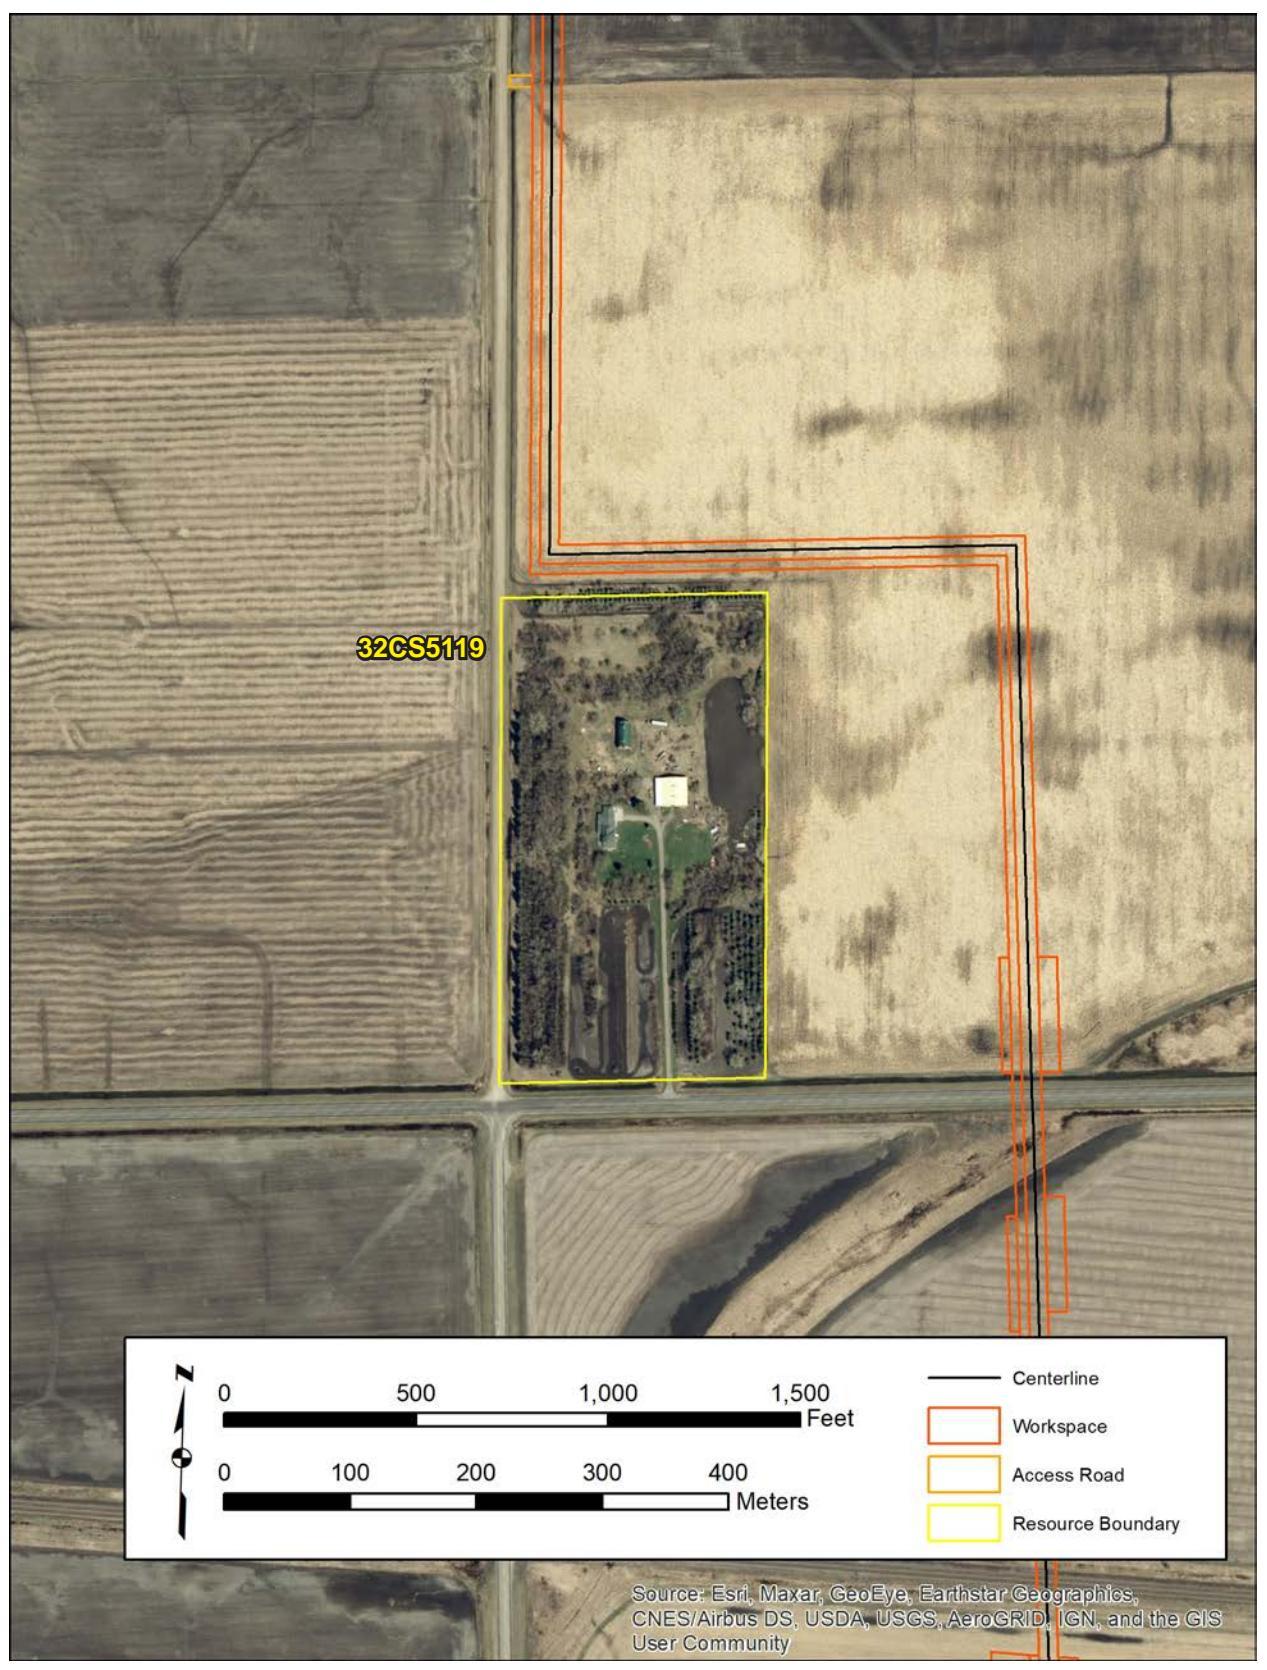
Figure 3. 32CS5119, proposed NRHP boundary.

*NRHP Assessment:* Meidinger recorded the resource's NRHP eligibility as unevaluated and noted that more current information was needed to make a determination. Based on ERM's current survey, 32CS5119 includes a modified American Foursquare dwelling and two modified outbuildings. The setting and feeling of the farmstead remains similar to that of the original landscape, especially since the roughly contemporary barn and windbreak still frames the main feature. Although the resource represents a typical example of the American Foursquare style, the multiple additions and modifications, along with the extensive use of replacement materials, have greatly impacted the resource's integrity of design, materials, workmanship, and feeling. The sequence of rear additions has vastly increased the scale of the dwelling, and have yielded unbalanced massing that projects away from the neat cube of the original American Foursquare footprint. Although an effort was made to incorporate materials and design elements like dormers that echo the original block, the overall effect is a dwelling that no longer captures

the essence of the American Foursquare form. Due to the loss of integrity, ERM recommends 32CS5119 ineligible under NRHP Criterion C. Additionally, the historic research carried out for this Project did not identify any significant events associated with his resource. Because of the architectural changes to the dwelling and the addition of a more recent outbuilding, the resource does not serve as a good example of an agricultural property from the region's early history. Thus, ERM recommends 32CS5119 not eligible for the NRHP under Criterion A. Further deed research is needed as a basis for evaluating the resource's NRHP eligibility under Criterion B.

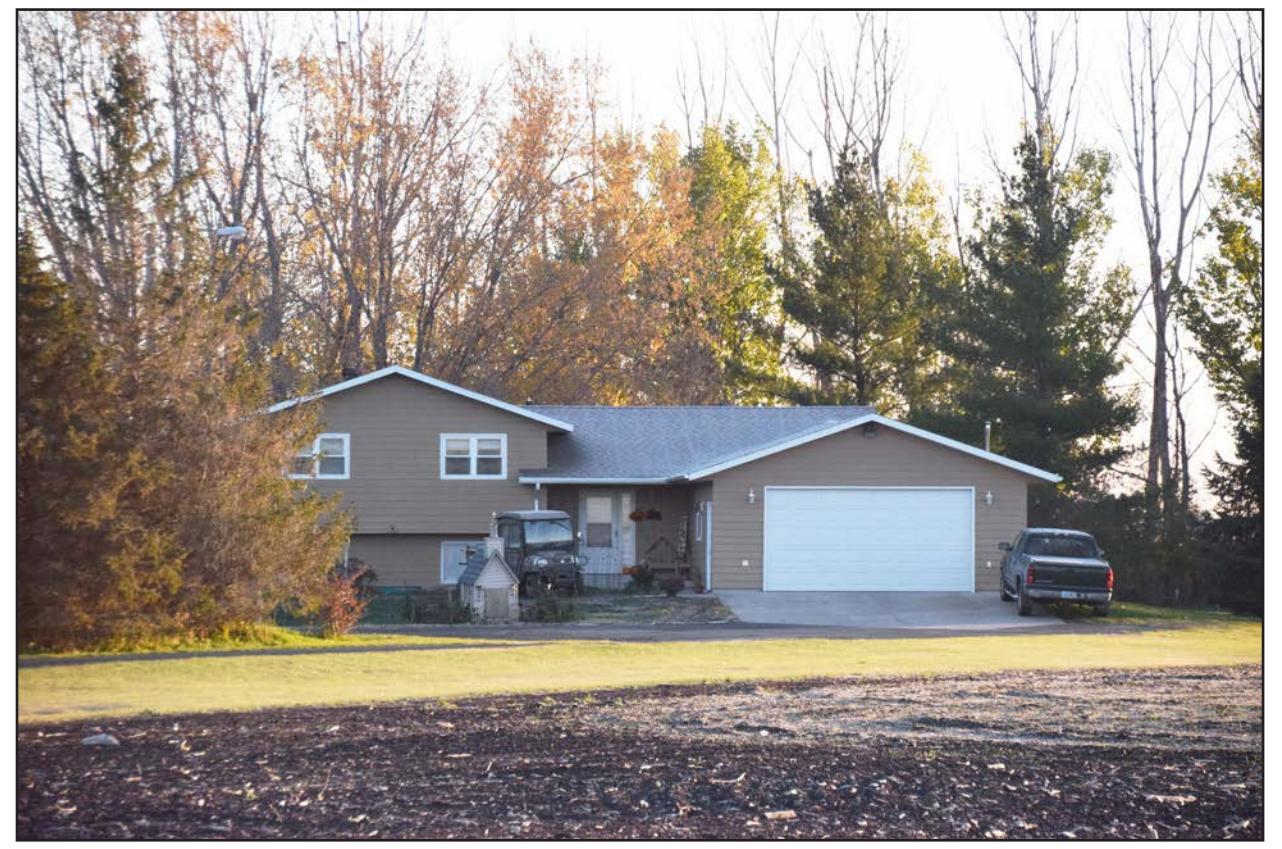
Figure 5. 32CS5283, Feature 1, southwest elevation, view to the northeast.

concrete block foundation (Appendix B, Figure 5). The dwelling included one-over-one double-hung vinyl windows on the first floor and vinyl casement windows on the basement level. The dwelling included a front-gable garage ell off the one-story, side-gable section. The dwelling was in good condition as of 2016. The utility building (Feature 2) was described as a front-gabled structure with a concrete slab foundation and casement windows in fair condition. ERM visited the resource in 2021 and noted no changes to the dwelling. Feature 2 was not visible from the public road, but based on aerial views, there do not appear to be any changes (Appendix B, Figure 6).

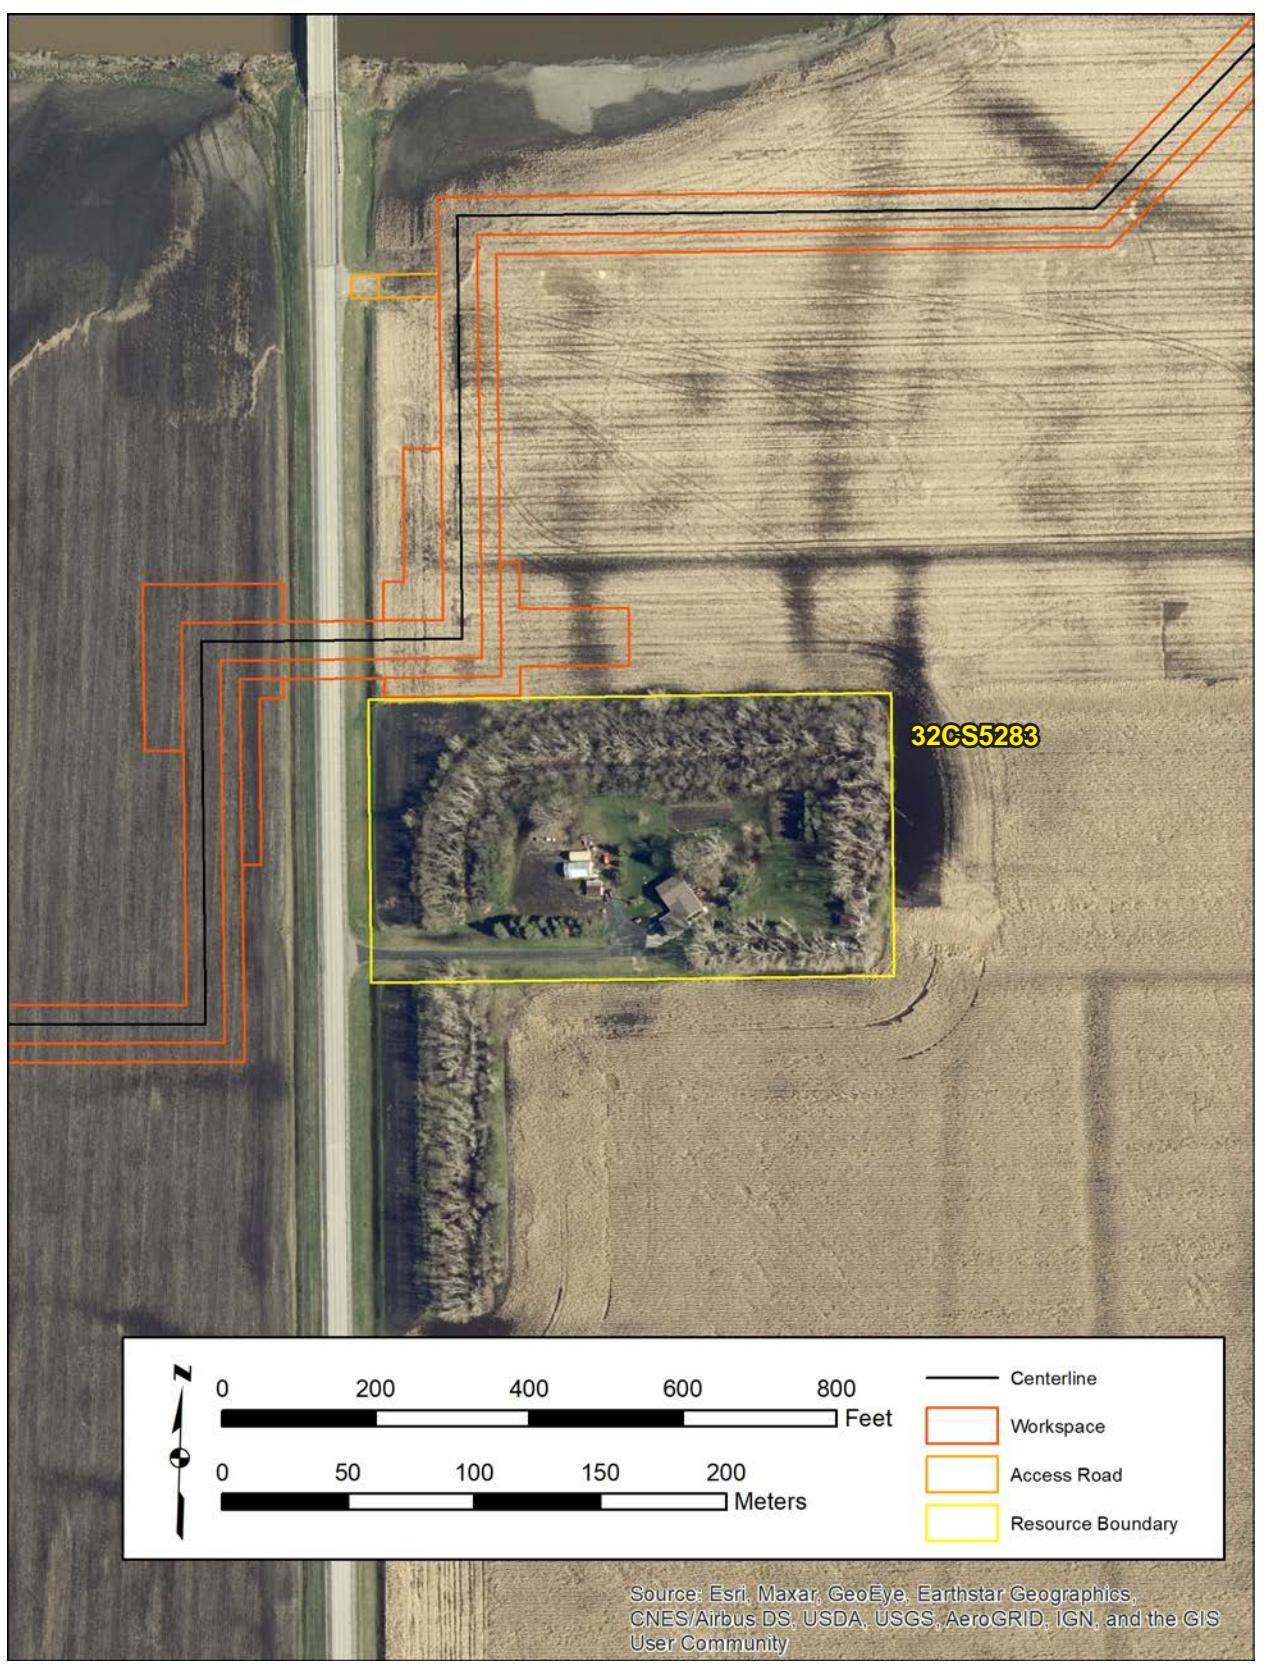
Figure 6. 32CS5283 in relation to the Project.

*NRHP Assessment:* Pratt recommended the resource as not eligible for the NRHP due to the dwelling's recent age and lack of historical significance. As 32CS5283 does not meet the 50-year threshold for NRHP-eligible properties, ERM also recommends the resource not eligible.

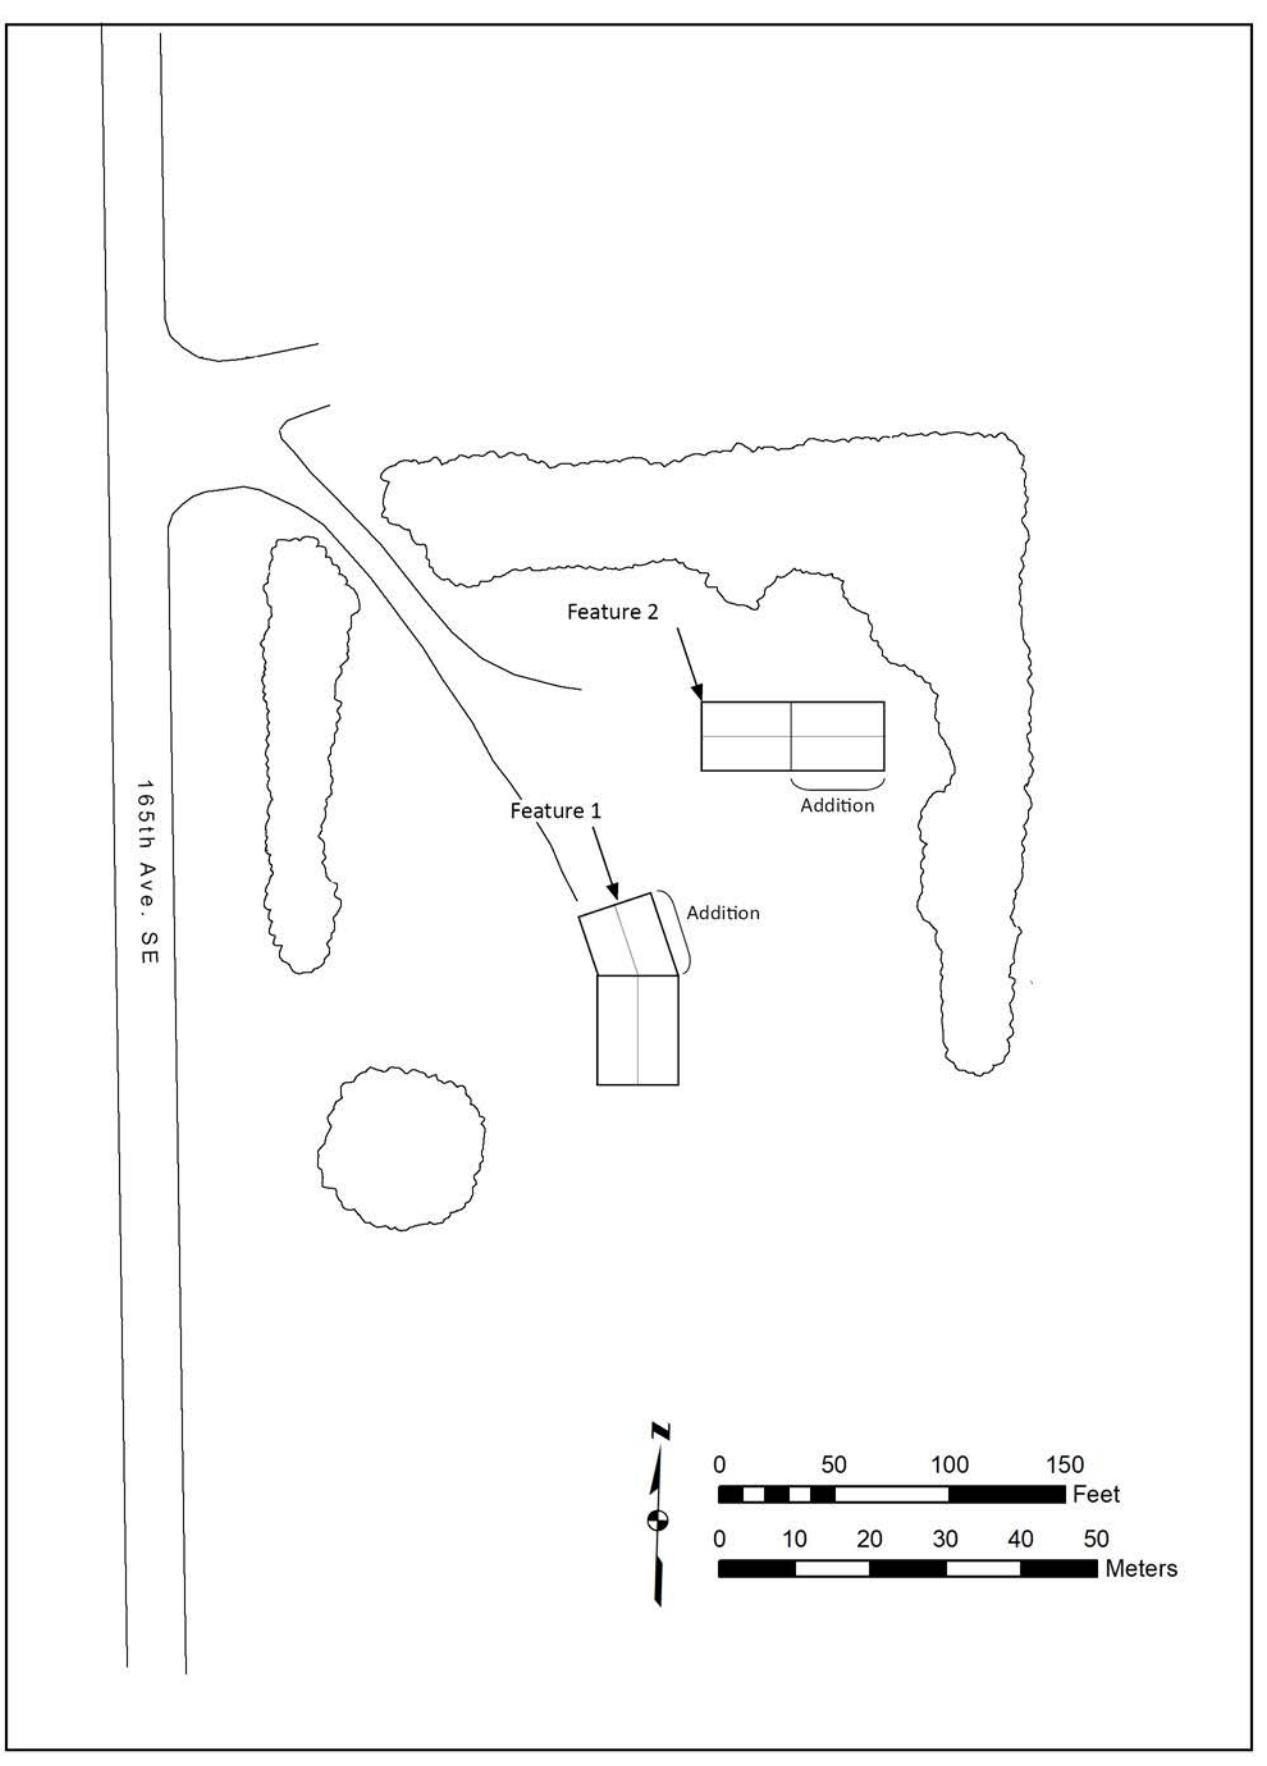
Figure 14. 32CS5353, sketch map.

32CS5353 consists of a one-story, modified, Compact Ranch style dwelling that was constructed in 1969, and a workshop (Appendix B, Figure 14). Feature 1, the dwelling, has a side- gable, asphalt shingle roof, aluminum siding, and a continuous concrete masonry unit foundation (Appendix B, Figure 15). It also features replacement vinyl casement windows as well as large single-pane picture windows with fixed shutters. The primary entrance is located on the west elevation through a vinyl door and a metal and glass storm door. The entry is accessed via poured concrete steps that are flanked by decorative metal handrails. The attached two- car garage on the north elevation is a 1978 addition, canted slightly to the

northwest. It features the same materials as the main block and has a personnel door on the west elevation and two overhead metal doors on the north elevation. The two garage doors have four fixed lights. Feature 1 and its addition are in good condition.

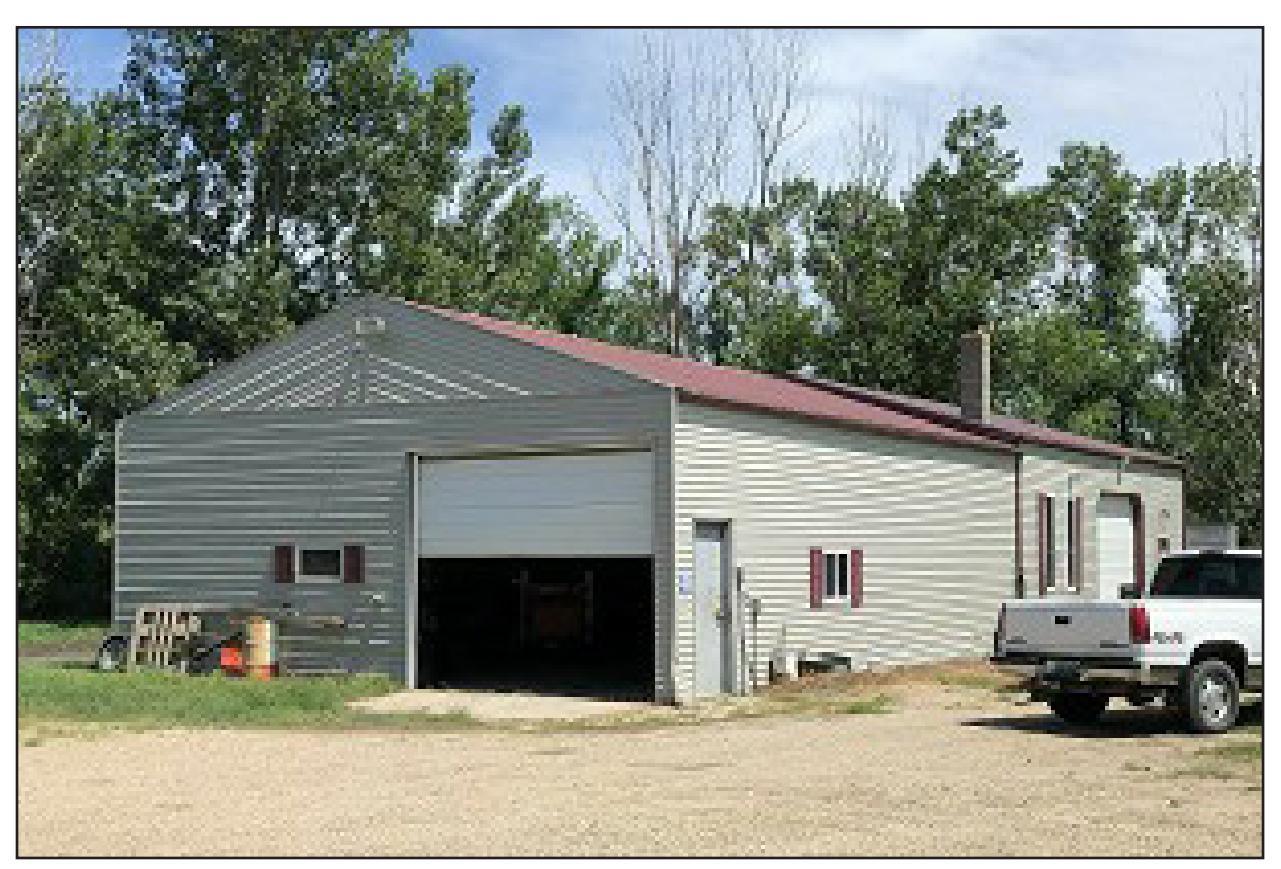
Figure 16. 32CS5353, Feature 2, west and south elevations, view to the northeast.

Feature 2 is a workshop located directly northeast of Feature 1 that was constructed in 1971, with a 1990 addition. It has a front-gabled, corrugated metal roof, vinyl siding, and a poured concrete foundation (Appendix B, Figure 16). There is an overhead metal door with a fixed light and a single fixed window with fixed shutters on the west elevation. A personnel door and another window are found on the south elevation. The east elevation contains the 1990s addition, which features an overhead bay door and additional windows on the south elevation, and a concrete masonry unit chimney within the southwest corner of the roof slope.

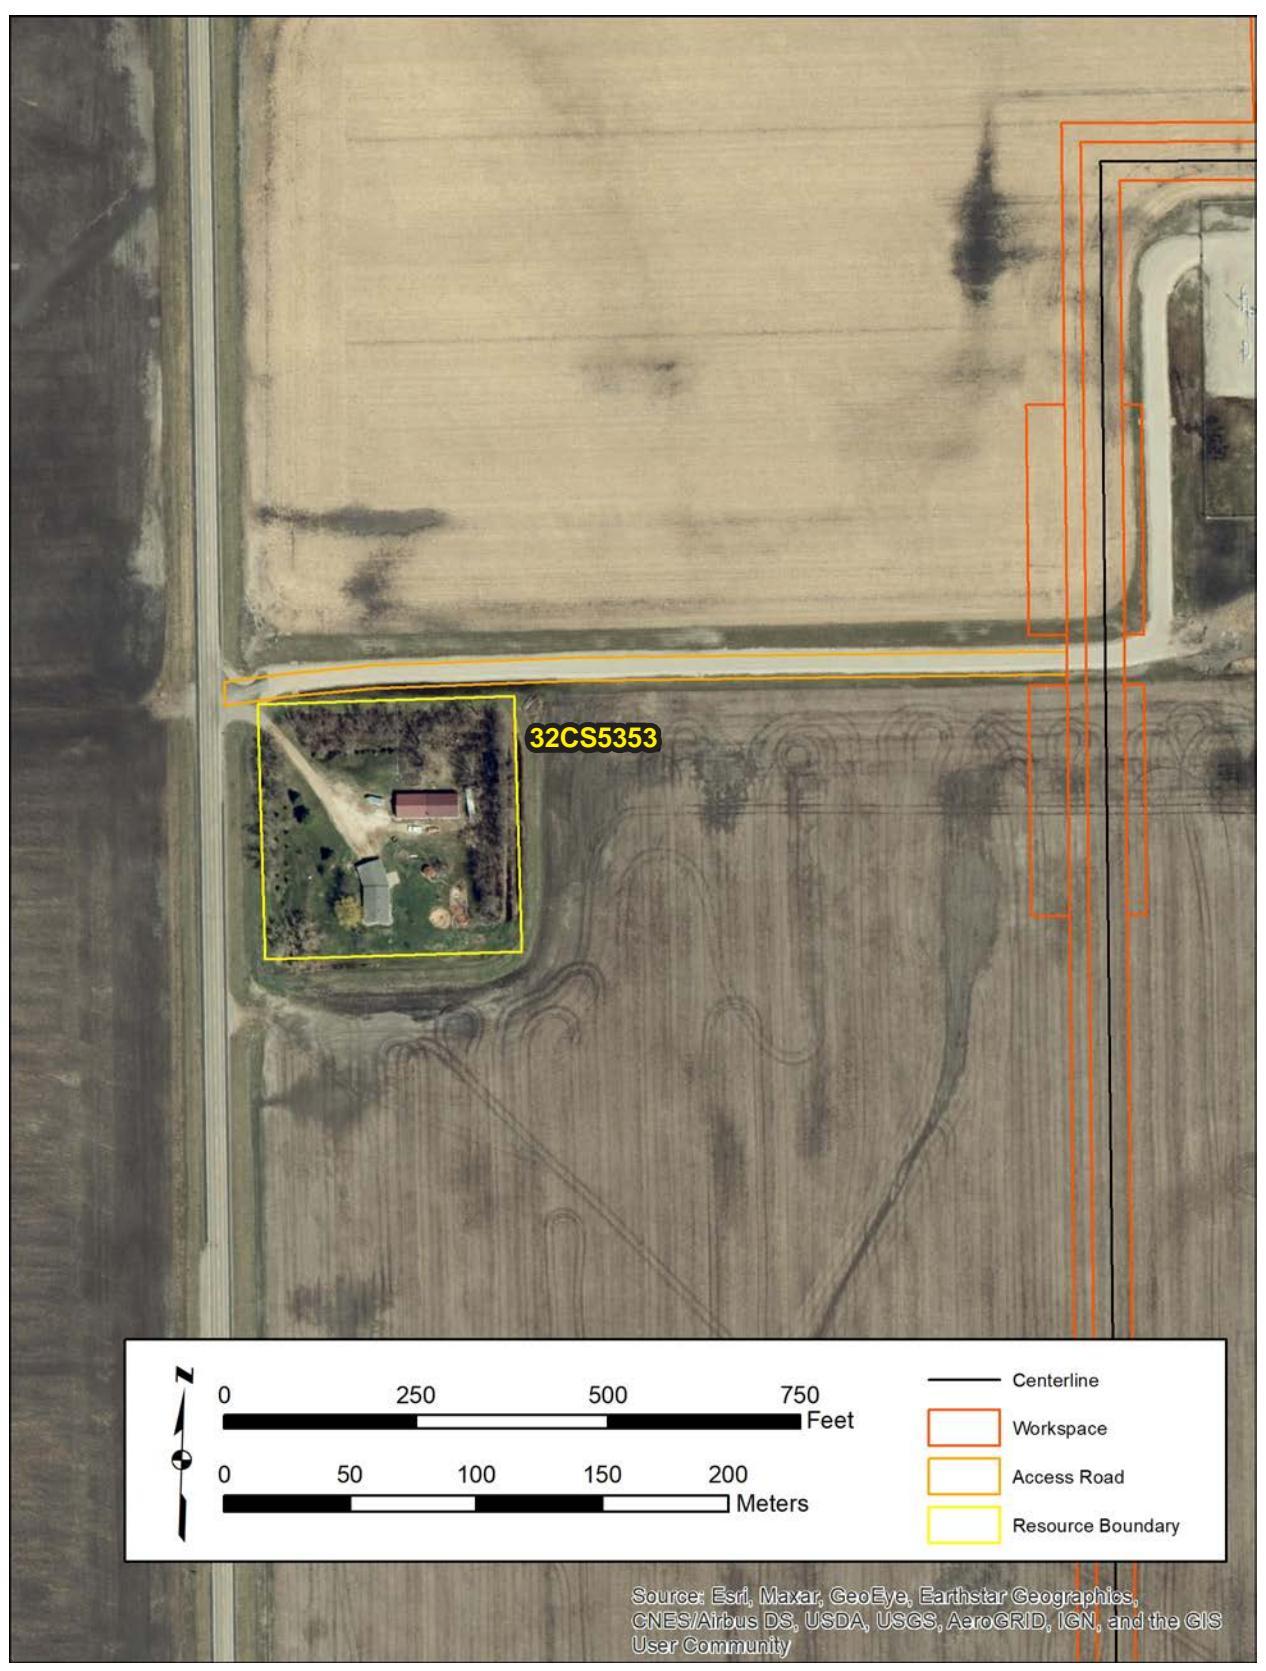
Figure 17. 32CS5353, proposed NRHP boundary.

*NRHP Assessment:* 32CS5353 consists of a modified Compact Ranch dwelling and a modified workshop, both of which have only recently reached sufficient age to be considered for NRHP eligibility. The dwelling has common features of the ubiquitous Compact Ranch style and does not exhibit remarkable design or workmanship. Furthermore, 32CS5353 has suffered a loss of integrity with the use of replacement windows and the idiosyncratic orientation of the garage to the original block, which is out of character in the archetypically rectangular design grammar of Ranch style architecture. Therefore, ERM recommends 32CS5353 ineligible under NRHP Criterion C. Historical research for the Project did not uncover any significant events associated with the resource, so it is also recommended ineligible under NRHP Criterion B.

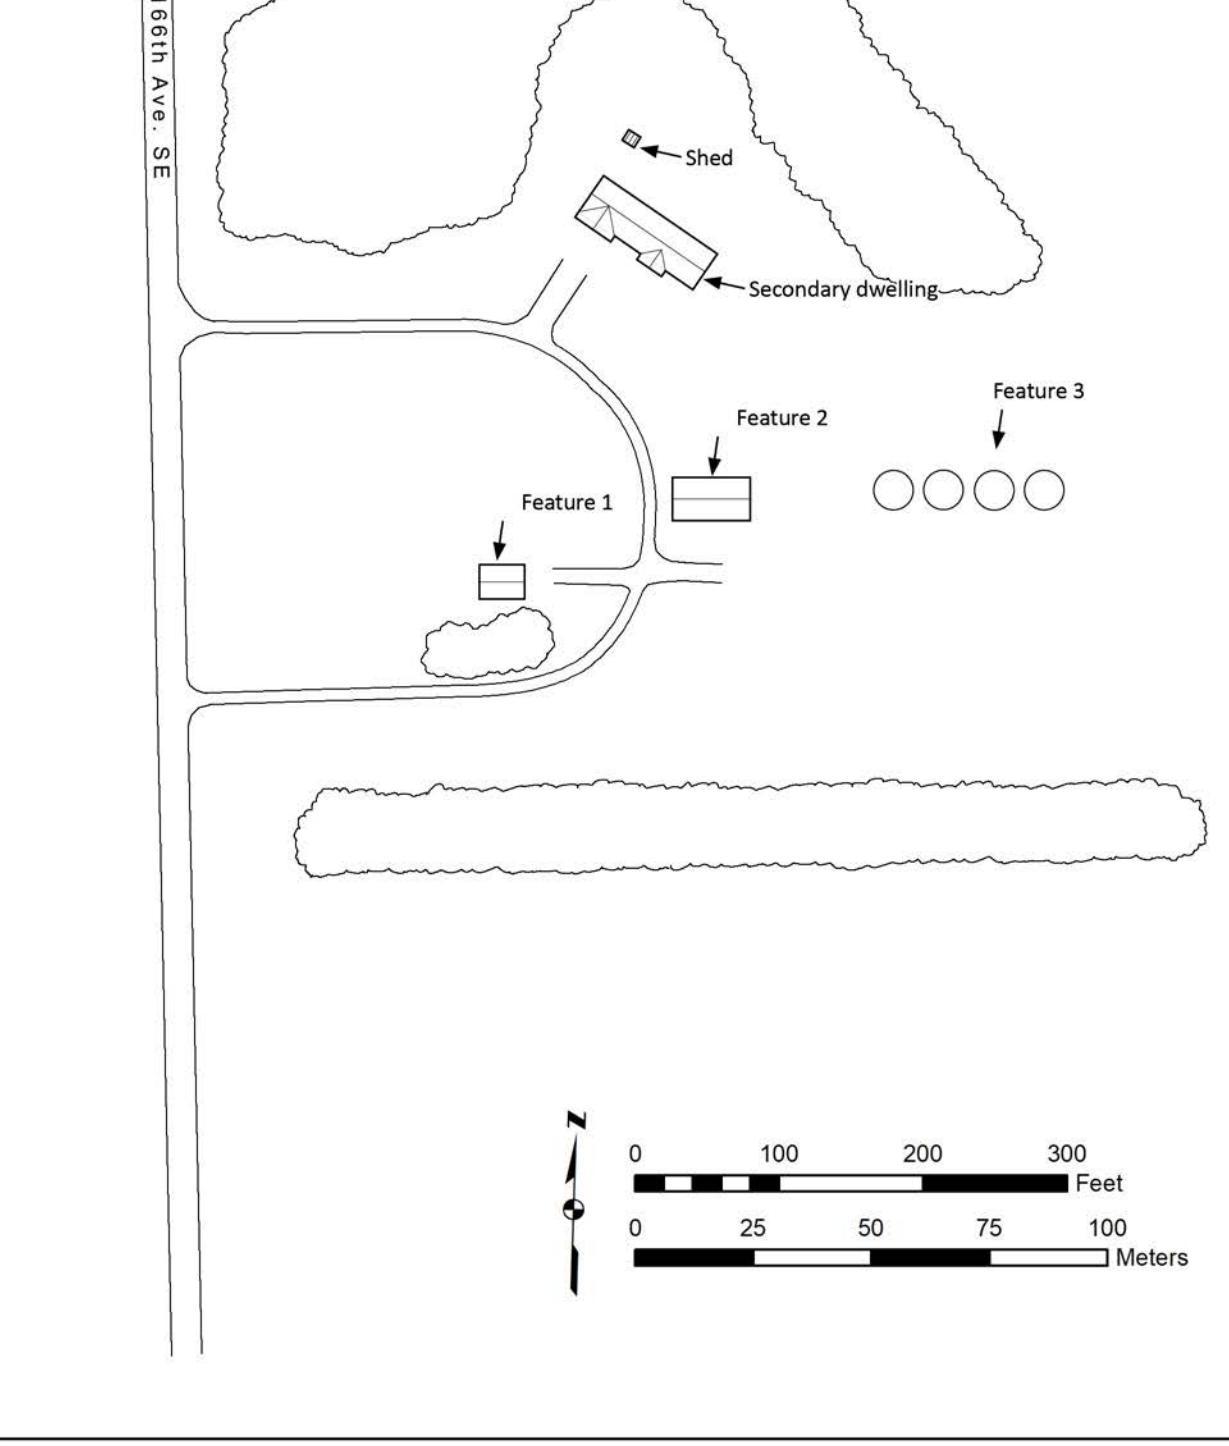
Figure 18. 32CS5354, sketch map.

32CS5354 includes a ca. 1940 dwelling, a barn, four grain bins, a secondary modern Ranch style dwelling, and a modern shed (Appendix B, Figure 18). The primary dwelling, Feature 1, is within the semicircular drive, and has a side-gable, asphalt shingle roof, vinyl siding, and the foundation is not visible from the right of way (Appendix B, Figure 19). It also has an interior, on-peak brick chimney located closest to the west elevation, and vinyl casement windows covered by storm windows. The primary entrance is located on the north entrance through a vinyl door with a fixed two-pane light. Feature 1 has been well kept and is in good condition, but it is unclear whether it is currently occupied.

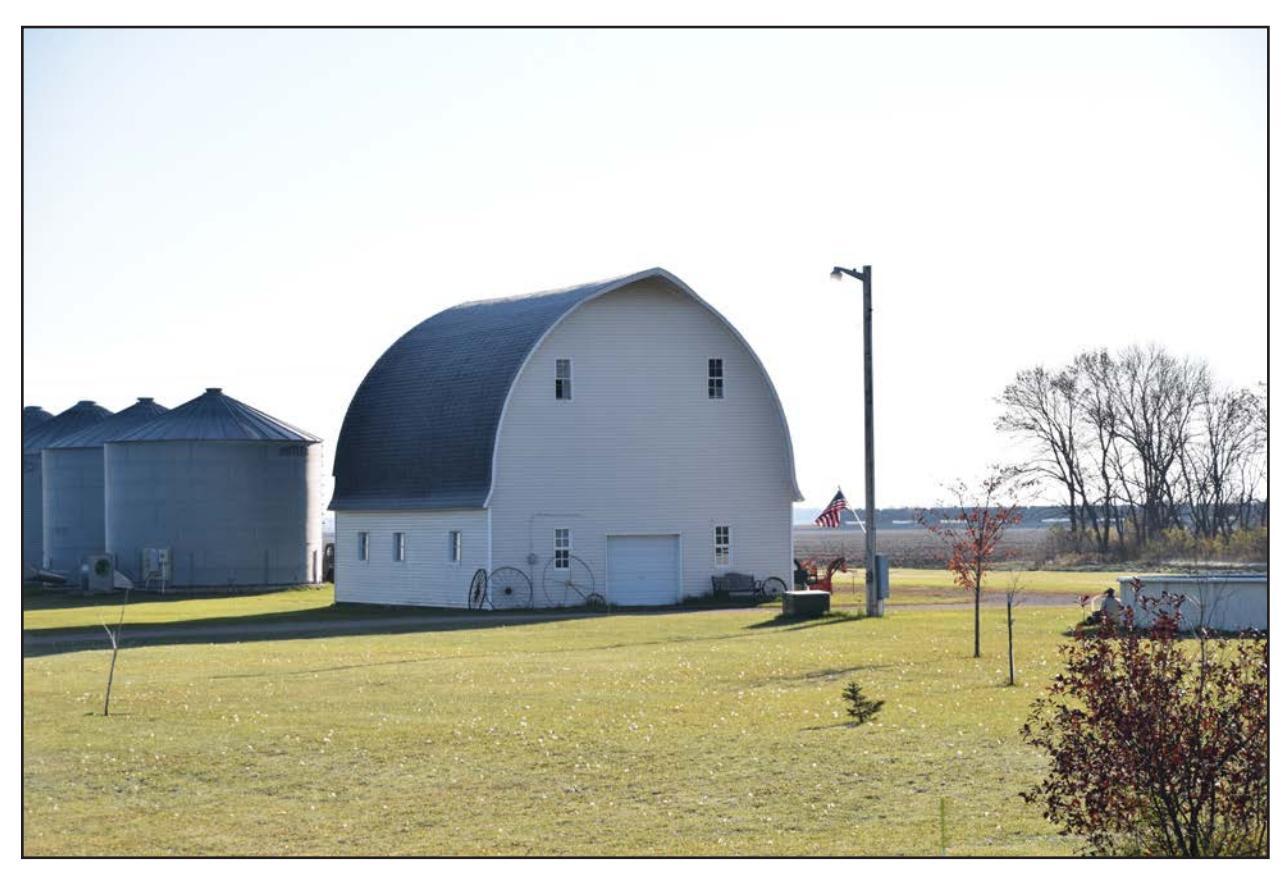
Figure 20. 32CS5354, Feature 2, barn, north and west elevations, view to the southeast.

Feature 2 is a ca. 1940 barn that is located slightly northeast of Feature 1. It has a Gothic arch, asphalt shingle roof, vinyl siding, and the foundation is not visible (Appendix B, Figure 20). It also has four-over-four single-hung wood sash as well as four-light fixed windows, and an overhead metal bay door that serves as the primary entrance on the western elevation. The barn is in fair condition, as the two upper windows have lost some glazing. Next, the four large metal grain bins are designated Feature 3. They were constructed pre-1984, are in good condition, and are located in a line directly east of Feature 2 (Appendix B, Figures 21 and 22).

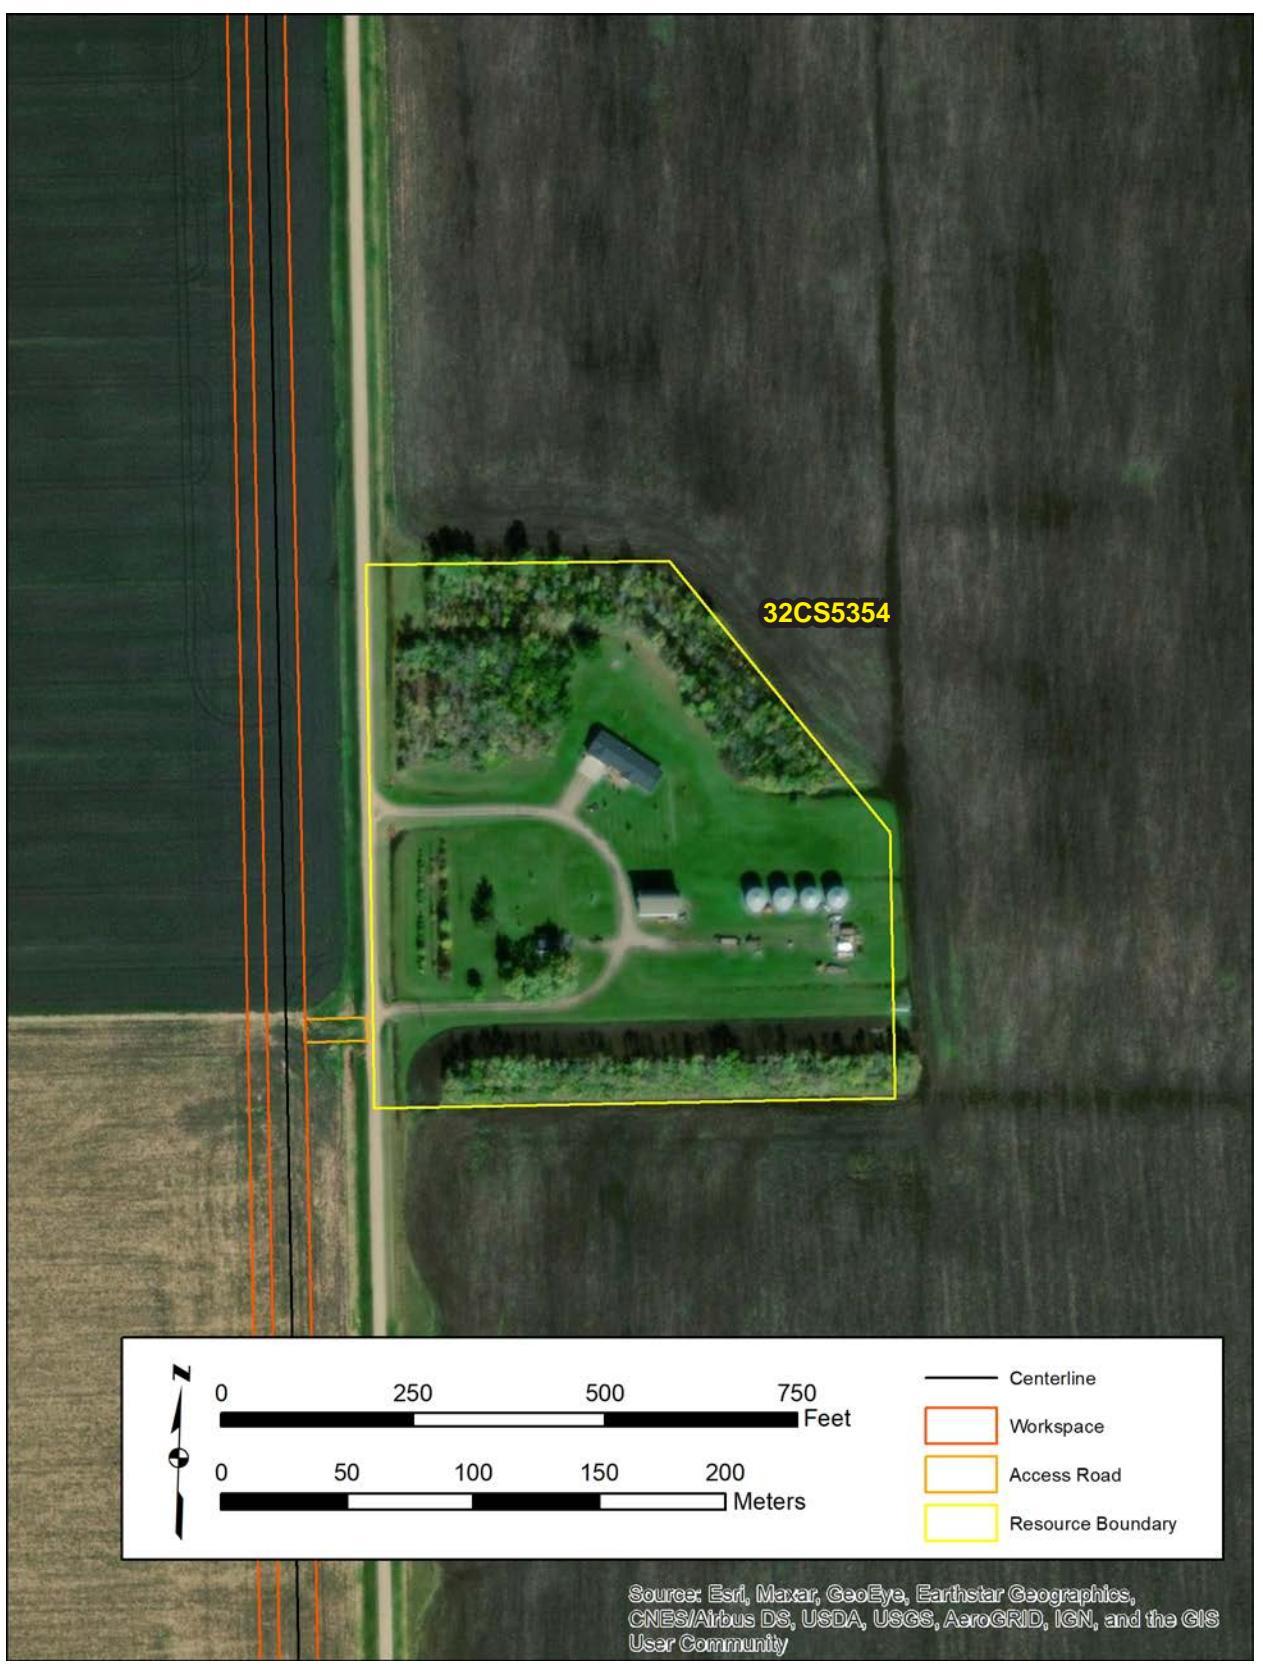
Figure 23. 32CS5354, proposed NRHP boundary.

NRHP Assessment: 32CS5354 includes three modified historic features and two modern features located in a rural area. The individual features display frequently used, modern replacement materials, and are otherwise well cared for in a manner that is sympathetic to the original workmanship and design. However, the generic form and updated materials of the original dwelling make it impossible to discern a specific style. Between 1984 and 1990, a building in the location of the secondary dwelling was razed; it was a large square footprint building that looks like barn in aerial imagery. As of 1984, there was another outbuilding between that barn and the barn that is still standing that was razed between 1990 and 1997, and another building within the semicircular drive that was razed between 1997 and 2003. These observations suggest that much of the farm's historic built environment has been lost and is now dominated by an architecturally incompatible modern dwelling, and thus 32CS5354 no longer retains integrity of association and feeling. That added to the loss of material integrity and lack of outstanding architectural character leads, ERM to recommend 32CS5354 ineligible for the NRHP under Criterion C. It is also considered ineligible under NRHP Criterion A because historical research for the Project did not identify any important events associated with the property. The resource also does not convey a compelling sense of the region's agricultural history, given the prominence of modern elements that have replaced earlier components of the working farm. Further deed research is still needed to evaluate NRHP eligibility under Criterion B.
