## APPENDIX 4D CLASS III HISTORIC STRUCTURES SURVEY REPORT

WBI Energy Transmission, Inc. Wahpeton Expansion Project, Cass and Richland Counties, North Dakota

28 February 2022 Project No.: 0611161

## CLASS III HISTORIC ARCHITECURAL SURVEY

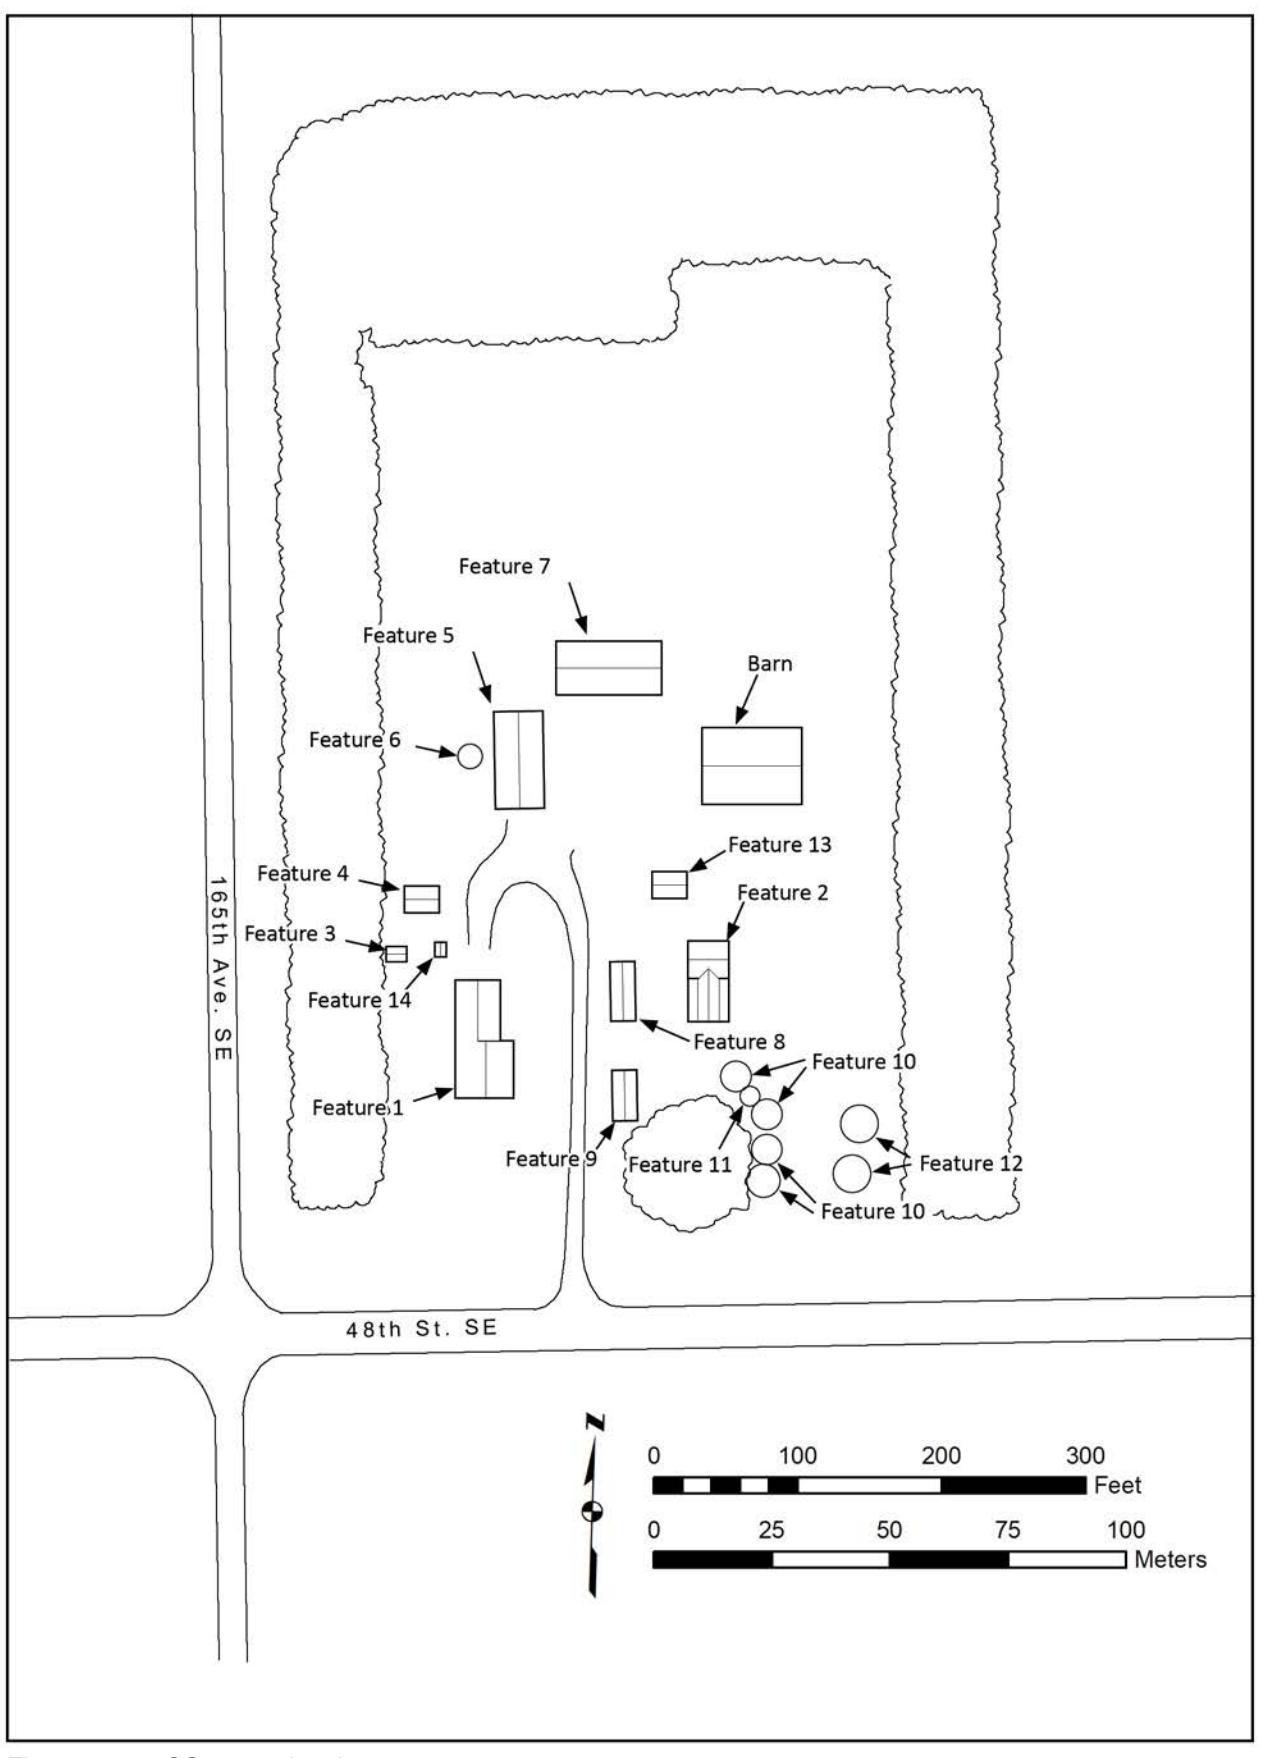
Figure 24. 32CS5355, sketch map.

32CS5355 consists of a one-story, ca. 1960, Linear Ranch style dwelling, a ca. 1900 equipment shed that may have originated as a dwelling, nine other outbuildings, a silo, and seven grain bins (Appendix B, Figures 24 and 25). The dwelling, Feature 1, has a side-gable, standing seam metal roof, vinyl siding, and a continuous concrete masonry unit foundation (Appendix B, Figure 26). It also features a narrow three pane picture window, and a large fixed square picture window. The primary entrance is located on the eastern elevation, but it is not visible from the public right-of-way. The dwelling is in good condition.

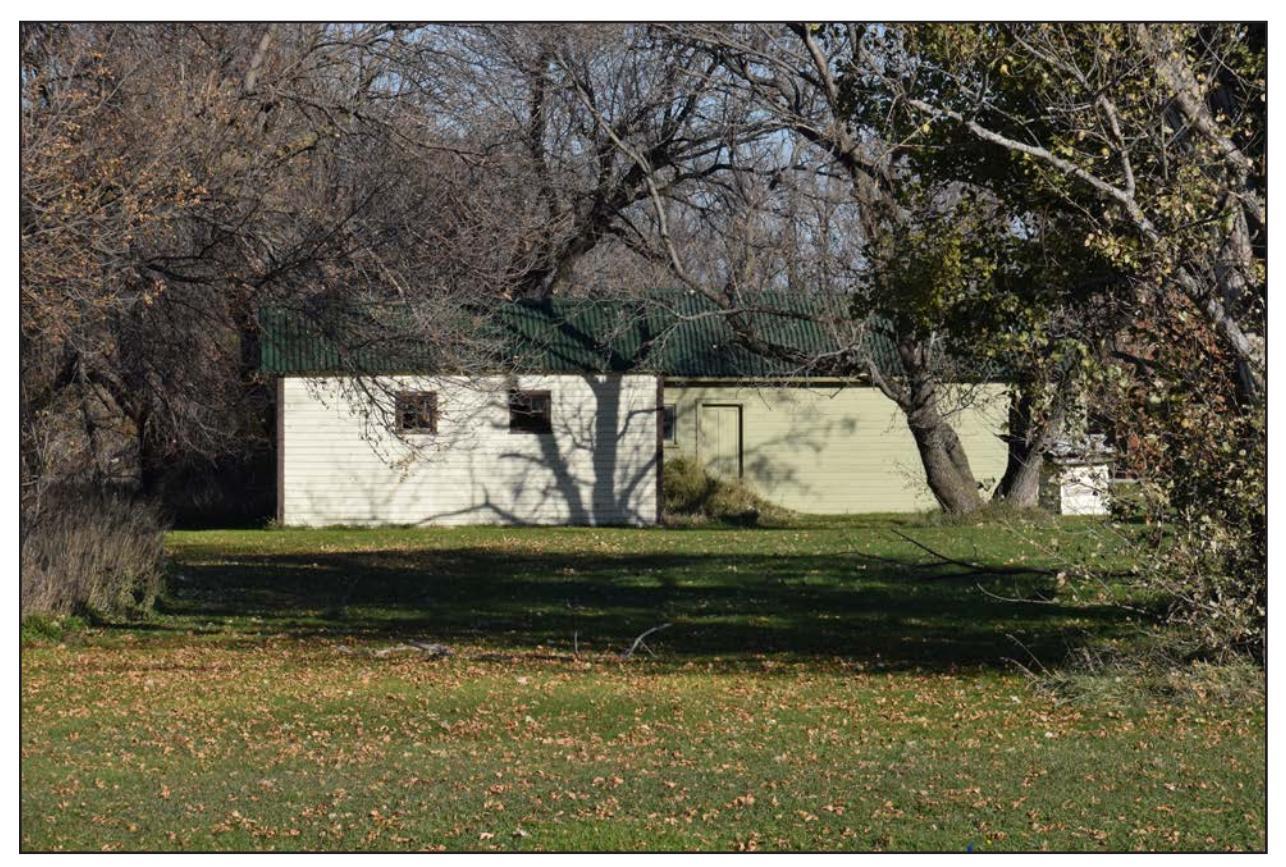
Figure 28. 32CS5355, (from left to right) Features 3, 4, 12, view facing north.

Feature 3 is a shed located to the northwest of the dwelling. It has a gabled roof clad in modern corrugated metal; it appears to retain original clapboard siding and four-light wood frame windows. Other details are not visible from the right-of-way, but the feature appears to be in good condition. Directly north of Feature 3 is Feature 4, a larger building that may serve as a shed or workshop. It has a side-gable roof clad in the same modern corrugated metal as Feature 3. Like Feature 3, Feature 4 has clapboard siding. Its primary entrance is located on the southern elevation. The entry has a wood, four-panel door, and there is a fixed four-light window to the west. It is also in good condition. Both Features 3 and 4 appear to date to the 1940s based on the appearance of the original materials (Appendix B, Figure 28).

To the southeast of Features 8 and 9 are Features 10–12, which consists of seven modern corrugated metal grain bins with conical caps (Appendix B, Figures 28 and 33). They are common prefabricated forms of different sizes that were constructed before 1984 and are in good condition. Finally, there are what appear to be two well pump houses, designated as Features 13 and 14. Feature 13 is a small gabled structure only visible in aerial views, located north of Feature 2, which may be the original residence on the property. Feature 14 is another pump house, located north of the current dwelling at the southeast corner of Feature 4. It features a gabled roof and is clad in aluminum siding, suggesting that it is contemporary with the construction of the ca. 1960 Ranch style dwelling.

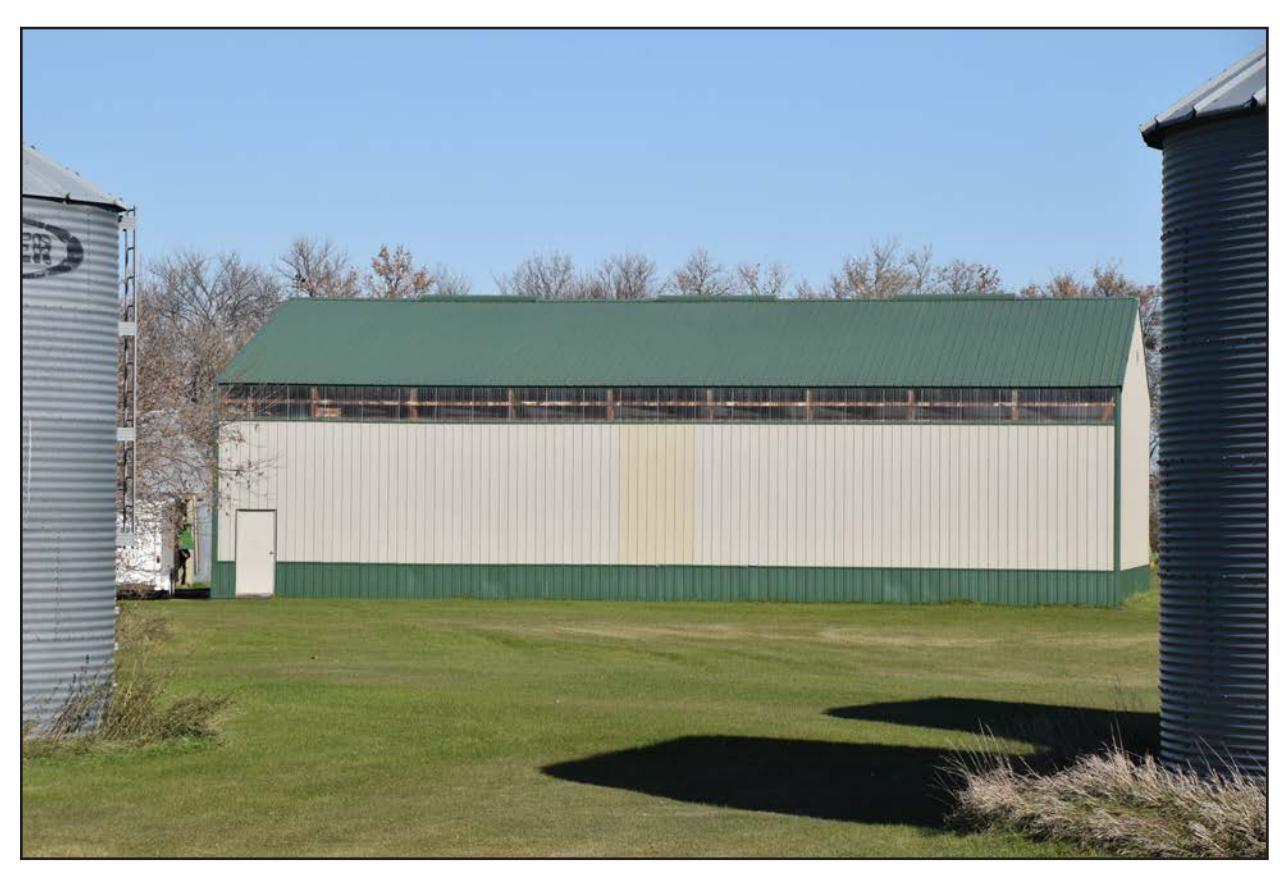
Figure 34. 32CS5355, Modern barn, south elevation, view facing north.

Finally, there is a modern barn, located southeast of the equipment shed that was constructed between 2003 and 2005. It is front-gable with a standing seam metal roof and sides, and a personnel door and ribbon of clerestory windows on the south elevation (Appendix B, Figure 34). Other details are not available due to the limited visibility from the public right of way, but it is in good condition.

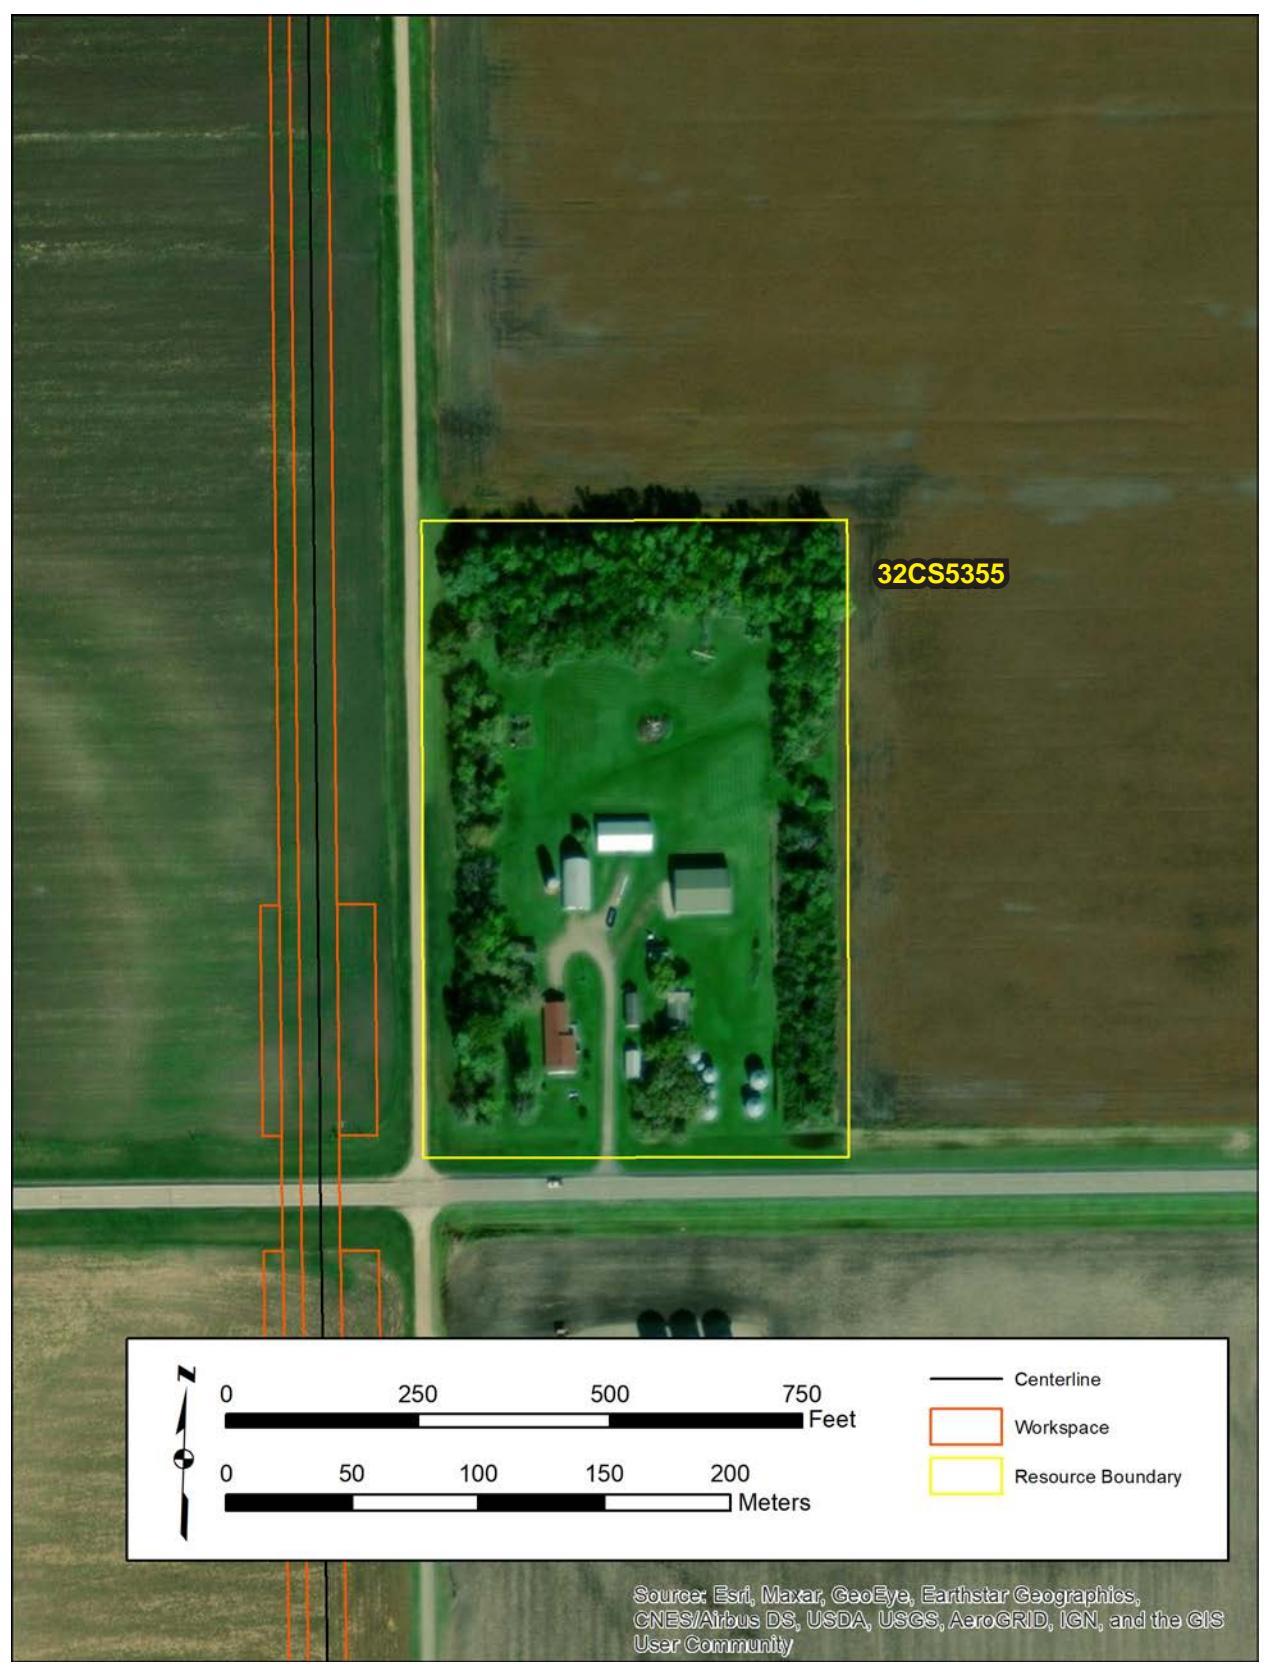
Figure 35. 32CS5355, proposed NRHP boundary.

NRHP Assessment: 32CS5355 includes a modified ca. 1960s dwelling and various agricultural outbuildings. The dwelling represents the Linear Ranch form, and the original materials have been replaced with common materials (vinyl siding and windows), such that they no longer convey significant workmanship or the aesthetic of the period. What may have been the original dwelling (Feature 2) maintains some historic design features and materials but has been converted into an equipment storage building and its condition has begun to deteriorate. Likewise, two buildings (Features 9 and 10) that may have served variously as bunkhouses, hay barns, and/or equipment storage facilities and workshops, retain some integrity of design and materials, but their condition is declining. The tile silo (Feature 6) is well preserved and together with Features 2, 9, and 10-12, conveys a sense of the farm's early history, However, the overall integrity of feeling and association for the resource has been compromised by the addition of various components dating to the second half of the twentieth century and the early twentyfirst century. Given the range in age reflected among the components of 32CS5355, this resource does not offer the best example of an early twentieth century agricultural property in southeast North Dakota. Therefore, ERM recommends 32CS5355 ineligible under NRHP Criteria A and C. Not only does 32CS5355 fail to coherently convey a sense of the farm's early history, but historical research for the Project did not identify any significant events associated with the property outside of the general theme of regional agricultural developments, further supporting the recommendation that it is ineligible under NRHP Criterion A. Further deed research is needed to evaluate NRHP eligibility under Criterion B.

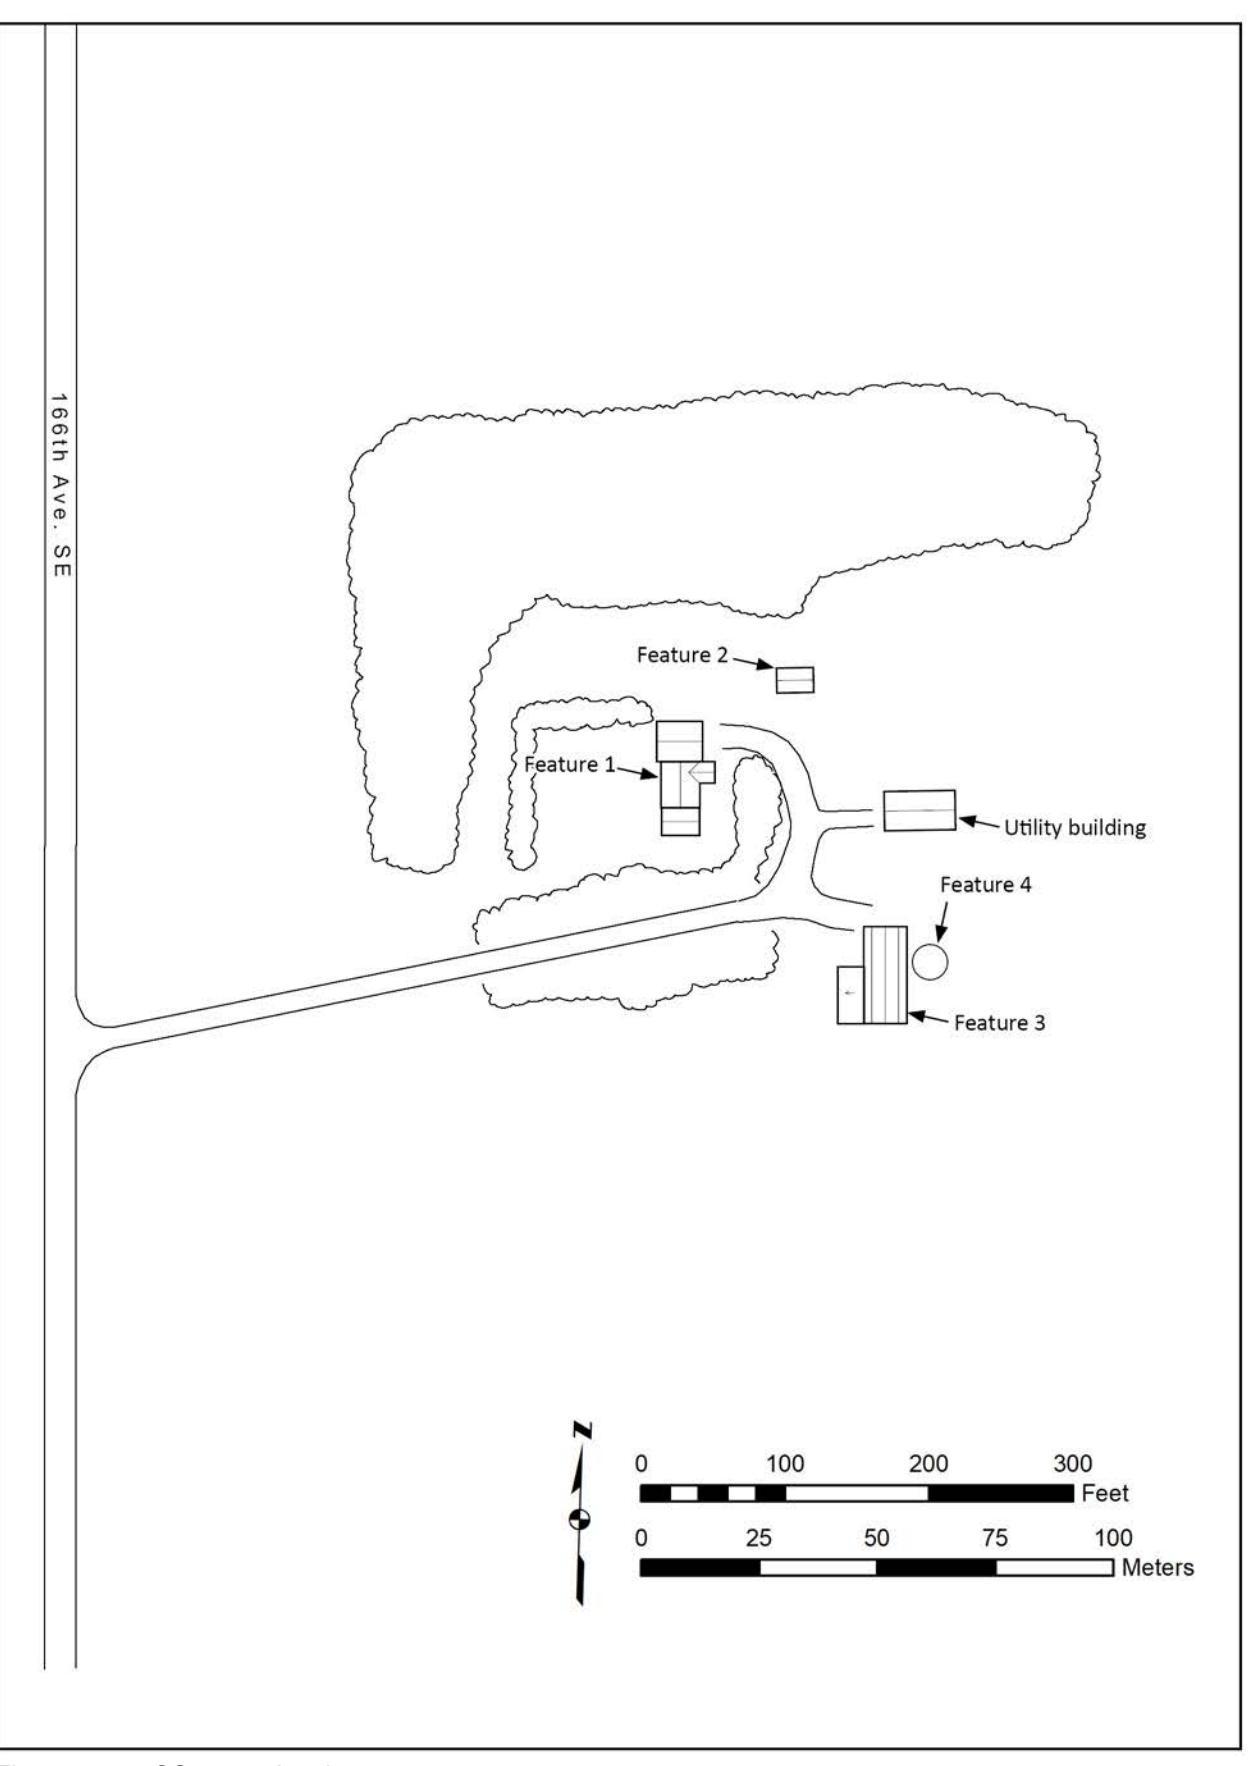
Figure 36. 32CS5356, sketch map.

32CS5356 includes a heavily modified, vernacular dwelling that was built ca. 1900, and five outbuildings and a silo (Appendix B, Figure 36). The two-story dwelling, Feature 1, has a side-gabled, asphalt shingle roof with a shed dormer, vinyl siding, and a continuous concrete masonry unit foundation constructed as a raised basement (Appendix B, Figure 37). The dwelling also features one-over-one and fixed (basement level) vinyl windows, and a corbelled, interior brick chimney on the north slope of the original block. The primary entrance is located on the south elevation of the enclosed hipped full-width front porch, but the door is not visible from the right-of-way due to the presence of plantings whose foliage obscure the view. The entrance is accessed via a wood stoop with a wood post foundation and set of poured concrete stairs. There is a one-story gable-front addition that was added to the north elevation in 1984. Another gabled addition was added to the first addition's east elevation (at the northeast corner) in 1990. Both additions feature the same materials as the main block. Feature 1 is in excellent condition.

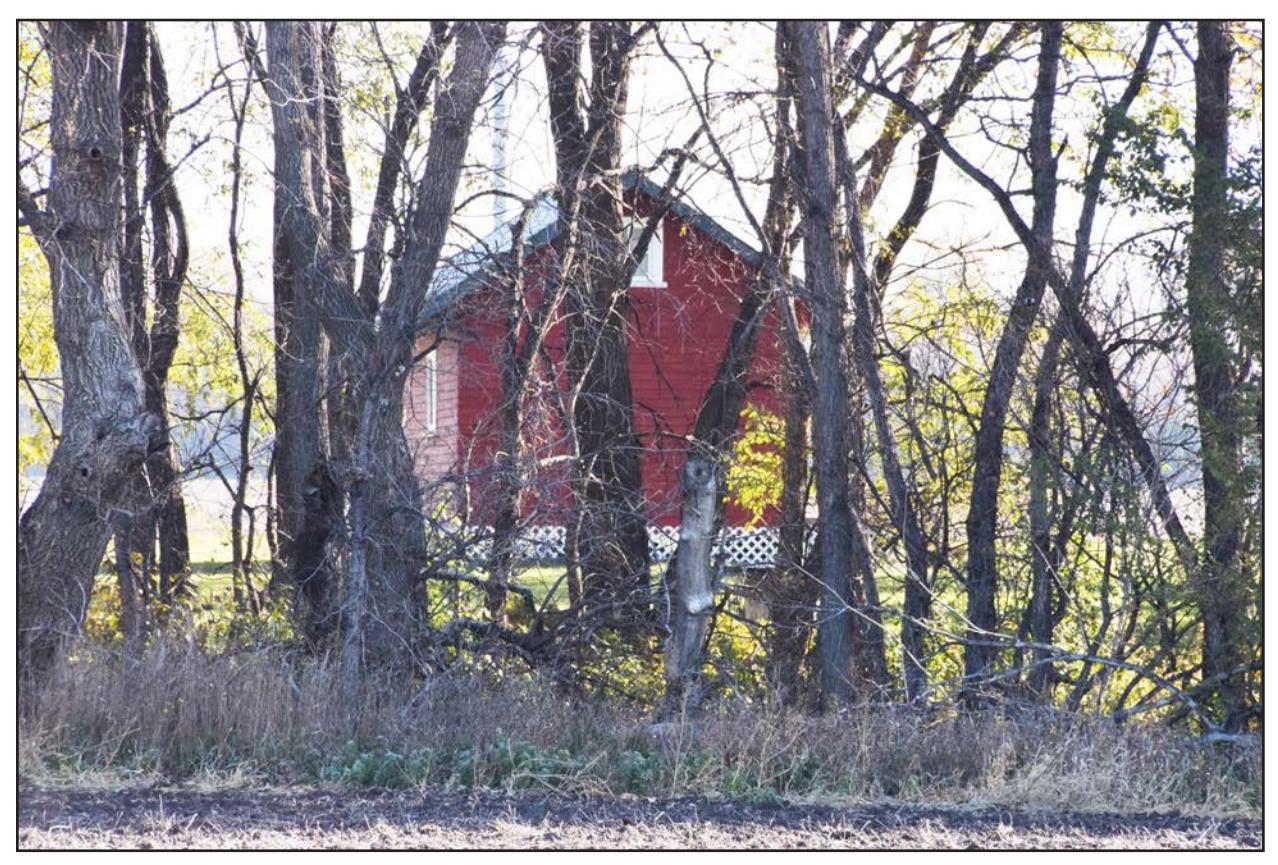
Figure 38. 32CS5356, Feature 2, west elevation, view facing east.

The garage located directly north of the dwelling was constructed in 1988. It is gabled and seems to feature the same materials as the dwelling but is only partially visible from the public right of way. Feature 2 is a one-and-a-half-story gabled building largely obscured by trees to the west. However, it features some kind of lap siding, two windows on its north elevation, a single window in the upper gable end of the west elevation, and it sits on a pier foundation concealed by lattice skirting (Appendix B, Figure 38). The garage and Feature 2 are in good condition.
