Re: WBI Energy Transmission, Inc.
Docket Nos. CP20-52-000 and CP20-52-001
North Bakken Expansion Project
Status Report No. 37

WBI Energy Transmission, Inc.
North Bakken Expansion Project Status Report No. 37
FERC Docket Nos. CP20-52-000
CP20-52-001

Reporting Period: April 1, 2022 through April 30, 2022

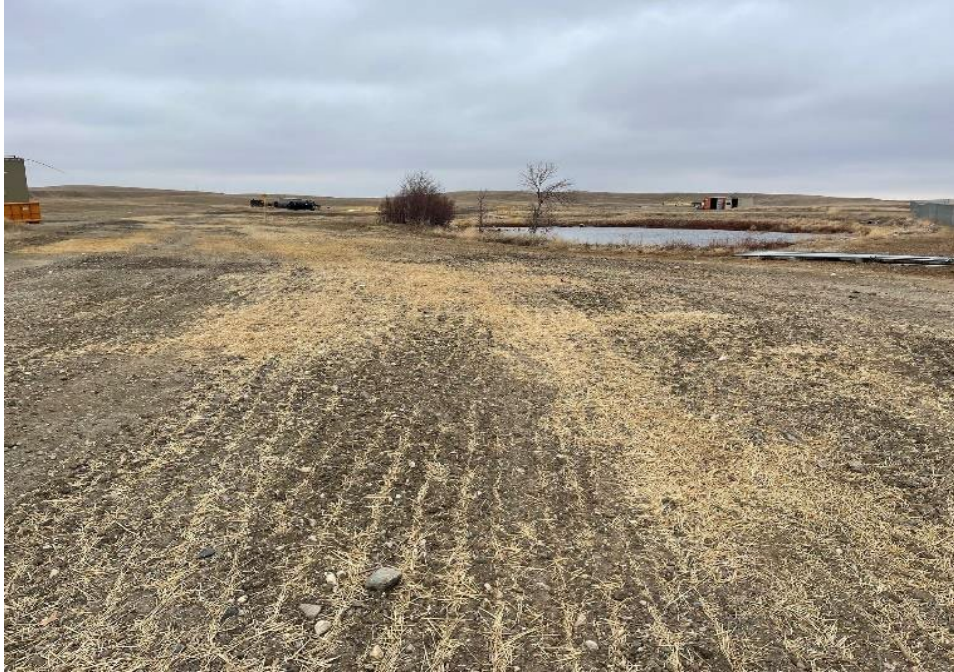
Location:
Sta. No. 9+00

Notes: Restored right-of-way remains properly mulched and crimped on the Line Section 30 Loop Pipeline.

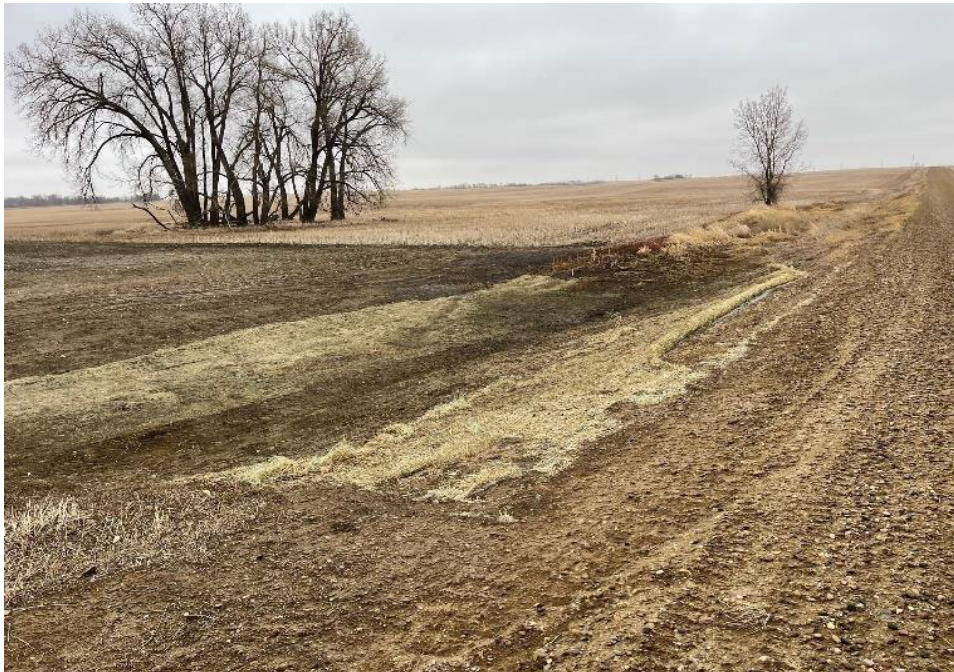
Location:
Sta. No. 169+25

Notes: Erosion control blankets need repair in bar ditch on the Line Section 30 Loop Pipeline.

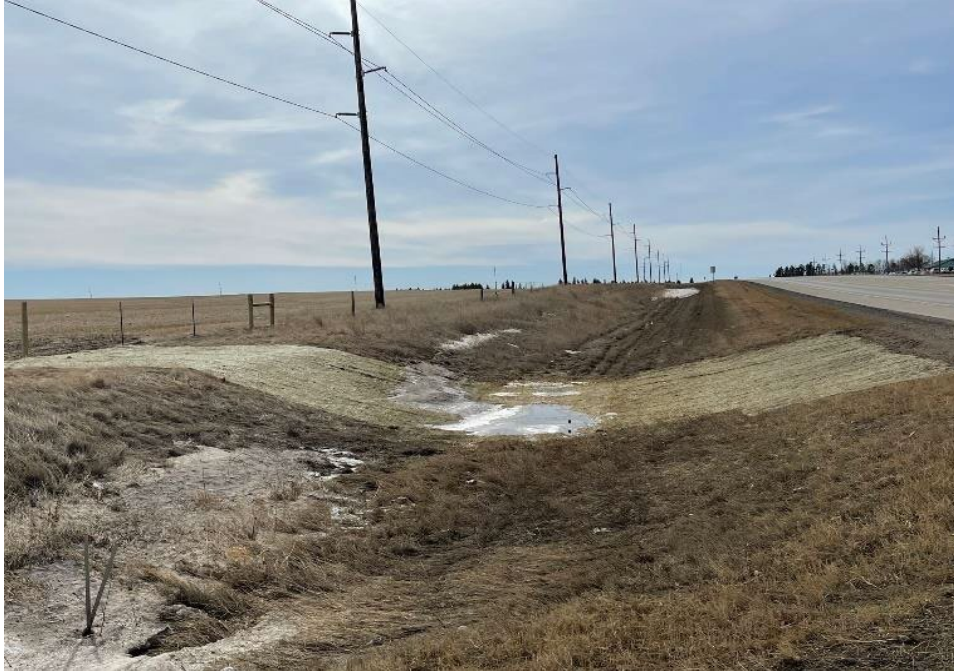
Location:
Sta. No. 334+43

Notes: Erosion control blanket in bar ditch remains in place and functioning on the Line Section 30 Loop Pipeline.

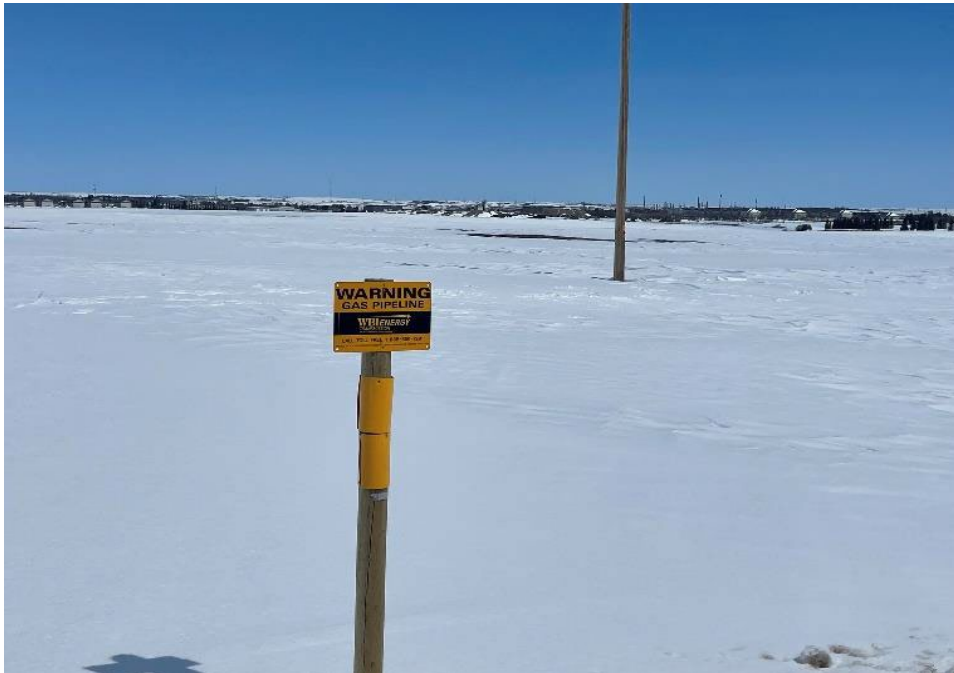
Location:
Sta. No. 277+19

Notes: Restored right-of-way remains frozen on the Line Section 30 Loop Pipeline.

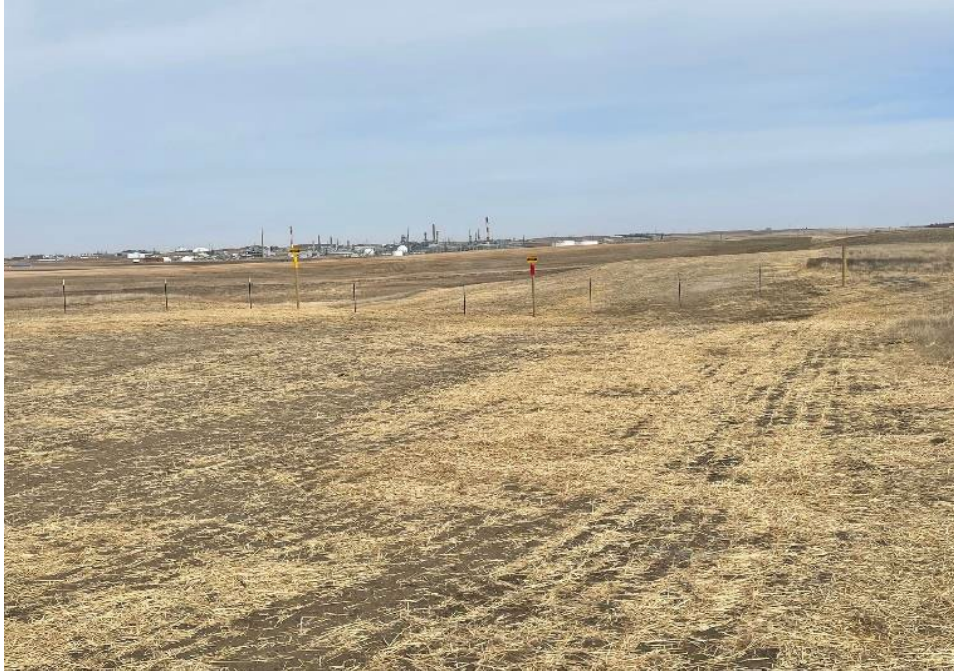
Location:
Sta. No. 134+80

Notes: Restored right-of-way remains properly mulched and crimped on the Tioga-Elkhorn Creek Pipeline.

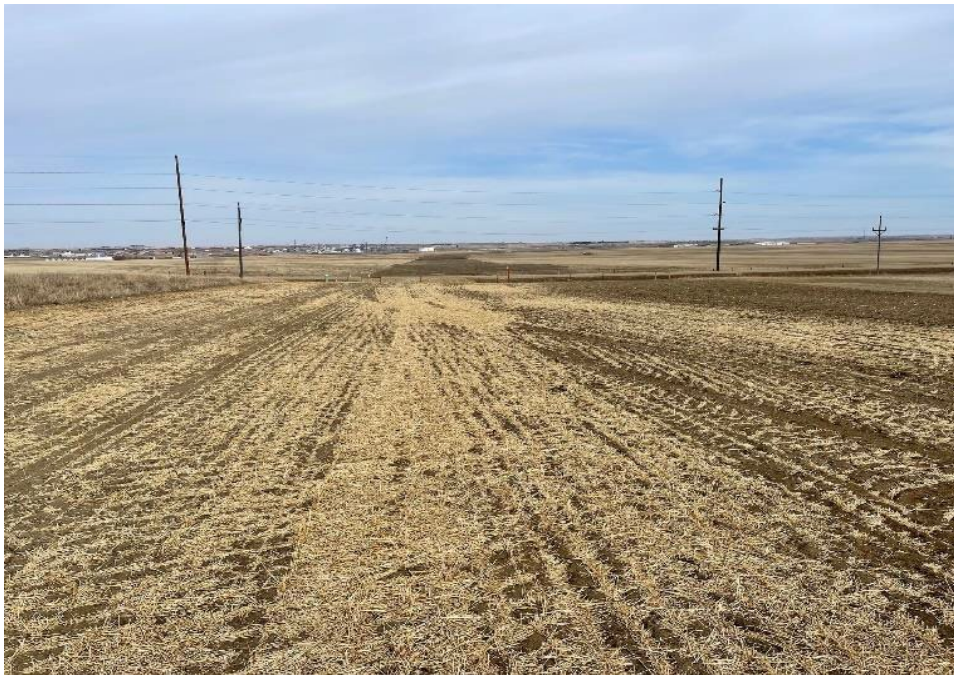
Location:
Sta. No. 169+05

Notes: Restored right-of-way remains properly mulched and crimped on the Tioga-Elkhorn Creek Pipeline.

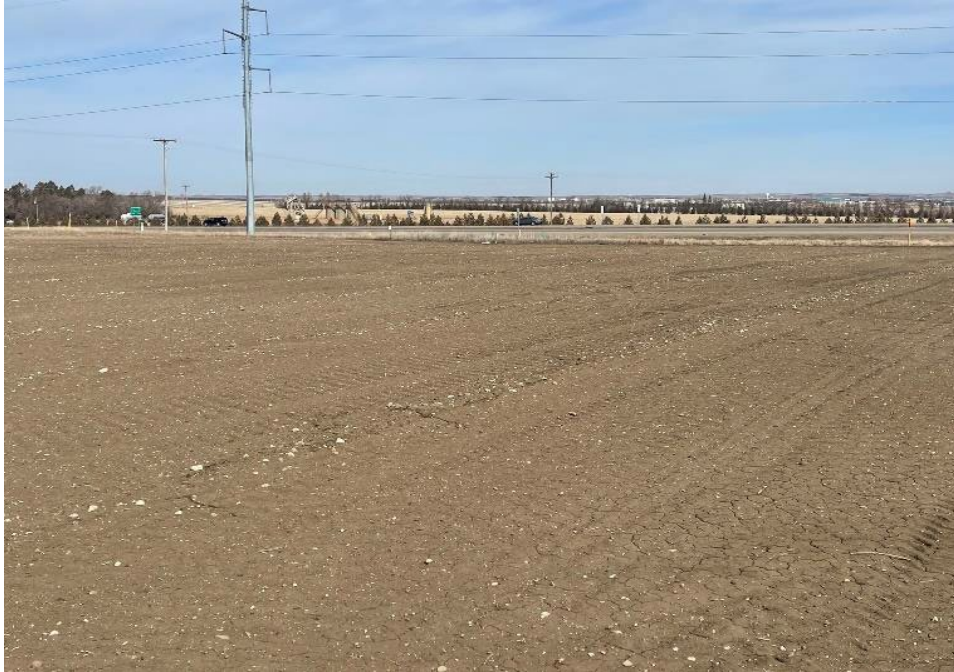
Location:
Sta. No. 286+21

Notes: No erosion issues along restored right-of-way on the Tioga-Elkhorn Creek Pipeline.

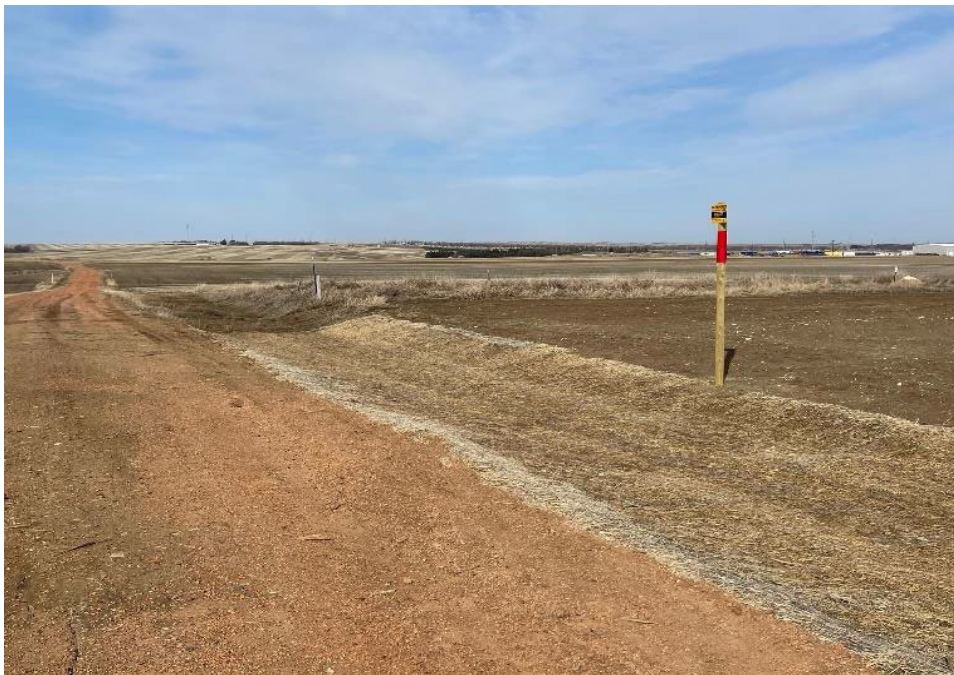
Location:
Sta. No. 309+09

Notes: Erosion control blanket in bar ditch remains in place and functioning on the Tioga-Elkhorn Creek Pipeline.

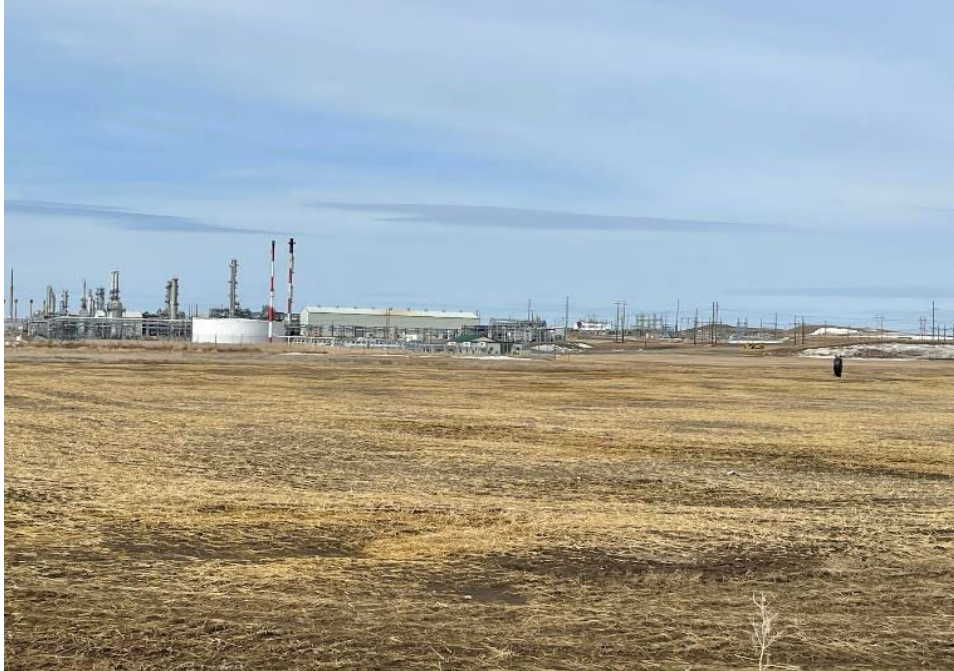
Location:
Sta. No. 26+51

Notes: Restored right-of-way remains properly mulched and crimped at the former Aux Sable Yard and on the Tioga-Elkhorn Creek Pipeline.

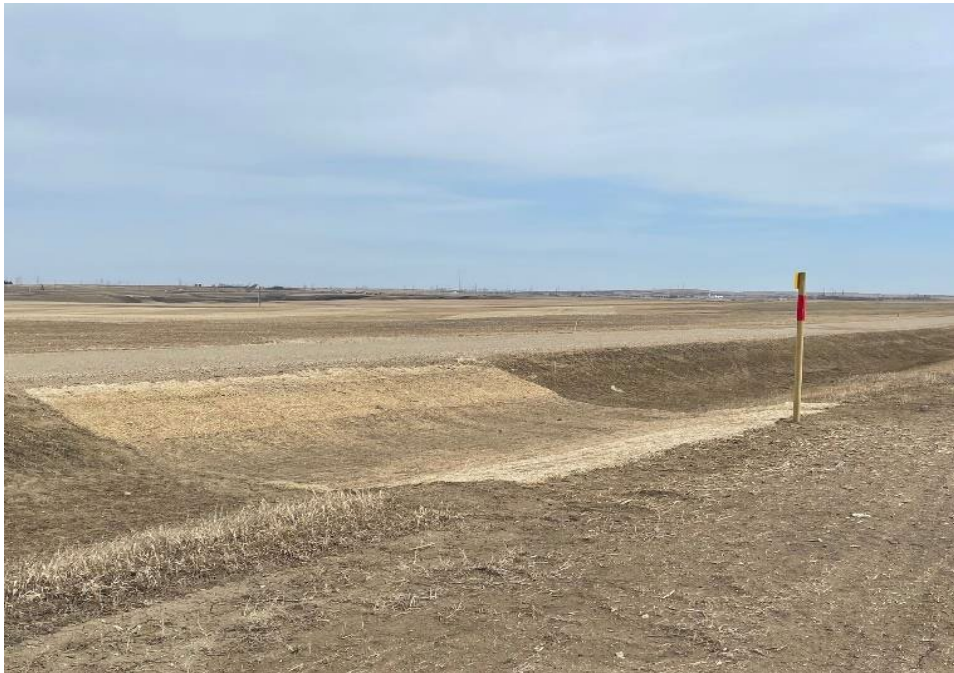
Location:
Sta. No. 111+40

Notes: Erosion control blanket in bar ditch remains in place and functioning on the Tioga-Elkhorn Creek Pipeline.

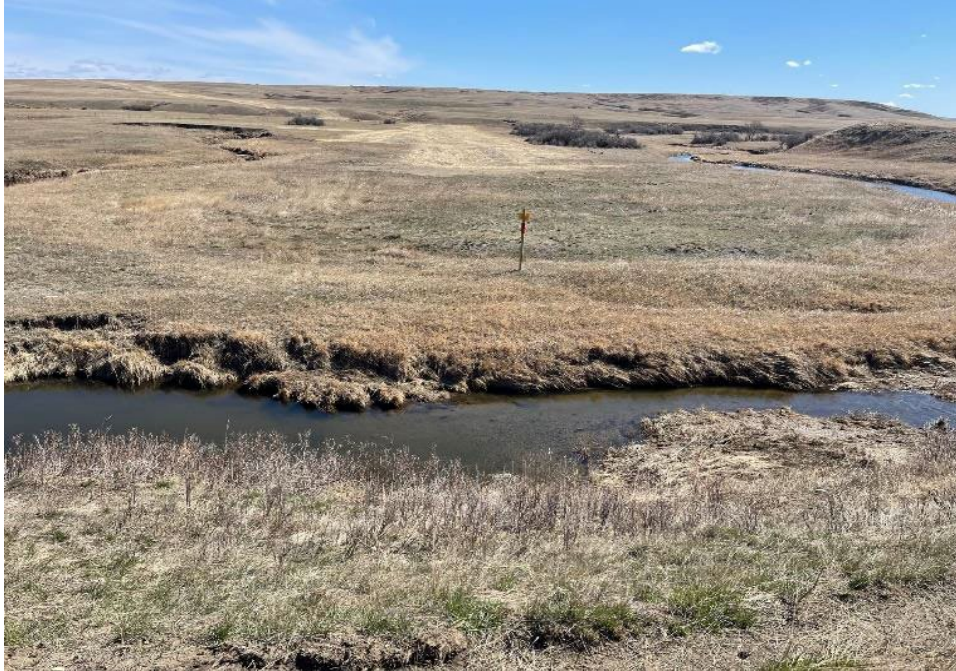
Location:
Sta. No. 962+70

Notes: No observed issues at HDD crossing of watercourse s-wm-eb-002 (Beaver Creek) on the Tioga-Elkhorn Creek Pipeline.

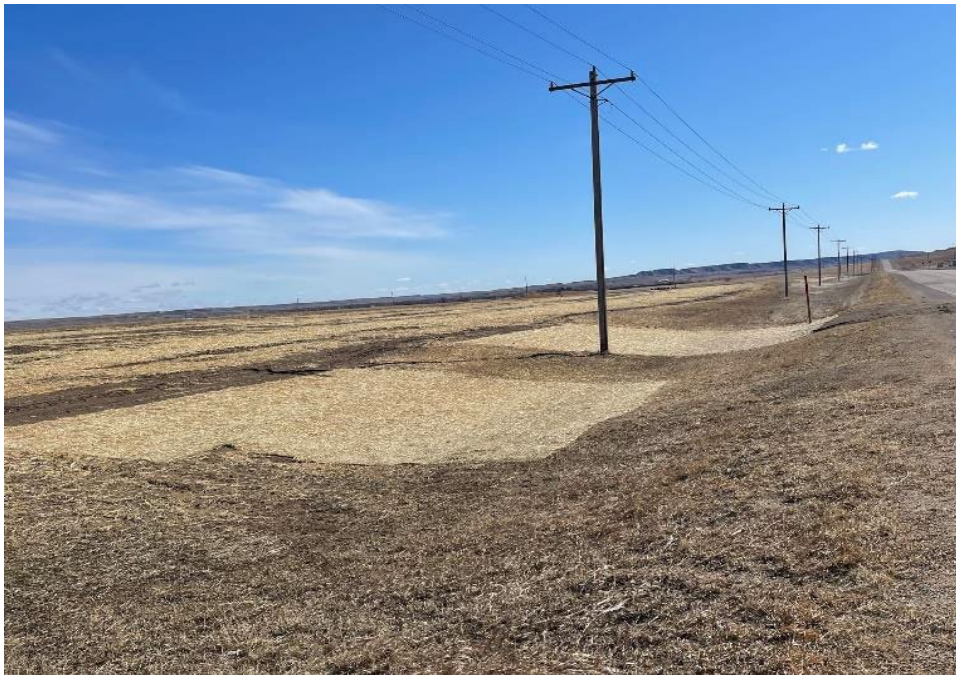
Location:
Sta. No. 1182+47

Notes: Erosion control blanket in bar ditch remains in place and functioning on the Tioga-Elkhorn Creek Pipeline.

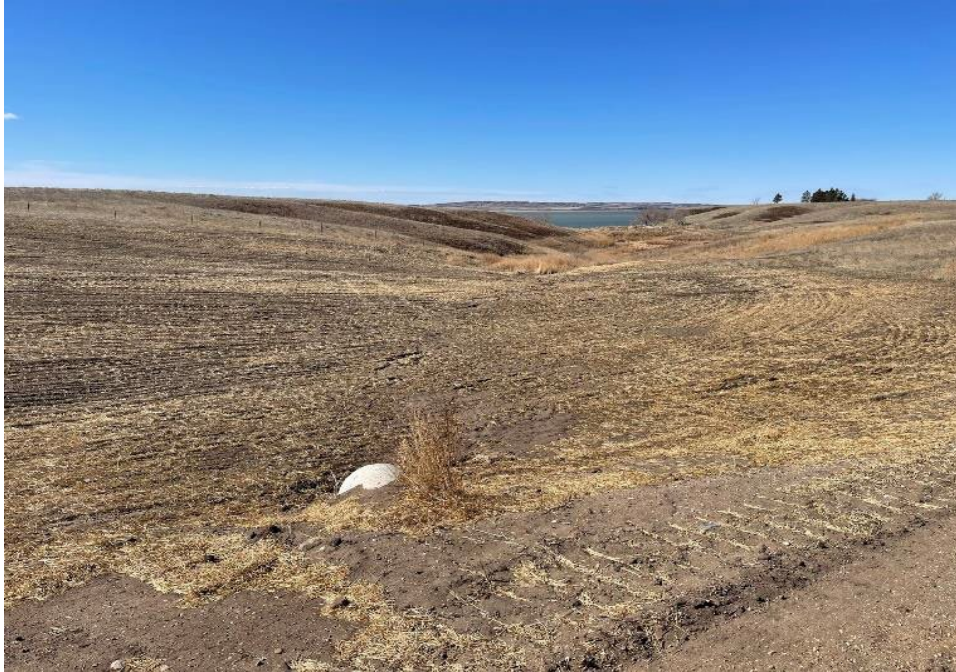
Location:
Sta. No. 1216+53

Notes: Minor rill/channel erosion from water runoff from culvert on the Tioga-Elkhorn Creek Pipeline right-of-way. This area will be addressed when conditions allow.

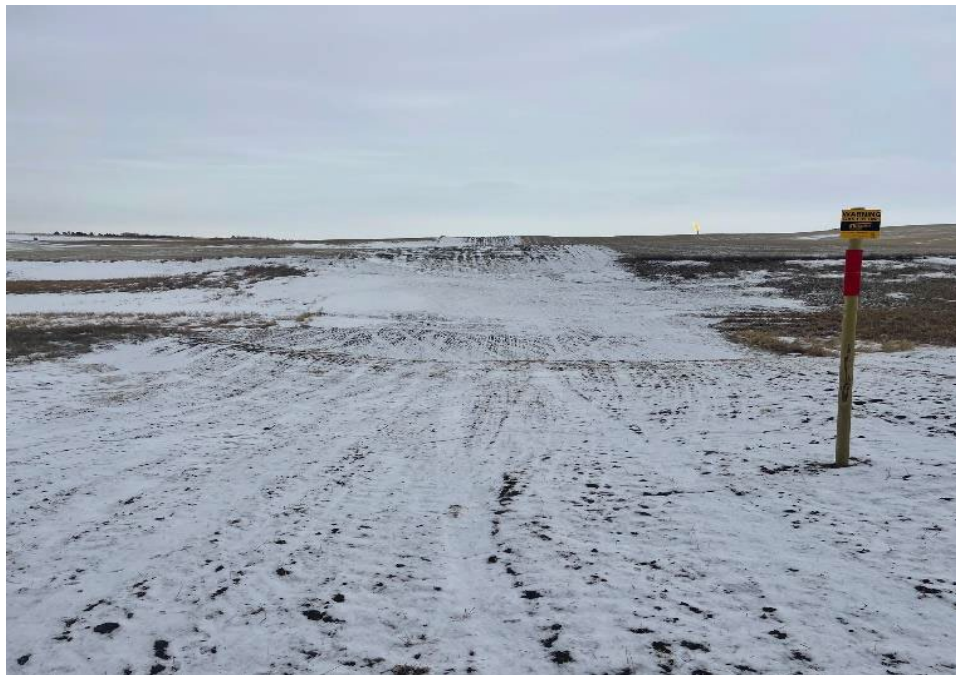
Location:
Sta. No. 676+98

Notes: Restored right-of-way and wetland s-wm-ee-001e remain frozen and stabilized on the Tioga-Elkhorn Creek Pipeline.

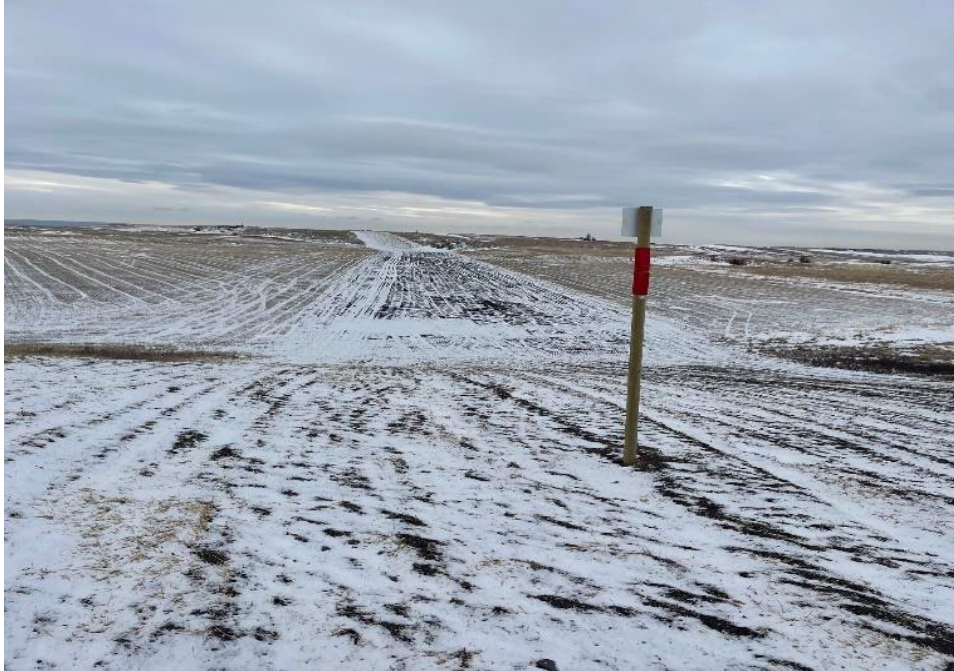
Location:
Sta. No. 700+00

Notes: Restored right-of-way remains frozen and stabilized on the Tioga-Elkhorn Creek Pipeline.

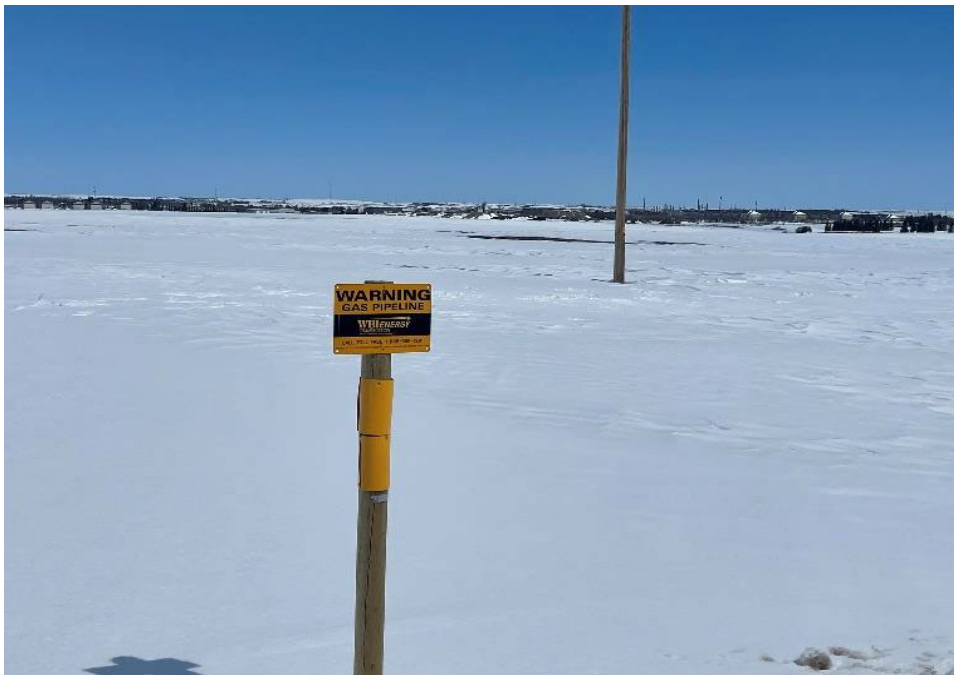
Location:
Sta. No. 277+19

Notes: Restored right-of-way remains frozen and stabilized on the Tioga-Elkhorn Creek Pipeline.

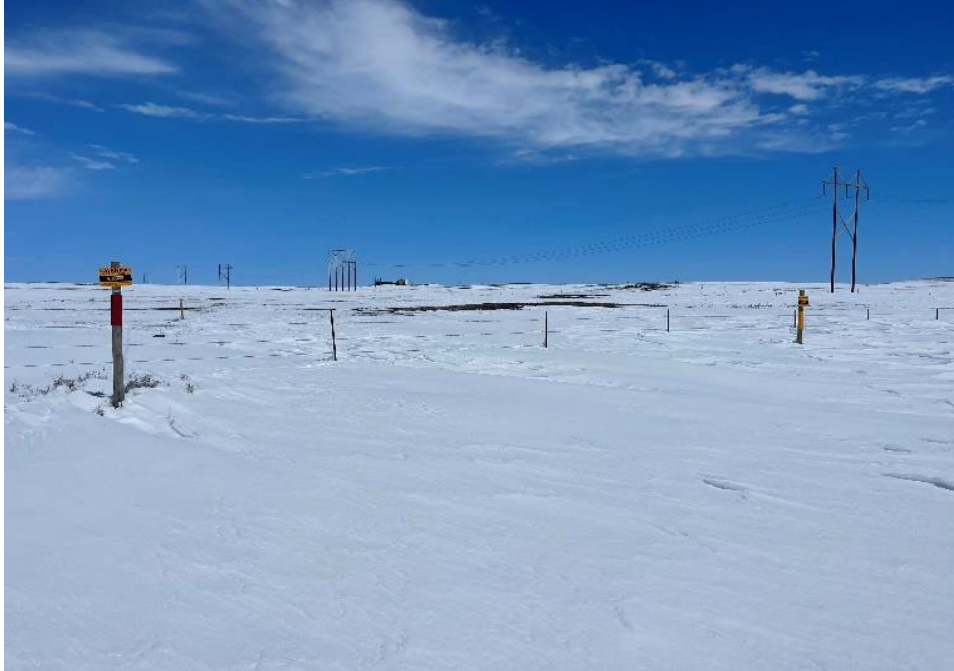
Location:
Sta. No. 216+21

Notes: Restored right-of-way remains frozen and stabilized on the Tioga-Elkhorn Creek Pipeline.

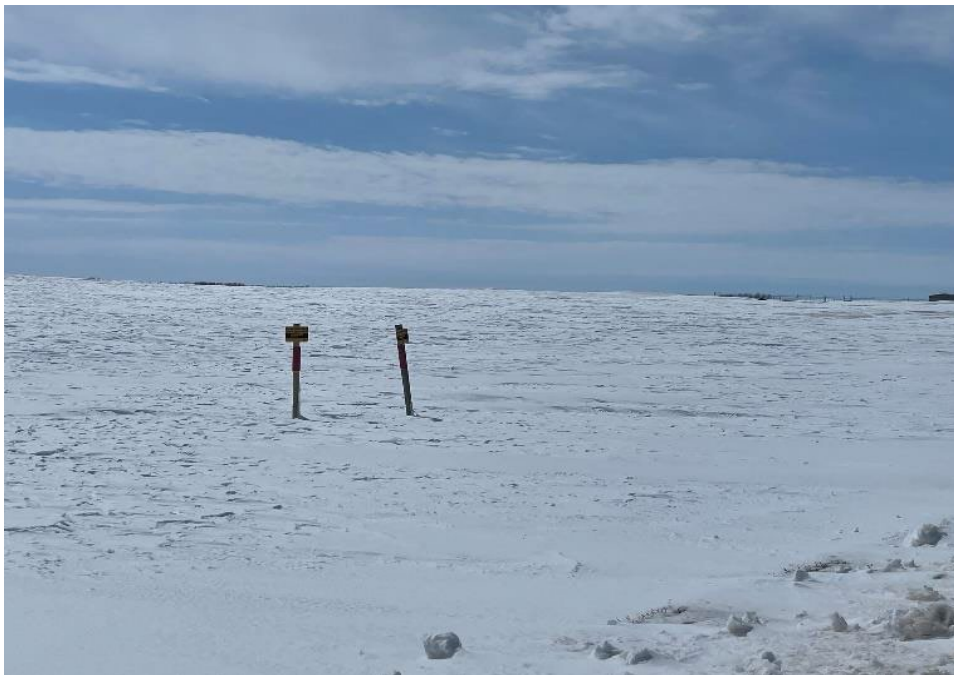
Location:
Sta. No. 1017+30

Notes: Restored right-of-way remains frozen and stabilized on the Tioga-Elkhorn Creek Pipeline.

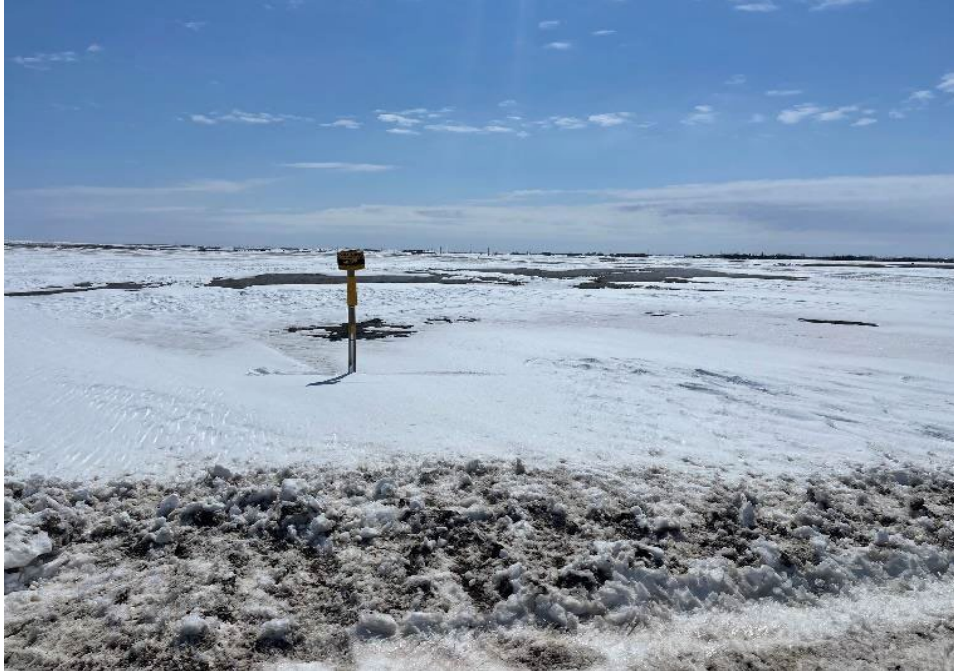
Location:
Sta. No. 111+78

Notes: Restored right-of-way remains frozen and stabilized on the Tioga-Elkhorn Creek Pipeline.

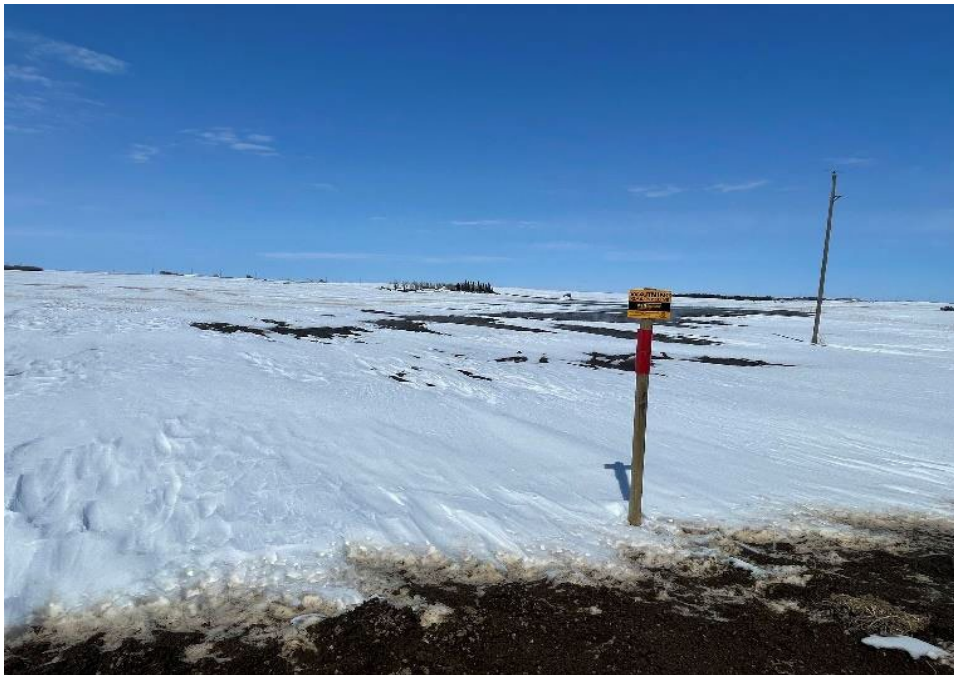
Location:
Sta. No. 393+34

Notes: Restored right-of-way remains frozen and stabilized on the Tioga-Elkhorn Creek Pipeline.

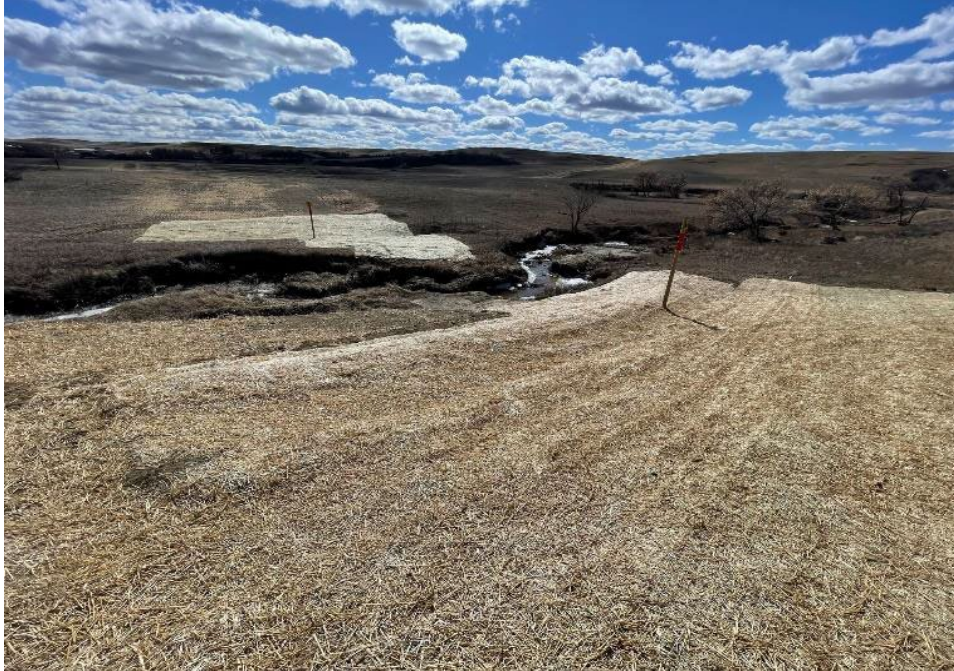
Location:
Sta. No. 2460+01

Notes: Erosion control blankets remain in place at wetland w-mk-ea-004e on the Tioga-Elkhorn Creek Pipeline.

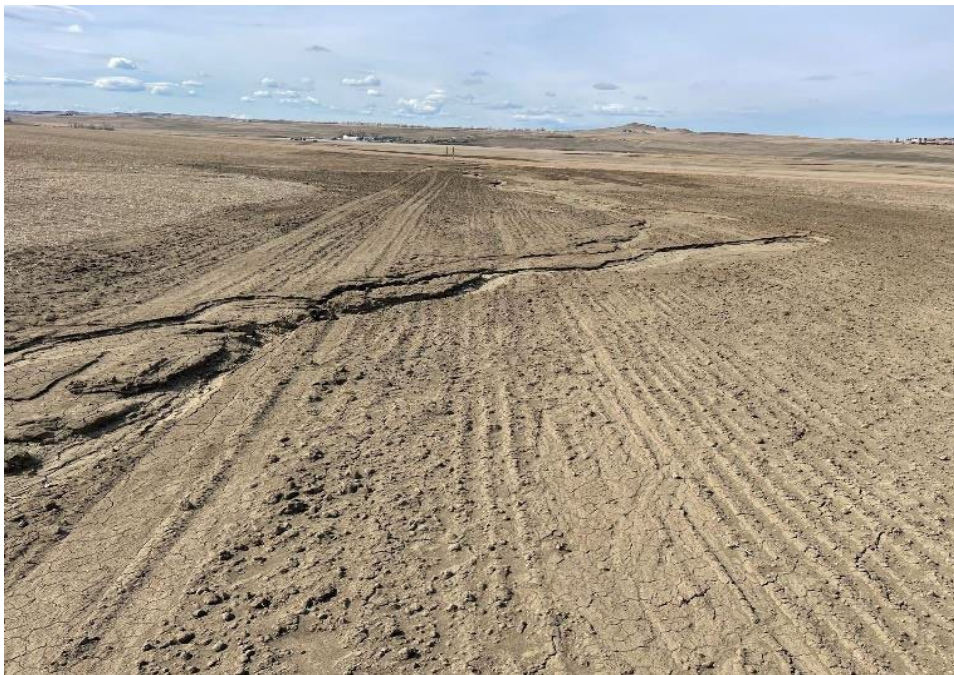
Location:
Sta. No. 2559+20

Notes: Minor rill/small channel erosion on the Tioga-Elkhorn Creek Pipeline right-of-way. This area will be addressed when conditions allow.

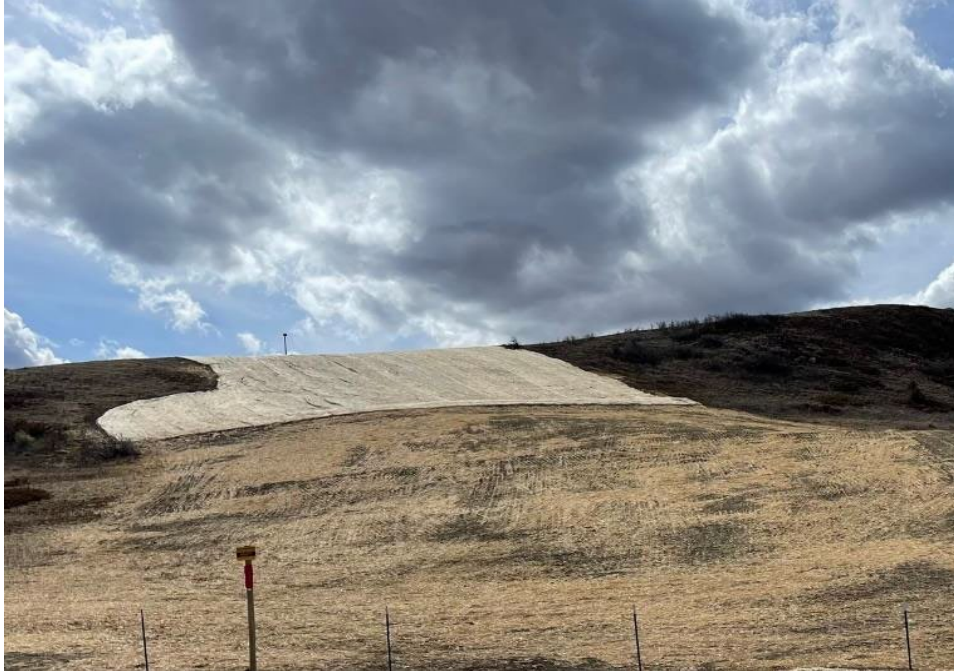
Location:
Sta. No. 3067+79

Notes: Erosion control blankets need to be restabilized on the Tioga-Elkhorn Creek Pipeline. This area will be addressed when conditions allow.

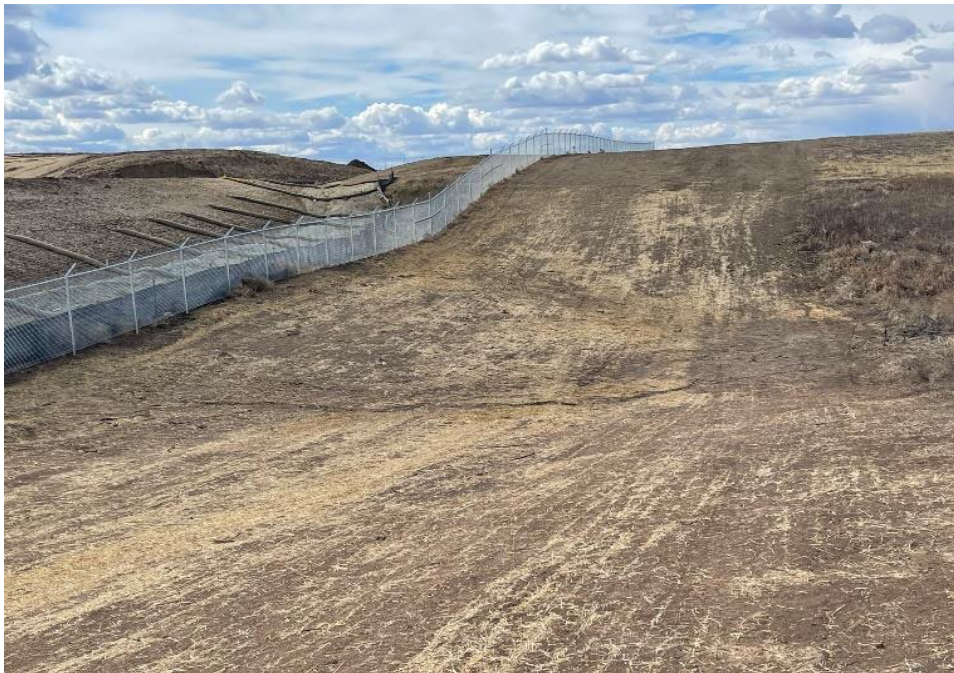
Location:
Sta. No. 3256+12

Notes: Minor rill/small channel erosion on the Tioga-Elkhorn Creek Pipeline right-of-way. This area will be addressed when conditions allow.

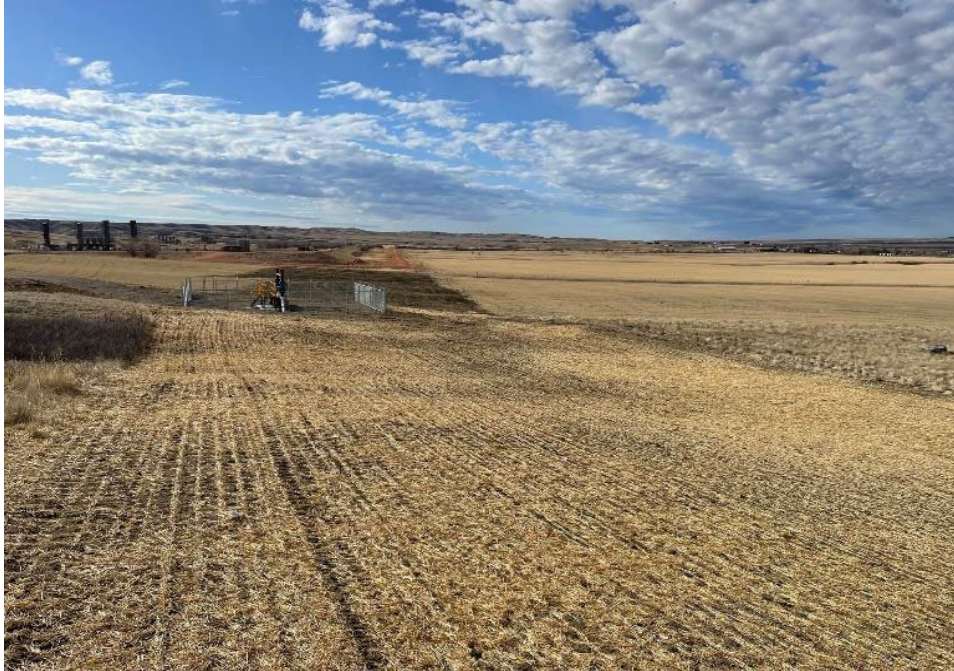
Location:
Sta. No. 1380+00

Notes: Restored right-of-way remains properly mulched and crimped on the Tioga-Elkhorn Creek Pipeline. The South Block Valve Setting is in the background.

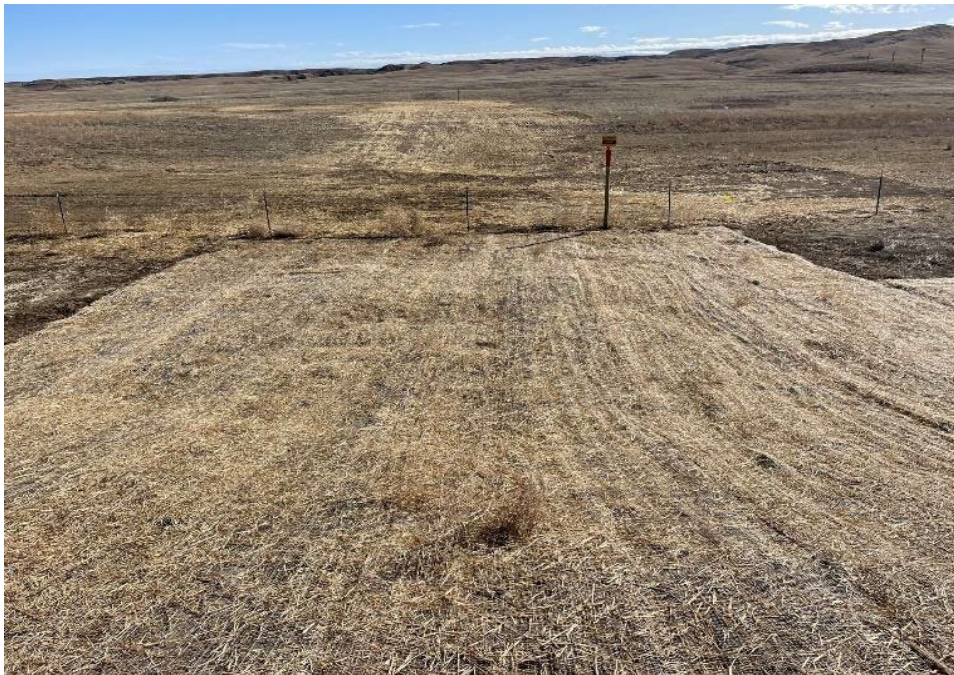
Location:
Sta. No. 1510+40

Notes: Erosion control blanket in bar ditch remains in place and functioning and restored right-of-way remains properly mulched and crimped on the Tioga-Elkhorn Creek Pipeline.

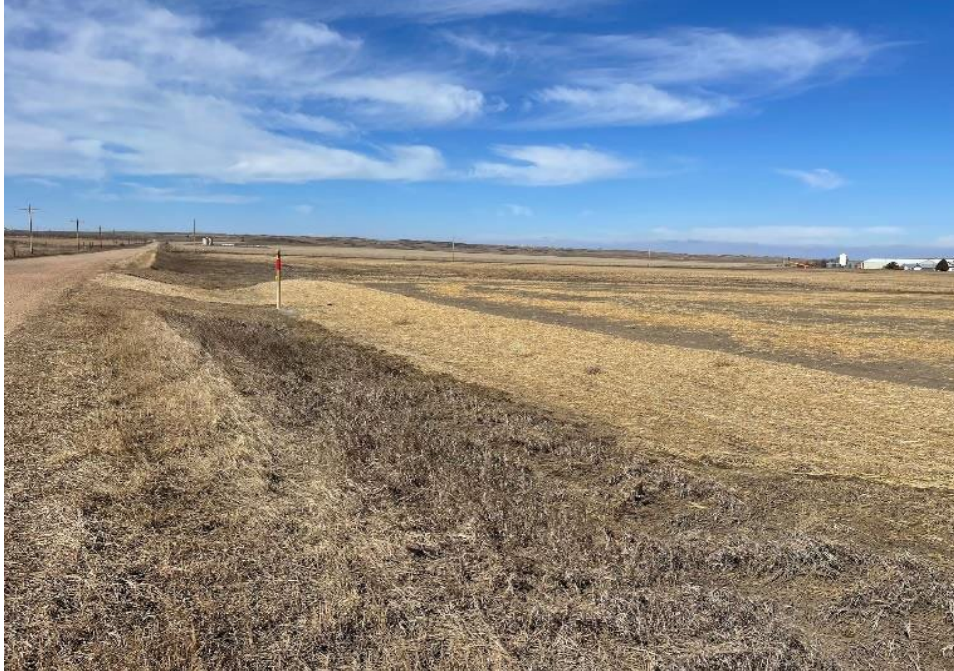
Location:
Sta. No. 1622+29

Notes: Erosion control blankets in bar ditch remains in place and functioning on the Tioga-Elkhorn Creek Pipeline.

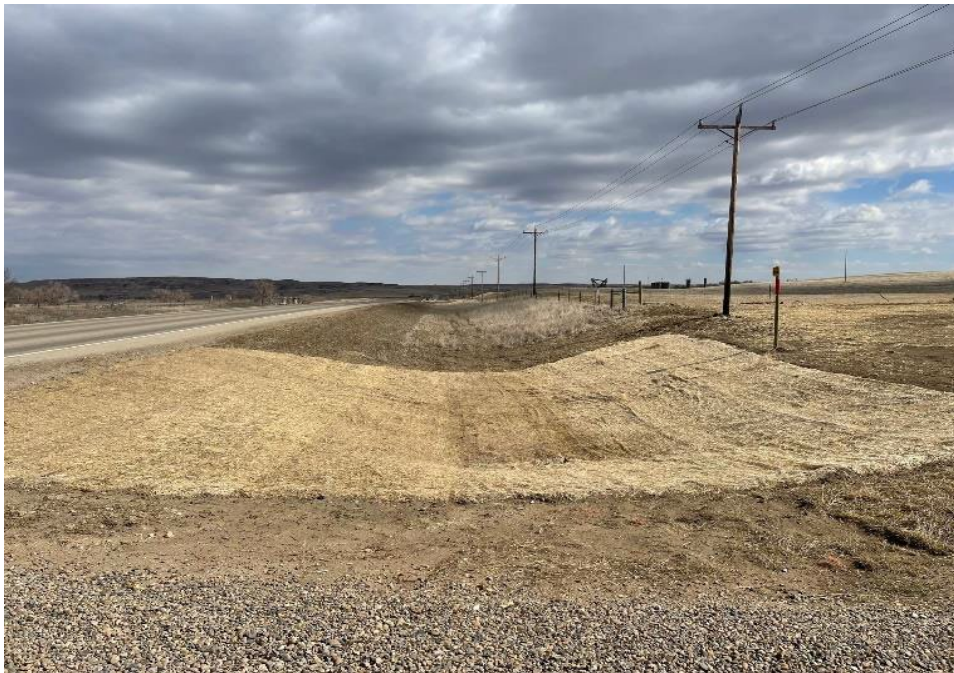
Location:
Sta. No. 1941+12

Notes: Erosion control blanket in bar ditch remains in place and functioning on the Tioga-Elkhorn Creek Pipeline.

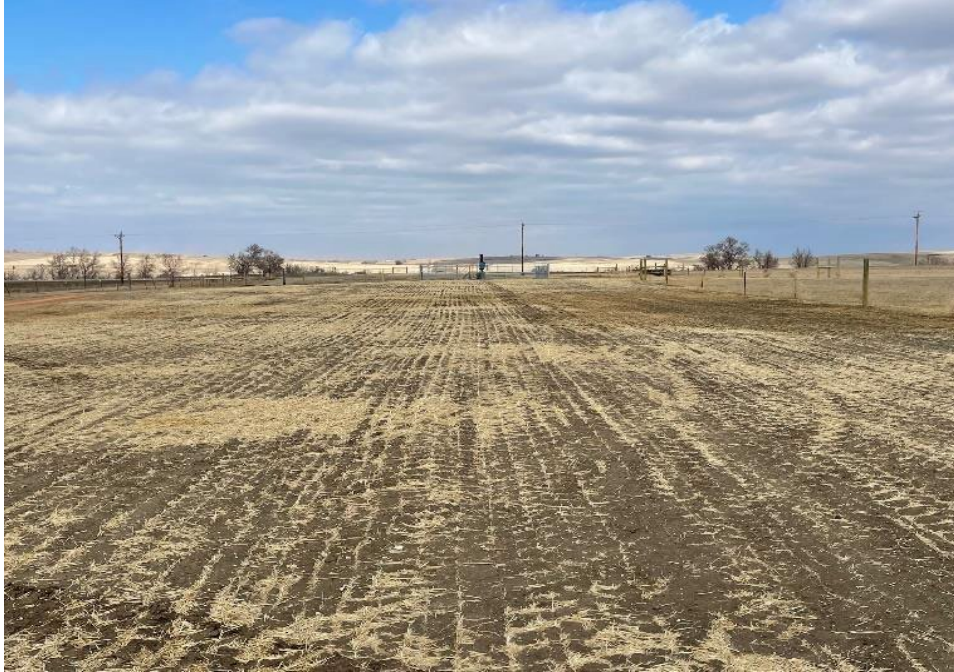
Location:
Sta. No. 1943+02

Notes: Restored right-of-way remains properly mulched and crimped on the Tioga-Elkhorn Creek Pipeline.

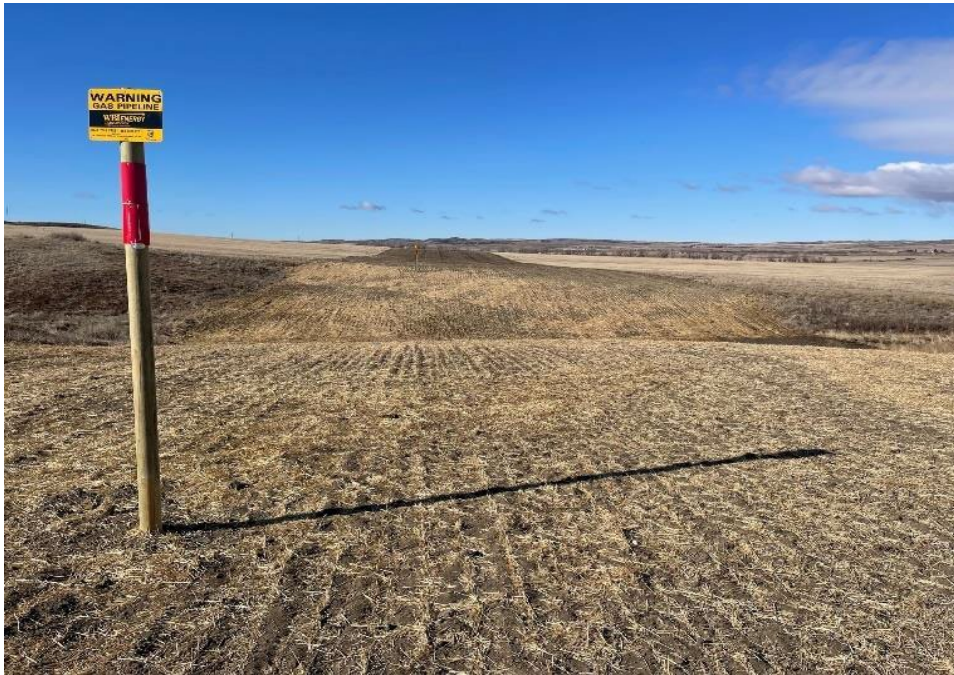
Location:
Sta. No. 2019+29

Notes: Restored right-of-way remains properly mulched and crimped on the Tioga-Elkhorn Creek Pipeline.

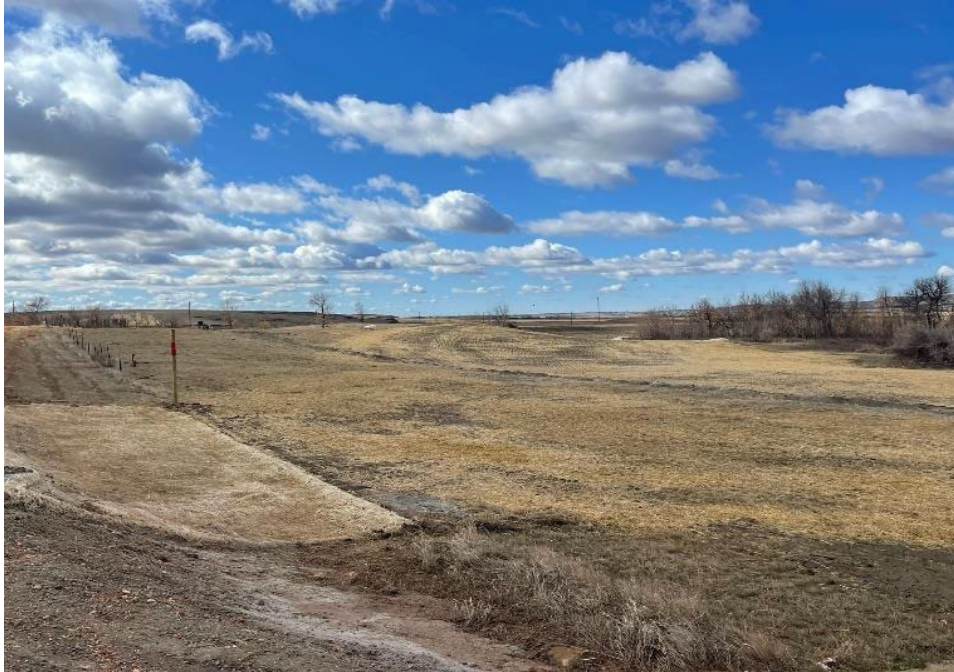
Location:
Sta. No. 2055+74

Notes: Erosion control blanket in bar ditch remains in place and functioning and restored right-of-way remains properly mulched and crimped on the Tioga-Elkhorn Creek Pipeline.

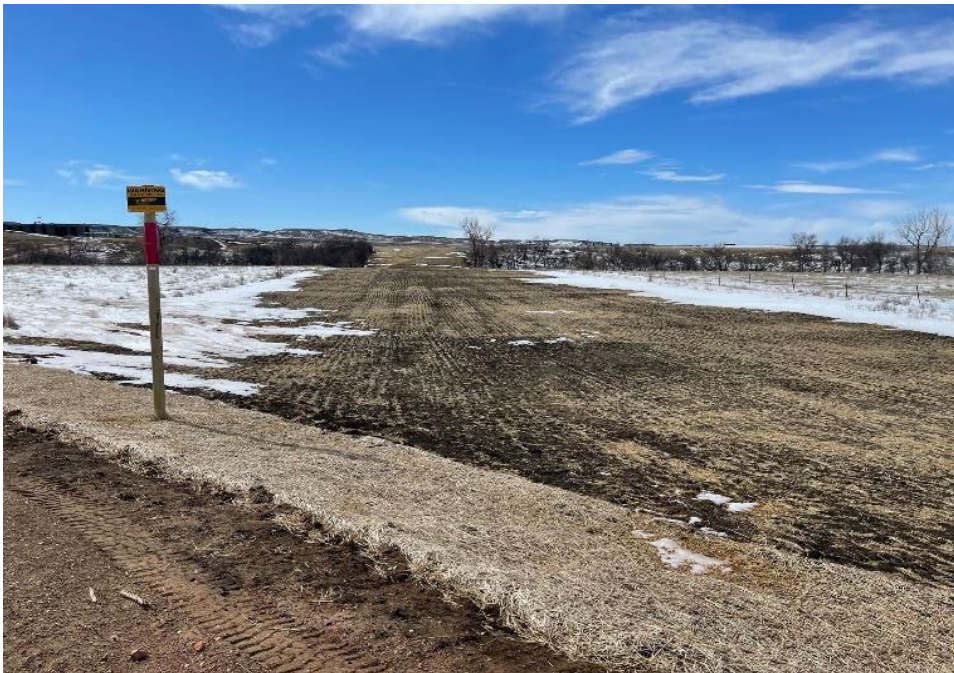
Location:
Sta. No. 1430+20

Notes: Erosion control blanket in bar ditch remains in place and functioning and restored right-of-way remains properly mulched and crimped on the Tioga-Elkhorn Creek Pipeline.

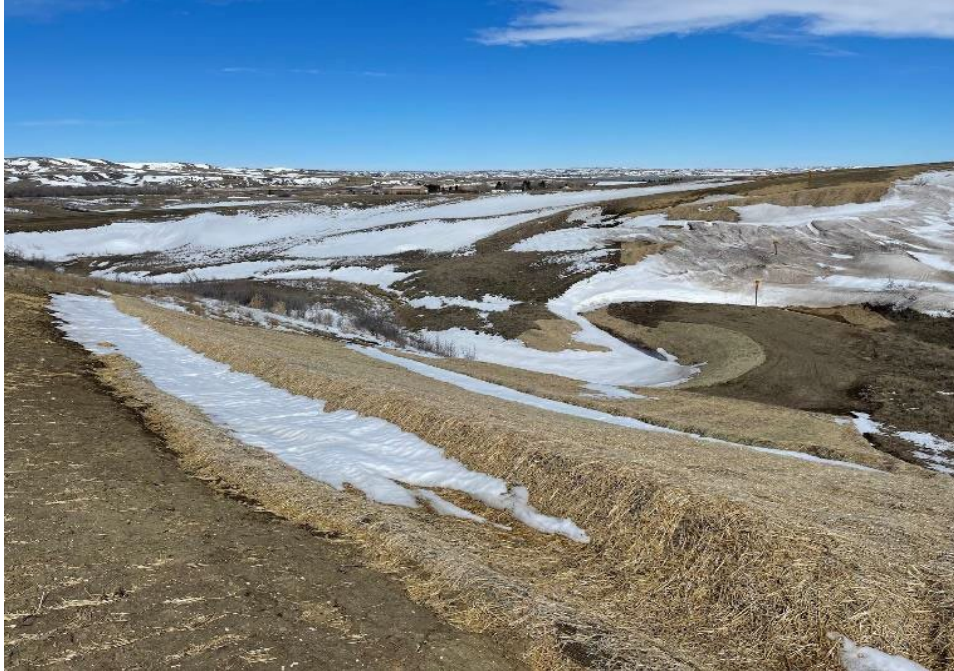
Location:
Sta. No. 1479+03

Notes: Erosion control blankets remain in place at wetland w-mk-ea-001e on the Tioga-Elkhorn Creek Pipeline.

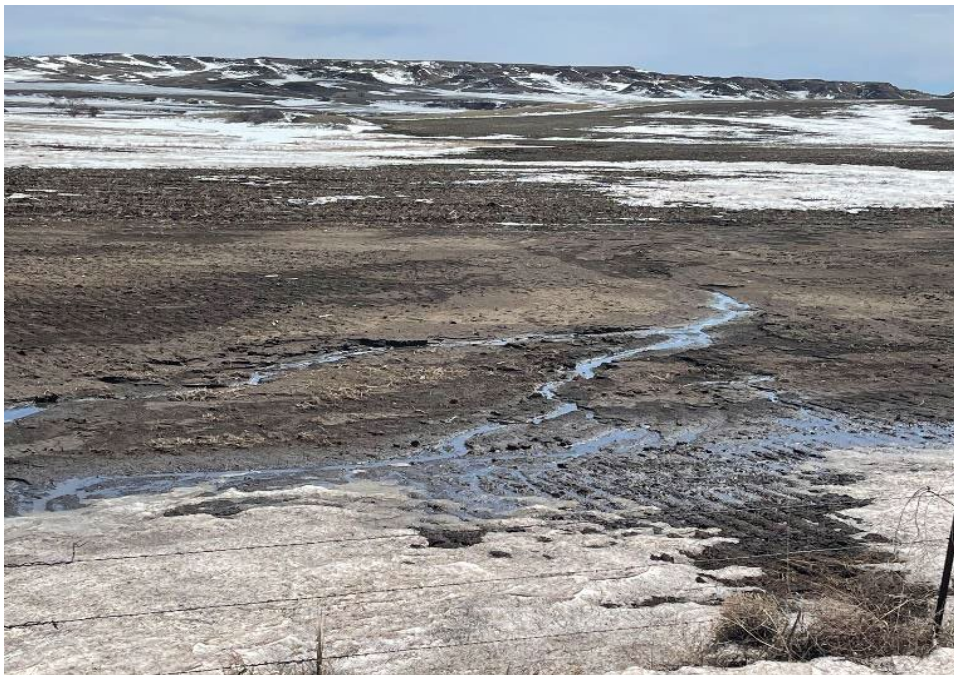
Location:
Sta. No. 1845+00

Notes: Minor rill/small channel erosion on the Tioga-Elkhorn Creek Pipeline right-of-way. This area will be addressed when conditions allow.
