Re: WBI Energy Transmission, Inc.
Docket Nos. CP20-52-000 and CP20-52-001
North Bakken Expansion Project
Status Report No. 37

WBI Energy Transmission, Inc.
North Bakken Expansion Project Status Report No. 37
FERC Docket Nos. CP20-52-000
CP20-52-001

Reporting Period: April 1, 2022 through April 30, 2022

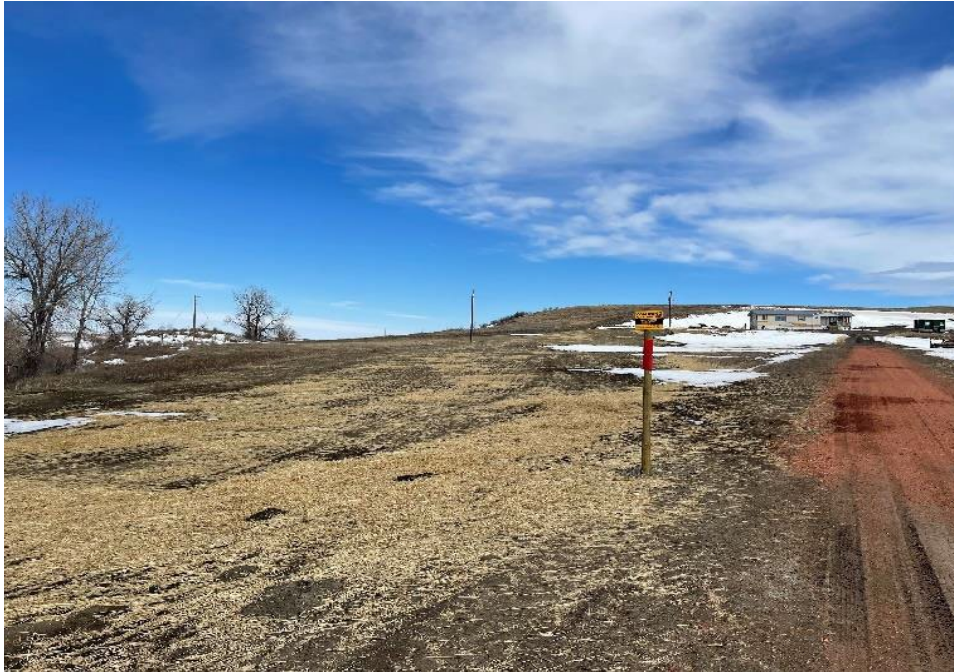
Location:
Sta. No. 2053+71

Notes: Restored right-of-way remains properly mulched and crimped on the Tioga-Elkhorn Creek Pipeline.

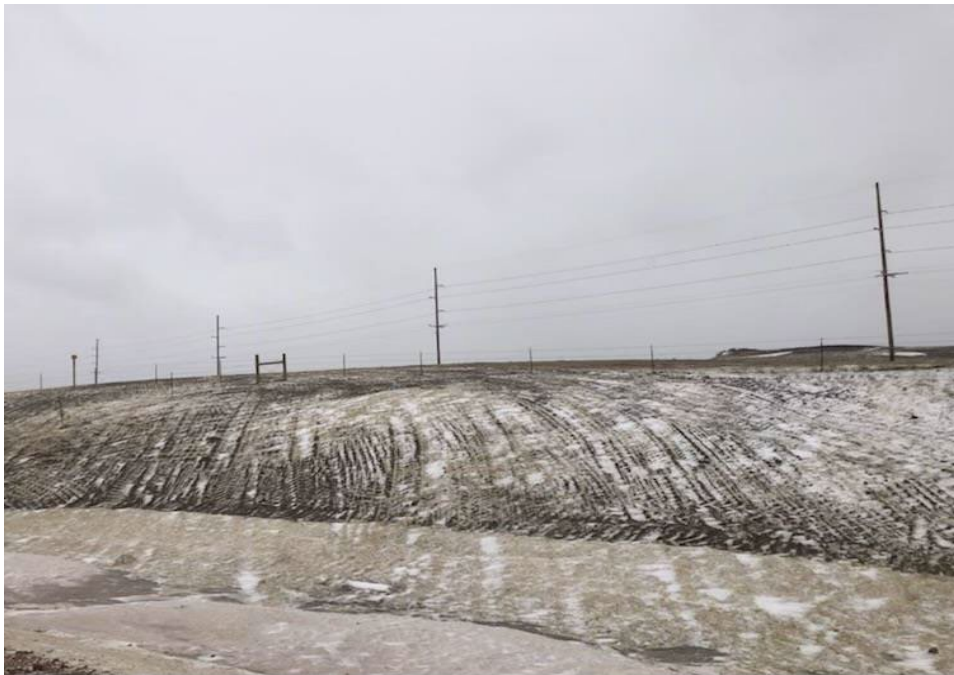
Location:
Sta. No. 2987+90

Notes: Erosion control blankets remain in place and functioning, and restored right-of-way remains frozen and stabilized on the Tioga-Elkhorn Creek Pipeline.

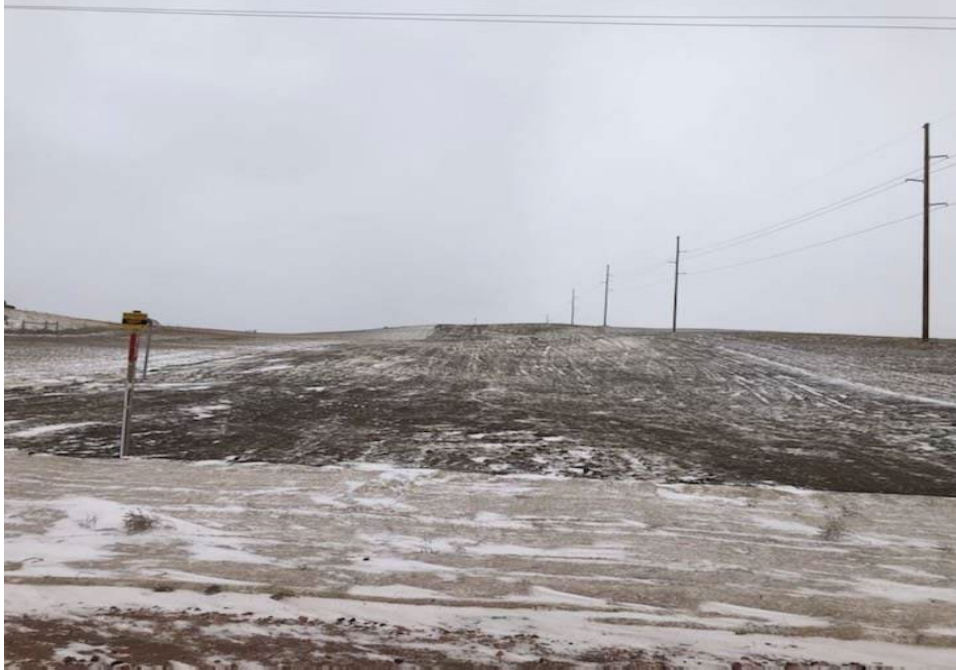
Location:
Sta. No. 3010+18

Notes: Erosion control blankets remain in place and functioning, and restored right-of-way remains frozen and stabilized on the Tioga-Elkhorn Creek Pipeline.

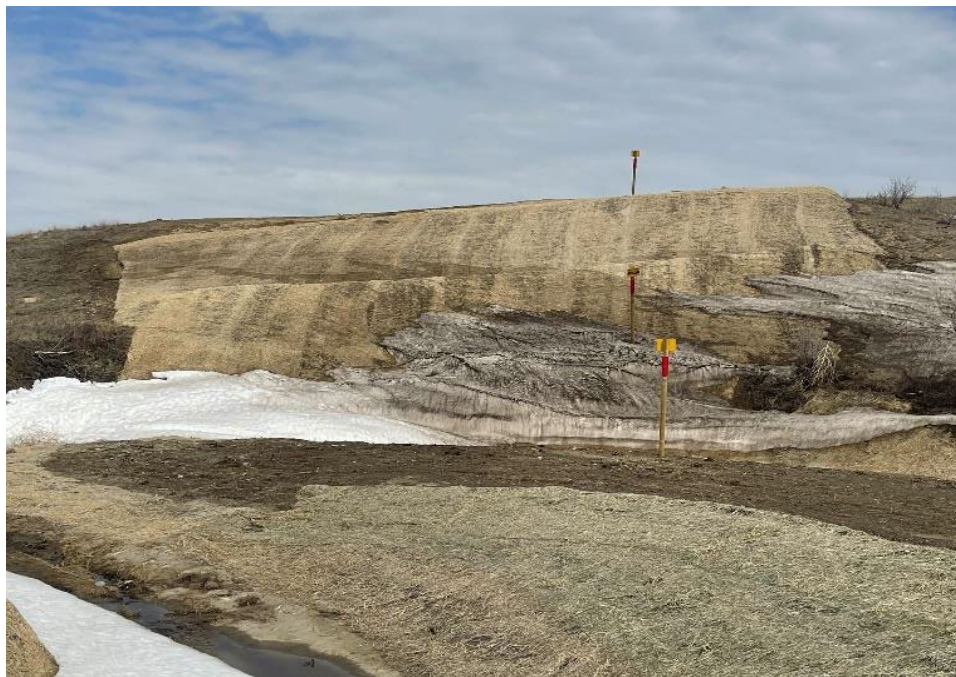
Location:
Sta. No. 1478+85

Notes: Erosion control blankets need to be repaired on the south slope of wetland w-mk-ea-001e on the Tioga-Elkhorn Creek Pipeline. This area will be addressed when conditions allow.

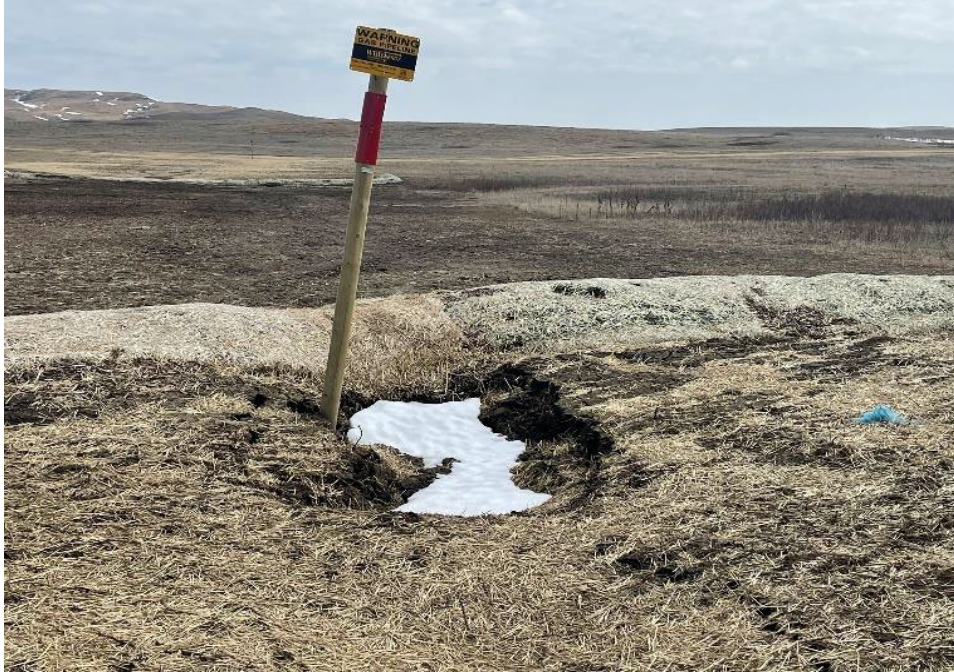
Location:
Sta. No. 1544+85

Notes: Trench settling in and outside of wetland w-mk-cb-002e on the Tioga-Elkhorn Creek Pipeline right-of-way. This area will be addressed when conditions allow.

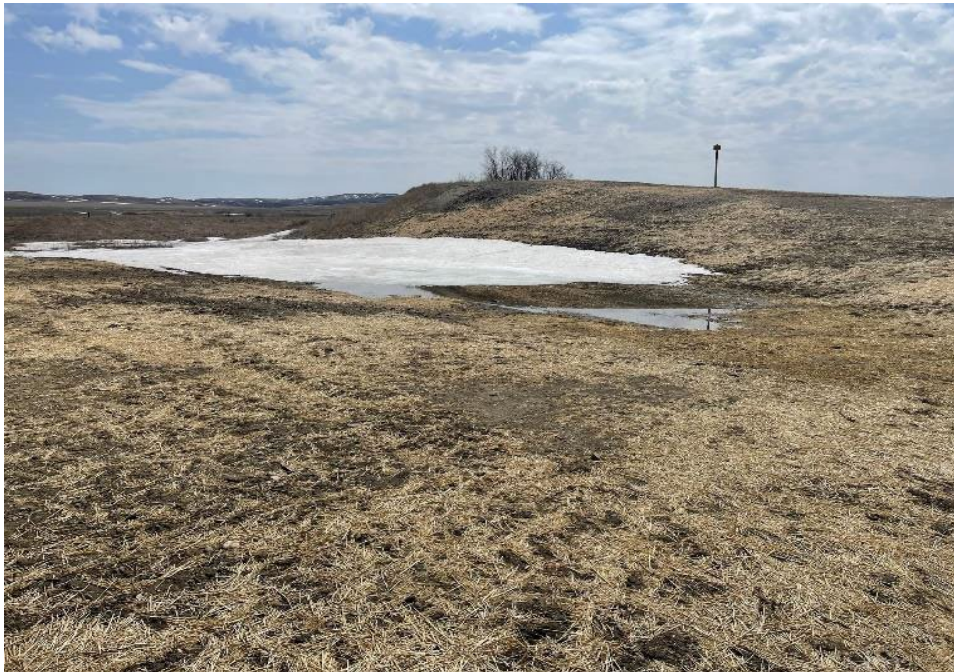
Location:
Sta. No. 1632+98

Notes: Erosion control blankets remain in place and functioning, and restored right-of-way remains frozen and stabilized on the Tioga-Elkhorn Creek Pipeline.

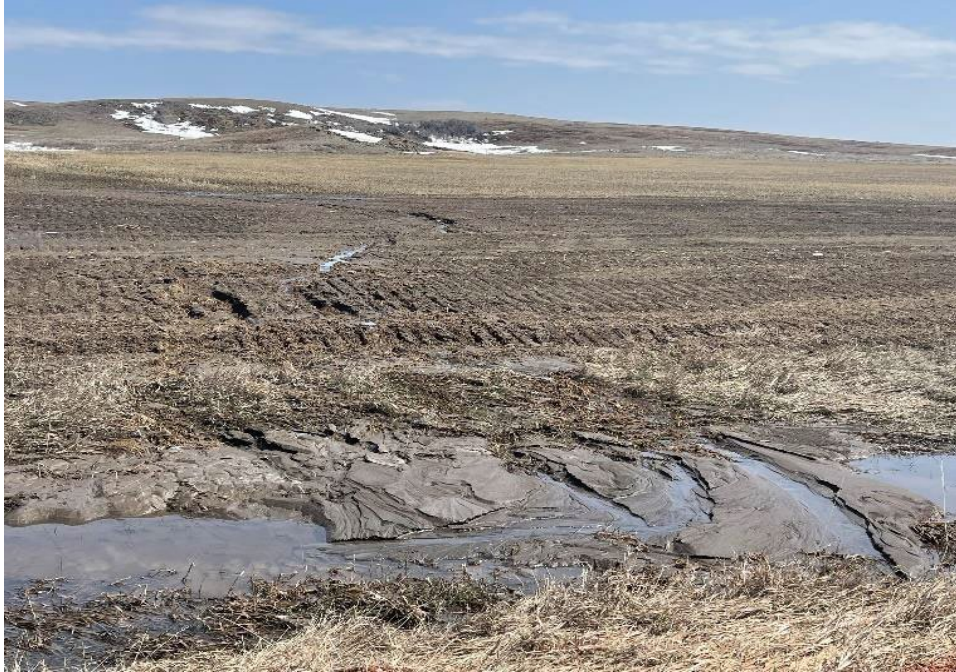
Location:
Sta. No. 2298+72

Notes: Minor
rill/small channel
erosion on the Tioga-
Elkhorn Creek
Pipeline right-of-way.
This area will be
addressed when
conditions allow.

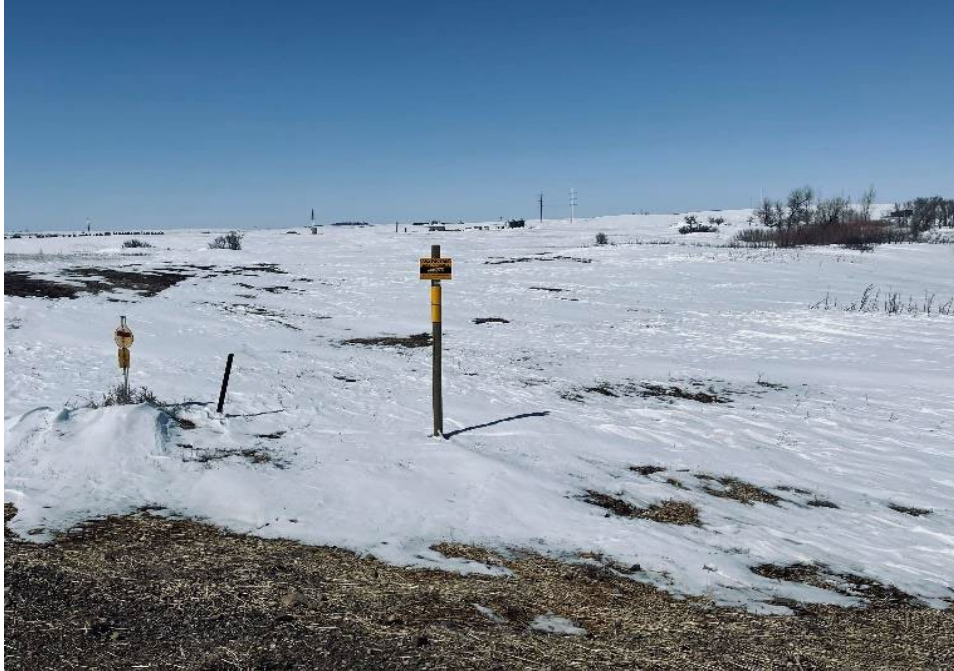
Location:
Sta. No. 57+71

Notes: Restored right-of-way remains frozen and stabilized on the Line Section 25 Loop Pipeline.

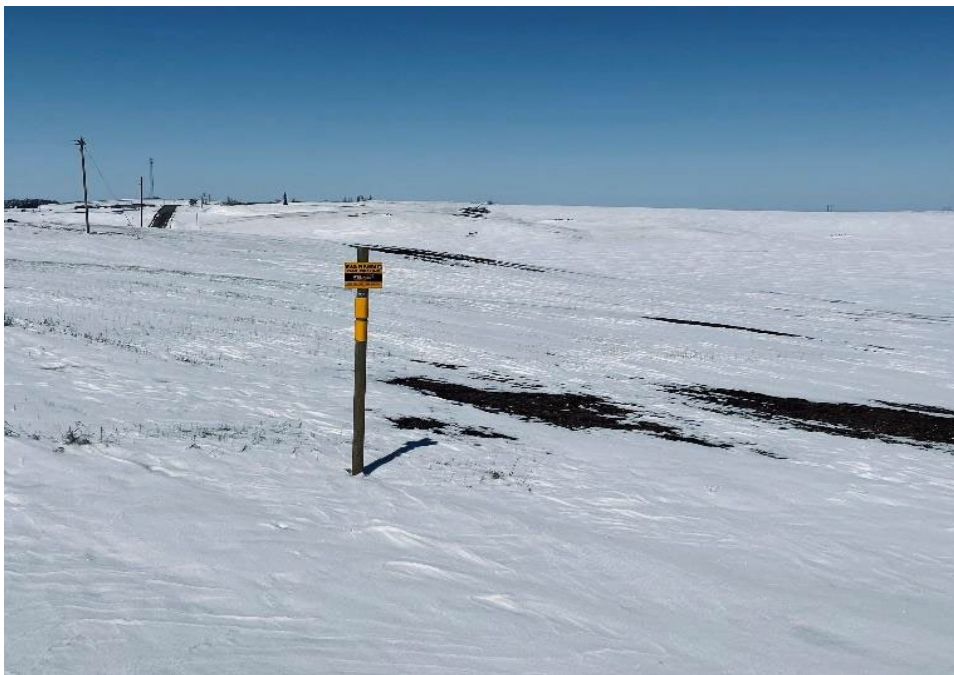
Location:
Sta. No. 108+42

Notes: Restored right-of-way remains frozen and stabilized on the Line Section 25 Loop Pipeline.
